SOUTHWEST MABOU WATERSHED RESTORATION AND MANAGEMENT PLAN

Submitted to the Atlantic Salmon Conservation
Foundation on behalf of the Inverness South Anglers
Association

Report Completed by
MacInnis Natural Resource Services Inc.

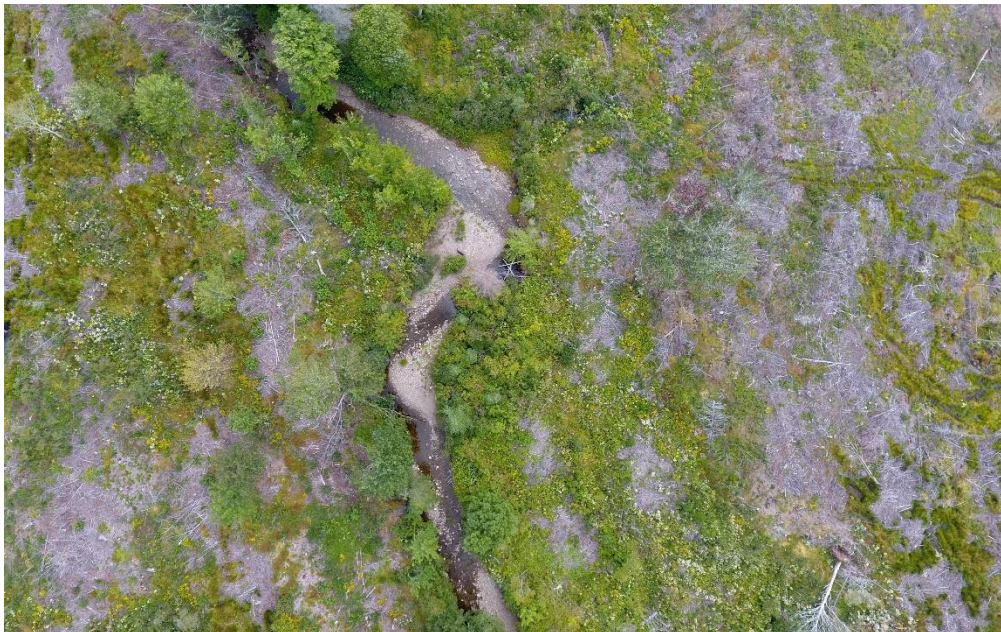
Figure 2: Riparian zone clearing, unnamed tributary to Southwest Mabou River.

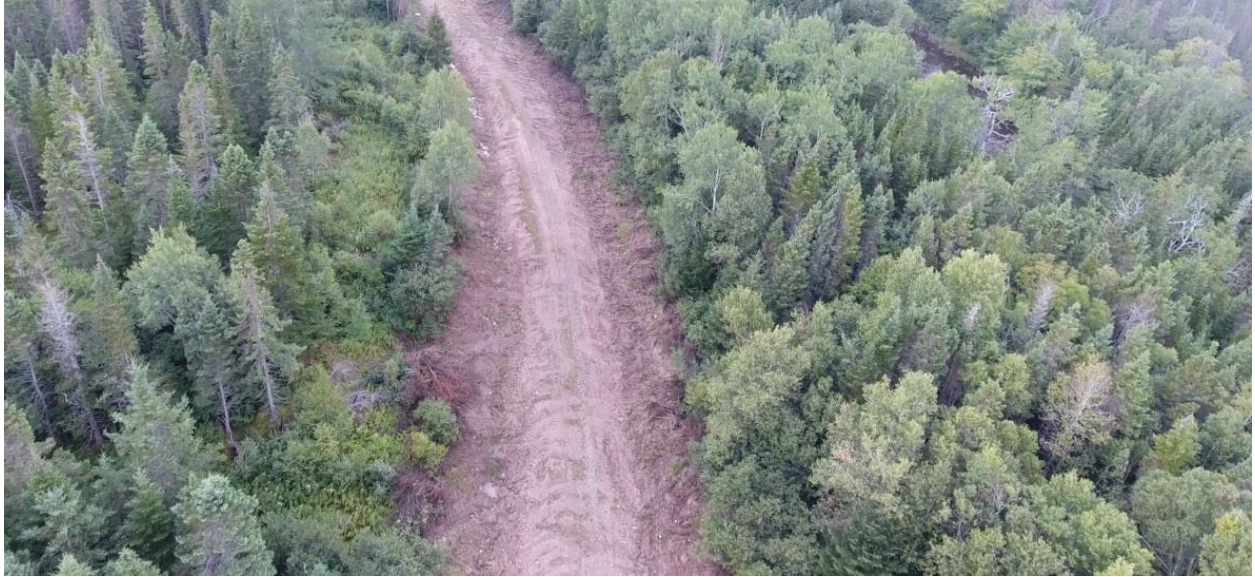
Figure 3: Road and newly constructed ditching leading to fine sediment runoff in MacLeod Brook.

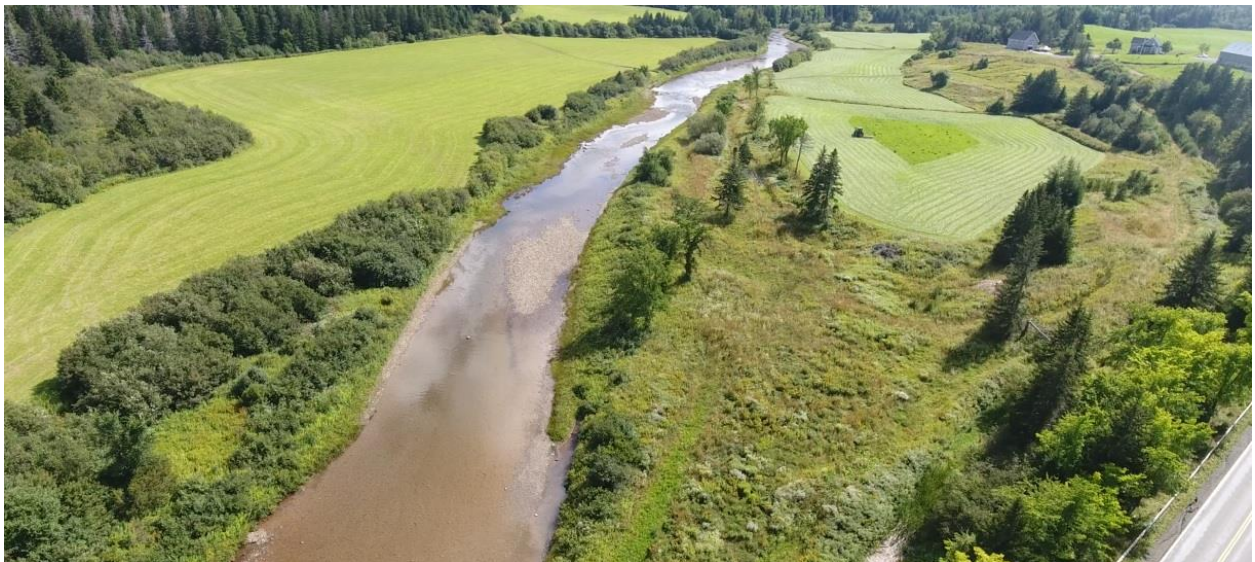
Figure 4: Active agriculture site, lower Southwest Mabou River. Above Route 19.

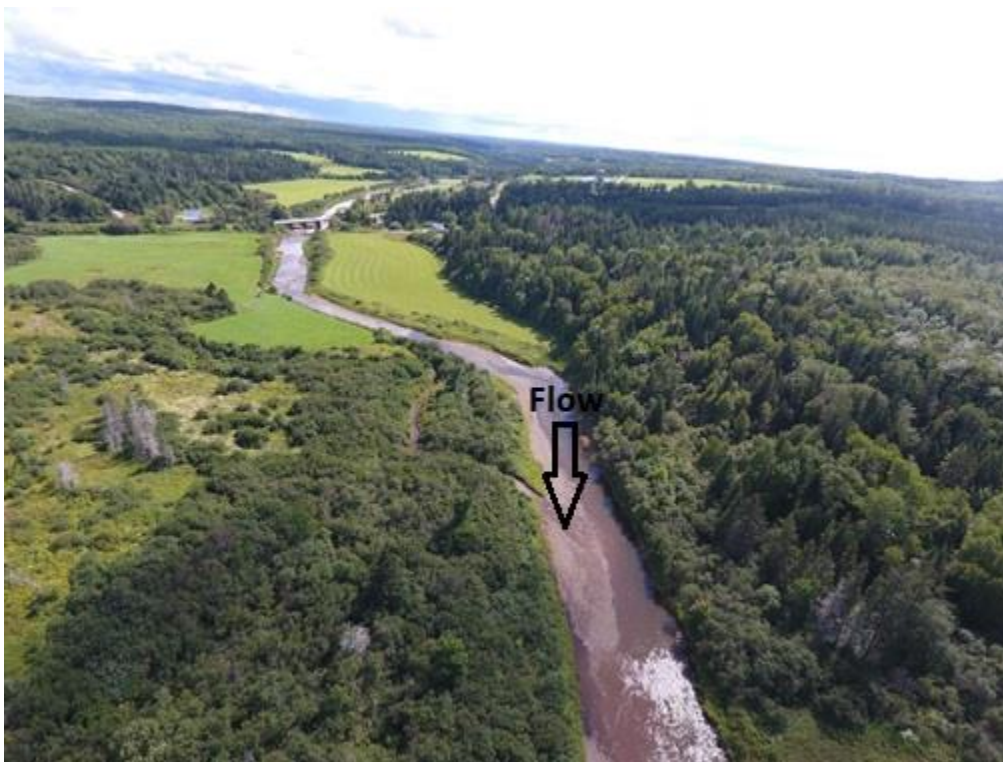
Figure 8: Upstream view of Route 19 Bridge. Channel lacks proper meander pattern, is over widened and has insufficient riparian zone.

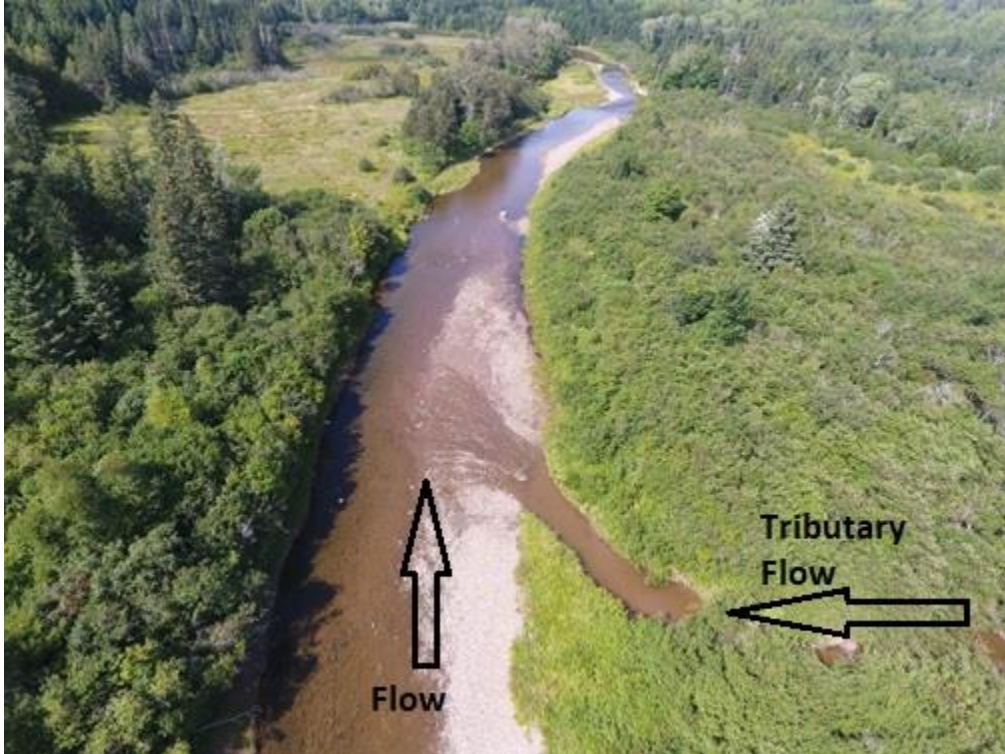
Figure 10: Entrance of small tributary. Over-widened channel limits fish passage from SW Mabou to tributary.

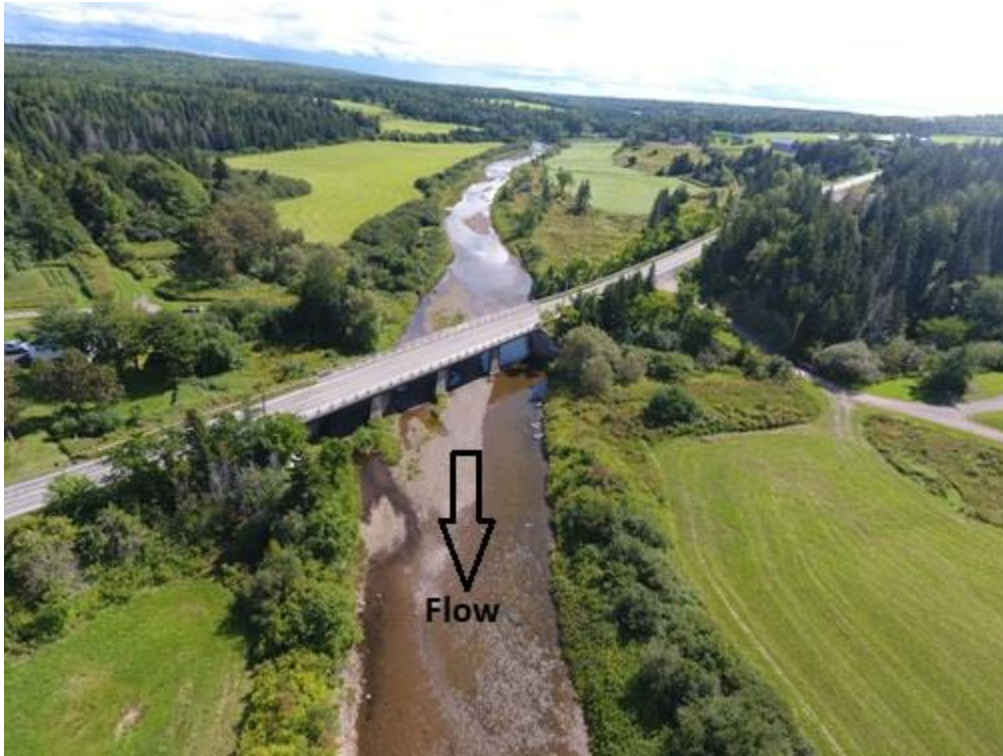
Figure 11: Route 19 Bridge, note scouring below bridge. Over-widened and shallow channel. Potential barrier for early run fall Atlantic salmon. Evidence of ice scouring of spawning habitat and lack of sufficient riparian zone.

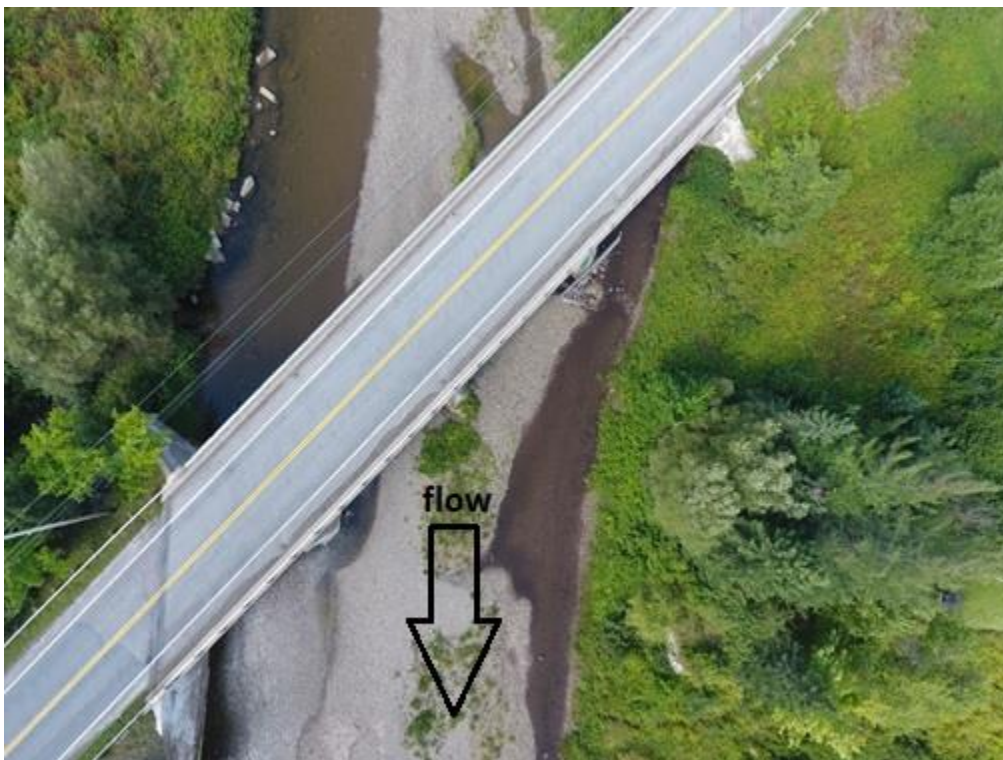
Figure 12: Route 19 Bridge, mid-channel substrate deposits and split channel. Channel is also over-widened.

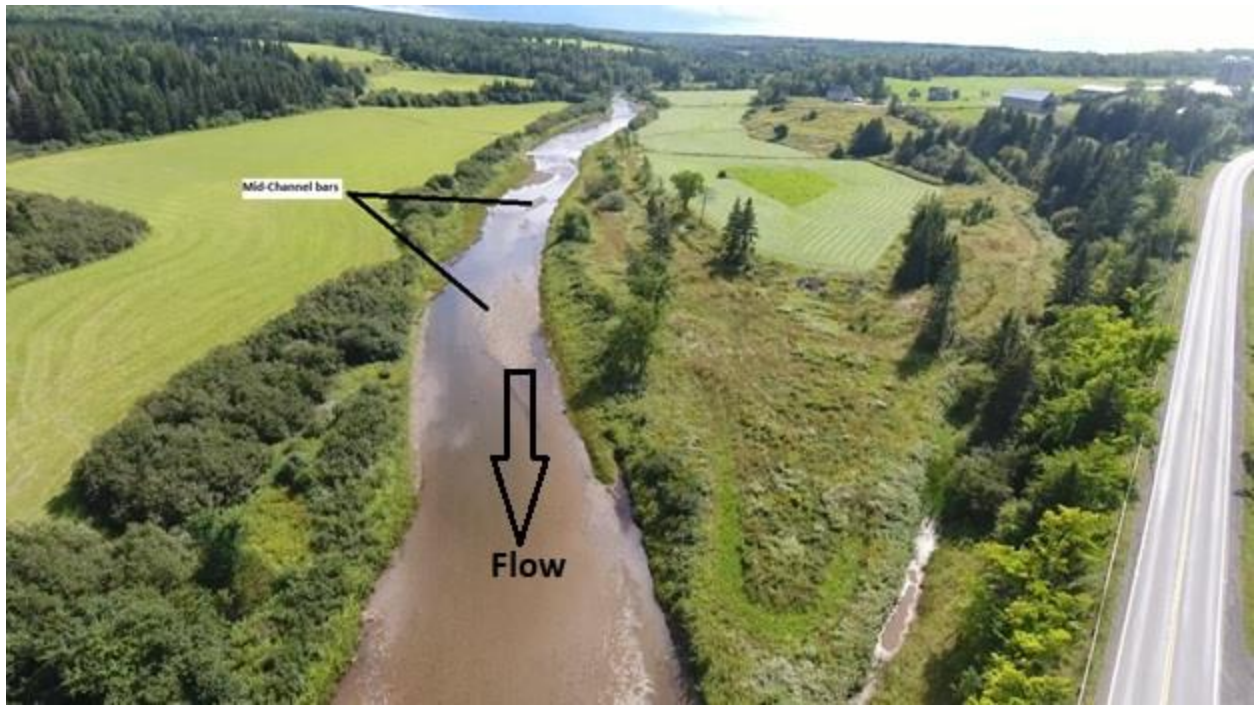
Figure 14: Upstream view from Route 19 Bridge. Over-widened channel, lacking pools and sufficient riparian zone.

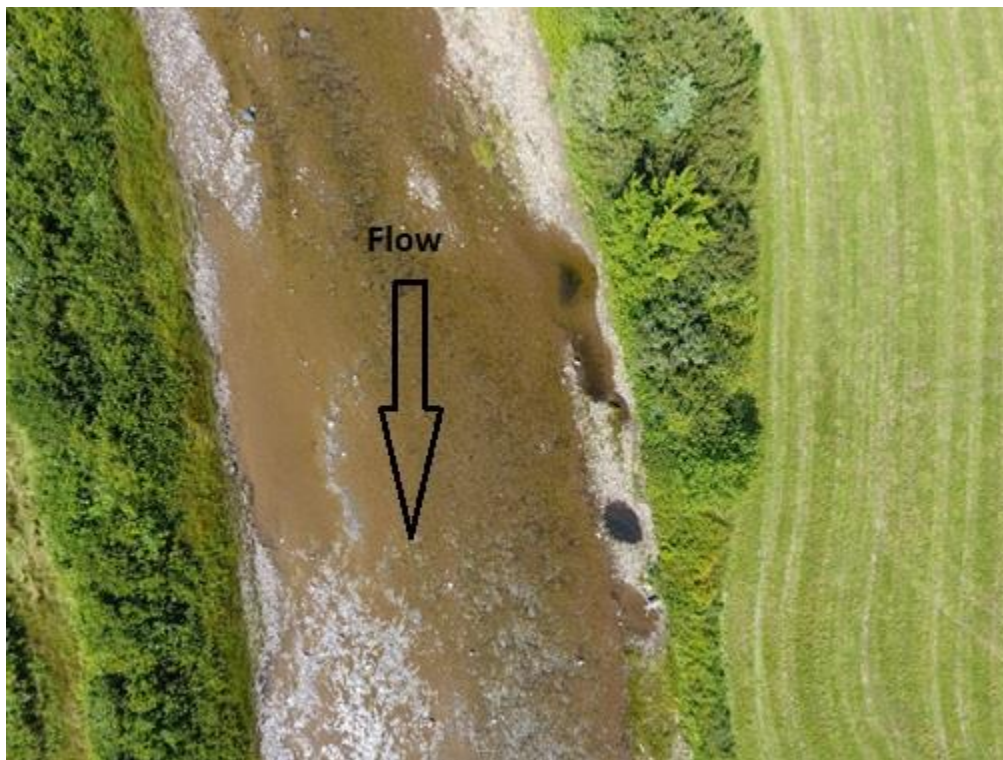
Figure 15: Ice-scouring pockets caused by over-widened channel.

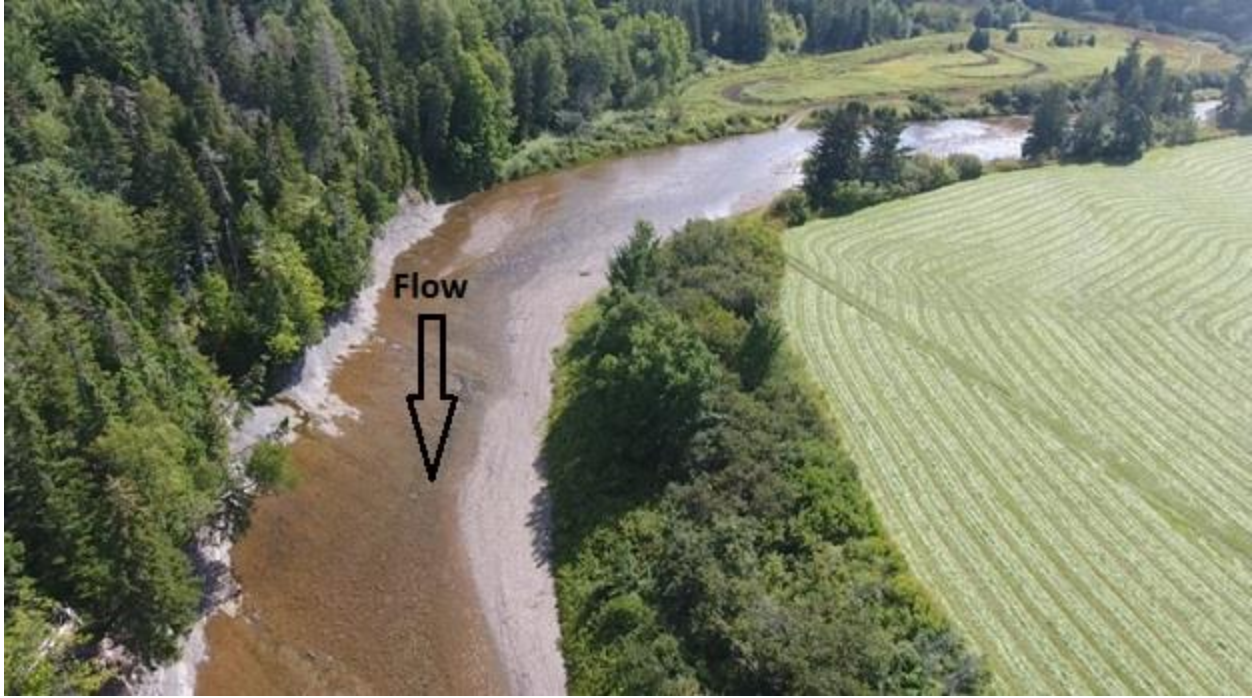
Figure 16: 1km above Route 19 Bridge. Eroding bank and heavily siltated bottom substrate. Over-widened and shallow habitat.

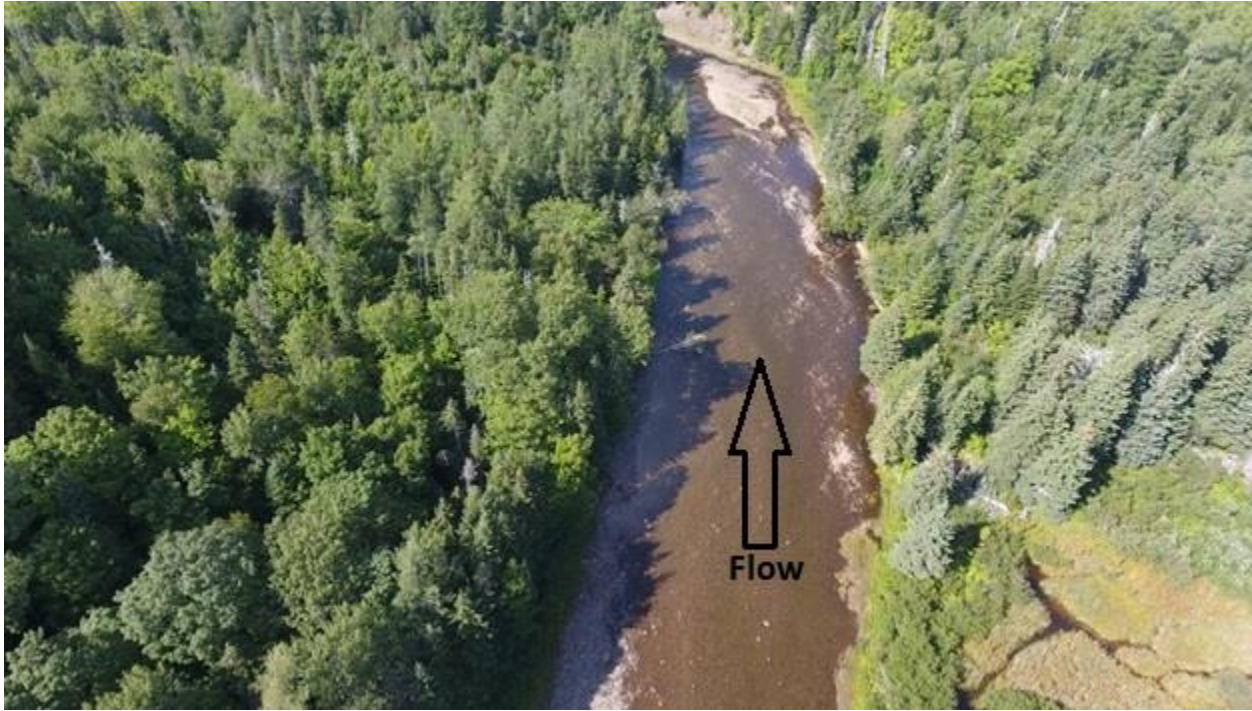
Figure 17: Over-widened and shallow channel, in between Moran Road crossing and Route 19. No pool habitat, no large woody debris and no overhead cover.

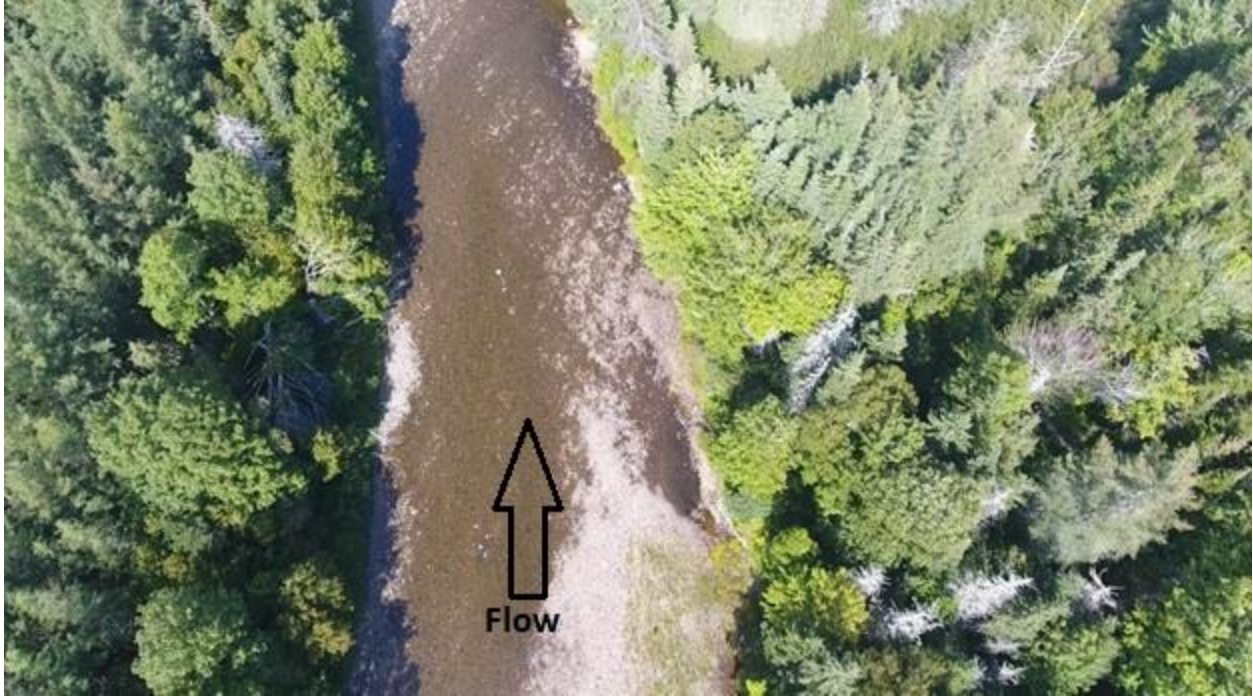
Figure 18: 1.5 km below Moran Road Bridge. Typical channel condition for this section of river. Over-widened, shallow and prone to ice-scouring.

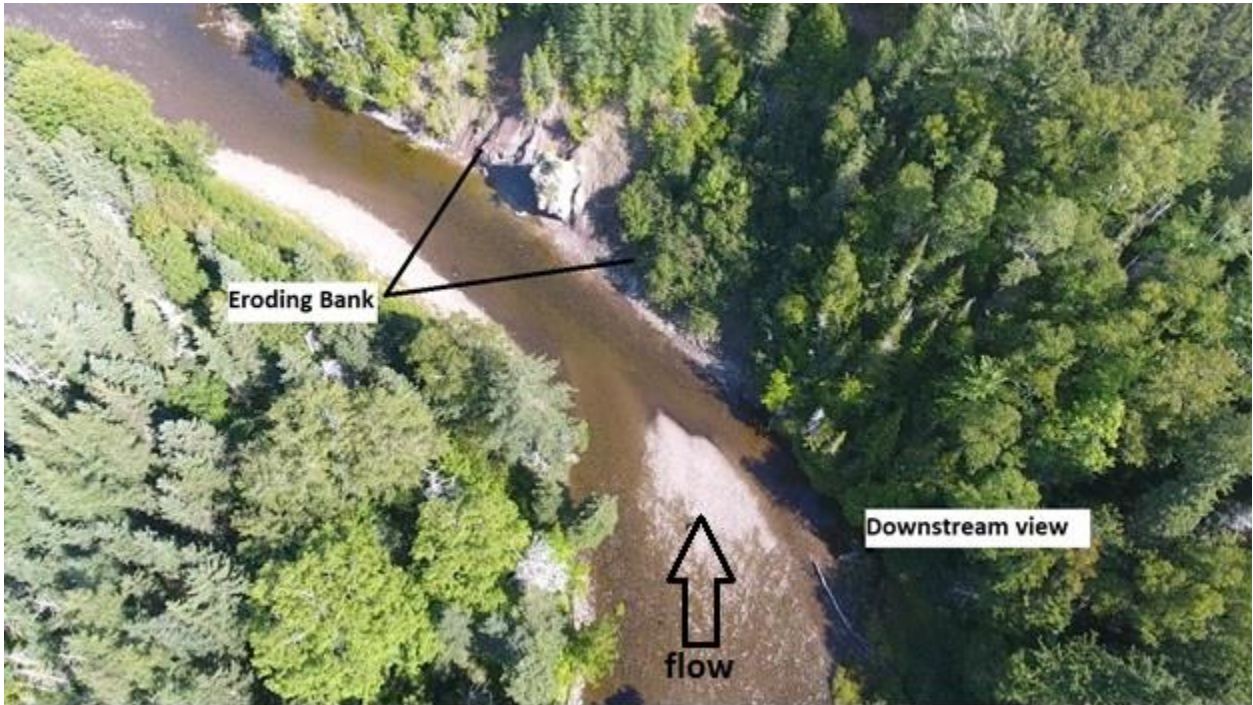
Figure 19: 500 meters below Moran Road bridge. Persistent over-widened channels, no pool habitat or overhead cover.

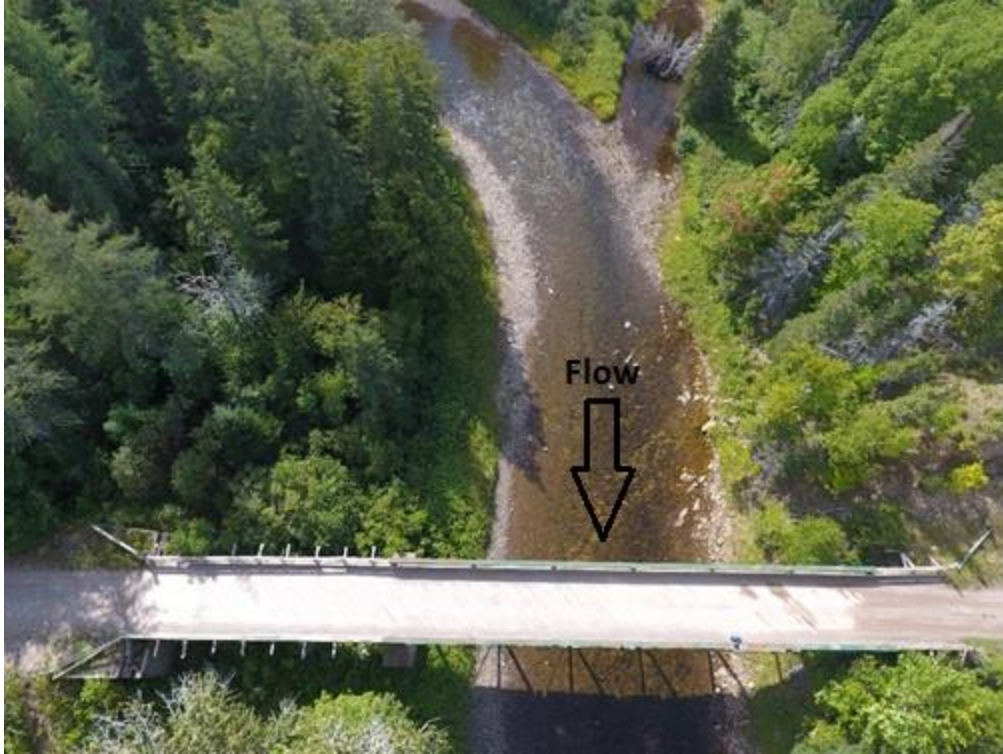
Figure 20: View above Moran Road bridge. (Note: little access for machines below bridge due to steep slopes)

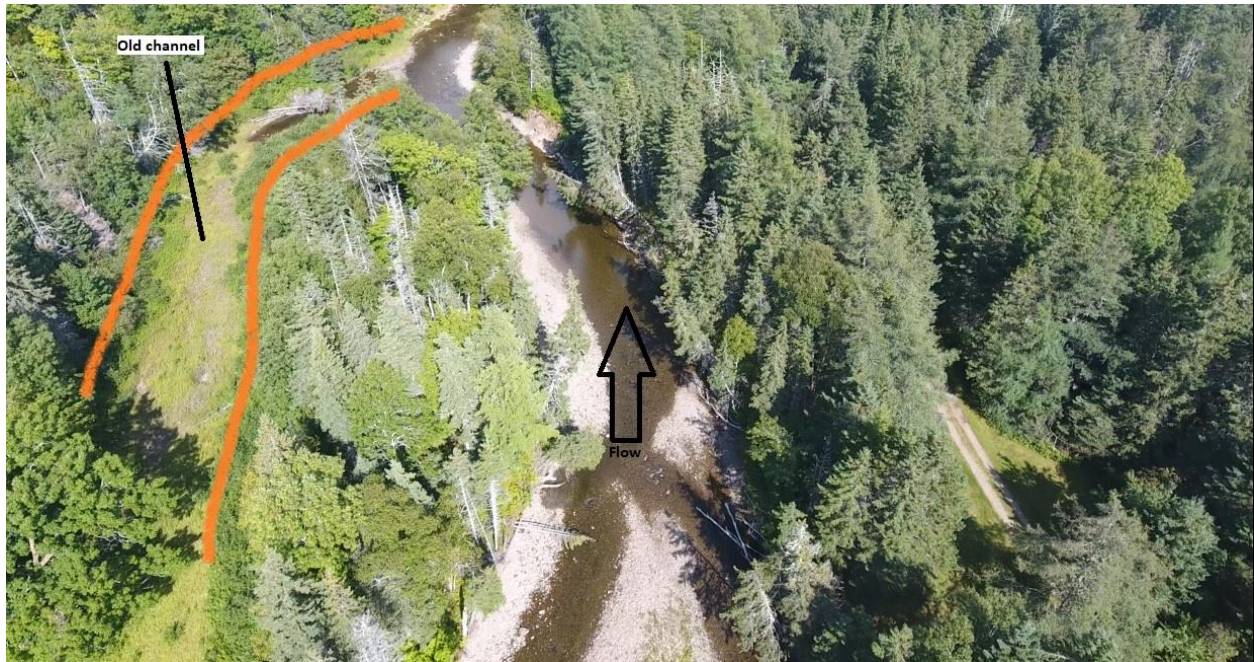
Figure 22: 500 meters Above Moran Road bridge, severe channel migration caused by over-widened channel above.

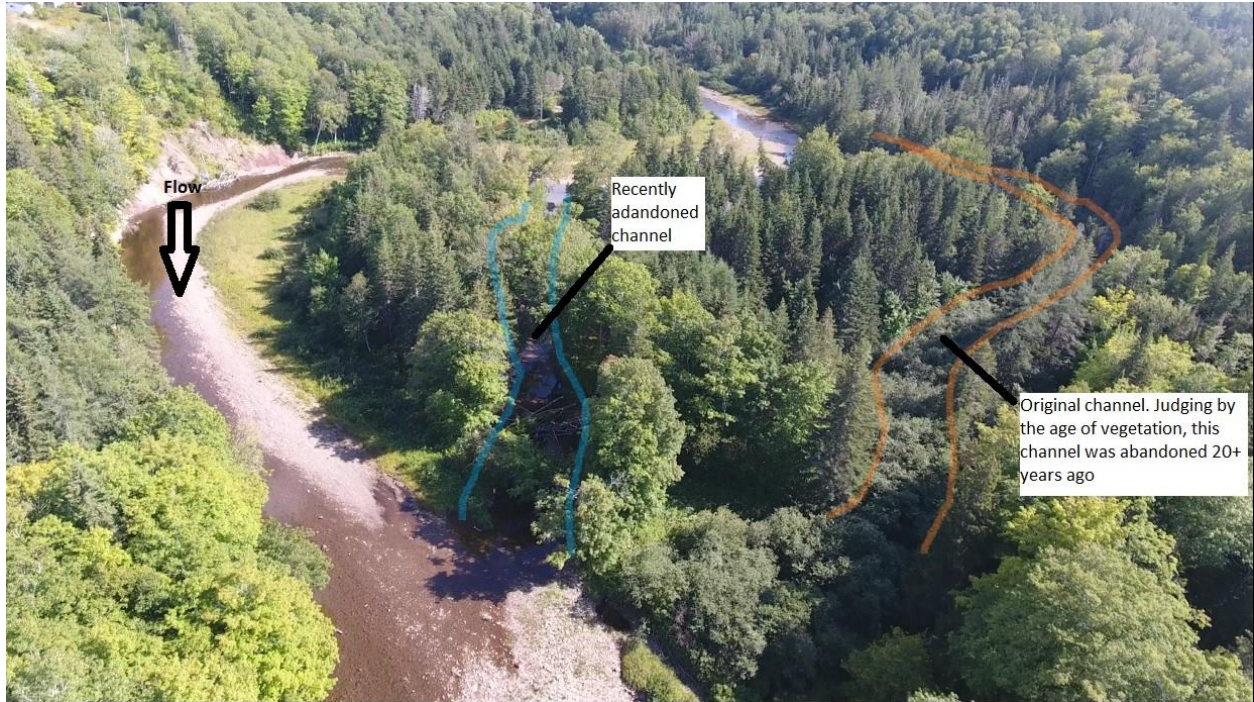
Figure 24: 2.5km above Moran Road bridge. Note - severe channel migration because of incised upstream habitat.

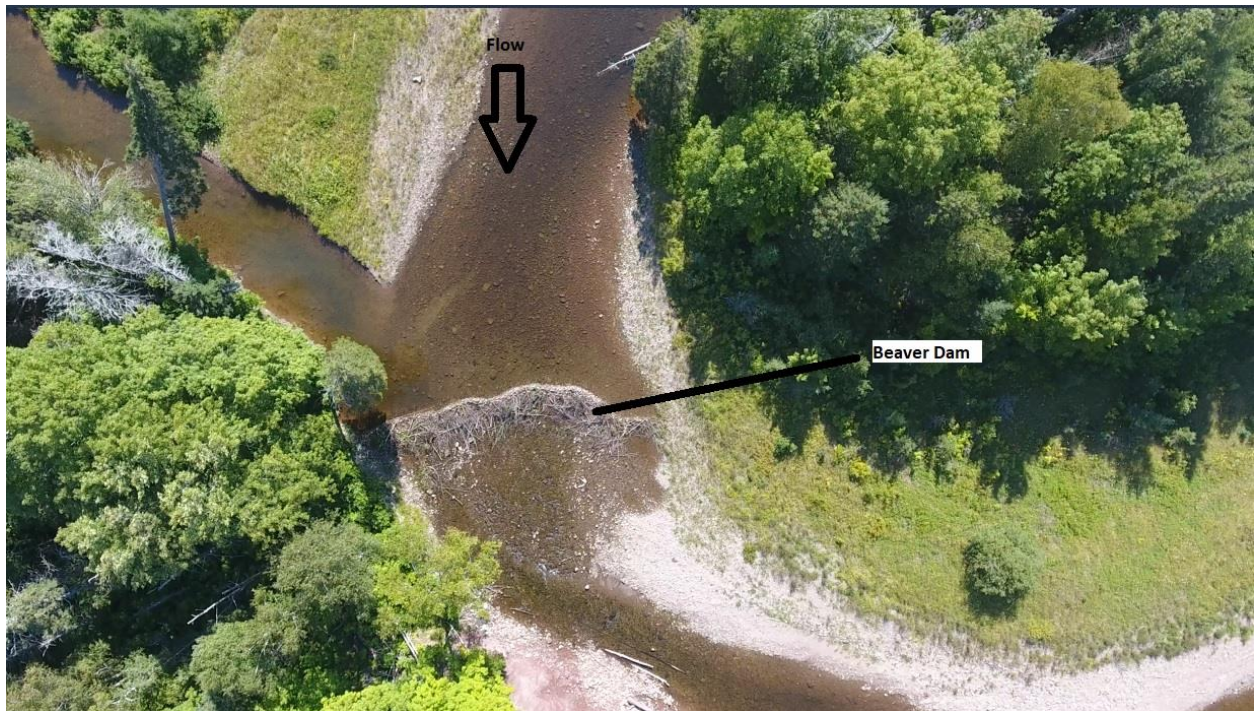
Figure 25: 3km above Moran Road bridge. This beaver dam is facilitating the natural deposition of sediment and is protecting the eroding bank downstream. Recommended course of action – leave.

The lower reaches of the river were completely void of beaver dams, except one located a kilometer above Moran Road bridge (Figure 25). The development of agriculture in the rich floodplain of the middle section of the Southwest Mabou has likely caused a shortage of young vegetation used by beavers during the construction of dams. The reestablishment of natural processes will result in channel migration and wetland development – thus impacting private property and requiring changes to land use. Natural processes can be artificially produced using stream restoration techniques, allowing for land-use practices to shift slowly over-time. For an illustration on how natural processes can restore an incised channel see figure 42 below. This type of regeneration is only possible if persistent impacts have been mitigated.

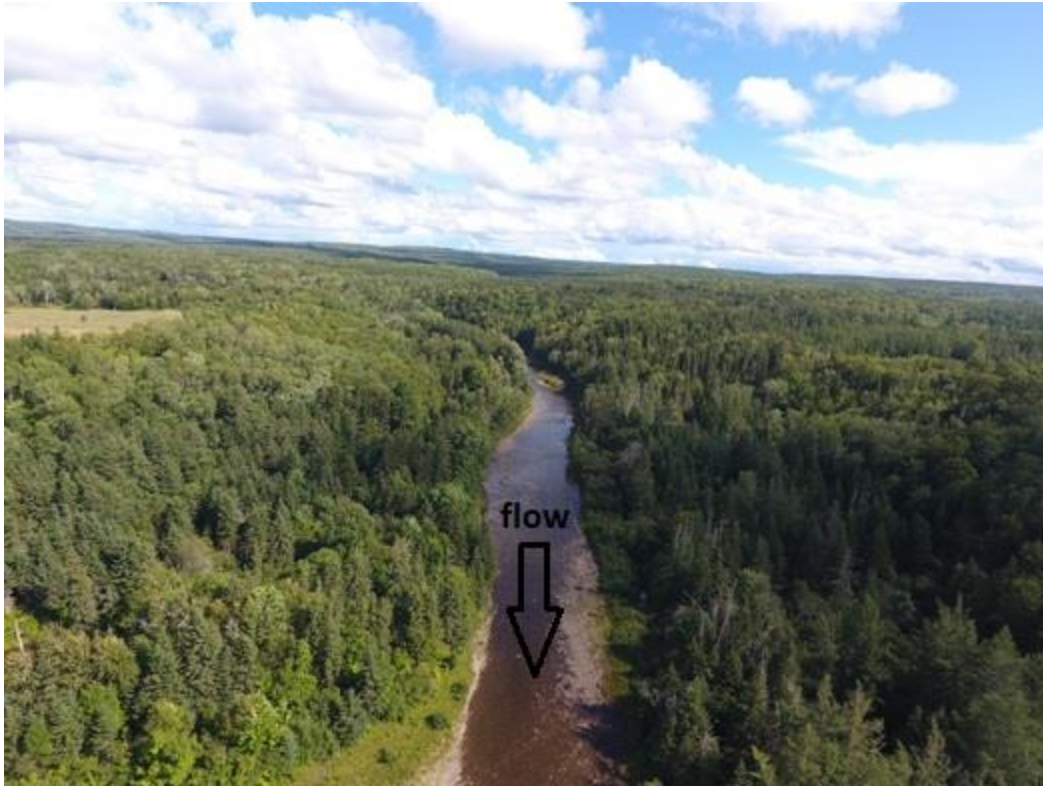
Figure 26: 3.5km above Moran Road bridge. Channel lacks meander pattern and is over-widened (Upstream view).

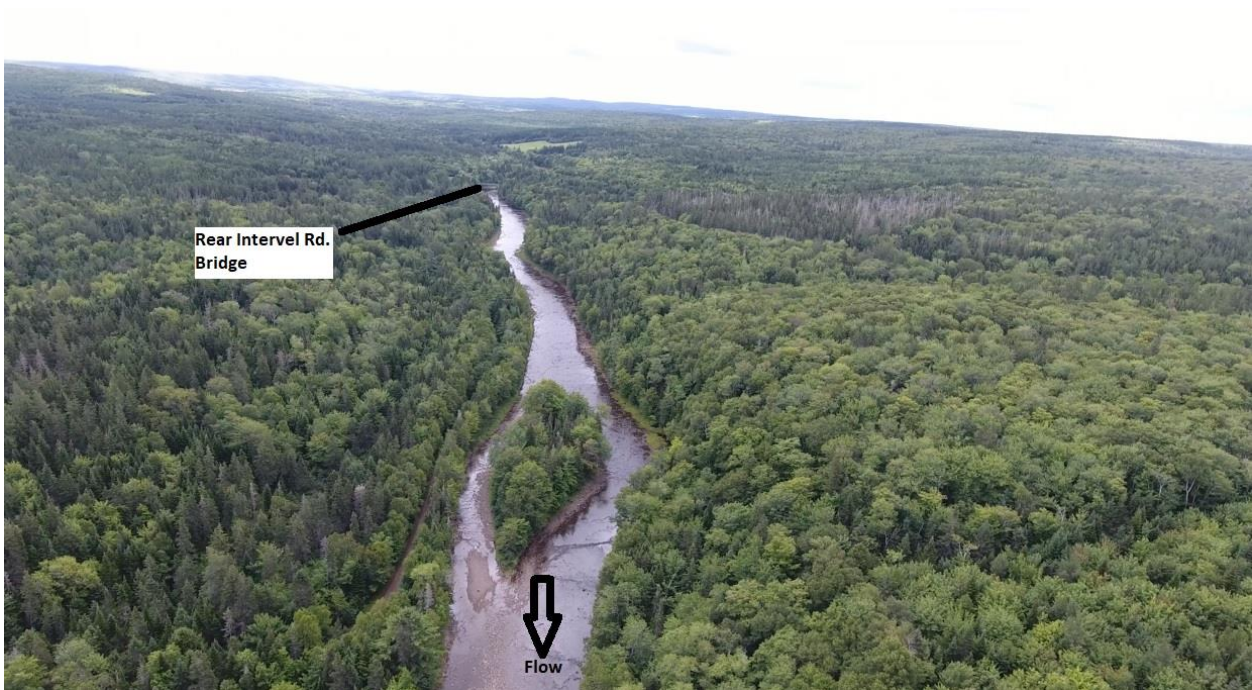
Figure 27: Looking upstream towards Rear Intervale Rd. bridge. Channel is over-widened, and the bottom substrate is predominantly bedrock for over 1km. This section of stream is easily accessible by heavy machinery.

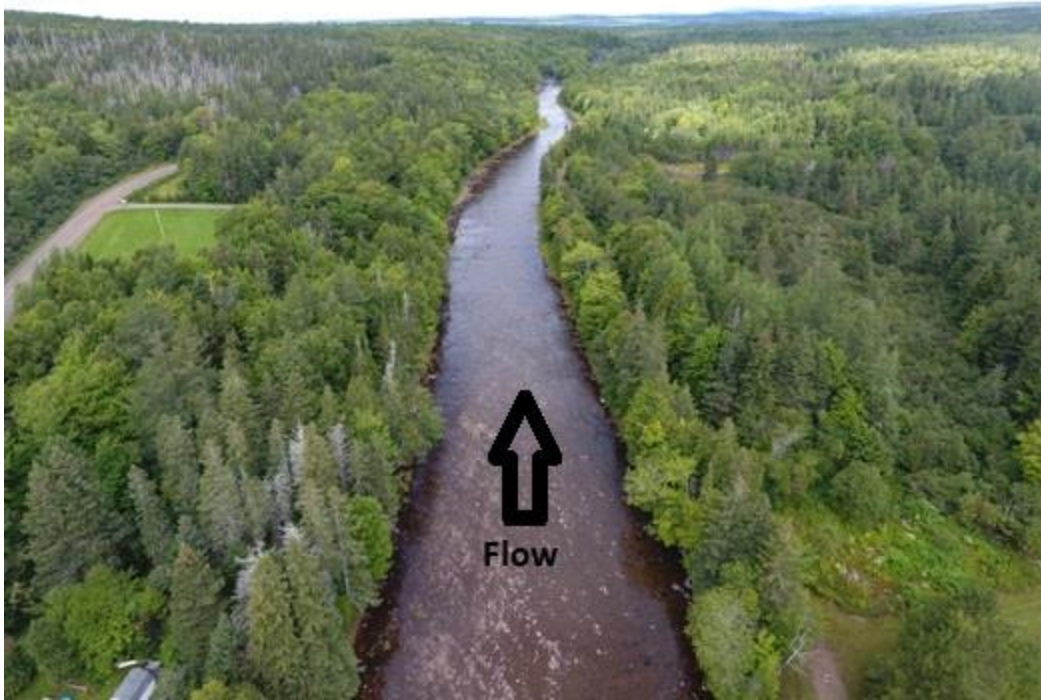
Figure 28: Downstream view below Rear Intervale Rd. Bridge. Channel lacks meander pattern, is over-widened and heavily bedrock laden.

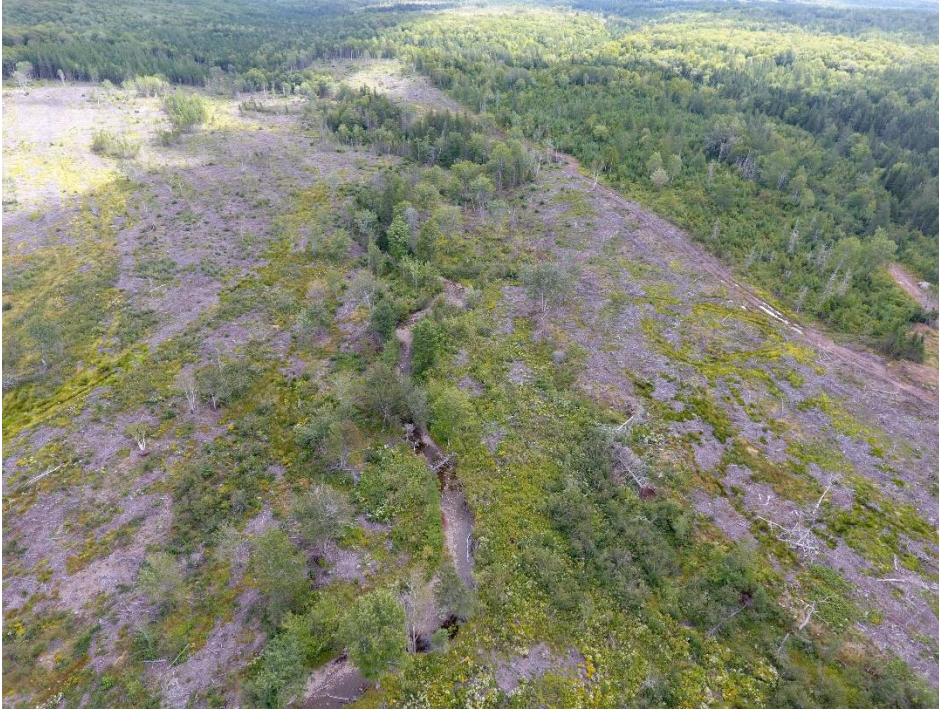
Figure 30: Unnamed Tributary (MacLeod Settlement). Riparian zone loss from recent forestry activity. 45.562751, 61.218869

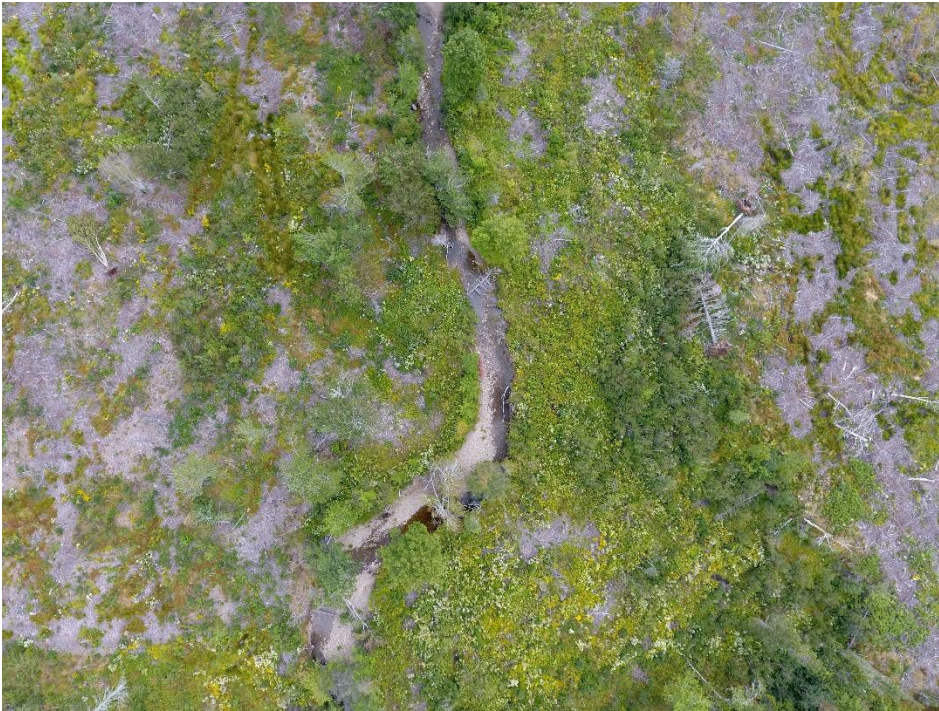
Figure 31: Unnamed Tributary, eroding banks and mobile substrate. Riparian zone loss.

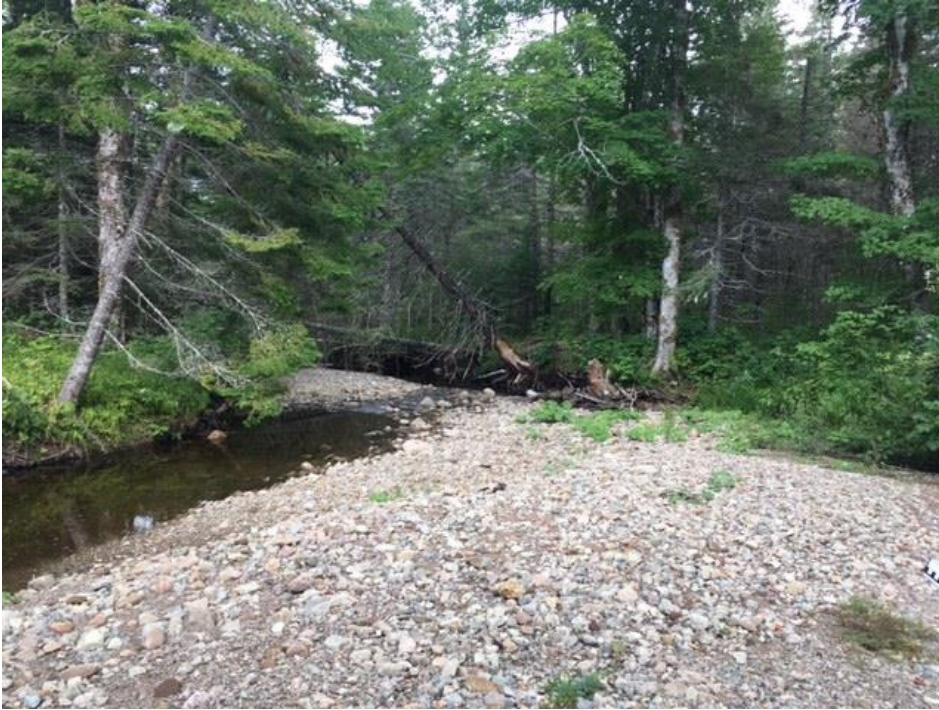
The Southwest Mabou river supports a small run of Atlantic salmon (*Salmo salar*) and brook trout (*Salvelinus fontinalis*). The river habitat is highly degraded, characterized by an over-widened and down-cut channel. Spawning habitat is sparsely found throughout the main channel, with bedrock substrate being the most prevalent. Two tributaries empty into the Southwest Mabou near MacLeod Settlement (MacLeod Brook and an unnamed tributary). Both these tributaries have been impacted by the disappearance of a stable riparian zone (Figure 30), leading to increased rates of bank erosion and a highly-mobile substrate (Figure 32).

Figure 32: Unnamed Tributary - Highly-mobile substrate, freshly deposited below riparian zone loss.

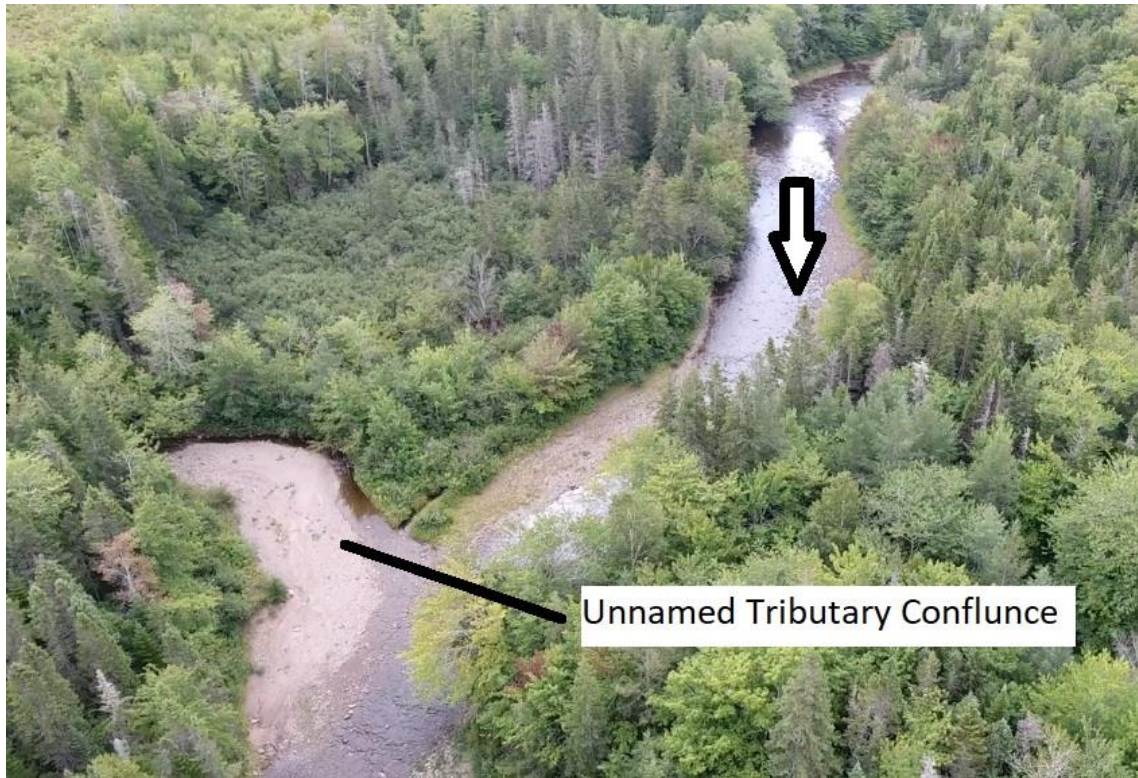
Figure 34: Unnamed tributary confluence – note the sedimentation from upstream erosion.

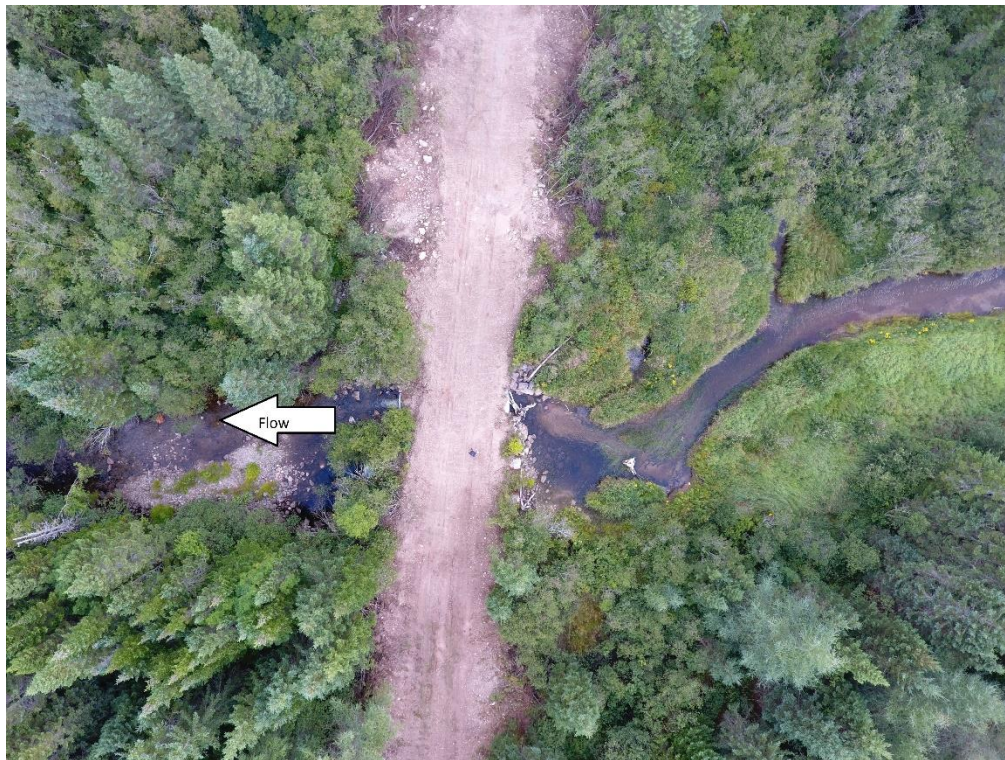
Figure 35: MacLeod Brook crossing. (Culvert requires fish passage remediation)

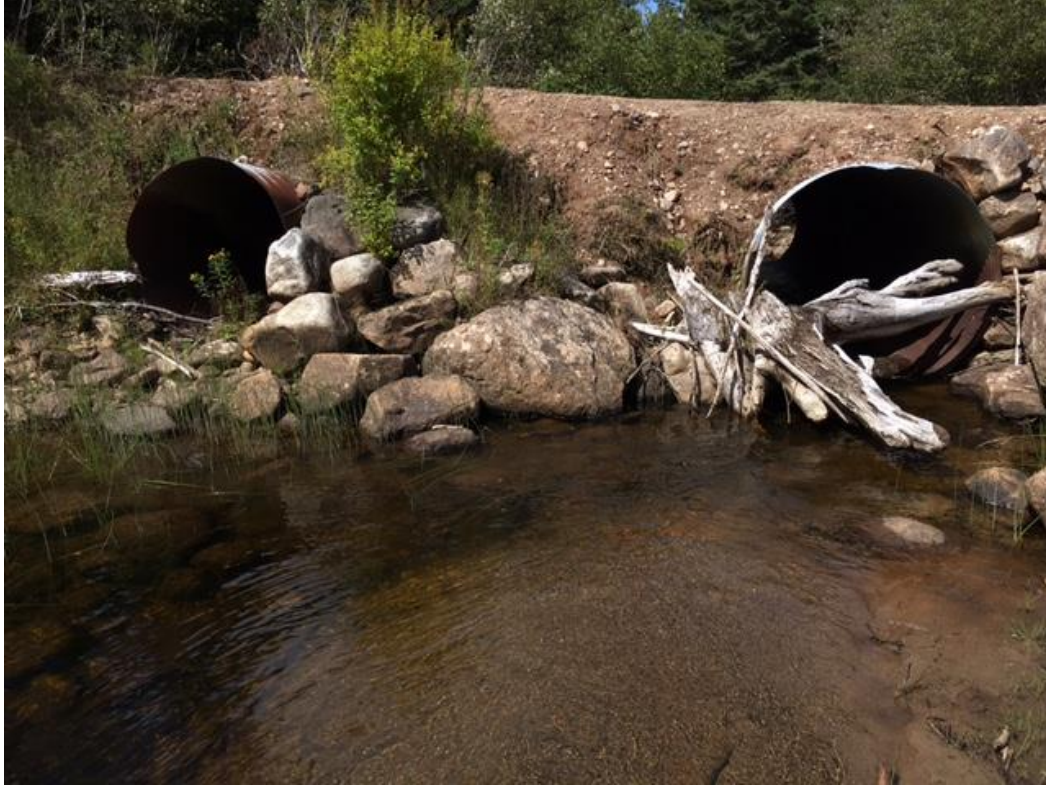
Figure 36: Fish passage barrier - MacLeod Brook (Looking downstream)

- Digger logs, deflectors and bank logs can be installed by the ISAA restoration crew on MacLeod Brook and the unnamed tributary.
- MacLeod Brook requires fish passage remediation, likely through a culvert replacement where the brook crosses MacLeod Settlement Road. The culvert should be surveyed in the spring of 2018 and be replaced by the summer of 2019 (Figure 36).

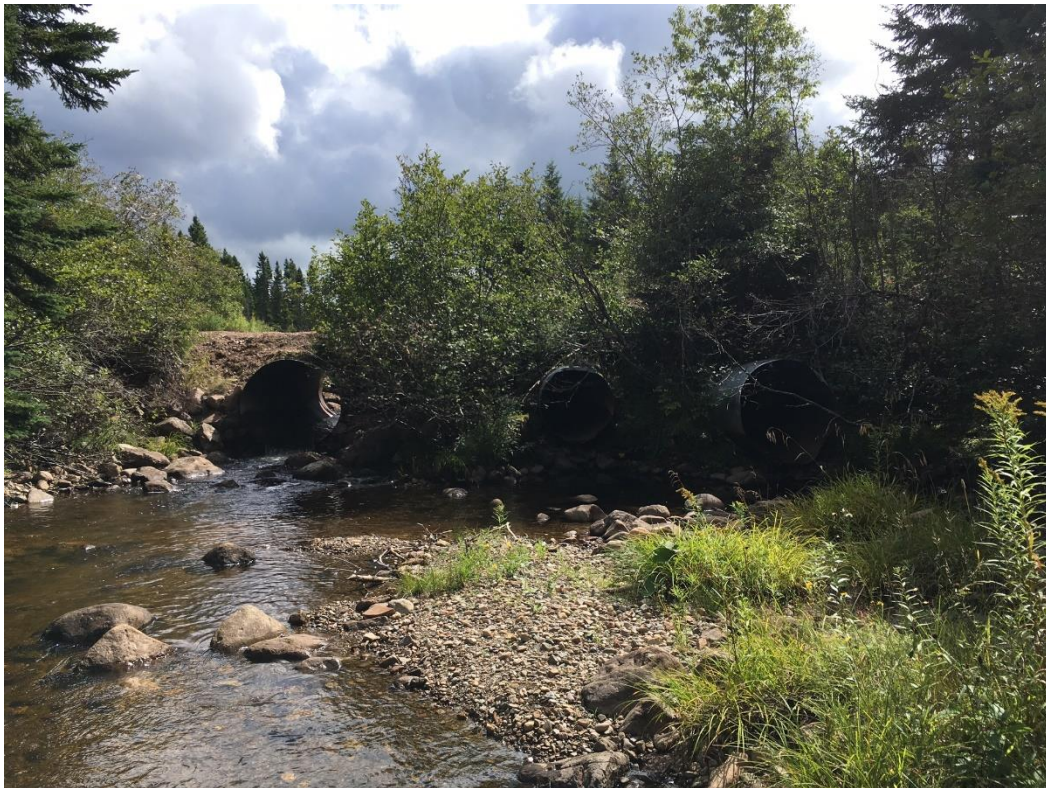
Figure 37: Culvert (Looking upstream) - Remediation required for fish passage
