SOUTHWEST MABOU WATERSHED RESTORATION AND MANAGEMENT PLAN

Submitted to the Atlantic Salmon Conservation
Foundation on behalf of the Inverness South Anglers
Association

Report Completed by
MacInnis Natural Resource Services Inc.

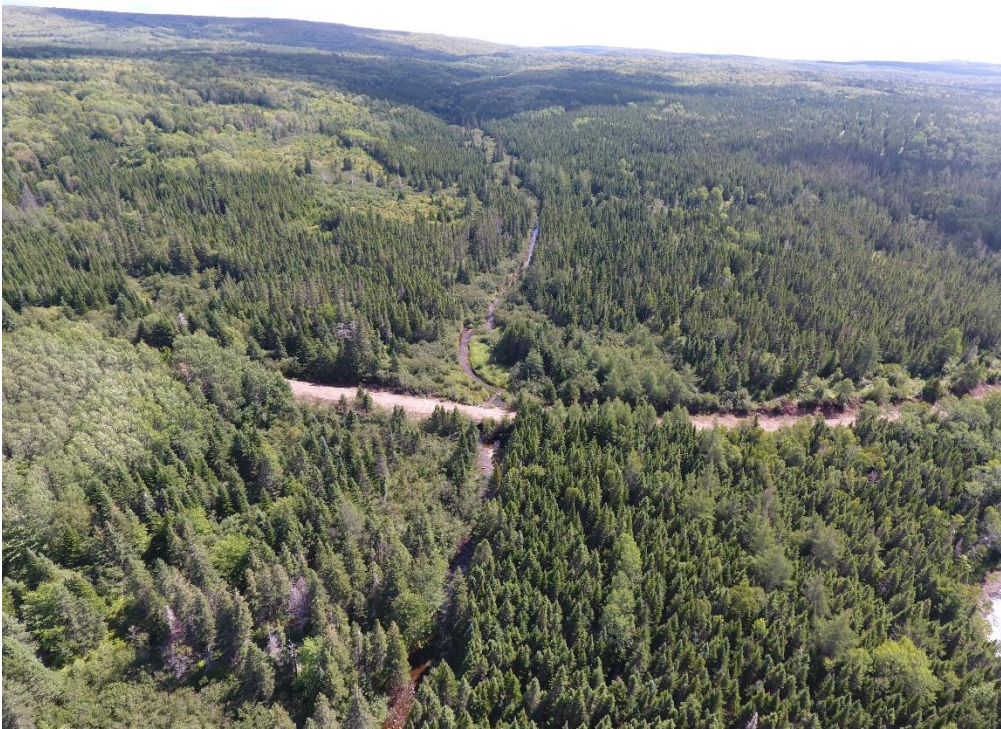
Figure 38: MacLeod Brook (looking upstream). Adequate riparian zone, habitat degradation persists from historical land use.

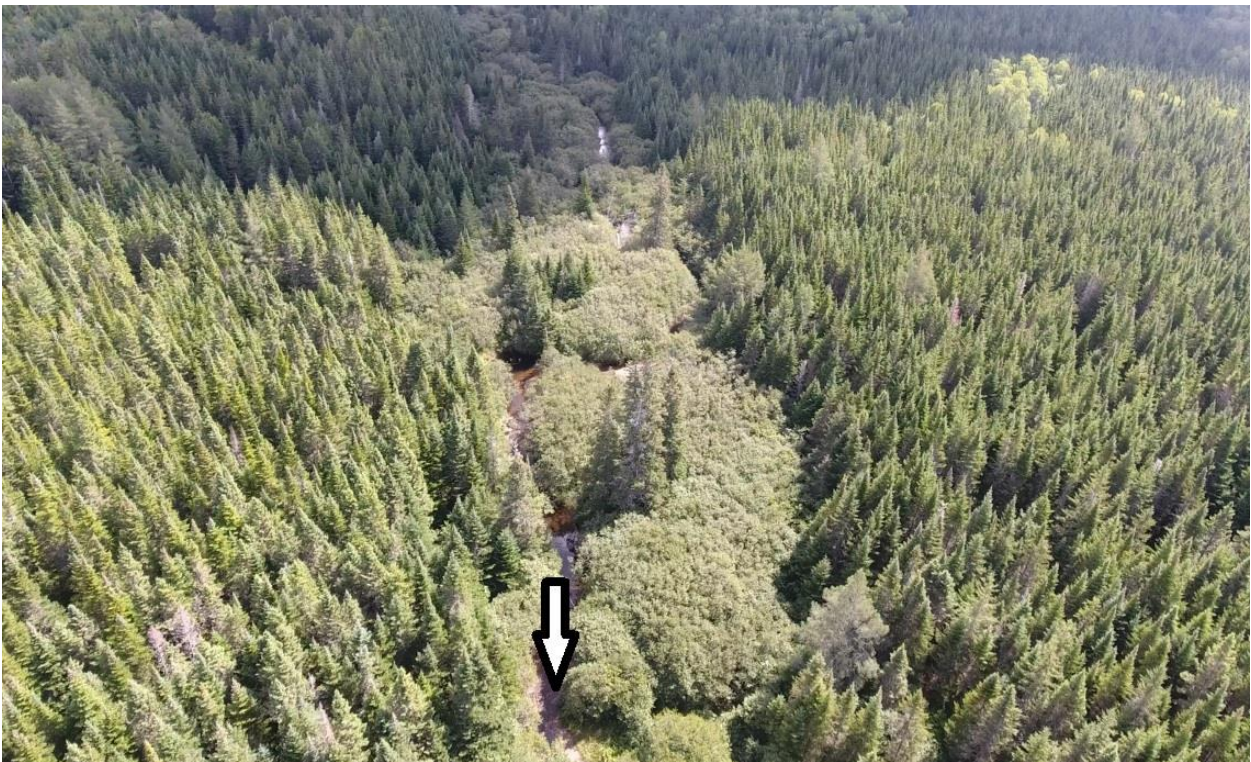
Figure 39: One kilometer upstream from culvert. Good riparian zone, habitat is lacking pools.

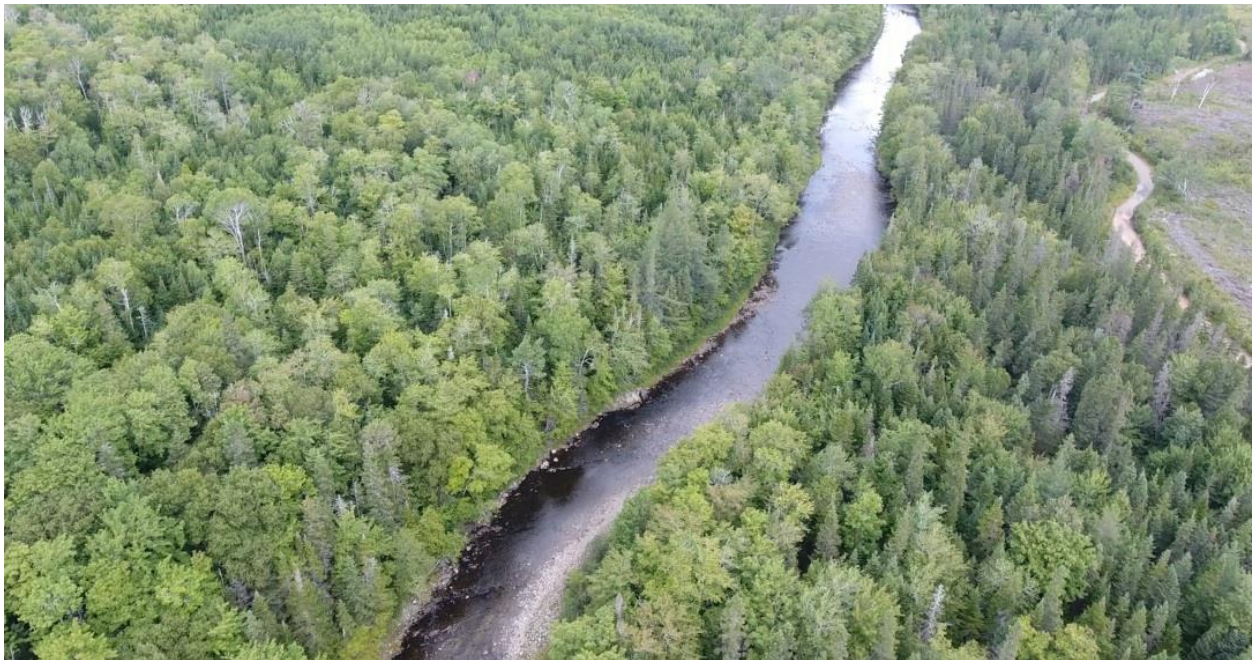
Figure 41: Upper Southwest Mabou (looking downstream) in MacLeod Settlement. Note the channel is over-widened and lacks a meander pattern.

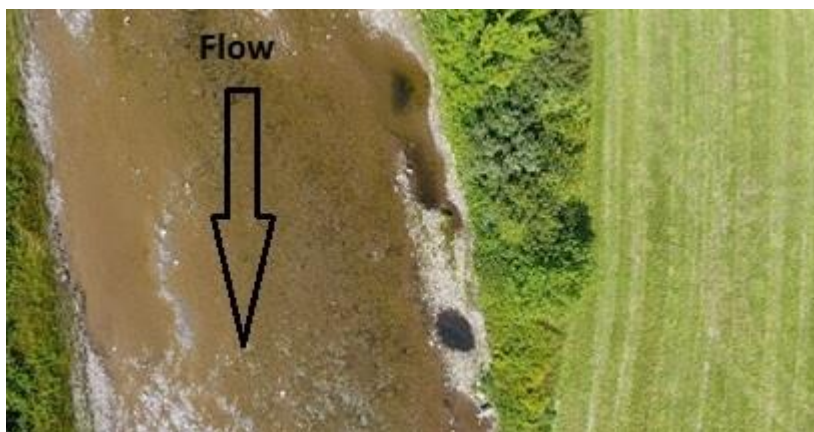
In northern climates, incised channels are prone to ice scouring during the winter and spring. Ice scouring can destroy salmonid redds and can greatly reduce egg survival (Figure 43).

Figure 43: Ice scouring on gravel bar above Route 19

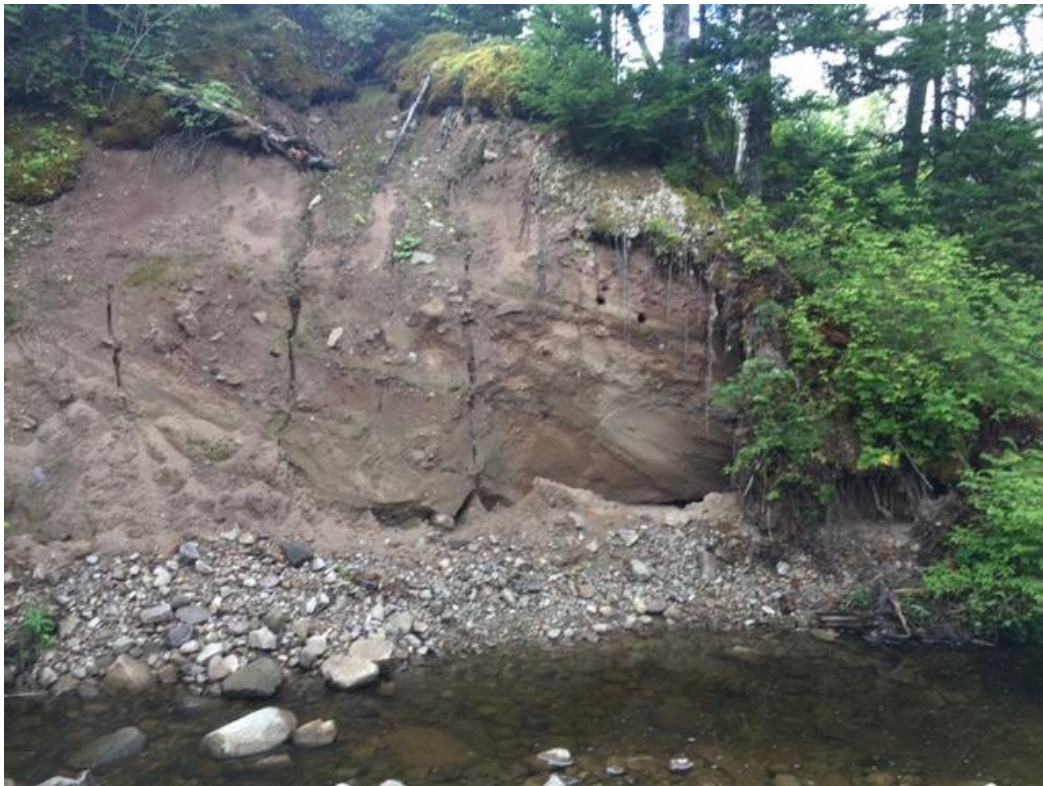
Figure 44: Actively eroding bank, downstream from unnamed tributary - MacLeod Settlement road crossing
