SALMONID HABITAT RESTORATION

INVERNESS SOUTH ANGLERS ASSOCIATION

Progress Report

Monday, June 12th, 2017

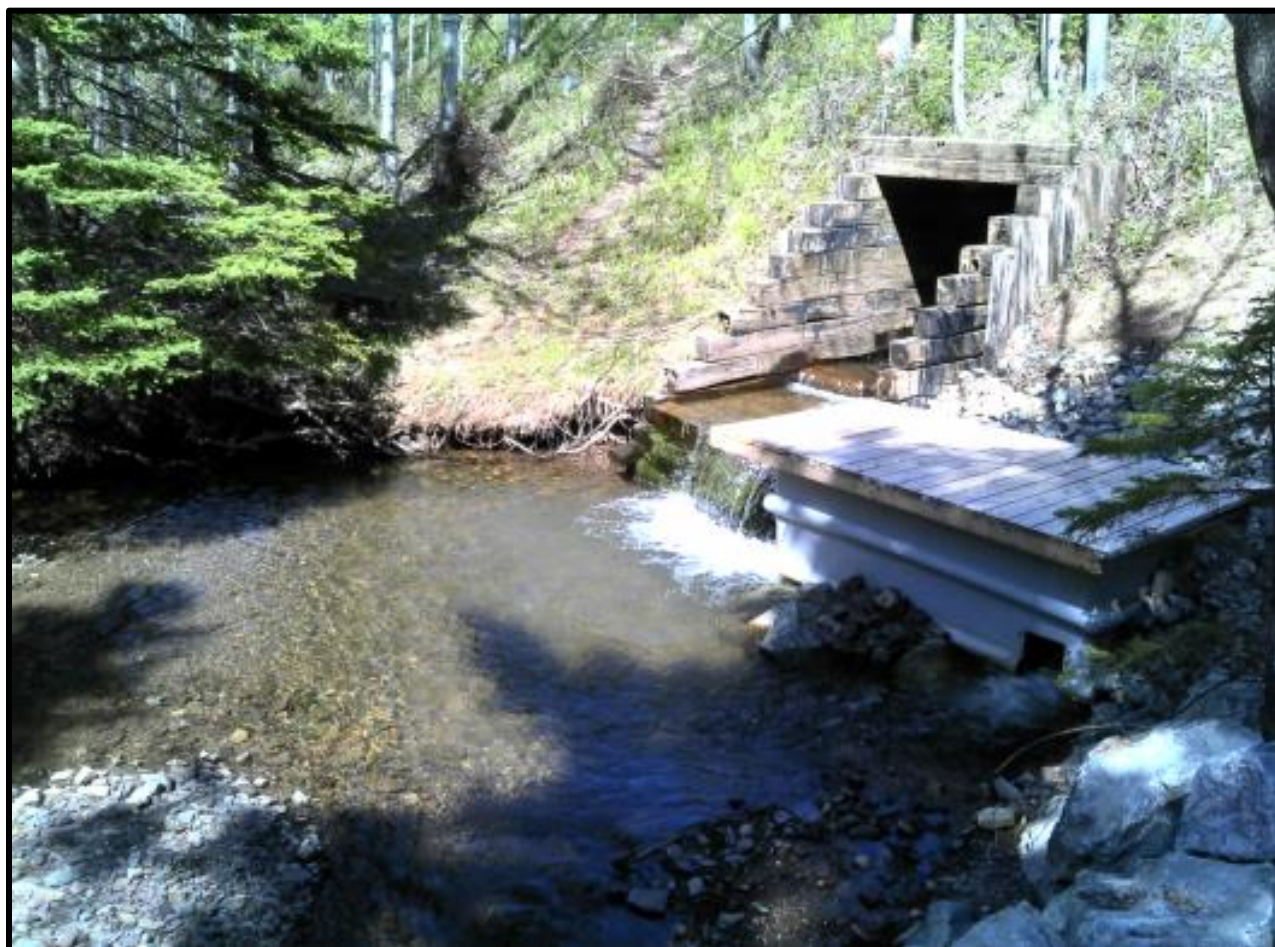
Way Point 04 – Fish Ladder/Bridge and Culvert

STRUCTURE PRESENT	WAY POINT #	COMMENTS
FISH LADDER/BRIDGE CULVERT	04	Looks good, mild siltation and rock buildup in culvert. Mild buildup of rocks in the fish ladder. Will need to be cleaned. The pool below the fish ladder had accumulated a lot of pebbles within the former pool; thus, changing the watercourse's morphology. More rocks are needed for bank stabilization on the left side of the downstream.
STRUCTURE PRESENT	WAY POINT #	COMMENTS
DIGGER LOG AND DEFLECTOR	05	More rocks are needed for the digger log stabilization. Mildly washed out. Maintenance.
STRUCTURE PRESENT	WAY POINT #	COMMENTS
DIGGER LOG AND DEFLECTOR	06	Doing well from last year. Deflector is well, needs more rocks to bring it up to bank height. Lots of rock around to do so.
STRUCTURE PRESENT	WAY POINT #	COMMENTS
BRIDGE STRUCTURE	03	Looks good, no clogging under this pre-existing structure.
DIGGER LOG	07	Structure needs to be fully replaced due to winter damage

Figure 3: Fish Ladder, Bridge, and Culvert of the More Brook.

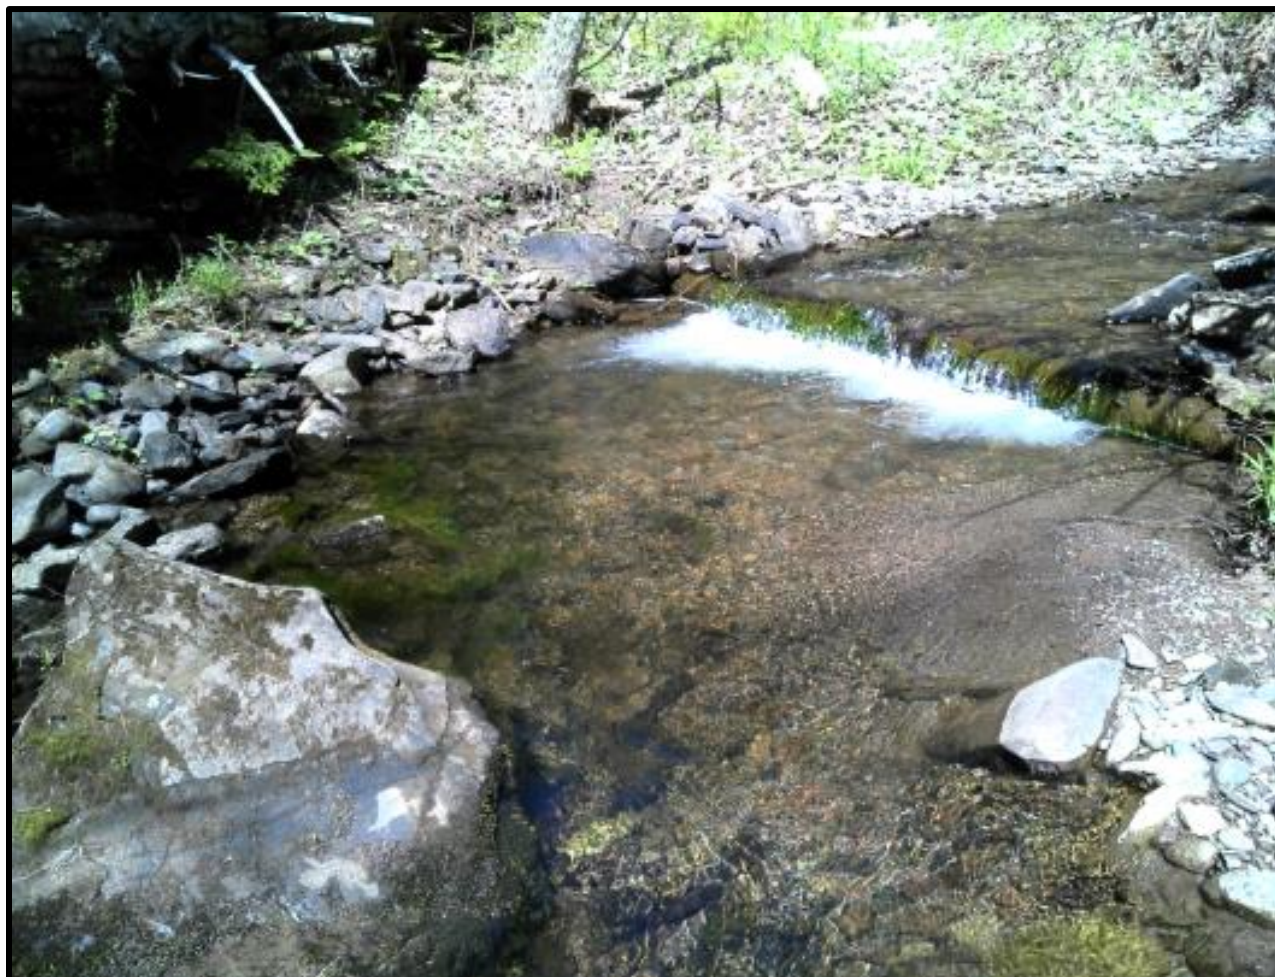
Way Point 05 – Digger Log and Deflector

An after picture for this structure is not available. Winter damage has been maintained.

Figure 4: A before picture of a digger log/deflector structure on the More Brook

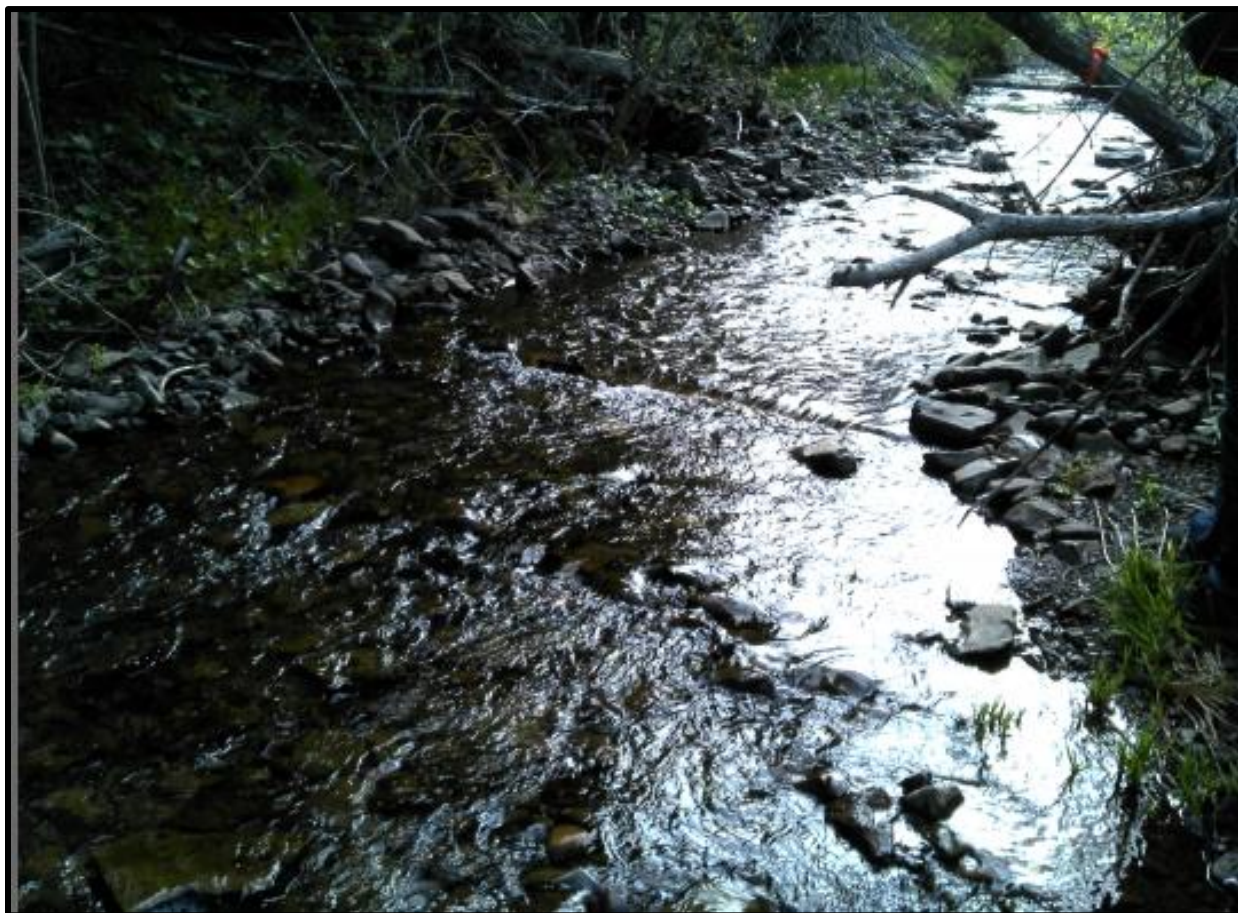
Way Point 07 – Digger Log and Deflector

Figure 5: Photo of digger log the needs to be fully replaced on the More Brook

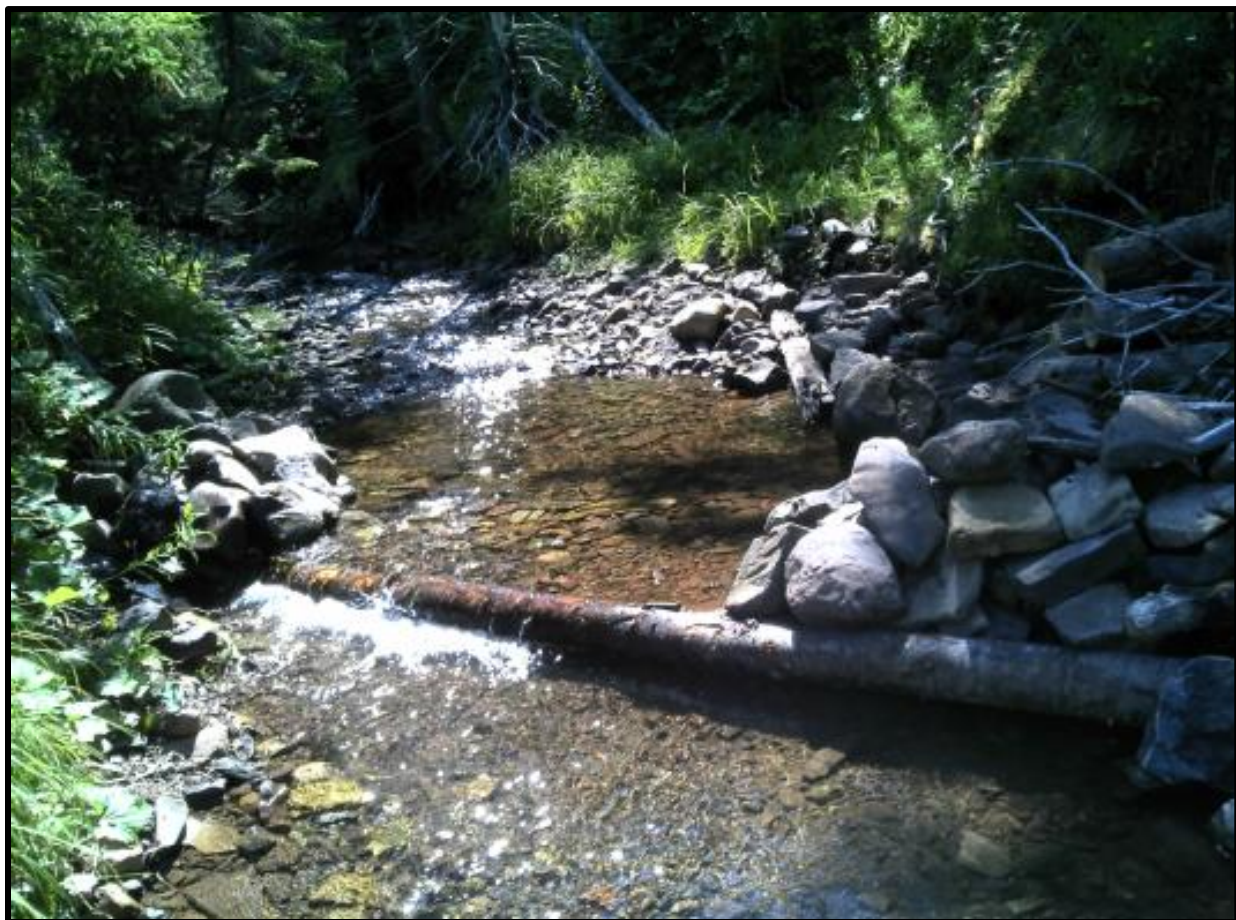
Way Point 10 – Digger Log and Deflector

DIGGERLOG AND DEFLECTOR	10	Structure has been built recently. No maintenance needed.
DIGGER LOG	11	New structure that was recently built. No deflectors needed due to the width of the river.
DIGGER LOG AND DEFLECTOR	13	Digger log needs to be fully replaced. Deflectors were maintained.

Figure 6: New structure recently built on the More Brook during the Enfield Training Session with Adopt a Stream.

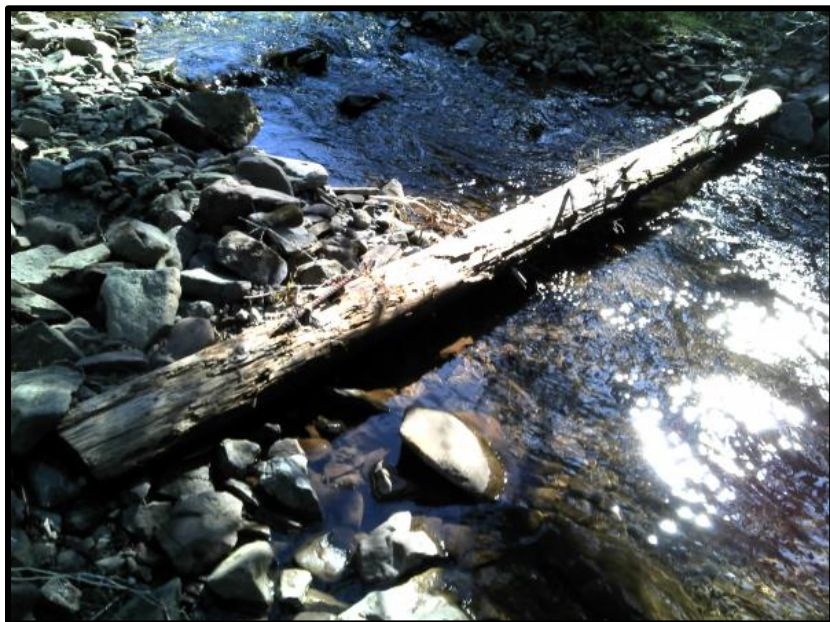
Way Point 11- Digger Log

Figure 7. A before picture; Digger log was removed and replaced during Enfield Training Session with Adopt a Stream.

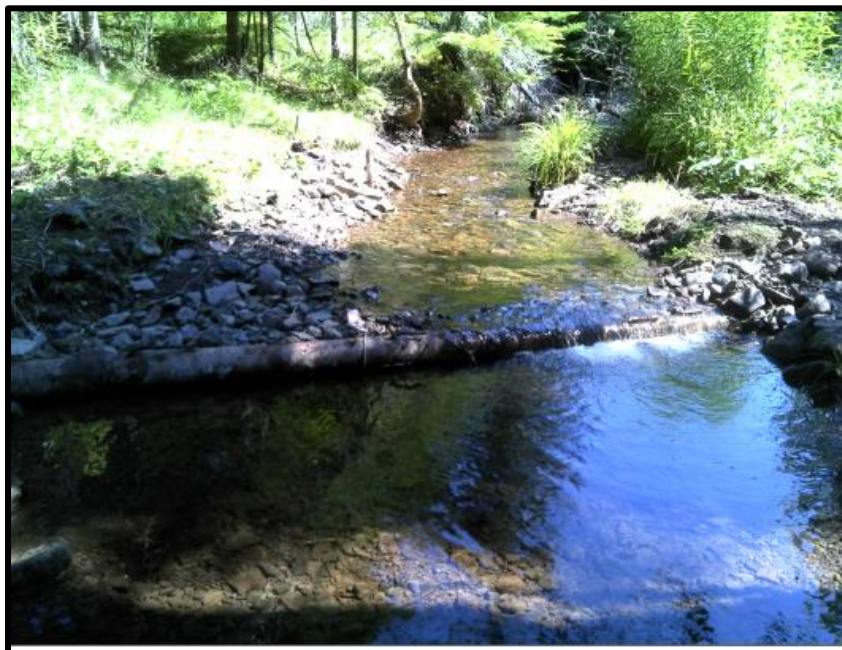
Figure 8. Replaced digger log structure installed by the Enfield Training Session with Adopt a Stream on the More Brook.

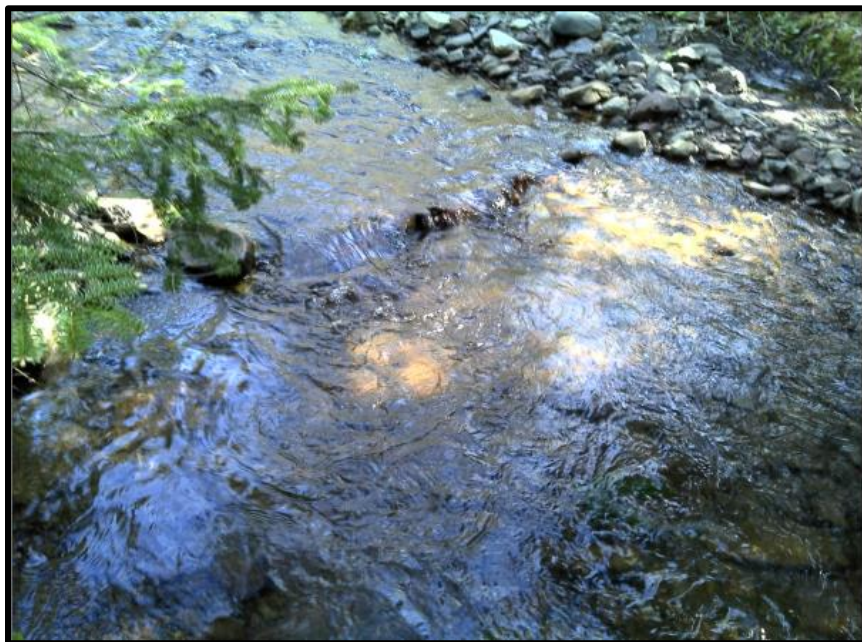
Way Point 13 – Digger Log and Deflector

Figure 9. A before picture of a digger log and deflector structure on the More Brook.

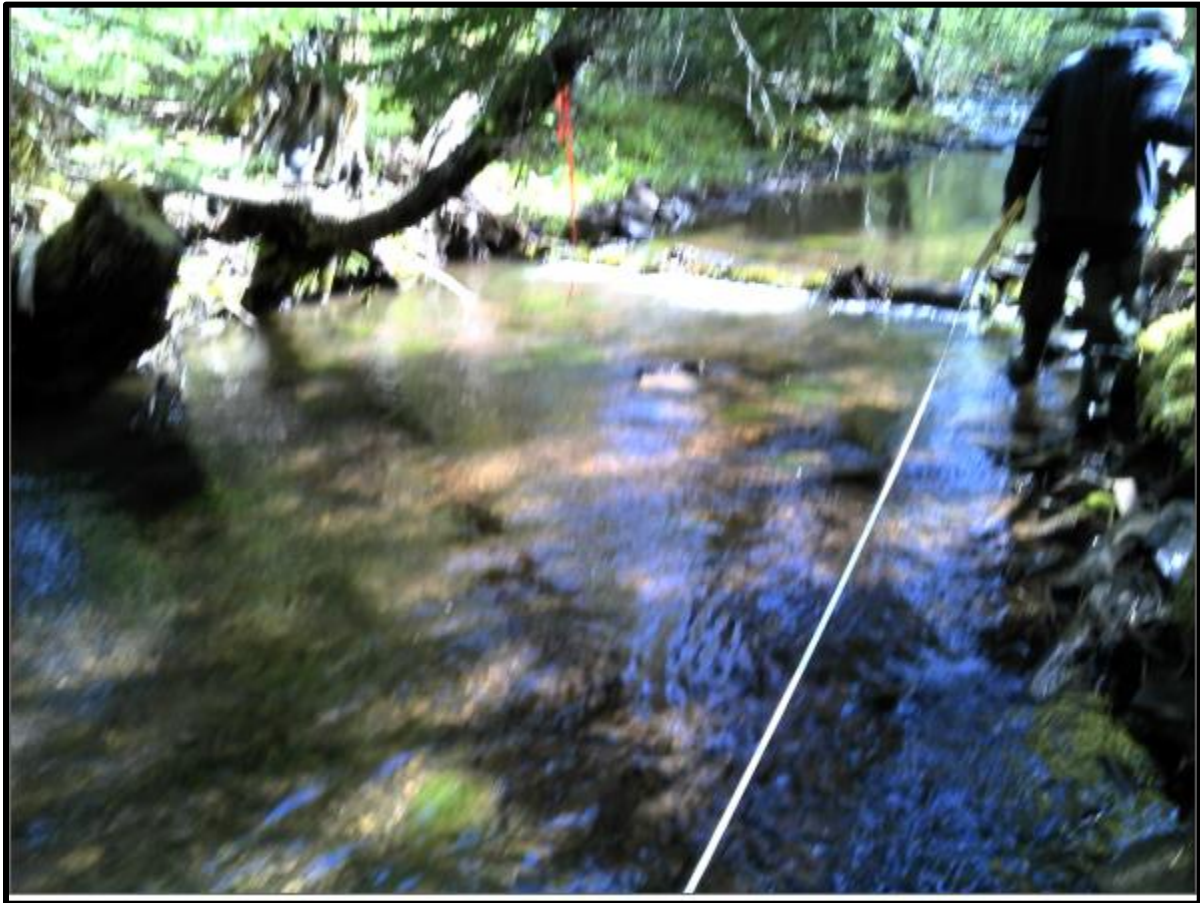
Way Point 56: Digger Log

STRUCTURE PRESENT	WAY POINT #	COMMENTS
Digger Log #1 <i>downstream</i>	55	Good condition. Sign says INV 233. Needs rocks.
Digger Log #7 <i>upstream</i>	56	Good Condition. Little short; could use a deflector on downstream.
Digger Log #8 <i>upstream</i>	57	Good Condition. Lots of oxygen. Good pool, 2-8 feet.
Digger Log #9 <i>upstream</i>	58	Between bank rocks look good. Good shade. Debris is embedded.
Digger Log #10 <i>upstream</i>	59	Nice pool, between 9-10 feet. Good oxygen. Can't take out, buried, creating pool.
Digger Log #2 <i>Downstream</i>	60	Good.
Digger Log #3 <i>Downstream</i>	61	Good.
Digger Log #4 <i>Downstream</i>	62	Needs to be reset.
Deflector	139	At Cathy's Farm by the bridge.

Figure 16. Digger Log structure on the Glendyre.

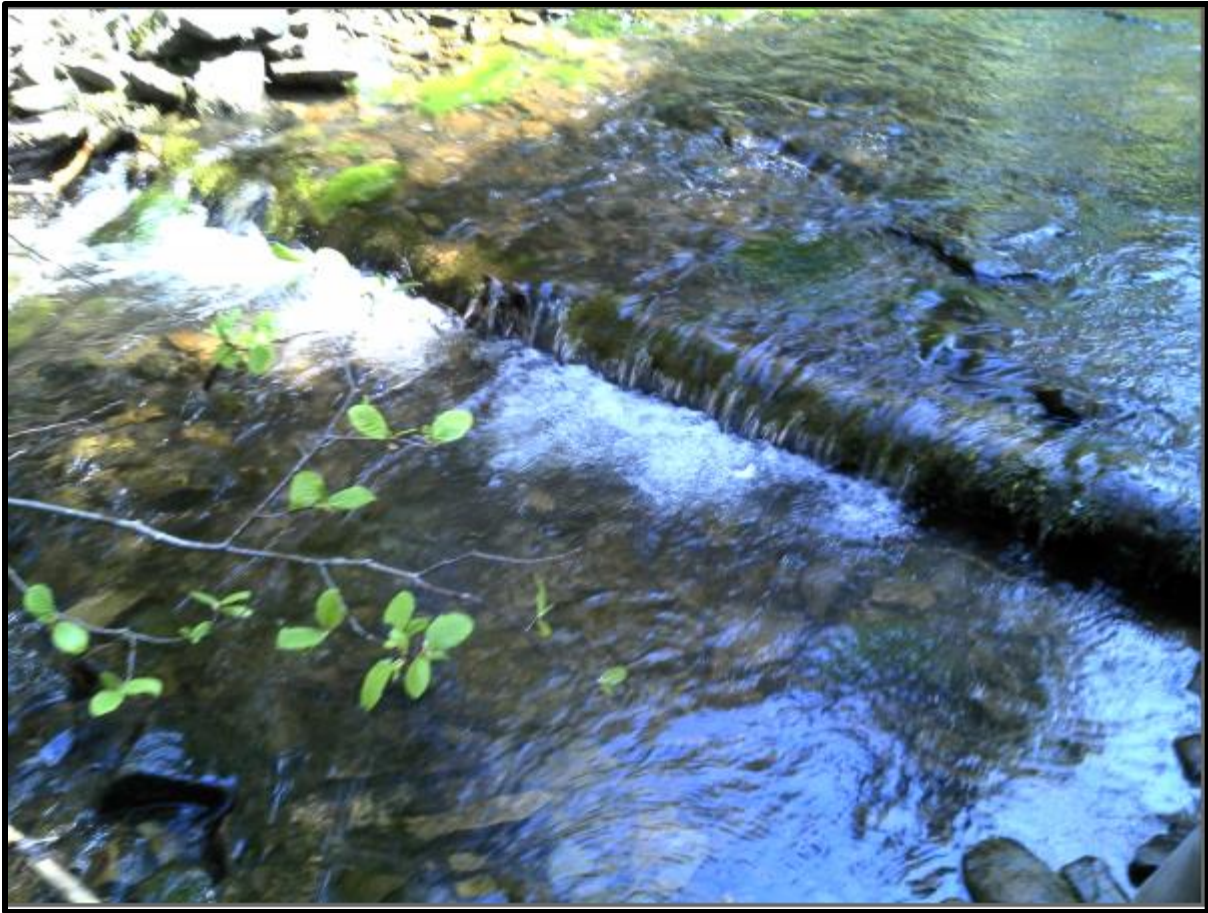
Way Point 58: Digger Log and Deflector

Figure 18. Digger Log and Deflector on the Glendyre River.

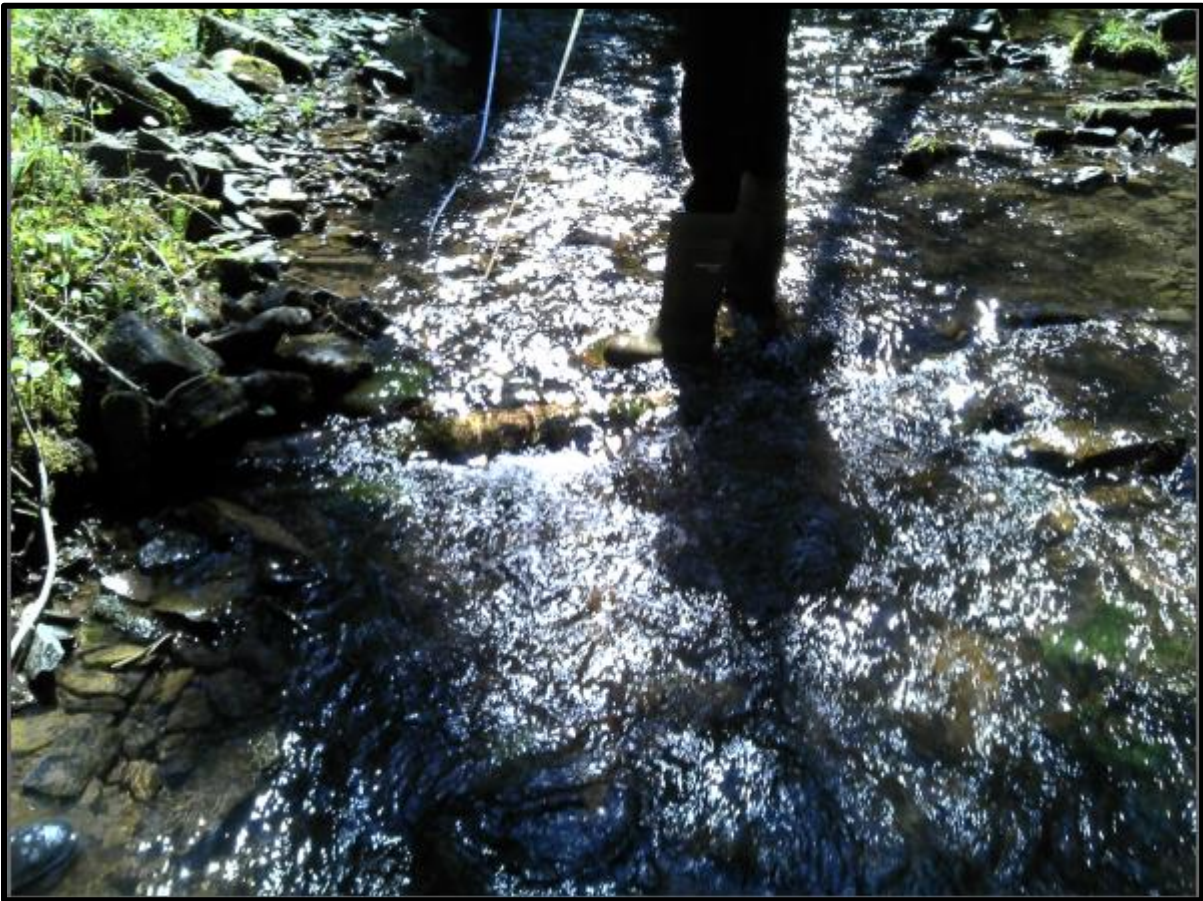
Way Point 59: Digger Log

Figure 19. Buried digger log that needs to be fully replaced.

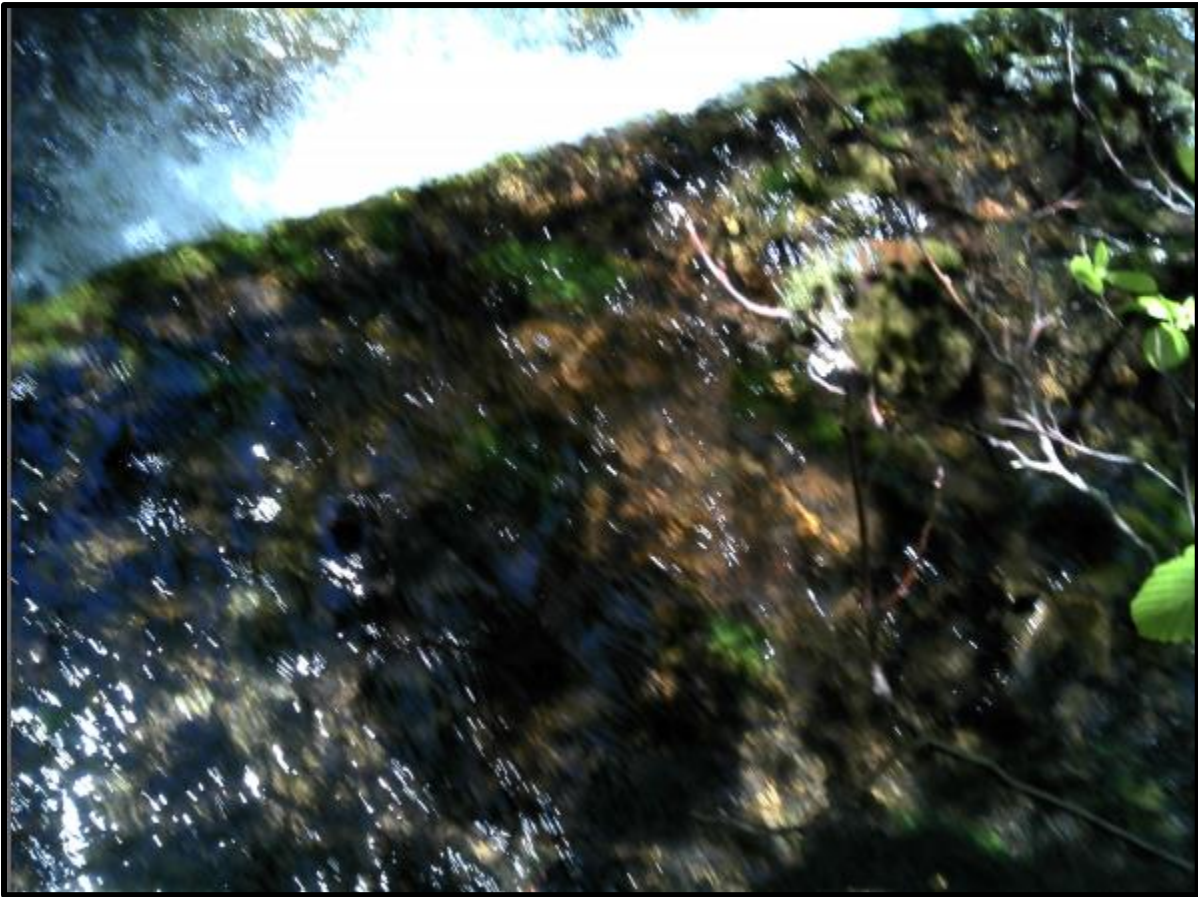
Way Point 60: Digger Log

Figure 20. Maintained Digger log structure.

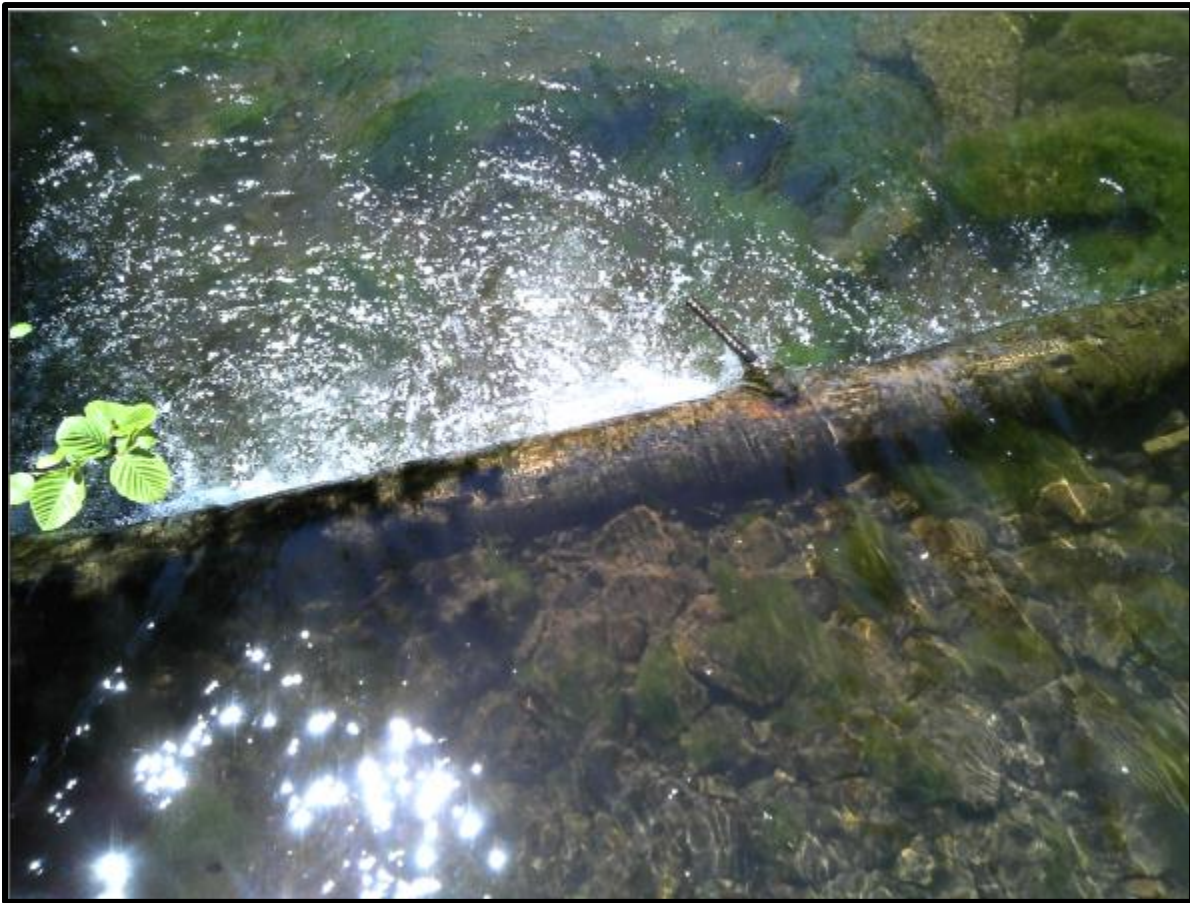
Way Point 61: Digger Log

Figure 21. Maintained digger log structure on the Glendyre.

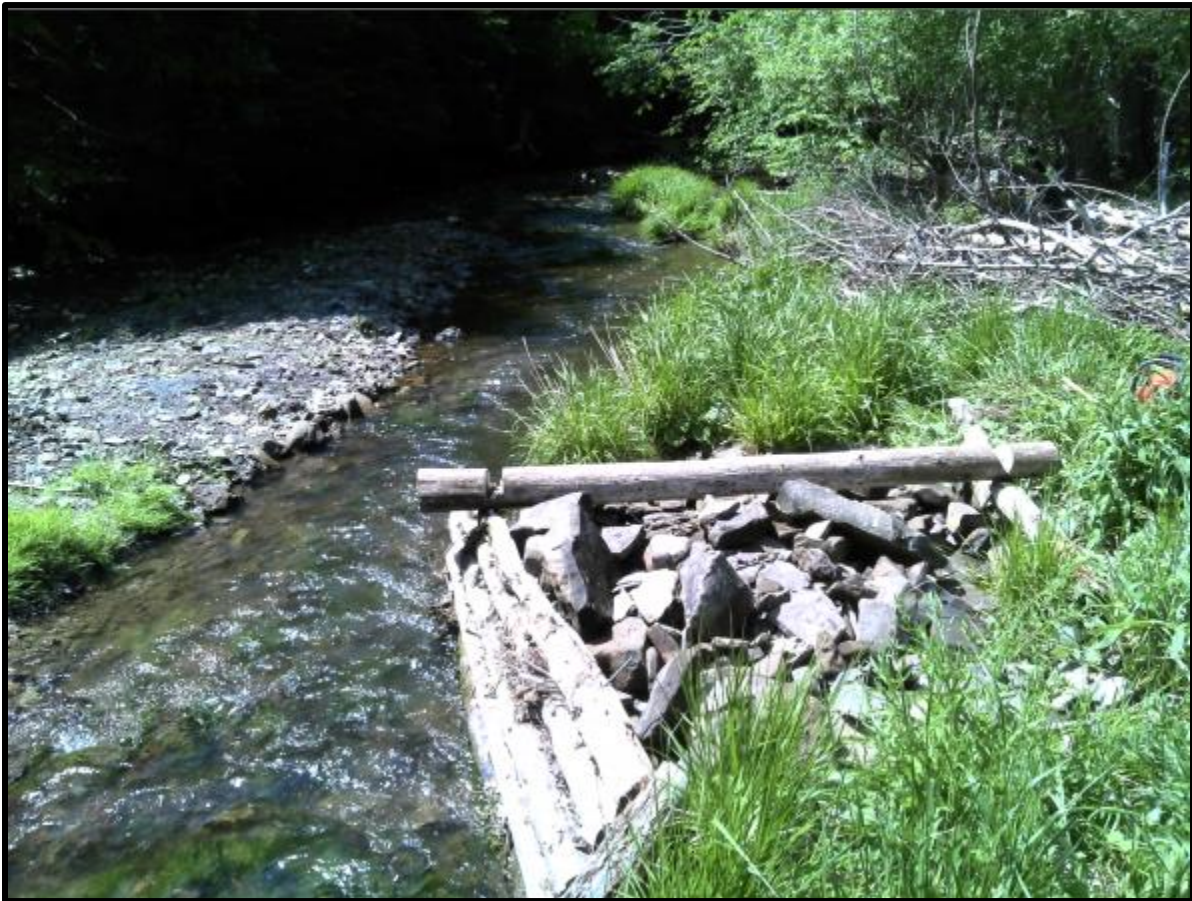
Way Point 139 – Deflector

Figure 22. Deflector that was maintained at waypoint 139.

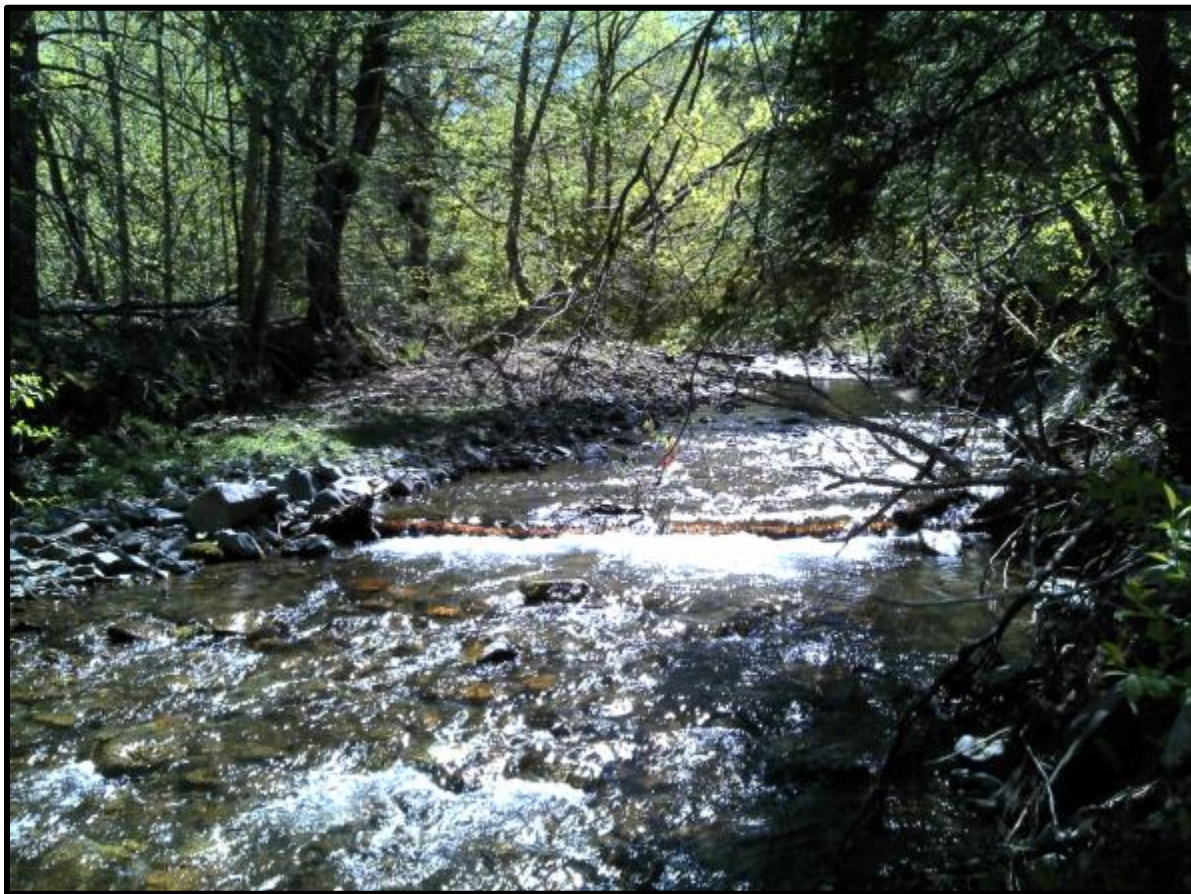
Way Point 20: Digger Log and Deflector

STRUCTURE PRESENT	WAY POINT #	COMMENTS
Digger Log and Deflector	20	Maintenance needed.
Digger Log and Deflector	21	Maintenance needed.
Digger Log and Deflector	22	Maintenance needed.
Digger Log and Deflector	23	Maintenance needed.
Digger Log and Deflector	24	Maintenance needed.
Digger Log # 6	64	Could use rock, but is great.
Digger Log # 7	65	Good condition, bank is eroding
Digger Log #8	66	Buried digger log. Used another log to put on top.
Digger Log #10	67	Two deflectors are very good condition. Built on more with rock.
Digger Log # 11	68	Nice Digger Log, could use more rock.

Figure 25. Digger log structure that was maintained.

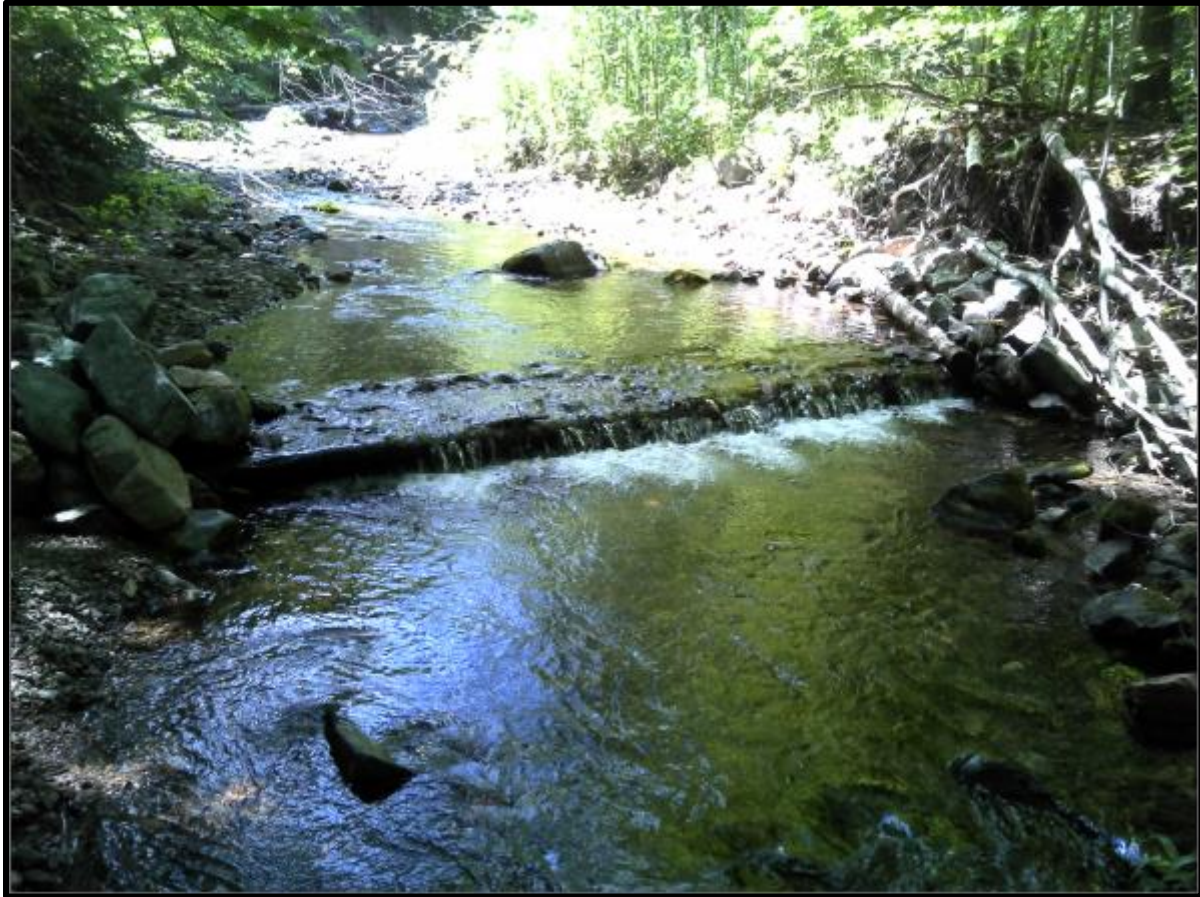
Way Point 64: Digger Log and Deflector

Figure 34. Maintained digger log and deflector structure.

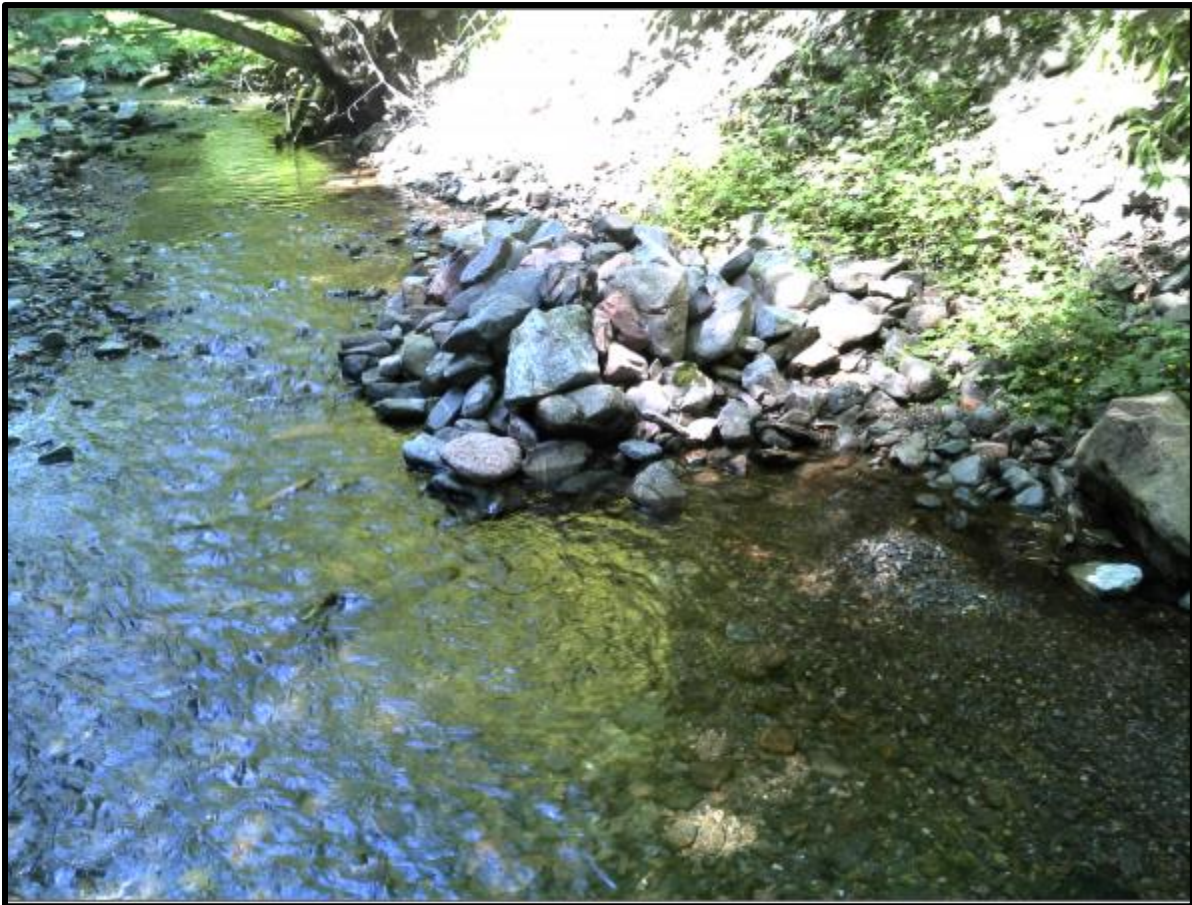
Way Point 66: Digger Log

Figure 35. Deflector structure that was maintained. Digger log was buried.

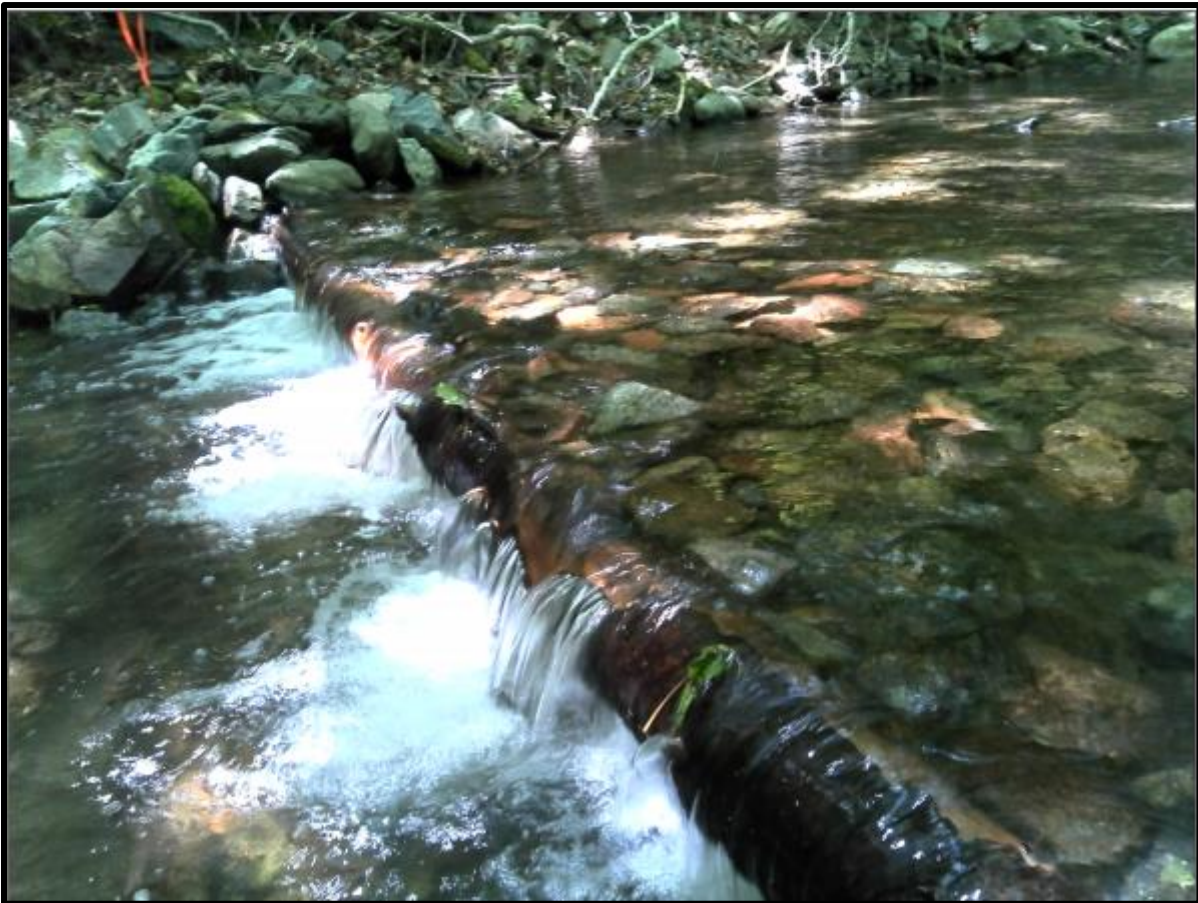
Way Point 68: Digger Log and Deflector

Figure 38. Digger log and deflector structure that was maintained.

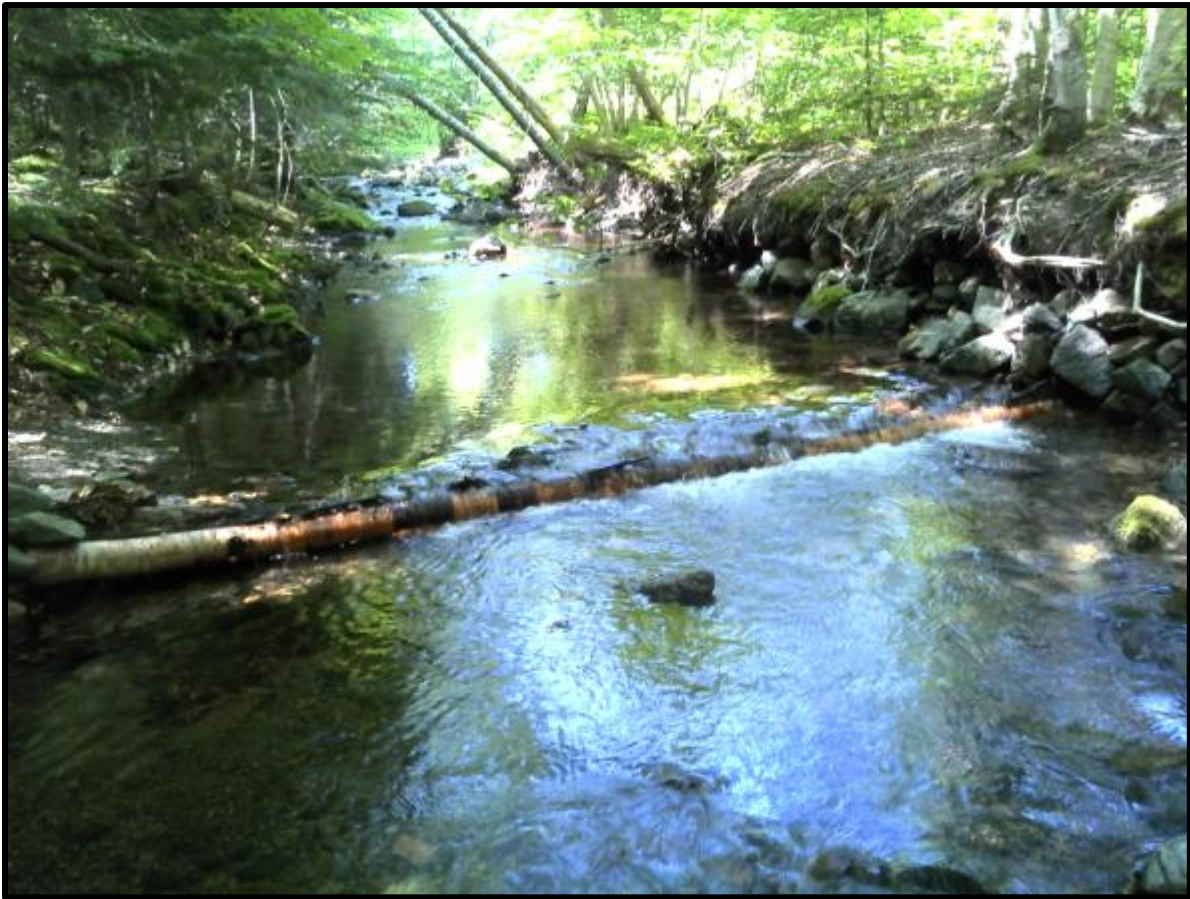
Way Point 69: Digger Log

Digger Log #12	69	Replace, to small. Debris from #12 can stay, its helping the bank. Debris can stay, minimum delimiting.
Digger Log #13	70	Add some rock on the left side along with the bottom. Big pooling.
Deflector #14	71	Deflector needs more rock.
Digger Log #15	72	Extension of digger log. 8-7 to the left.
Digger Log #16	73	Looks good needs extensions.
Digger Log #17	74	Was an old fish hut. Needs logs and possibly deflectors.
Digger Log #18 Deflector	75	Good rock work or wood deflector.
Digger Log #19	76	Needs rock deflector. Good clear debris.
Digger Log #20	77	Looks good. Rock Deflector. Needs some rock maintenance

Figure 39. Maintained digger log structure.

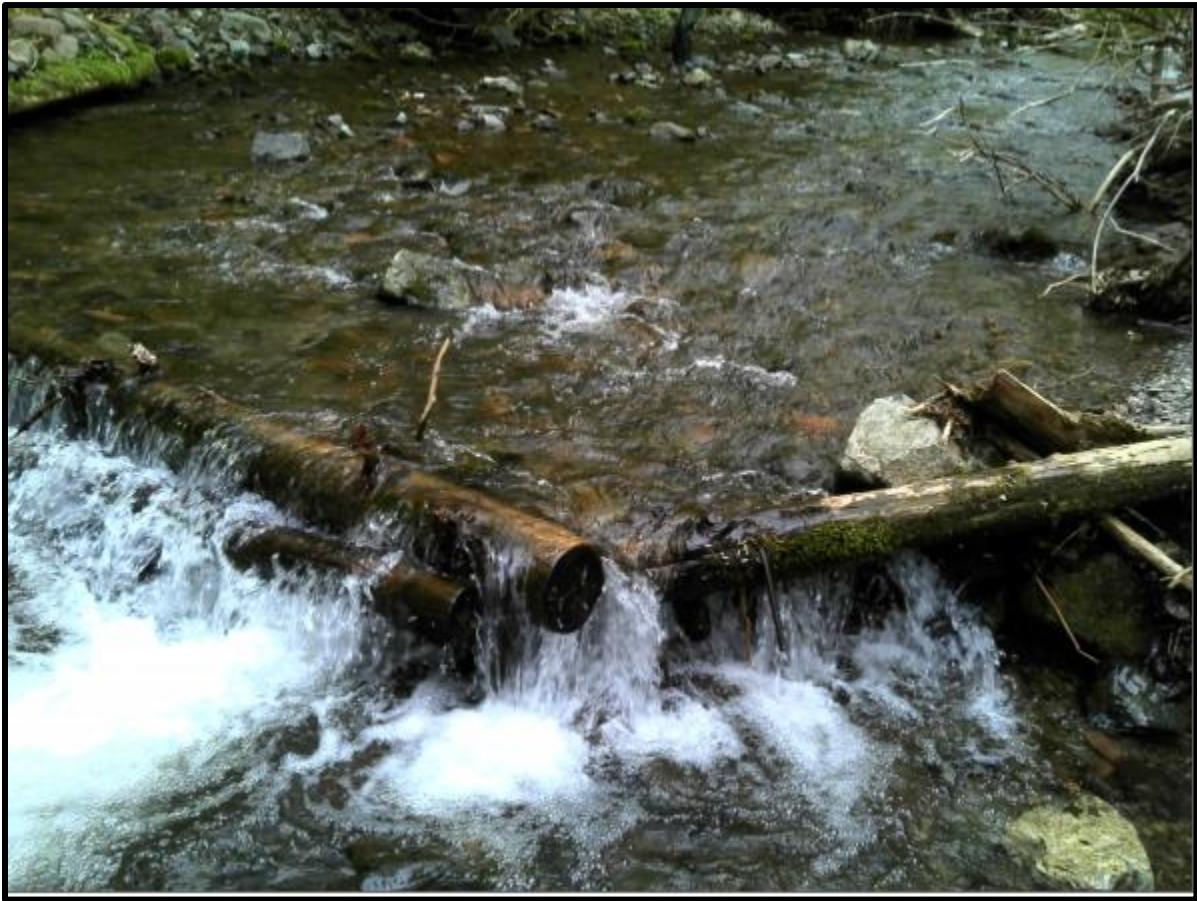
Way Point 70: Digger Log

Figure 40. Digger log structure that needed maintenance.

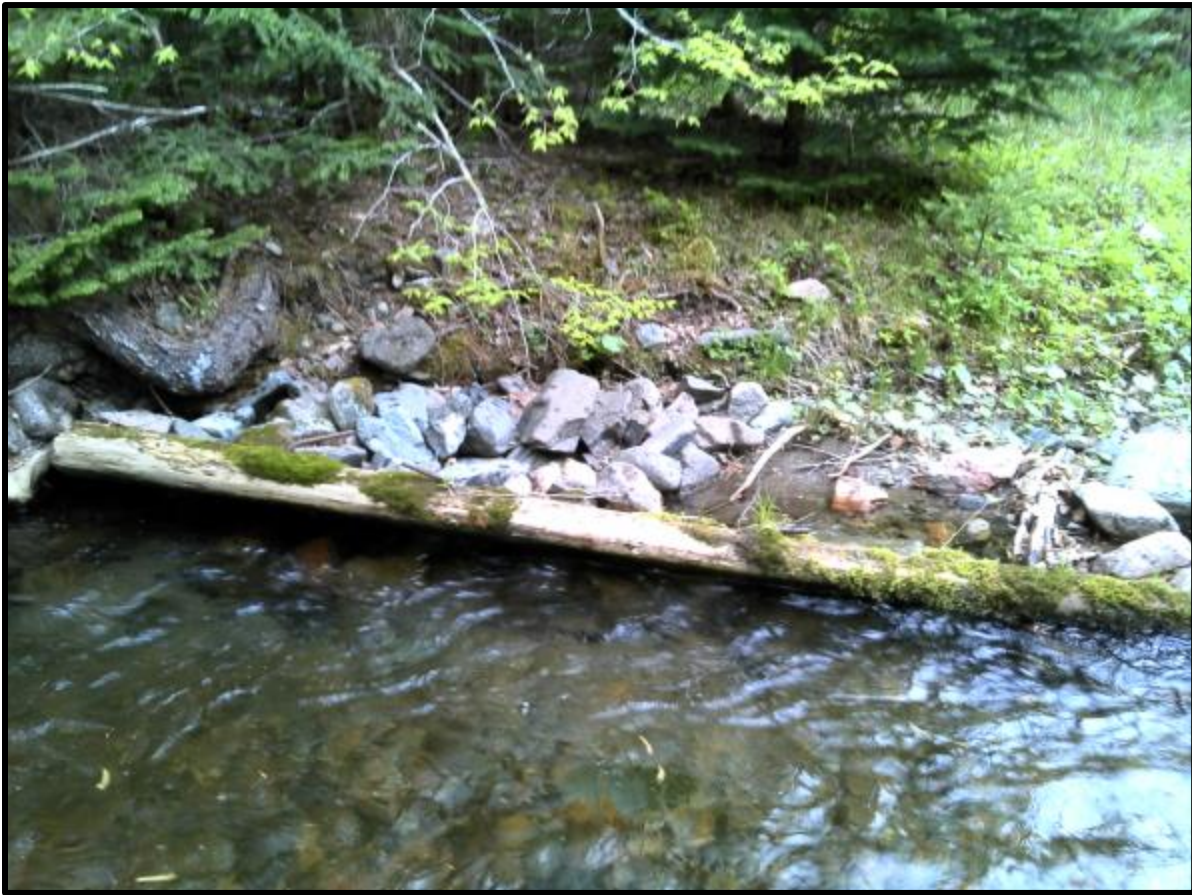
Way Point 71: Deflector

Figure 41. Deflector structure before maintenance.

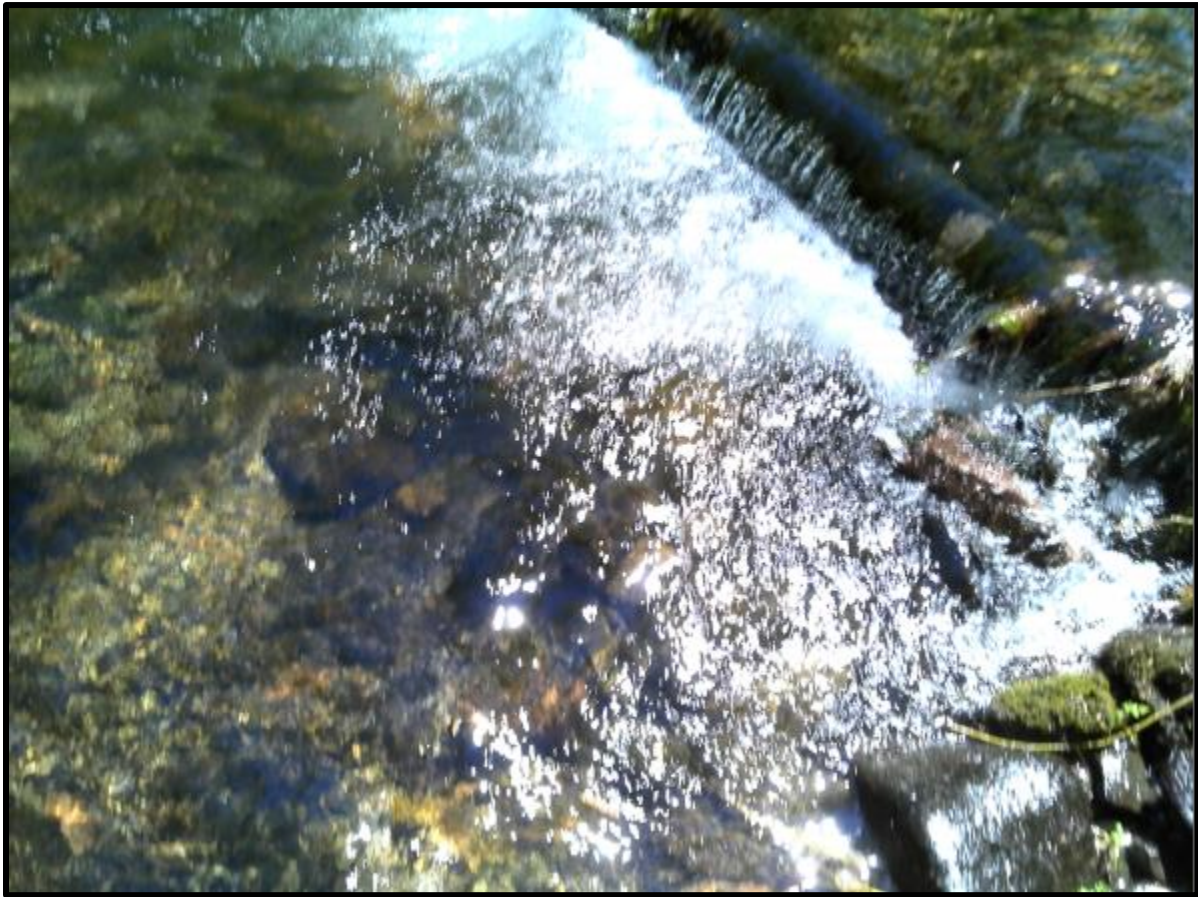
Way Point 77: Digger Log

Figure 42. Digger log that was maintained.
