SALMONID HABITAT RESTORATION

INVERNESS SOUTH ANGLERS ASSOCIATION

Progress Report

Monday, June 12th, 2017

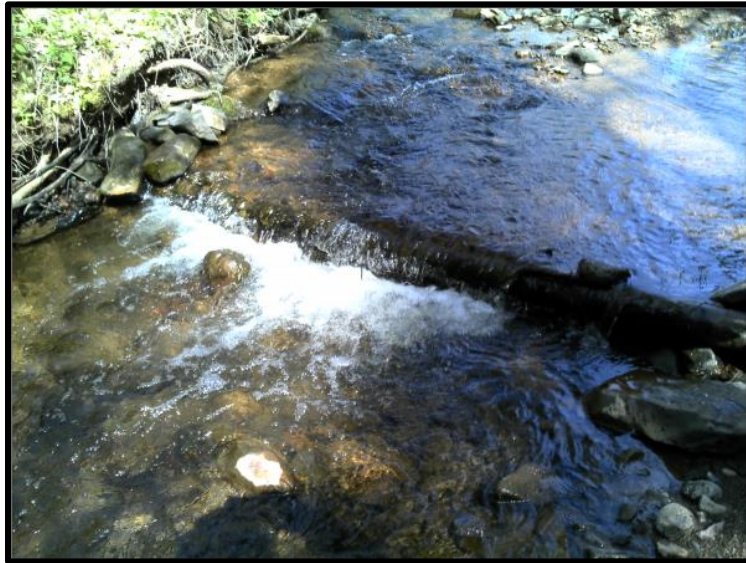
Way Point 36 – Digger Log

STRUCTURE PRESENT	WAY POINT #	COMMENTS
Digger Log	36	Starting from the head of the river. Looks good; has good shade.
Digger Log	37	Has debris overhead but is not hurting anything.
Digger Log	38	Broke down and cast aside.
Digger Log	39	Looks good but needs maintenance.
Digger Log	40	Looks good. Needs rock.
Digger Log	41	Looks good, no problems. Needs some bank rock, but there is no rock around.
Deflector/Bank Log	42	Looks good.
Digger Log	43	Needs more rock for the deflector. Log is working.
Digger Log	44	Looks good, needs maintenance.
Deflector	45	Looks good.
Digger Log	46	Maintenance.
Digger Log	47	Good condition.
Deflector	48	
Digger Log	49	Needs maintenance.
Digger Log	50	Needs maintenance.
Digger Log	51	Needs maintenance.
Deflector	52	Needs maintenance.
Digger Log	53	Looks good, need maintenance.
Digger Log	54	Slight maintenance needed.

Figure 45. Before picture of digger log structure.

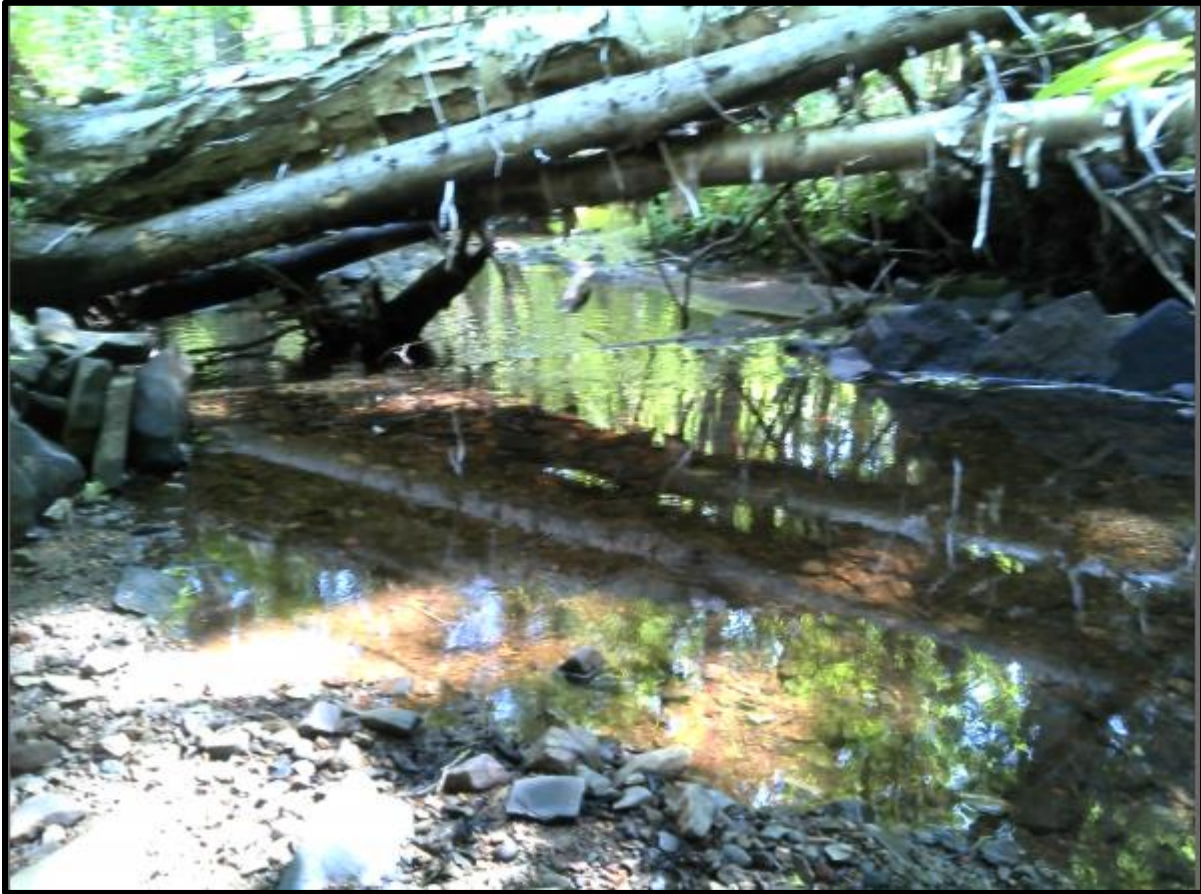
Way Point 37- Digger Log

Figure 47. An after picture of a digger log structure with debris overhead.

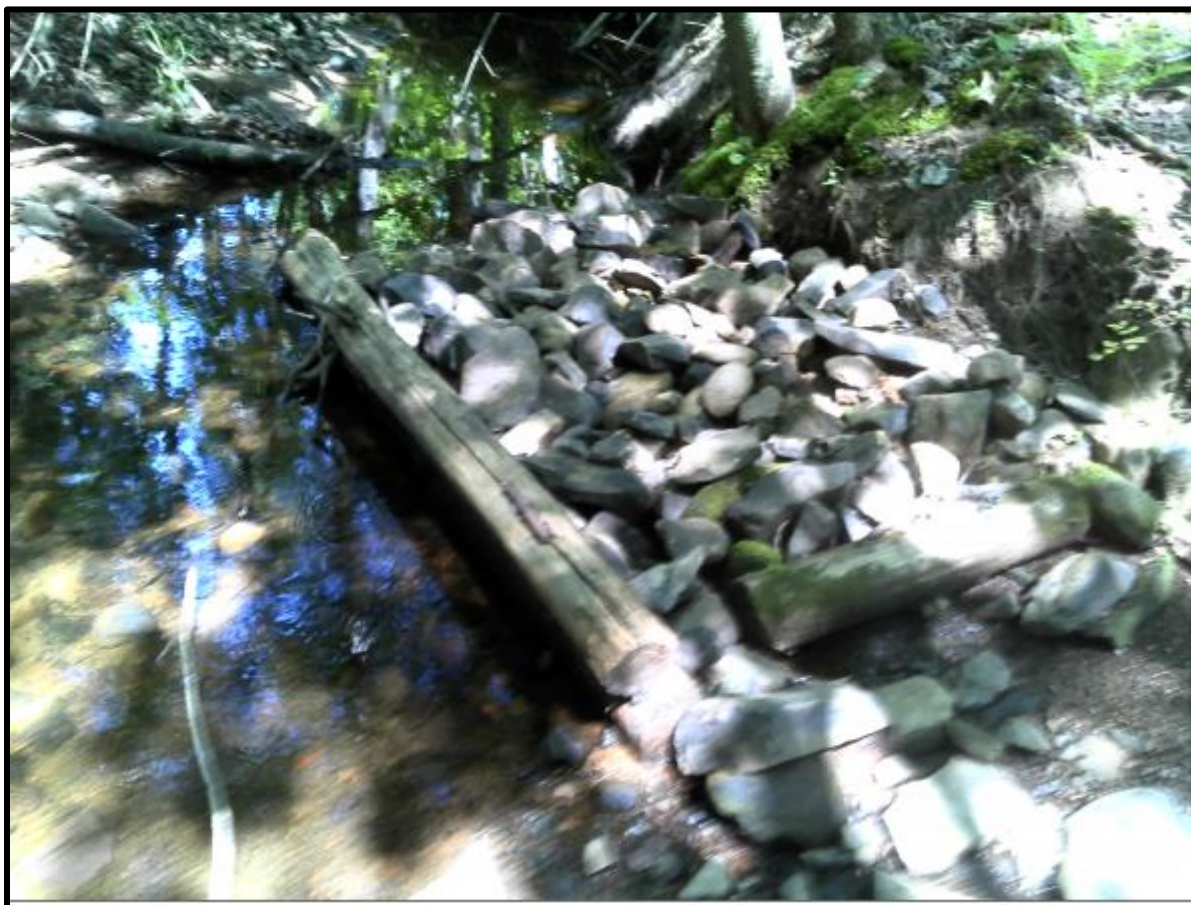
Way Point 38 – Deflector

- Original structure at this way point was a digger log but was cast aside; therefore, it needs to be fully replaced.

Figure 48. Deflector structure that was maintained.

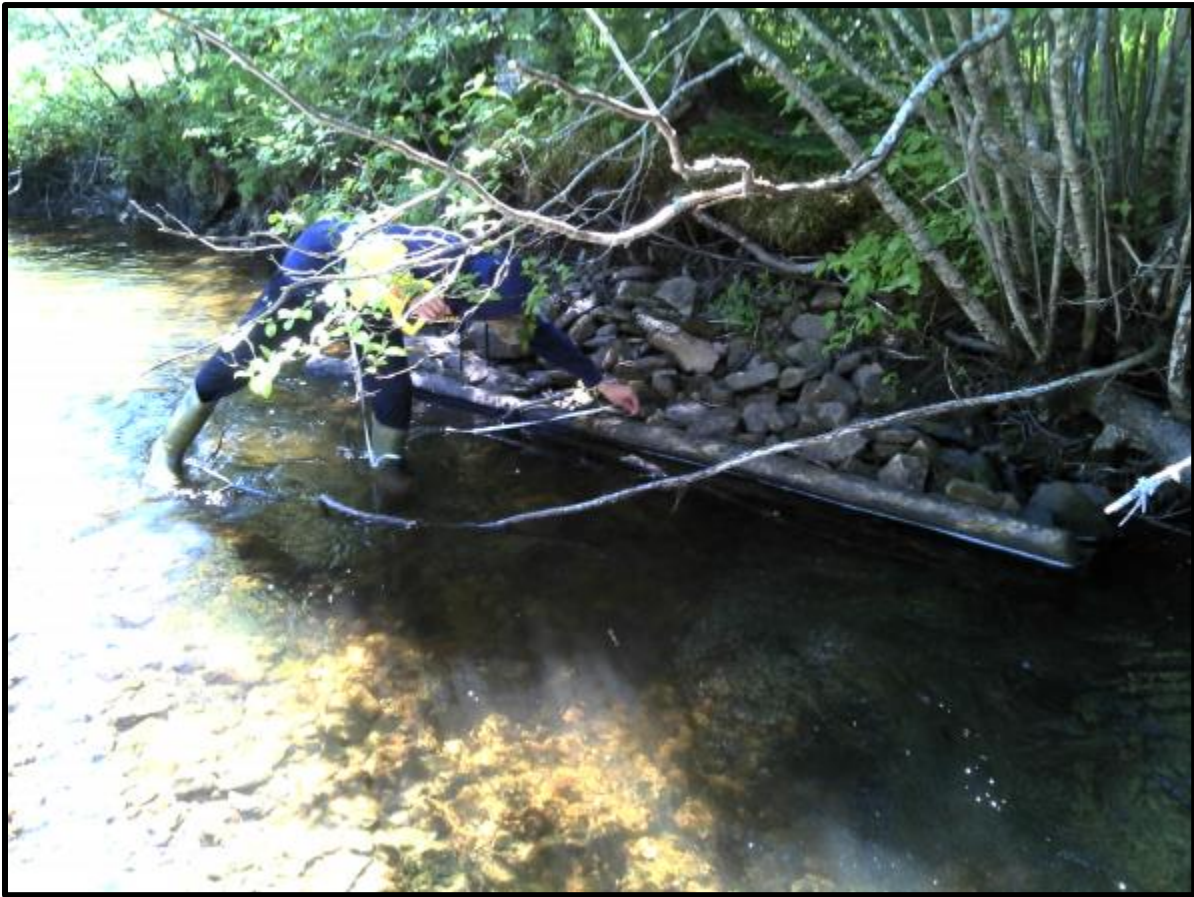
Way Point 151 – Deflector

Figure 68. Deflector structure at waypoint 151 that was maintained.

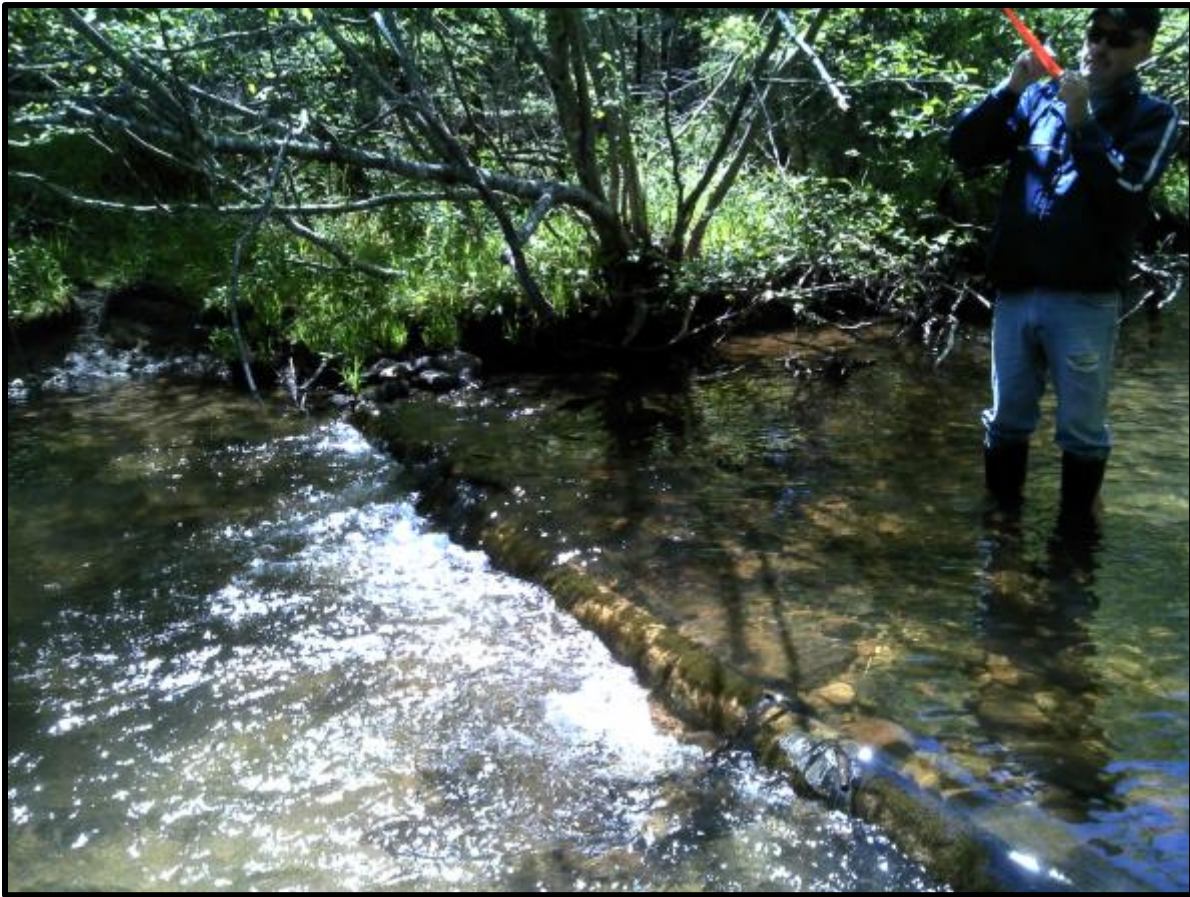
Way Point 153 – Digger Log

Figure 70. Digger Log structure that was maintained at waypoint 153.

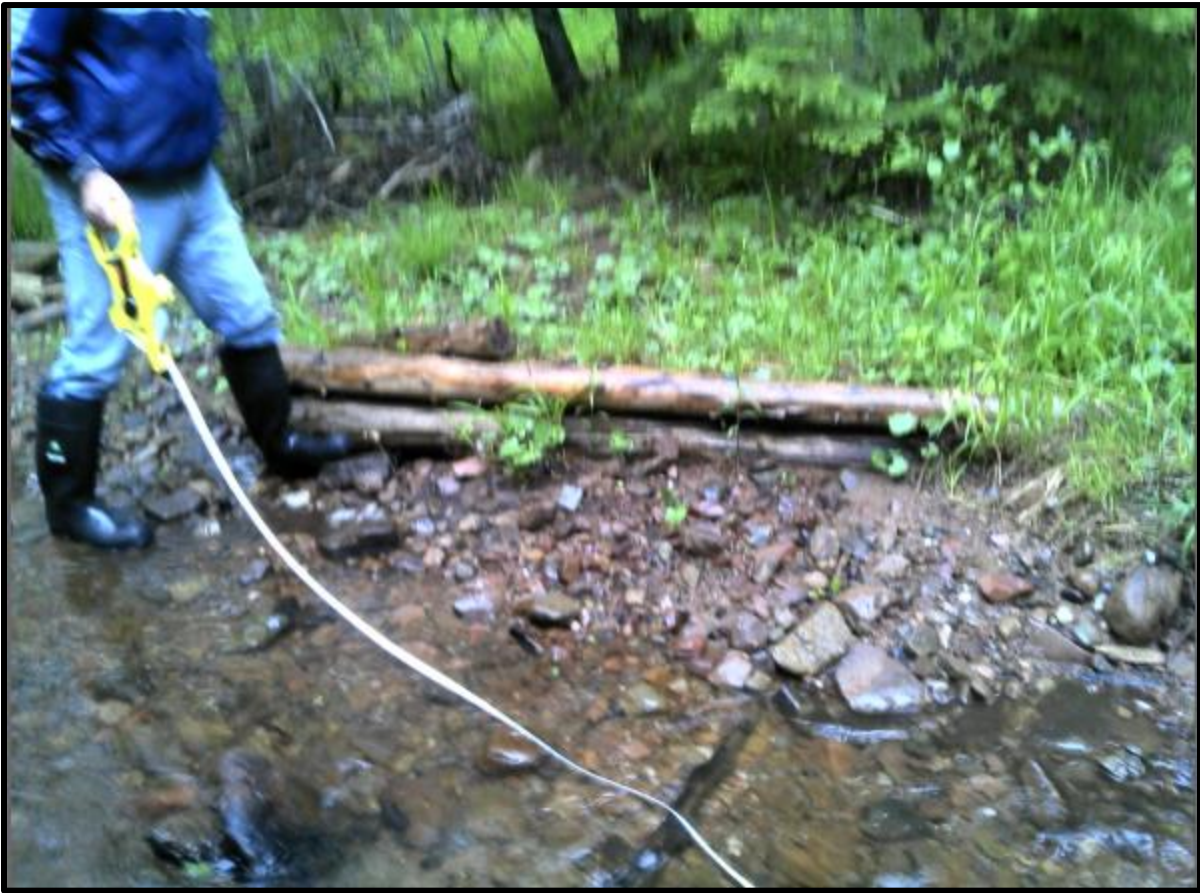
Way Point 166 – Deflector

Figure 73. Deflector at waypoint 166 that needed maintenance.

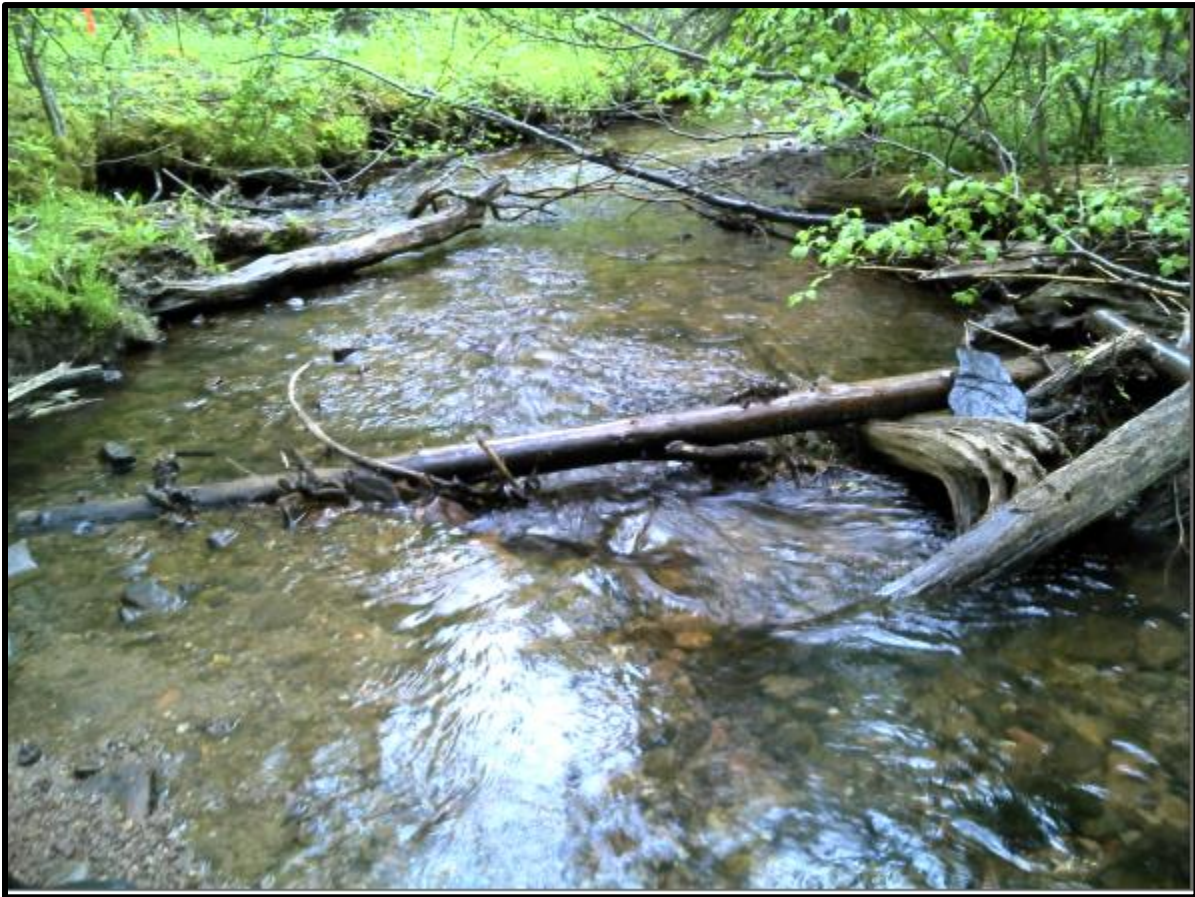
Way Point 167 – Digger Log

Figure 74. Uplifted digger log structure at waypoint 167.

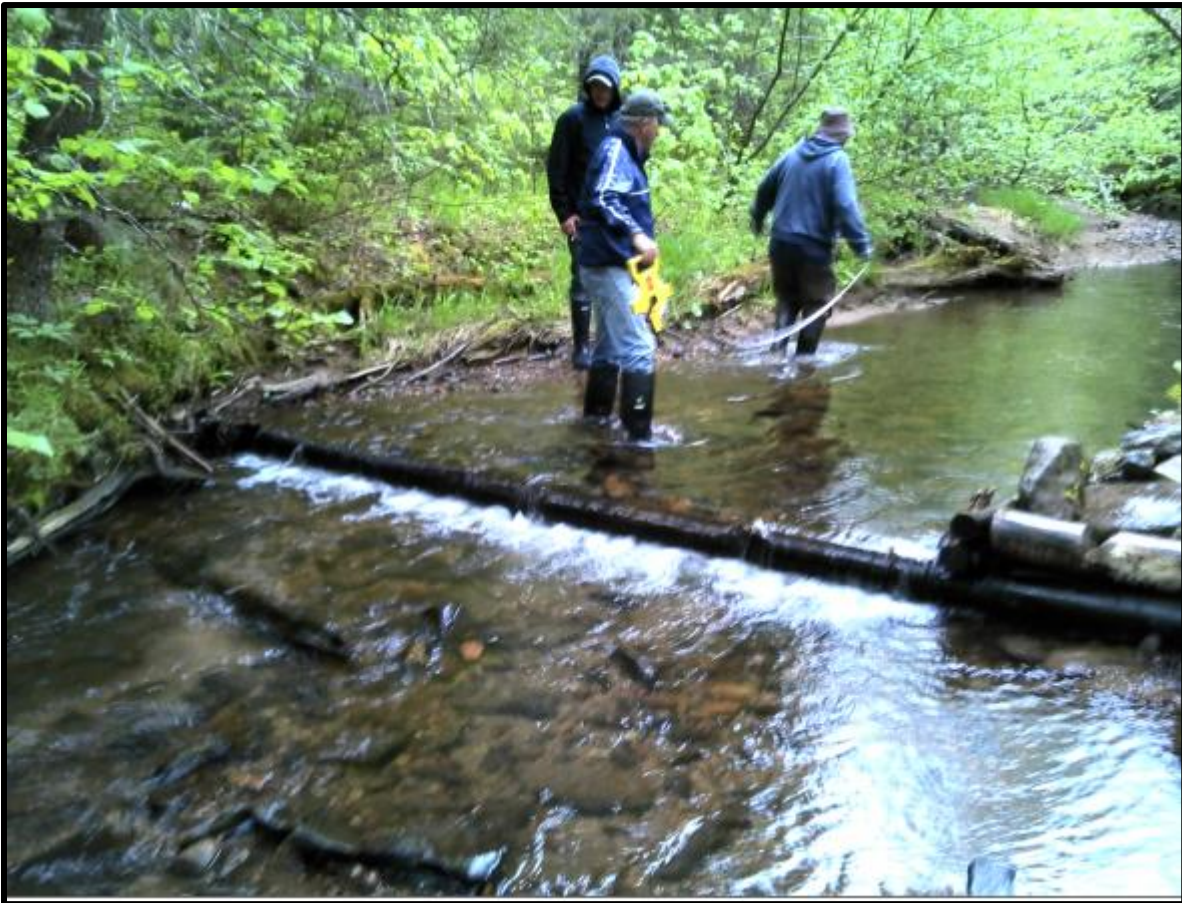
Way Point 168 – Digger Log & Deflector

Figure 75. Digger log and deflector that was maintained at waypoint 168.

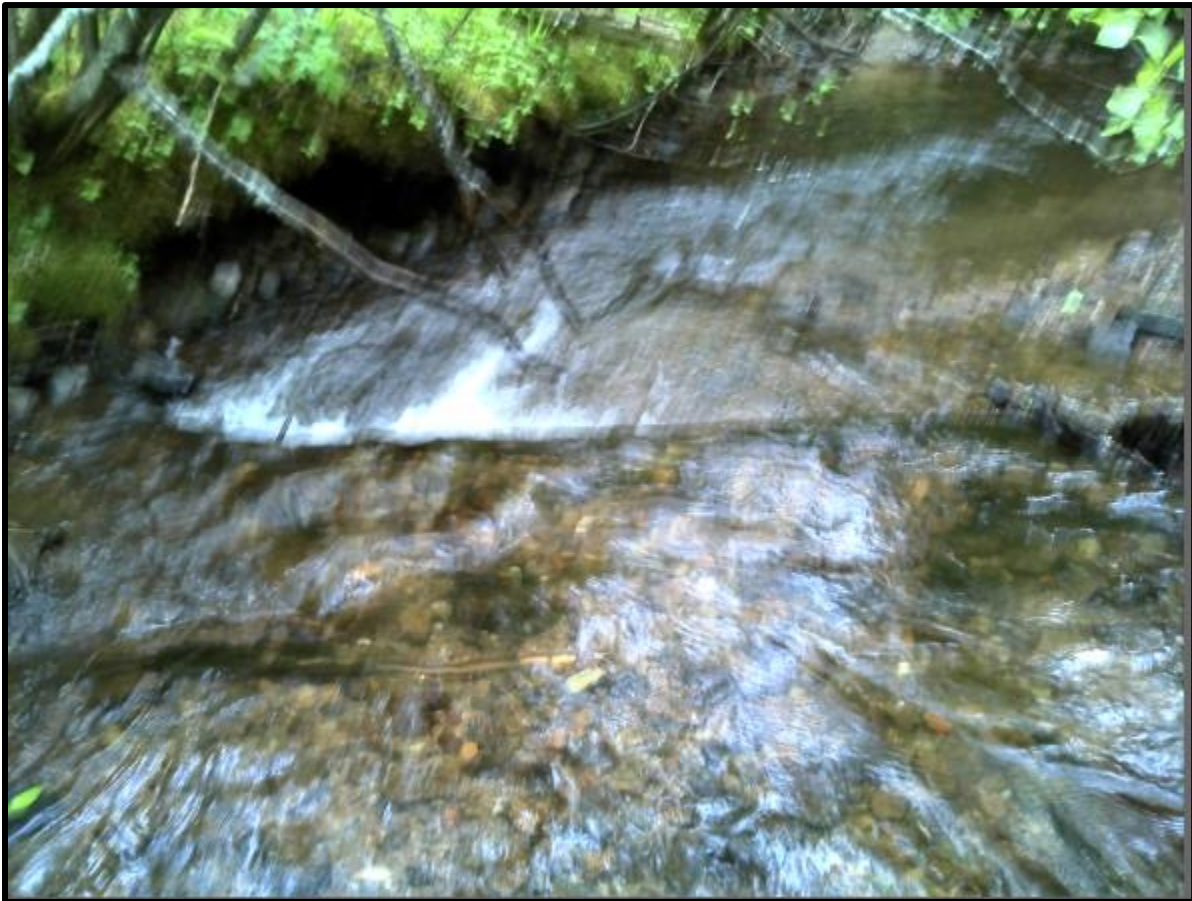
Way Point 169 – Digger Log

STUCTURE PRESENT	WAY POINT #	COMMENTS
Digger Log and Deflector	146	Looks good needs maintenance.
Digger Log and Deflector	147	Looks good, maintenance needed.
Digger Log and Deflector	148	Good. Needs maintenance,
Digger Log and Deflector	149	Okay condition. Needs maintenance.
Digger Log and Deflector	150	Looks nice. Good pooling area.
Digger Log and Deflector	151	Looks good. Maintenance needed.
Digger Log and Deflector	152	Looks good. Maintenance needed.
Digger Log and Deflector	153	Looks good. Maintenance needed.
Digger Log and Deflector	154	Looks good. Maintenance needed.
Digger Log & Deflector	162	Digger log is buried. Maintenance needed on deflector.
Deflector	164	Two deflectors.
Deflector	165	Needs more rock and debris removal.
Deflector	166	Maintenance needed.
Digger Log	167	Needs to be resealed. Maintenance is needed.
Digger Log and Deflector	168	Looks good, rock is needed.
Digger Log	169	Nice pool. Needs rock.

Figure 76. Digger Log structure at waypoint 169.

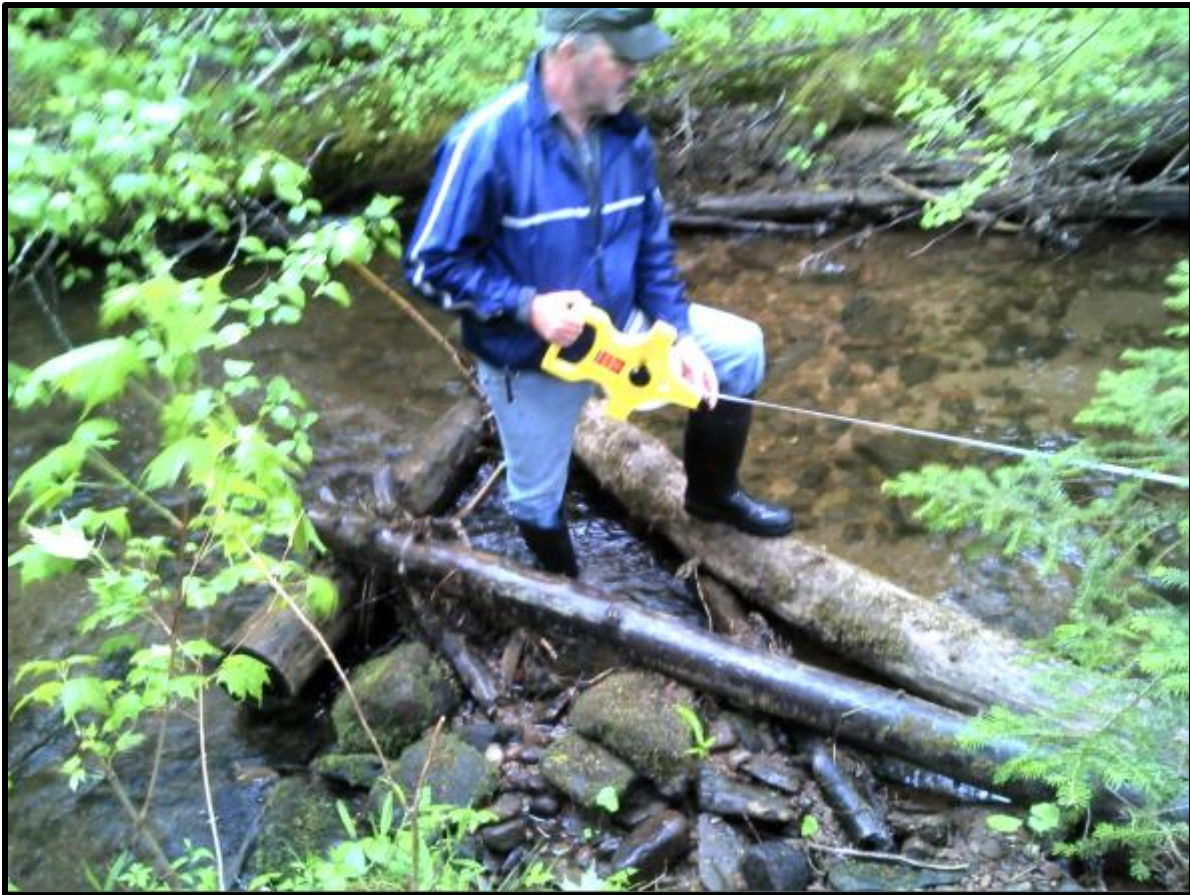
Way Point 170 – Digger Log and Deflector

Digger Log and Deflector	170	Maintenance needed.
Digger Log	171	Needs maintenance.

Figure 77. Digger log and deflector at waypoint 170.

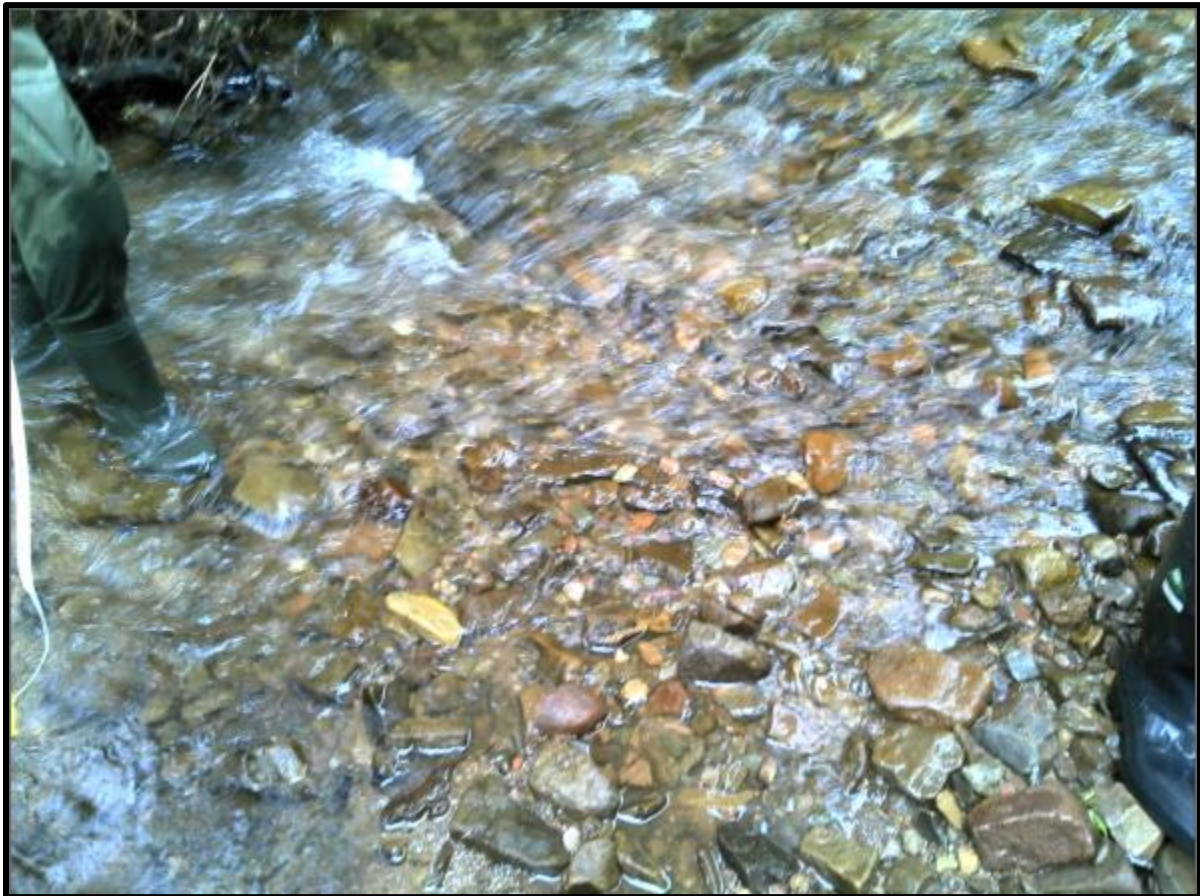
Way Point 79 – Digger Log

STRUCTURE PRESENT	WAY POINT #	COMMENTS
Digger Log	78	Nothing can be done.
Digger Log	79	Needs debris removal. Maintenance needed.
Digger Log	80	More rock needed.
Digger Log	81	Repairs needed.
Digger Log	82	Looks good. Needs debris removal.
Deflector	83	Nice pool.
Digger Log	84	Little maintenance is needed.
Digger Log	85	Good condition.
Digger Log	86	Functioning well. Debris removal needed.
Deflector	87	Maintenance.
Digger Log	88	Deflector needed. Debris removal needed.
Digger Log	89	Maintenance needed. Nice pool.
Digger Log	90	Maintenance needed.
Digger Log	91	Maintenance needed.
Digger Log	92	Slight maintenance.
Digger Log	93	Needs maintenance.
Digger Log	94	Debris removal needed.
Digger Log	95	Maintenance and debris removal needed.
Digger Log	96	Looks good.
Digger Log	97	Not functioning. Nothing can be done.
Digger Log	98	Maintenance needed.
Digger Log and Deflector	99	Beautiful.
Digger Log	100	Nice pooling, small maintenance needed.

Figure 98. Digger log that needs to be fully replaced.

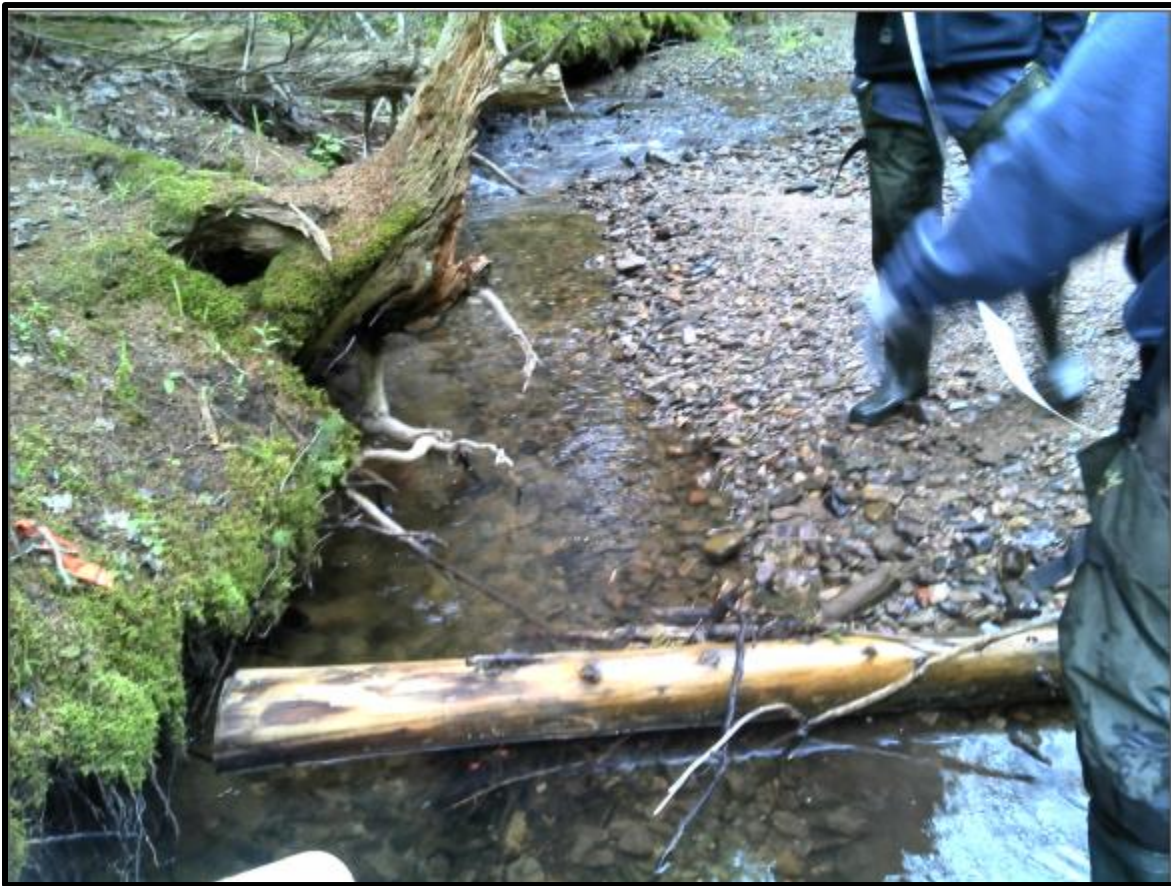
Way Point 81 – Digger Log

Figure 99. Digger Log Structure.

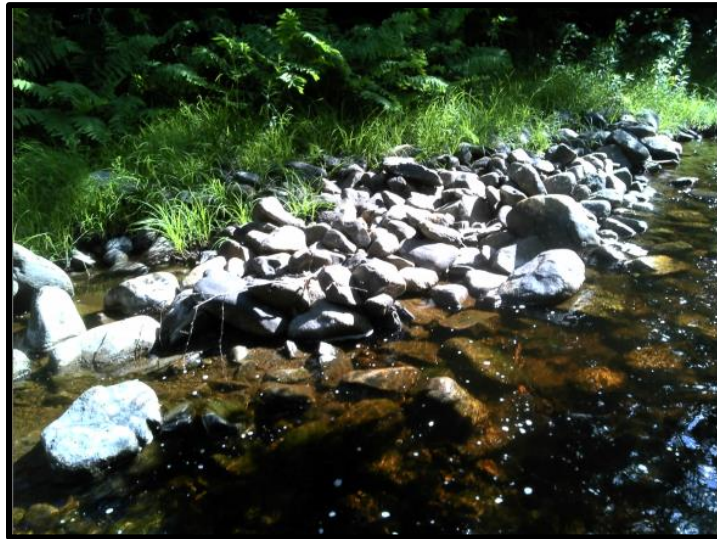
Way Point 176 - Deflector

Figure 134. Before picture of deflector at way point 176.
