SALMONID HABITAT RESTORATION
INVERNESS SOUTH ANGLERS ASSOCIATION

Winter Damage Assessment

Date: 2019

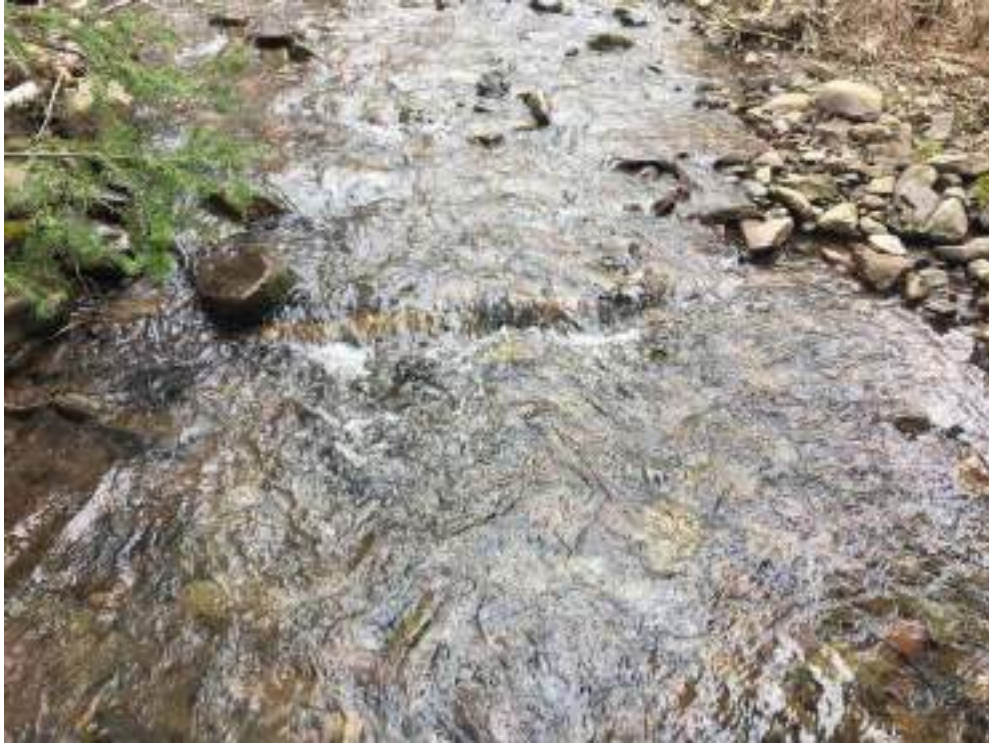
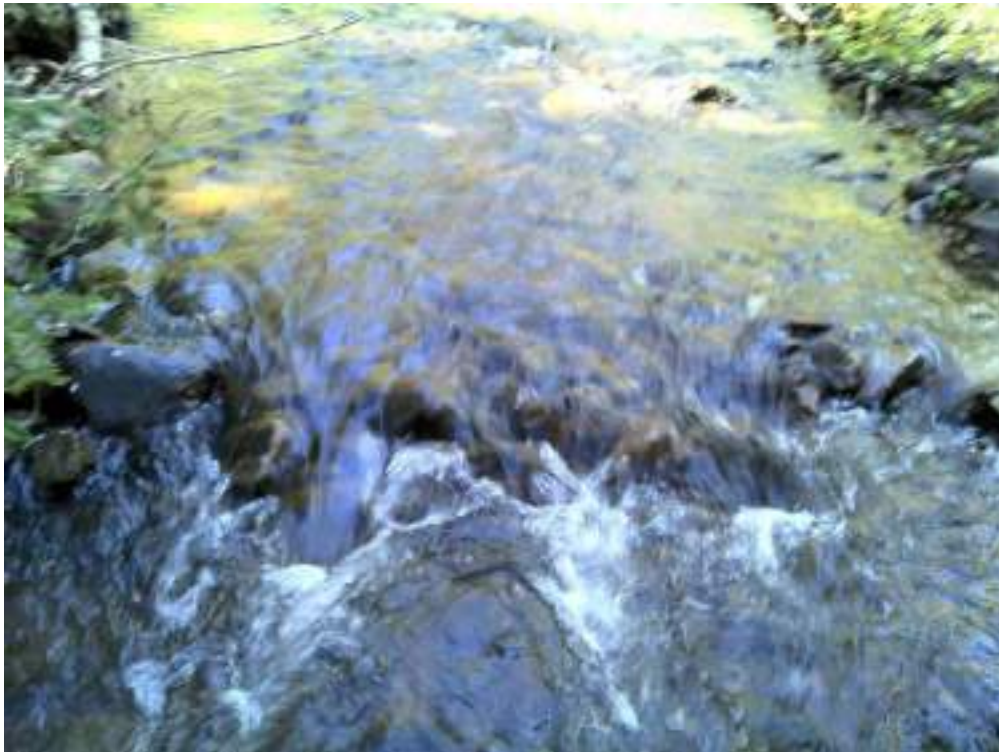
Figure 14. Showing before and after photos of digger log #6 upstream from the road. This structure is buried into the substrate and need removal and replacement.

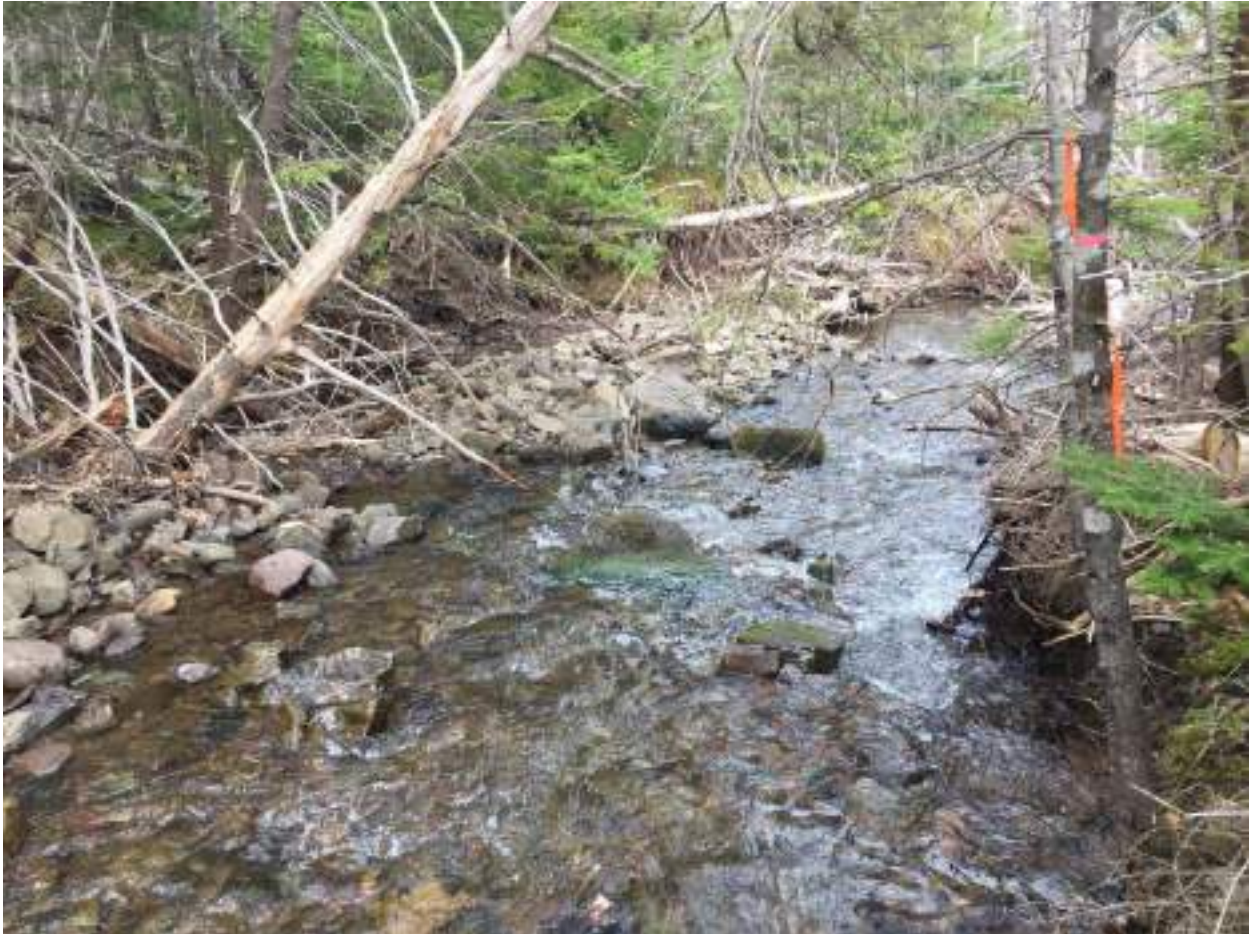
After structure 6 there was a location that was flagged of for a diggerlog installation from the Adopt a stream training in 2017. The cut log was found nearby – uninstalled.

Figure 15. Showing the location of an uninstalled digger log from the 2017 adopt a stream training.

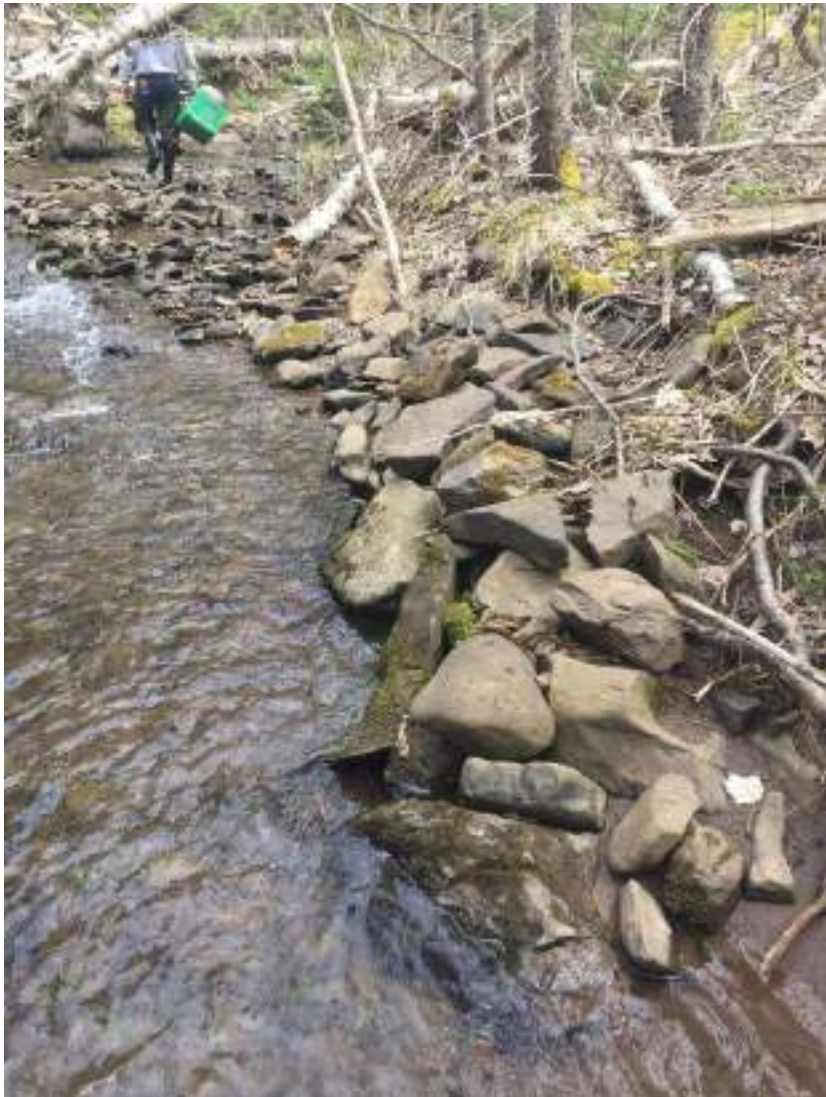
Figure 19. Bank stabilization - structure #9 downstream from the road.

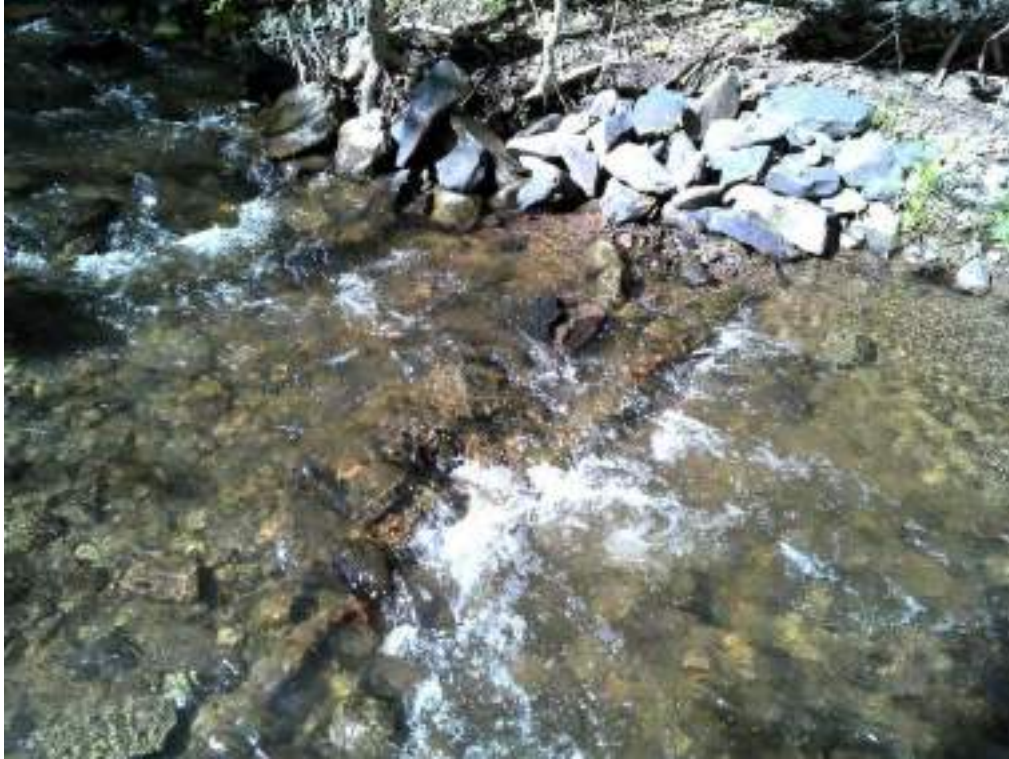
Figure 26. This photo shows a buried digger log - structure #16 on the downstream side of the road. This structure could not be maintained and needs a replacement

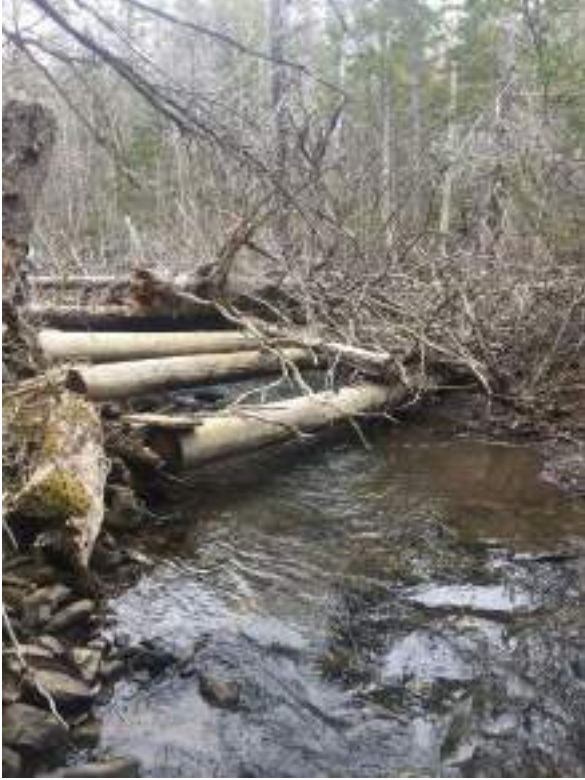
Braid in river:

Found after structure #13 Downstream from the road.

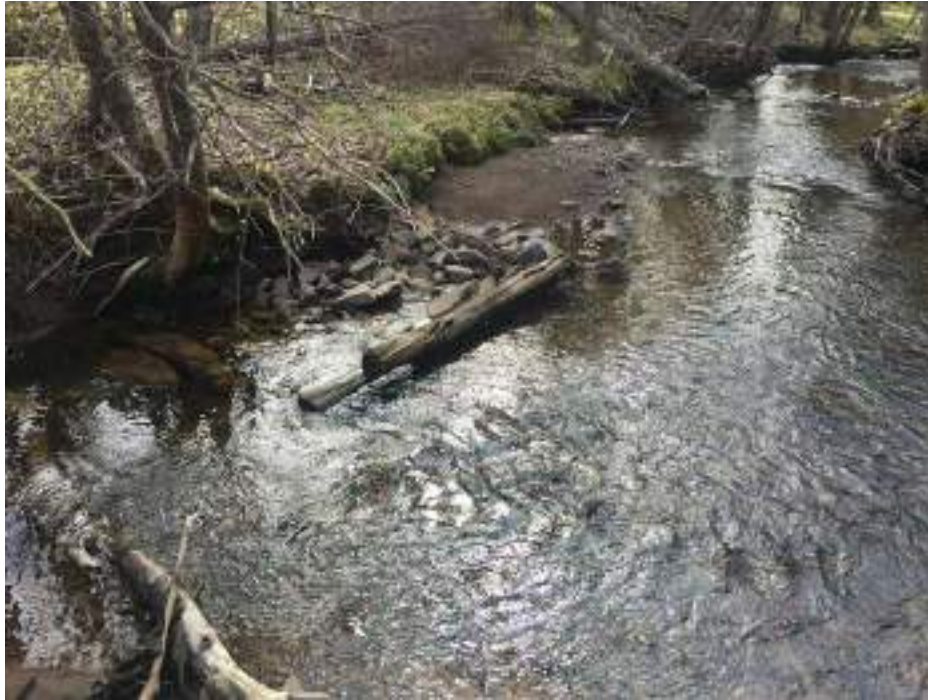
Figure 50. Structure #2 - Deflector that needs replacement. No maintenance completed.

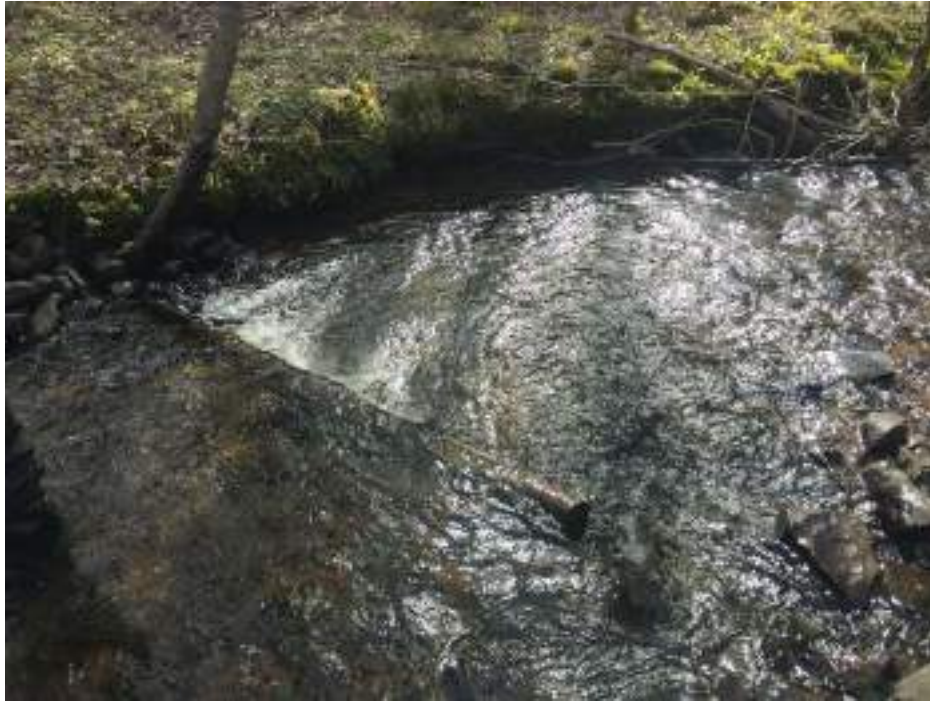
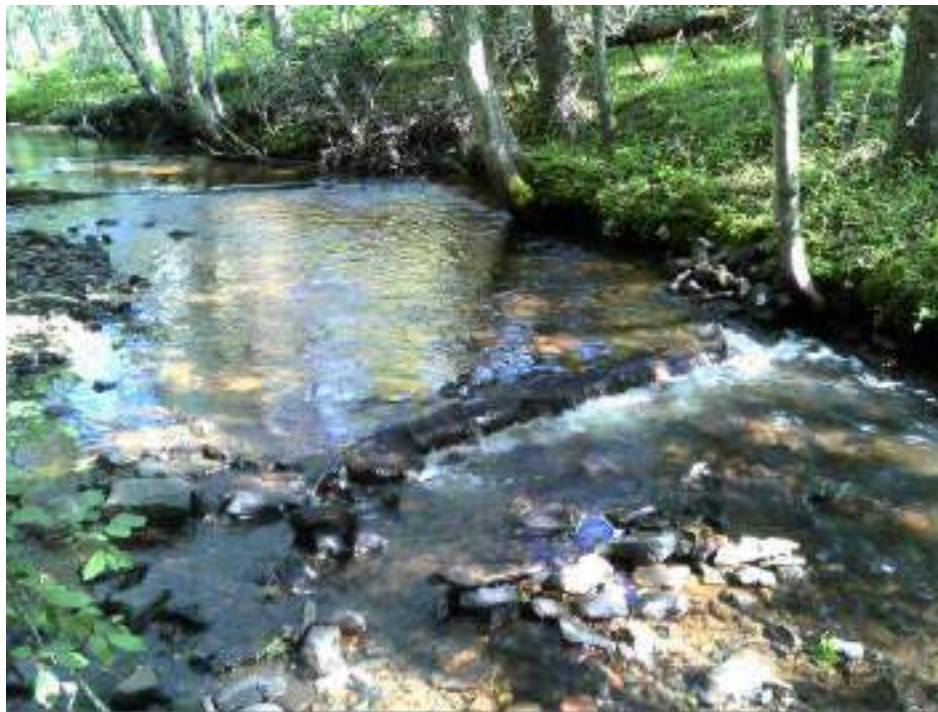
Figure 51. Structure #3 - Diggerlog. Before and after pictures of attempted maintenance. This structure needs an extension on the upstream side of the log.

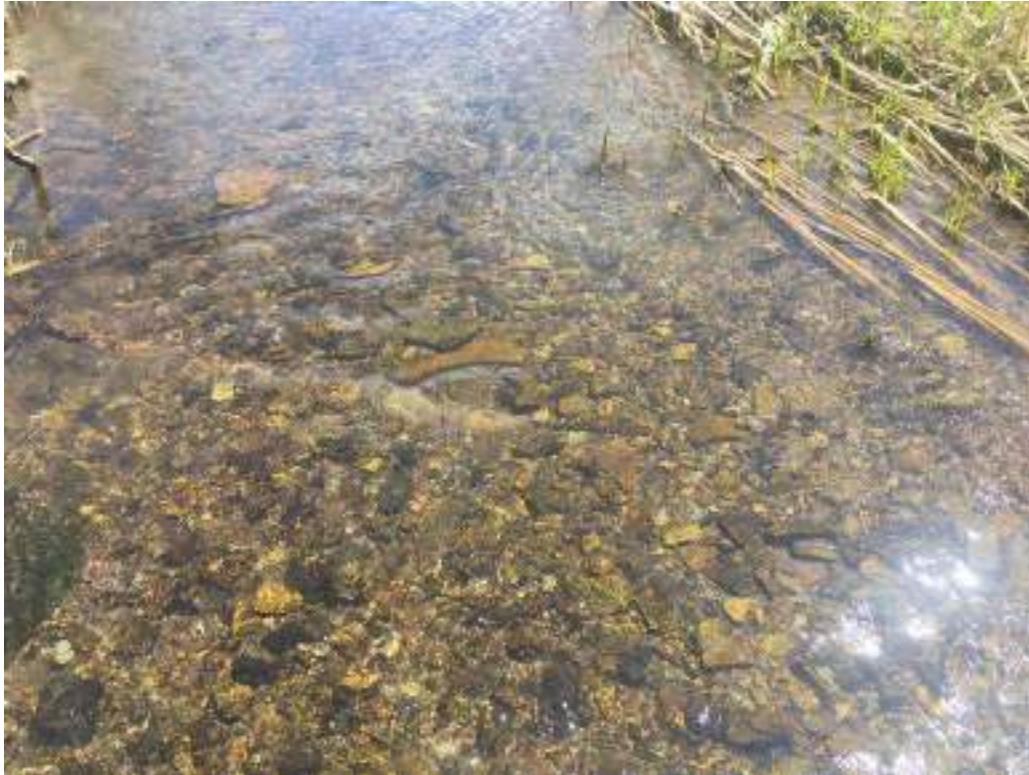
Figure 82. Structure #7 - buried diggerlog that needs a replacement.

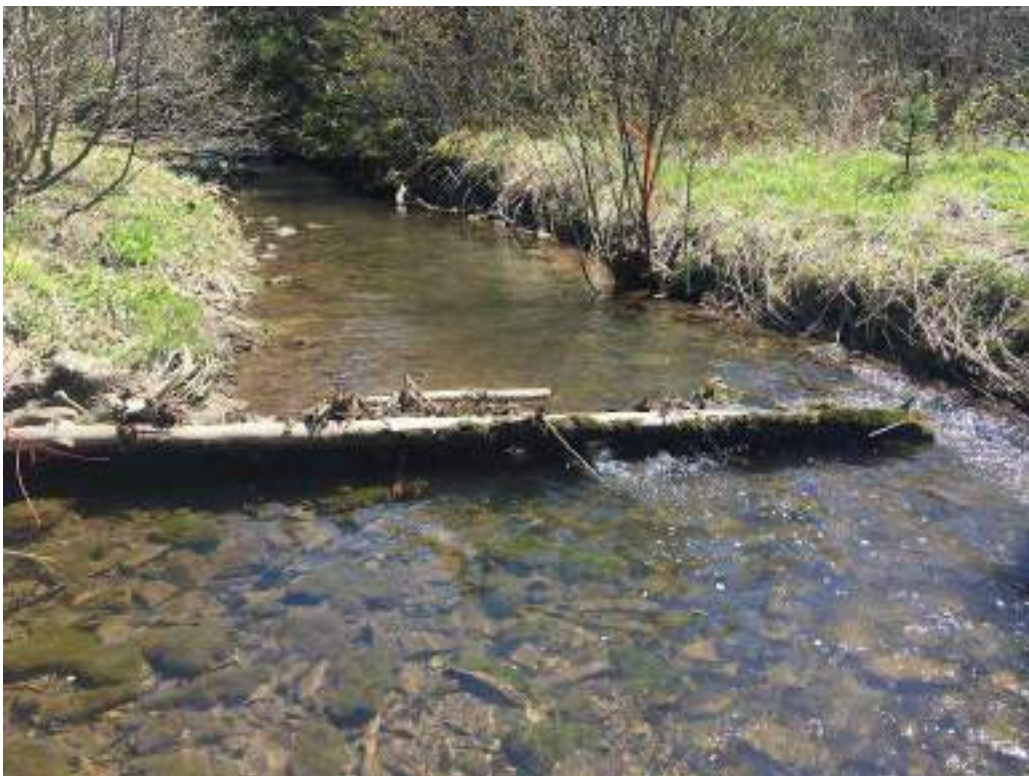
Figure 83. Structure #8 - diggerlog that needs a replacement. This is the last structure on the downstream side of Smithville Road.

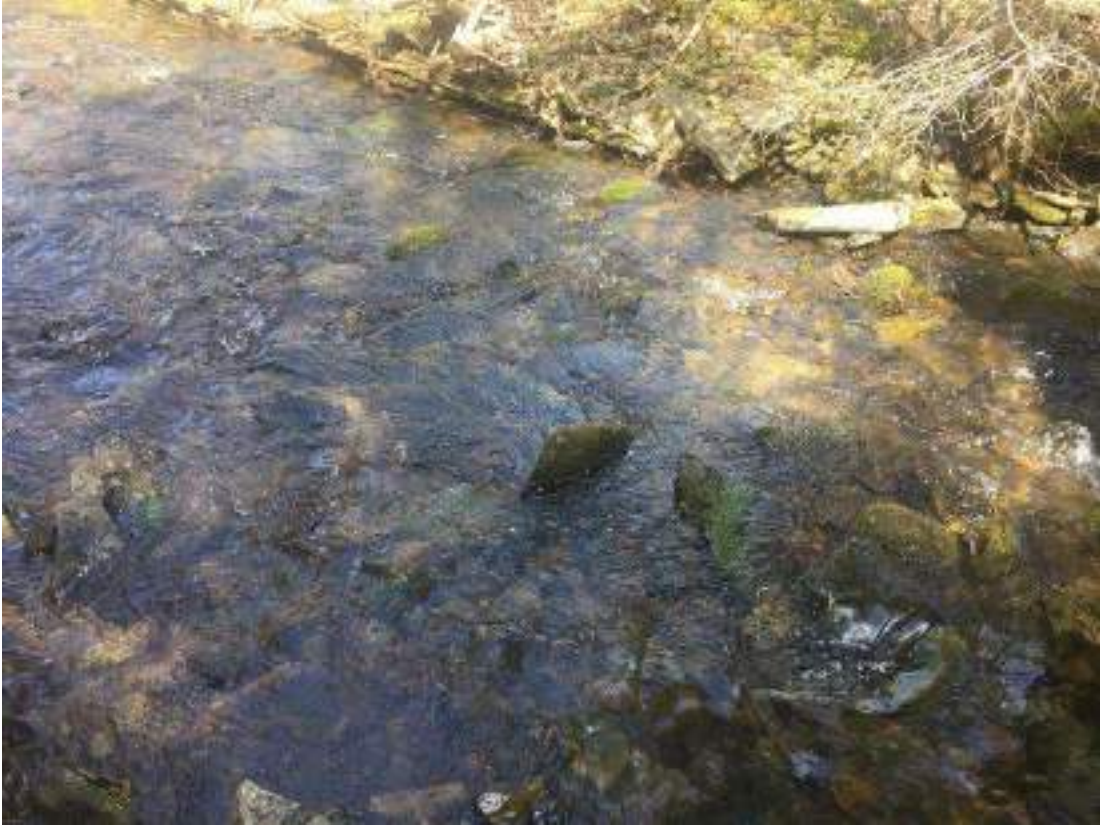
Figure 88. Diggerlog #13 - buried and needs replacement.

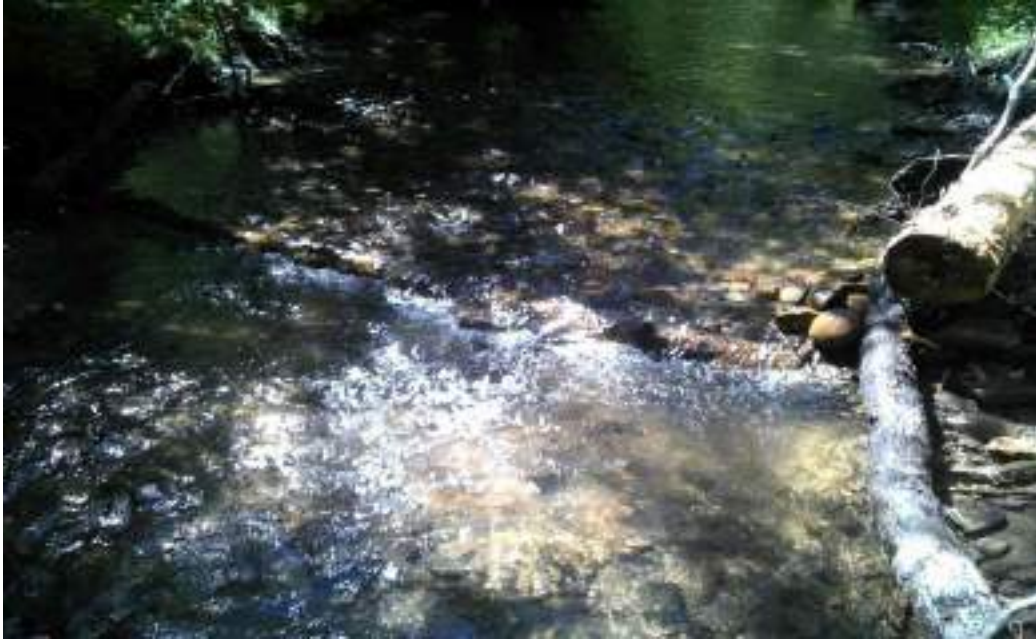
Figure 99. Diggerlog #5 - maintenance was attempted but not successful. This structure may need replacement.

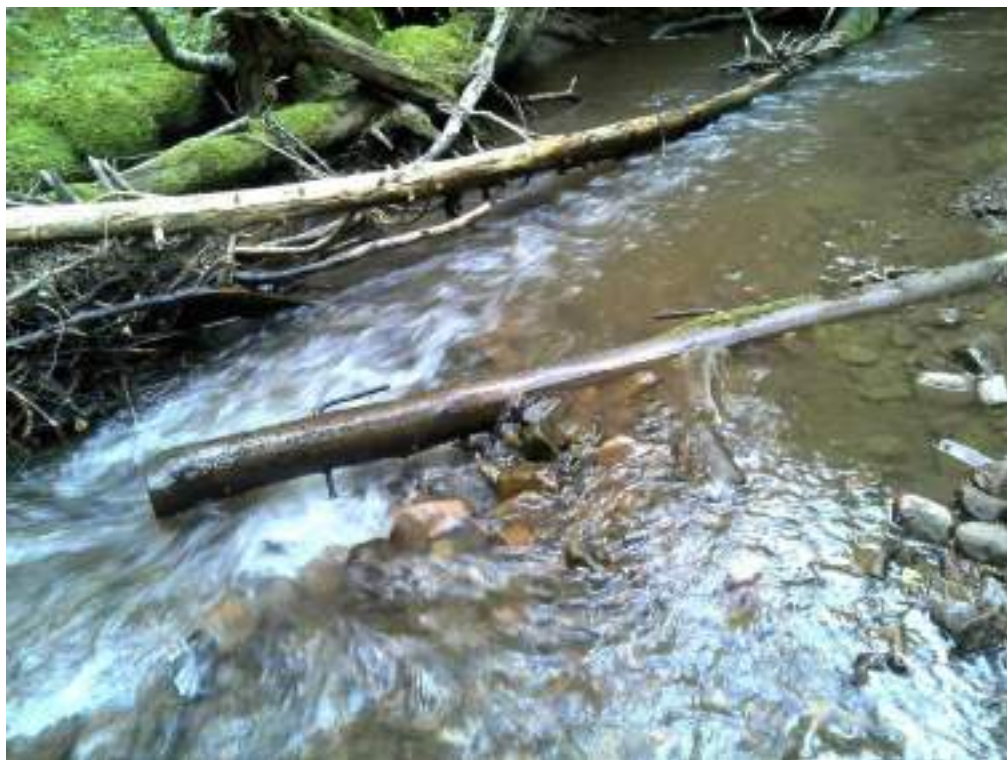
Figure 110. Diggerlog #16 - no maintenance performed. Structure needs to be removed and replaced.

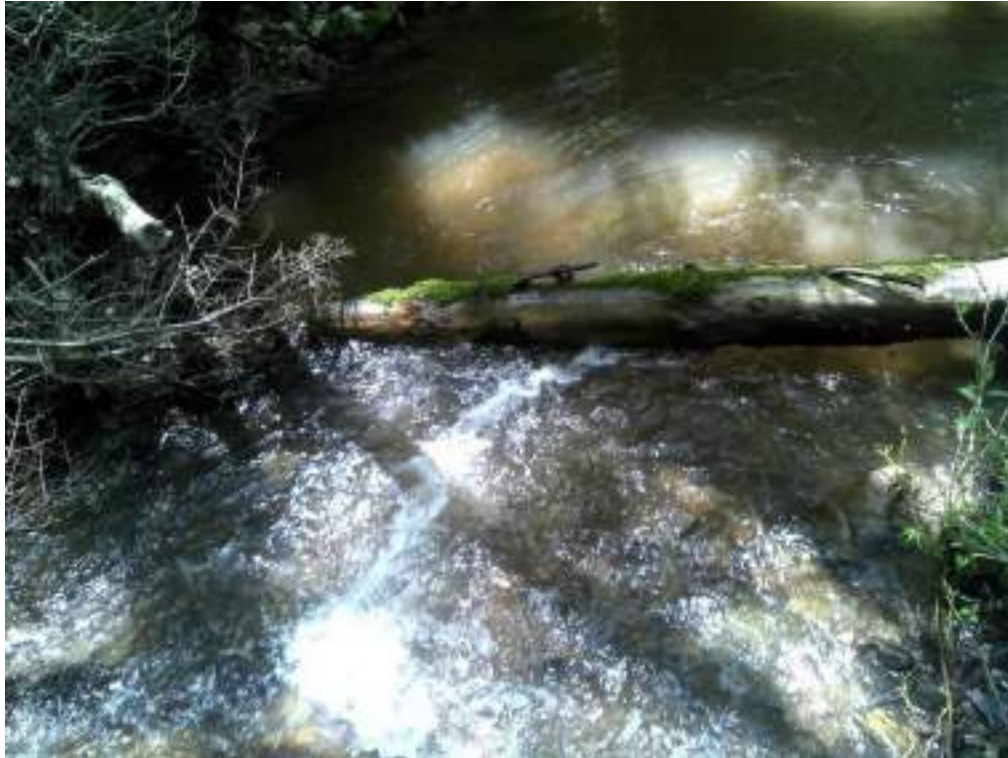
Figure 117. Diggerlog #23 - structure is washed out underneath. No maintenance performed - recommended removal.

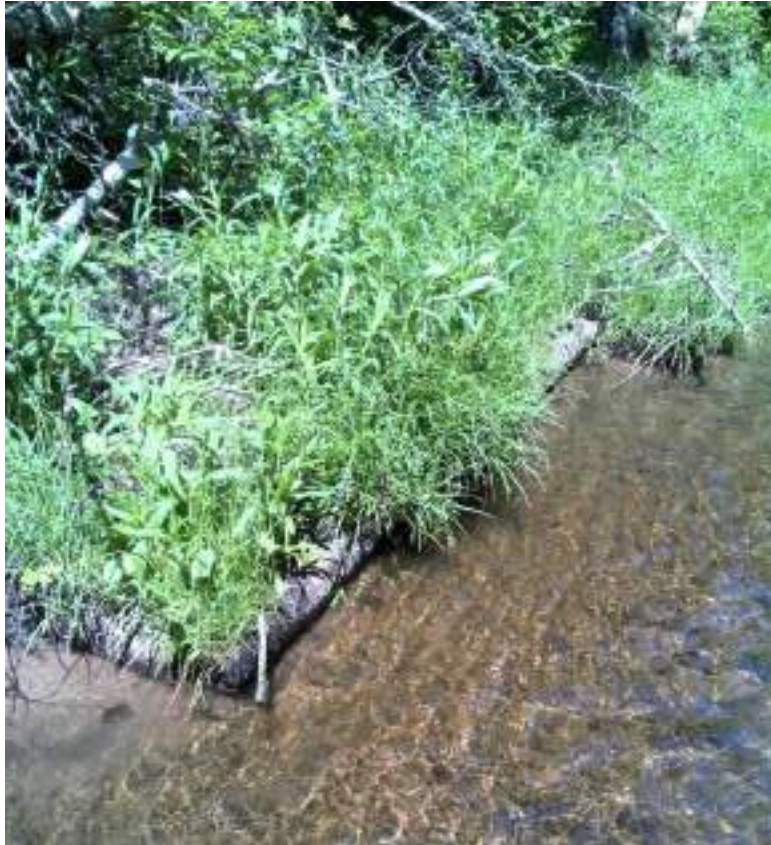
Figure 142. Deflector #5 - this deflector is in very good condition and is now becoming part of the bank side and has lots of vegetation growth.

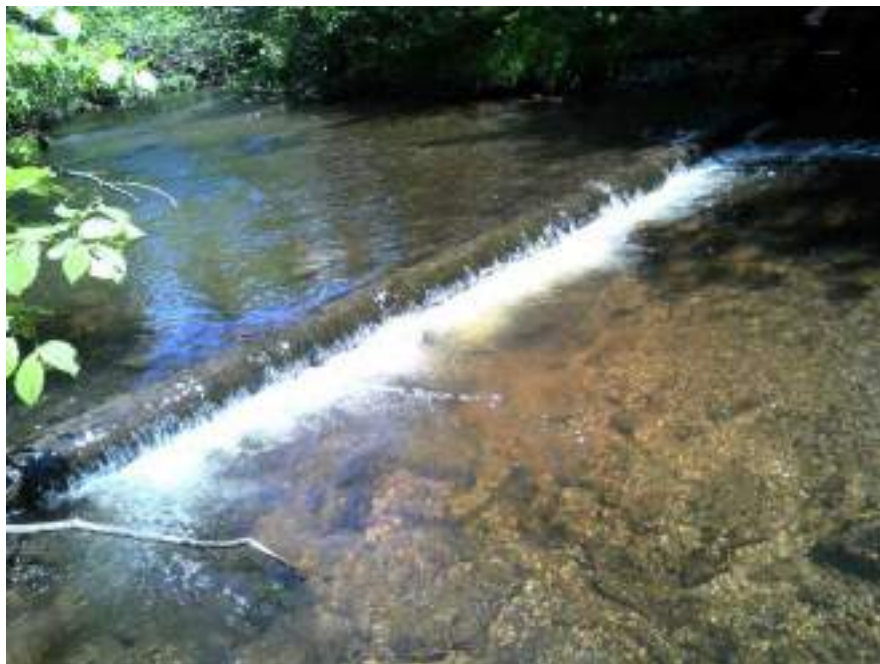
Figure 143. Diggerlog #6 - after picture of maintenance performed. This structure was in very good condition.

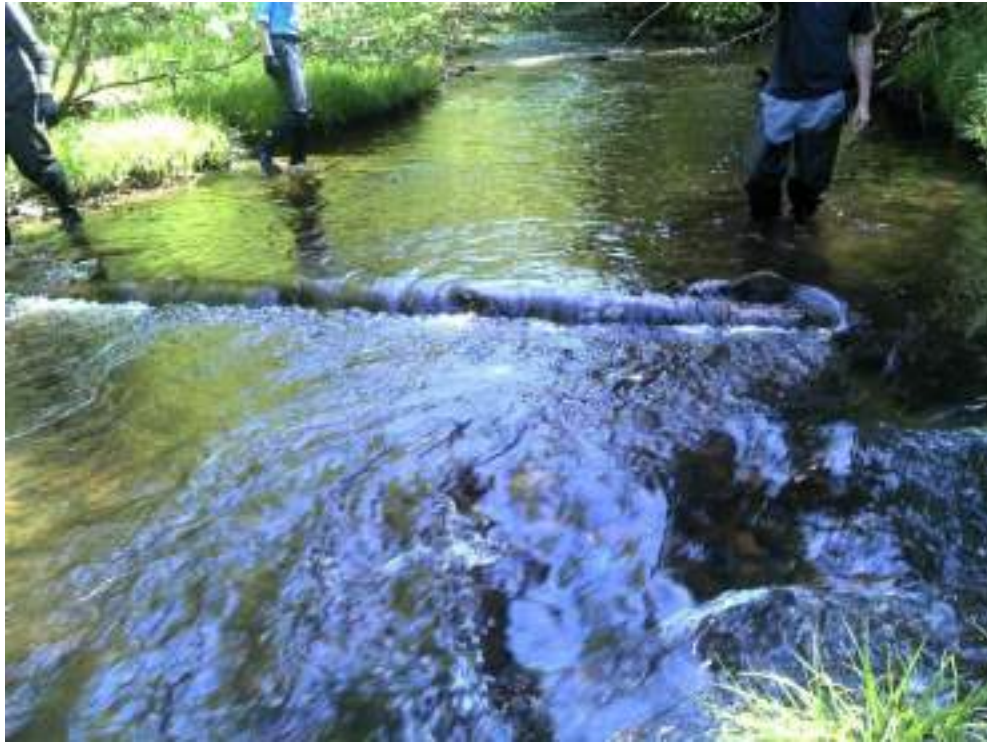
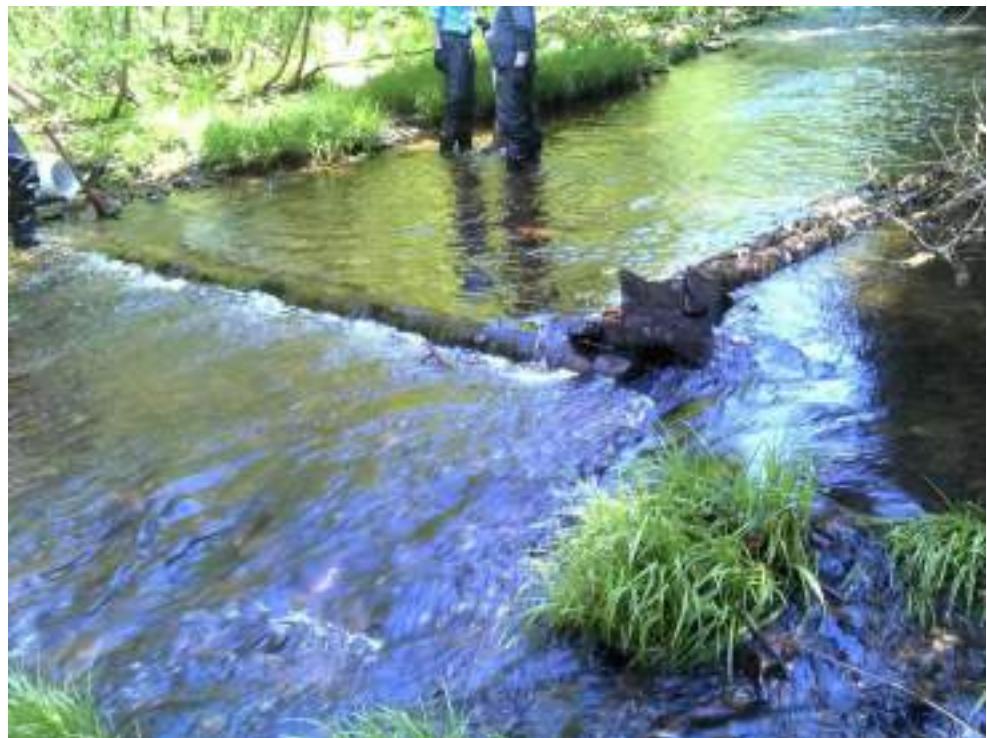
Figure 144. Diggerlog #7 - before and after picture of maintenance performed. This structure is too short and may require a full replacement or permanent extension. Debris materials were added to direct waterflow over the log.

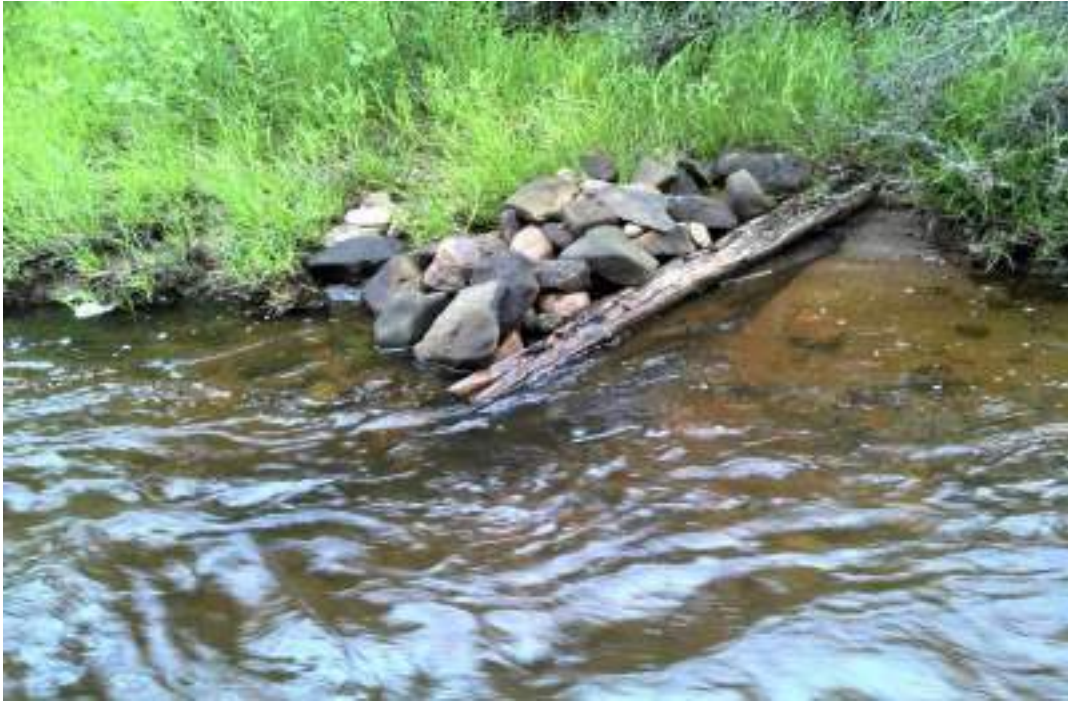
Figure 155. Deflector #8 - after picture of maintenance. The front of the structure is missing and needs to be fixed. Rock was added to help deflect the waterflow from the bank.

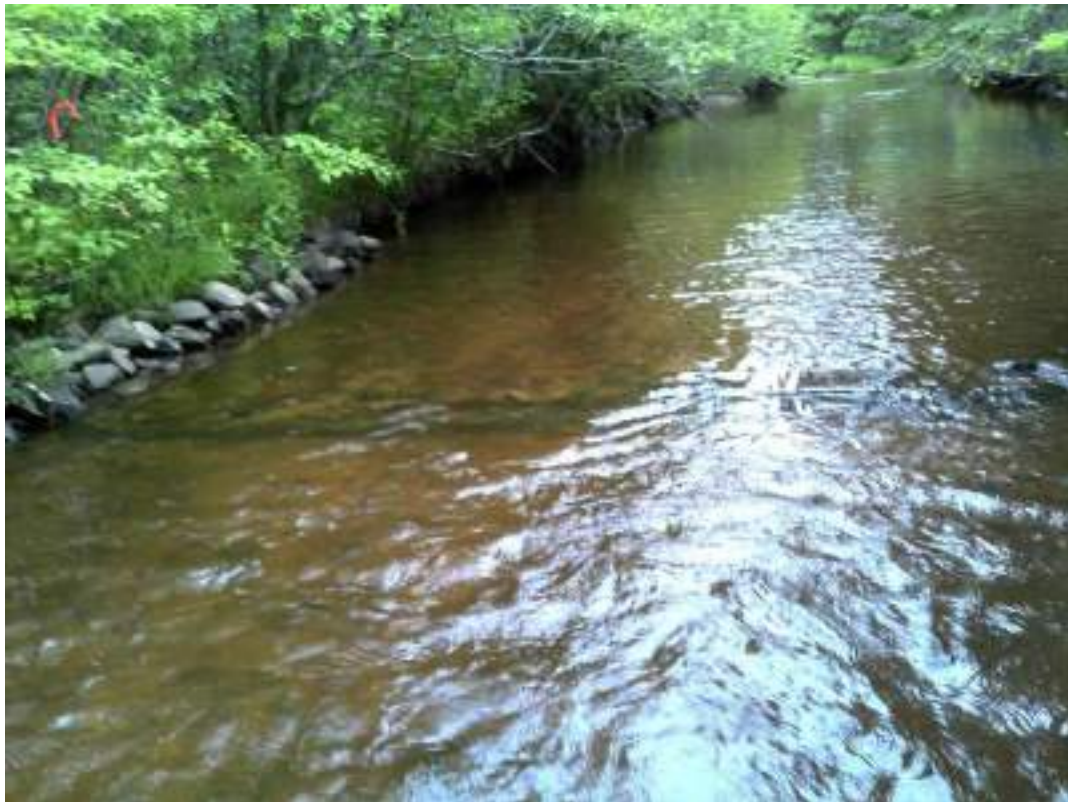
Figure 156. Bank rock/stabilization #9 - after picture of maintenance performed. There is also an old diggerlog log here that is buried into the substrate.

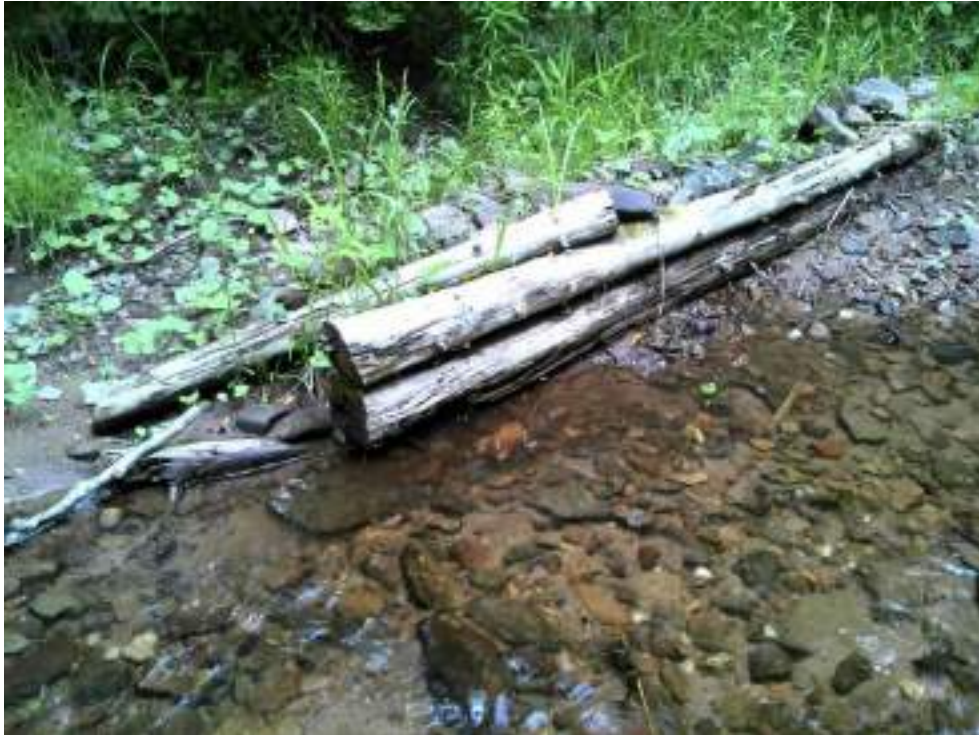
Figure 162. Deflector #1 - this structure is no longer in the channel and needs to be replaced, and repositioned.

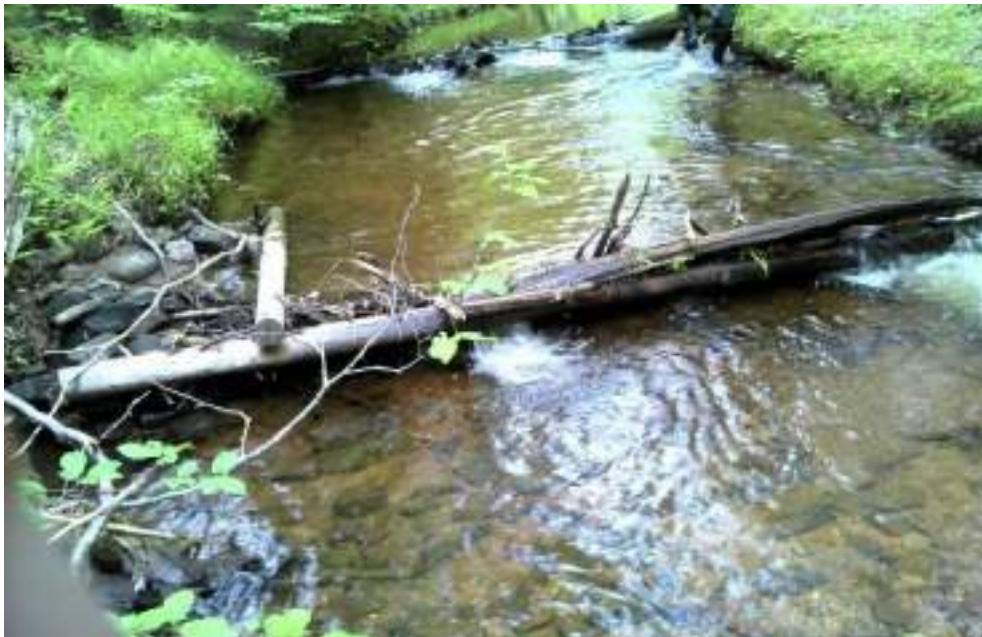
Figure 163. Diggerlog #2 - this structure was undercut in some areas and had a large amount of debris caught on the top of the log. No maintenance was performed.

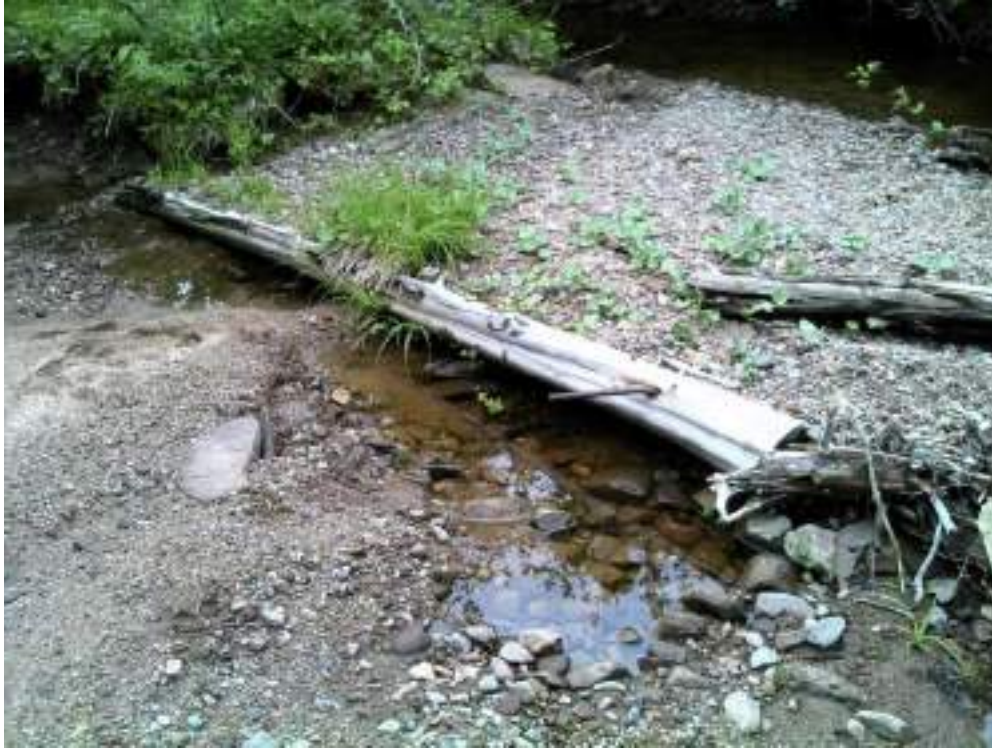
Figure 166 - Diggerlog #5 - the channel had changed course and the structure is no longer in the channel. This structure needs to be replaced, and repositioned.

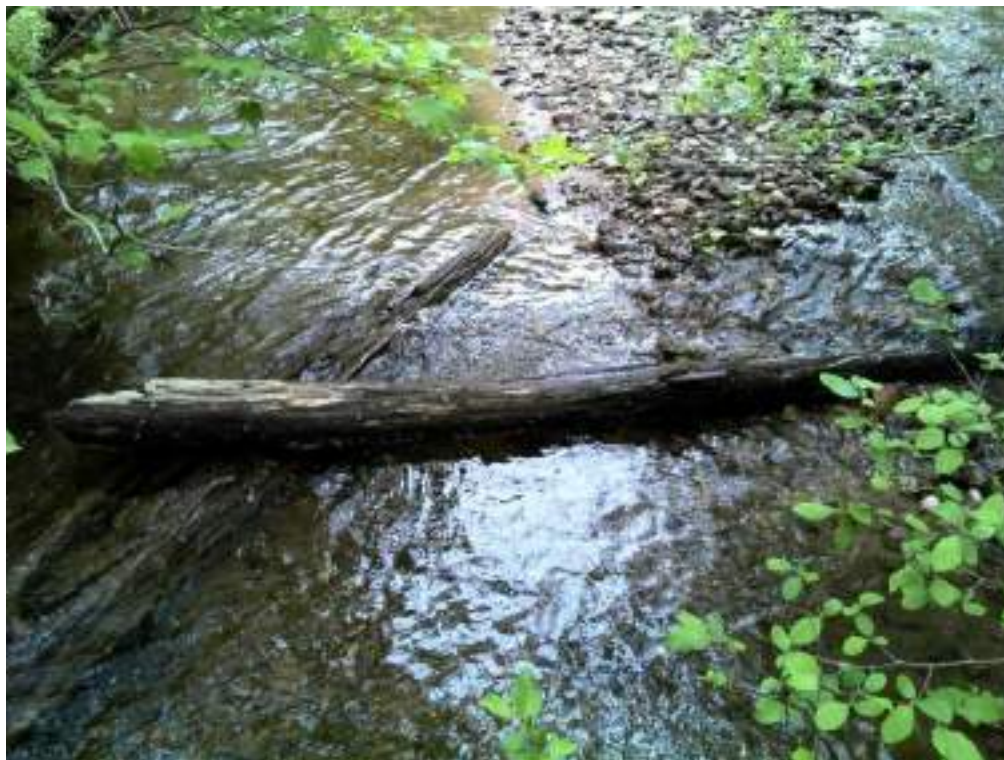
Figure 167. Diggerlog #6 - this structure needs to be replaced.

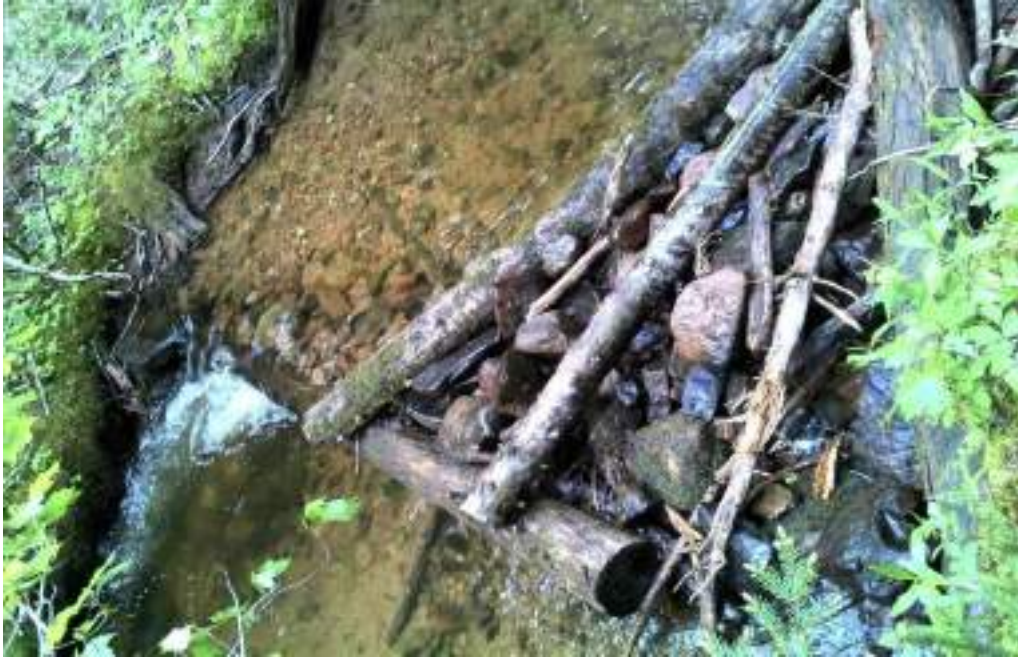
Figure 168. Diggerlog #7 - after picture of the maintenance performed. Debris materials were added to the upstream side of the log to help direct waterflow.

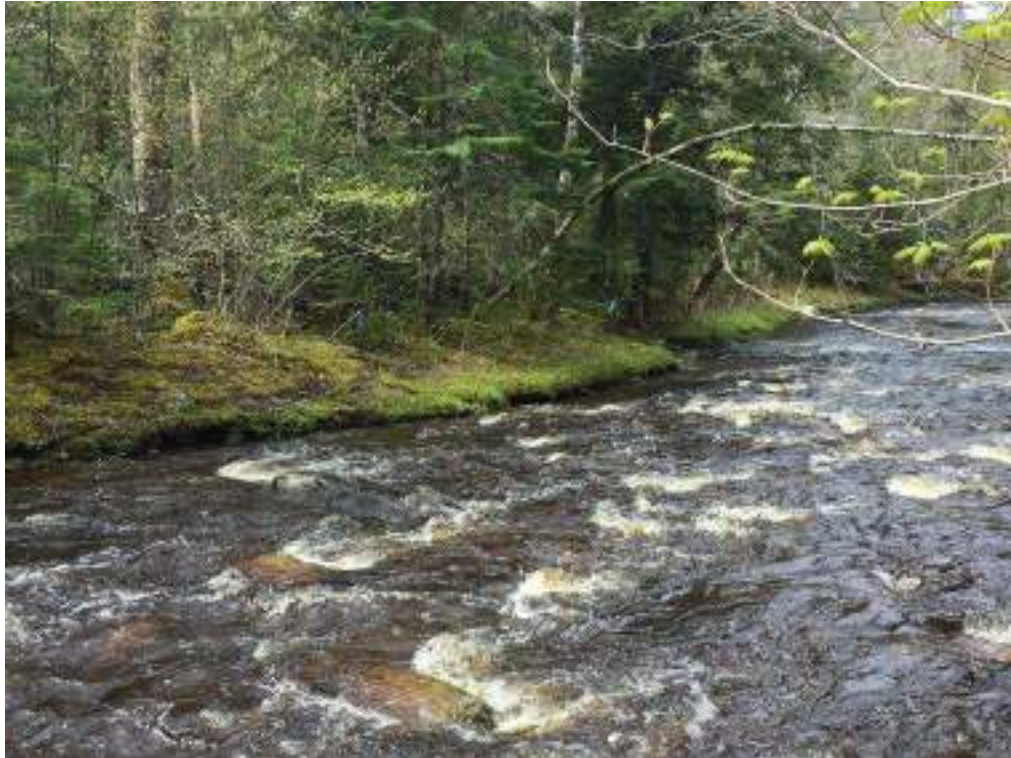
The photos below show the upstream structures from MacDonald Bridge on Campbells Road. No maintenance was done due to the poor condition of the structures. Bank rock remained in good condition, but the deflector structures had blown out over the winter months due to them not being braced in by logs and rebar. Each deflector and rock sill will require a full rebuild.

Figure 247. Structure #61 Deflector - missing and requires a rebuild.

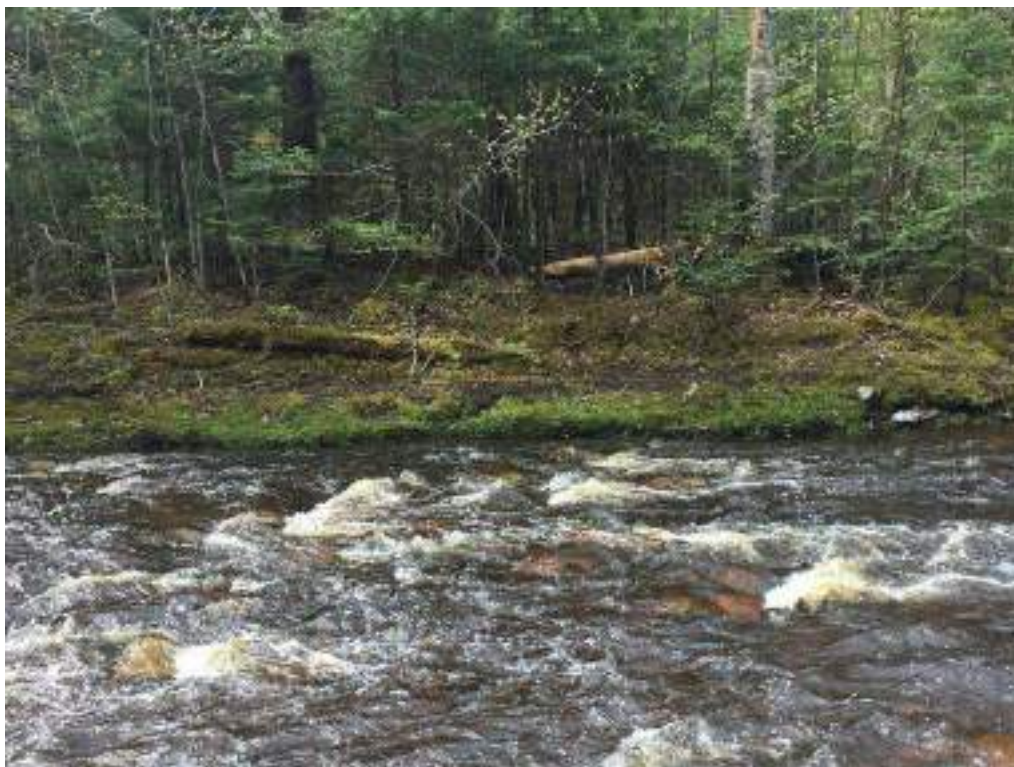
Figure 248. Structure #62 Deflector - missing and requires a rebuild.

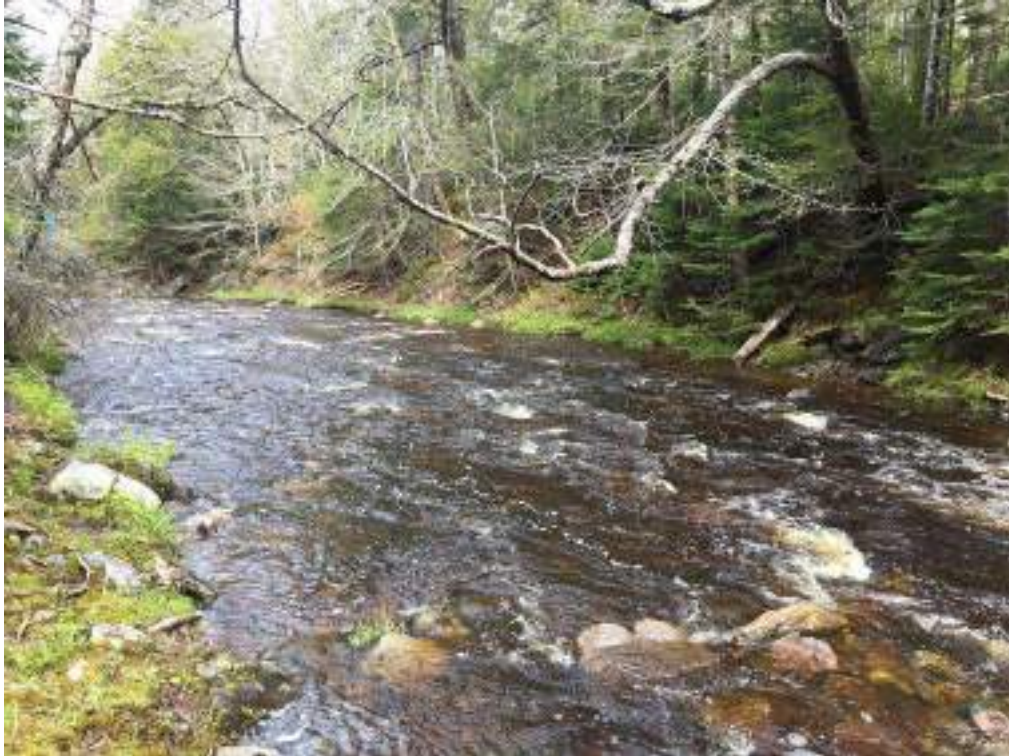
Figure 249. Structure #63 Deflector - missing and requires a rebuild.
