# Fish Habitat Restoration Plan: Southwest Mabou River Watershed

Submitted to the Atlantic Salmon Conservation Foundation

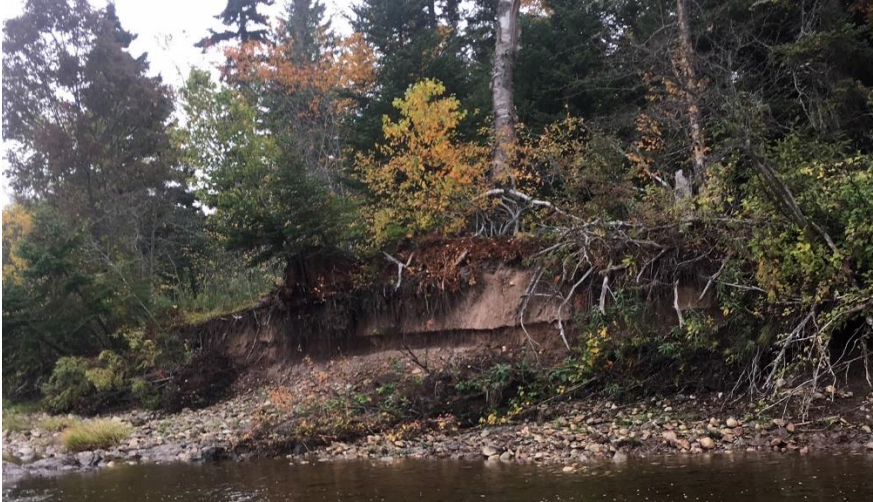
The incised channel that is predominant through the Southwest Mabou has resulted in severe bank erosion. As Figure 1 depicts, without access to the floodplain, high flow events are restricted to the channel, causing over-widening and a loss of pool depth. While erosion is a natural process for river systems, the absence of large woody debris and channel meander has limited the natural sorting function that would otherwise be found in the Southwest Mabou. Figure 2 provides an example of the extreme erosion that is found throughout the main channel. Figure 3 is an example of where a natural formation has benefitted the channel health. The beaver dam in this picture has promoted the settling of moving bed loads and is creating a well-defined gravel bar and meander. Restoration efforts should attempt to mimic this type of natural process. In areas where natural structures were absent (figure 4), channel braiding (i.e. split channels) were common.

*Figure 2: Typical stream bank erosion on lower section of Southwest Mabou*

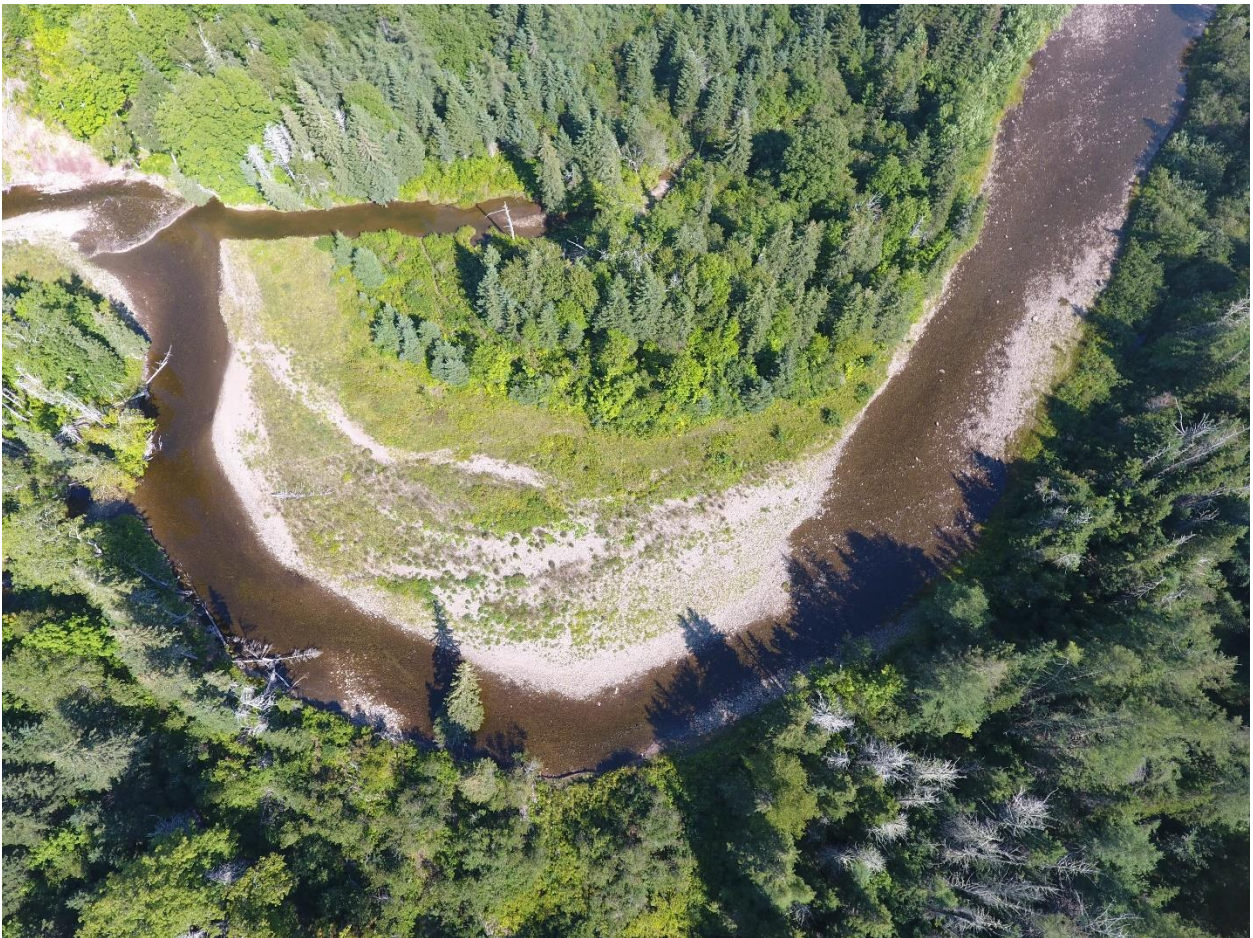
*Figure 3: Channel meandering re-establishing above beaver dam.*

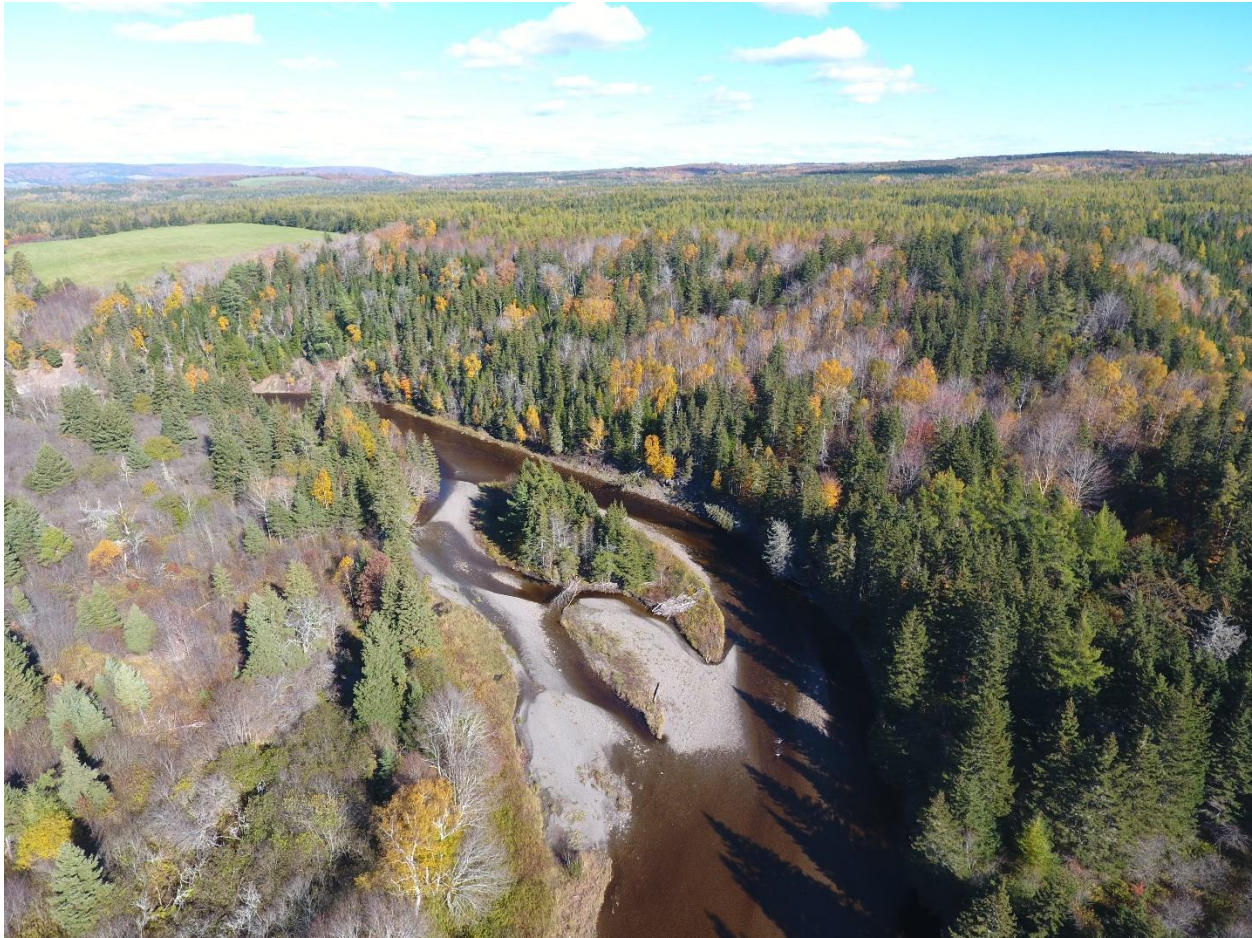
*Figure 4: Severely over-widened and split channel.*

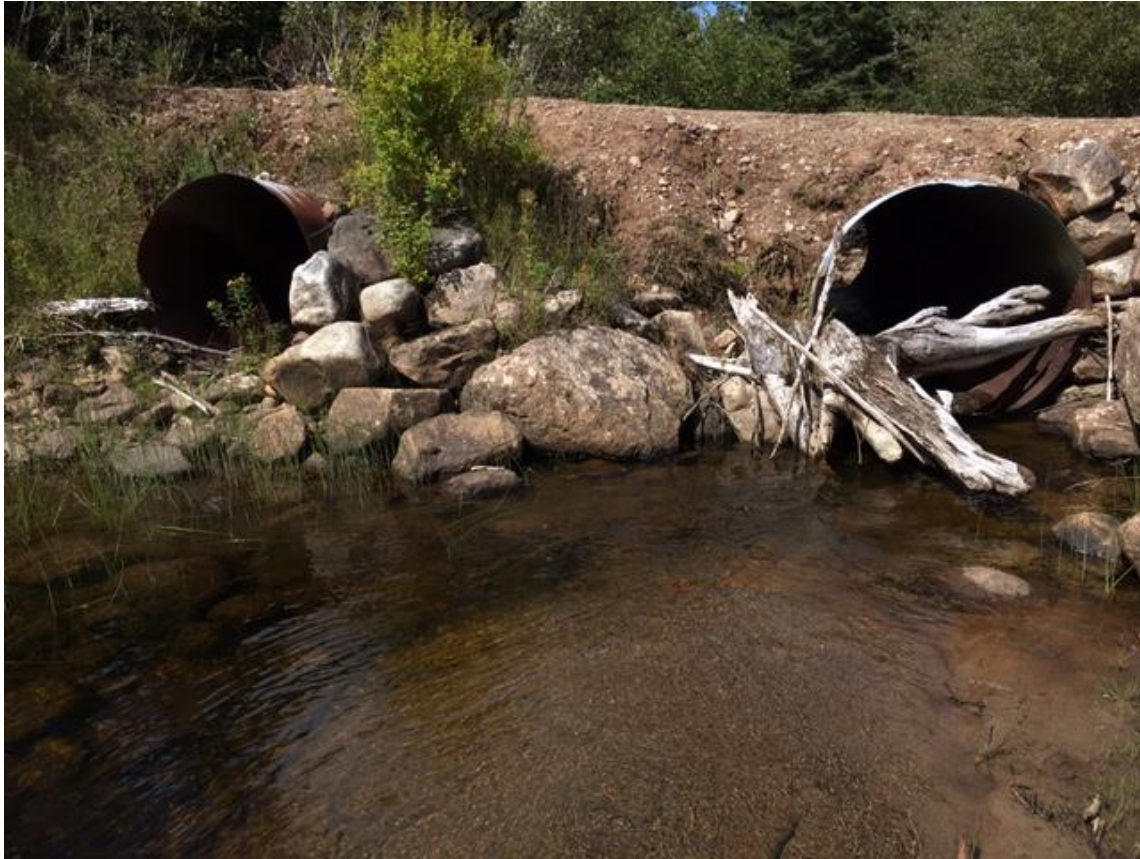
The upper section of the Southwest Mabou (above MacLeod Settlement) contains more suitable and productive habitat than the lower reaches. However, this section still requires habitat restoration actions. MacLeod Brook, a cold-water tributary to the Southwest has limited fish passage to 90% of its watershed. A triple culvert installed decades ago is breached and deteriorating (Figure 5). Above the barrier culvert the remainder of MacLeod Brook has been impacted by historic land-clearing and more recent forestry practices. An unnamed tributary, roughly the same size as MacLeod Brook was recently impacted by riparian zone loss (Figure 6) and the ditching along several forestry roads were transporting fine sediments and silt (figure 7). Much of the land surrounding the upper section of the Southwest Mabou river is comprised of small cobble, gravel and fine sediment, making it particularly vulnerable to landscape changes (Figure 8). The removal of mature forest from much of the riparian zones on the unnamed tributary will likely limit the amount of large woody debris that will enter the stream channel.

*Figure 5: Barrier culvert - lower MacLeod Brook*

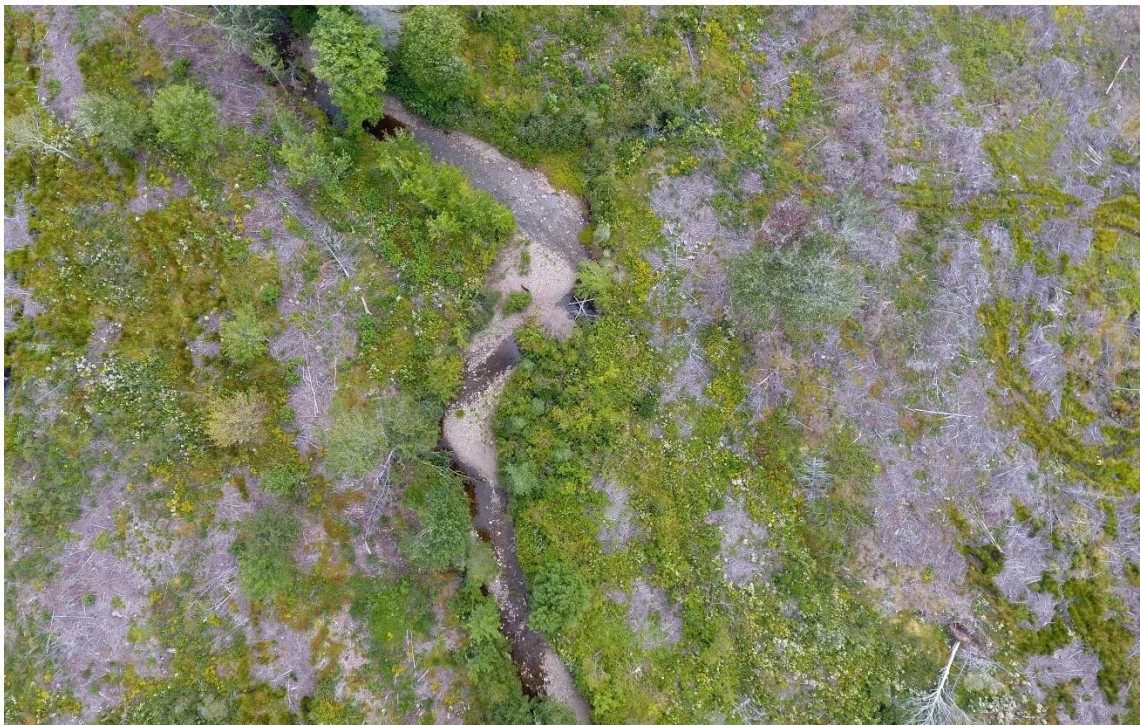
*Figure 6: Riparian zone loss*

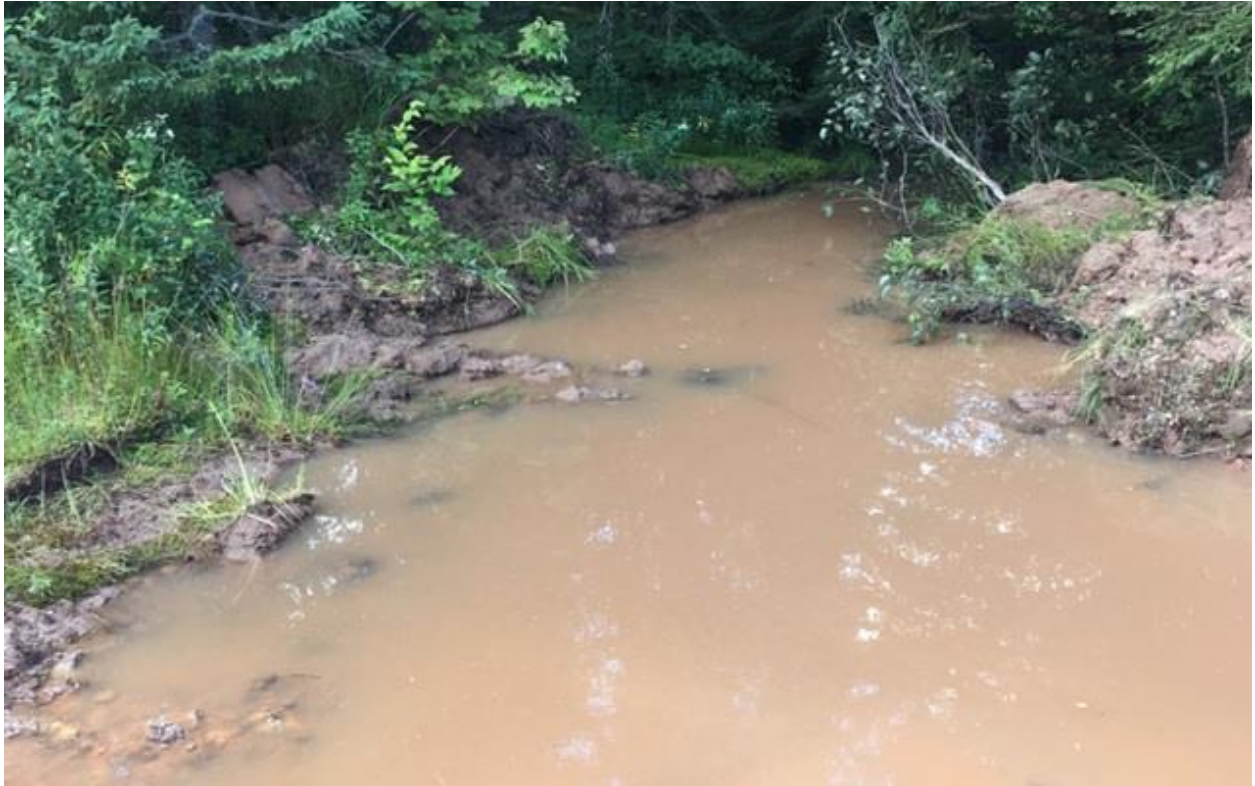
*Figure 7: Siltation from forestry road ditch*

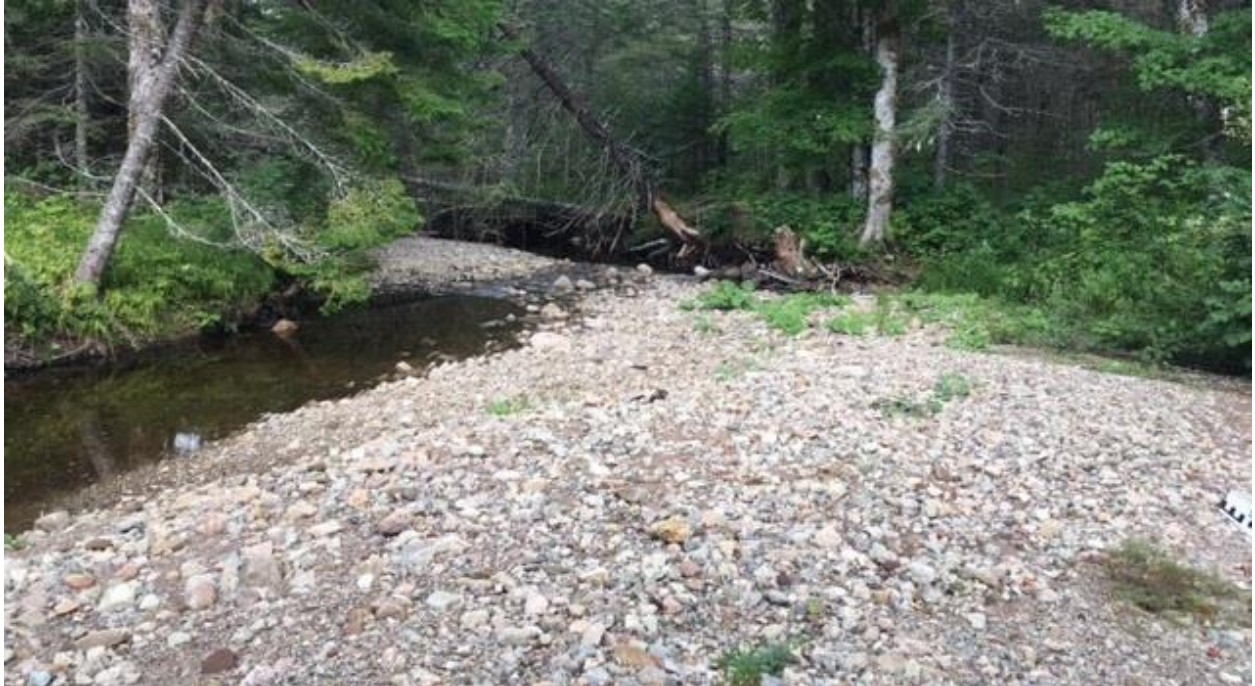
*Figure 8: Mobile substrate*

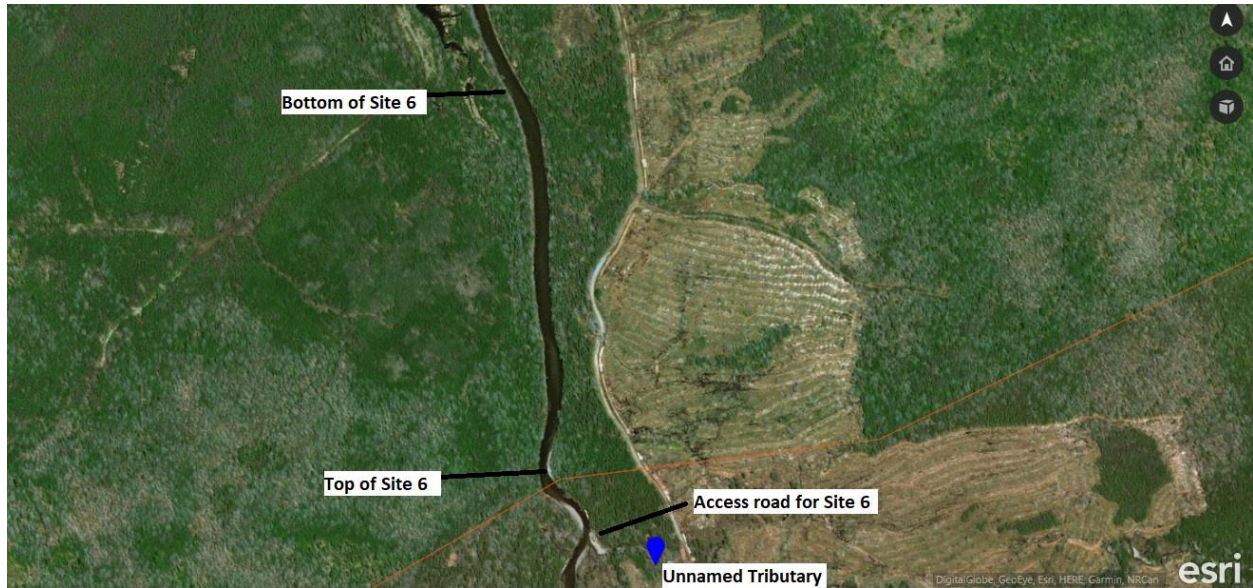
Figure 17: Satellite image of site 6. Note recent forest harvesting and the absence of a channel meander throughout the site.

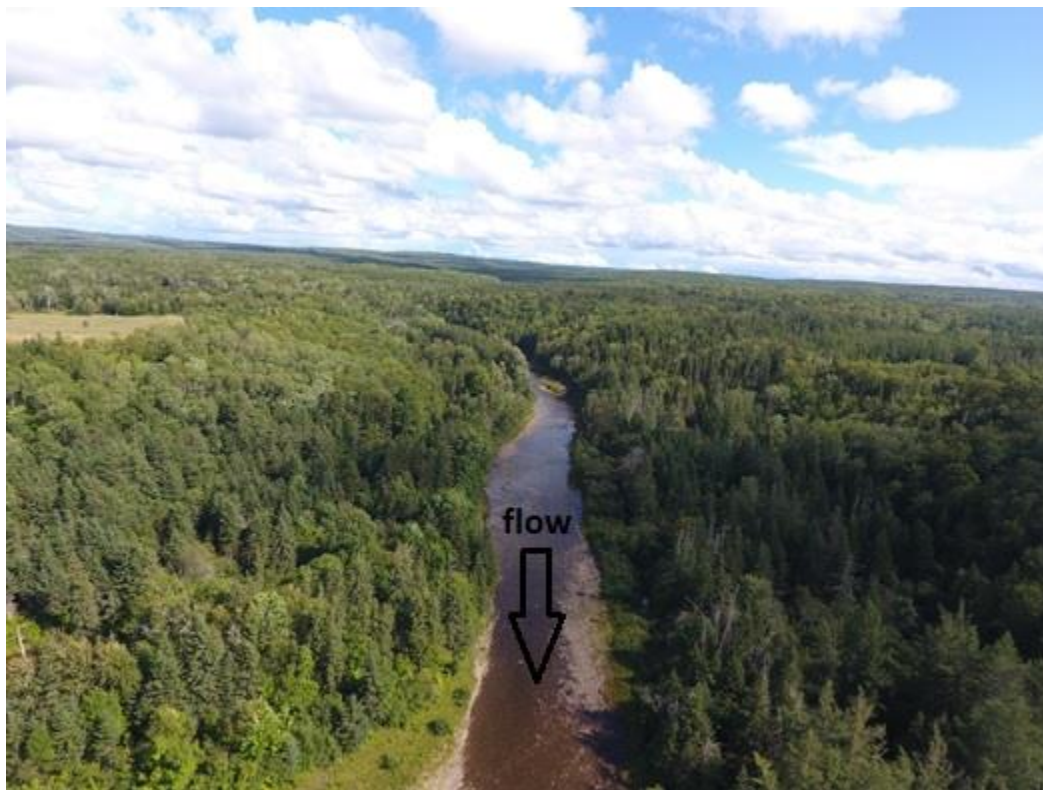
Figure 20: Glencoe section of Upper Southwest Mabou. The channel is over-widened and lacks a meander pattern.

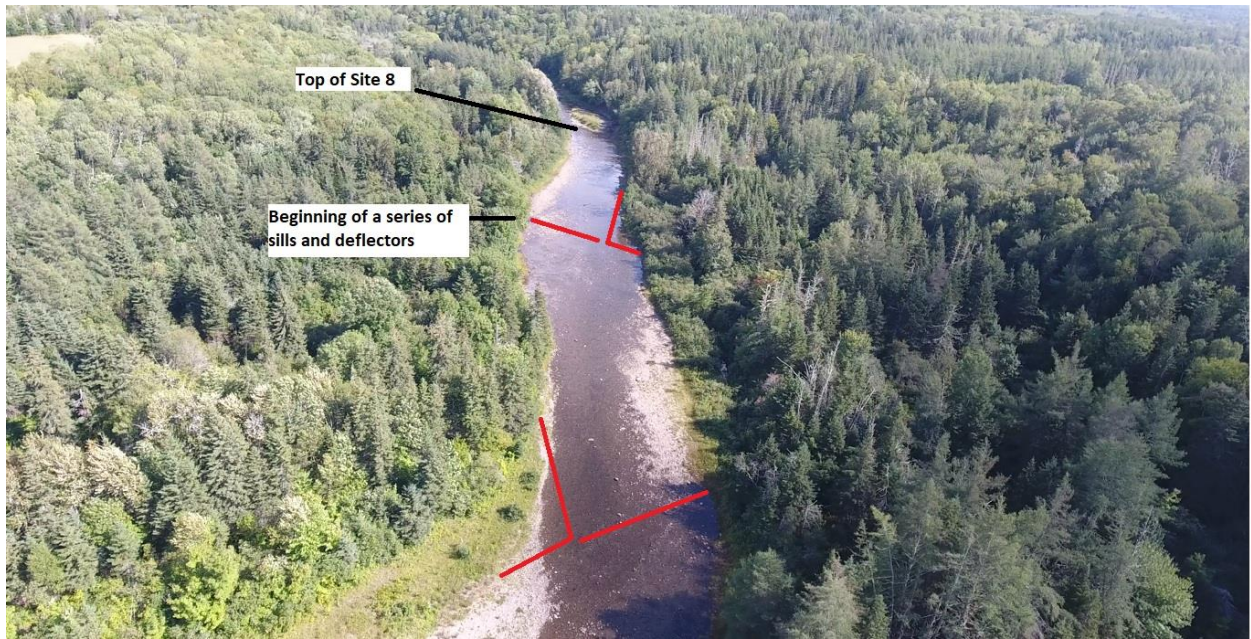
Figure 29: Site 8

8) Moran	61°24'45.7"W 45°59'0.2"N	61°24'50.2"W 45°58'26.4"N	Gravel bottom, some bedrock. Stream bed is highly mobile and forming mid-channel bar.	Yes	15

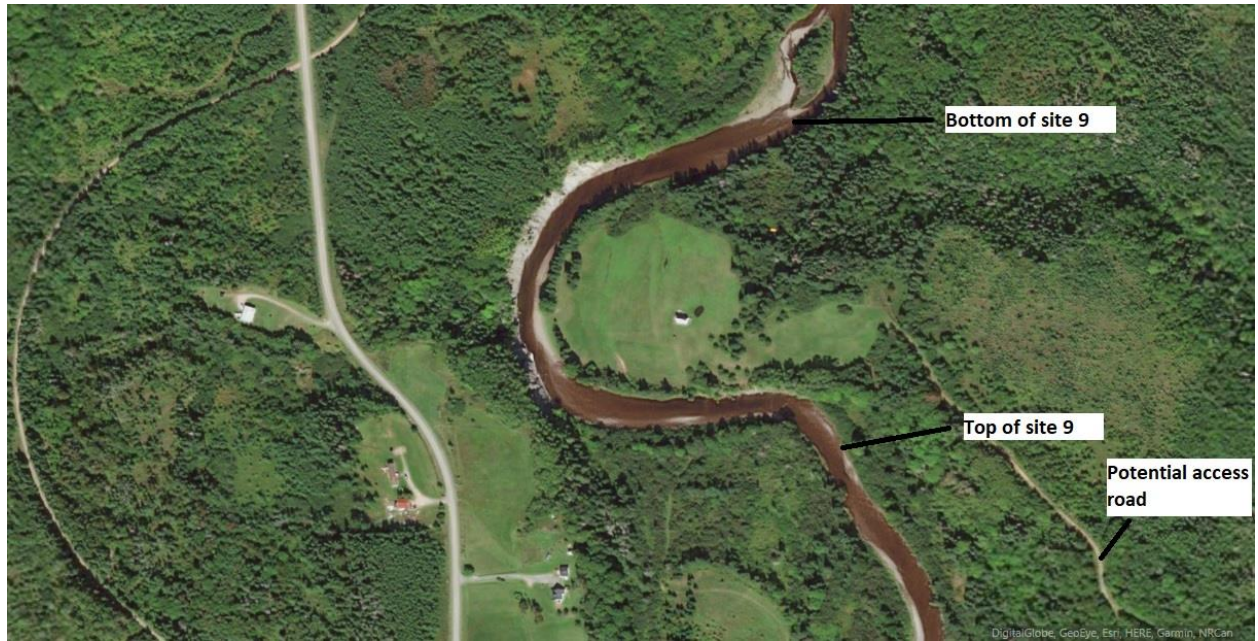
Figure 31: Site 9

9) Cottage	61°27'6.2"W 46°00'36.1"N	61°27'3.3"W 46°00'24.7"N	Gravel, small cobble and some small boulders. Bank erosion is significant.	Yes	20
10) Route 19	61°27'5.6"W 46°01'23.1"N	61°27'9.7"W 46°00'59.8"N	Gravel, fines, some bedrock and small cobble.	Yes	20
