MULL RIVER RESTORATION PROJECT

2023

Abstract

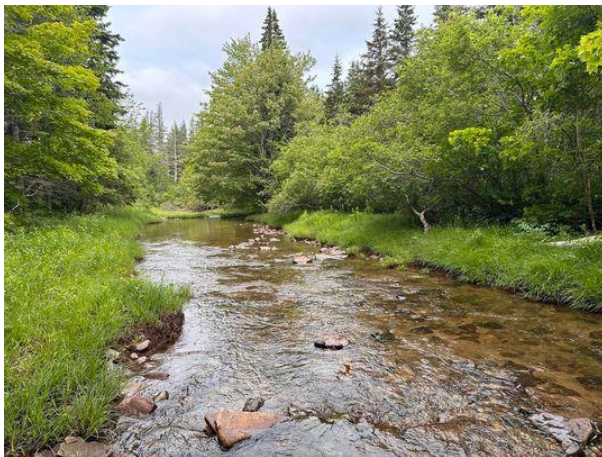
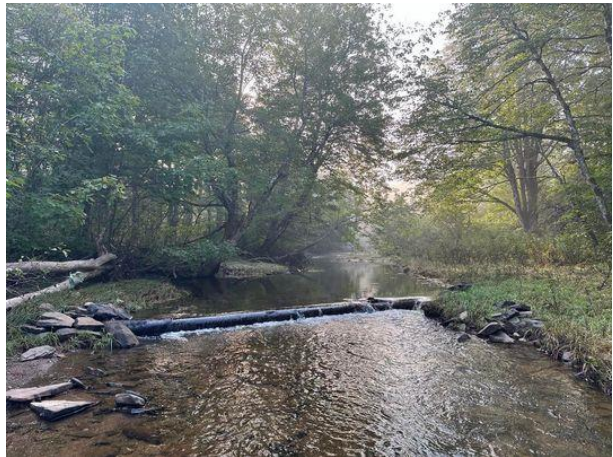
Before and after photo of the first digger log structure installed on the Mull River, 2023.

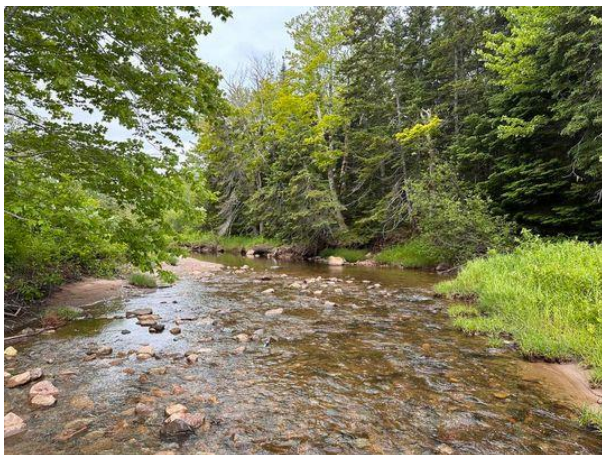
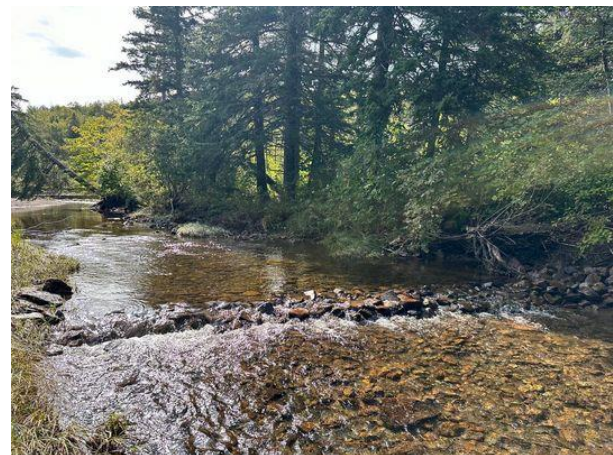
Before and after photo of a rock sill structure installed on the Mull River, 2023.

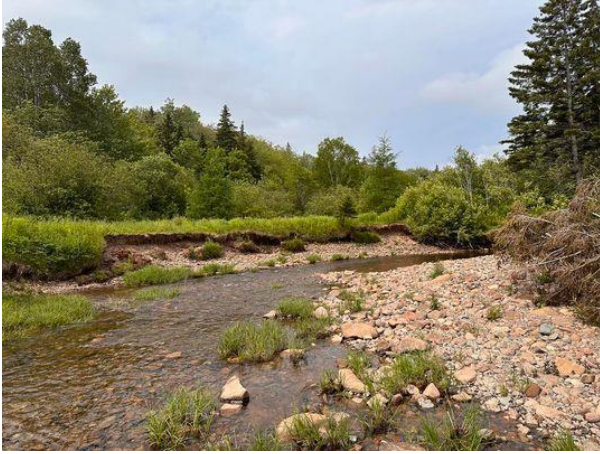
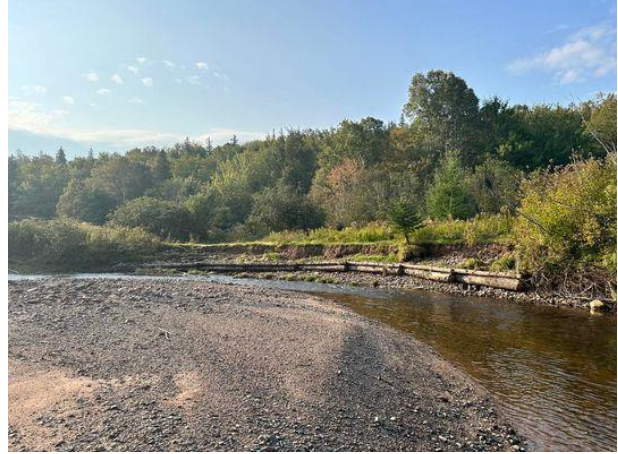
Before and after photo of a bank stabilization structure, built logs and hand rock, 2023.

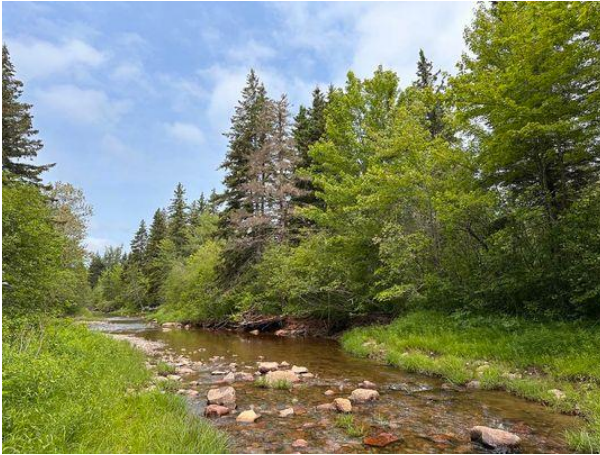
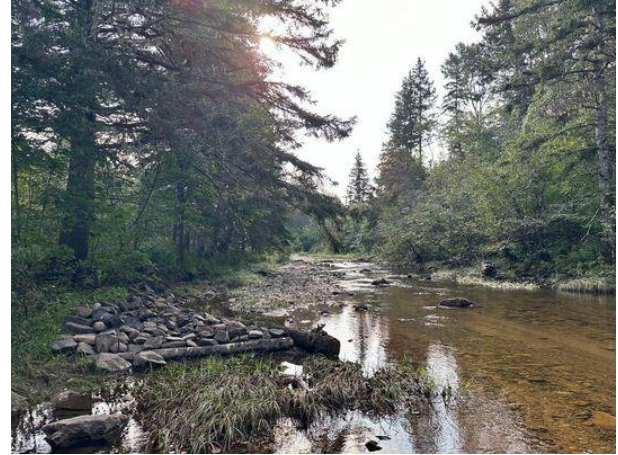
Before and after photo of a deflector structure built on the Mull River, 2023.
