# Salmonid Habitat Restoration

Southwest Mabou River and Unnamed Tributary Installation Project

2020

Date: December 2020

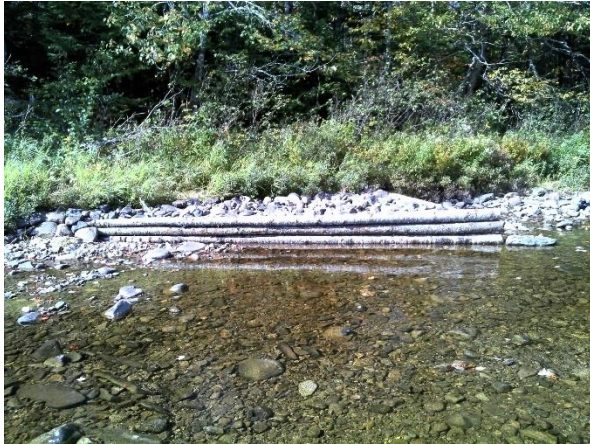
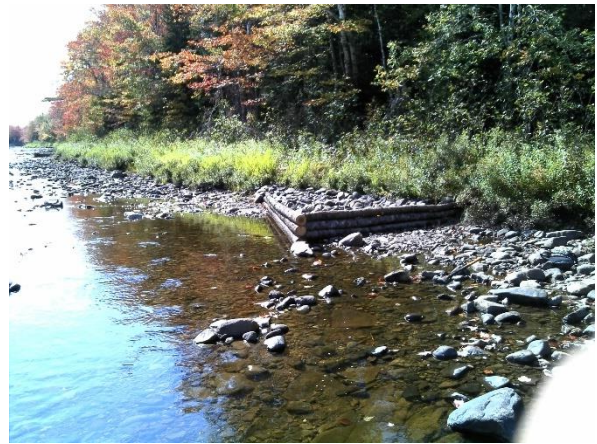
**Structure #1.** Deflector – 6x3 meters, 3 tiers filled in with rock

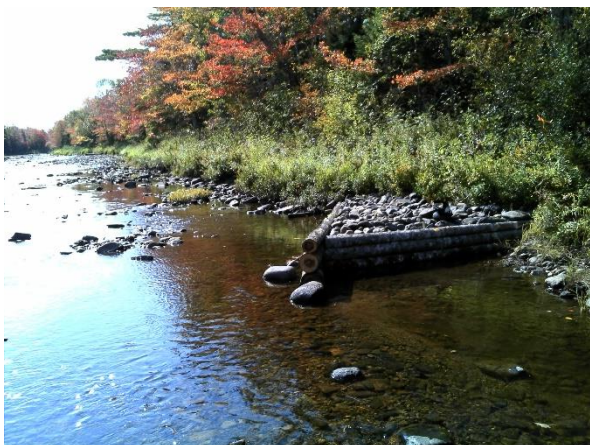
**Structure #2.** Double Deflector w/ #3 – 6x3 meters, 3 tiers filled in with rock

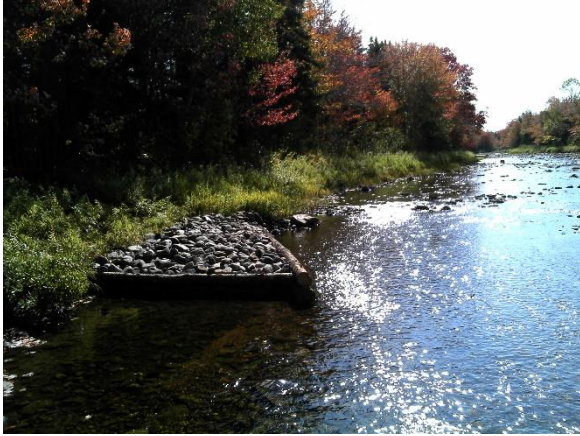
**Structure #3.** Double Deflector w/ #4 - 6x3 meters, 3 tiers filled in with rock

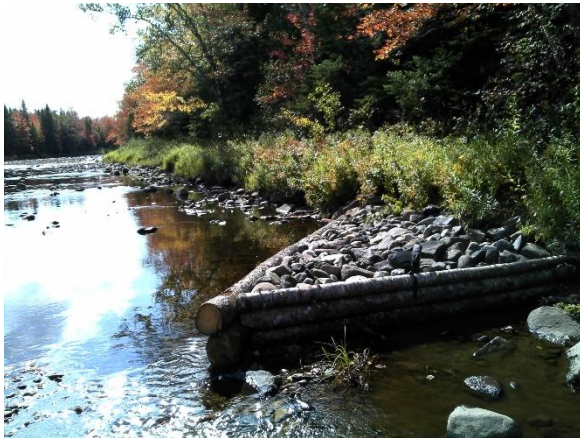
**Structure #4.** Double Deflector w/ #5 - 6x3 meters, 3 tiers filled in with rock

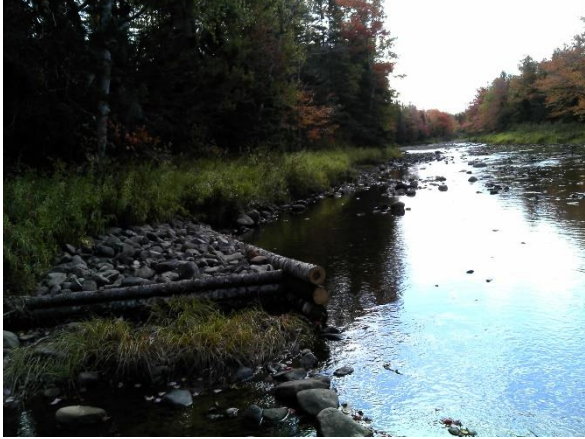
**Structure #5.** Double Deflector w/ #4 - 6x3 meters, 3 tiers filled in with rock

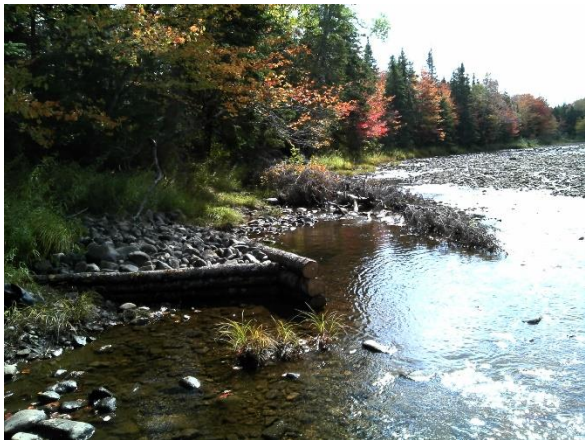
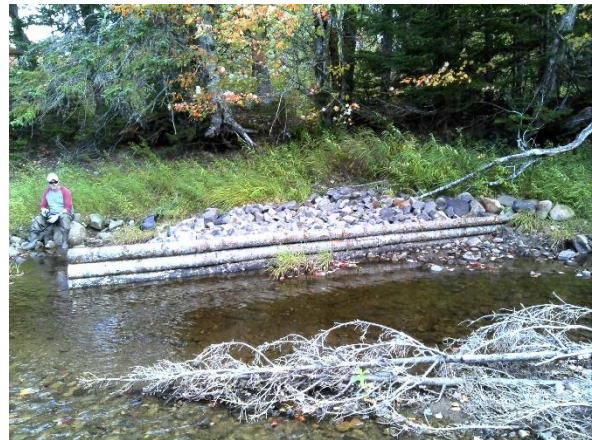
**Structure #6.** Deflector - 6x3 meters, 3 tiers filled in with rock

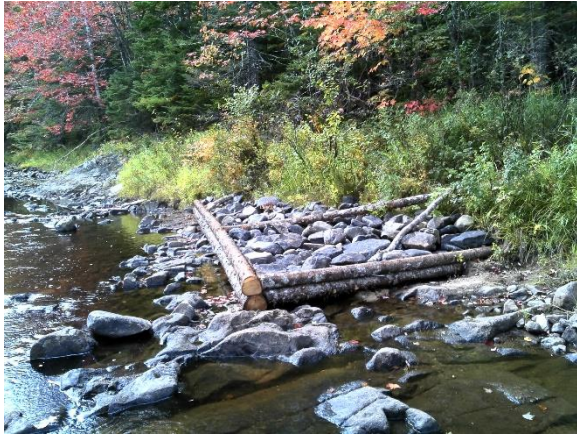
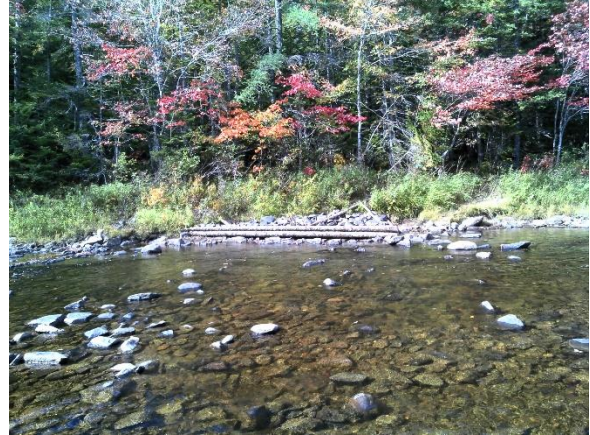
**Structure #7.** 6x3 meters, 2 tiers filled in with rock. Its placed-on bedrock, so the structure is braced to the bank.

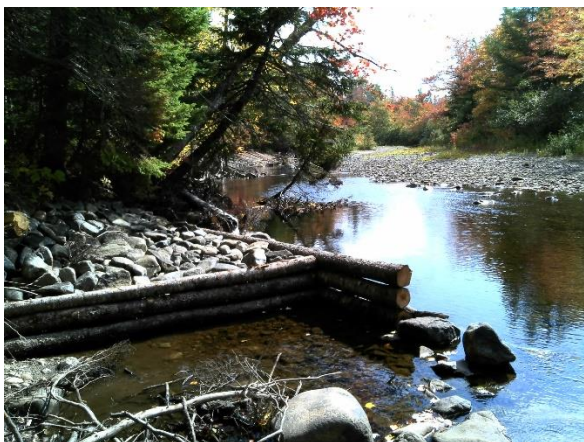
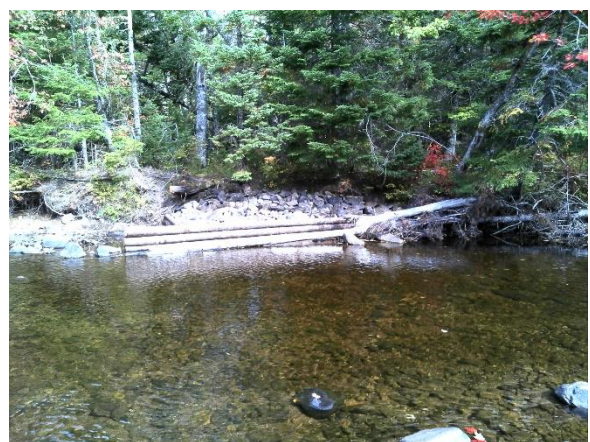
**Structure #8.** Deflector - 6x3 meters, 3 tiers filled in with rock. Tucked behind a tree.

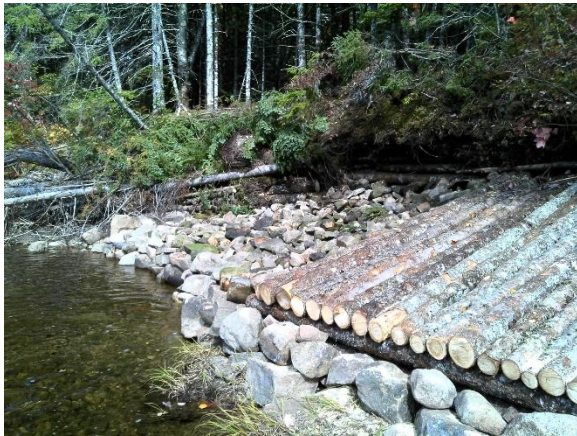
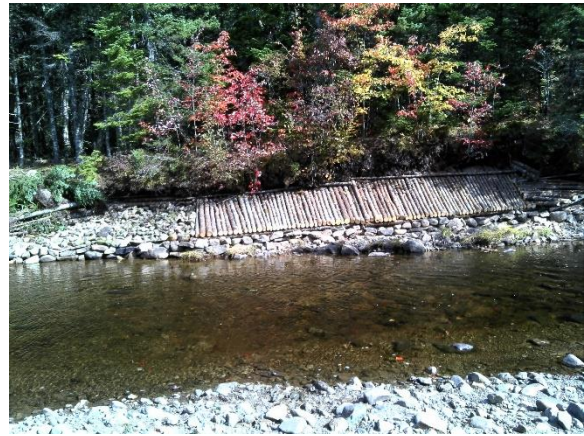
**Structure #9.** Bank Stabilization – approximately 40 ft long. It has timber bracing the rock to help prevent erosion. The front is rock and filled in with debris and brush.

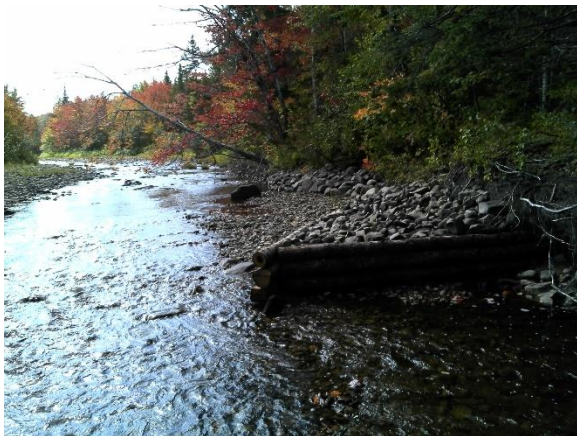
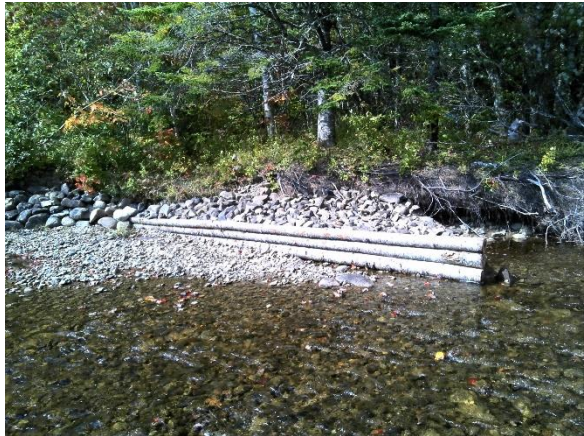
**Structure #10.** Deflector - 6x3 meters, 3 tiers filled in with rock. This structure is near the confluence of a small cold-water tributary.

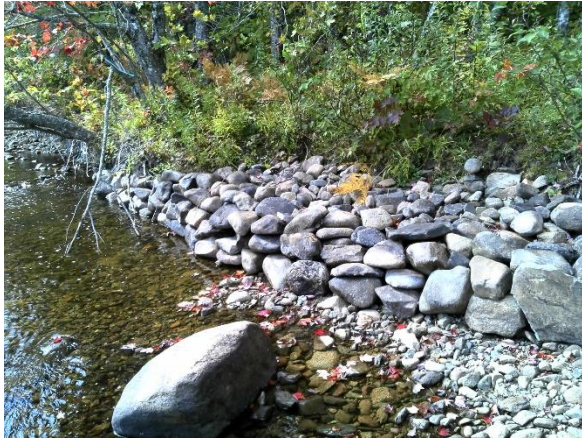
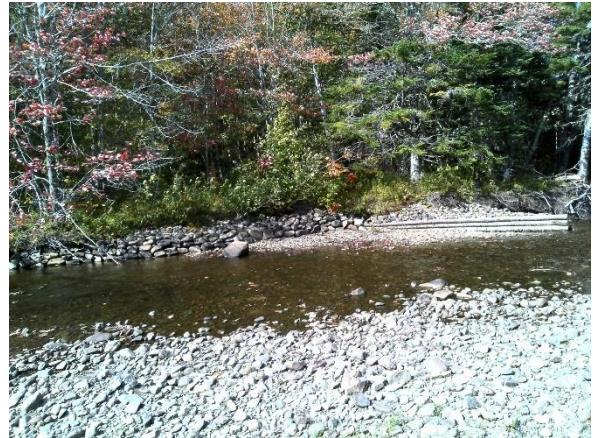
**Structure #11.** Bank Stabilization – approximately 25 ft long, filled in with rock to the bank.

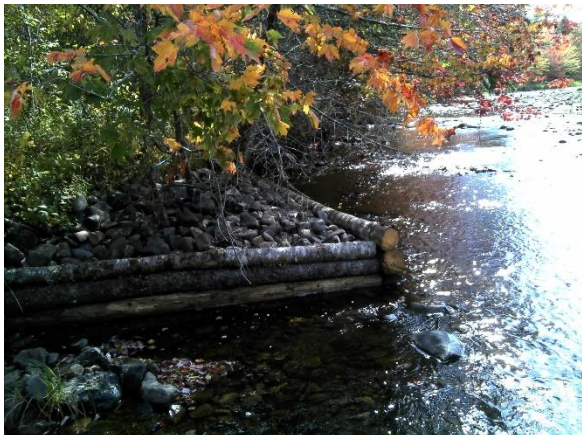
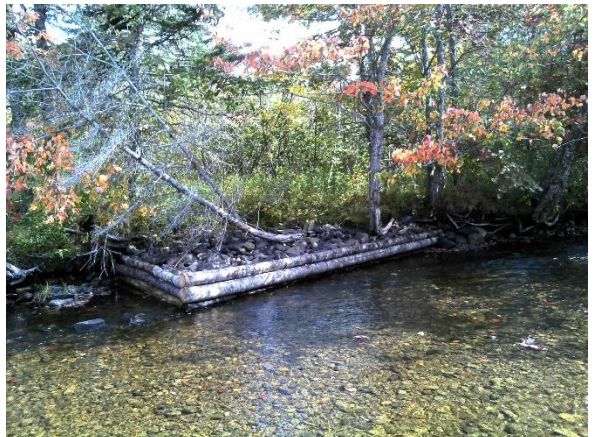
**Structure #12.** Deflector - 6x3 meters, 3 tiers filled in with rock

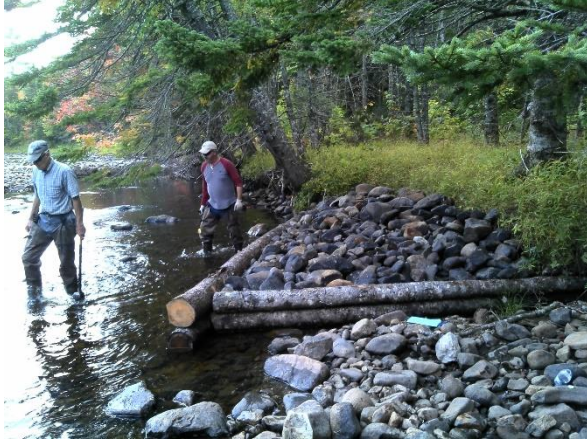
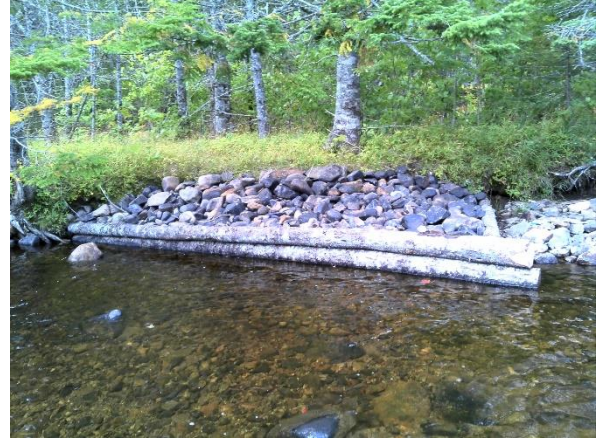
**Structure #13.** Deflector - 6x3 meters, 3 tiers filled in with rock. Big logs were used.

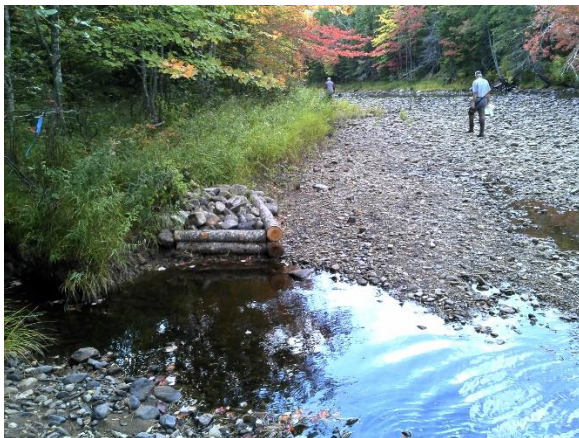
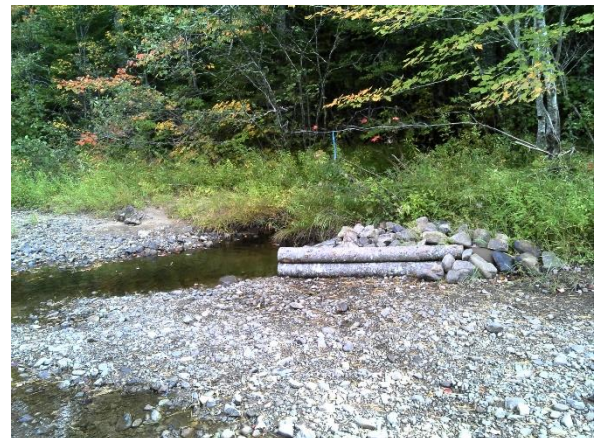
**Structure #14.** Deflector – 2x1 meters, 2 tiers filled in with rock. It is protecting the confluence of a cold-water tributary.

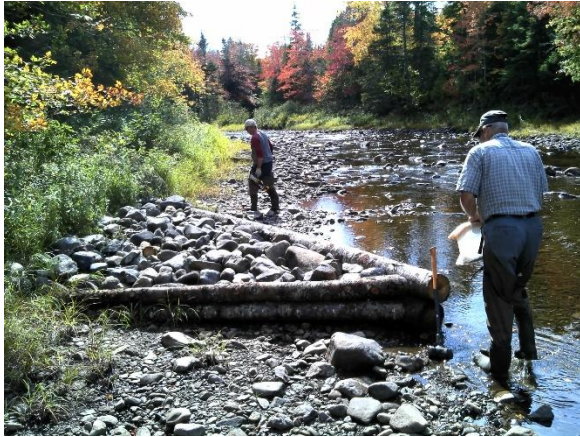
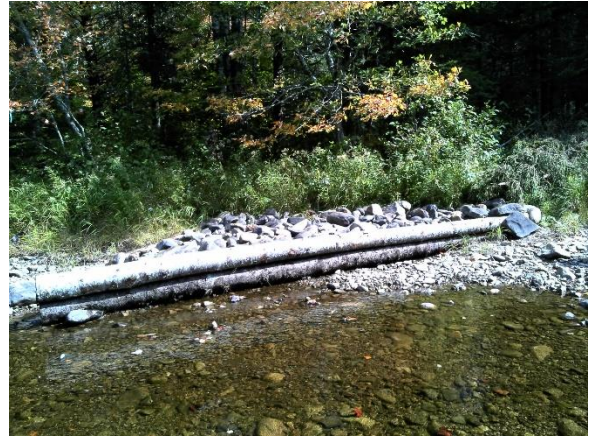
**Structure #15.** Deflector - 6x3 meters, 3 tiers filled in with rock

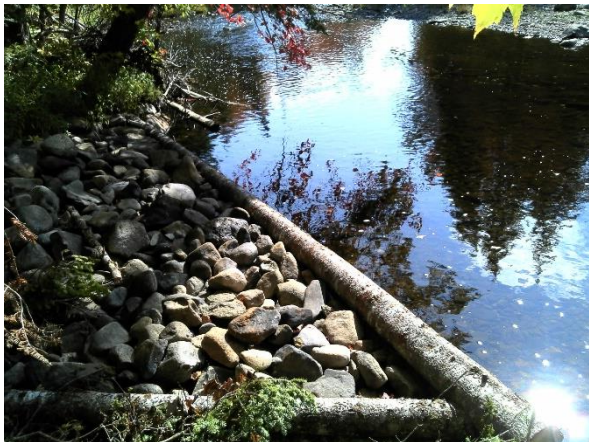
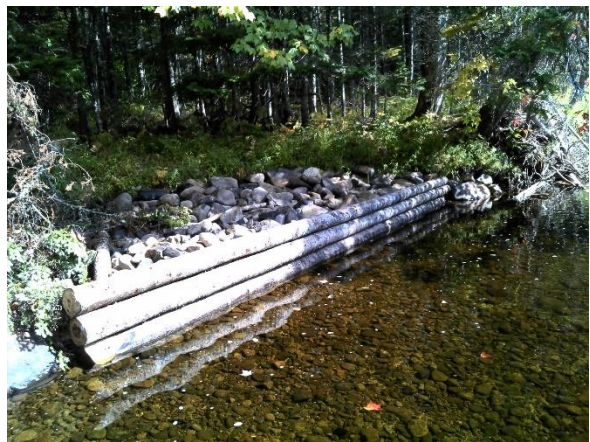
**Structure #16.** Deflector - 6x3 meters, 3 tiers filled in with rock. Brush was placed below.

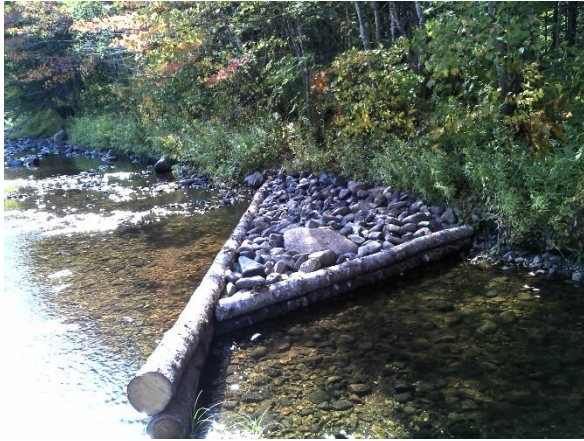
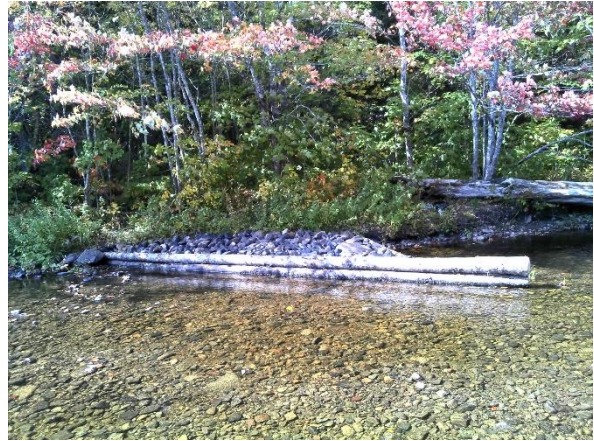
**Structure #17.** Deflector – 7x3 meters, 2 tiers filled in with rock

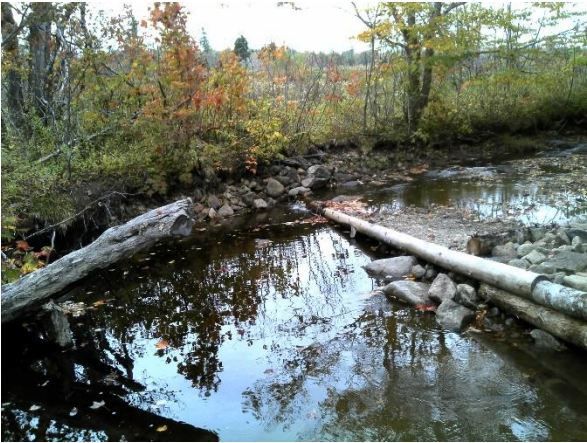
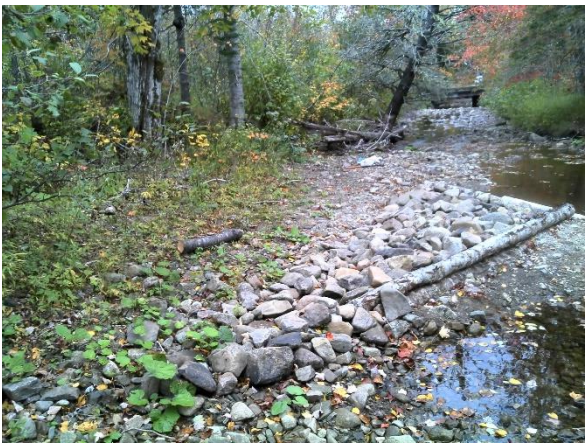
**Structure #18.** Digger Log with Deflectors – deflector is 4x1 meters, two tiers filled with rock and is attached to a digger log measured to the channel width.

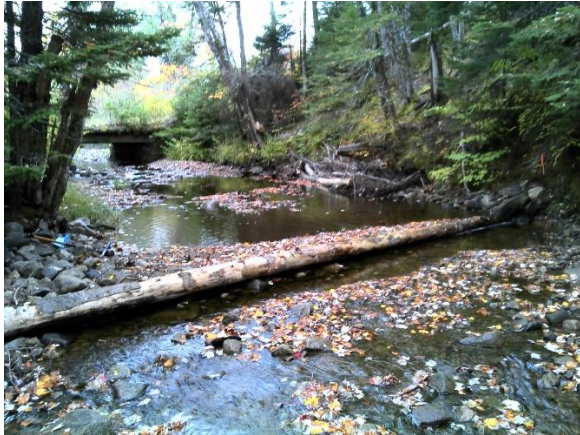
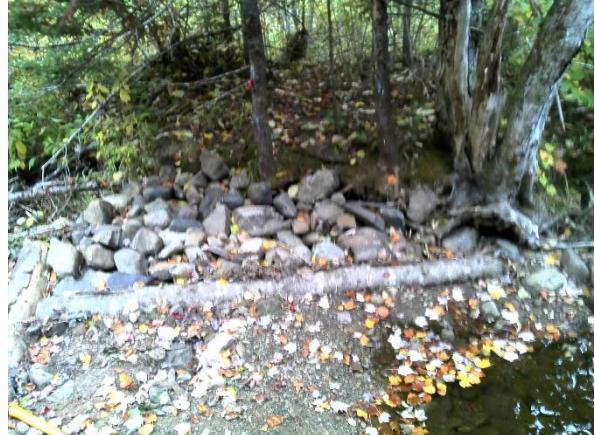
**Structure #19.** Digger Log with Deflector – deflector is 4x1 meters, 2 tiers filled with rock and is attached to a digger log measured to the channel width.

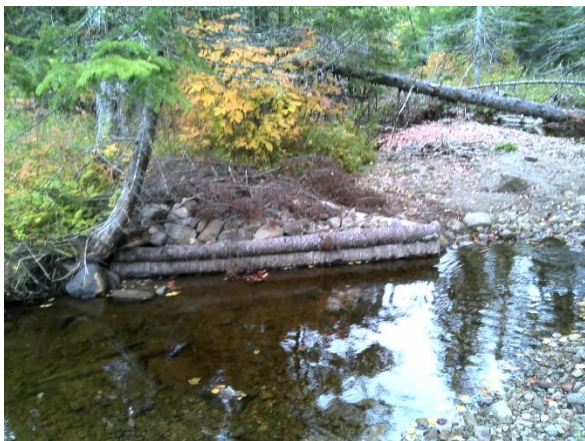
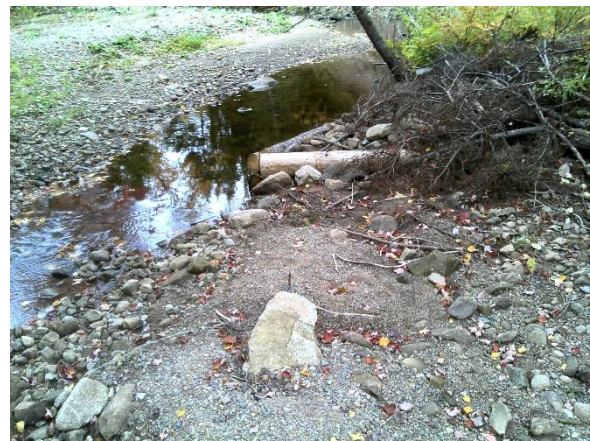
**Structure #20.** Deflector – 4x2 meters, 2 tiers filled with rock. Big logs used.

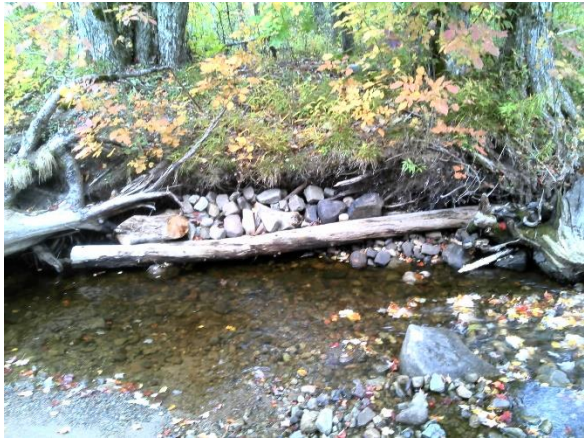
**Structure #21.** Bank Stabilization – log with rock used to protect the bank

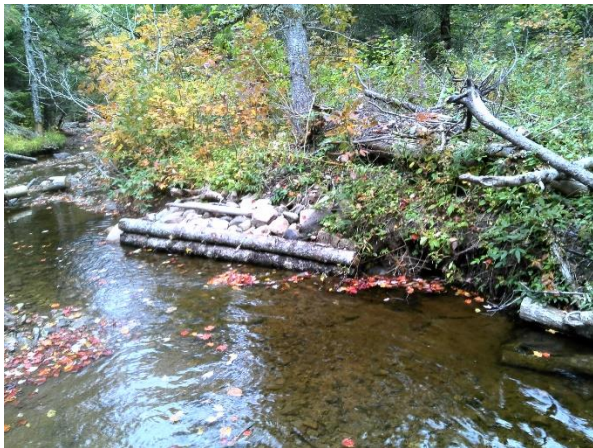
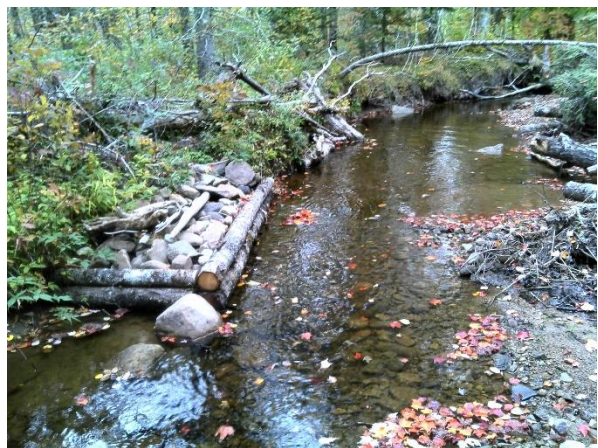
**Structure #22.** Deflector – 4x2 meters, 2 tiers filled with rock

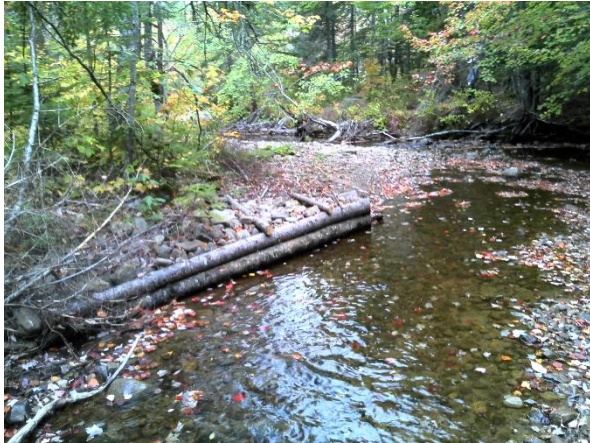
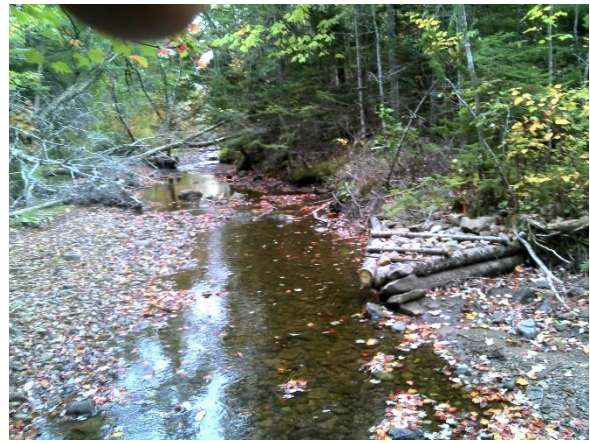
**Structure #23.** Deflector – 4x2 meters, 2 tiers filled with rock

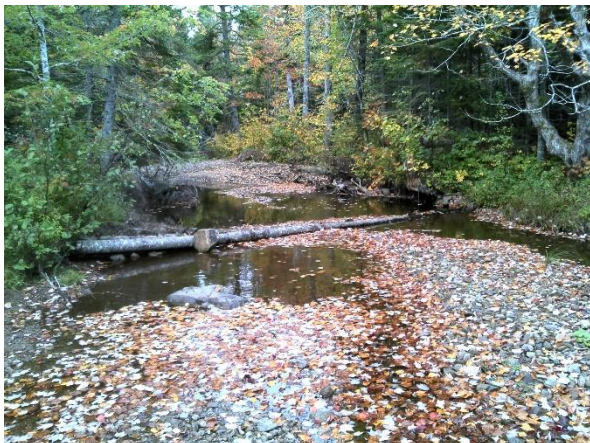
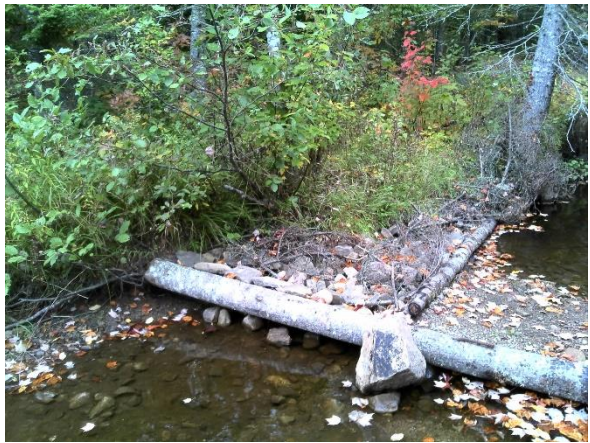
**Structure #24.** Digger Log with Deflector – deflector is 4x2 meters, 2 tiers filled with rock and is attached to a digger log measured to the channel width.
