Stream Habitat Restoration

Upper Southwest Mabou River Installation Project

Date: December 2021

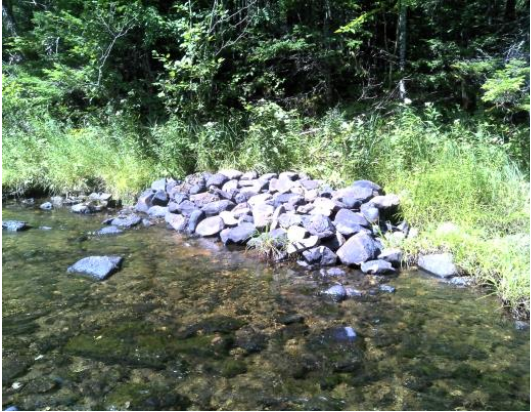
1. Rock Deflector 4x2 meters,
N45.90899° W61.36102°

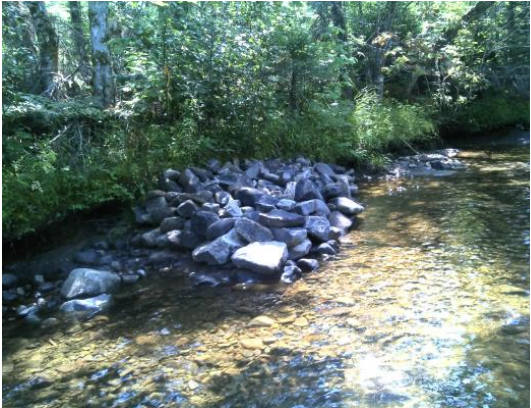
2. Rock Deflector 4x2 meters,
N45.90876° W61.36116°

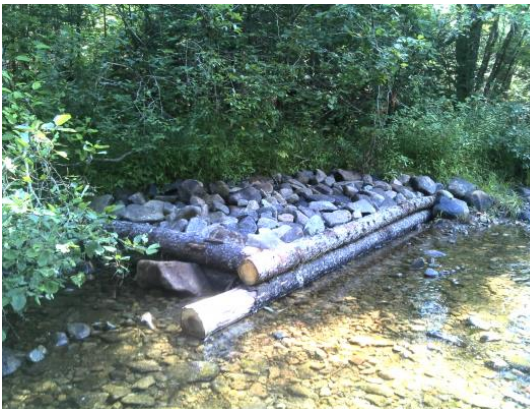
3. Deflector, 6x3 meters, 2 tiers,
N45.90830° W61.36135°

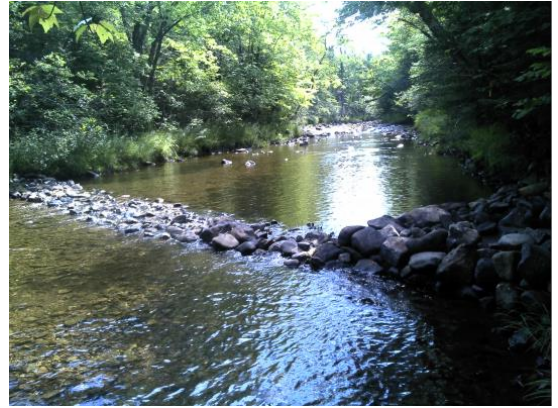
4. Rock Deflector 6x3 meters, and Rock
Sill, 30 degrees, N45.90733°
W61.36098°

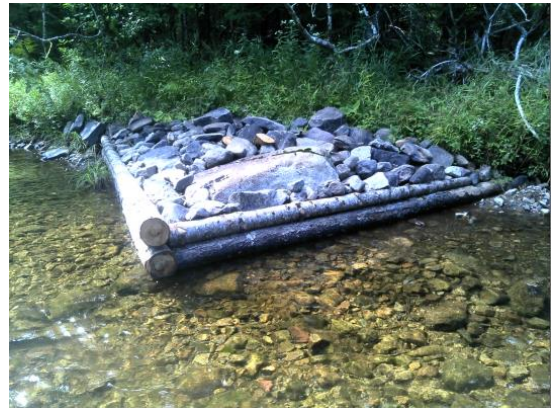
5. Deflector, 4x2 meters, 2 tiers,
N45.90666° W61.36030°

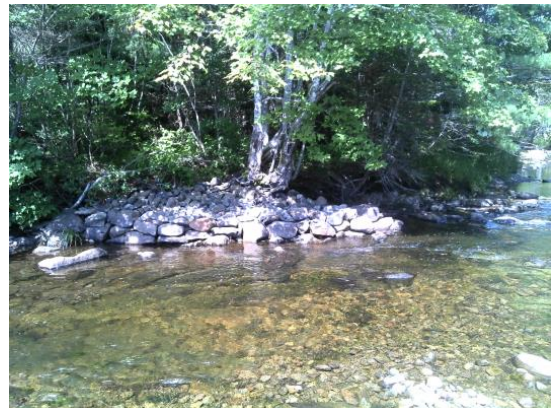
6. Rock Deflector, 6x3 meters, 2 tiers,
N45.90611° W61.36024°

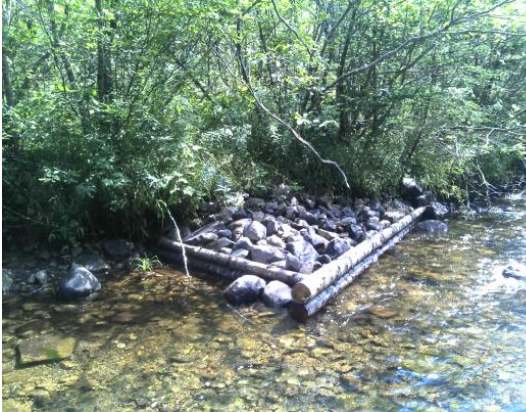
7. Deflector, 6x3 meters, 2 tiers,
N45.90550° W61.36033°

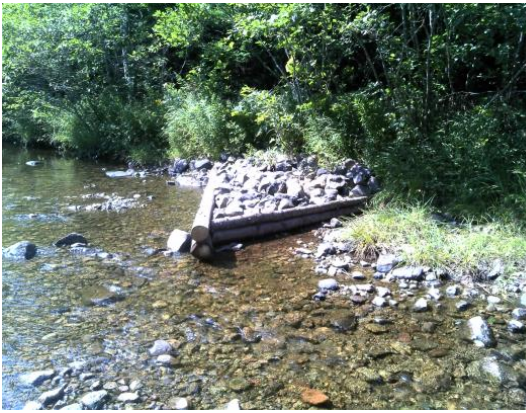
8. Deflector, 6x3 meters, 2 tiers,
N45.90496° W61.36014°

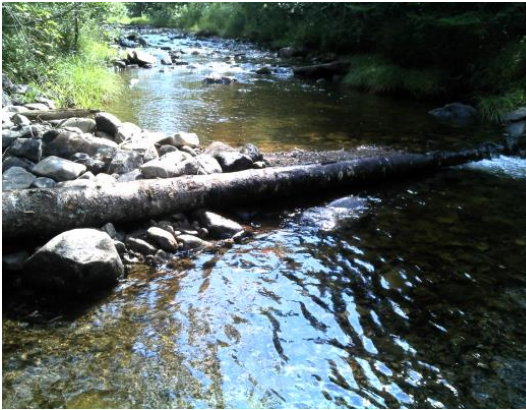
9. Digger Log and Rock Deflector, 6x3
meters, N45.90399° W61.35907°

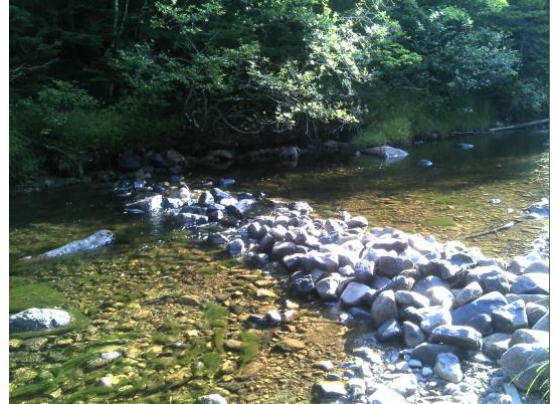
10. Rock Sill, 30 degrees, N45.90384°
W61.35849°

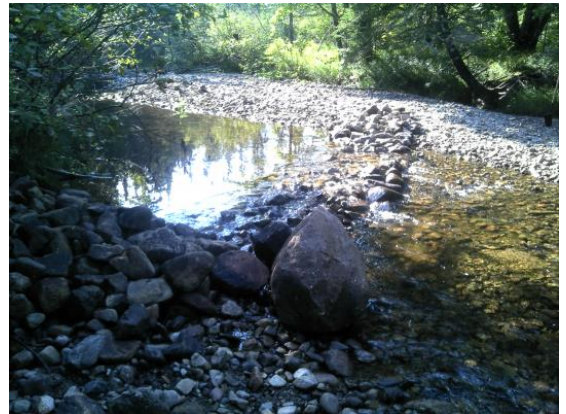
11. Rock Sill, 30 Degrees, N45.90308°
W61.35741°

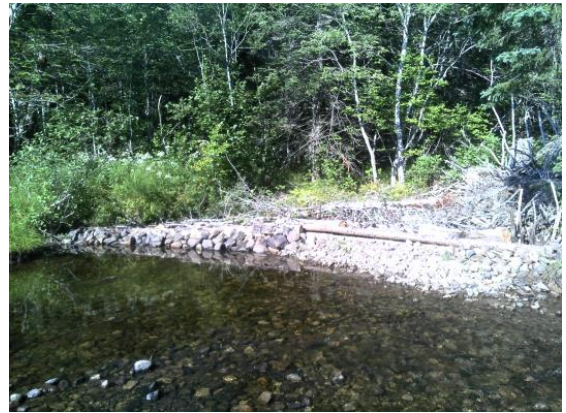
12. Channel Blocker, logs, and rock,
N45.90276° W61.35708°

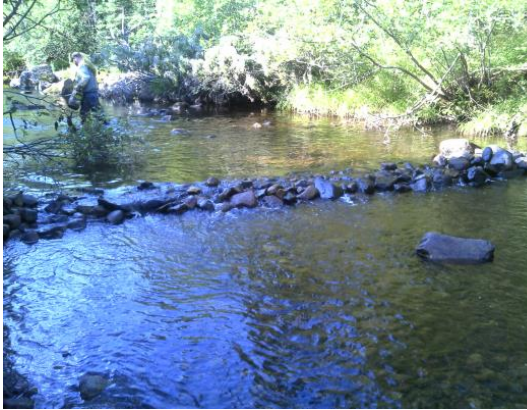
13. Rock Sill, 30 Degrees, N45.90232°
W61.35722°

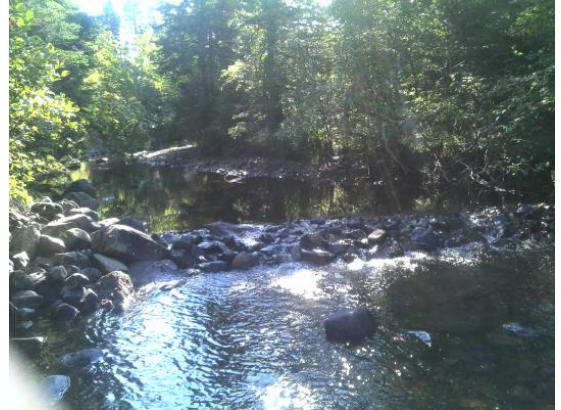
16. Rock Sill and Rock Deflector, N45.90171° W61.35584°

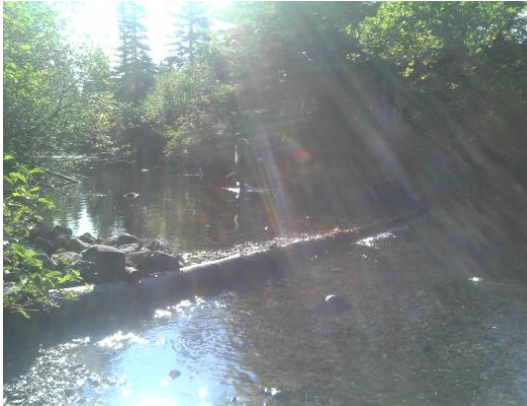
14. Digger Log and Deflector, 4x2 meters, N45.90183° W61.35691°

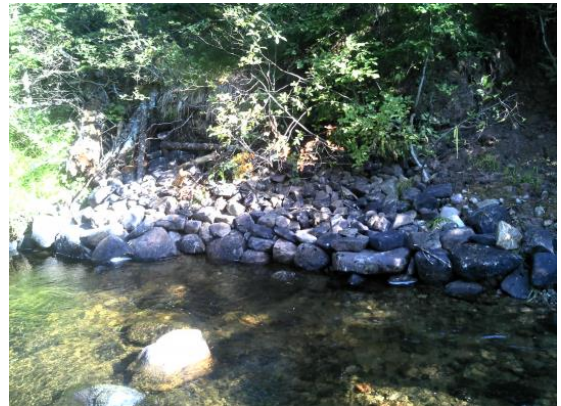
17. Bank Stabilization, N45.90164° W61.35535°

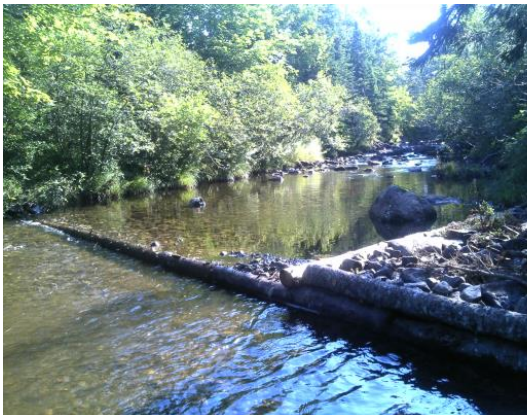
15. Digger Log and Deflector, 6x3 meters, N45.90173° W61.35632°

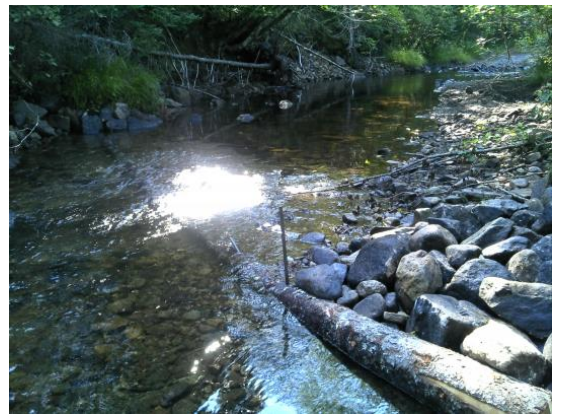
18. Digger Log and Deflector, 6x3 meters, N45.90160° W61.35526°

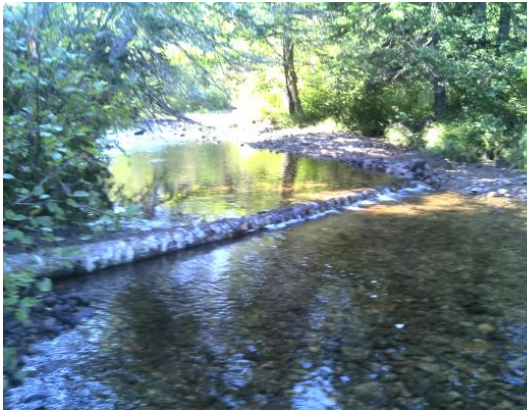
19. Digger Log, N45.90118° W61.35518°

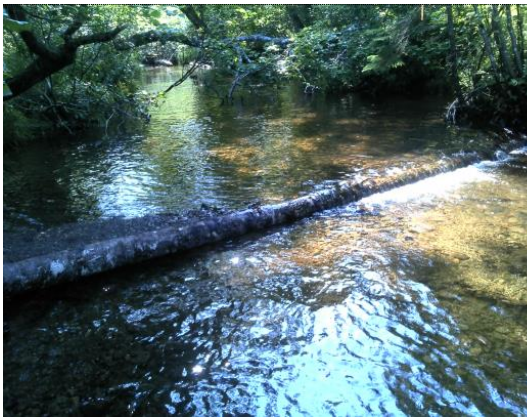
20. Digger Log, N45.90089° W61.35505°

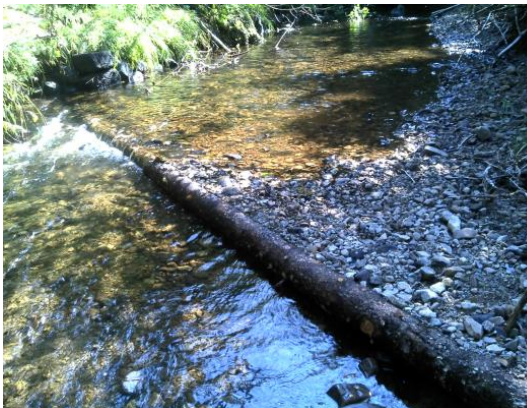
21. Digger Log, N45.90066° W61.35462°

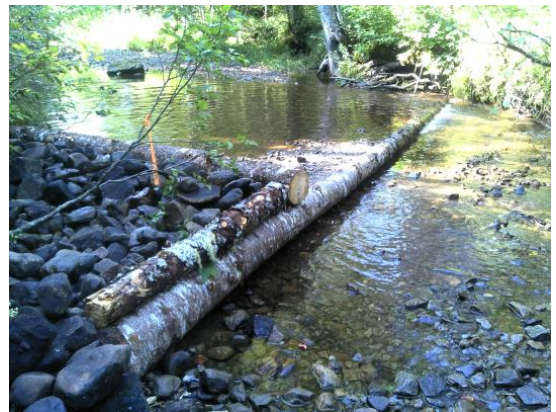
22. Digger Log and Deflector, 6x3 meters, 2 tiers, N45.90035° W61.35438°

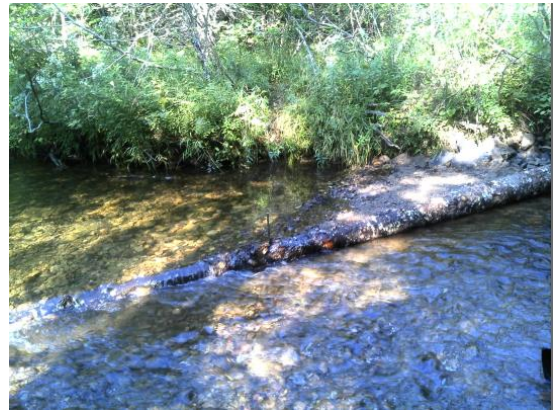
23. Digger Log, N45.90000° W61.35450°

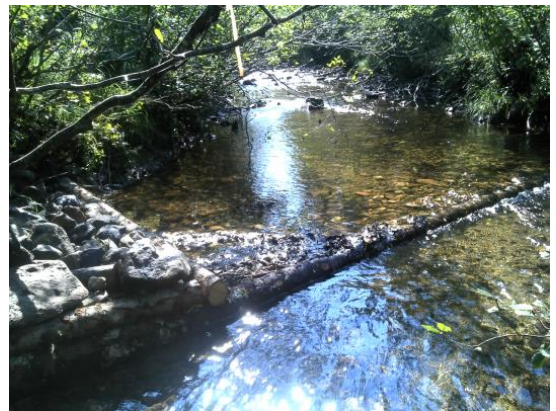
24. Digger Log and Deflector, 4x2 meters, 2 tiers, N45.89957° W61.35450°

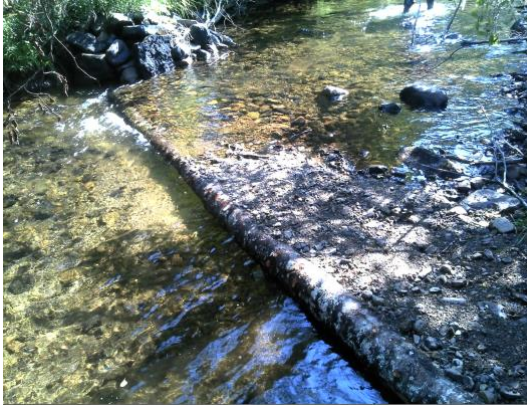
25. Digger Log, N45.89938° W61.35423°

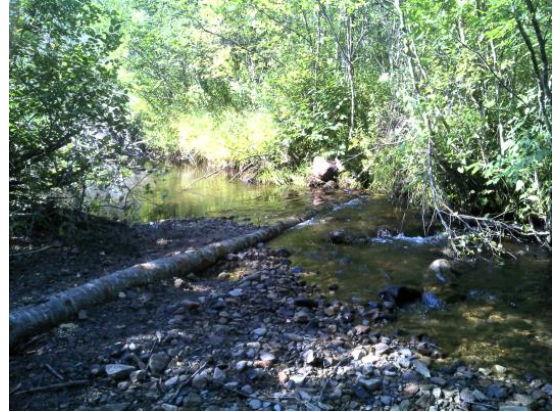
28. Digger Log, N45.89857° W61.35381°

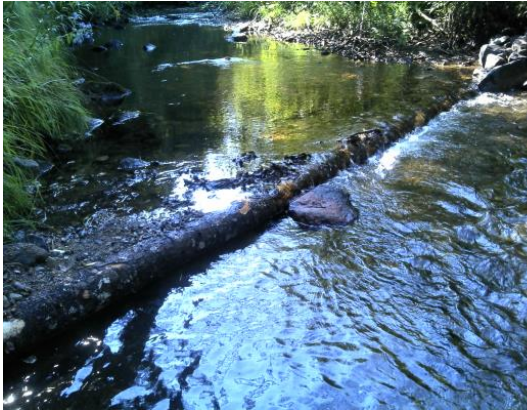
26. Digger Log, N45.89925° W61.35386°

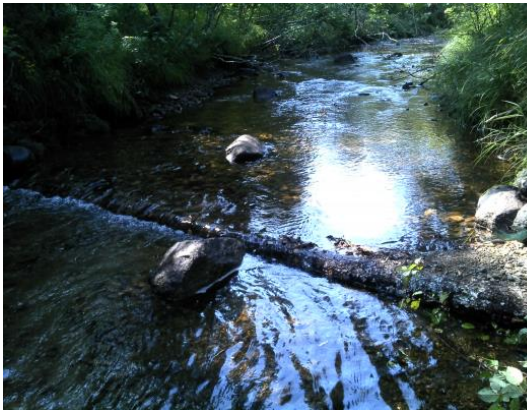
27. Digger Log, N45.89885° W61.35369°
