MONITORING PROGRAM, 2023 FINAL REPORT

Inverness South Anglers Association

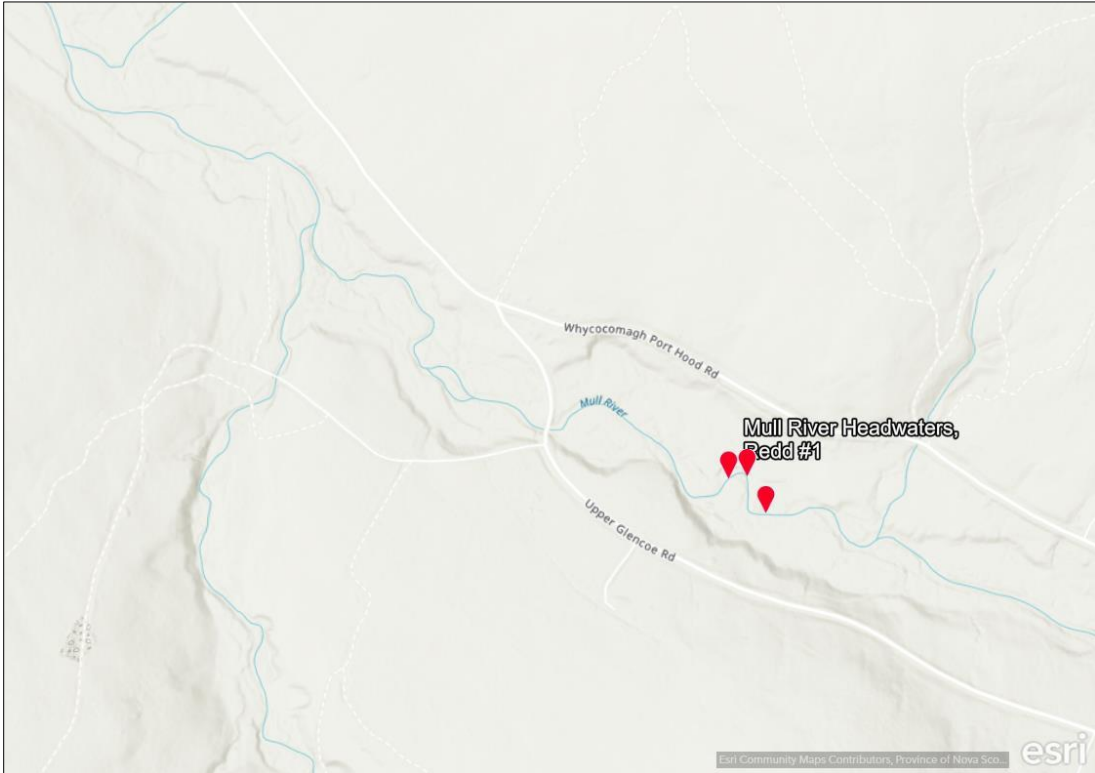
Figure 8: Showing salmon redds identified at 2023 project site.

Surveys conducted in the 2023 spawning season showed that there are adult salmon returning to the watershed to spawn. It is important to note that an active beaver dam on the 2023 project site does block fish passage. Beyond this point there were no redds identified. This issue raises the question of other blocked fish passage and aquatic connectivity in the region. Although this is a natural occurrence, there are other human caused issues preventing fish passage such as degraded and outdated culverts. On the Southwest Mabou River, there were several large redds identified. This is an indication of a high population of large breeding females making good use of the idea spawning habitat that the Southwest has to offer. With future restoration efforts it is ISAA's goal to increase spawning habitat throughout the Mabou Harbour watershed.
