SALMONID HABITAT RESTORATION

INVERNESS SOUTH ANGLERS ASSOCIATION

Progress Report

Monday, June 12th, 2017

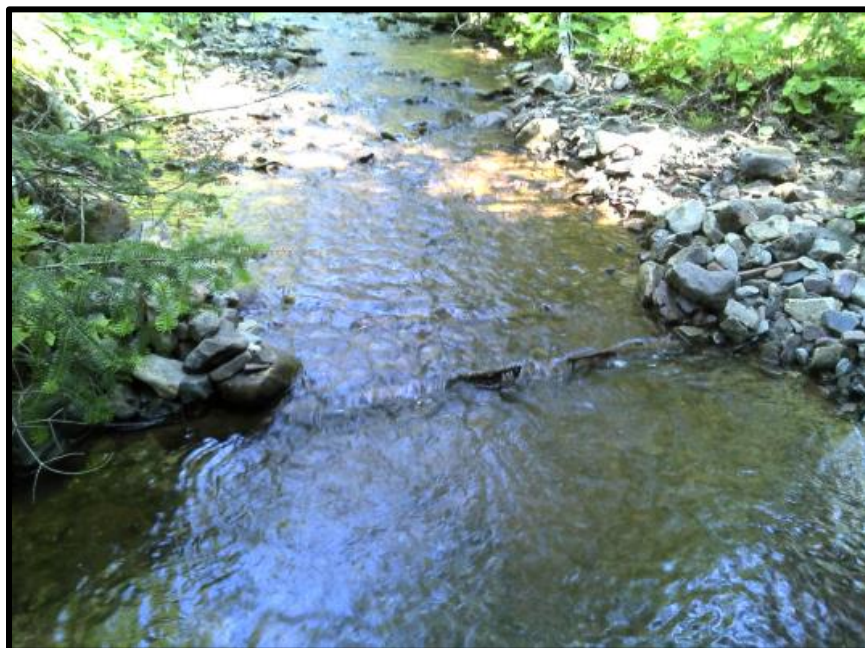
Way Point 13 – Digger Log and Deflector

DIGGERLOG AND DEFLECTOR	10	Structure has been built recently. No maintenance needed.
DIGGER LOG	11	New structure that was recently built. No deflectors needed due to the width of the river.
DIGGER LOG AND DEFLECTOR	13	Digger log needs to be fully replaced. Deflectors were maintained.

Figure 10: An after picture of the maintained digger log deflectors on More Brook.

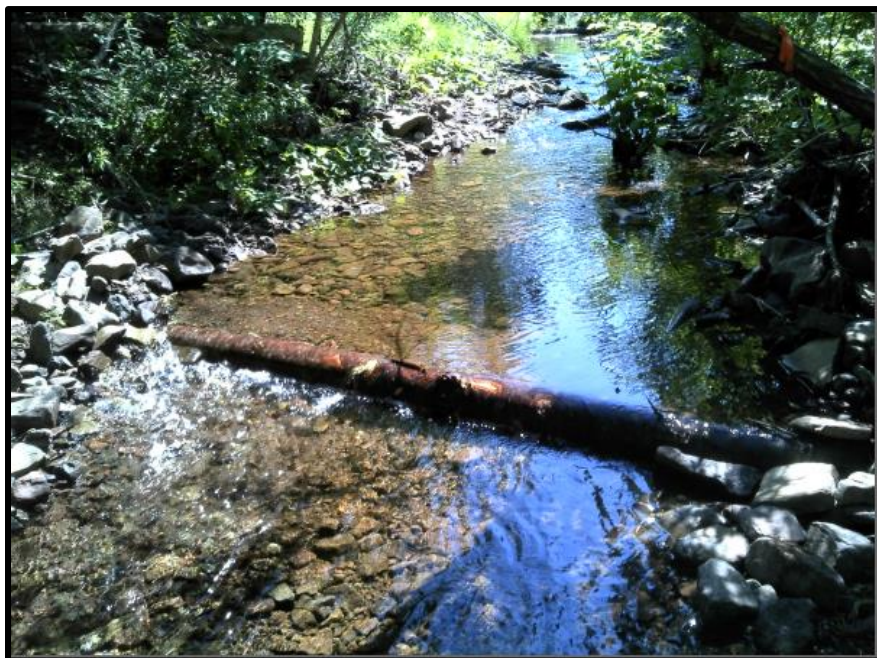
Figure 11. New Digger Log installed during the Enfield Training Session with Adopt a Stream with on the More Brook.

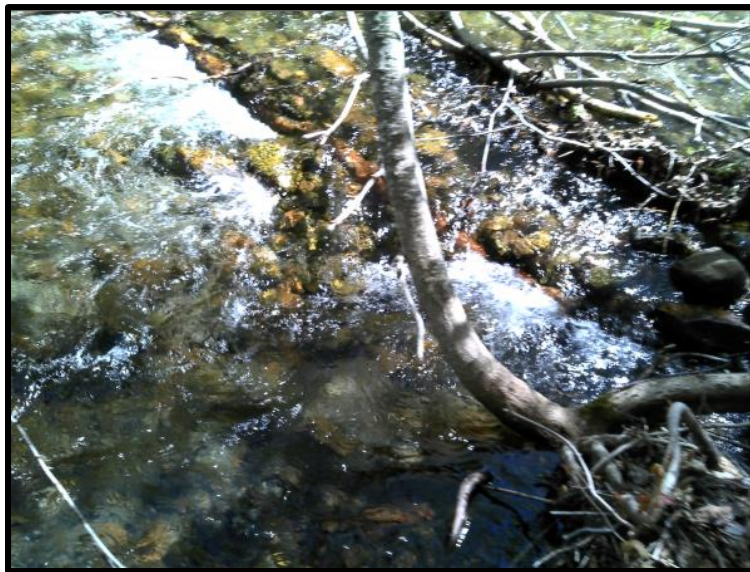
Way Point 21: Digger Log and Deflector

Figure 26. Before picture of the digger log and deflector.

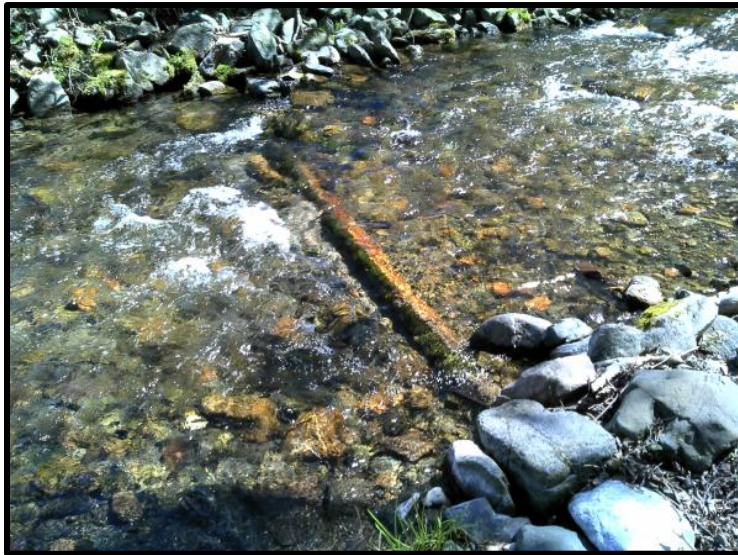
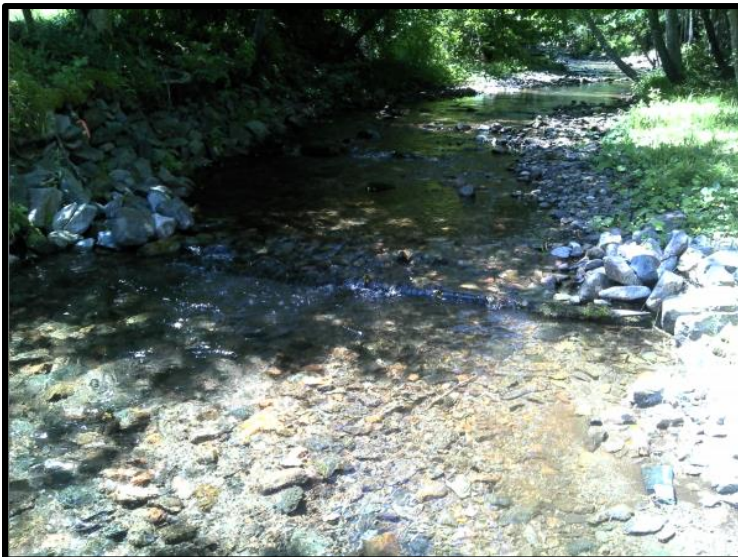
Way Point 22: Digger Log and Deflector

Figure 28. Before picture of the digger log and deflector.

Figure 29. After picture of the digger log and deflector.

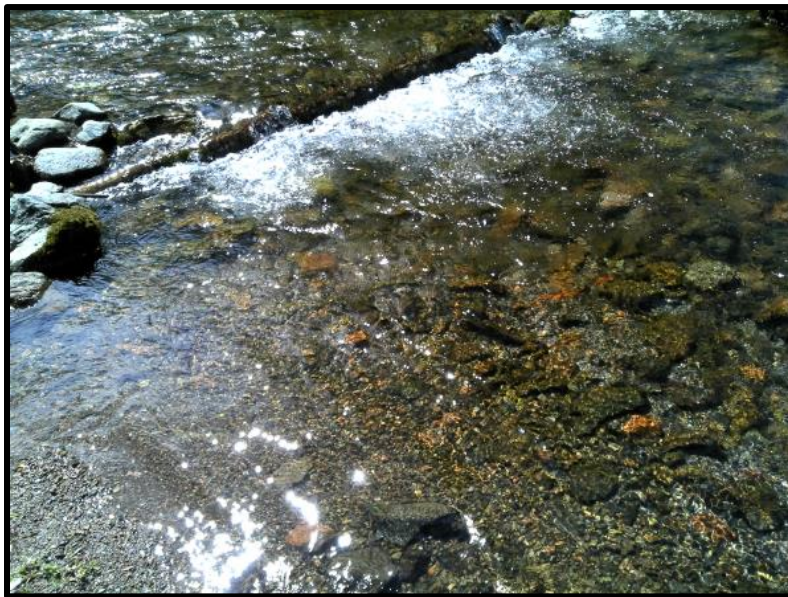
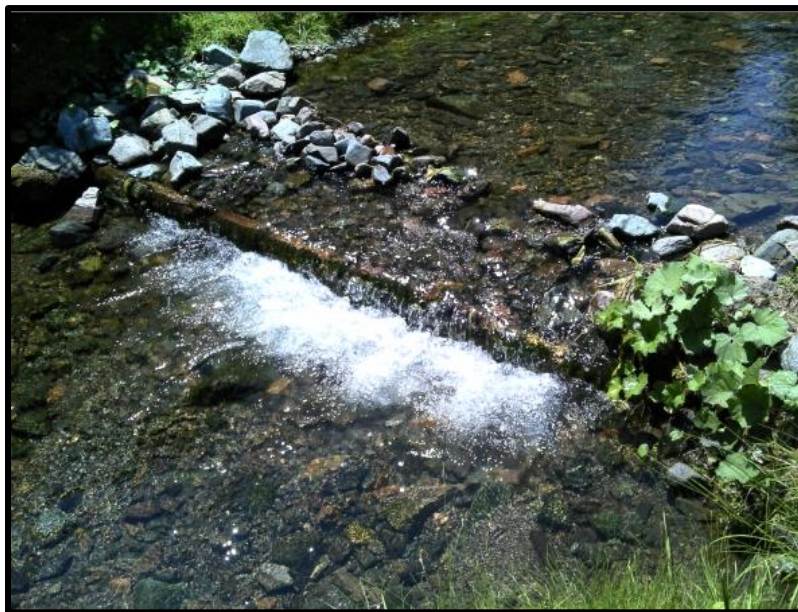
Way Point 23: Digger Log and Deflector

Figure 30. Before picture of the digger log and deflector.

Figure 31. After picture of the digger log and deflector.

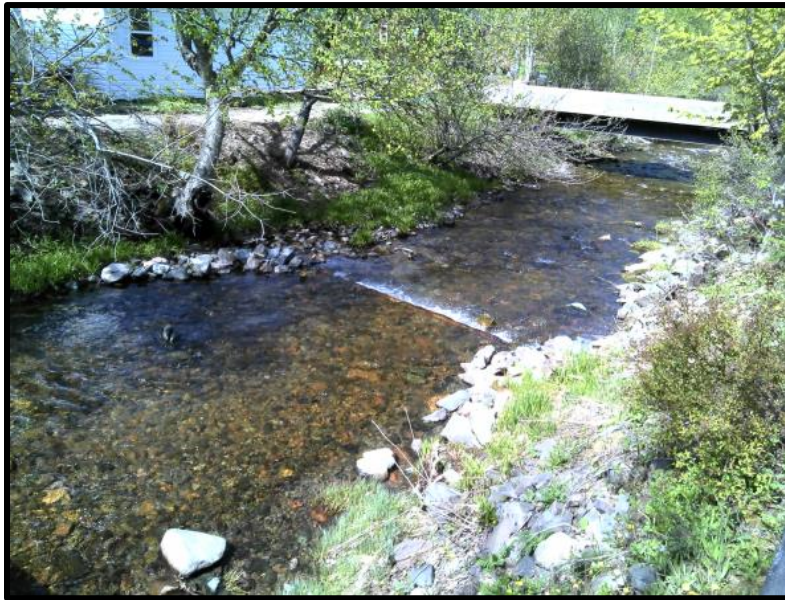
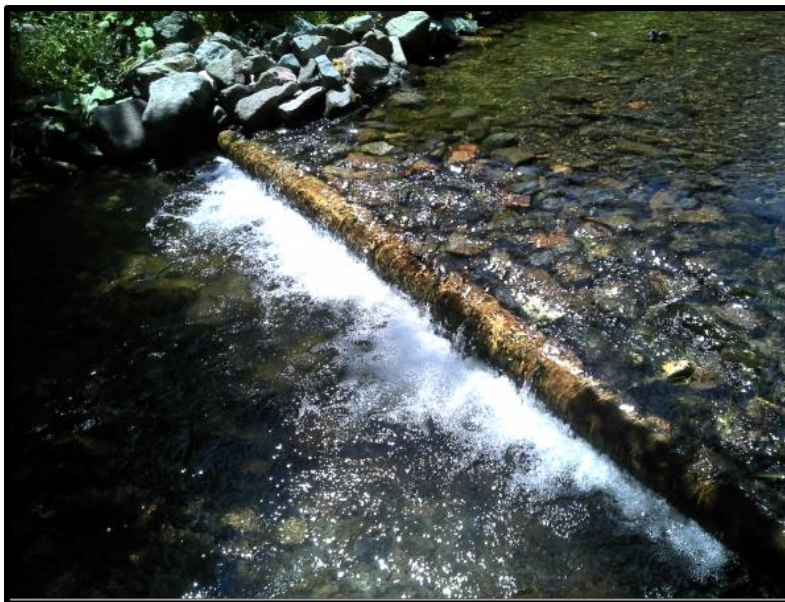
Way Point 24: Digger Log and Deflector

Figure 32. Before picture of the digger log and deflector.

Figure 33. After picture of the digger log and deflector.

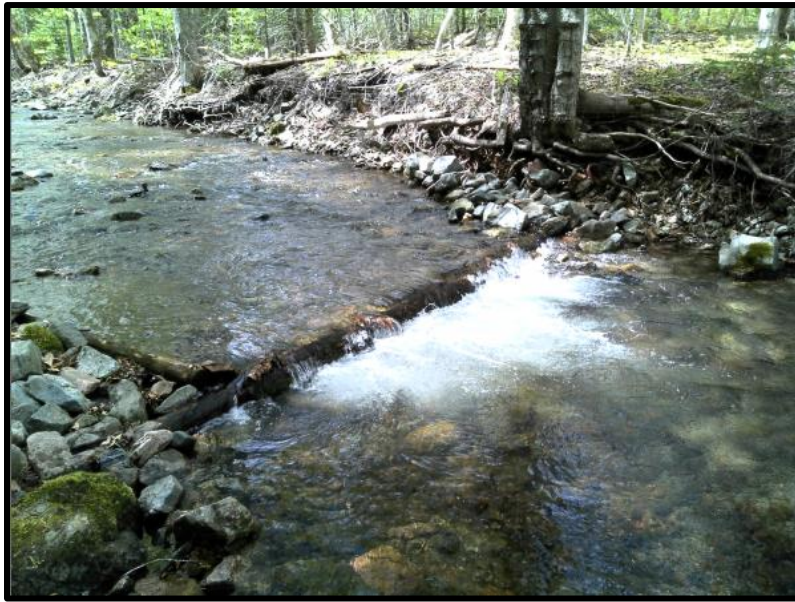
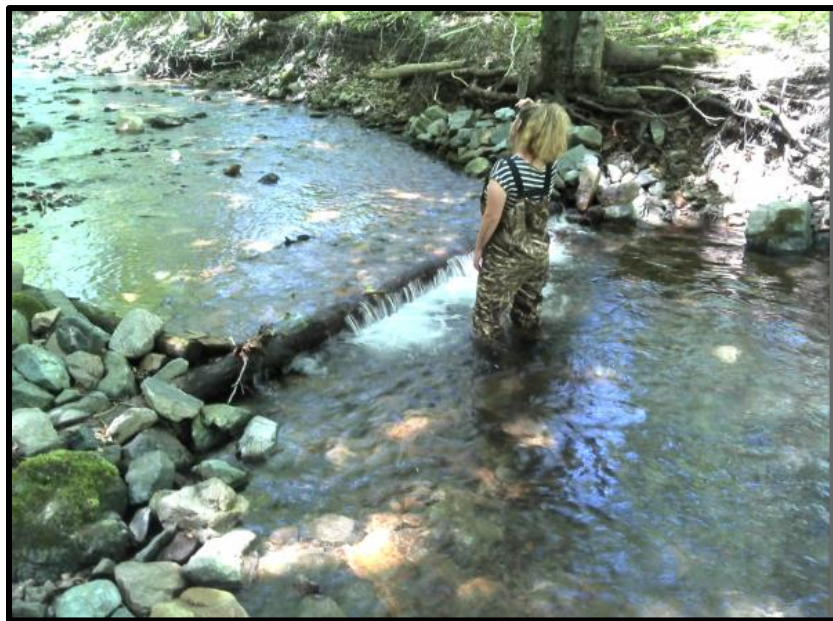
Way Point 67: Digger Log and Deflector

Figure 36. Before picture of a digger log and deflector structure that was maintained.

Figure 37. After picture of the digger log and deflector structure.

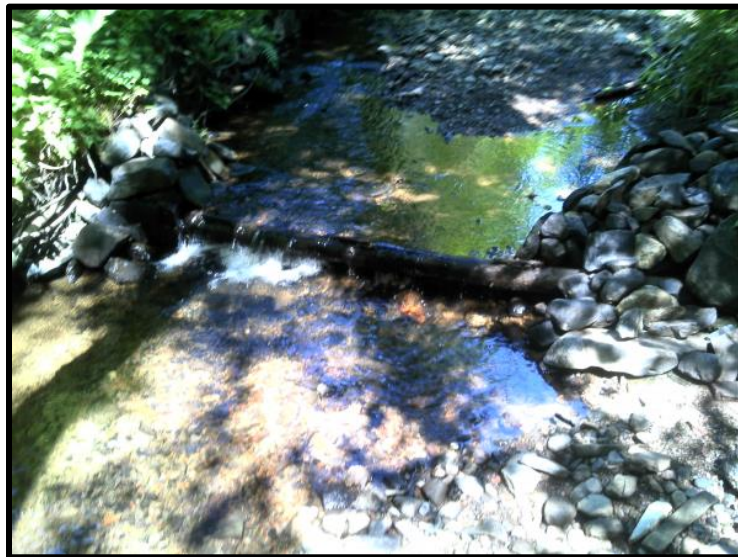
Figure 46. After picture of the digger log structure.

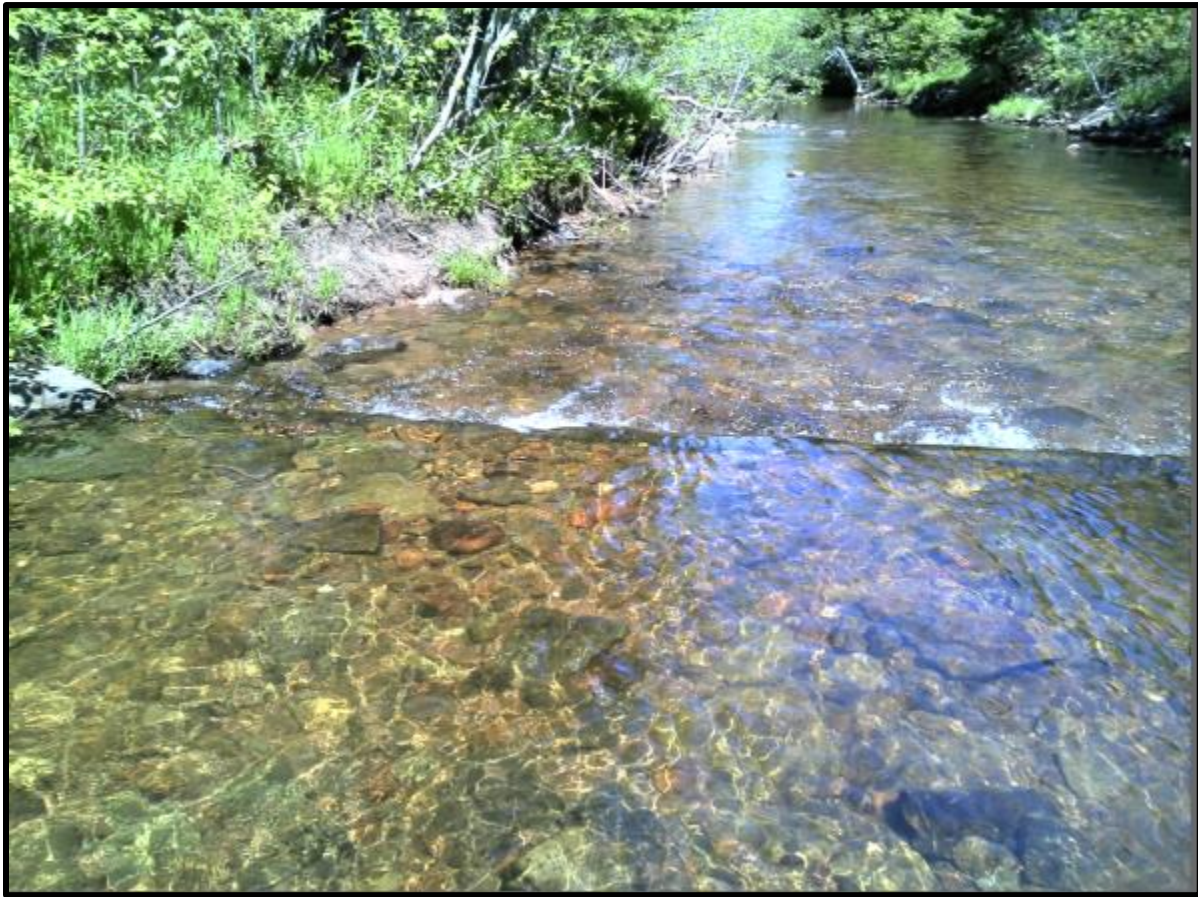
Way Point 148 – Digger Log

Figure 65. Digger Log structure for waypoint 148.

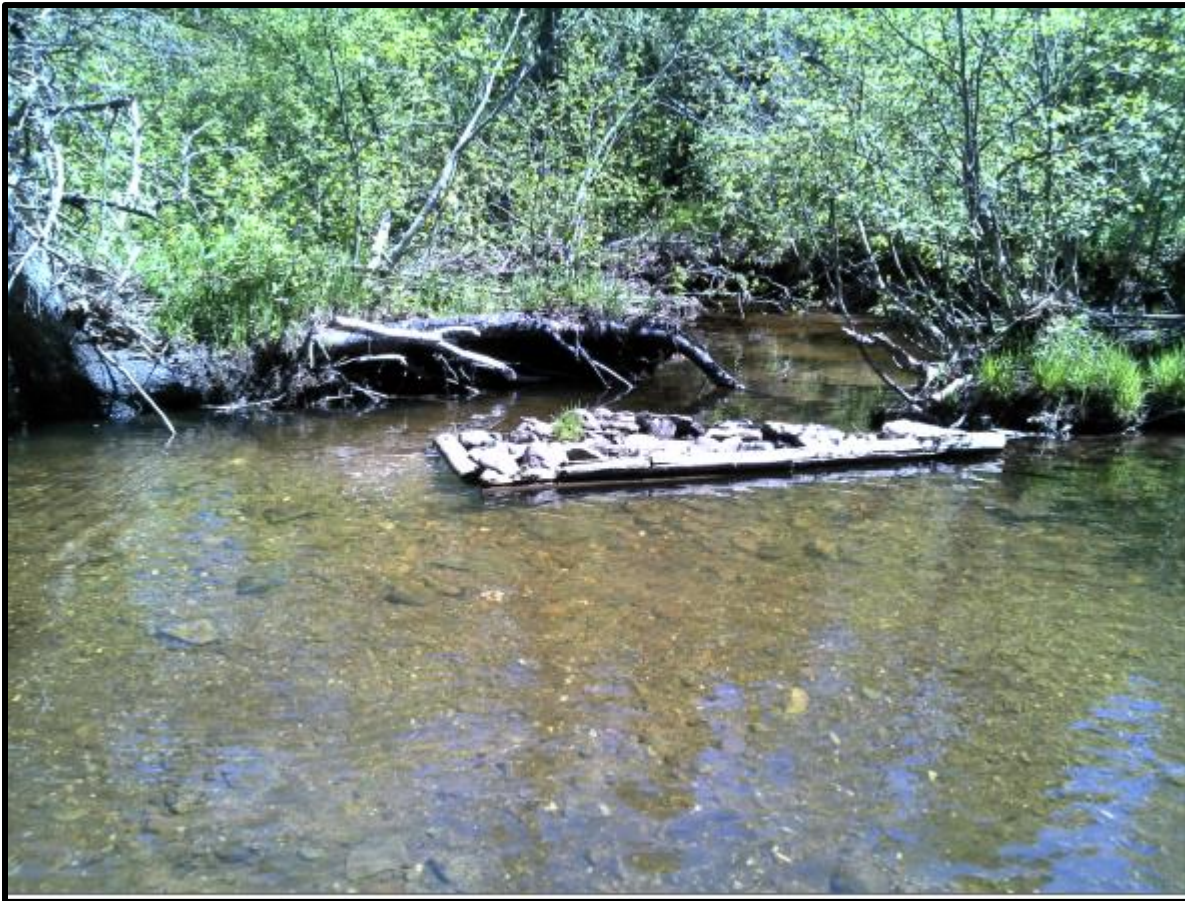
Way Point 149 – Deflector

Figure 66. Deflector structure for waypoint 149.

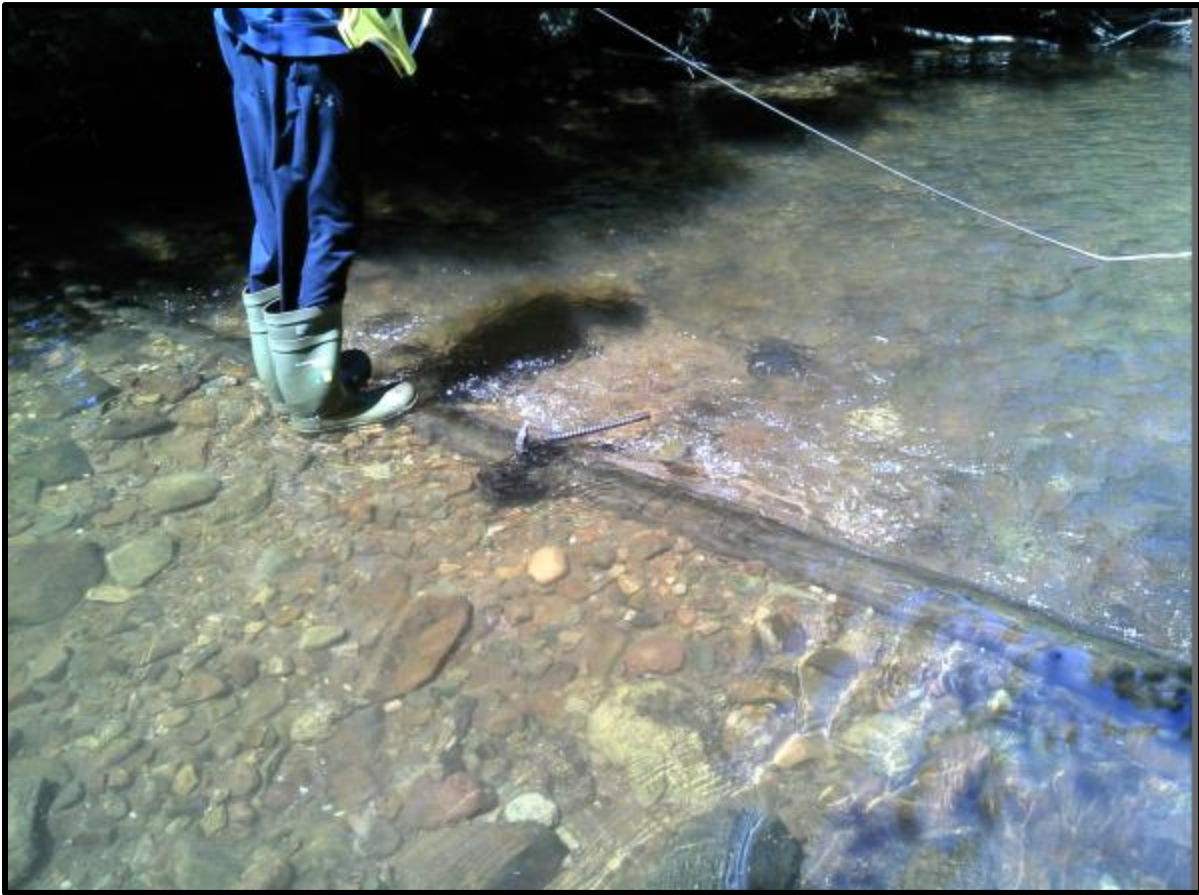
Way Point 150 – Digger Log

Figure 67. Digger Log structure for waypoint 150.

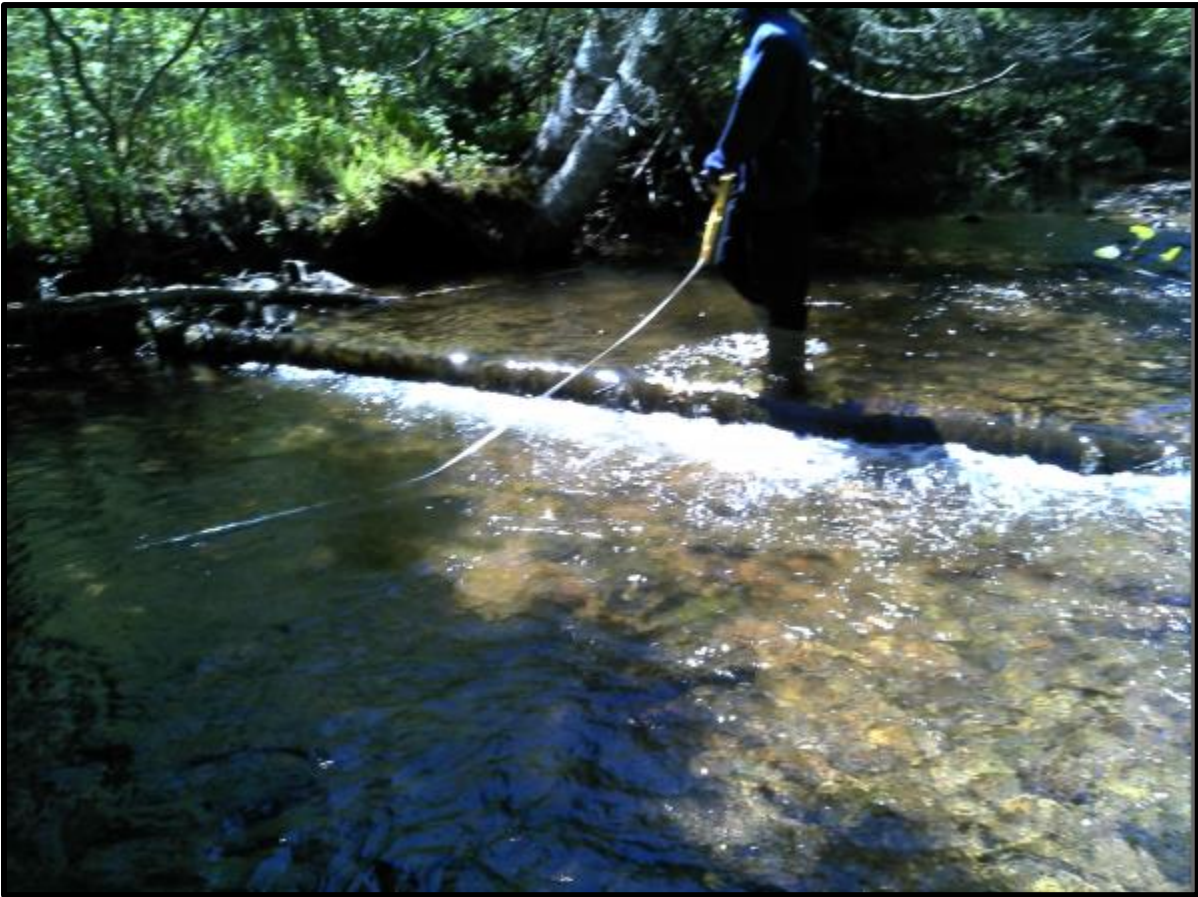
Way Point 152 – Digger Log

Figure 69. Digger Log structure at waypoint 152.

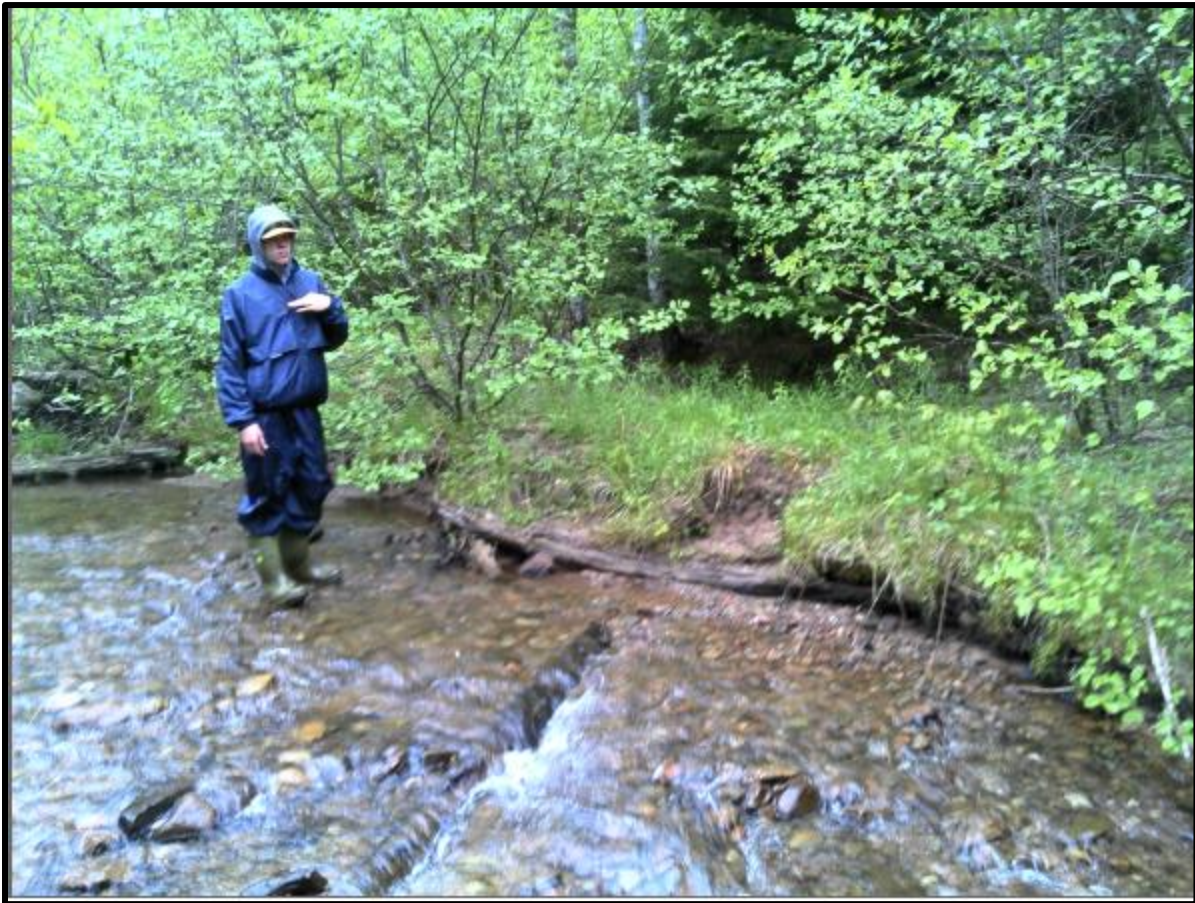
Way Point 162 – Digger Log

Figure 71. Digger Log structure at waypoint 162.

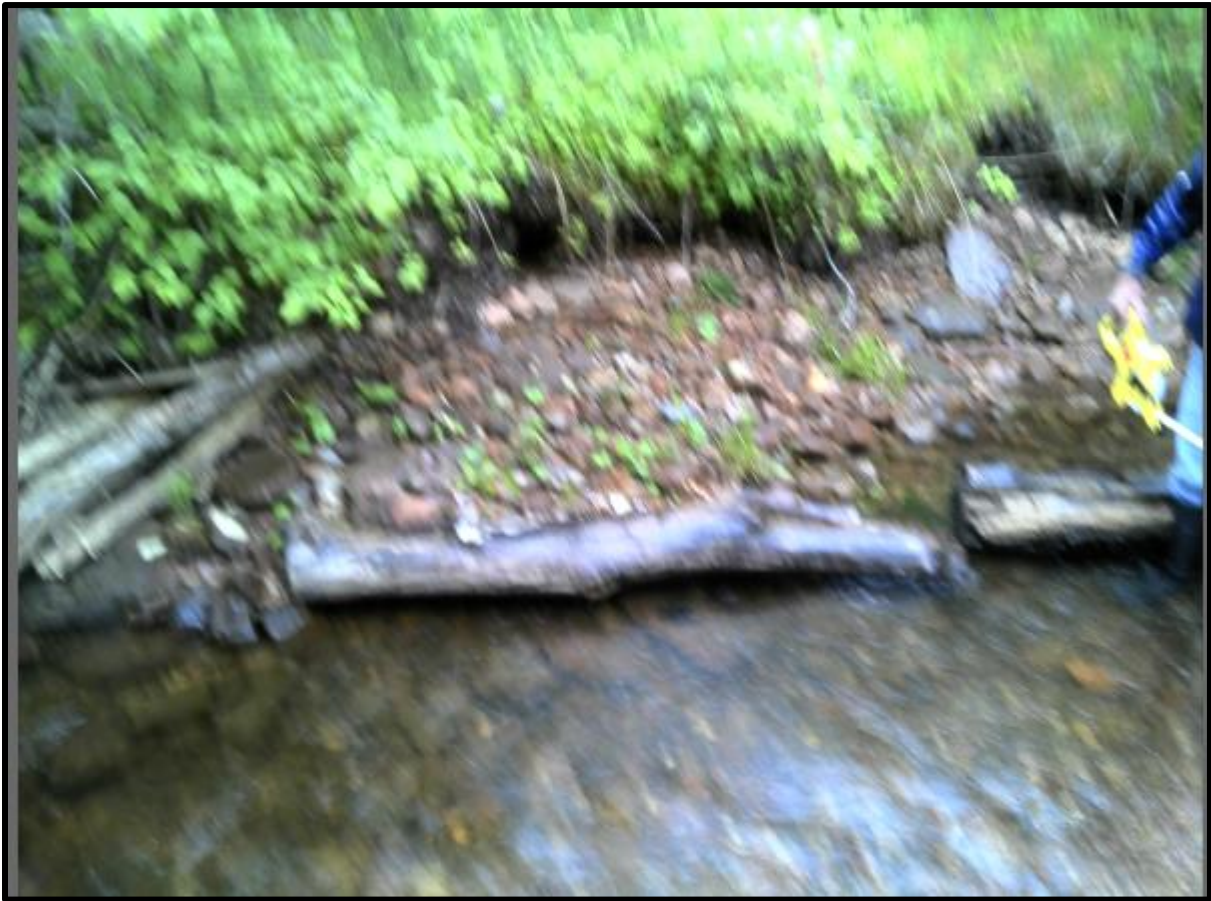
Way Point 164 – Deflector

Figure 72. Deflector structure at waypoint 164.

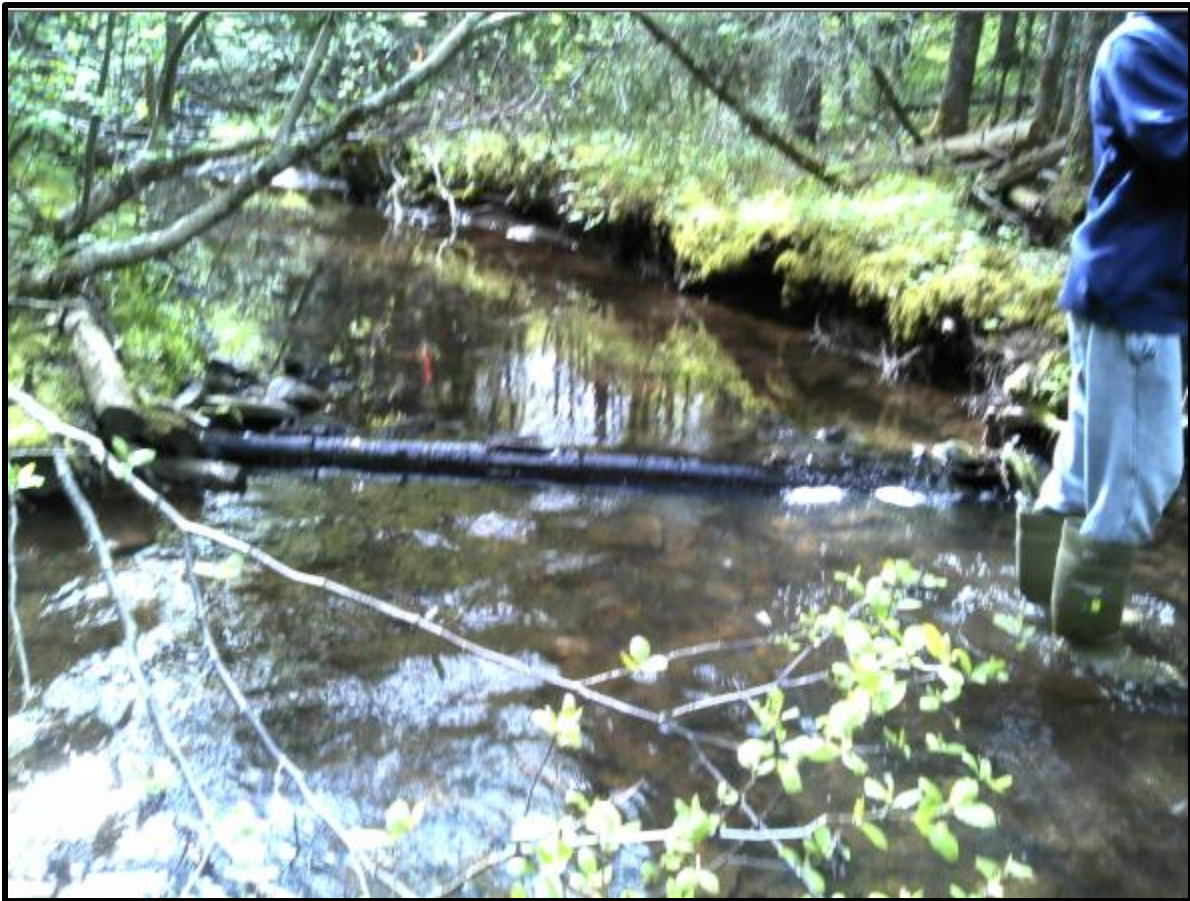
Way Point 124 – Digger Log

Figure 81. Digger Log structure at waypoint 124.

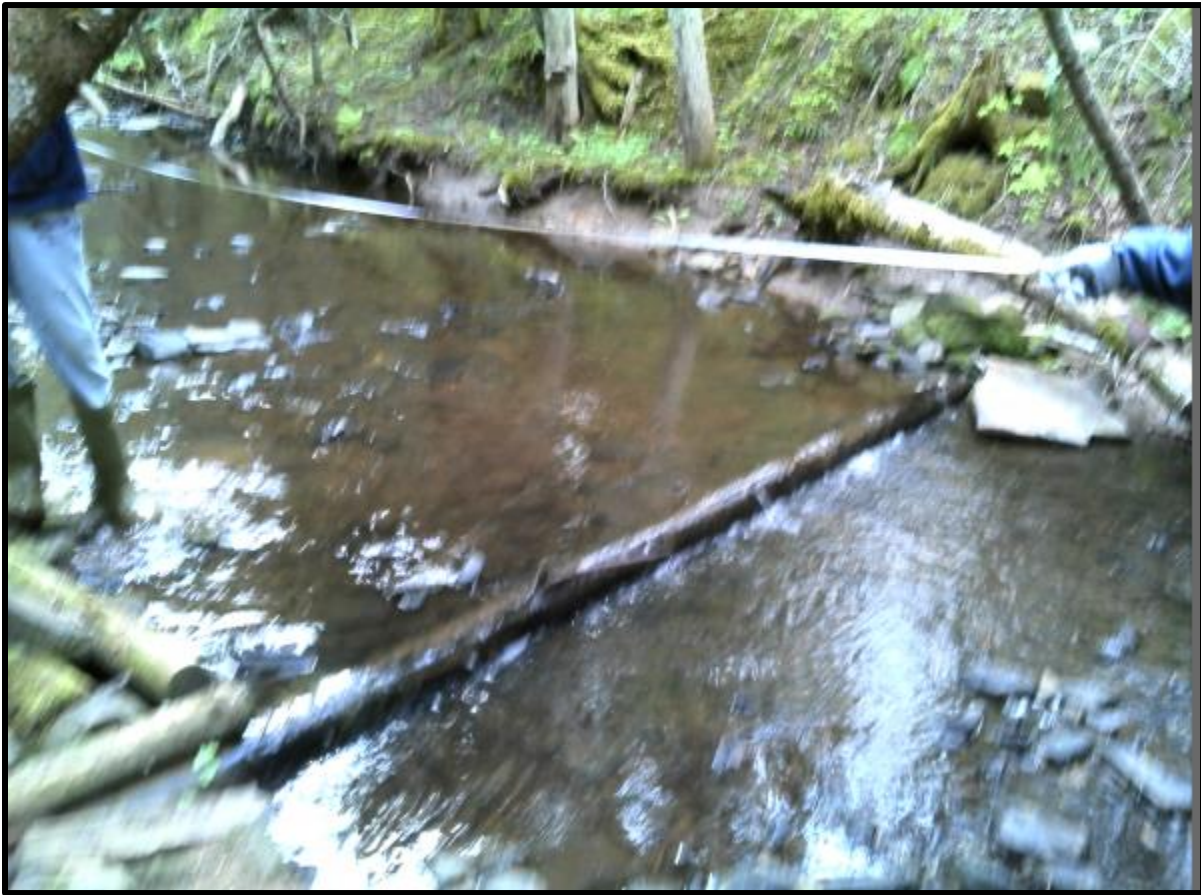
Way Point 127 – Digger Log

Figure 82. Digger Log structure at waypoint 127.

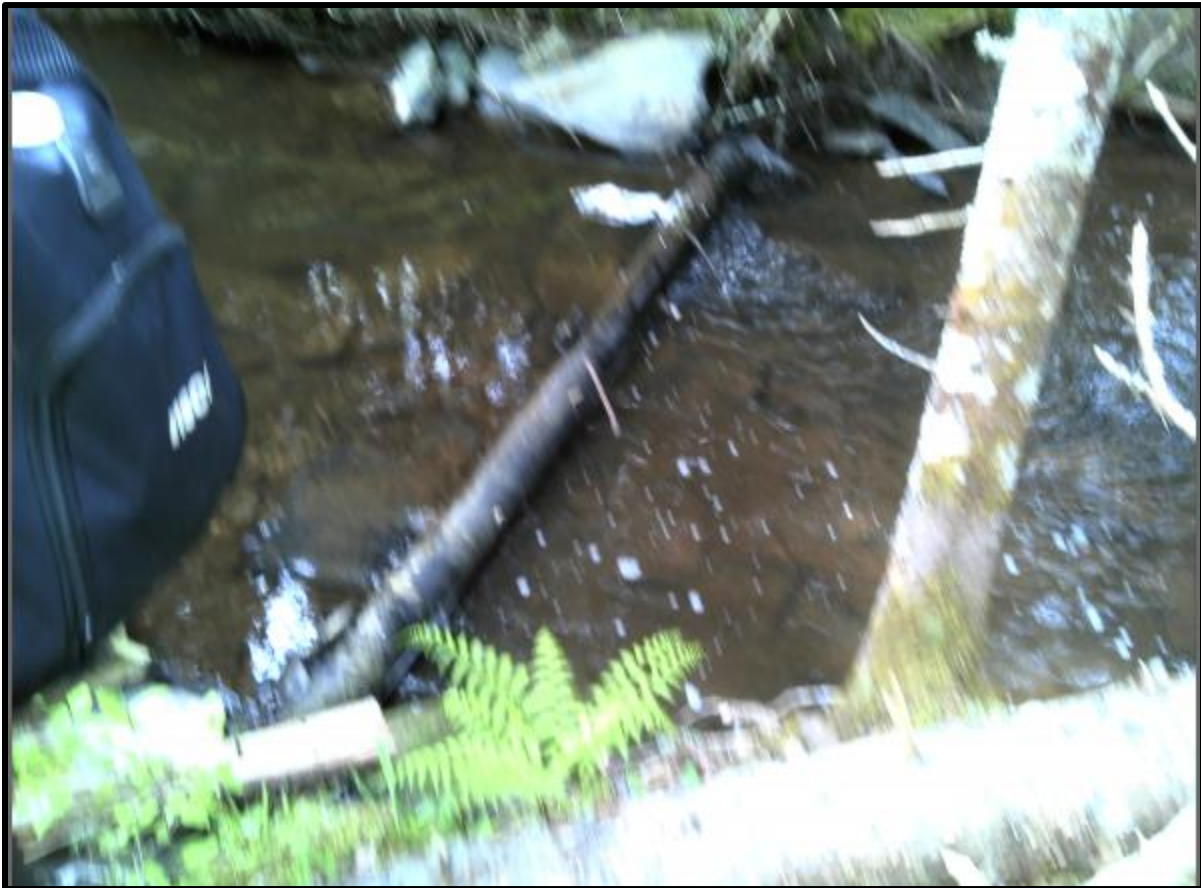
Way Point 128 – Digger Log

Figure 83. Digger Log structure at waypoint 128.

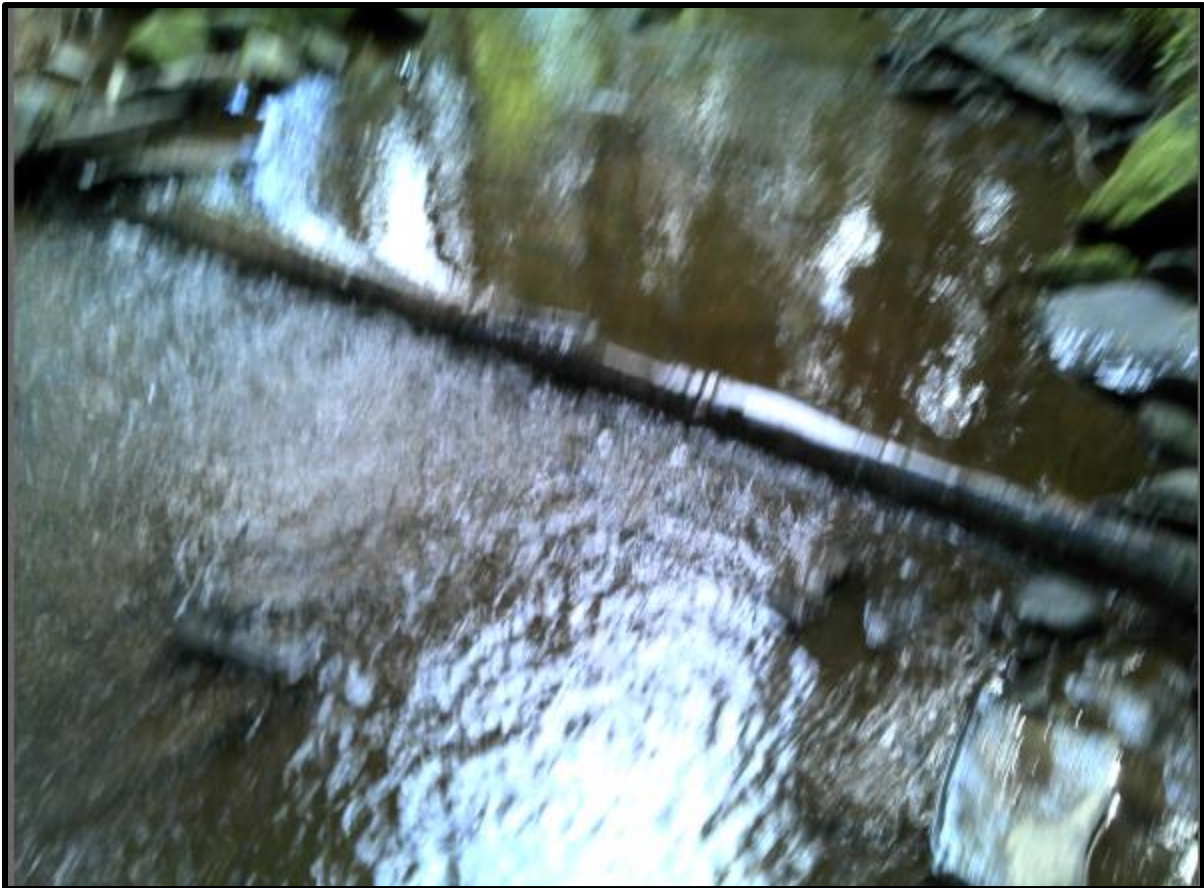
Way Point 130 – Digger Log

Figure 84. Digger Log structure at waypoint 130.

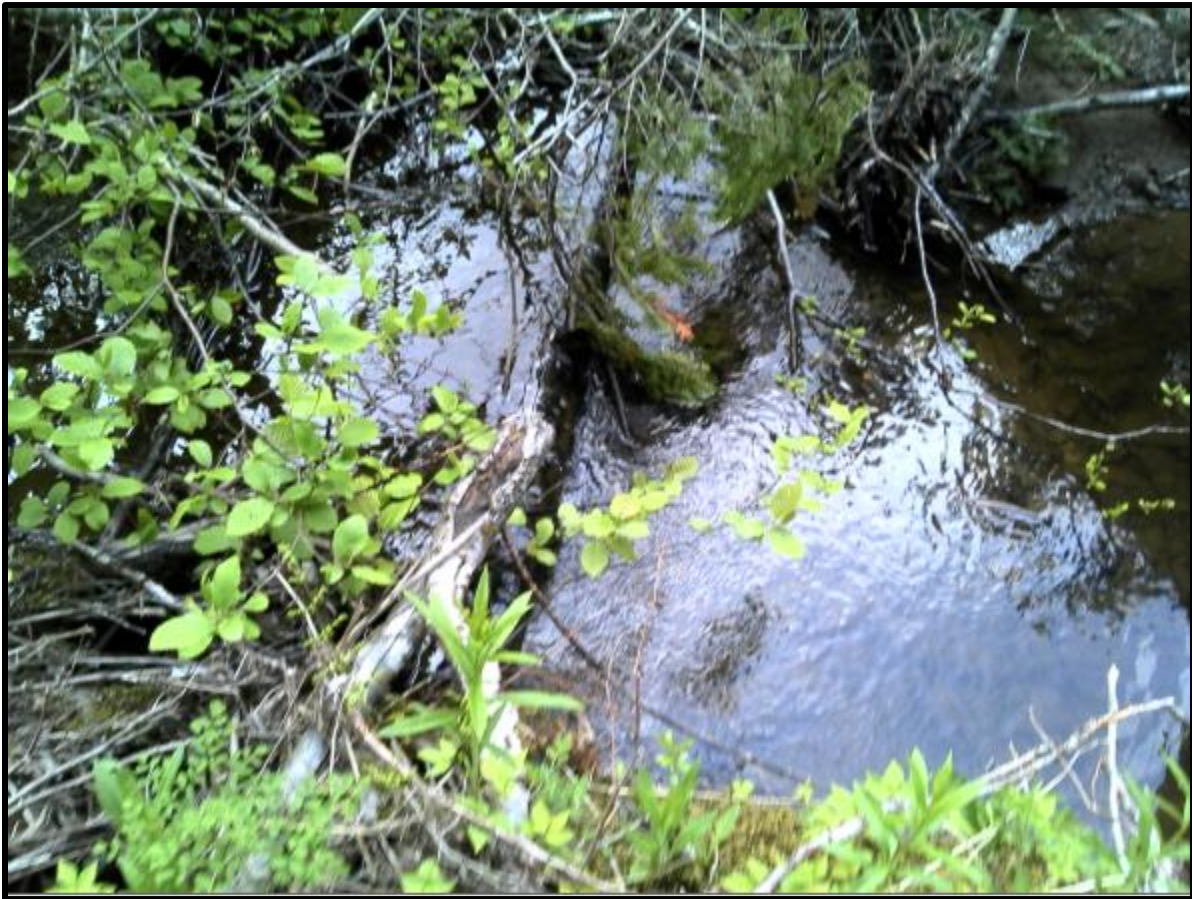
Way Point 133 – Digger Log

Figure 86. Digger Log structure at waypoint 133.

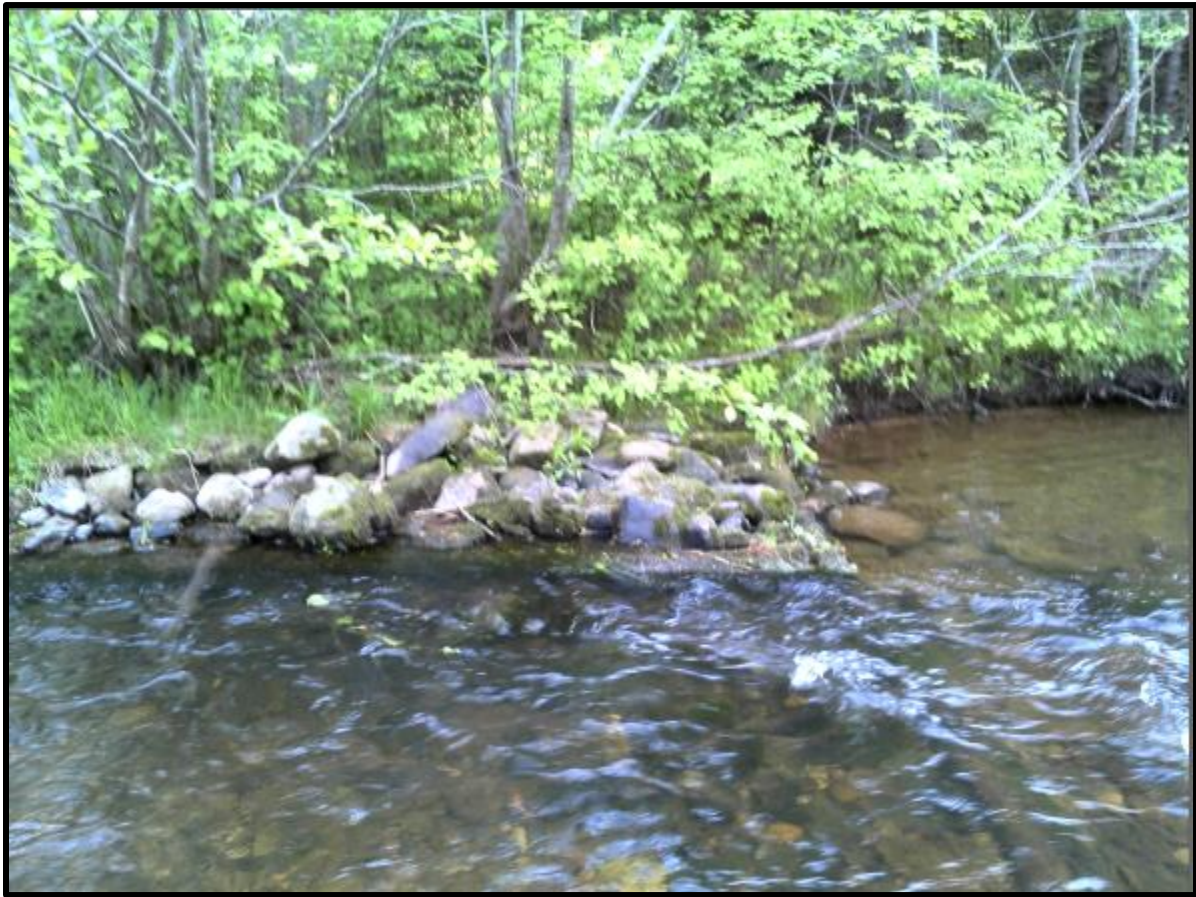
Way Point 137 – Deflector

Figure 89. Deflector structure at waypoint 137.

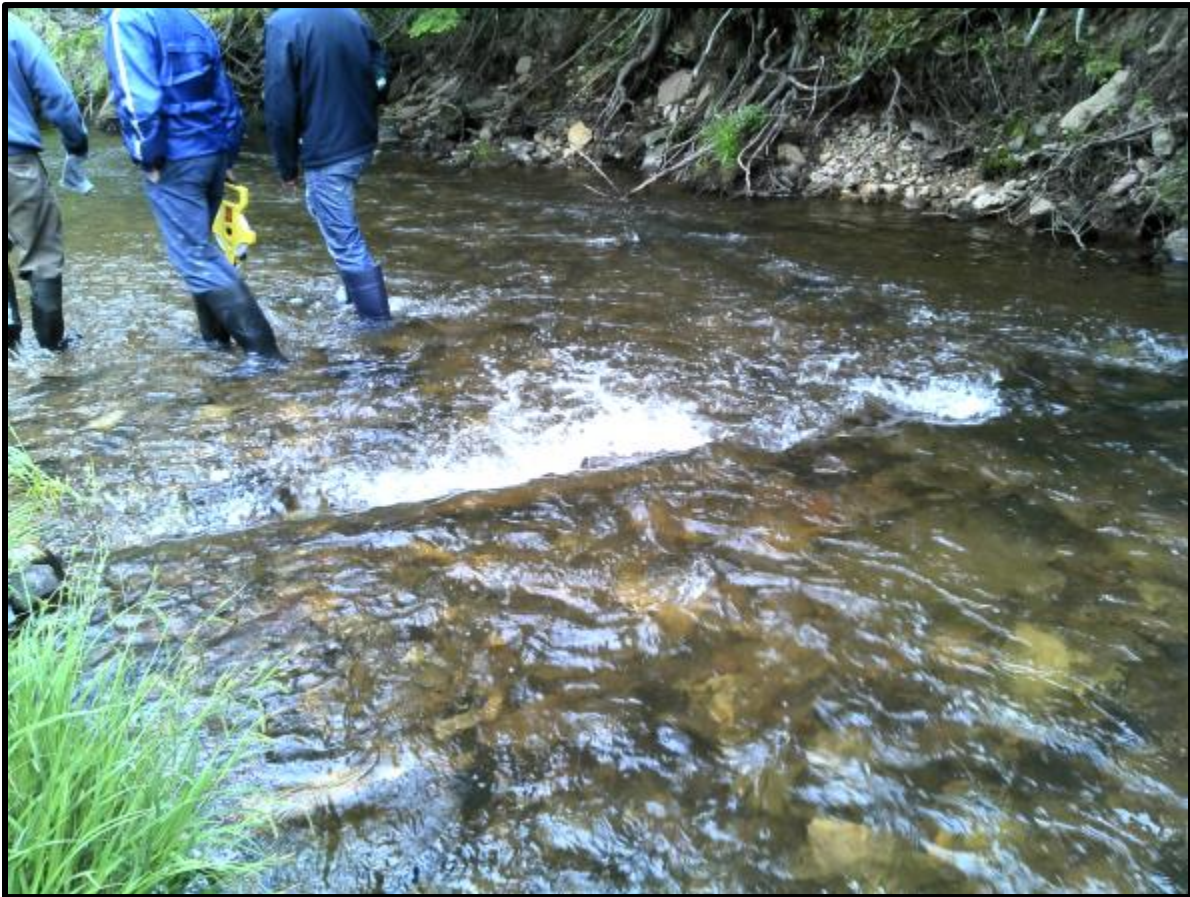
Way Point 138 – Digger Log

Figure 90. Digger Log Structure at waypoint 138.

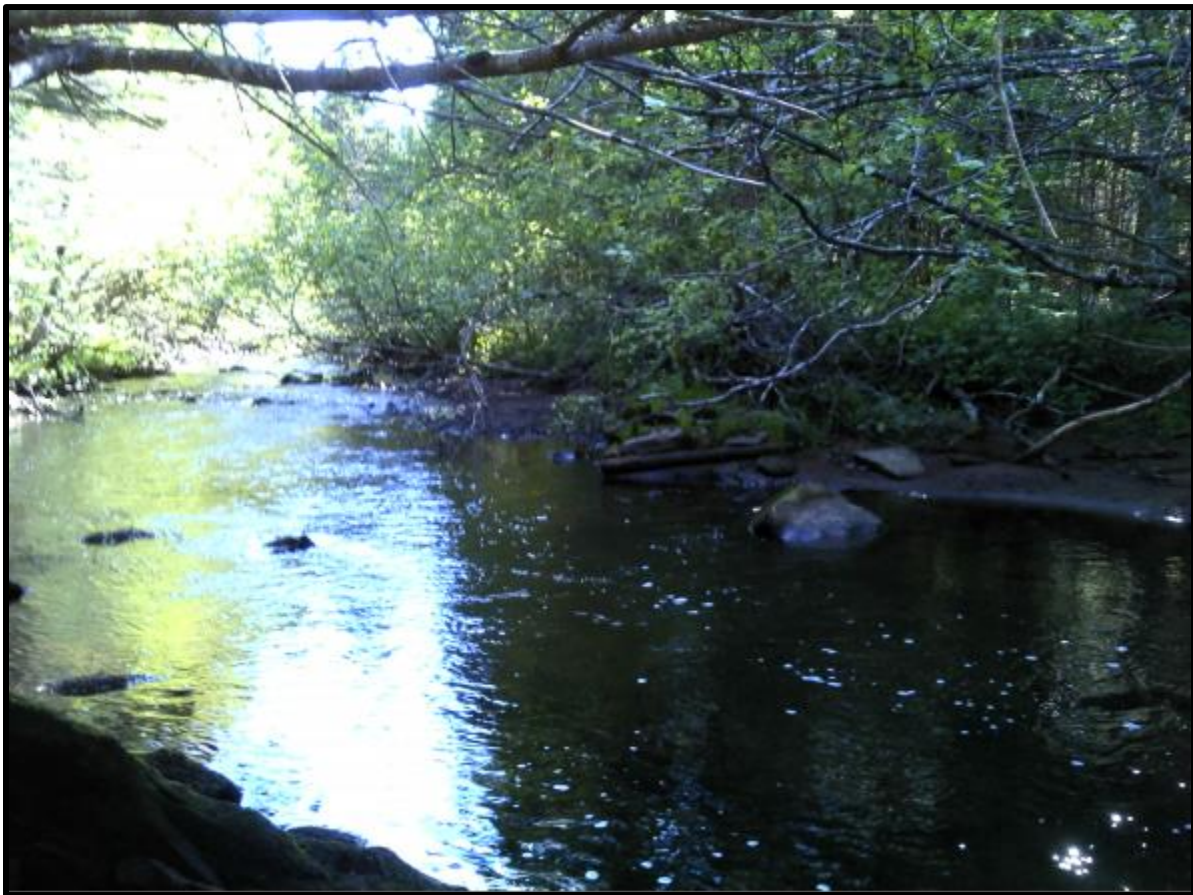
Way Point 140 – Deflector

Figure 91. Deflector structure at waypoint 140.

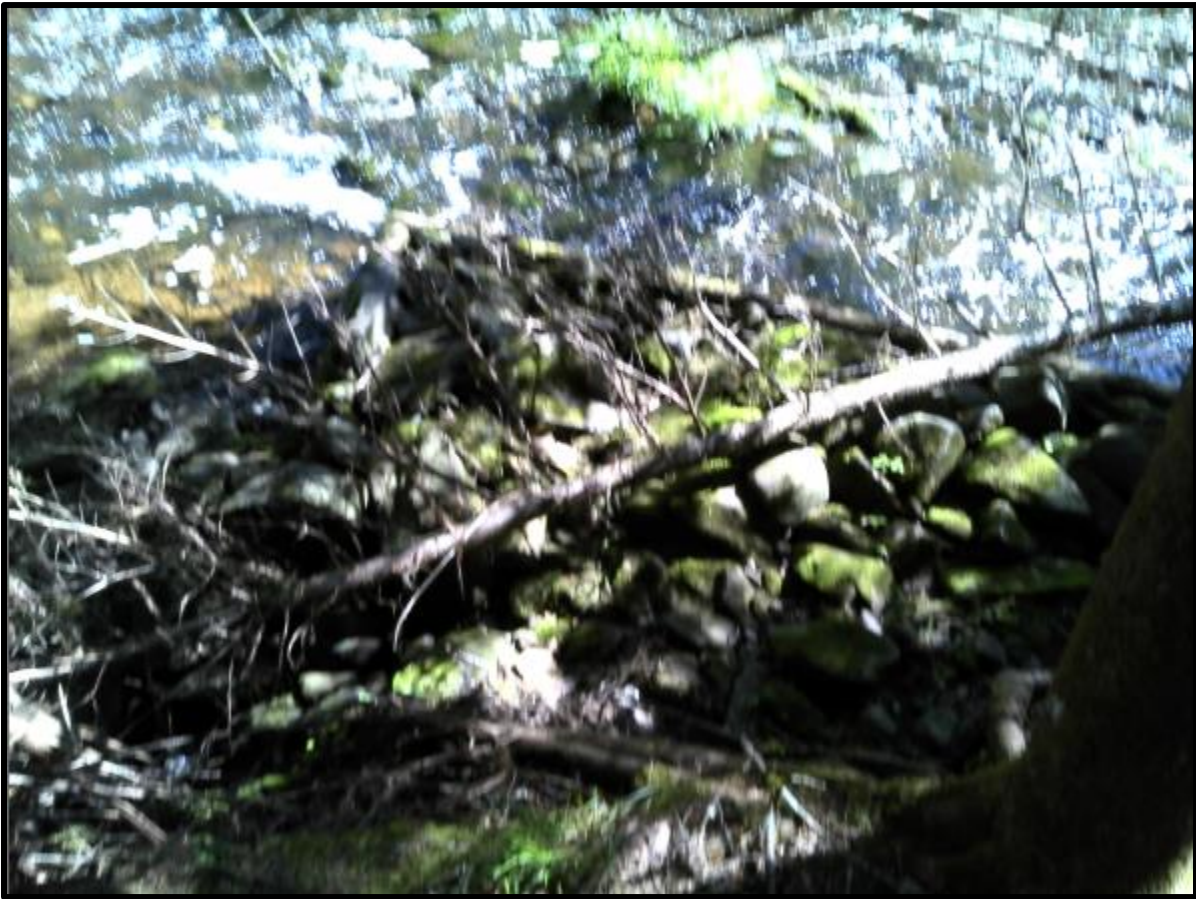
Way Point 141 – Deflector

Figure 92. Deflector structure at waypoint 141.
