SALMONID HABITAT RESTORATION

INVERNESS SOUTH ANGLERS ASSOCIATION

Progress Report

Monday, June 12th, 2017

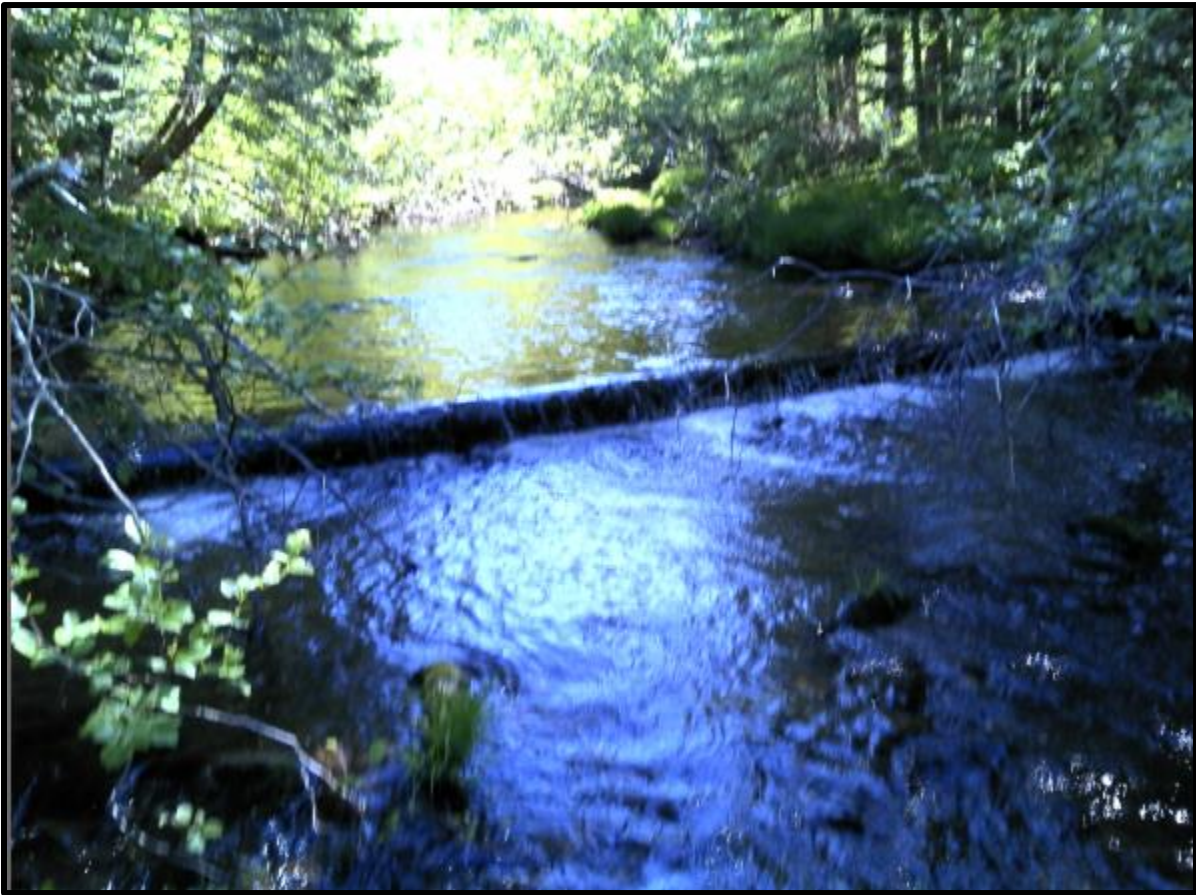
Way Point 143 – Digger Log

Figure 94. Digger Log Structure at waypoint 143.

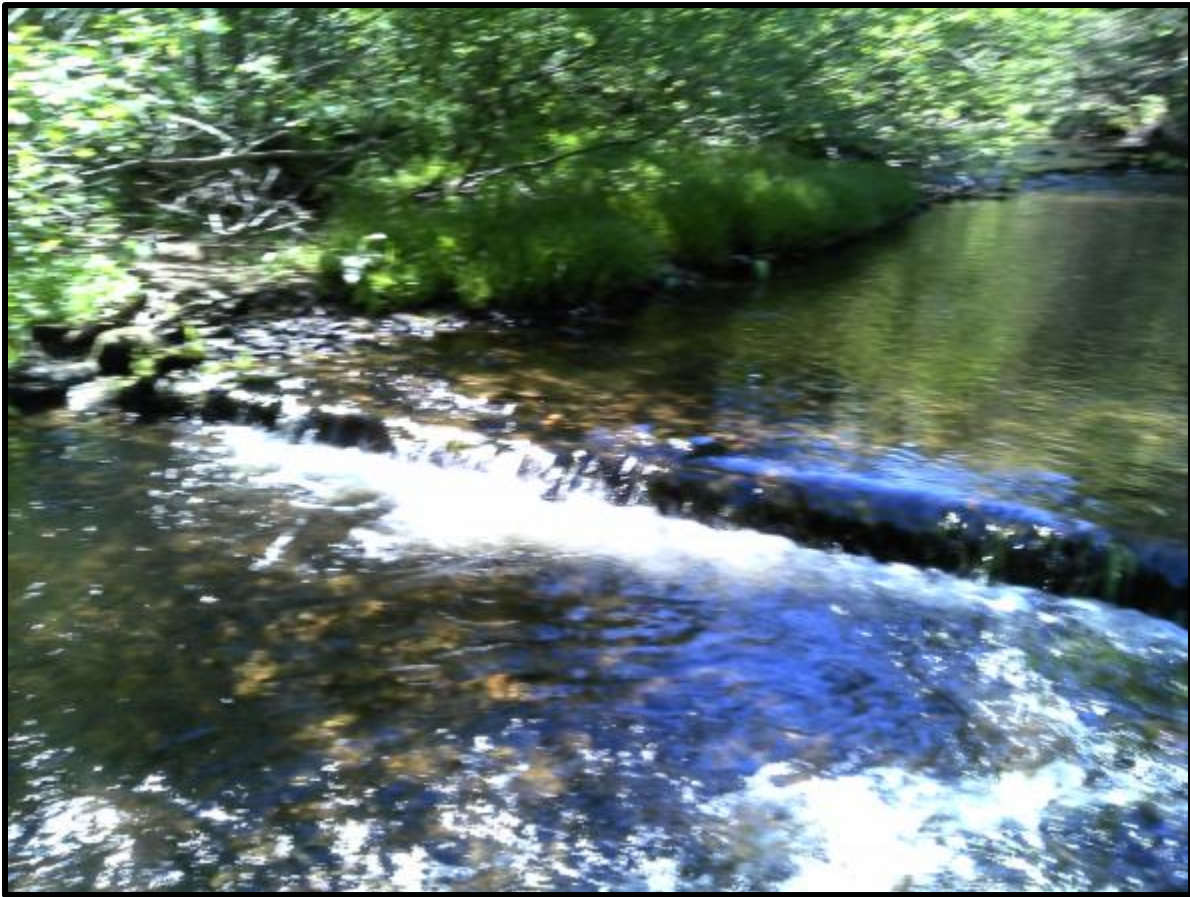
Way Point 144 – Digger Log

Figure 95. Digger Log Structure at waypoint 144.

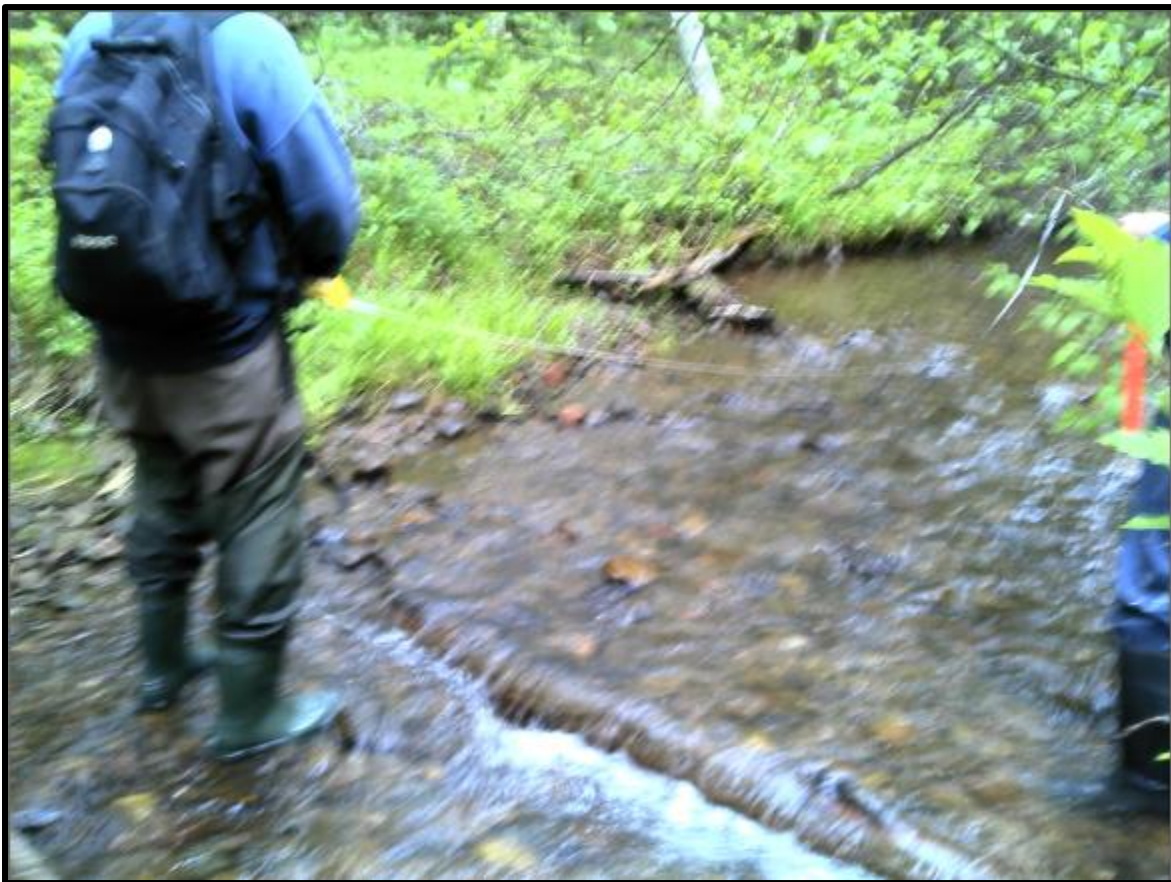
Way Point 86 – Digger Log

Figure 101. Digger Log structure at waypoint 86.

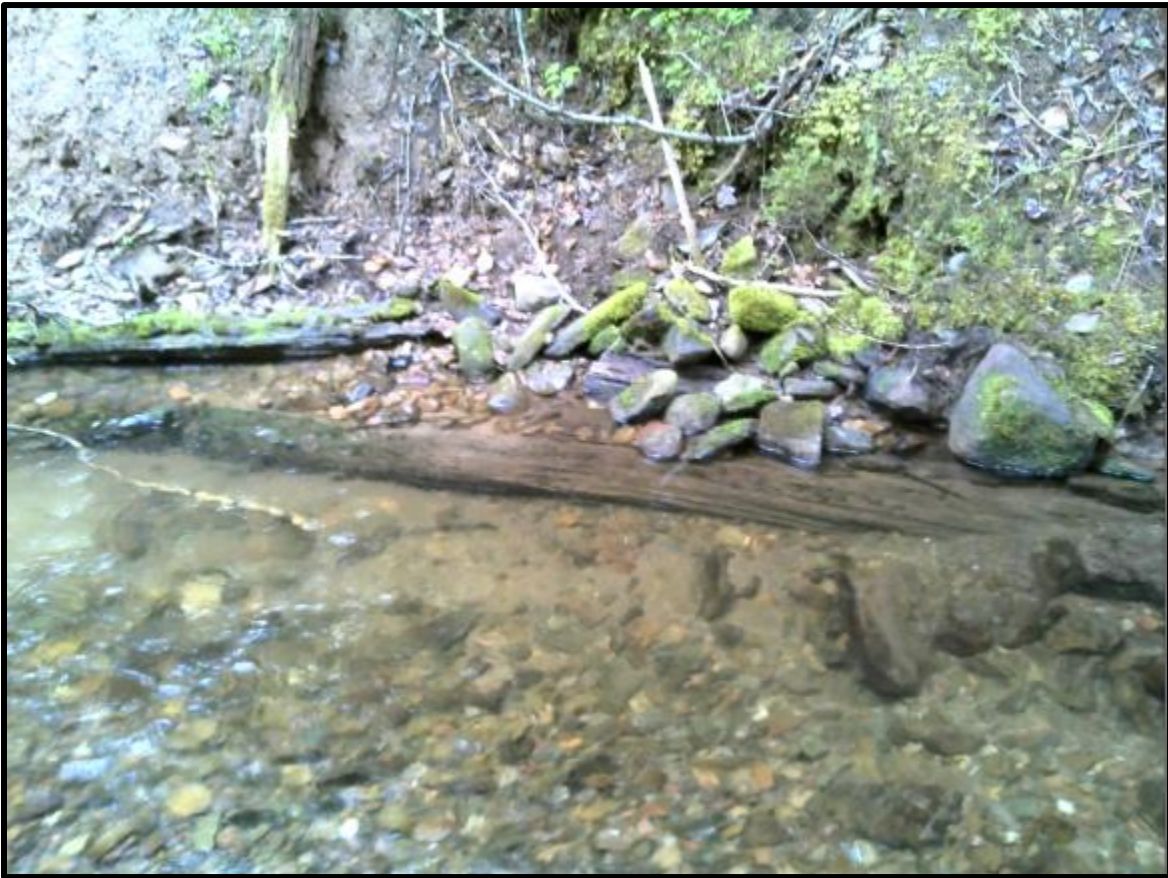
Way Point 87 – Deflector

Figure 102. Deflector structure at waypoint 87.

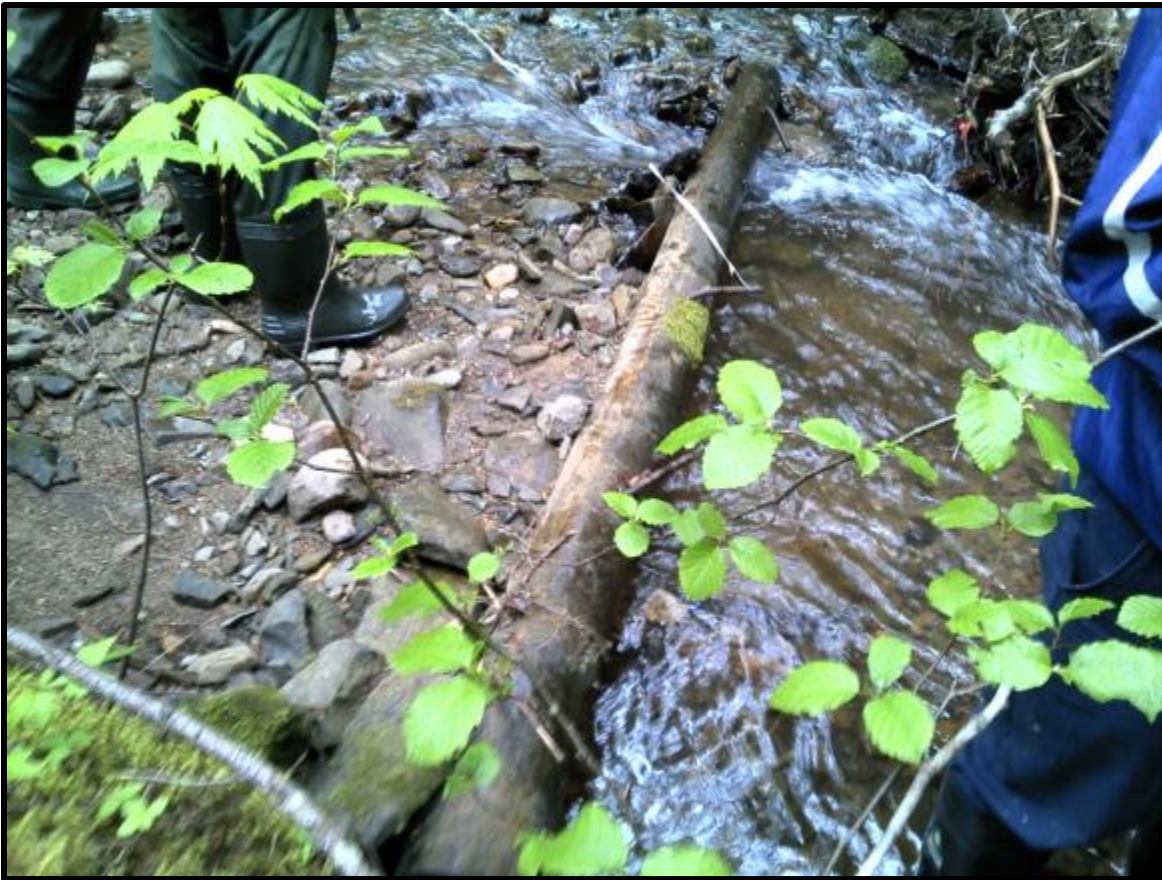
Way Point 88 – Digger Log

Figure 103. Digger Log structure at waypoint 88.

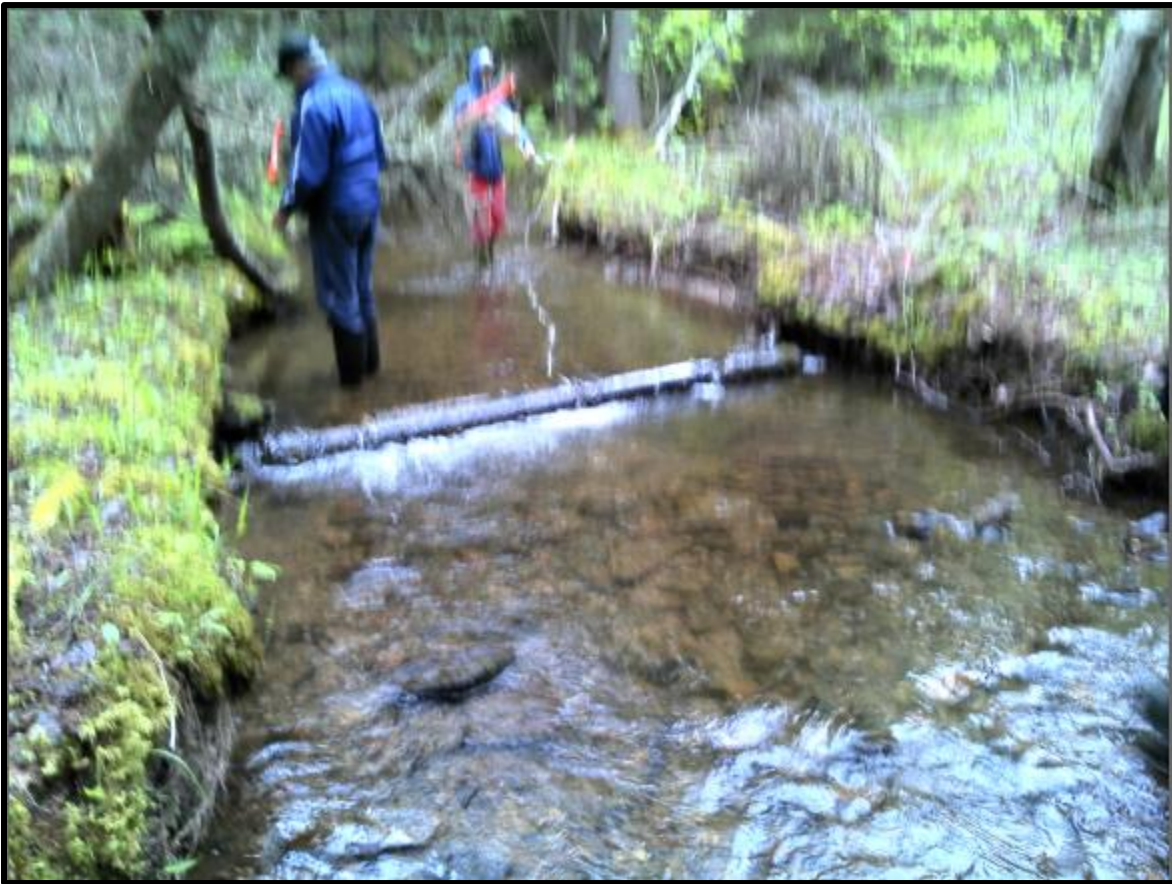
Way Point 89 – Digger Log

Figure 104. Digger Log structure at waypoint 89.

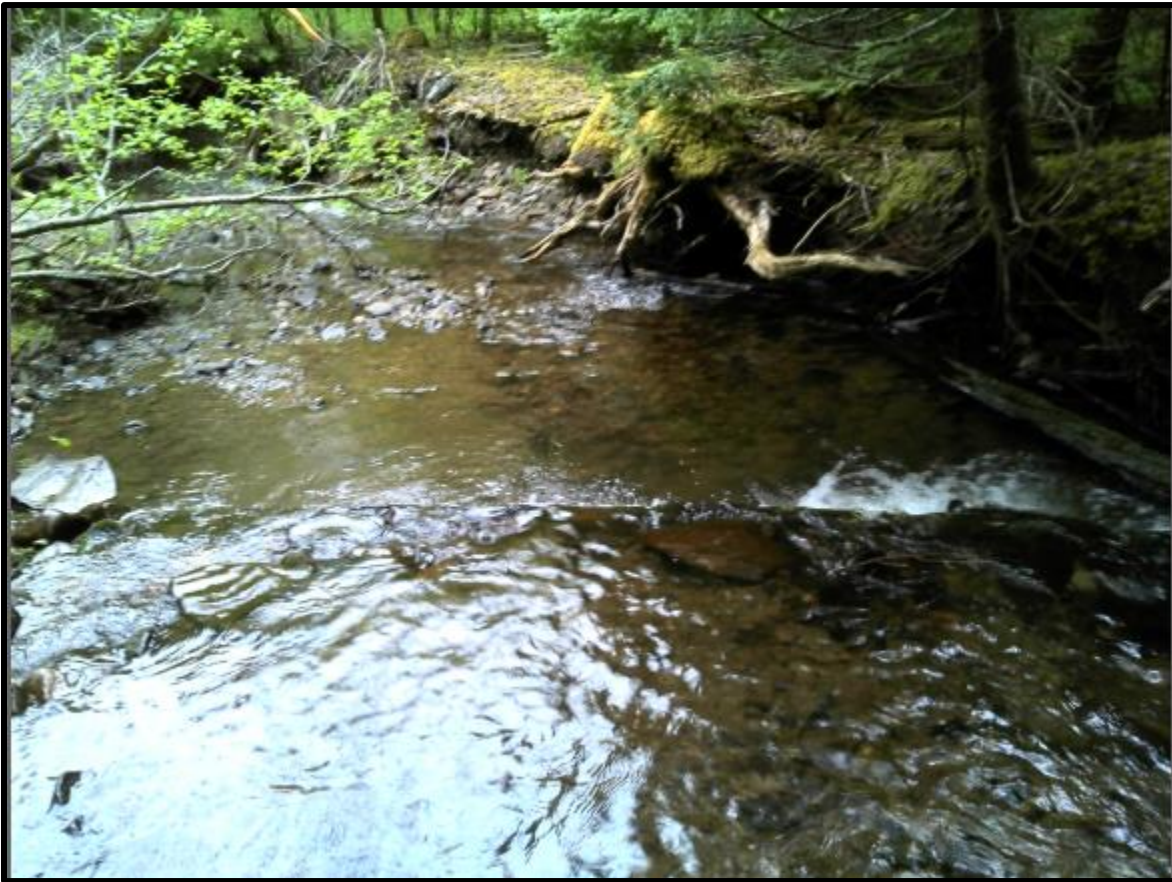
Way Point 96 – Digger Log

Figure 111. Digger Log Structure at waypoint 96.

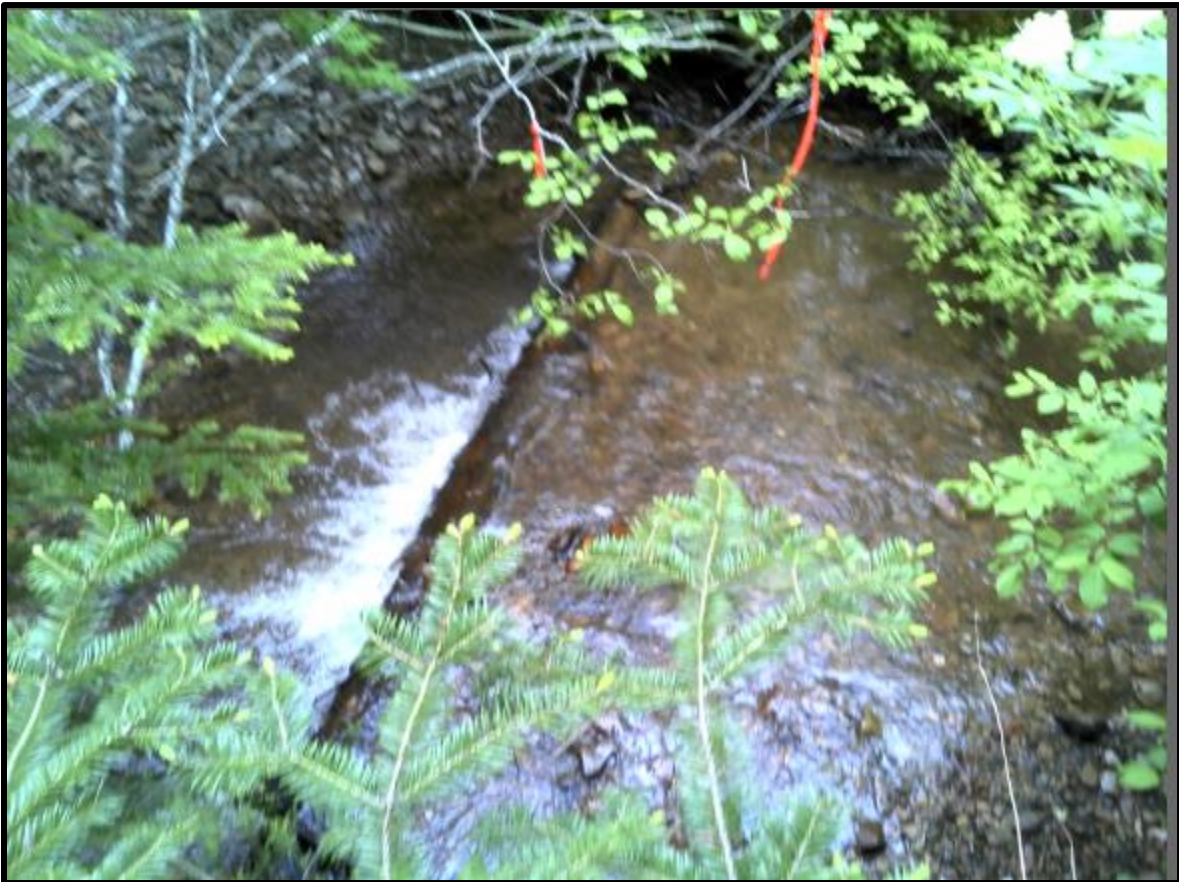
Way Point 117 – Digger Log

Figure 128. Digger Log structure at waypoint 117.

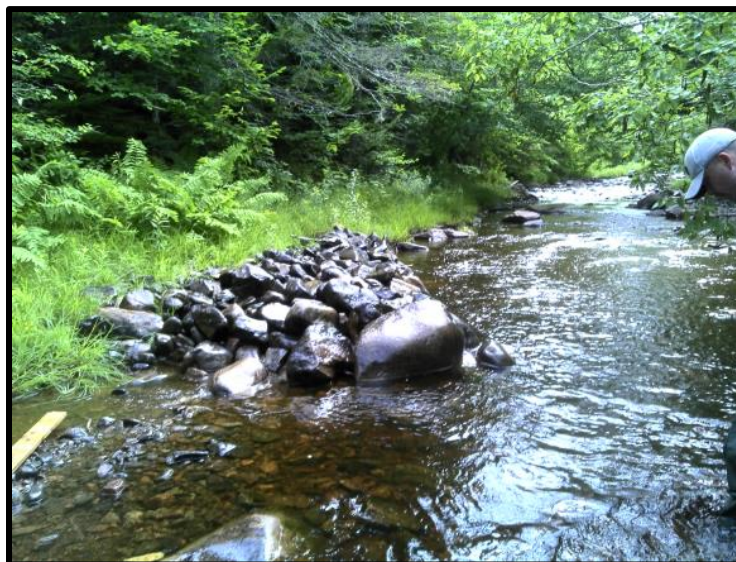
Way Point 176 - Deflector

Figure 135. After picture of deflector at way point 176.

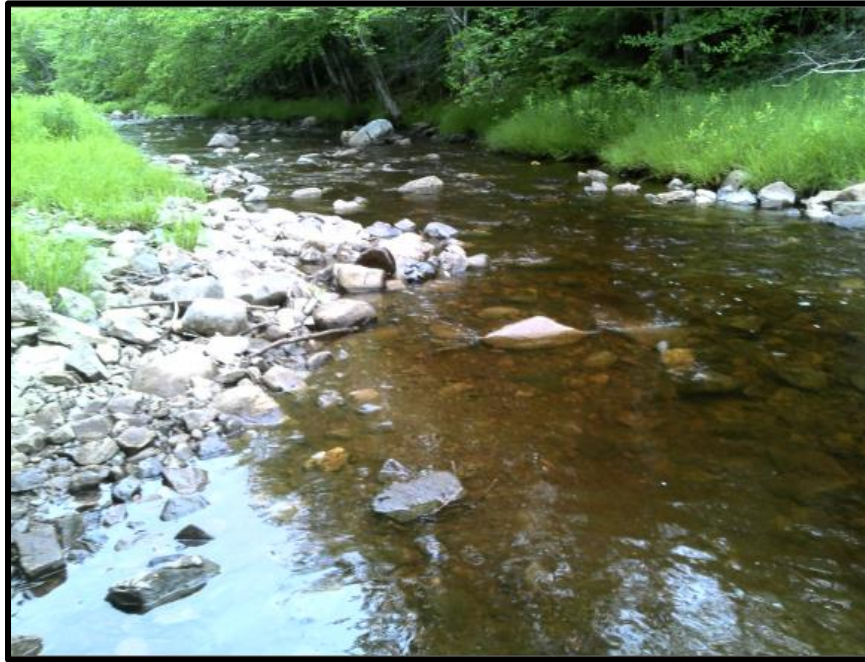
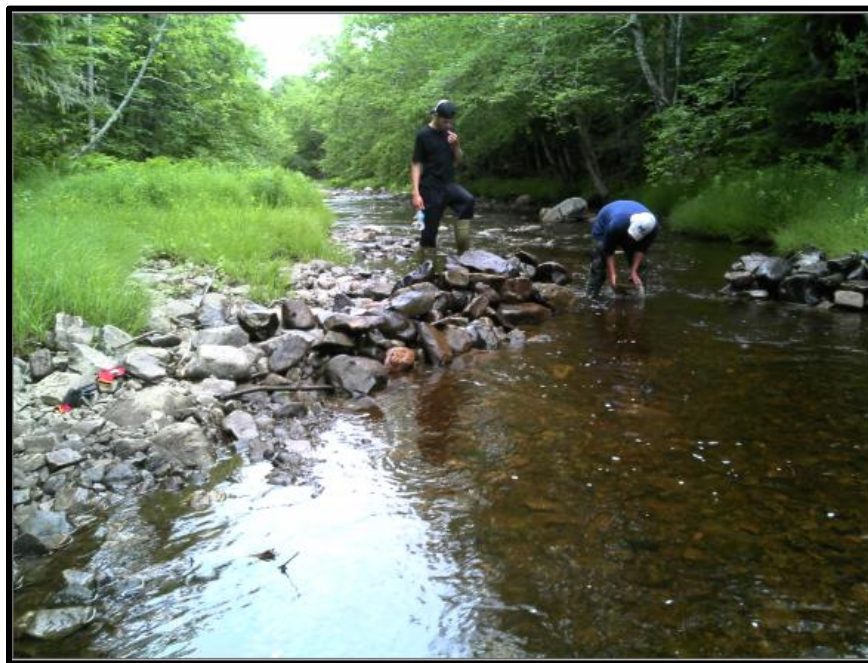
Way Point 177 – Deflector

Figure 136. Before picture of deflector at way point 177.

Figure 137. After picture of deflector at way point 177.

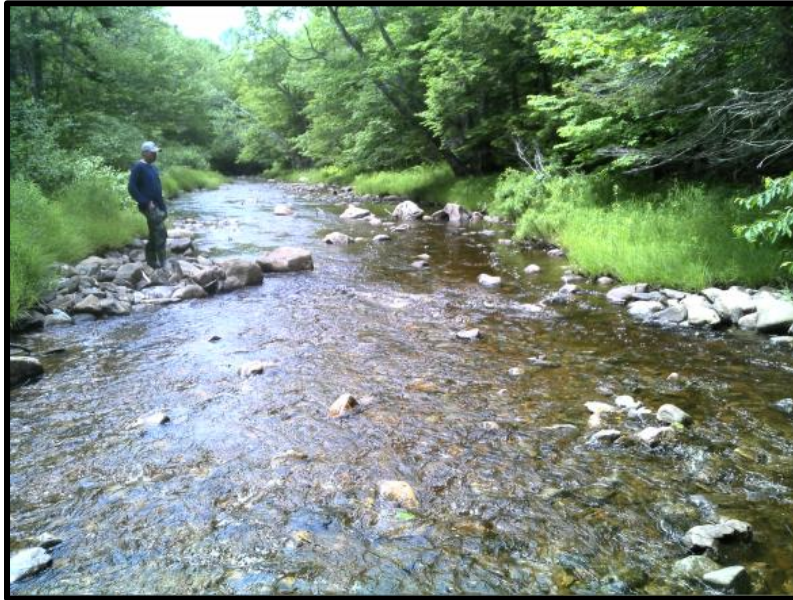
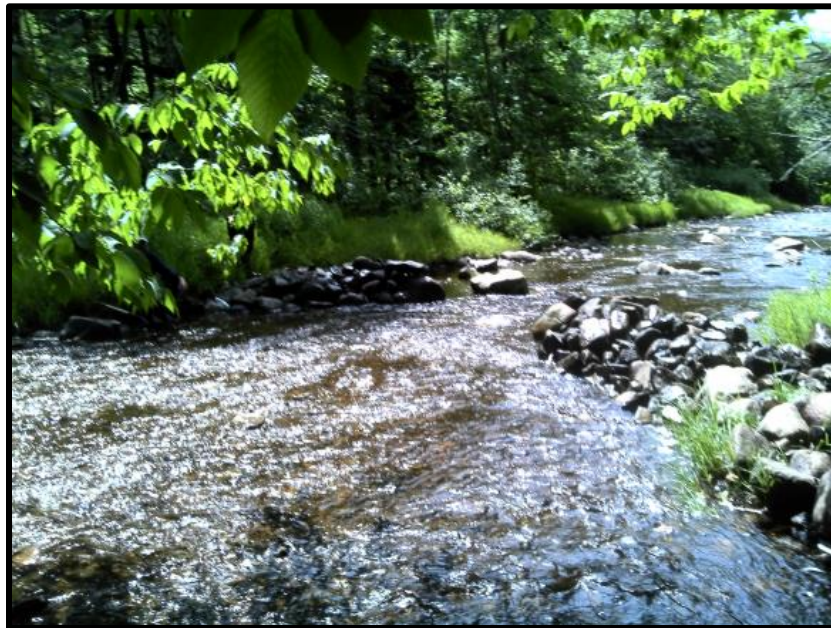
Way Point 178 – Deflector

Figure 138. Before picture of deflector at way point 178.

Figure 139. After picture of deflector at waypoint 178.

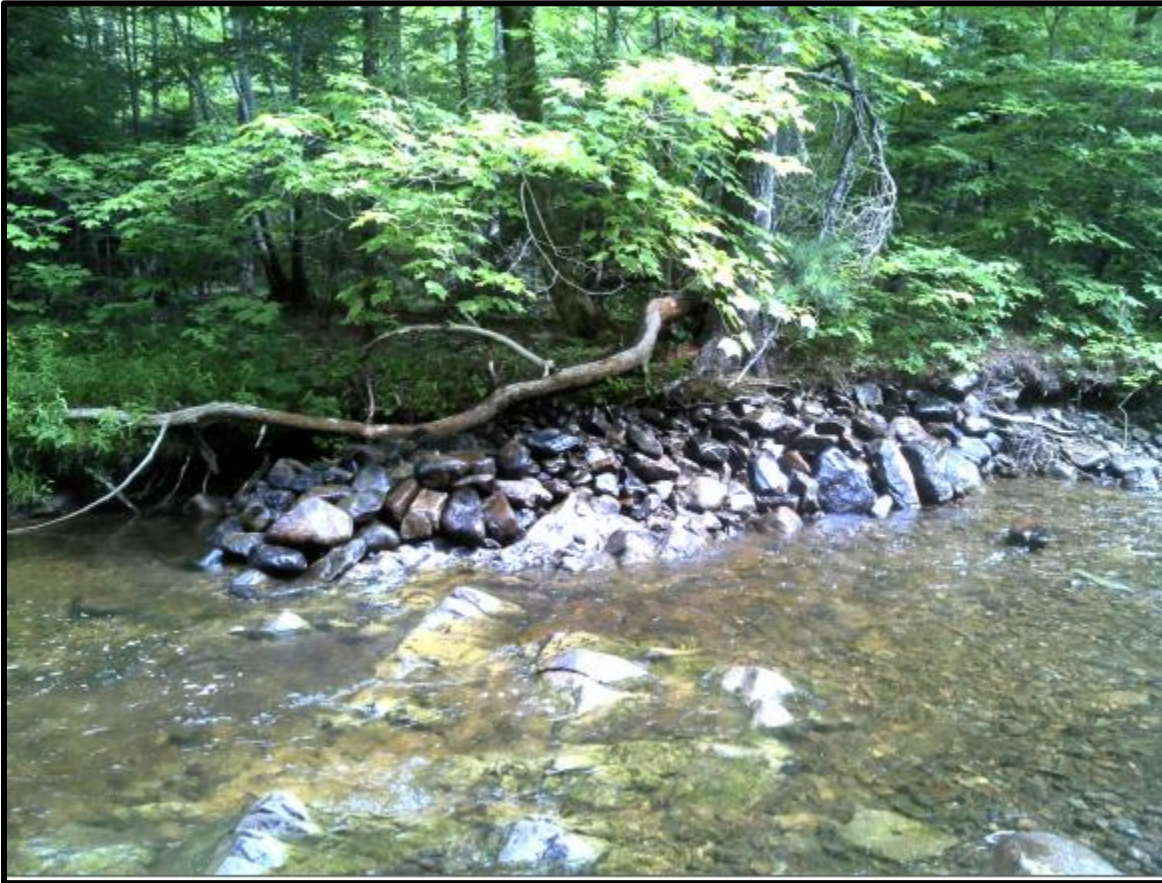
Way Point 183 – Deflector

Figure 140. After picture of deflector at waypoint 183.

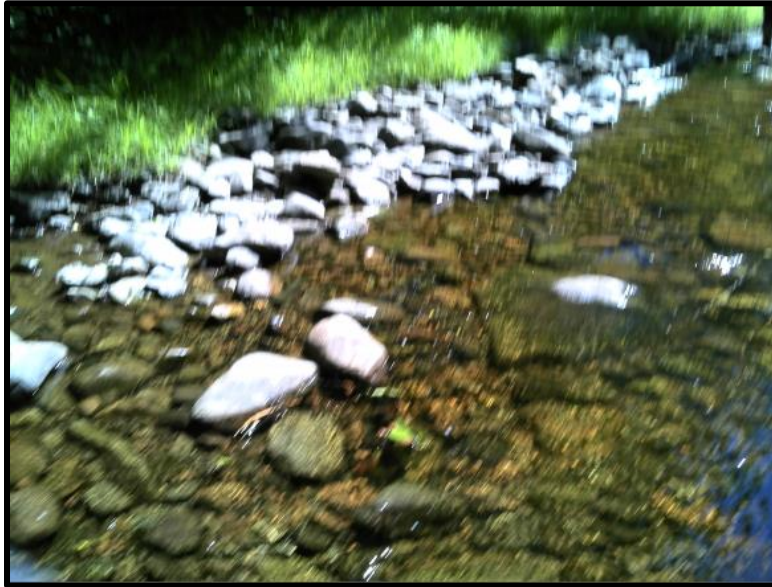
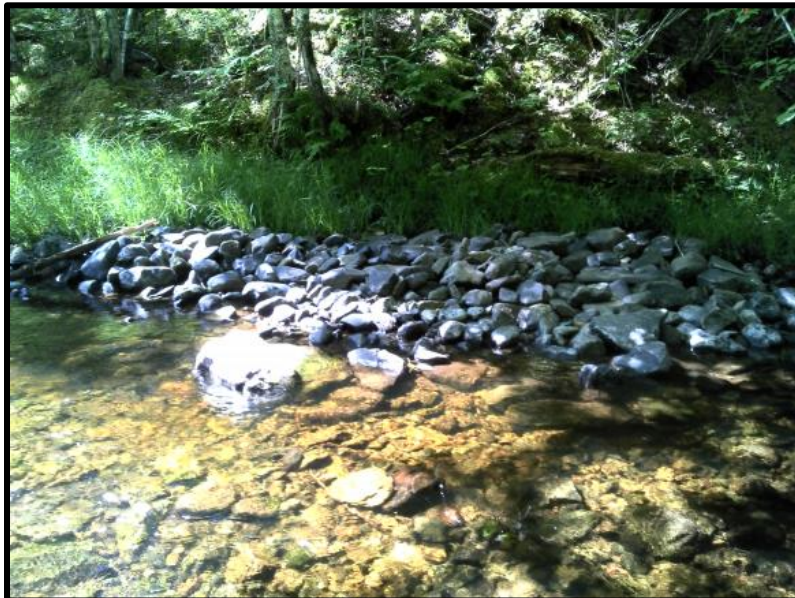
Way Point 184 – Deflector

Figure 141. Before picture of deflector at way point 184.

Figure 142. After picture of deflector at way point 184.

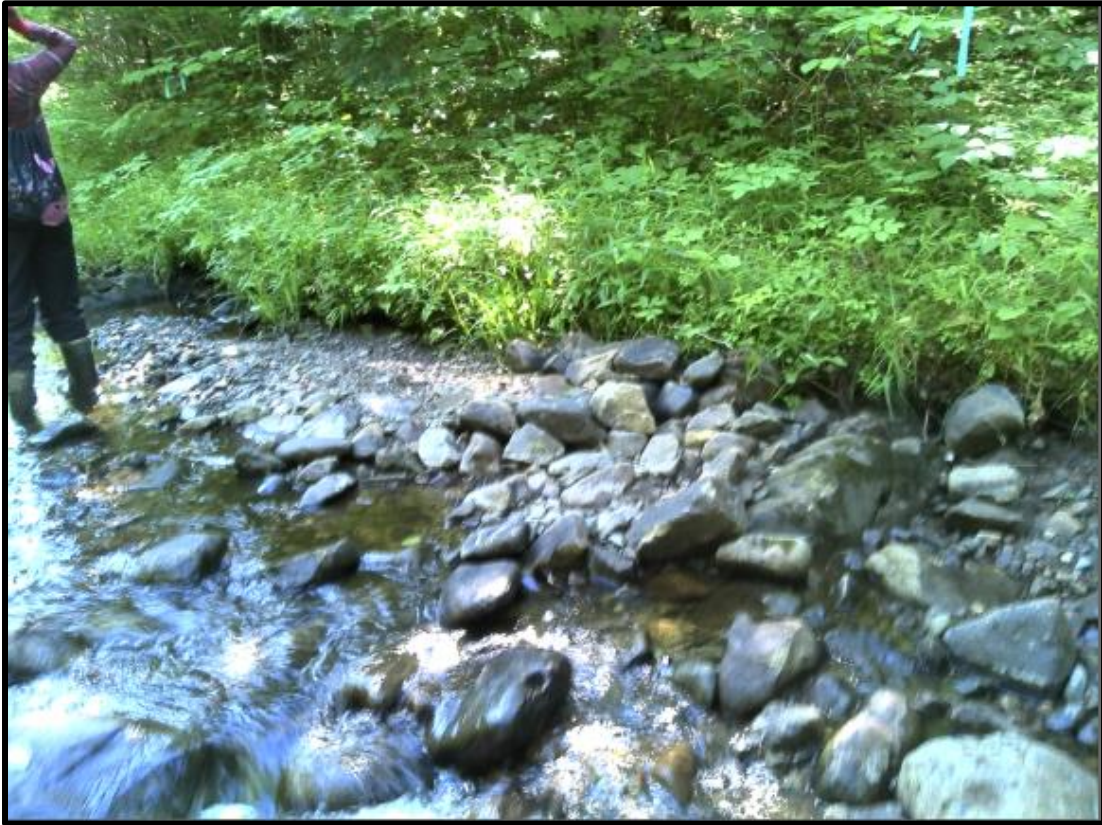
Way Point 187 – Deflector

Figure 143. Before picture of deflector at way point 187.

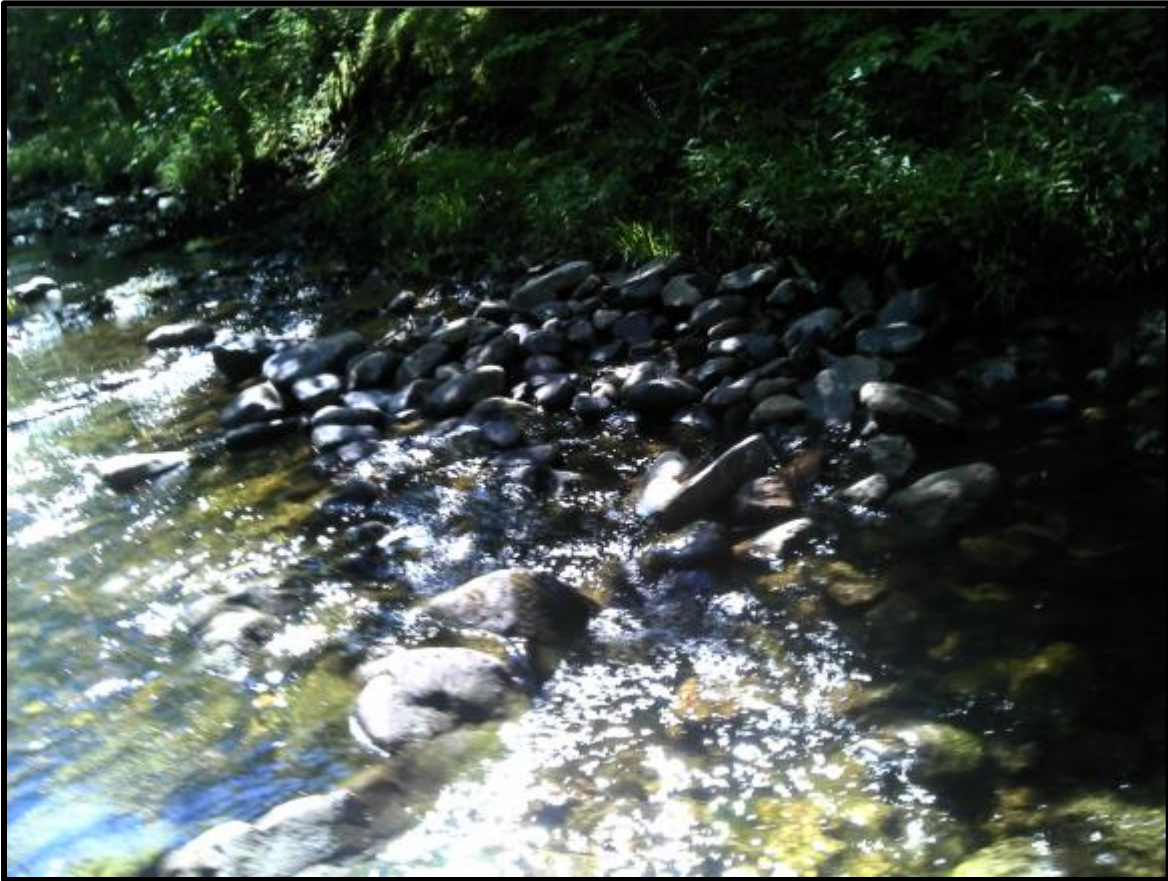
Way Point 189 – Deflector

Figure 144. Before picture of deflector at waypoint 189.

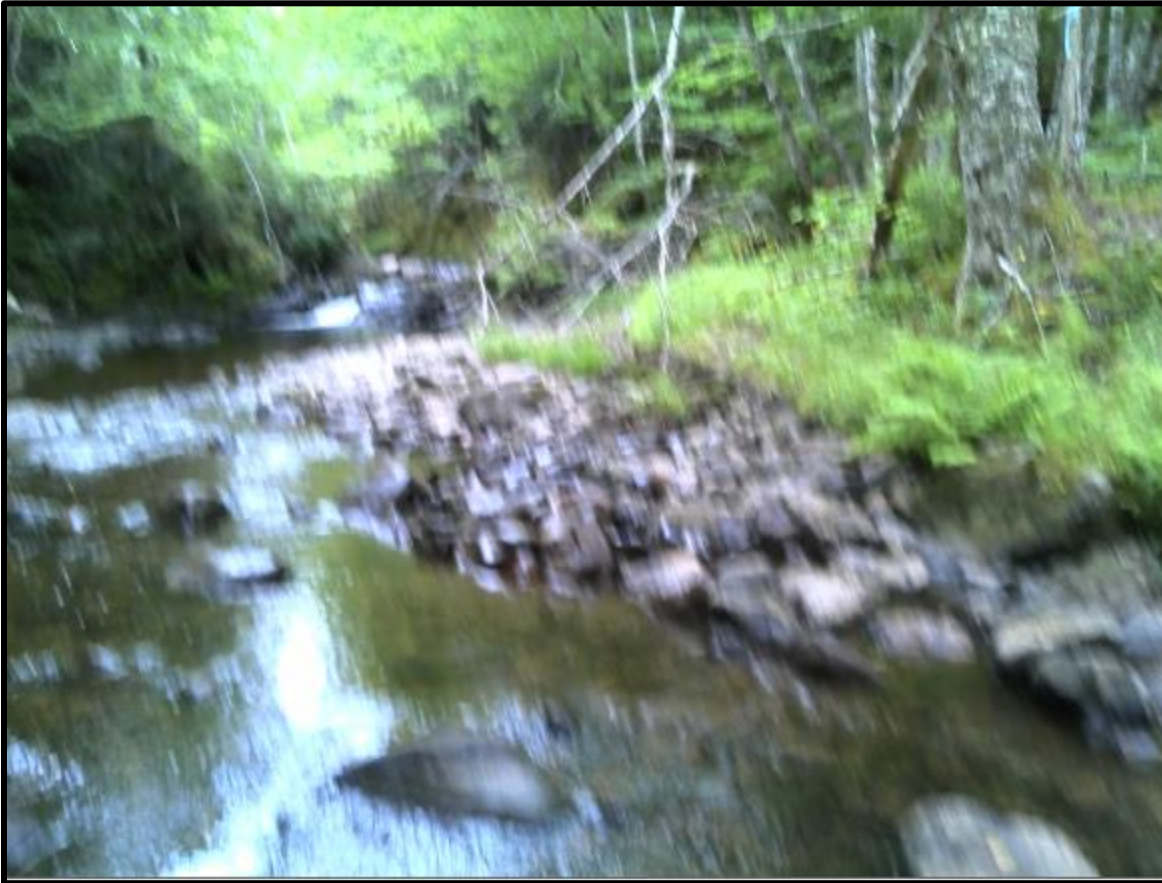
Way Point 190 – Deflector

Figure 145. Before picture of deflector at waypoint 190.

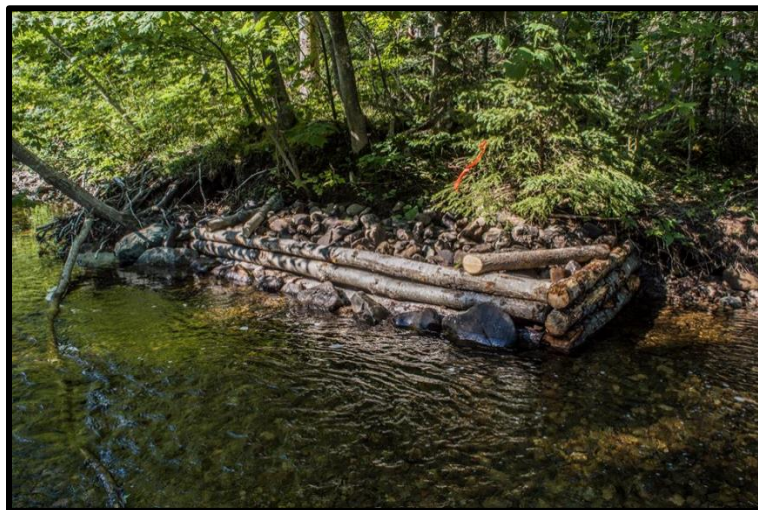
Way Point 206 – Deflector

Figure 146. Before picture of a deflector at waypoint 206.

Figure 147. After picture of deflector at waypoint 206.

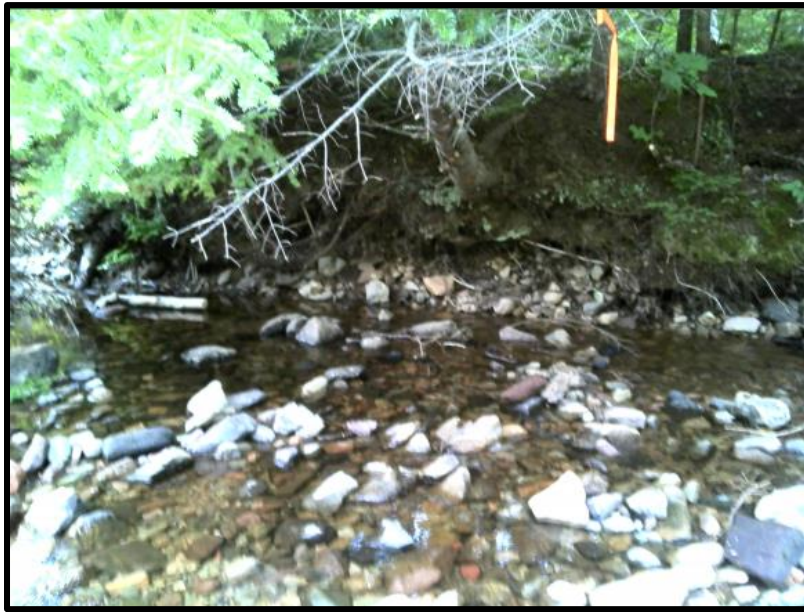
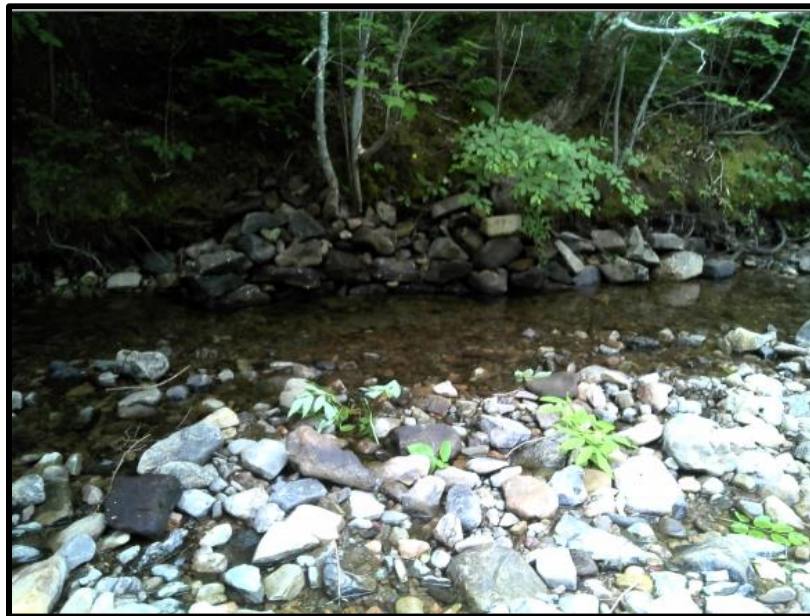
Way Point 209 – Bank Rock

Figure 148. Before picture of bank rock structure at waypoint 209.

Figure 149. Progress picture of bank rock structure for way point 209.

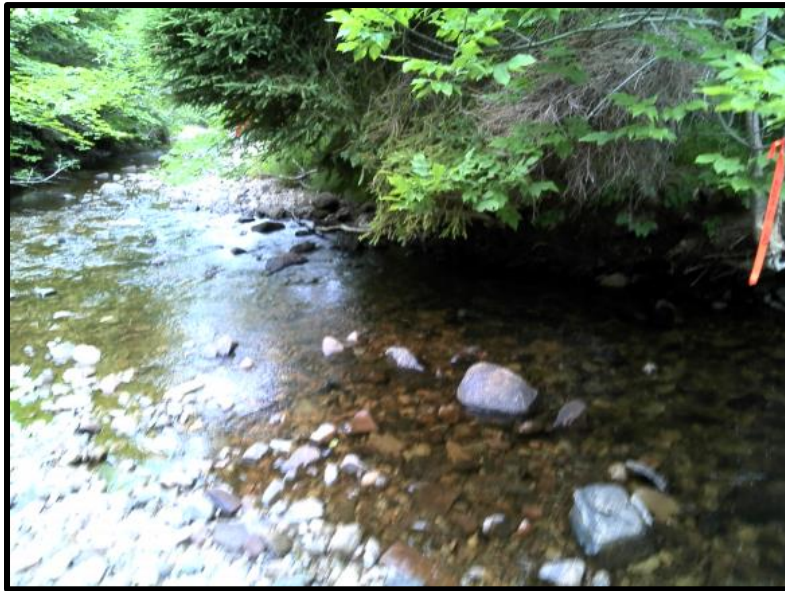
Way Point 211 – Deflector

Figure 150. Before picture of deflector structure at way point 211.

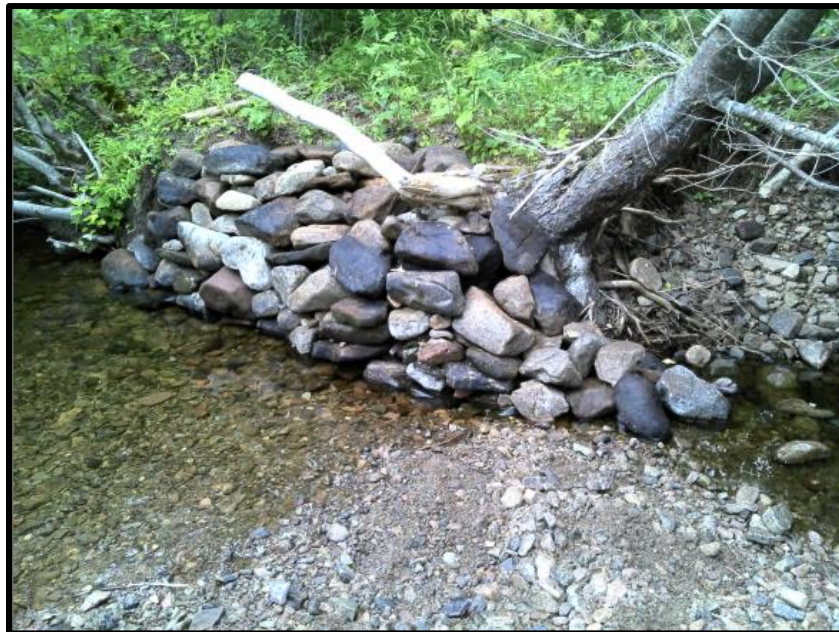
Way Point 213 – Two Tier Bank Rock

Figure 151. Before picture of two tier bank rock at way point 213.

Figure 152. After picture of two tier bank rock at way point 213.

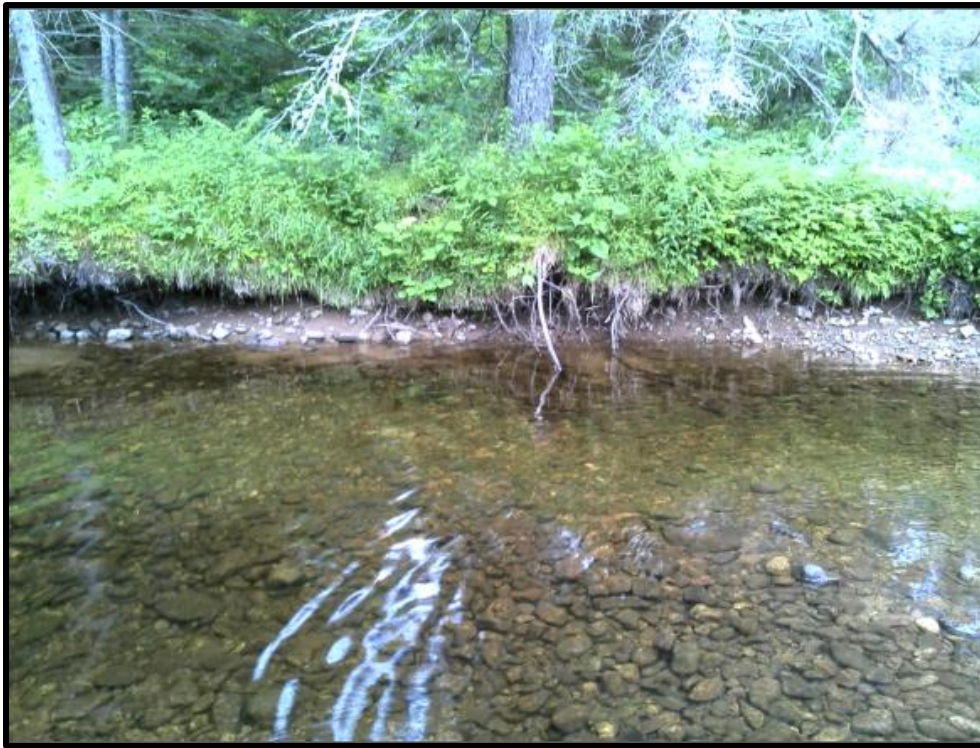
Way Point 214 – Bank Rock

Figure 153. Before picture of bank rock structure for way point 214.

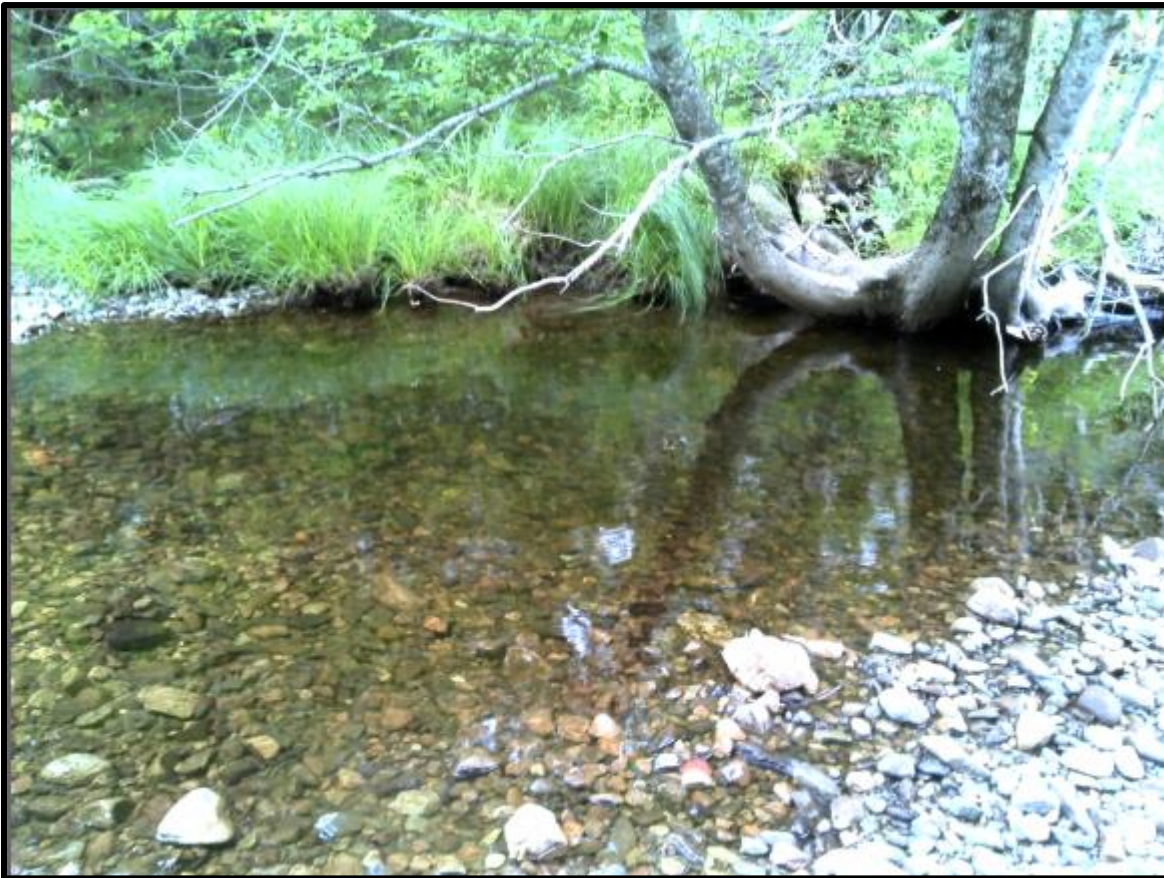
Way Point 216 – Deflector

Figure 155. Before picture of a deflector for way point 216.

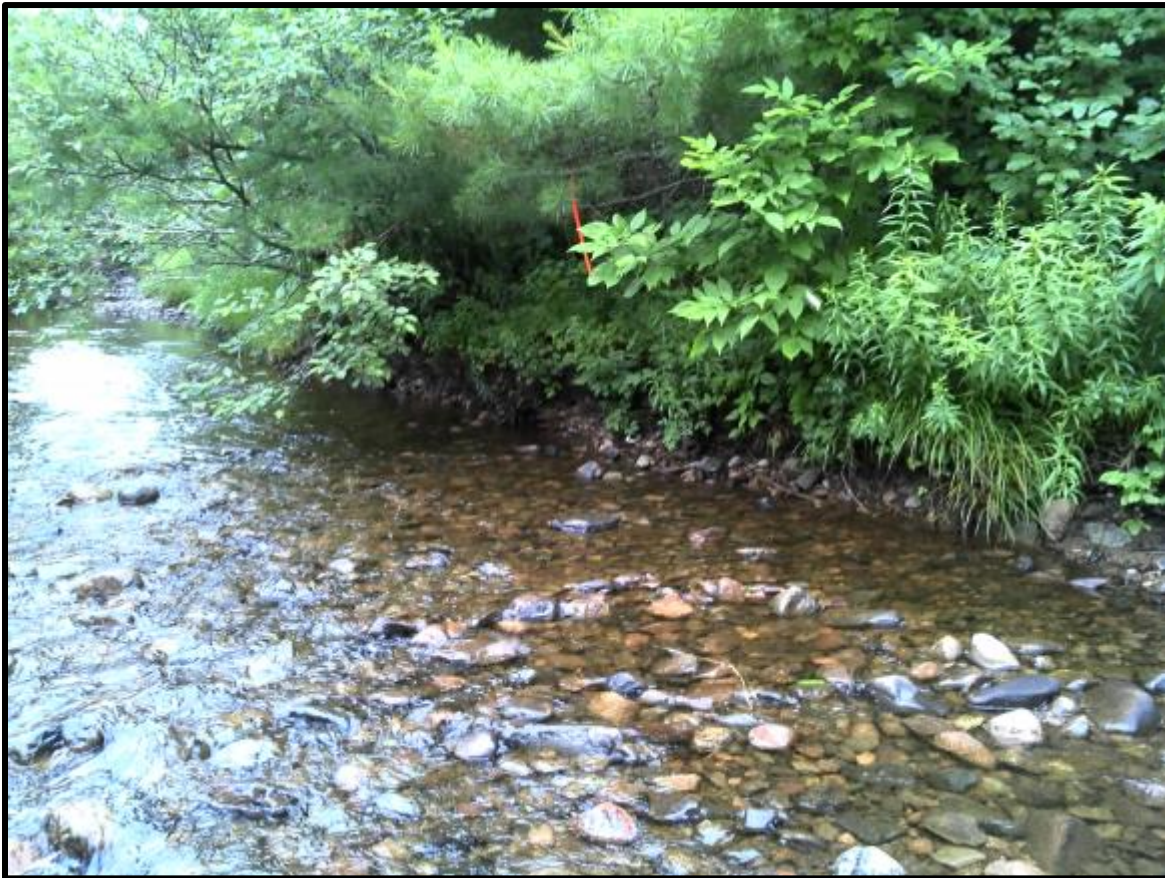
Way Point 217-218 – Digger Log and Deflector

Figure 156. Before picture of a digger log and deflector structure for way point 217 and 218.

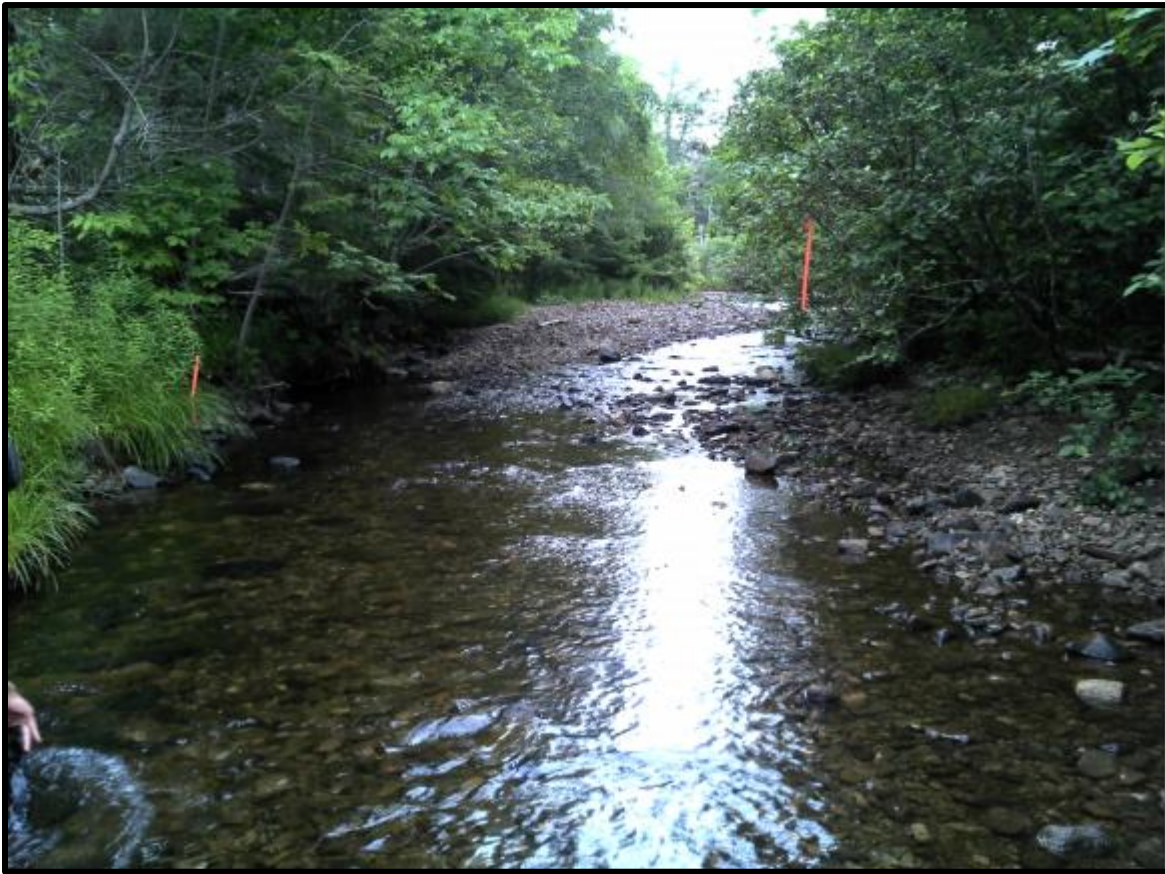
Way Point 220-221 – Digger Log and Deflector

Figure 158. Digger log and deflector before picture at way point 220-221.
