# Fish Habitat Restoration Plan: Southwest Mabou River Watershed

Submitted to the Atlantic Salmon Conservation Foundation

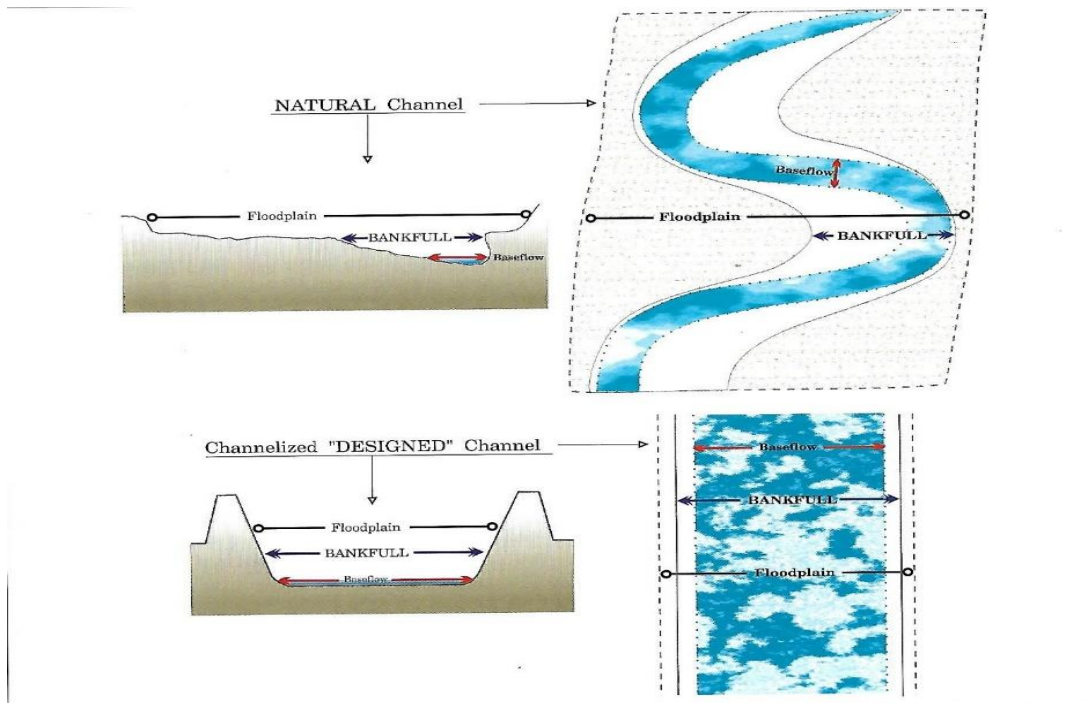
Figure 1: Comparison of degraded "designed" channel dimensions and patterns with a natural channel. (Rosgen 1993)

The incised channel that is predominant through the Southwest Mabou has resulted in severe bank erosion. As Figure 1 depicts, without access to the floodplain, high flow events are restricted to the channel, causing over-widening and a loss of pool depth. While erosion is a natural process for river systems, the absence of large woody debris and channel meander has limited the natural sorting function that would otherwise be found in the Southwest Mabou. Figure 2 provides an example of the extreme erosion that is found throughout the main channel. Figure 3 is an example of where a natural formation has benefitted the channel health. The beaver dam in this picture has promoted the settling of moving bed loads and is creating a well-defined gravel bar and meander. Restoration efforts should attempt to mimic this type of natural process. In areas where natural structures were absent (figure 4), channel braiding (i.e. split channels) were common.
