SALMONID HABITAT RESTORATION
INVERNESS SOUTH ANGLERS ASSOCIATION

Winter Damage Assessment

Date: 2019

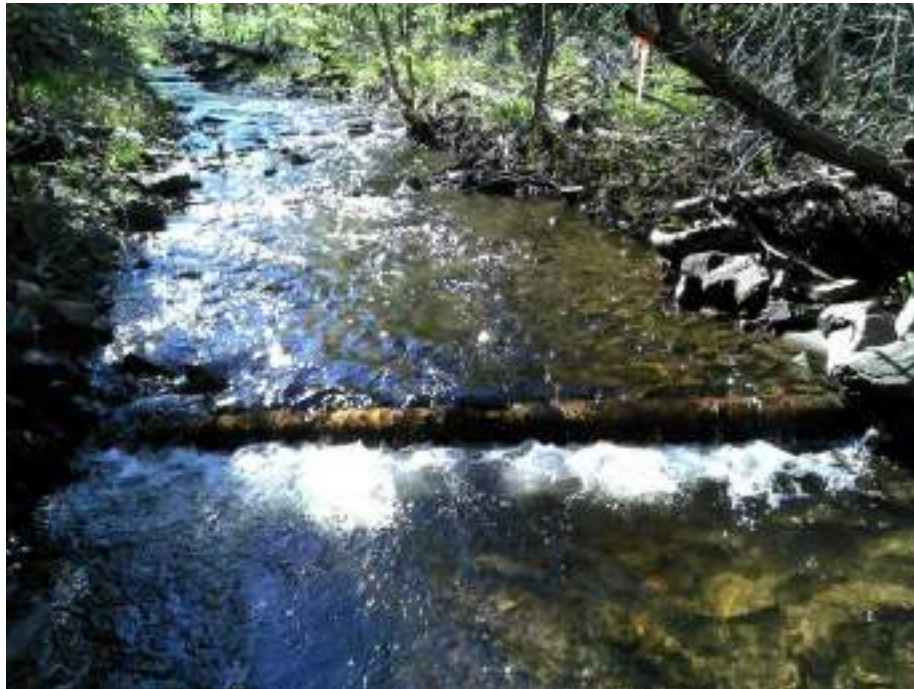
Figure 9. Showing the first digger log structure upstream from the road. Before and after picture of performed maintenance.

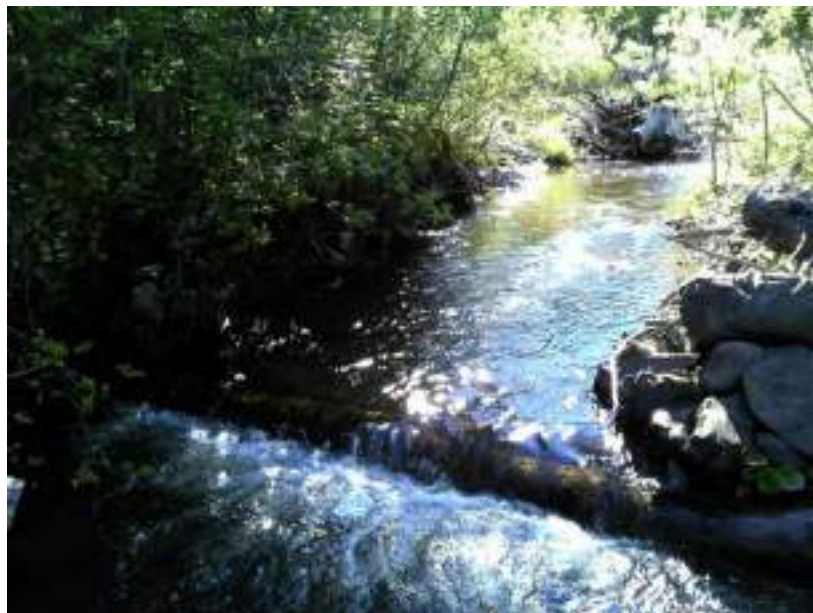
Figure 10. Showing a before and after picture of the maintenance preformed on the second diggerlog upstream from the road.

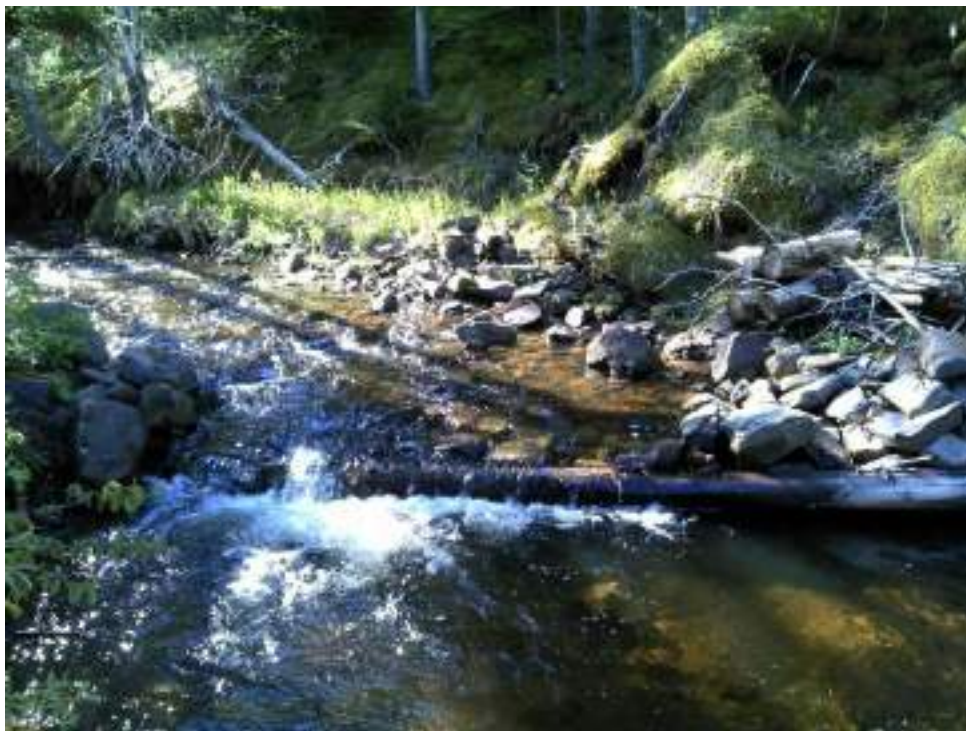
Figure 11. Before and after picture of digger log #3 upstream from the road.

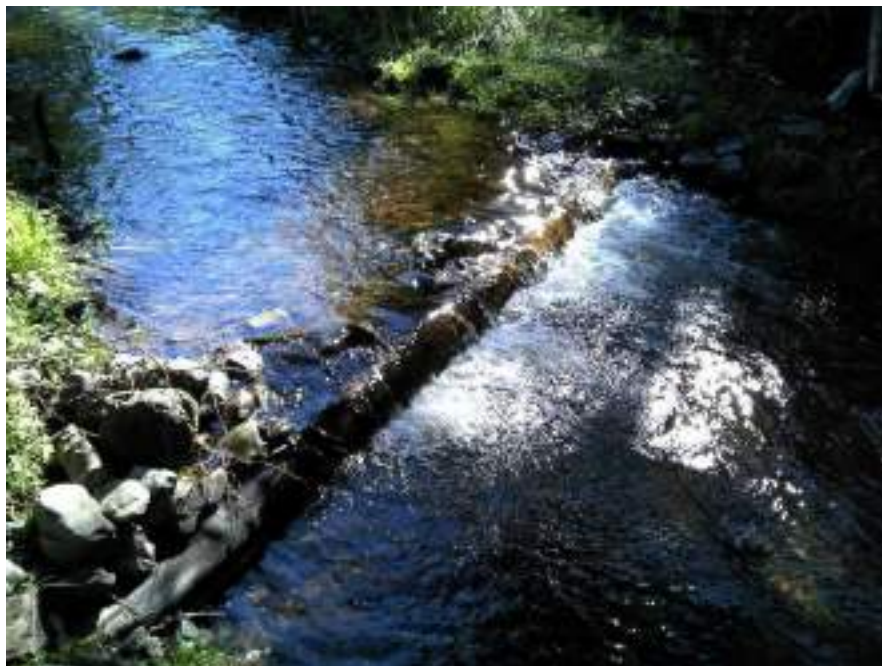
Figure 12. Showing before and after pictures of digger log #4 upstream from the road.

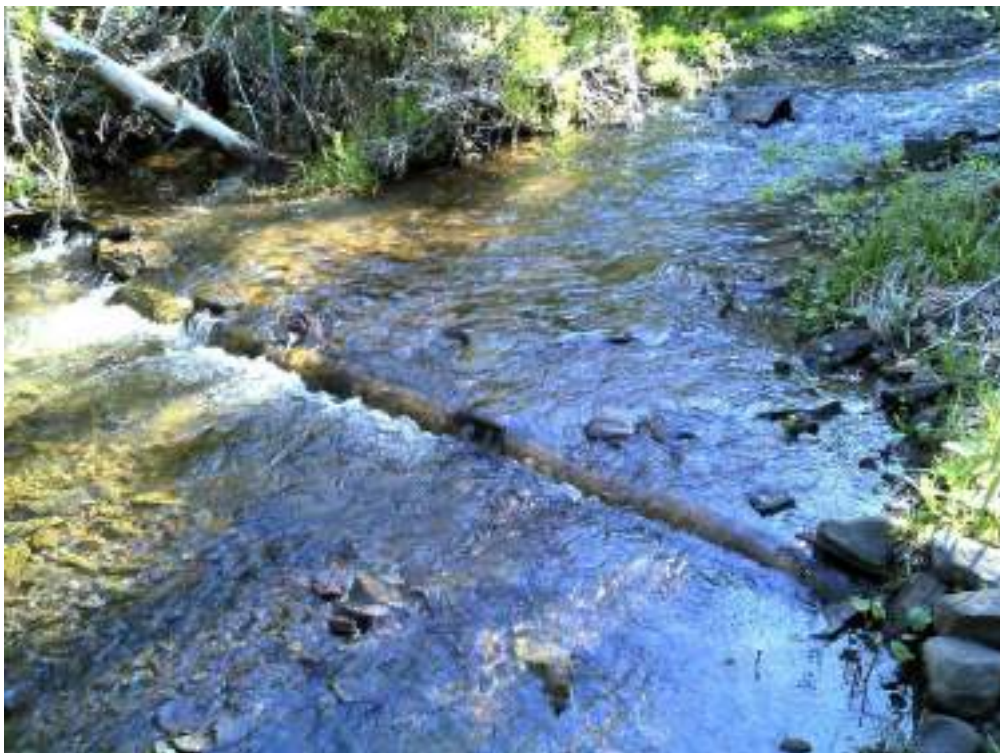
Figure 13. Showing before and after pictures of digger log #5 upstream from the road.

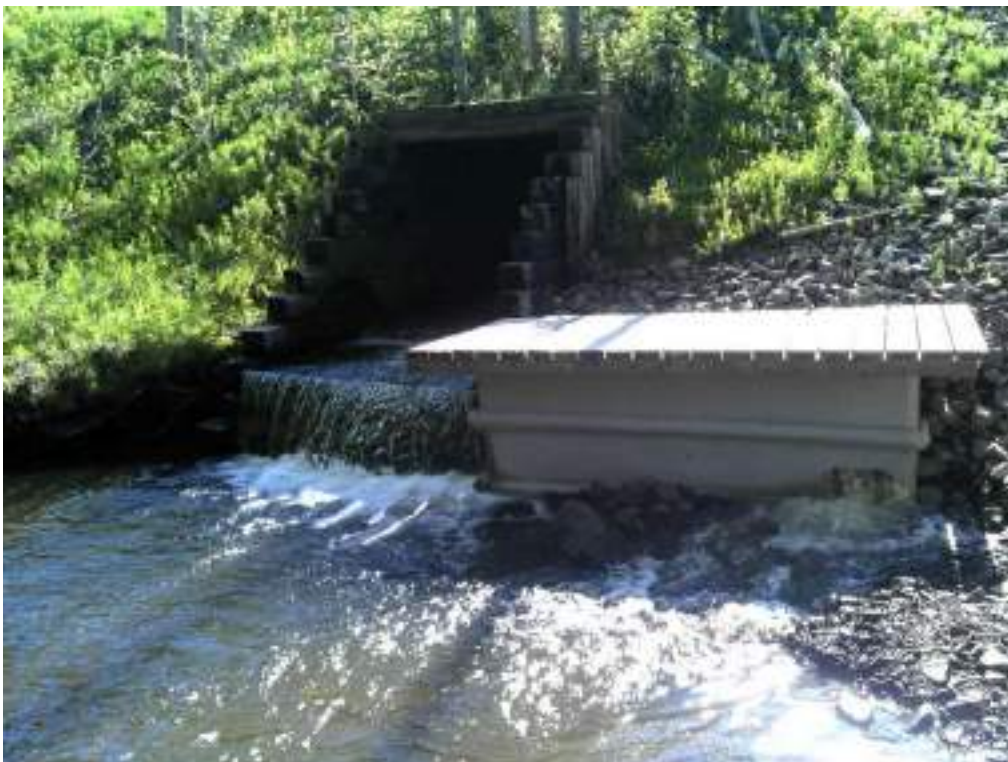
Figure 16. Showing the before and after photos of the fish ladder downstream from the road. The structure was fully blocked up with rock and other woody debris. The fish ladder is now flowing water and is providing upstream access to migrating fish species.

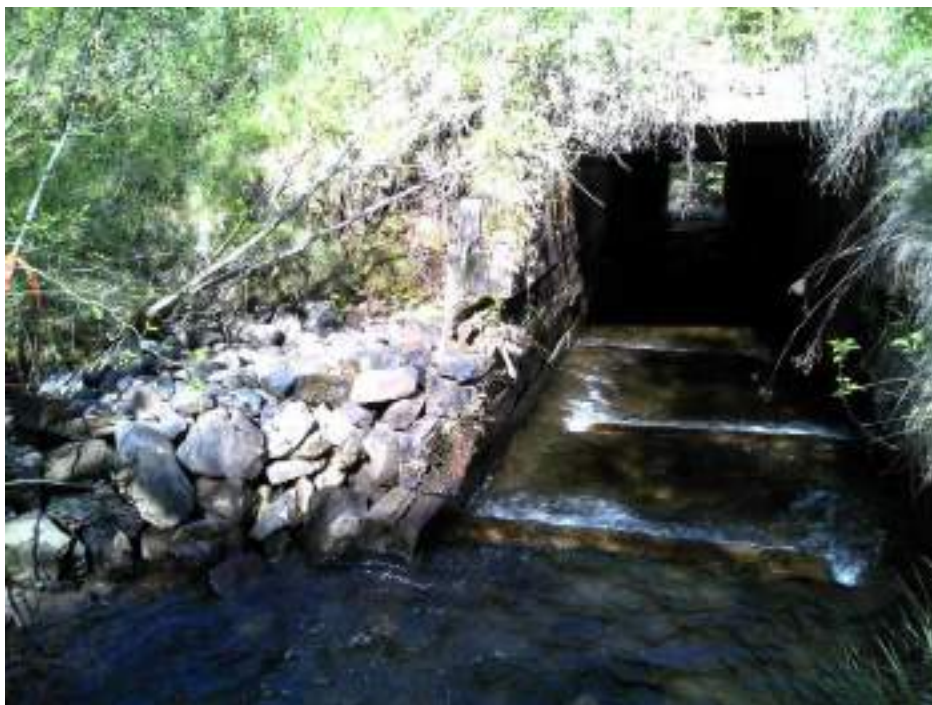
Figure 17. Showing the baffles in the boxed culvert. Rock was added on the left-hand side to avoid any further bank erosion from occurring.

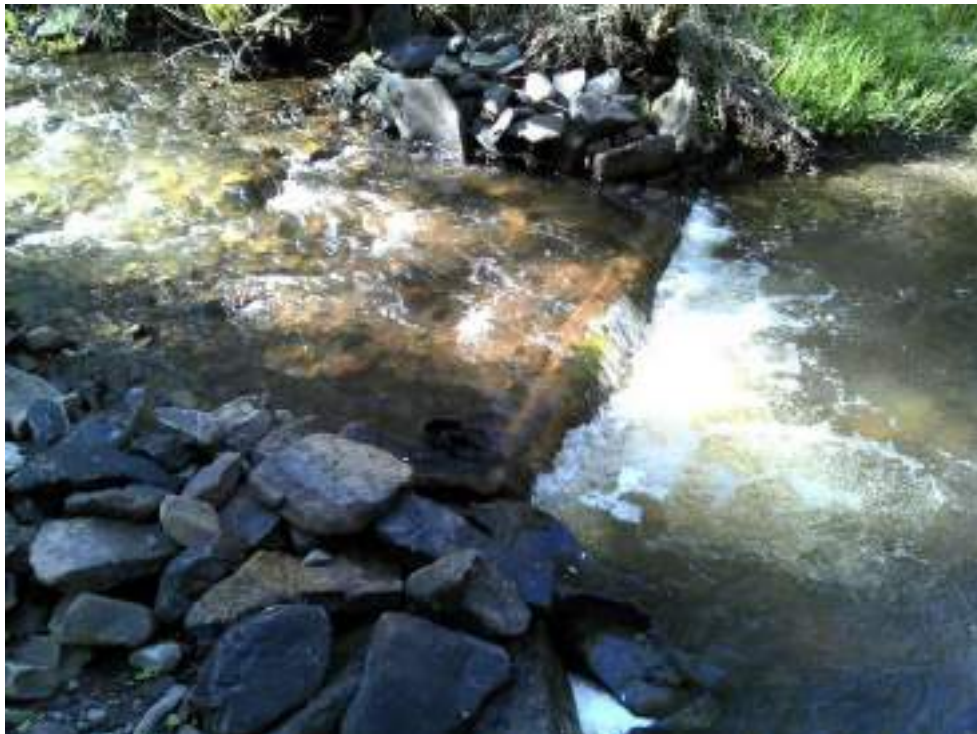
Figure 18. Showing the before and after photos of a digger log - structure #8 downstream from the road.

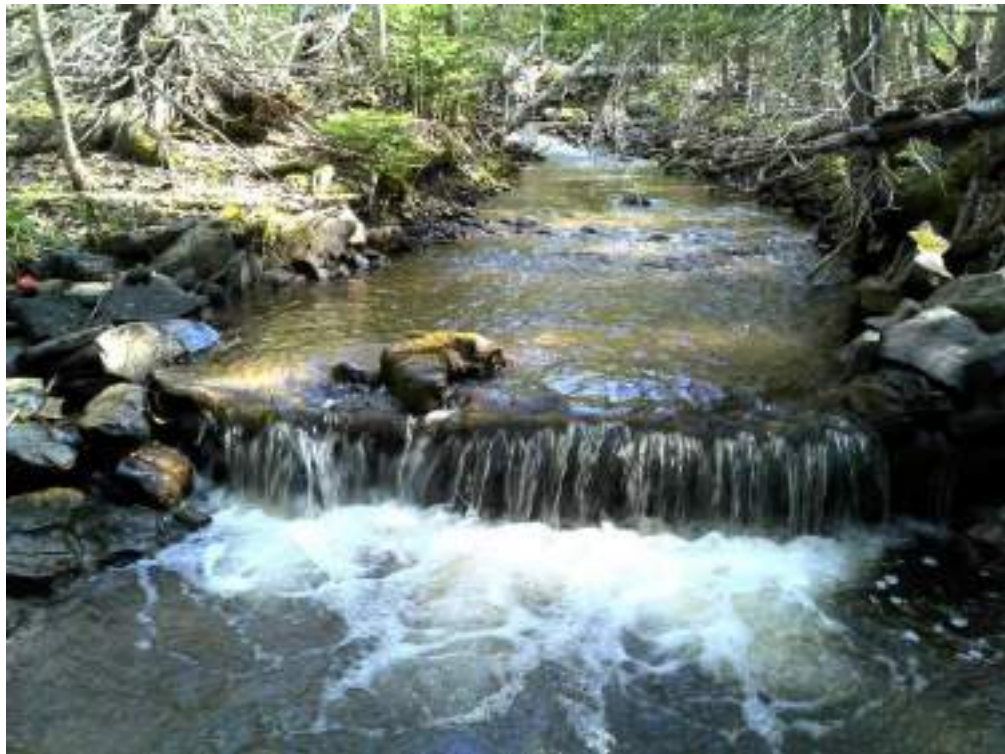
Figure 20. Showing the before and after photos of a diggerlog - structure #10 downstream from the road.

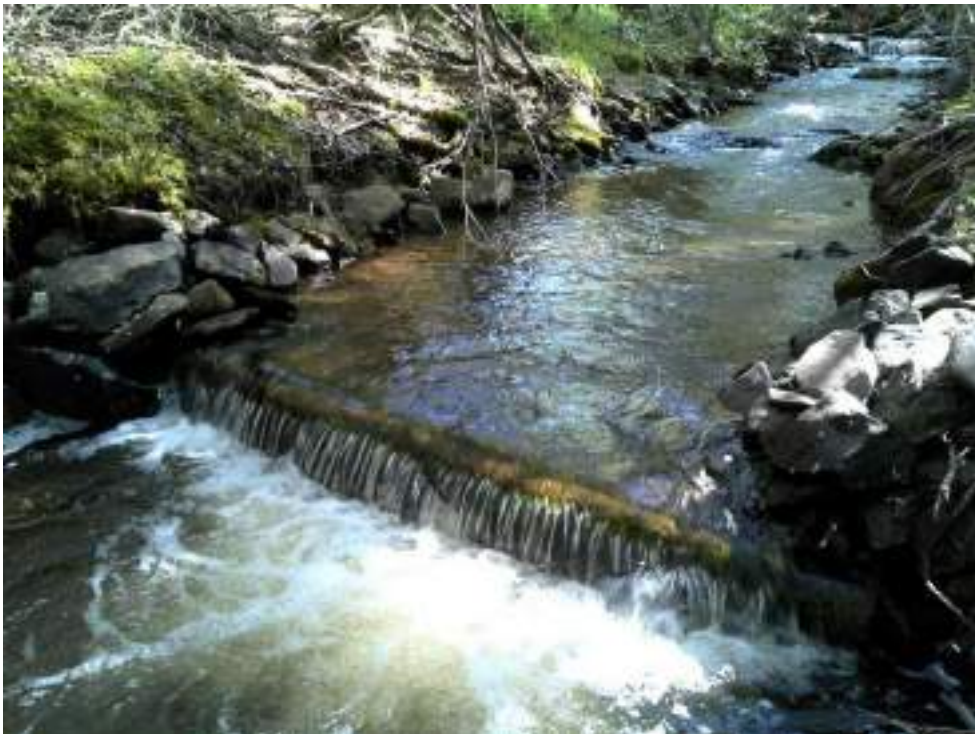
Figure 21. Showing the before and after photos of a digger log - structure #11 downstream from the road.

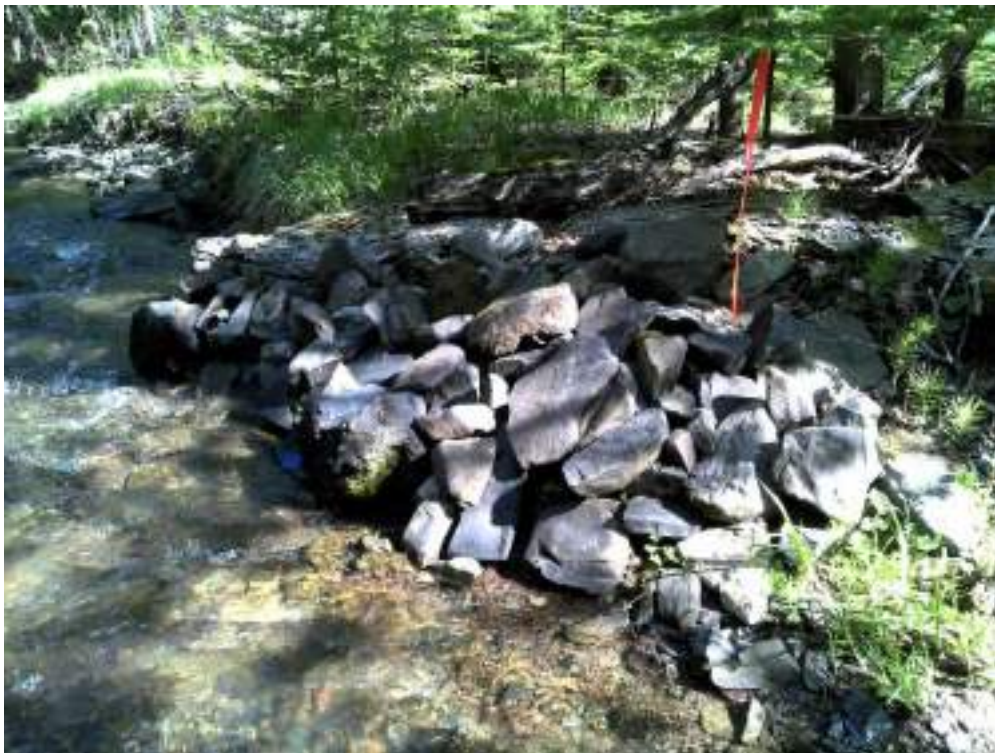
Figure 22. Showing the before and after pictures of a bank stabilization structure #12 - downstream from the road.

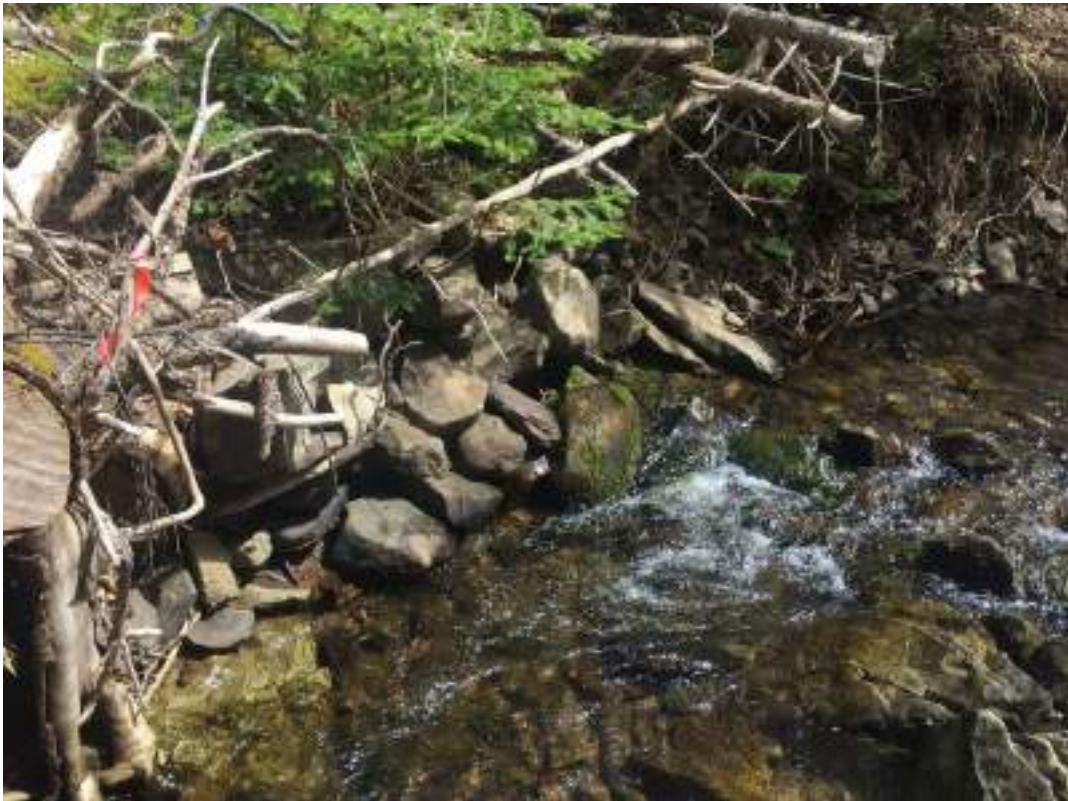
Figure 23. Showing a bank stabilization structure - #13 downstream from the road

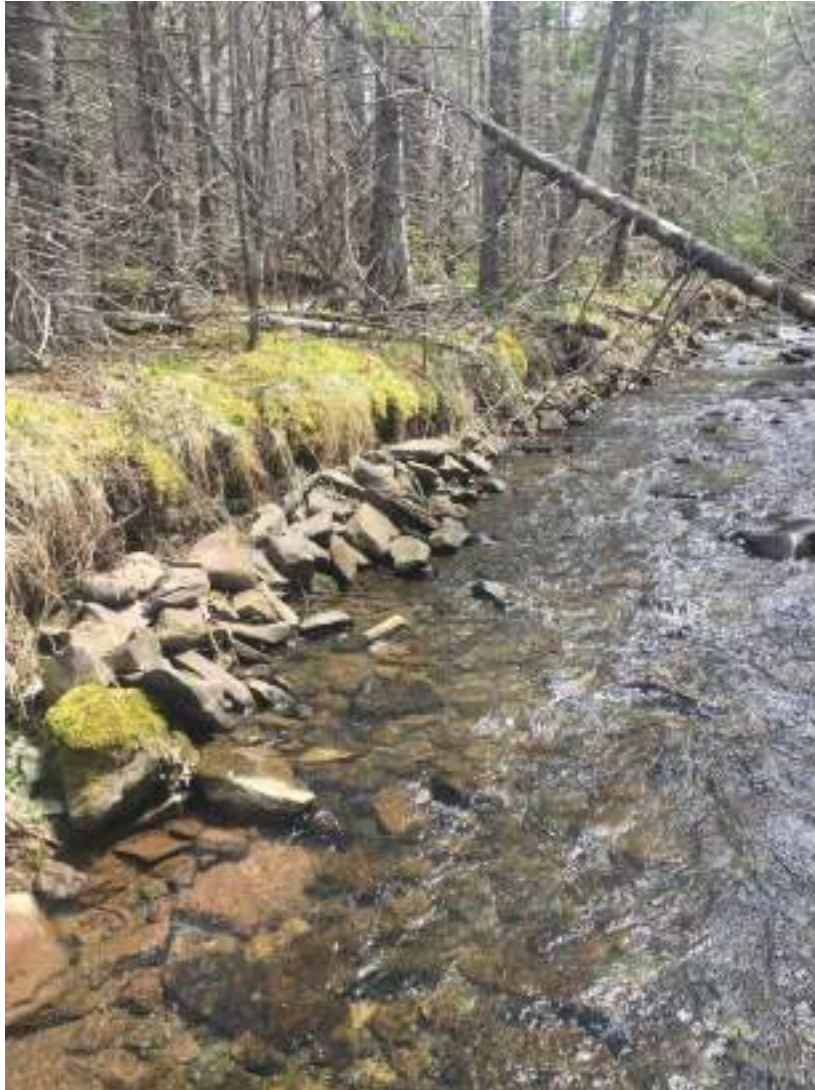
Figure 24. Showing a bank stabilization structure #14 - downstream from the road.

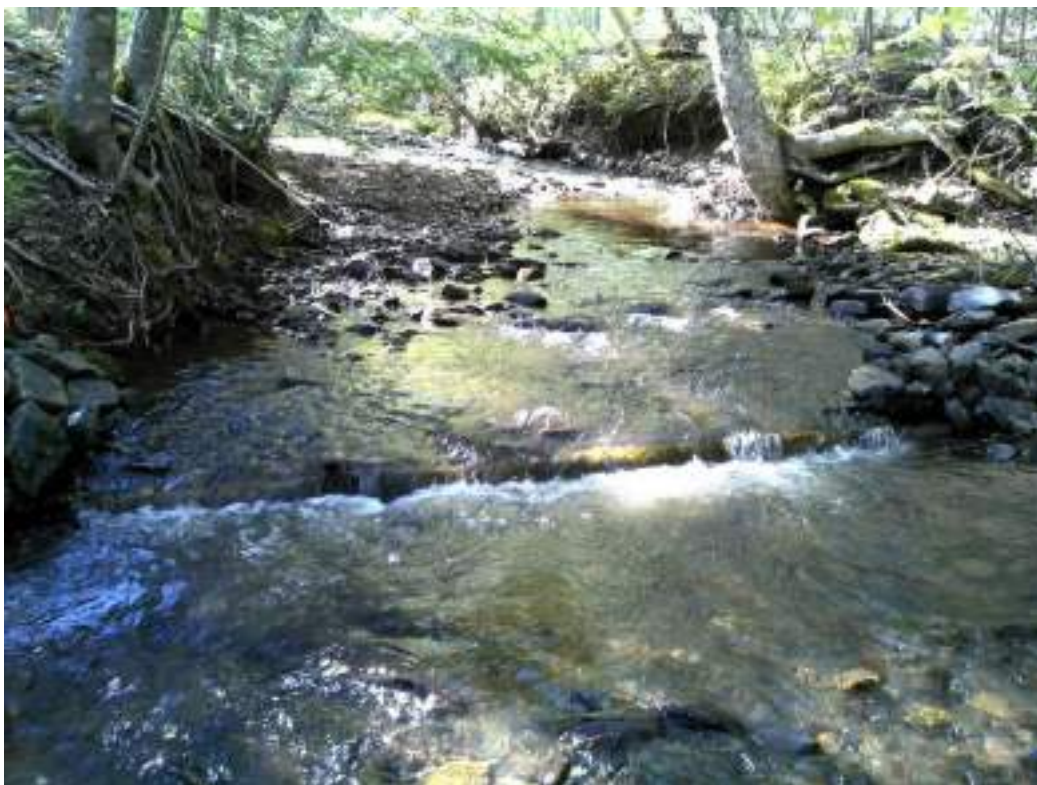
Figure 25. Showing the before and after photos of a digger log structure - #15 downstream from the road.

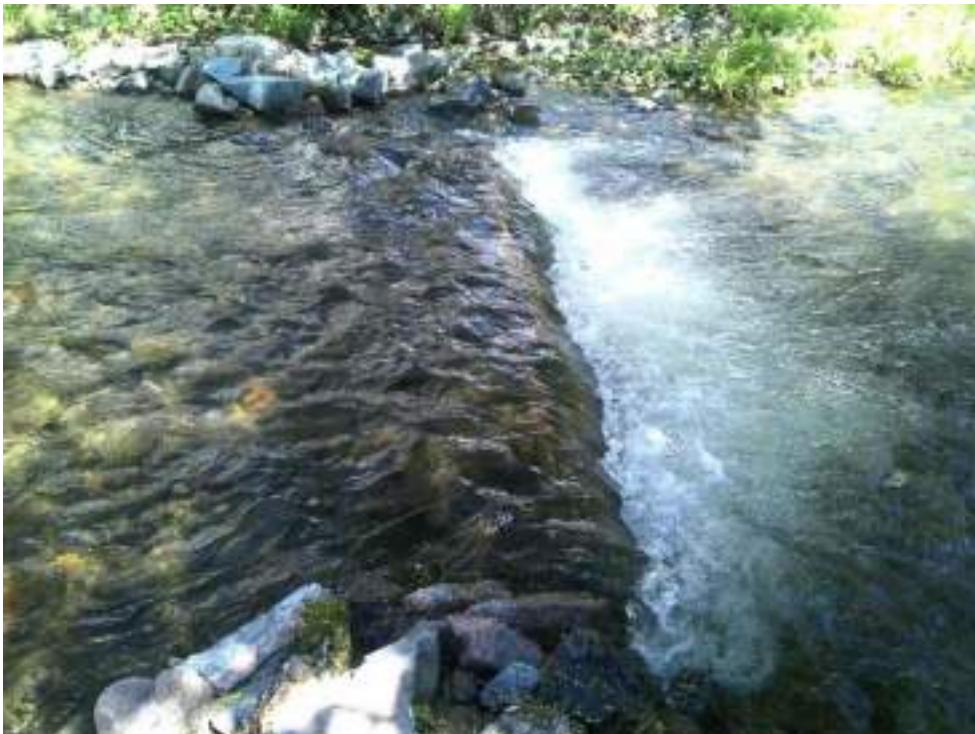
Figure 28. Diggerlog #1 - before and after pictures of maintenance. This is the furthest structure downstream.

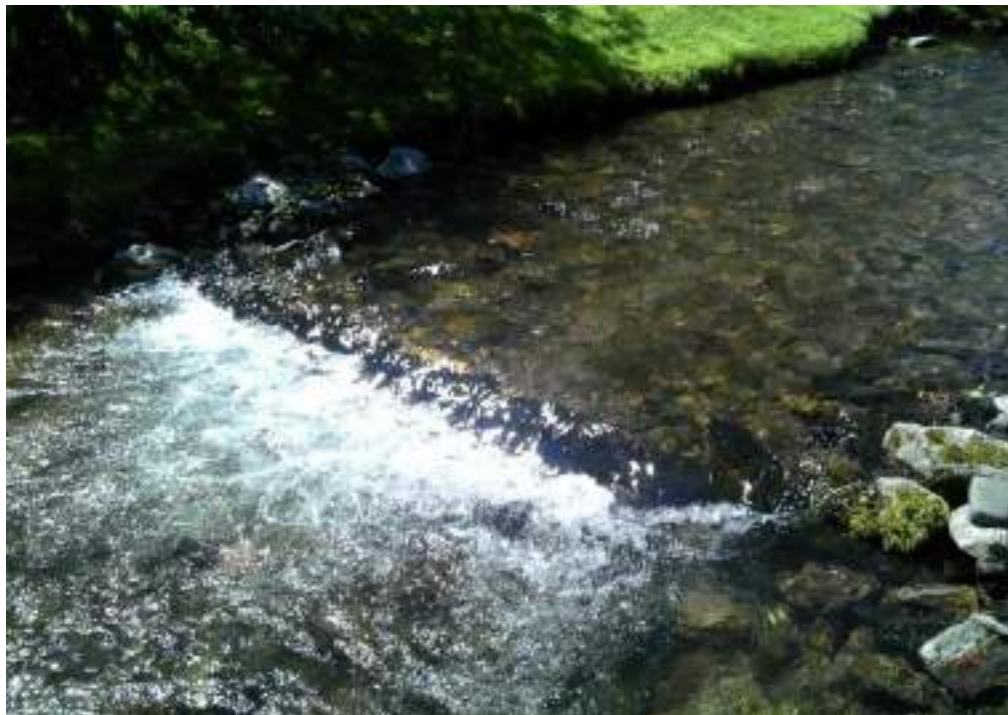
Figure 29. Diggerlog #2 - before and after pictures of maintenance.

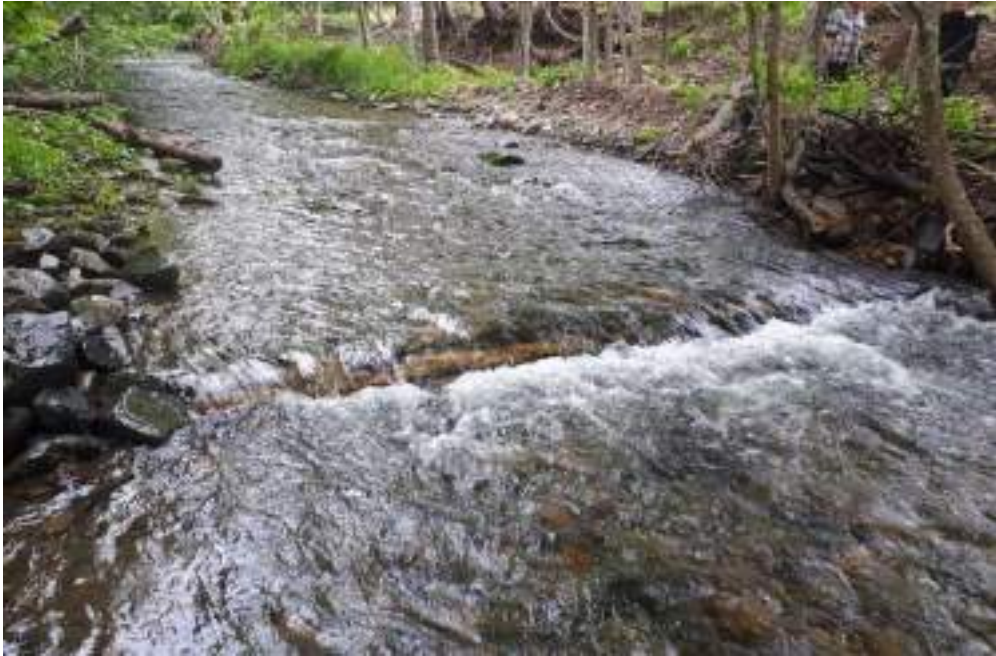
Figure 31. Diggerlog #4 - before and after pictures of maintenance.

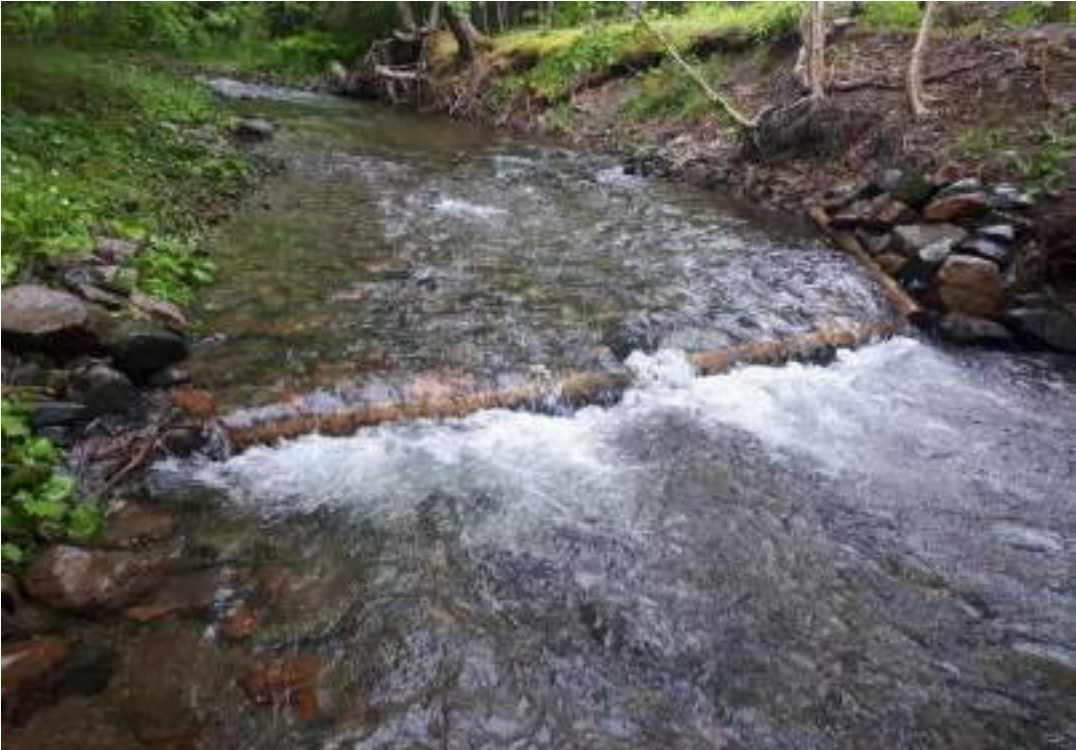
Figure 32. Diggerlog #5 - before and after pictures of maintenance.

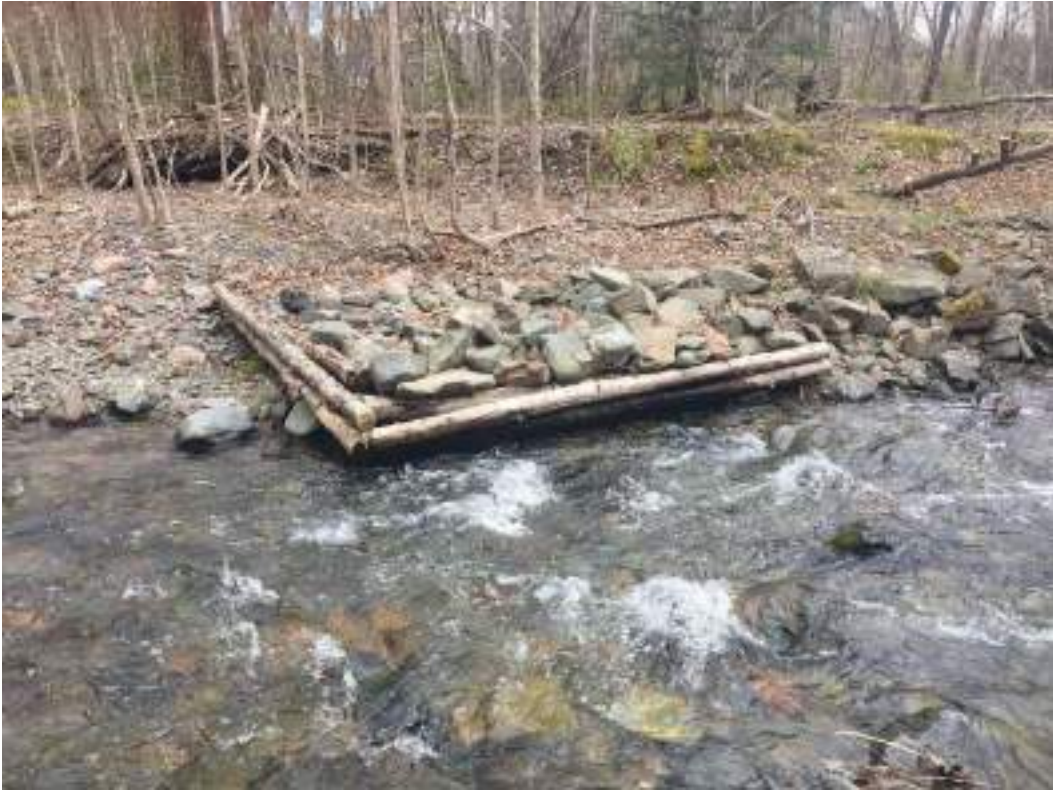
Figure 33. Deflector #6 - before and after picture of maintenance performed.

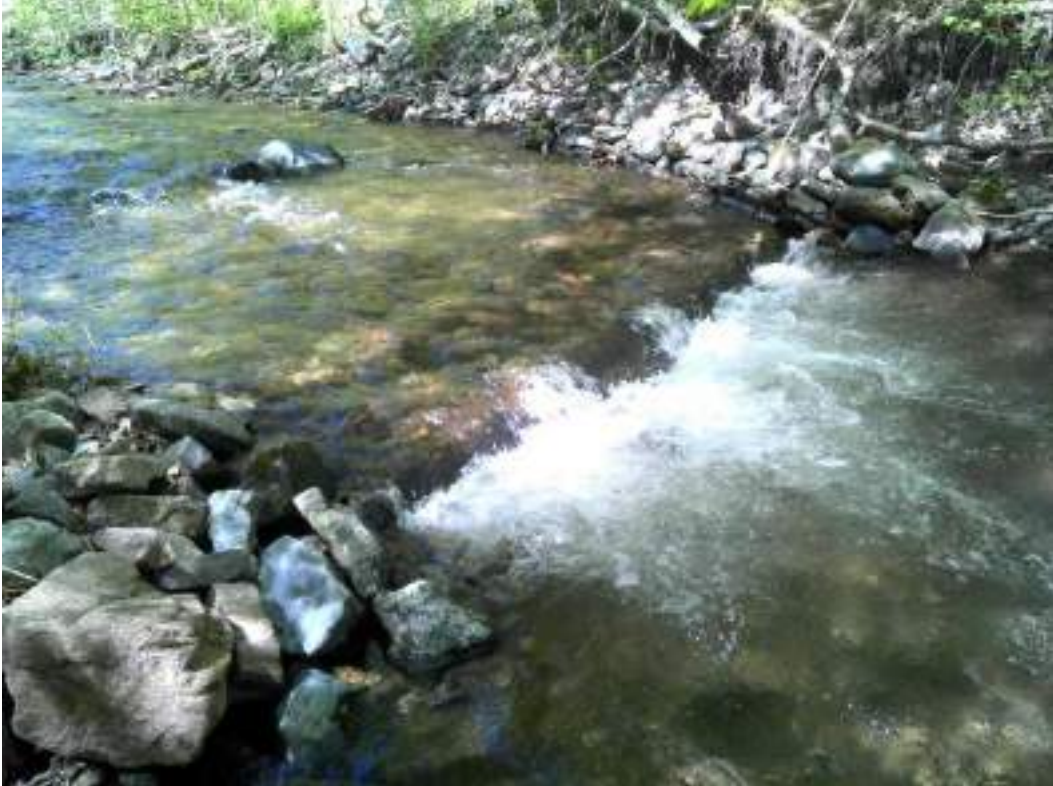
Figure 34 - Diggerlog #7 - before and after pictures of maintenance performed.

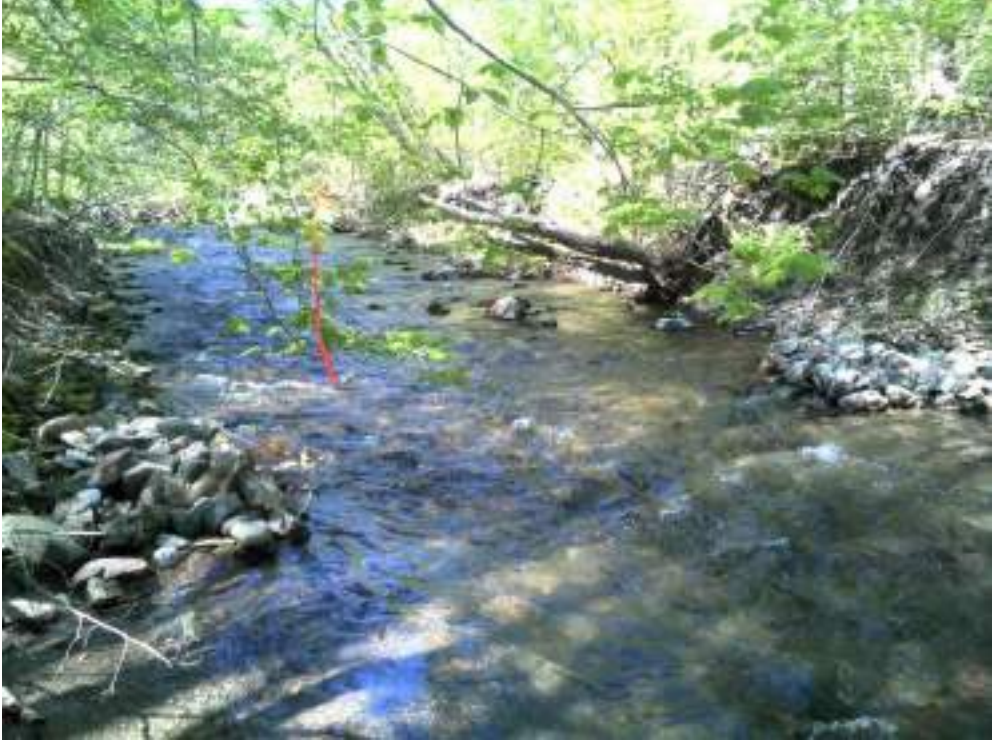
Figure 35. Deflector #8 - before and after pictures of maintenance.

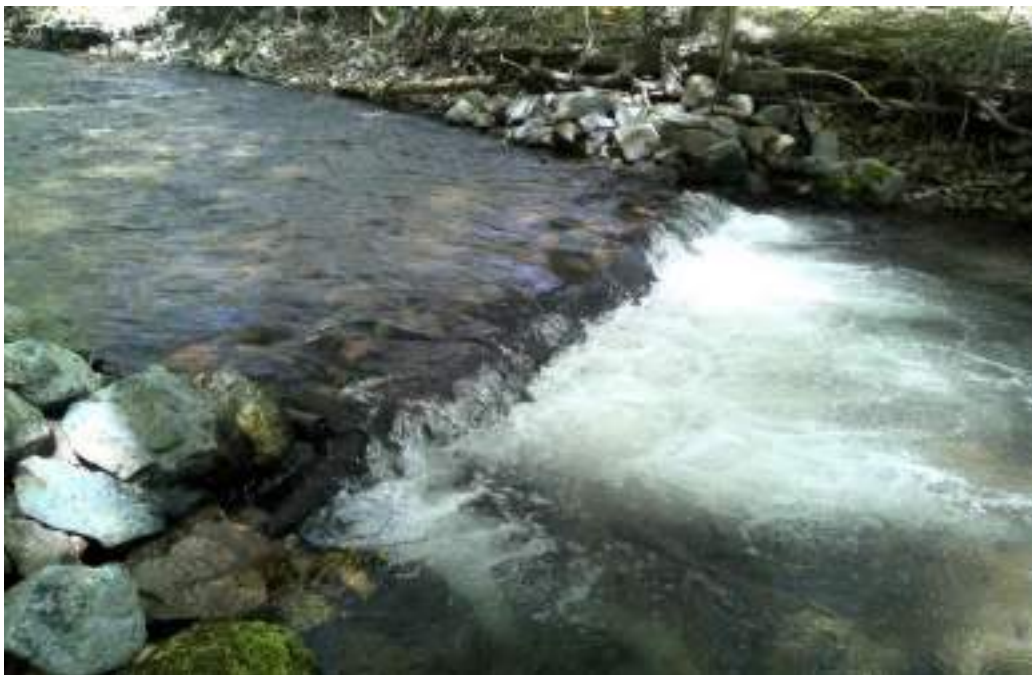
Figure 36. Diggerlog #9 - before and after pictures of maintenance.

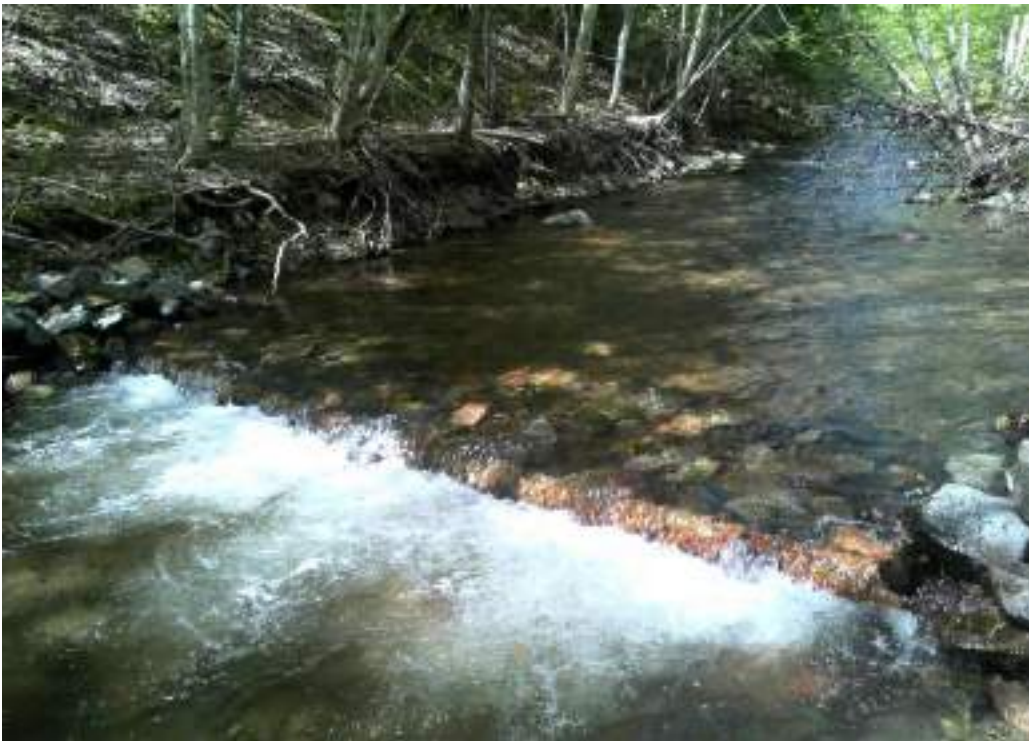
Figure 37. Diggerlog #10 - before and after pictures of maintenance.

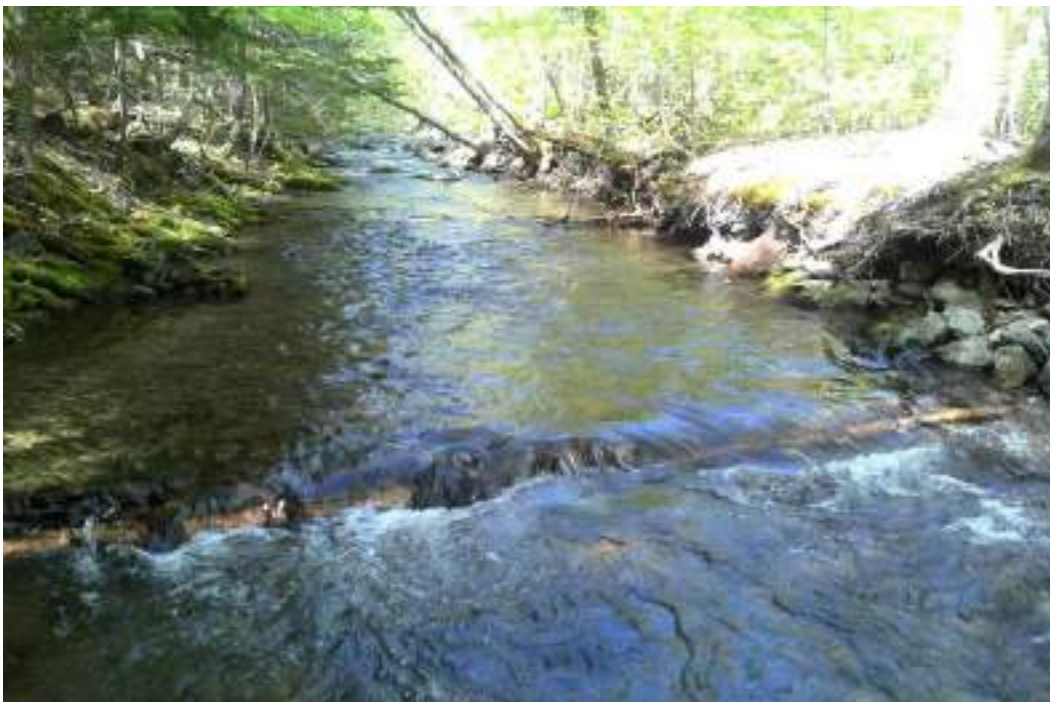
Figure 38. Diggerlog #11 - before and after pictures of maintenance.

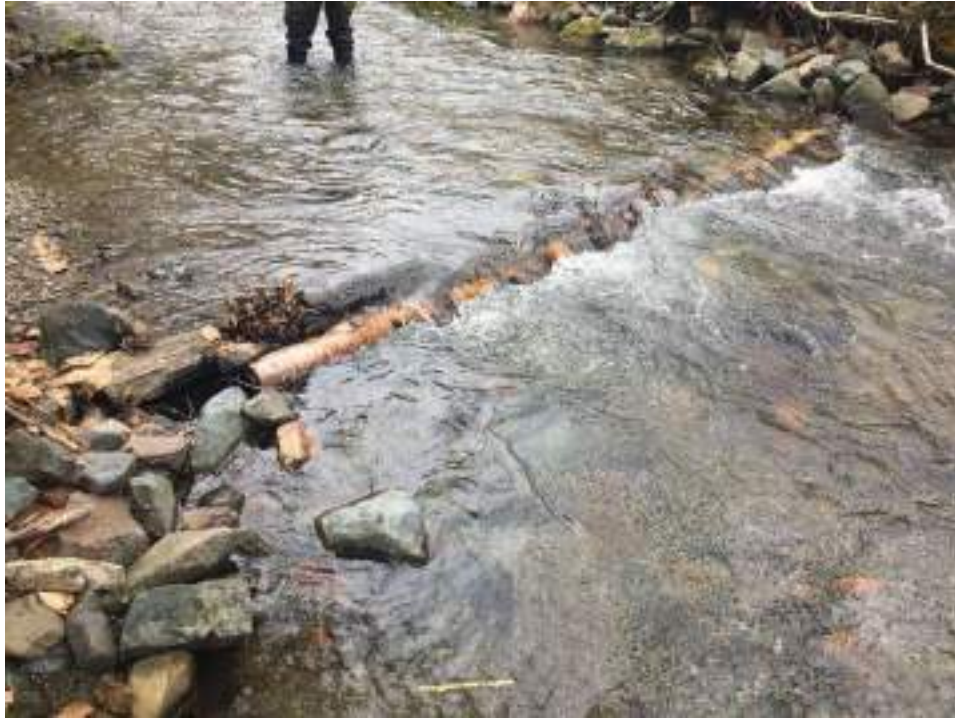
Figure 39. Diggerlog #12 - before picture of maintenance. No after photo taken.

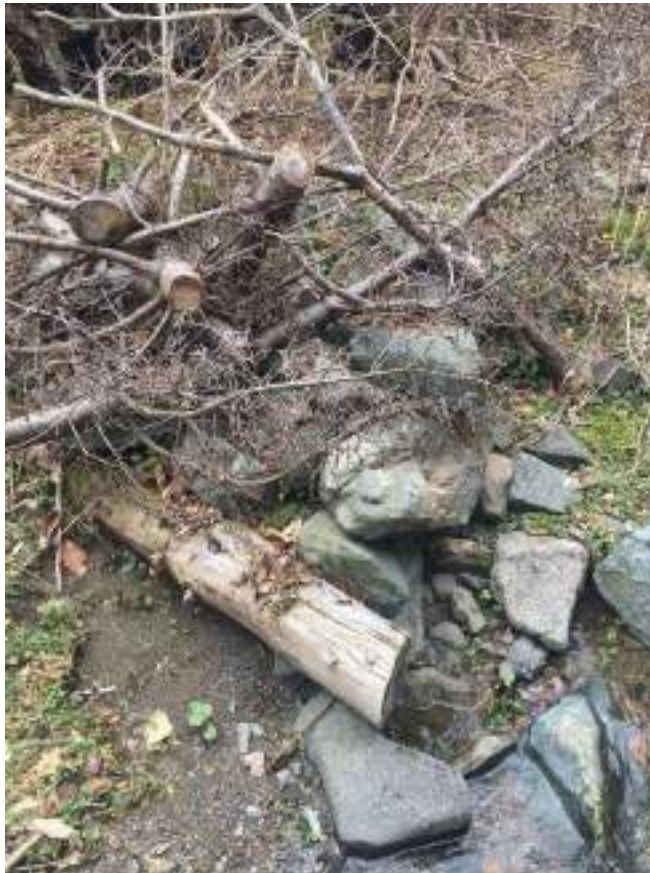
Figure 40. Deflector #13 - structure is no longer in-stream.

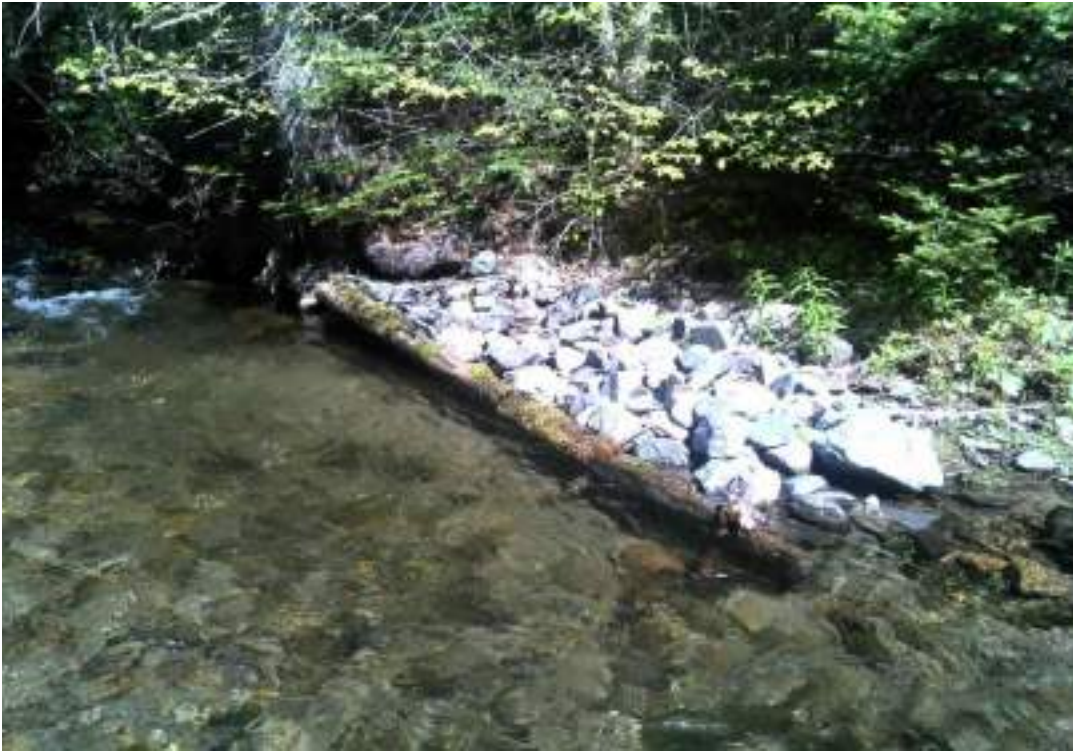
Figure 42. Deflector #15 - before and after pictures of maintenance.

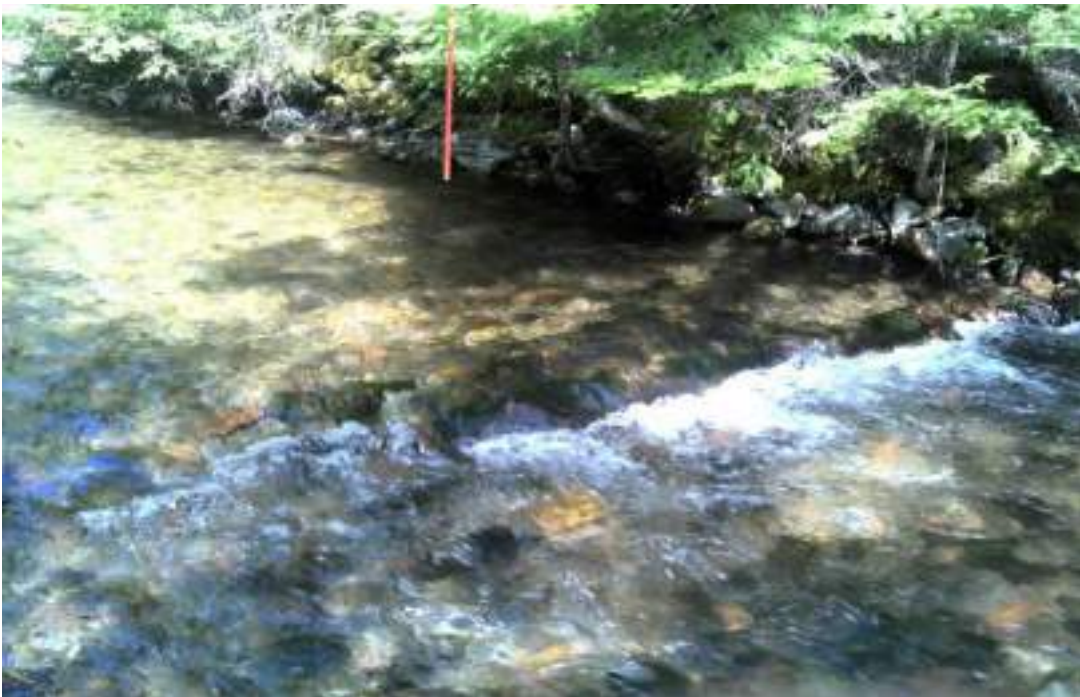
Figure 43. Diggerlog #16 - buried diggerlog. Before and after pictures show attempted maintenance on the structure.

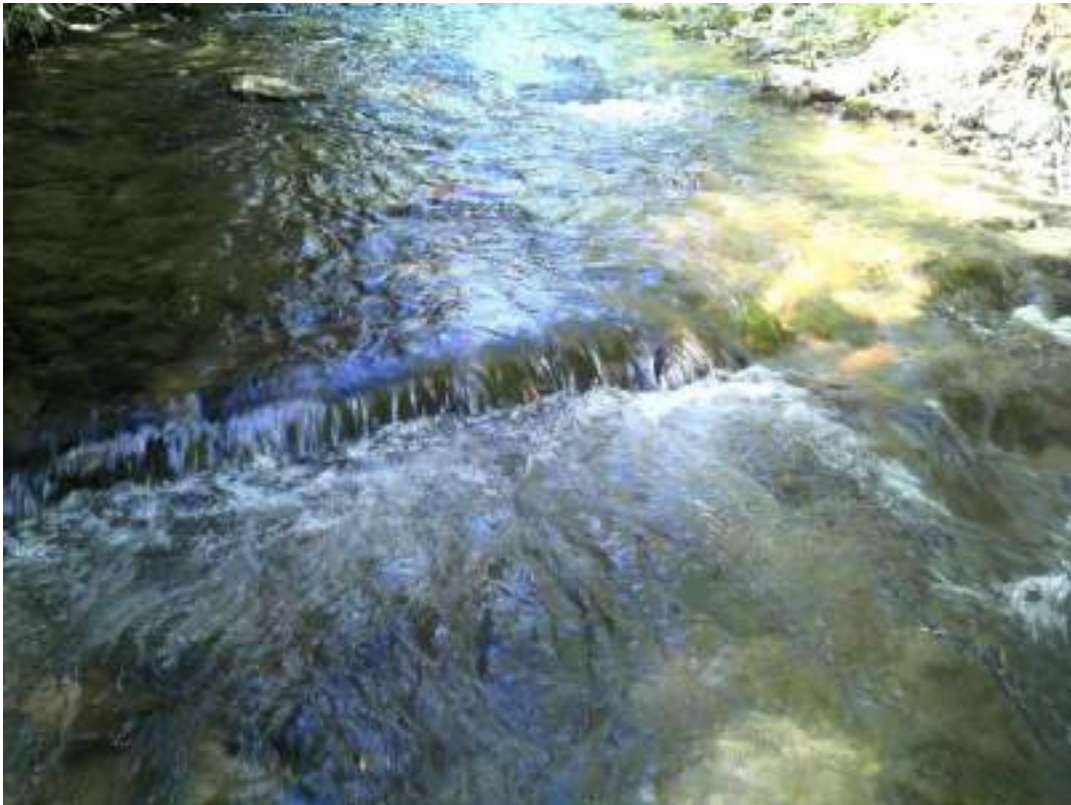
Figure 44. Diggerlog #17 - before and after pictures of maintenance.

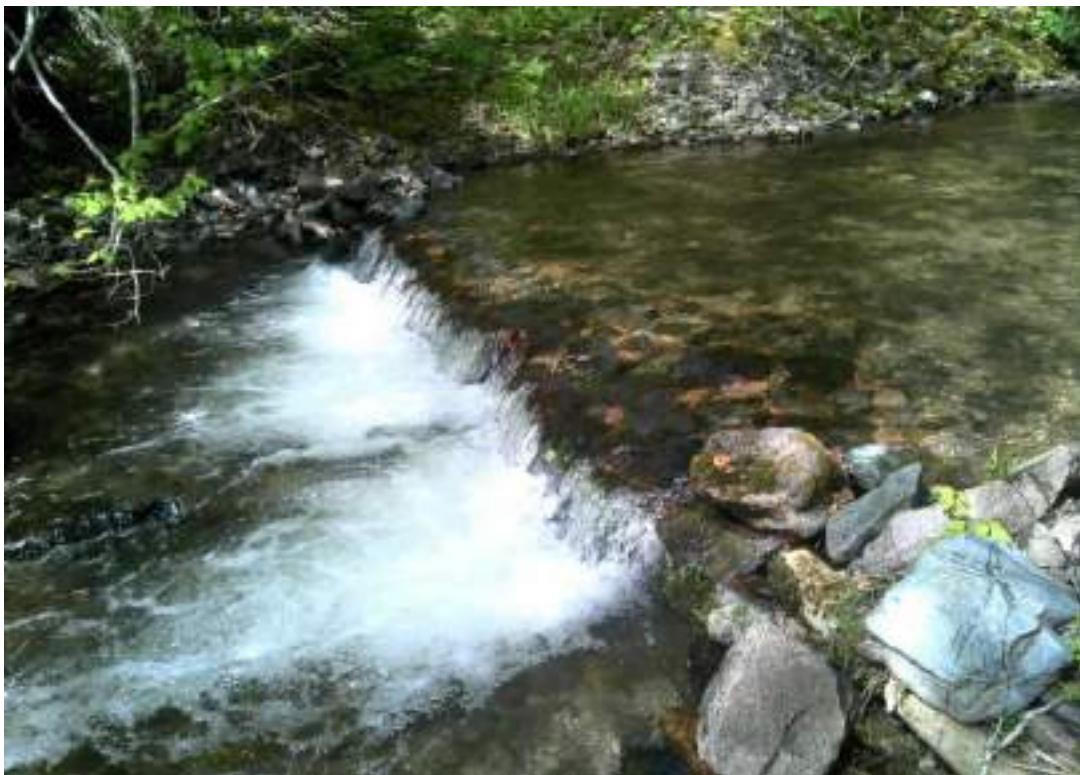
Figure 45. Diggerlog and deflector #18 - before and after pictures of maintenance.
