SALMONID HABITAT RESTORATION
INVERNESS SOUTH ANGLERS ASSOCIATION

Winter Damage Assessment

Date: 2019

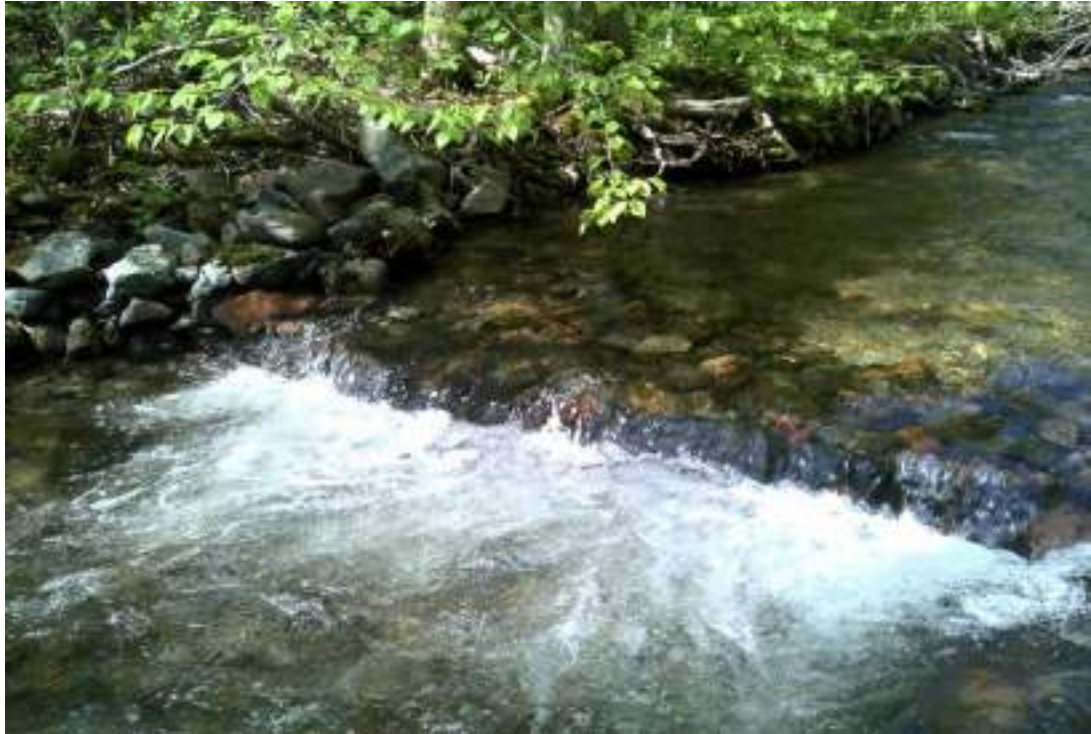
Figure 46. Diggerlog #19 - before and after pictures of maintenance.

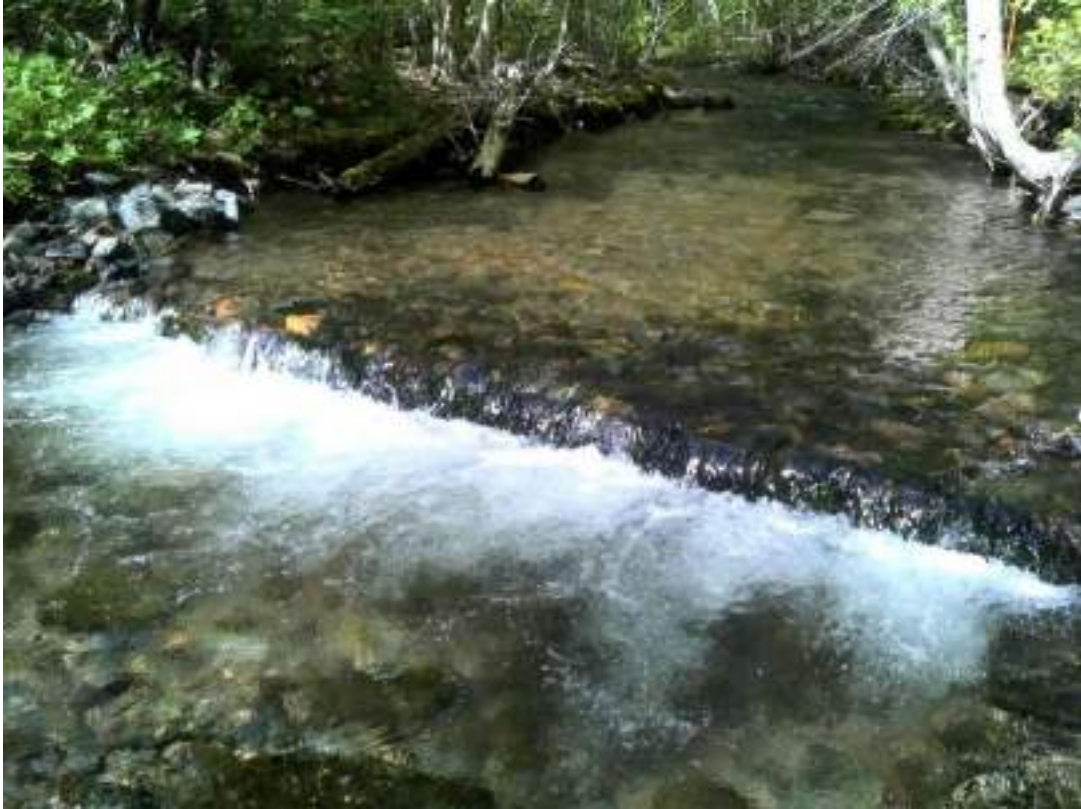
Figure 47. Diggerlog #20 - before and after pictures of maintenance.

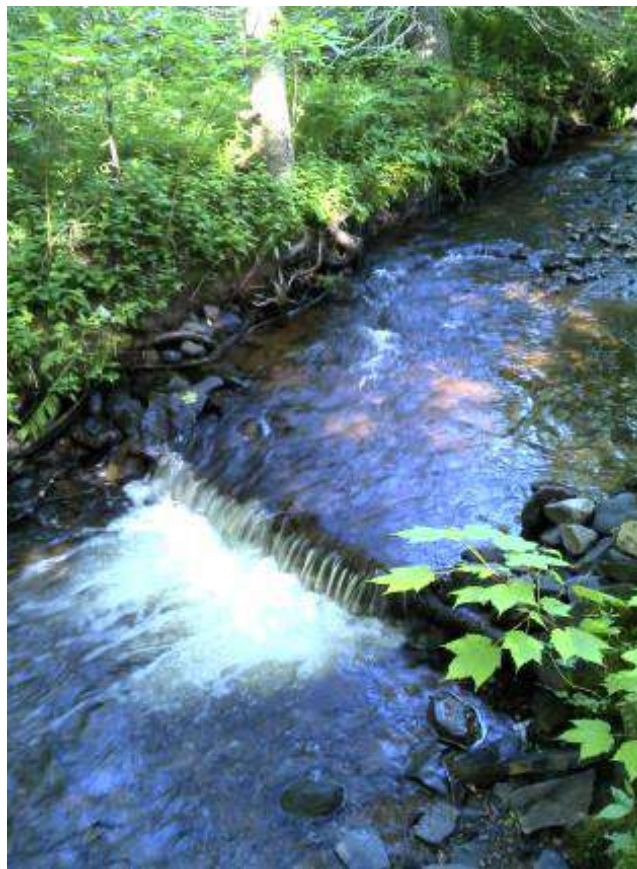
Figure 49. Digger log #1 - furthest structure upstream. Before and after pictures of the completed maintenance.

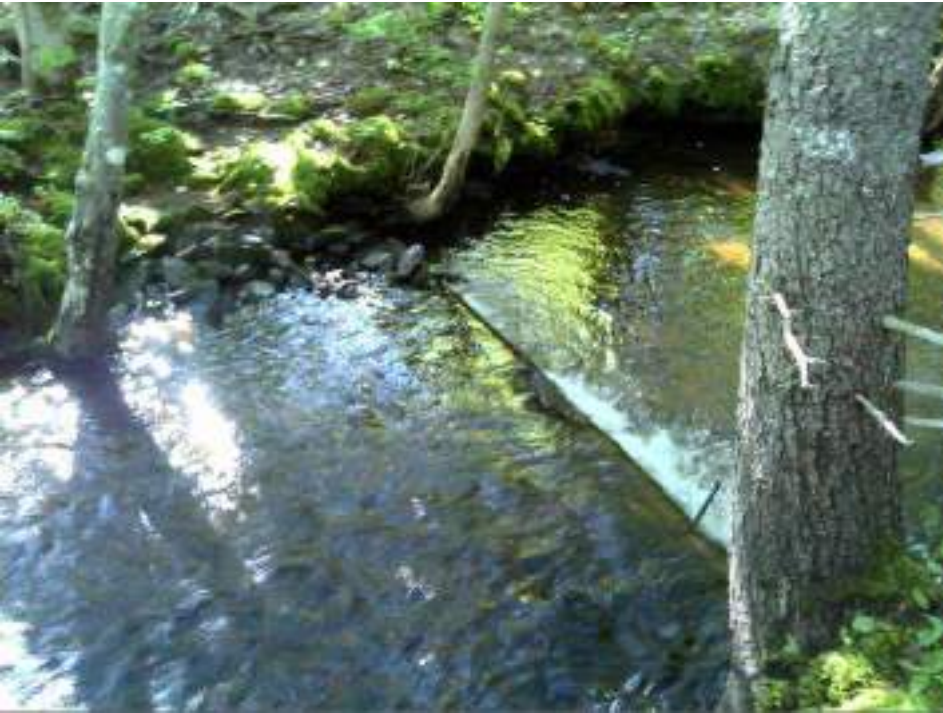
Figure 52. Structure #4 - Before and after picture of the maintenance completed on a digger log.

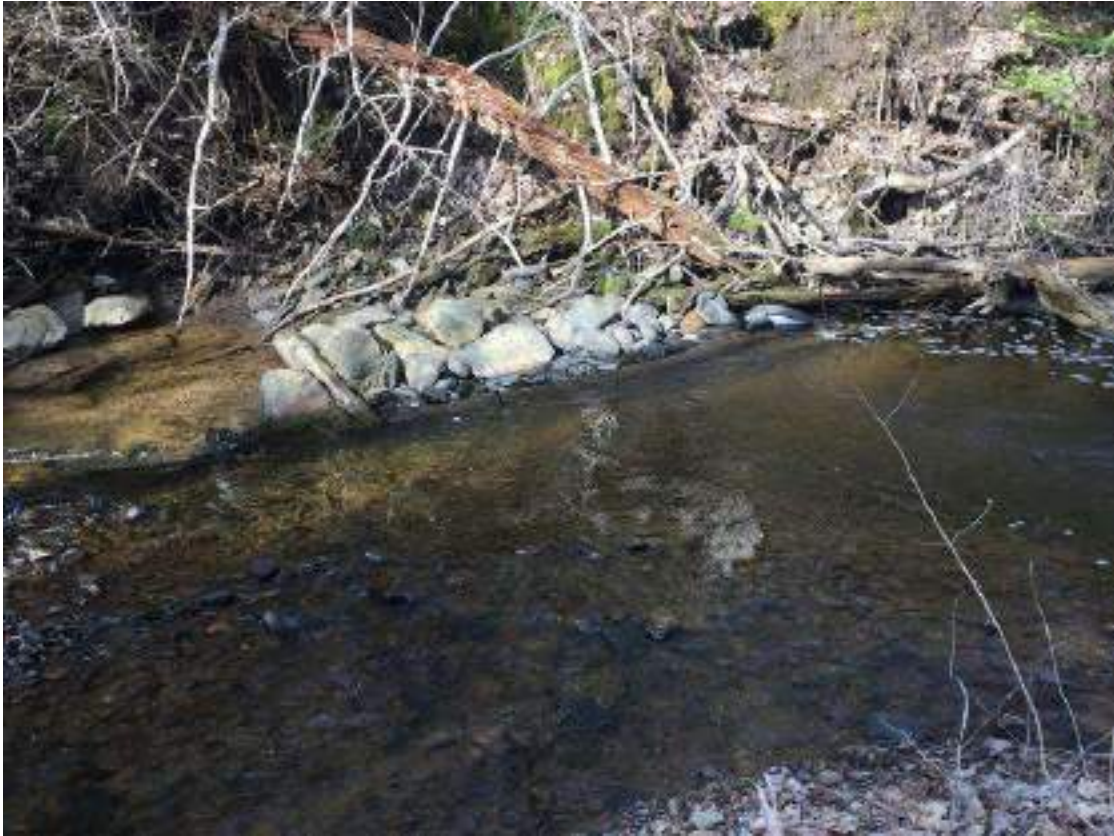
Figure 53. Structure #5 - after picture of the maintenance completed on a deflector.

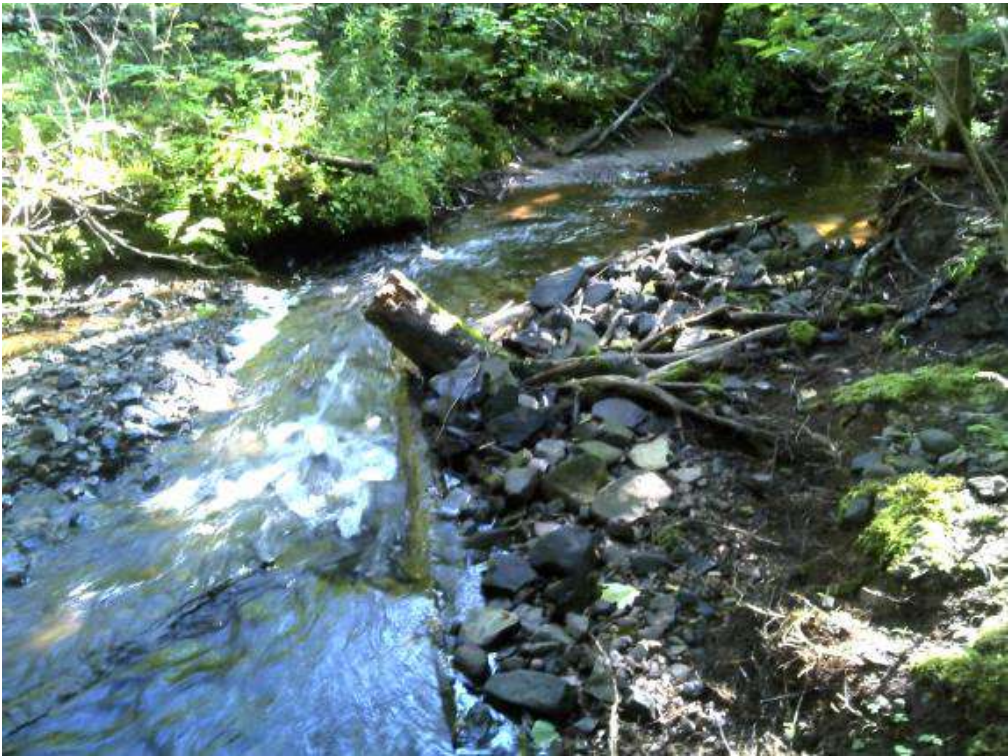
Figure 54. Structure #6 - before and after picture of the maintenance completed on a deflector.

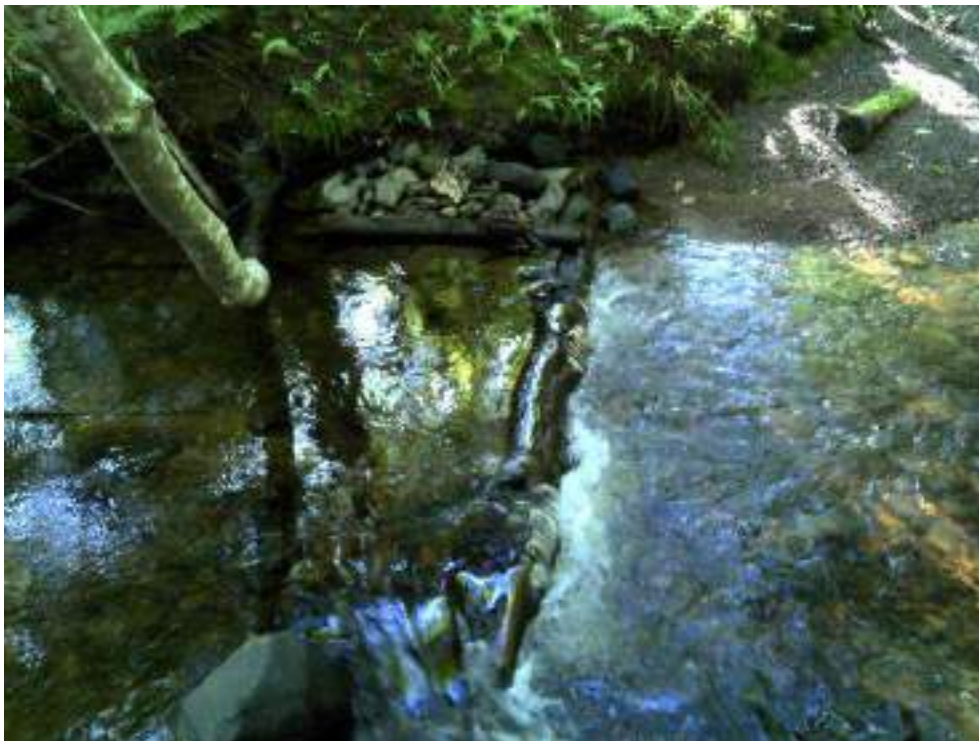
Figure 55. Structure #7 - Before and after picture of the maintenance completed on a digger log and deflector structure.

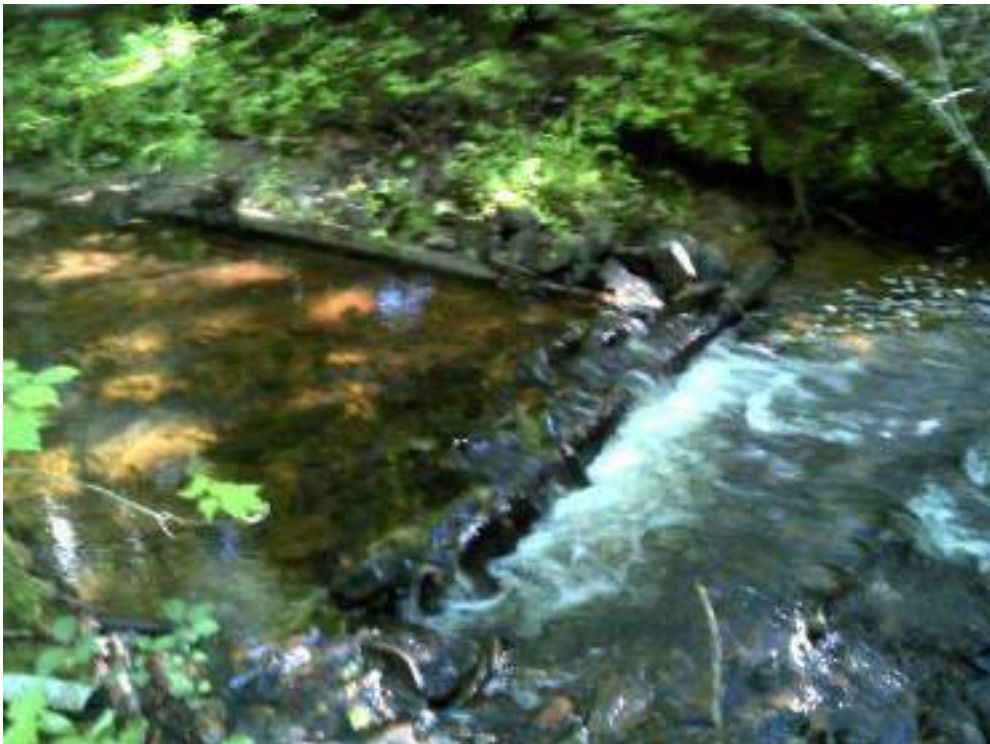
Figure 56. Structure #8 - before and after picture of the maintenance completed on a digger log and deflector structure.

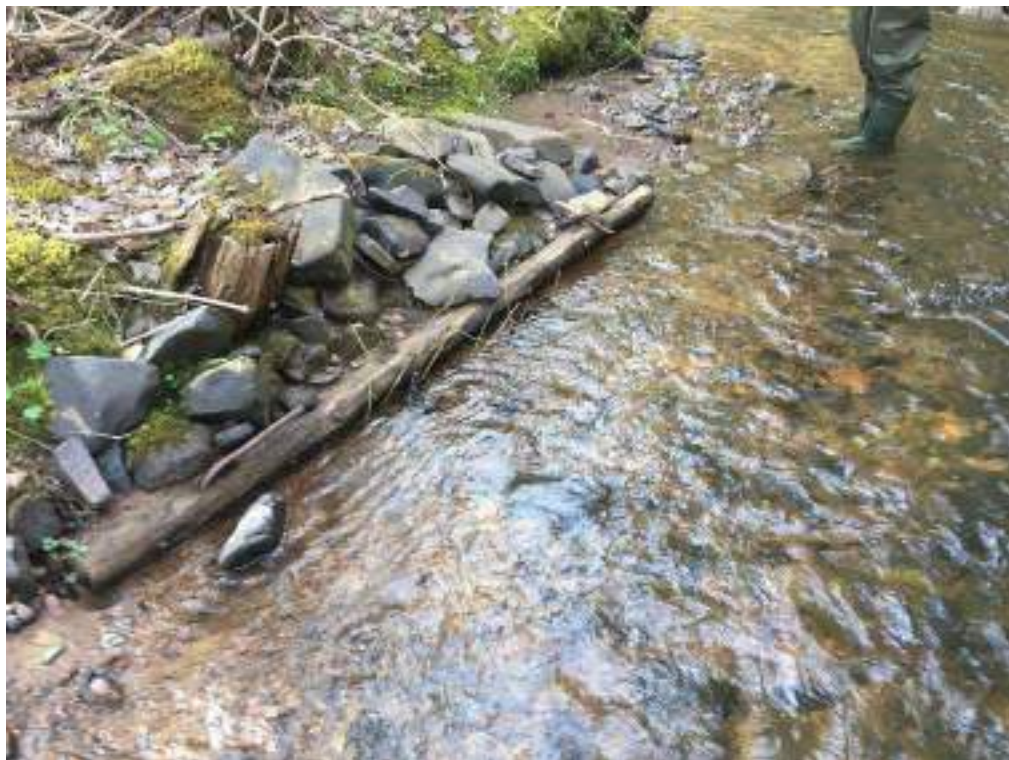
Figure 57. Structure #9 - Before and after picture of the maintenance completed on a deflector.

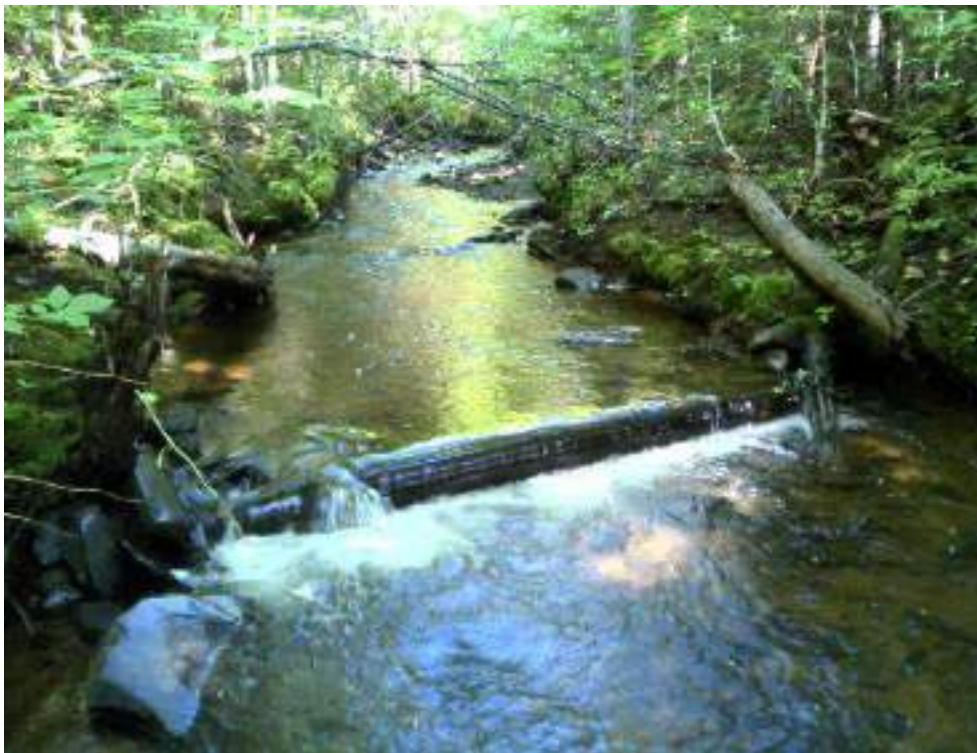
Figure 58. Structure #10 - Before and after picture of the maintenance completed on a diggerlog.

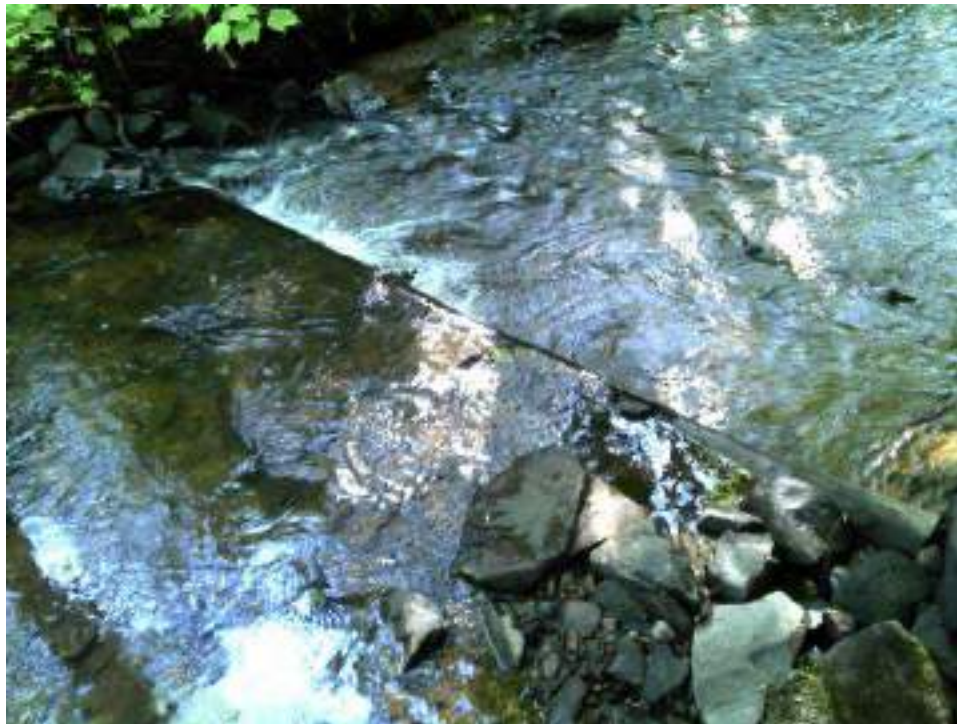
Figure 59. Structure #11 - Before and after picture of the maintenance completed on a digger log.

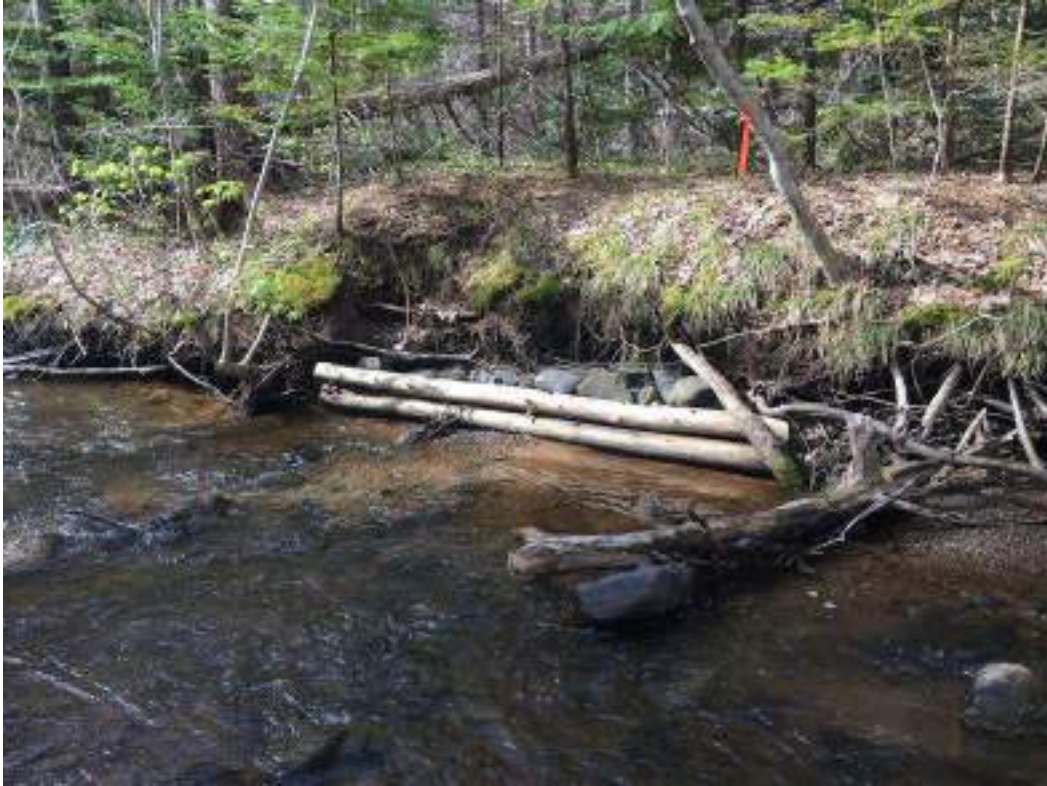
Figure 60. Structure #12 - After picture of the maintenance completed on a two-tier bank stabilization structure.

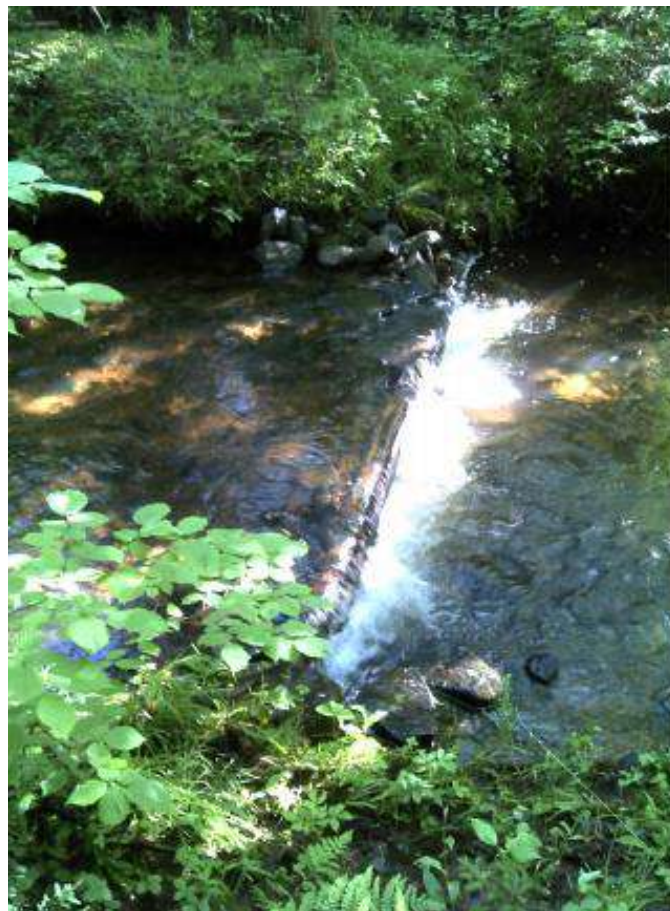
Figure 61. Structure #13 - Before and after picture of the maintenance completed on a digger log.

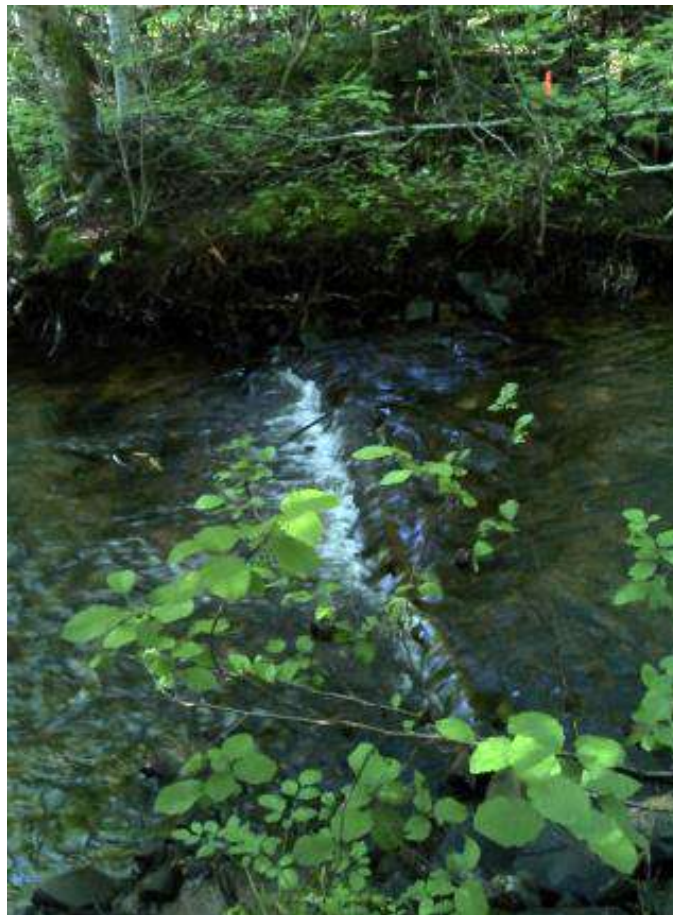
Figure 62. Structure #14 - Before and after picture of the maintenance completed on a diggerlog.

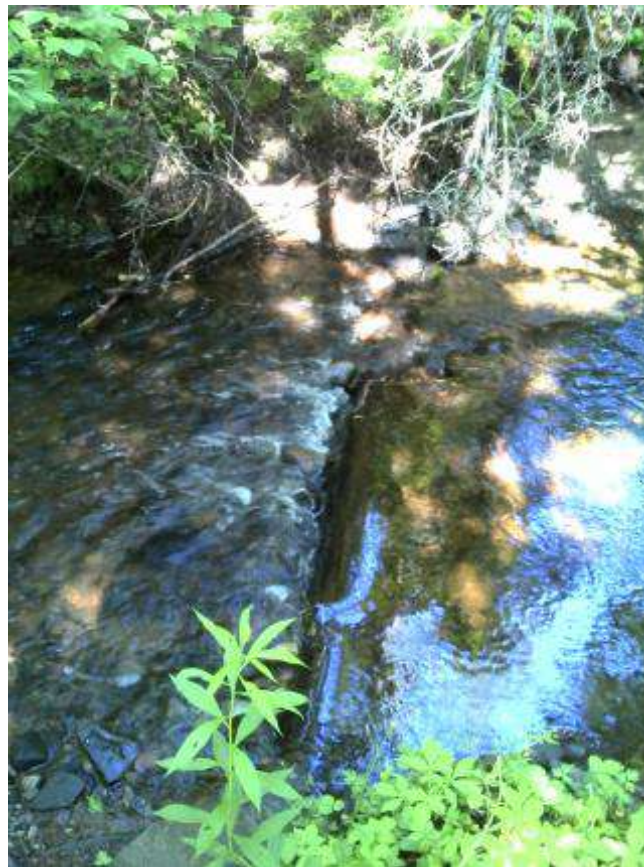
Figure 63. Structure #15 - Before and after picture of the maintenance completed on a digger log.

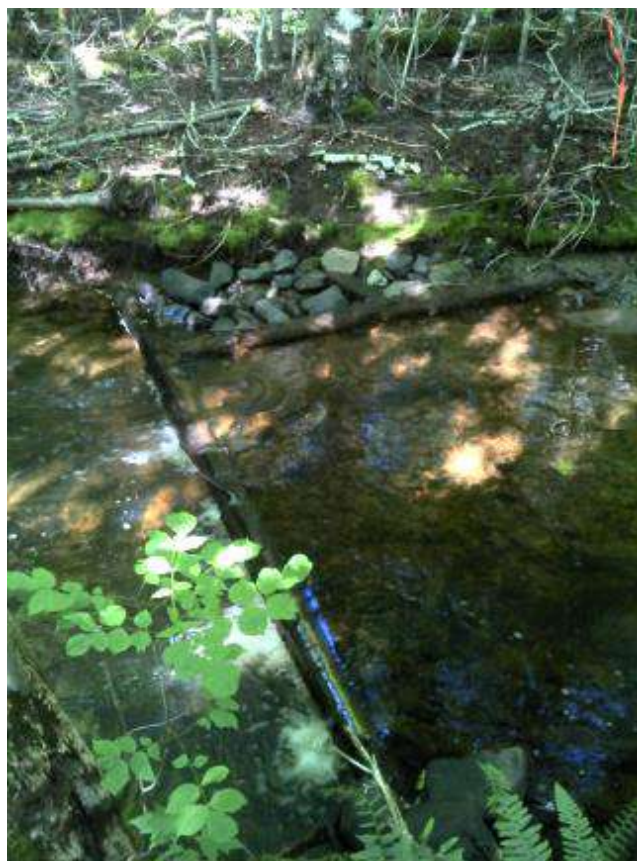
Figure 64. Structure #16 - Before and after picture of the maintenance completed on a digger log and deflector structure.

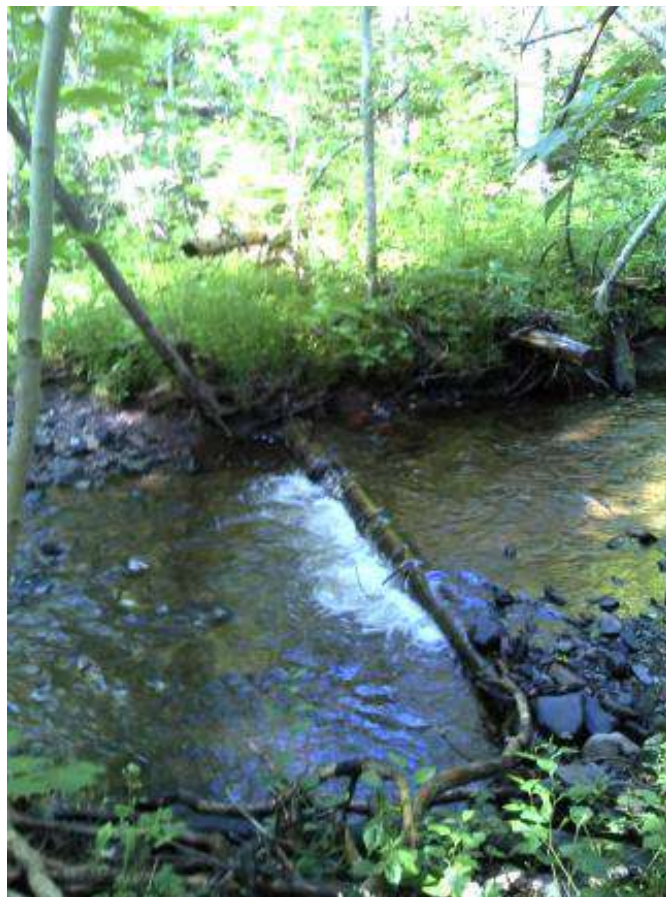
Figure 65. Structure #17 - Before and after picture of the maintenance completed on a diggerlog.

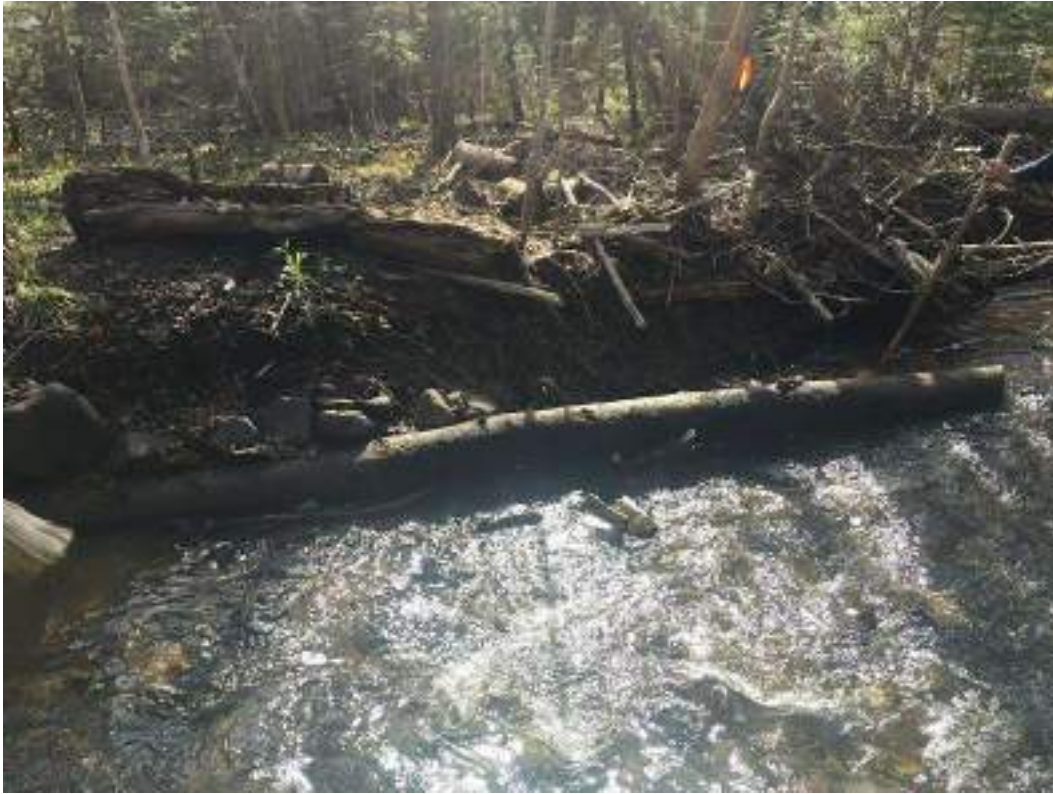
Figure 66. Structure #18 - Before picture of a deflector structure. No after picture of maintenance

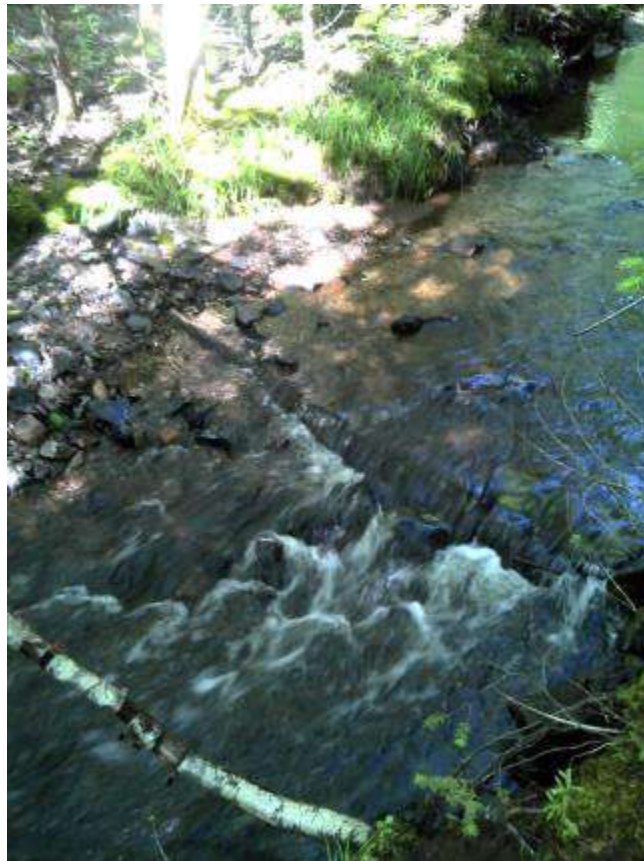
Figure 67. Structure #19 - Before and after picture of the maintenance attempted on a digger log.

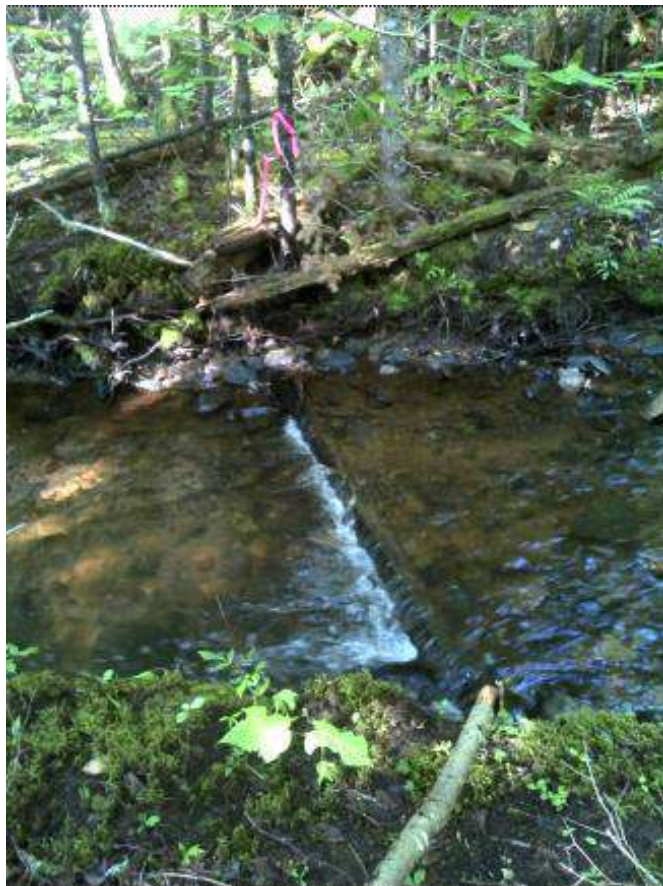
Figure 68. Structure #20 - Before and after picture of the maintenance completed on a diggerlog.

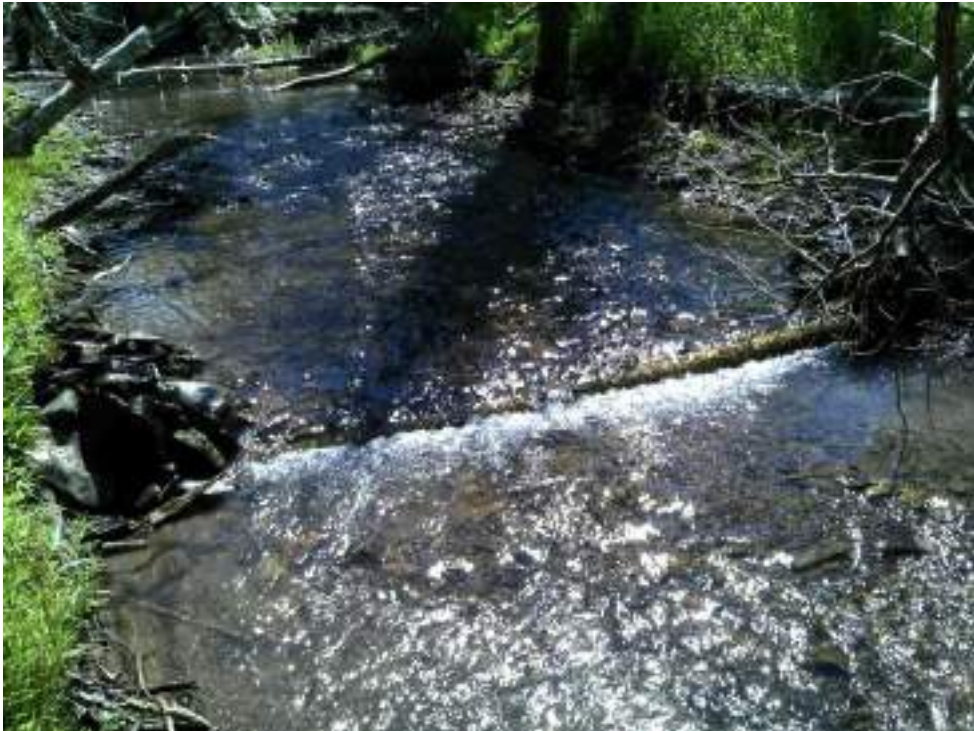
Figure 76. First diggerlog structure upstream from Trans Canada Trail

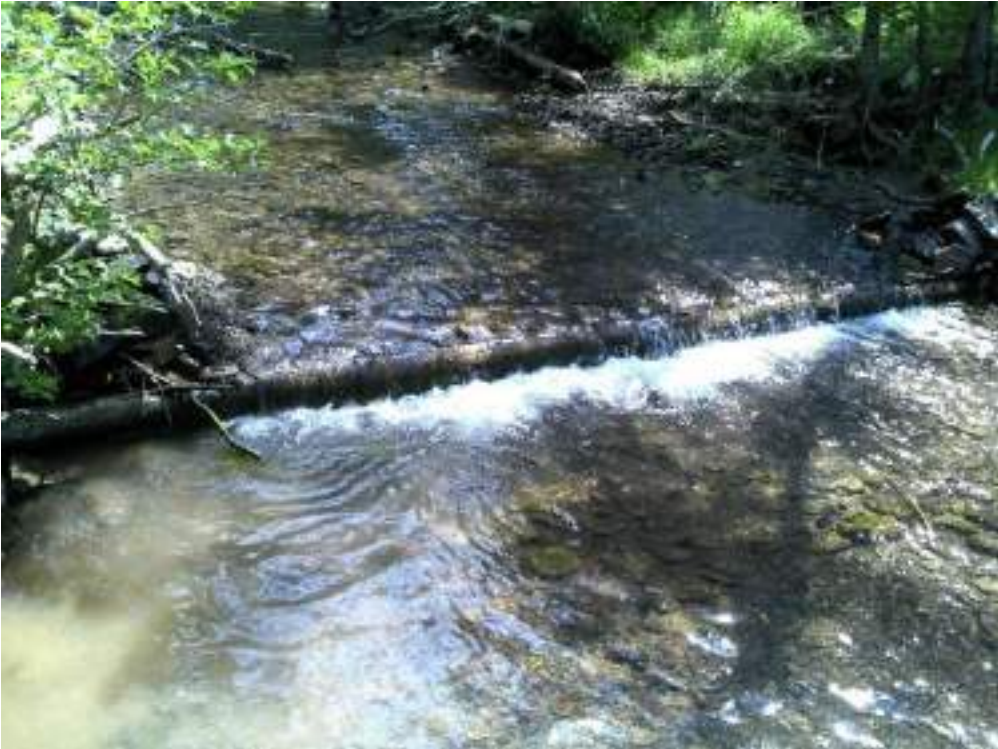
Figure 77. Digger log structure #2 upstream from the Trans Canada Trail.

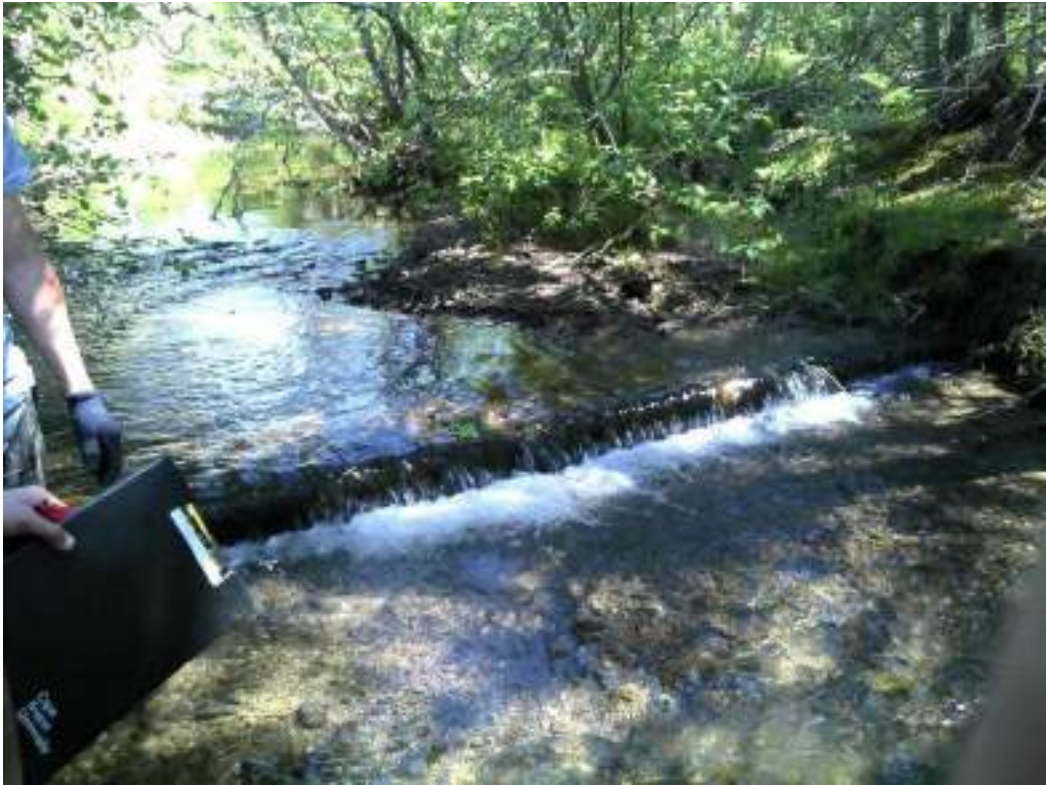
Figure 78. Diggerlog structure #3 upstream from the Trans Canada Trail.

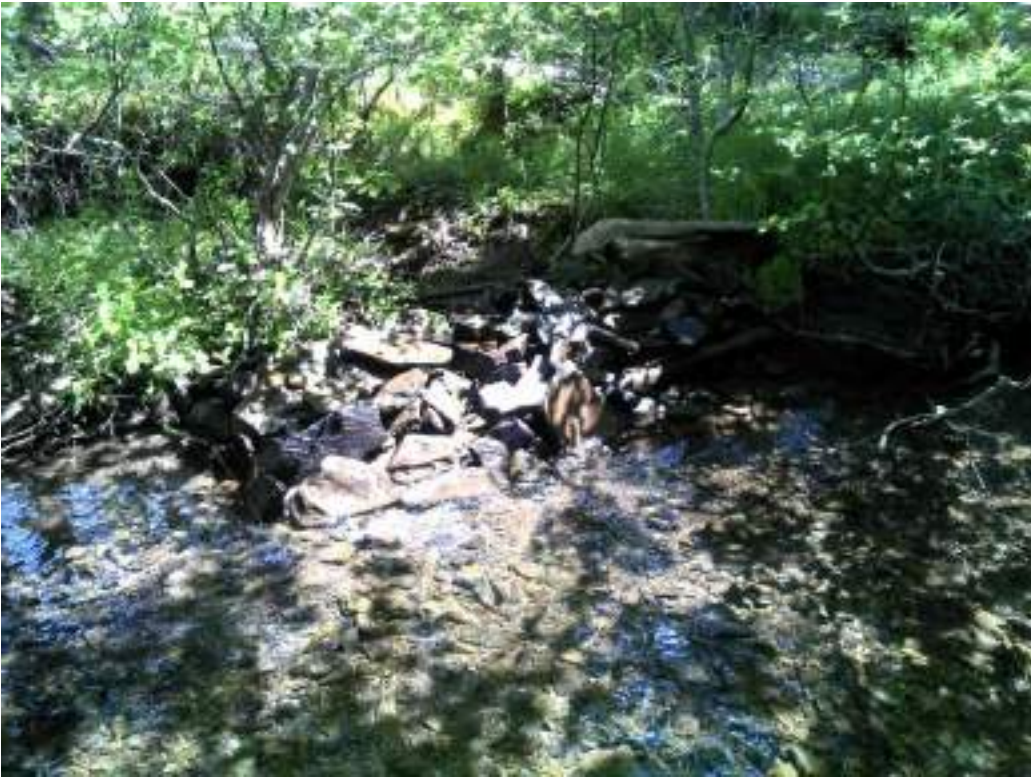
Figure 79. Deflector structure #4 upstream from the Trans Canada Trail..

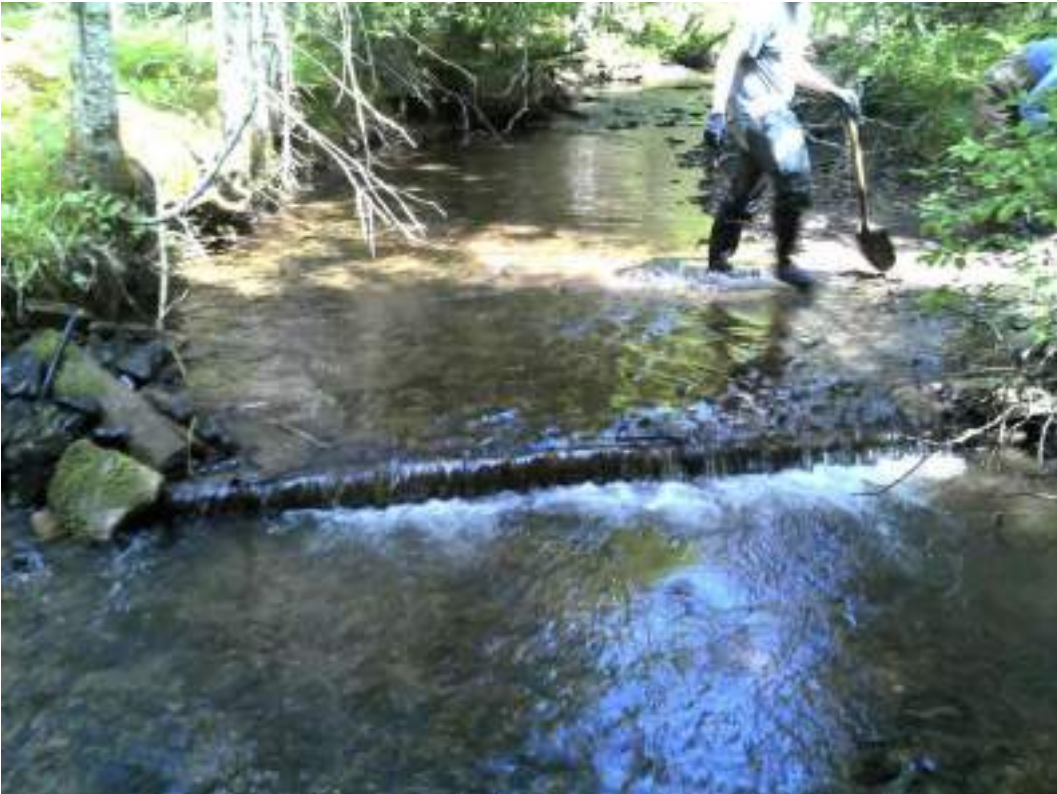
Figure 80. Diggerlog structure #5 upstream from the Trans Canada Trail.

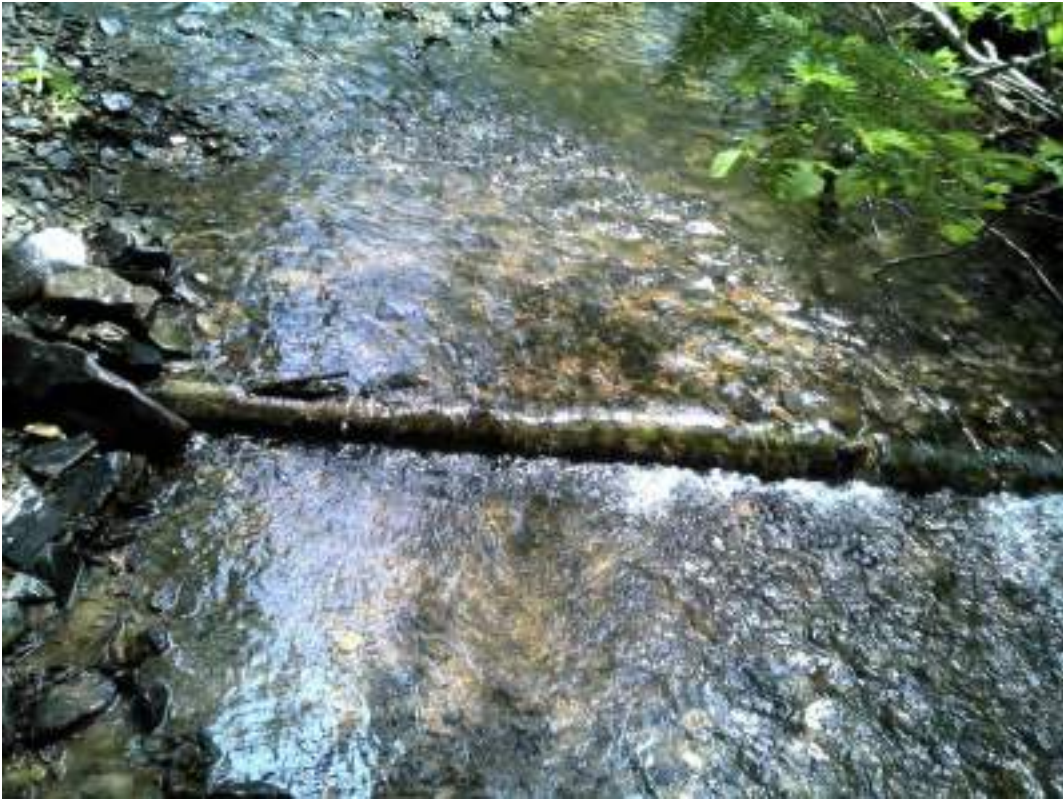
Figure 81. Diggerlog structure #6 upstream from the Trans Canada Trail.

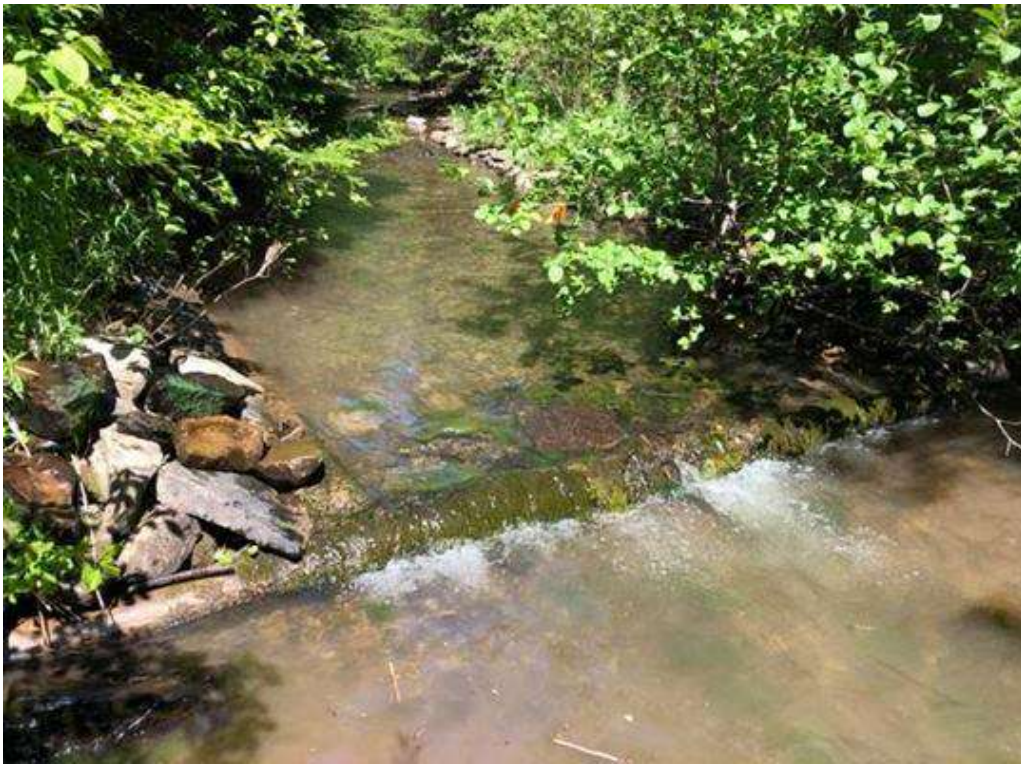
Figure 84. Diggerlog structure #9 - downstream side of Smithville Road.

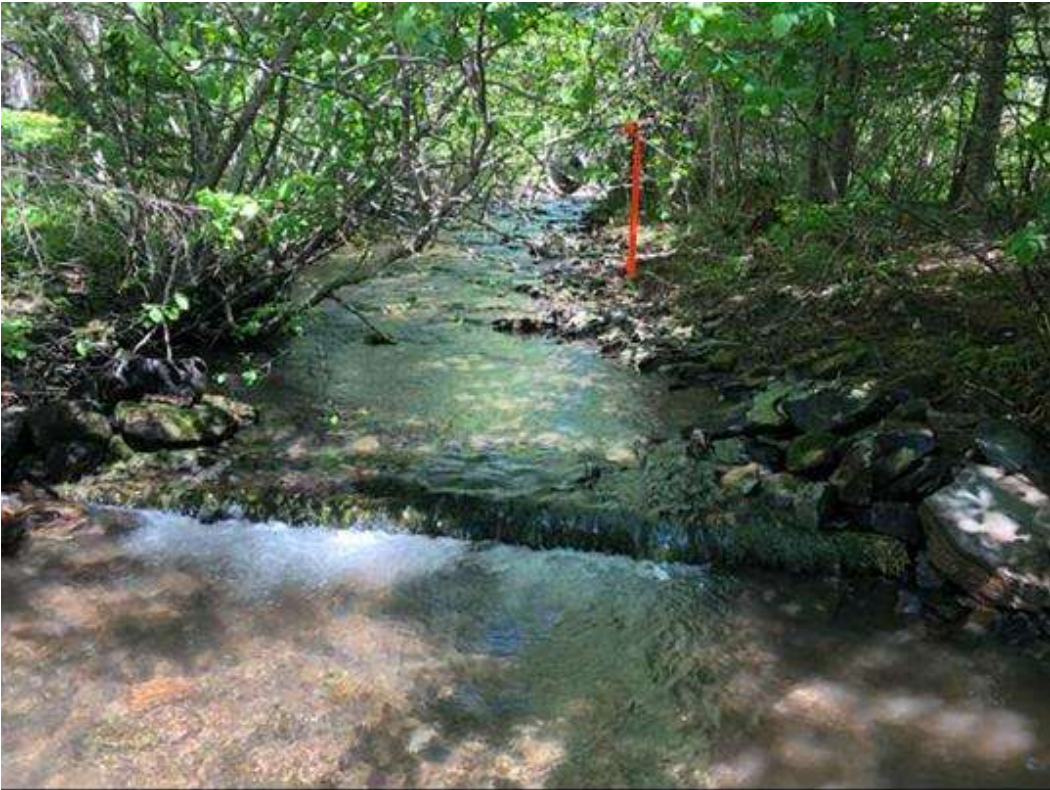
Figure 85. Diggerlog structure #10 - downstream side of Smithville Road.

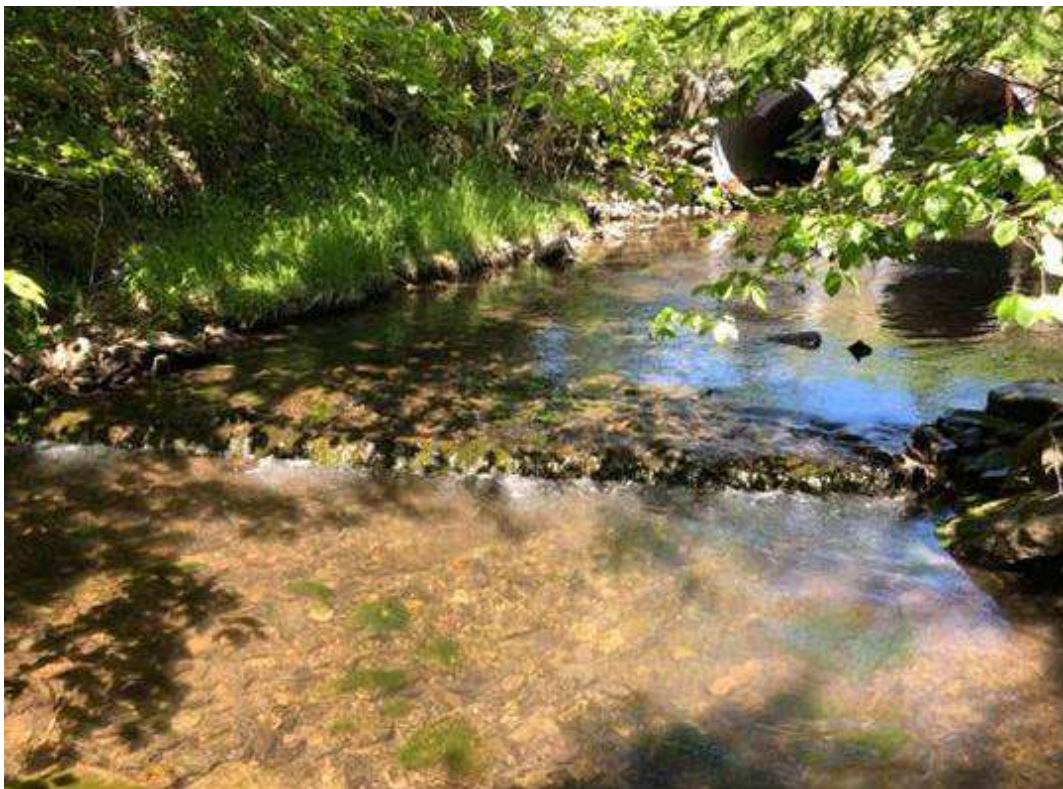
Figure 86. Diggerlog structure #11 - downstream side of Smithville Road.

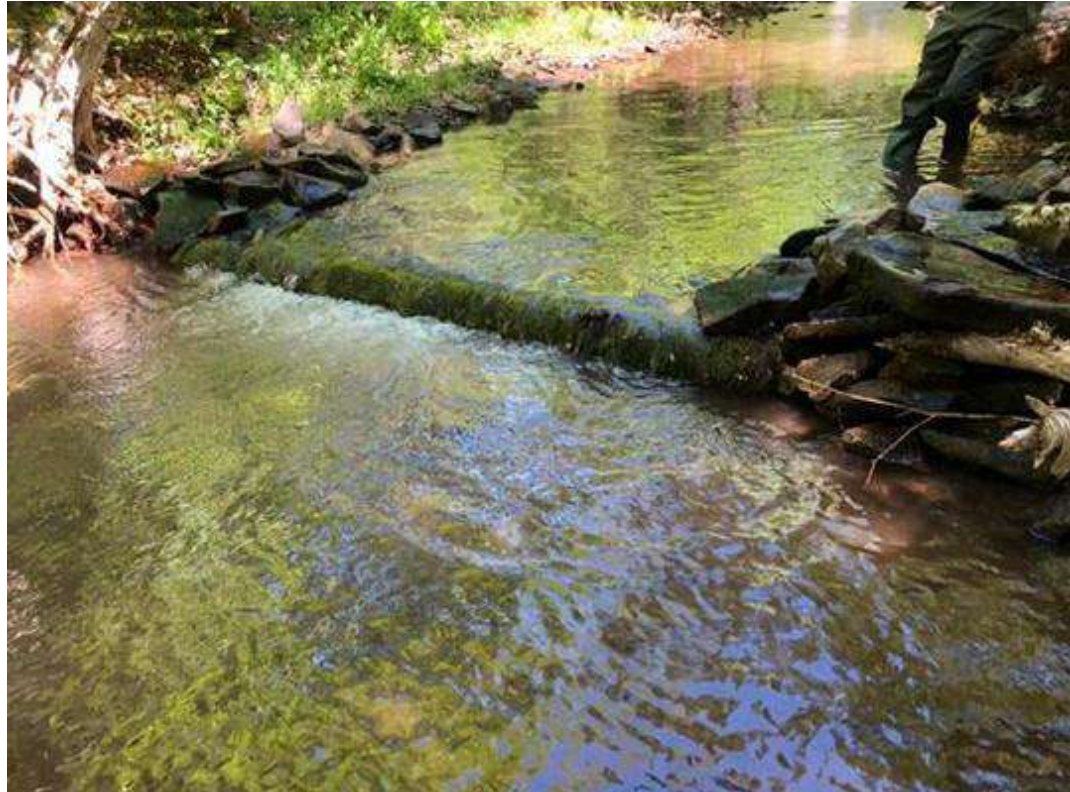
Figure 89. Diggerlog #14 - upstream from Smithville Road.
