SALMONID HABITAT RESTORATION
INVERNESS SOUTH ANGLERS ASSOCIATION

Winter Damage Assessment

Date: 2019

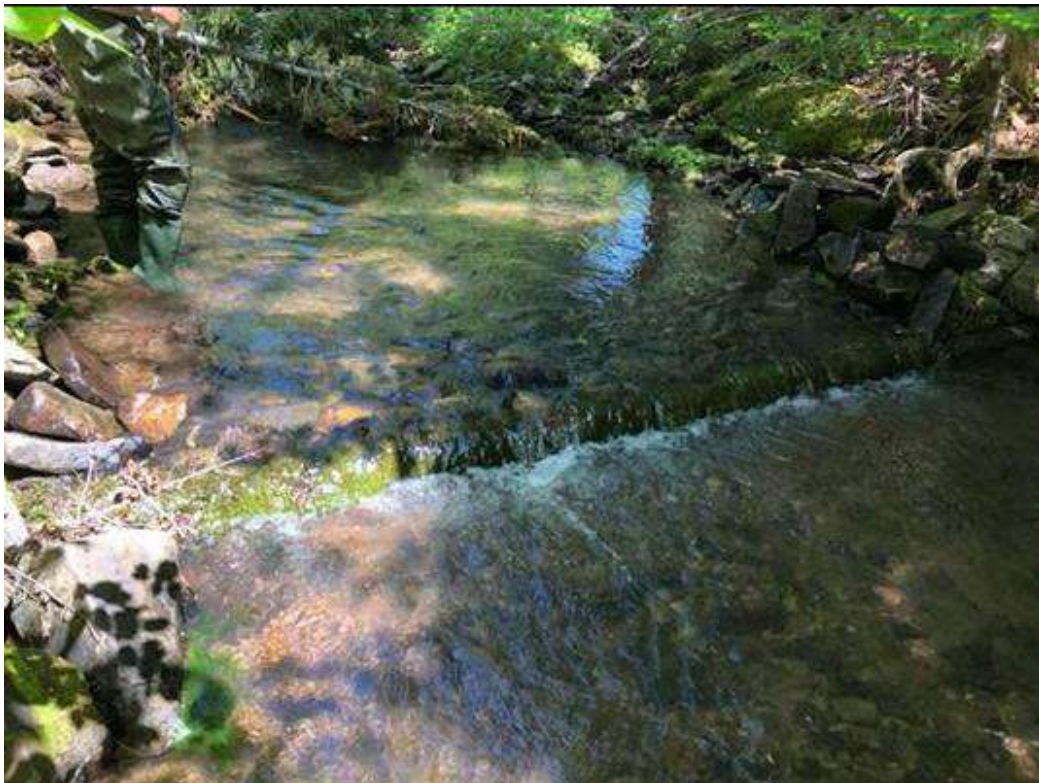
Figure 90. Diggerlog #15 - upstream from Smithville Road.

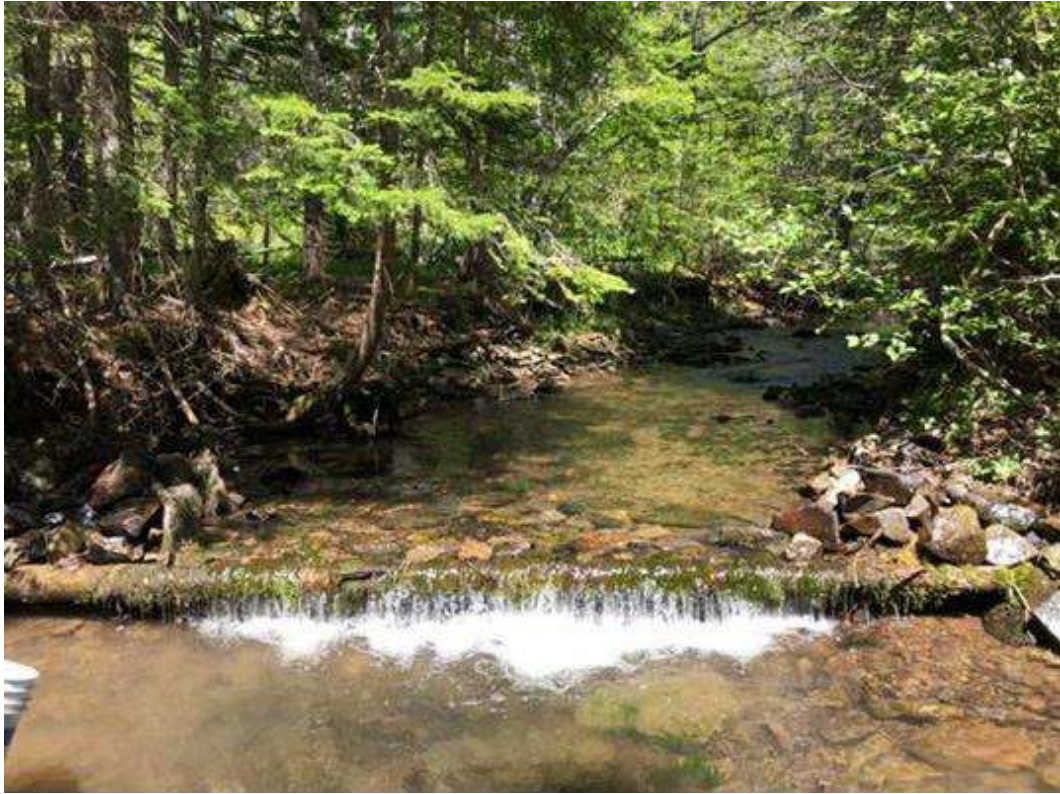
Figure 91. Diggerlog #16 - upstream from Smithville Road.

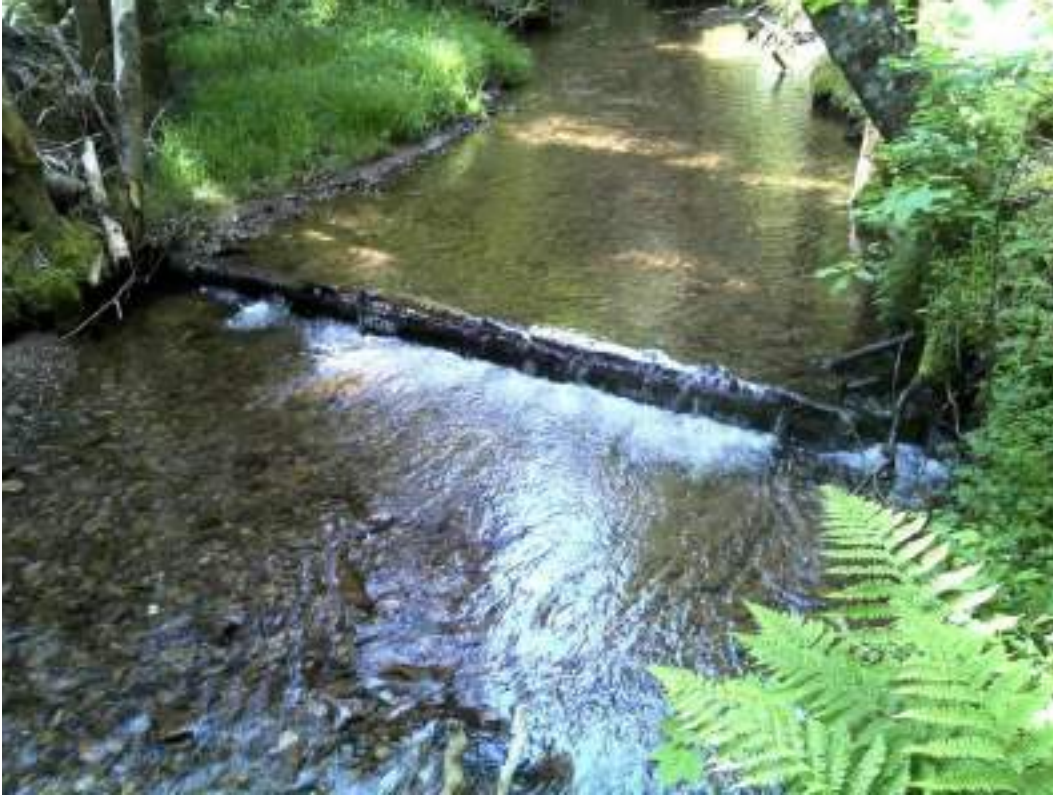
Figure 95. Diggerlog structure #1 furthest upstream - after photo of maintenance.

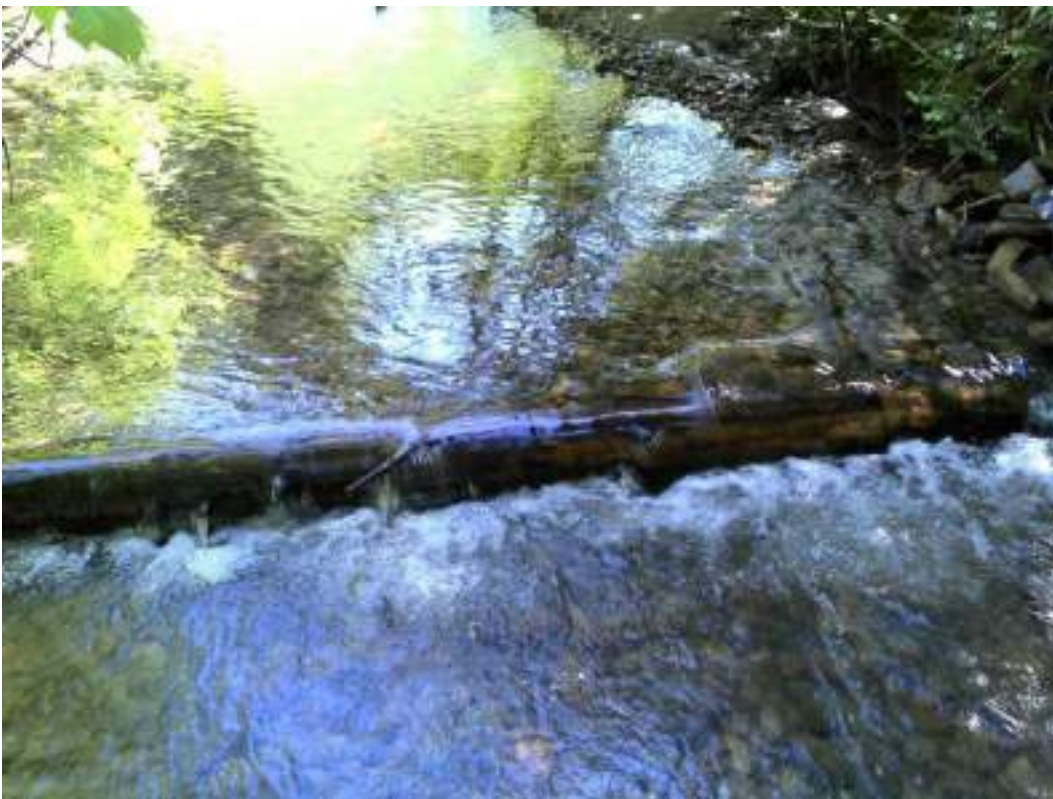
Figure 96. Diggerlog #2 - after photo of maintenance.

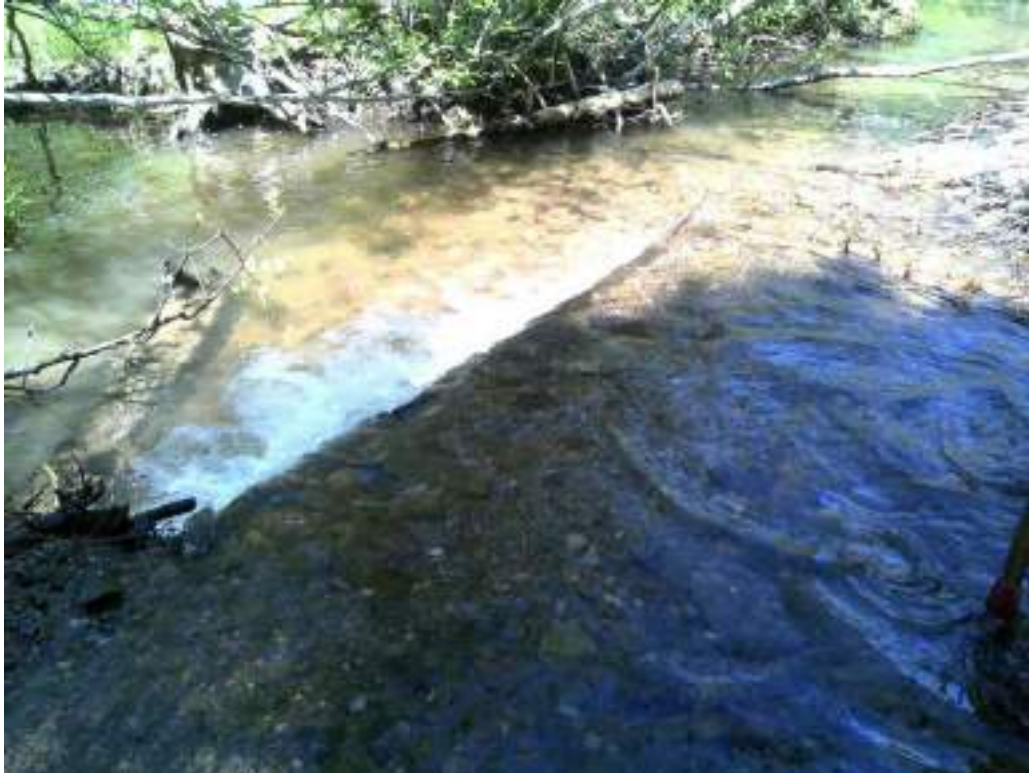
Figure 97. Diggerlog #3 - this picture is taken after maintenance, showing the extension added on the downstream side to restrict water flow to log.

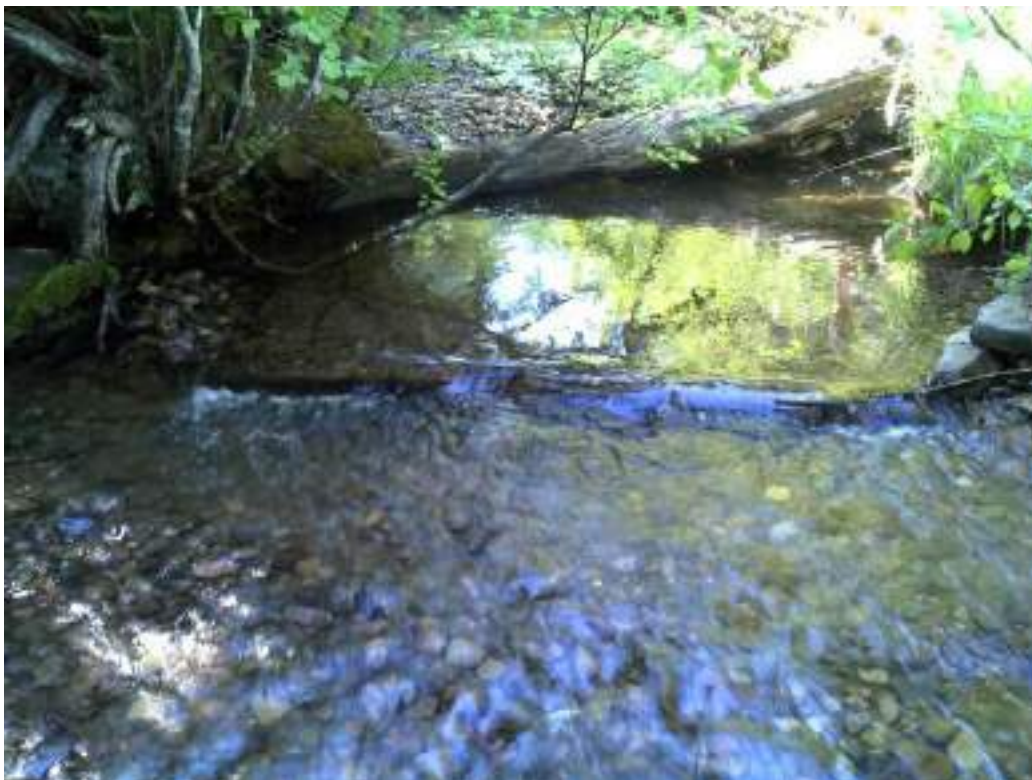
Figure 98. Diggerlog #4 - after picture of maintenance performed.

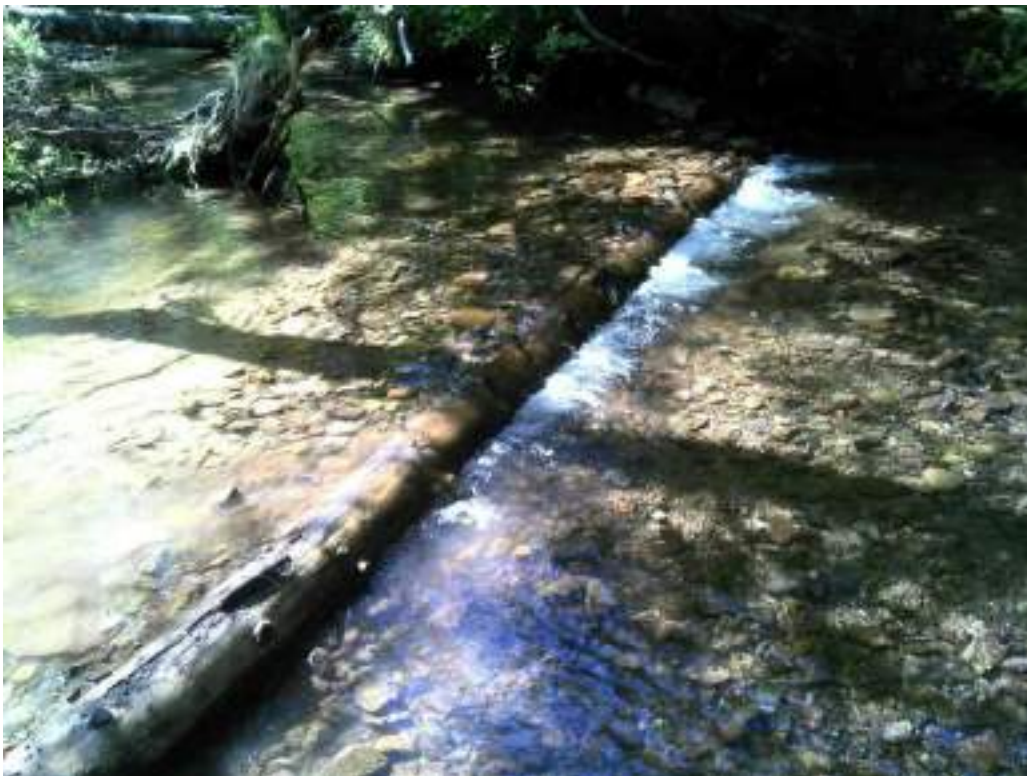
Figure 100. Diggerlog #6 - after picture of maintenance performed.

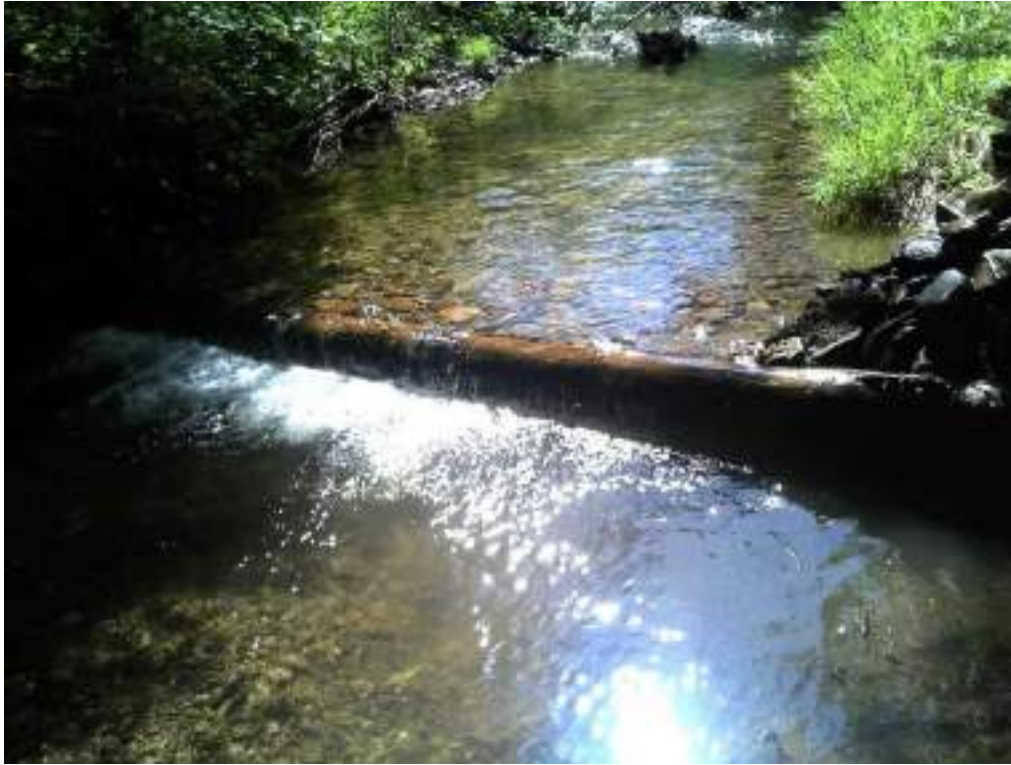
Figure 101. Diggerlog #7 - after picture of maintenance performed.

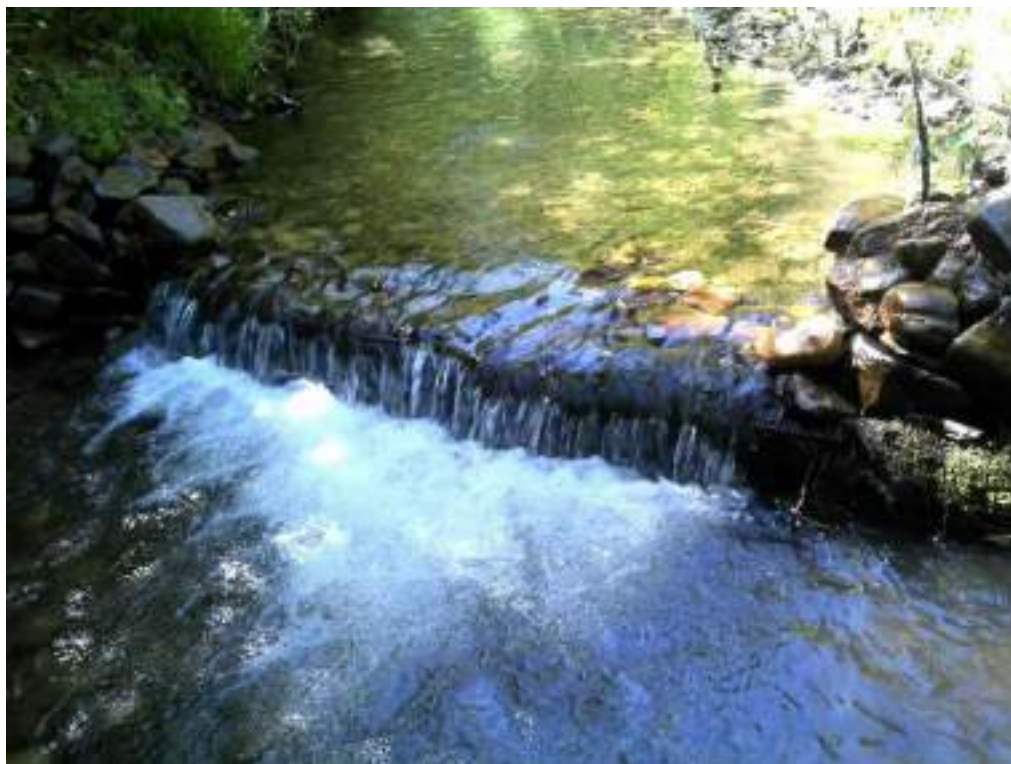
Figure 102. Diggerlog #8 - after picture of maintenance performed.

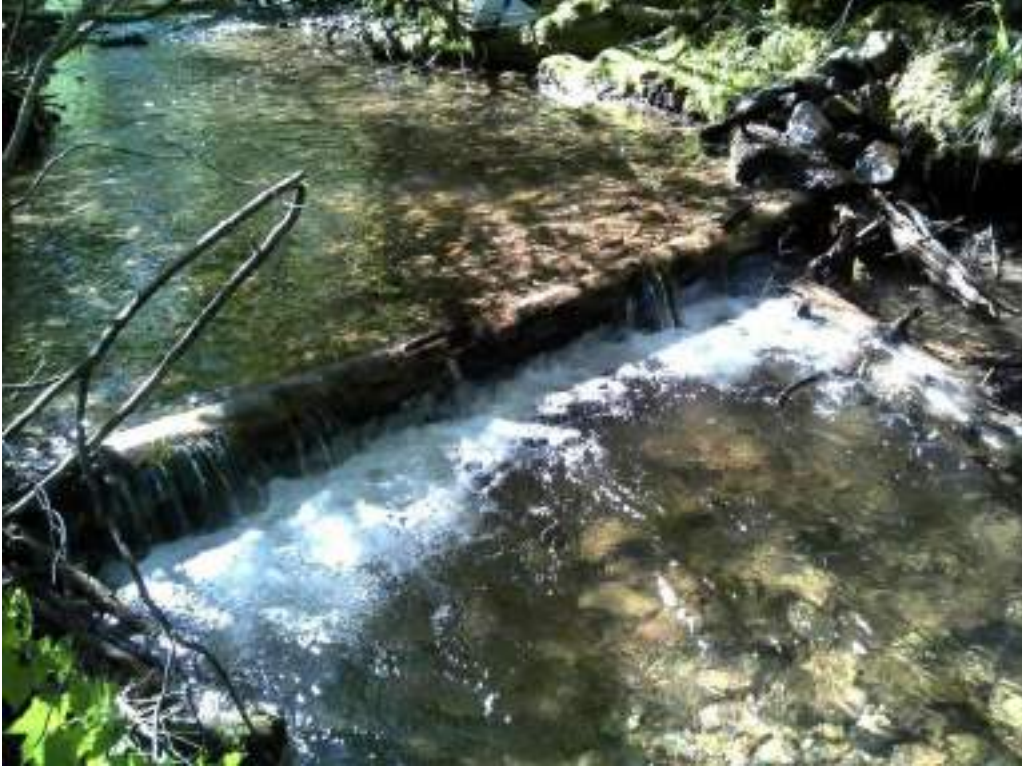
Figure 103. Diggerlog #9 - after picture of maintenance performed.

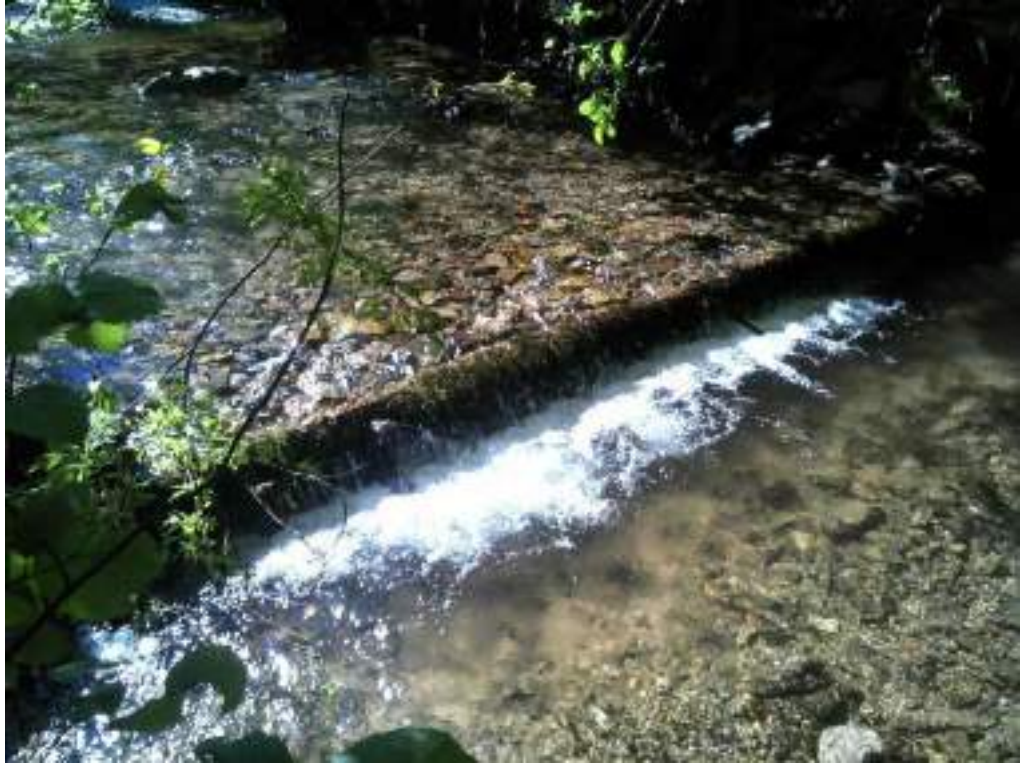
Figure 104. Diggerlog #10 - after picture of maintenance performed.

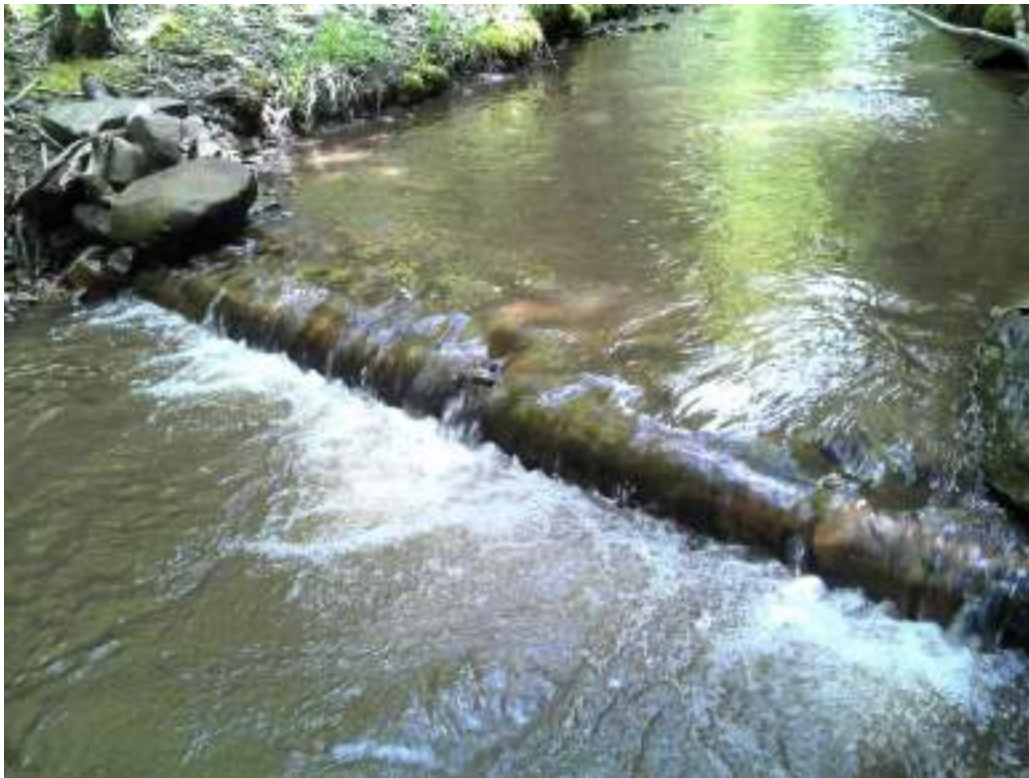
Figure 105. Diggerlog #11 - after picture of maintenance performed.

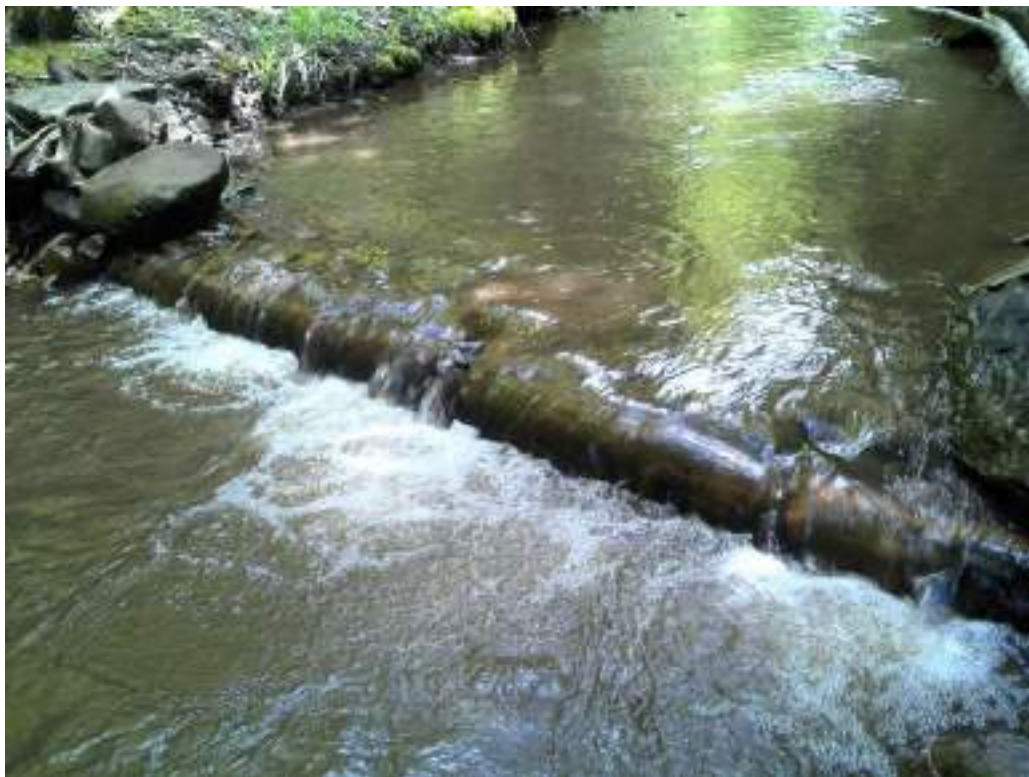
Figure 106. Diggerlog #12 - after picture of maintenance performed.

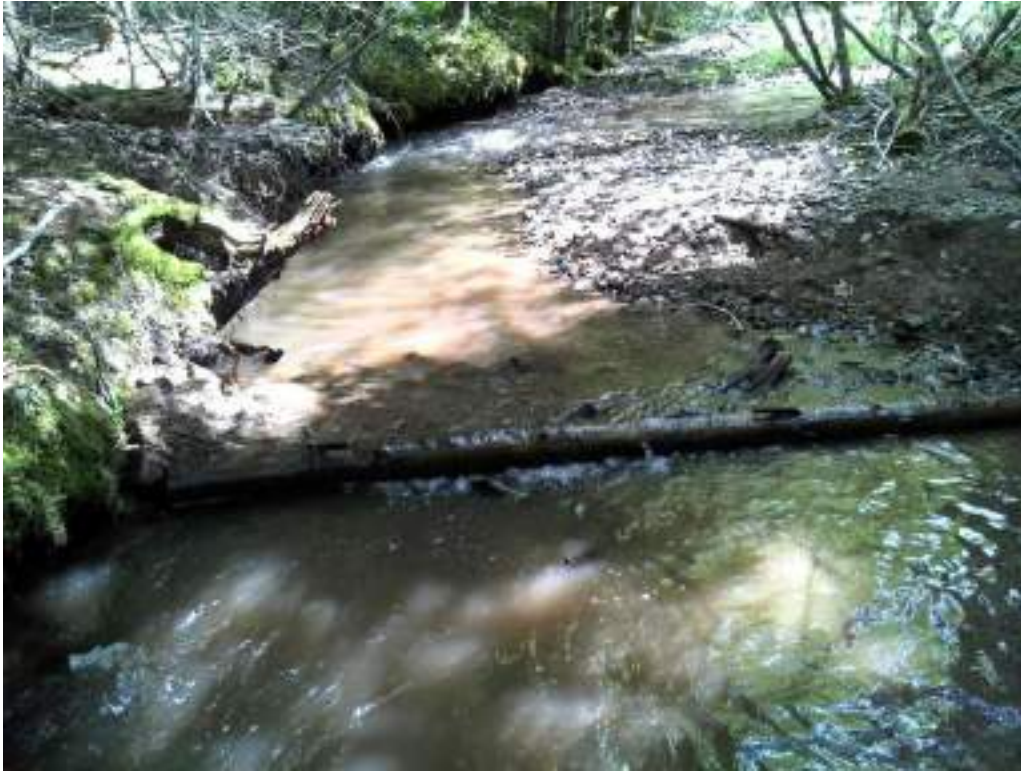
Figure 107. Diggerlog #13 - picture of the maintenance attempted on this structure.

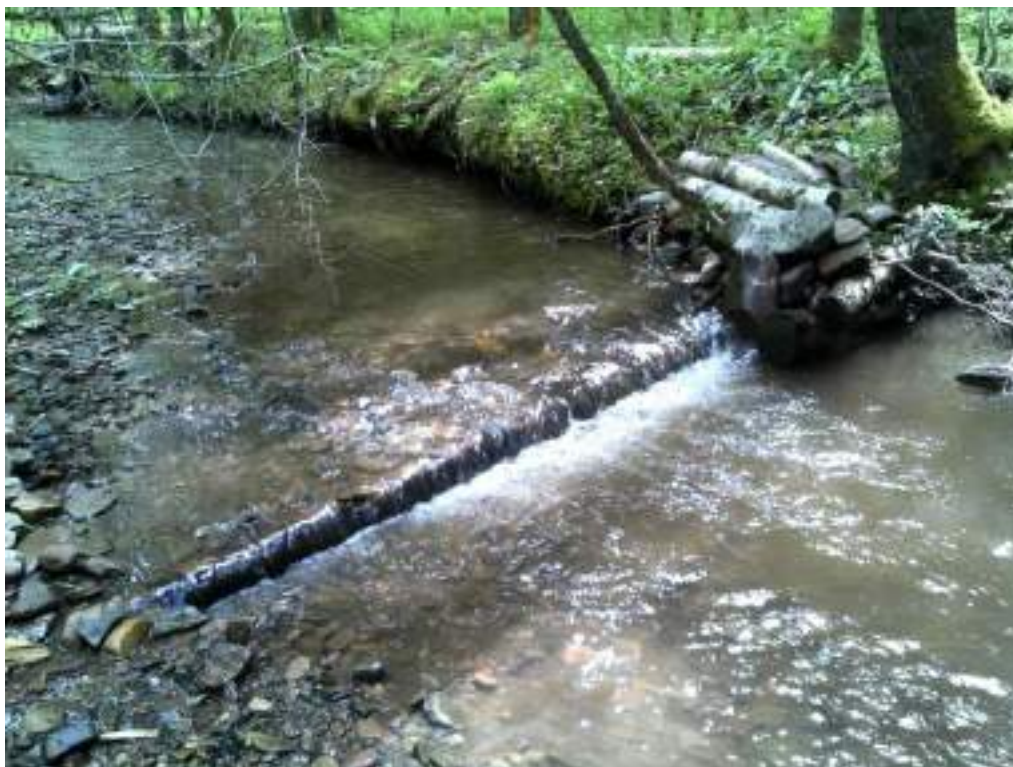
Figure 108. Diggerlog #14 - after picture of maintenance performed.

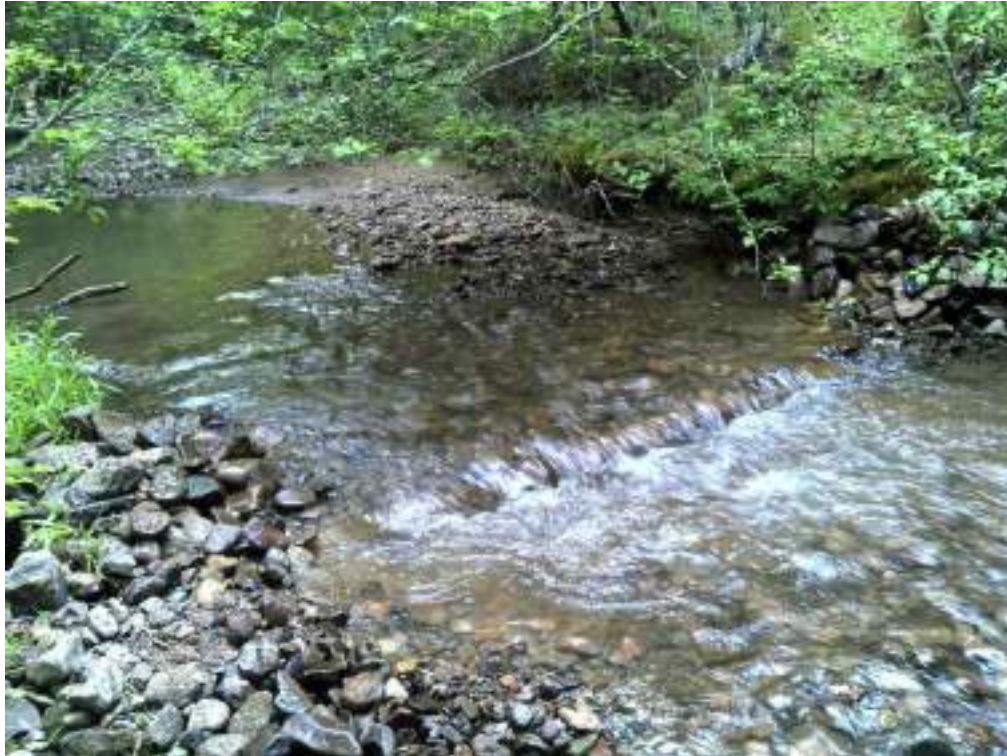
Figure 109. Diggerlog #15 - after picture of maintenance performed.

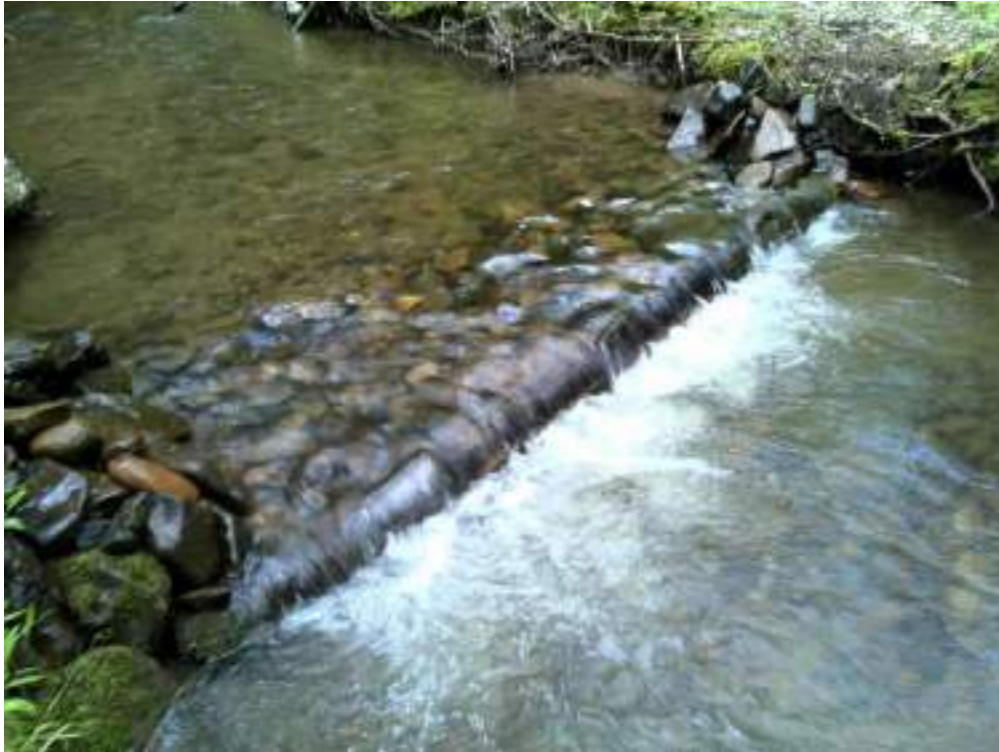
Figure 111. Diggerlog #17 - after picture of maintenance performed.

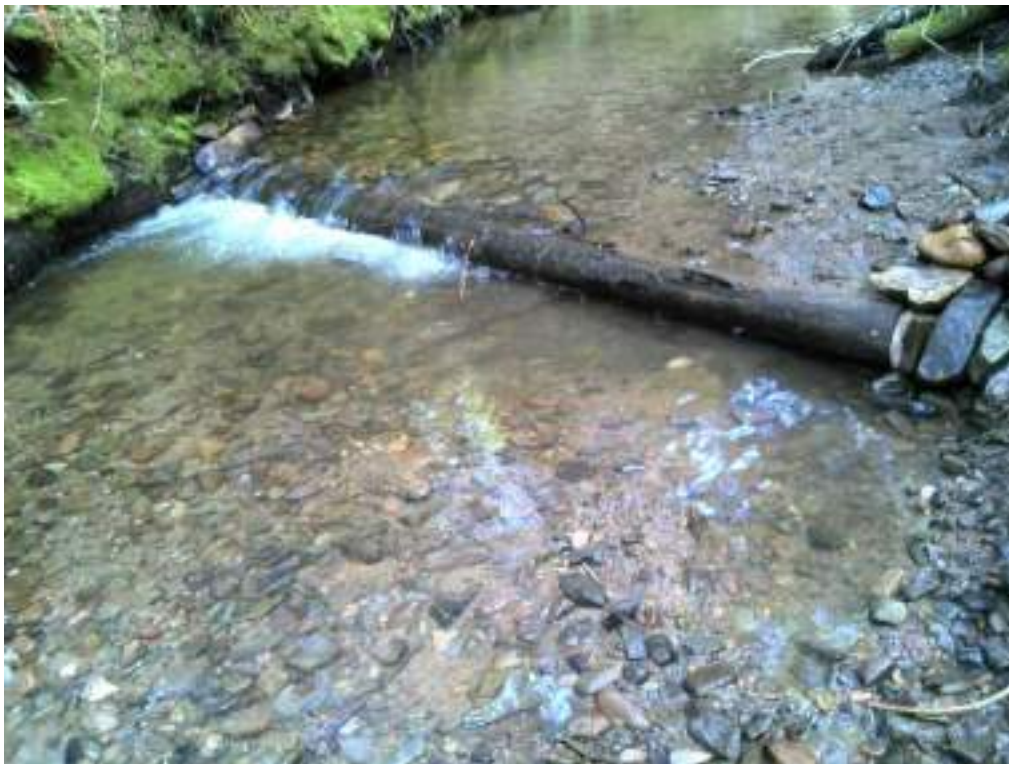
Figure 112. Diggerlog #18 - after picture of maintenance performed.

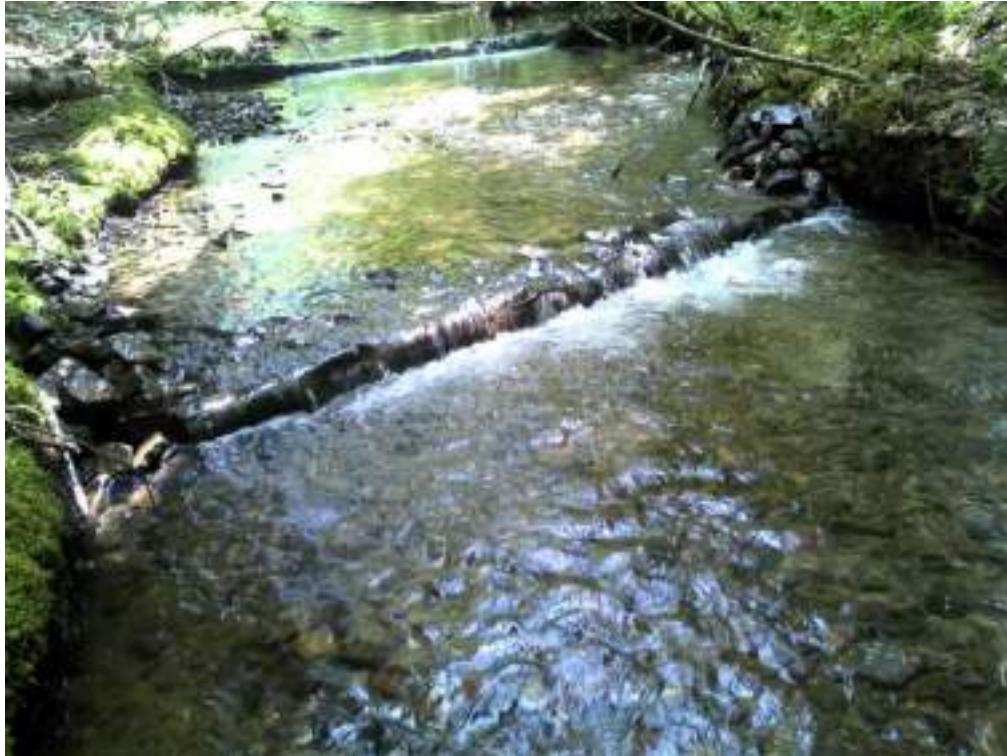
Figure 113. Diggerlog #19 - after picture of maintenance performed.

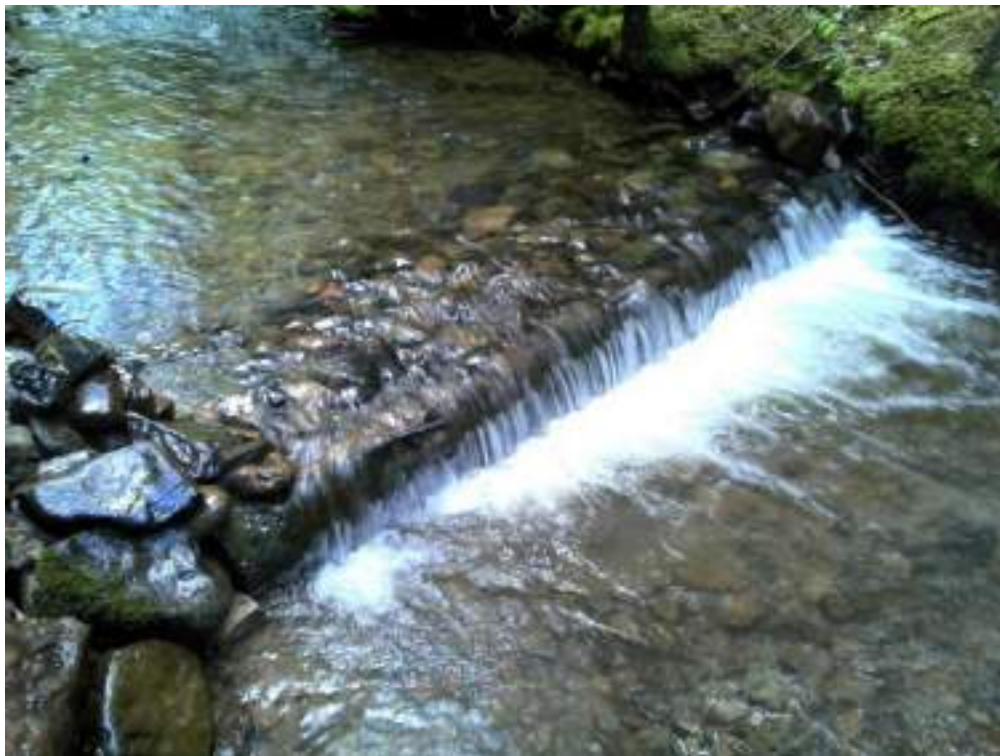
Figure 114. Diggerlog #20 - after picture of maintenance performed.

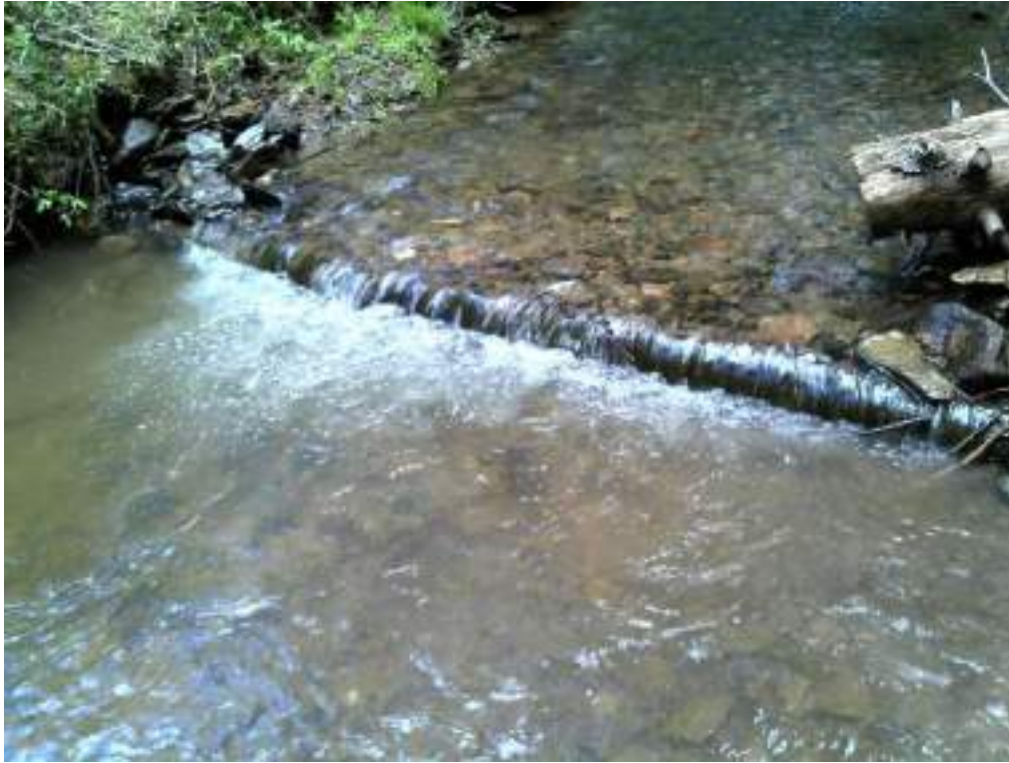
Figure 115. Diggerlog #21 - after picture of maintenance performed.

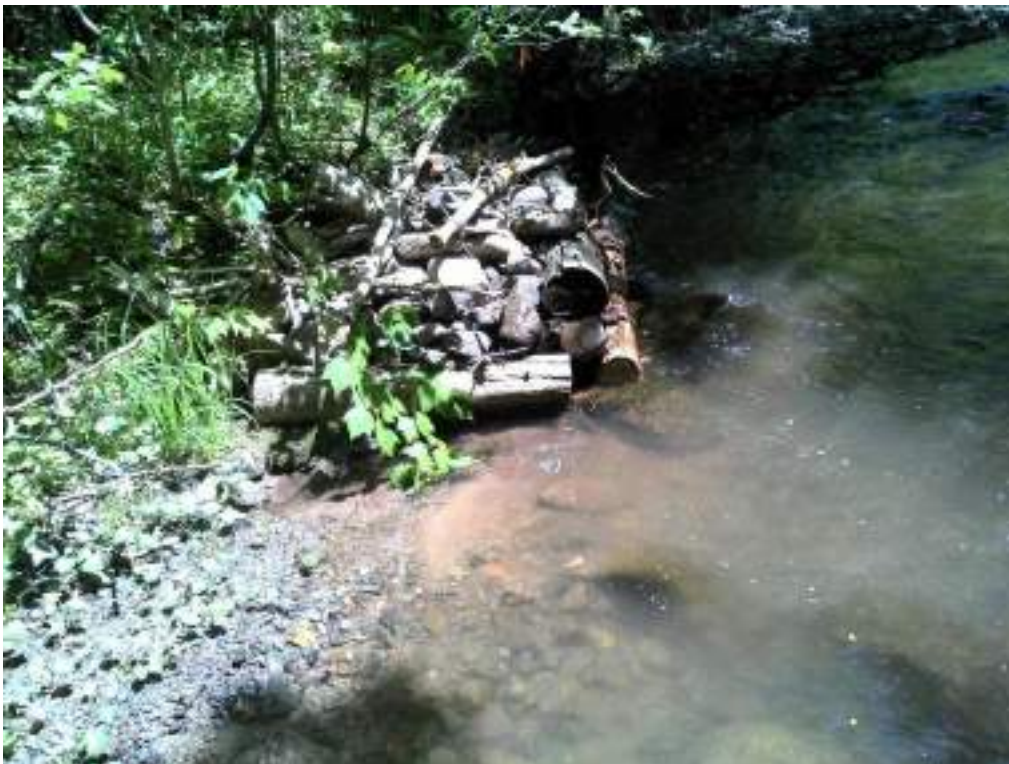
Figure 116. Deflector structure #22 - after picture of maintenance performed.

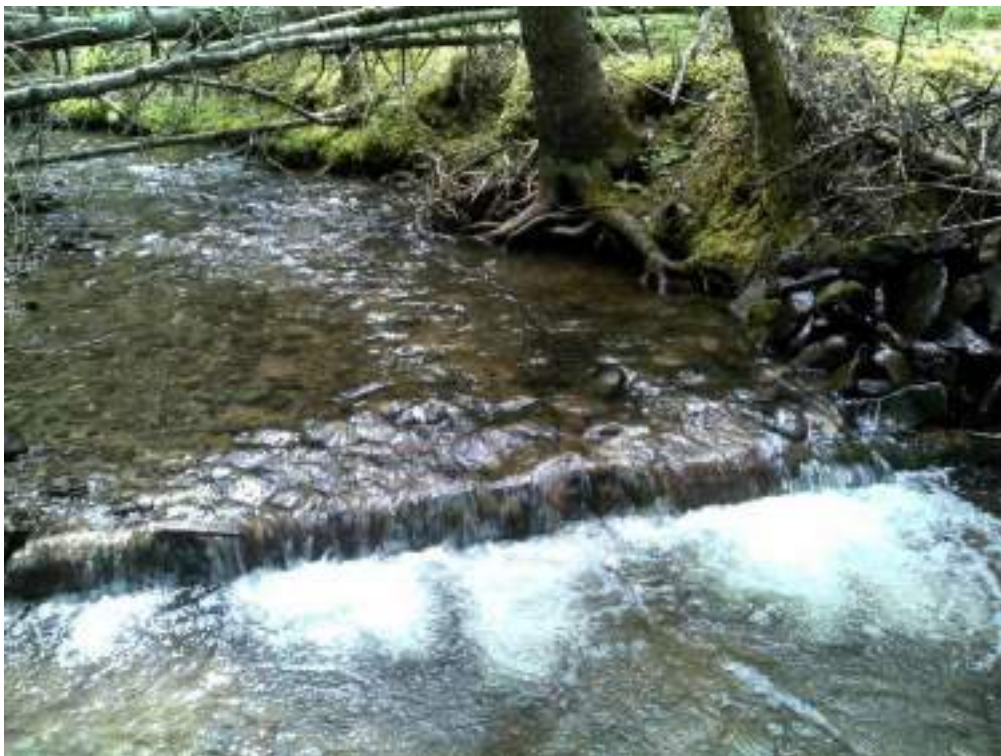
Figure 118. Diggerlog #24 - after picture of maintenance performed.

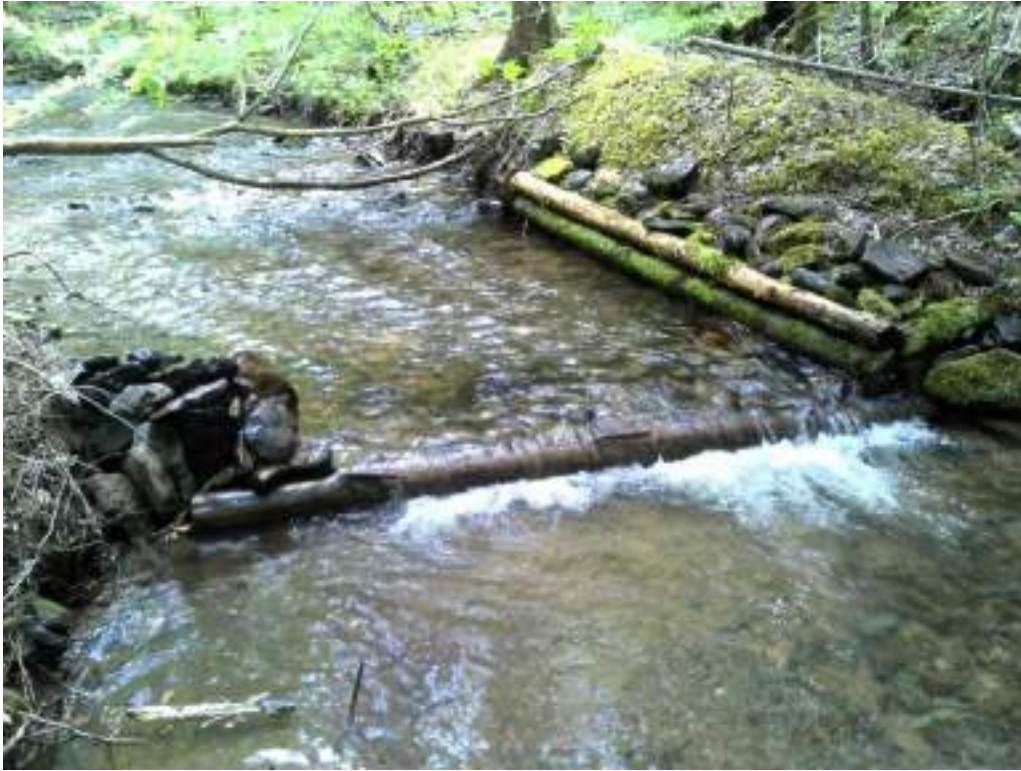
Figure 119. Diggerlog and deflector structure #25 - after picture of maintenance performed.

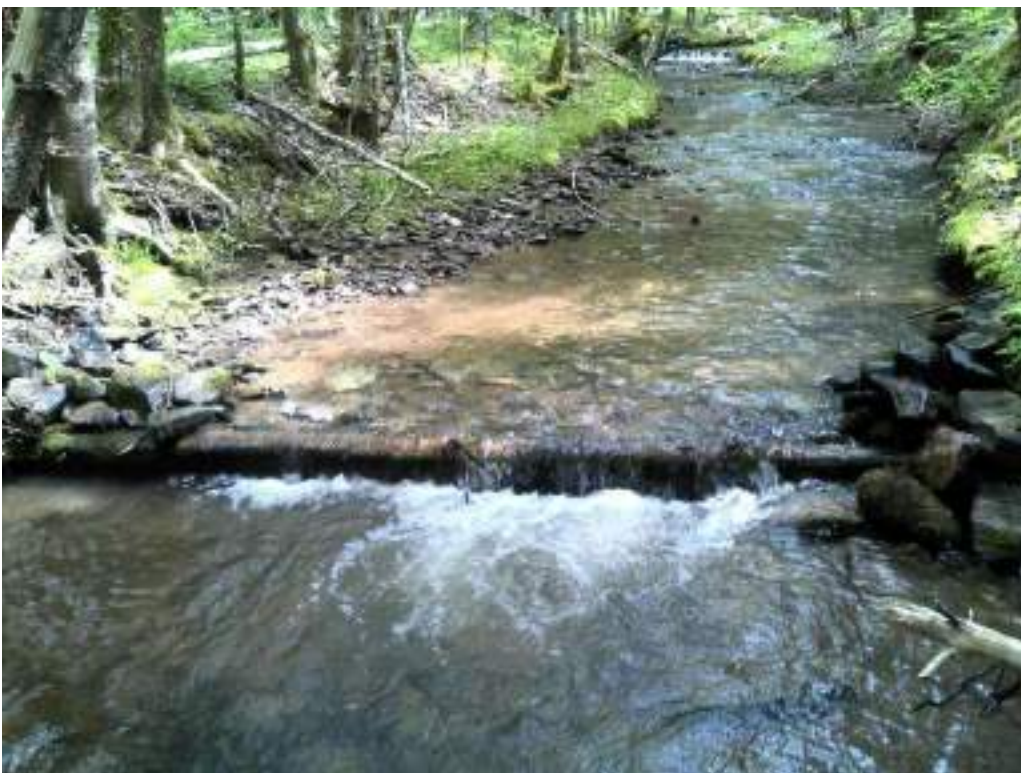
Figure 120. Diggerlog #26 - after picture of maintenance performed.

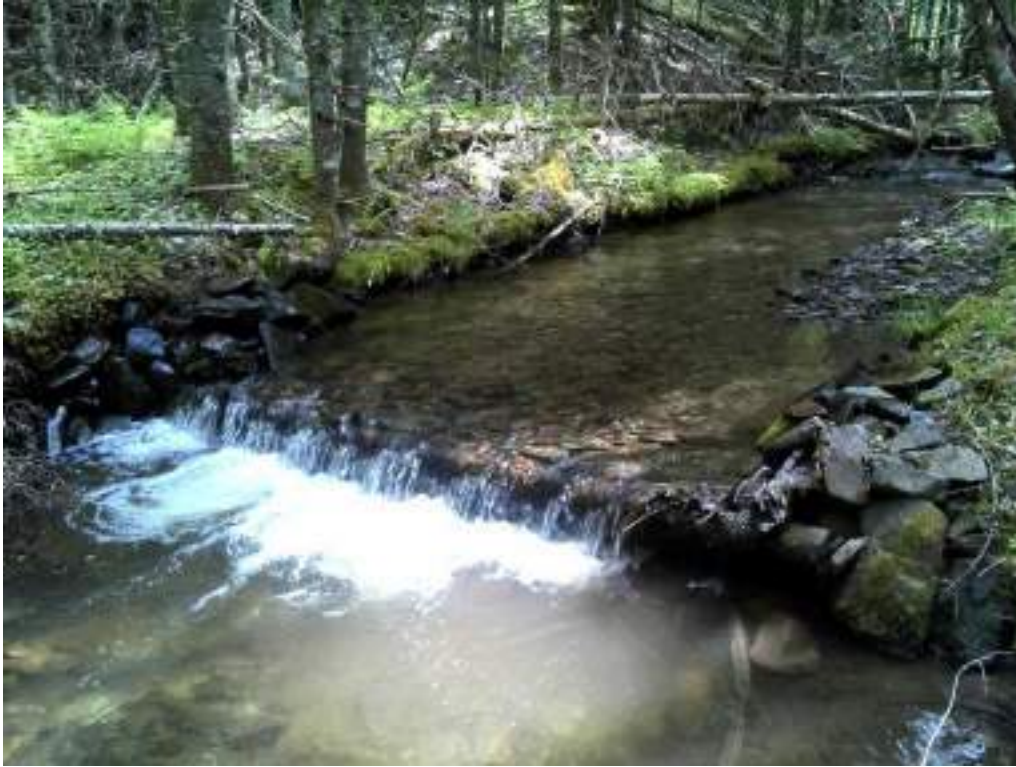
Figure 121. Diggerlog #27 - after picture of maintenance performed.

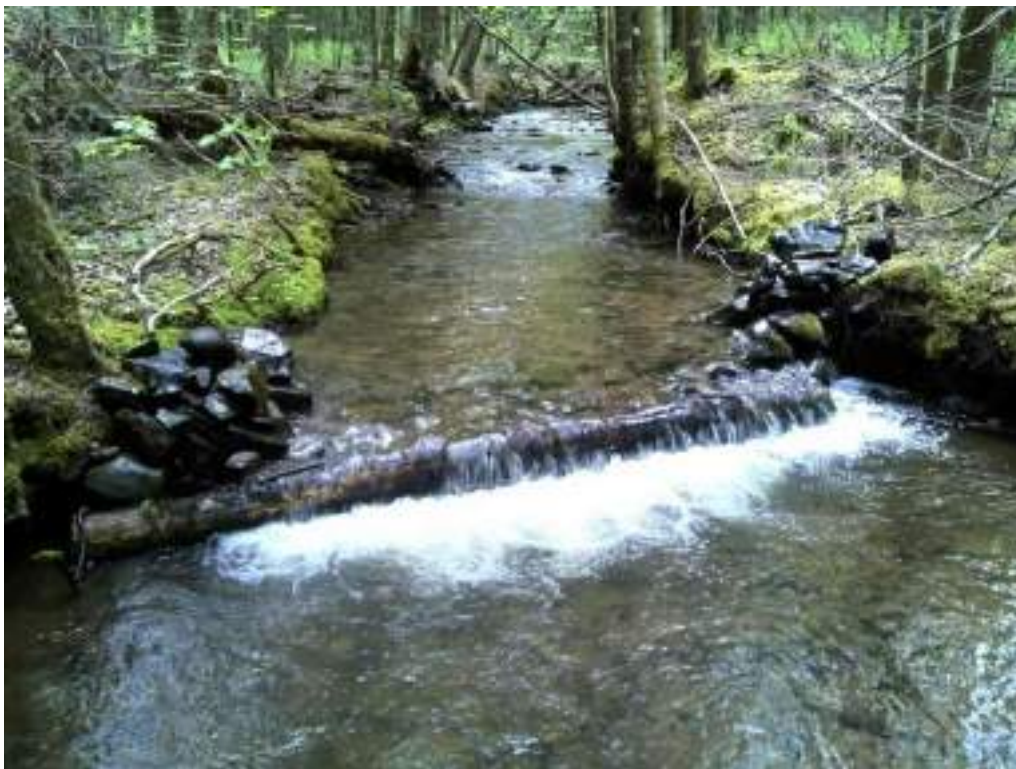
Figure 122. Diggerlog #28 - after picture of maintenance performed.

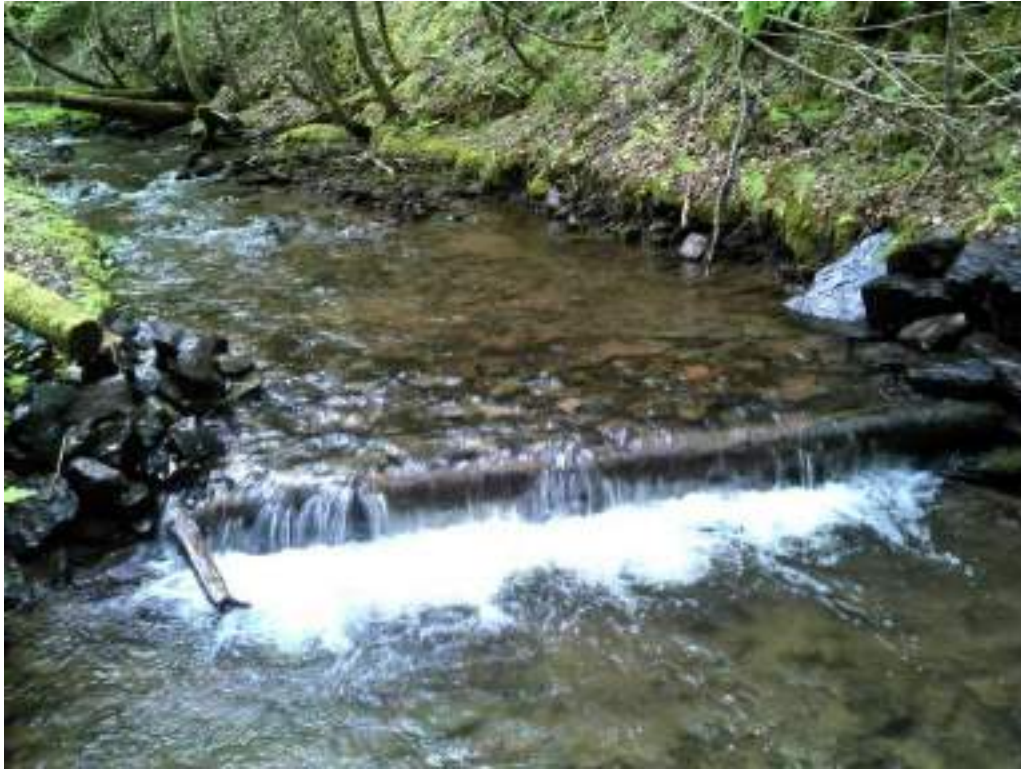
Figure 123. Diggerlog #29 - after picture of maintenance performed.
