SALMONID HABITAT RESTORATION
INVERNESS SOUTH ANGLERS ASSOCIATION

Winter Damage Assessment

Date: 2019

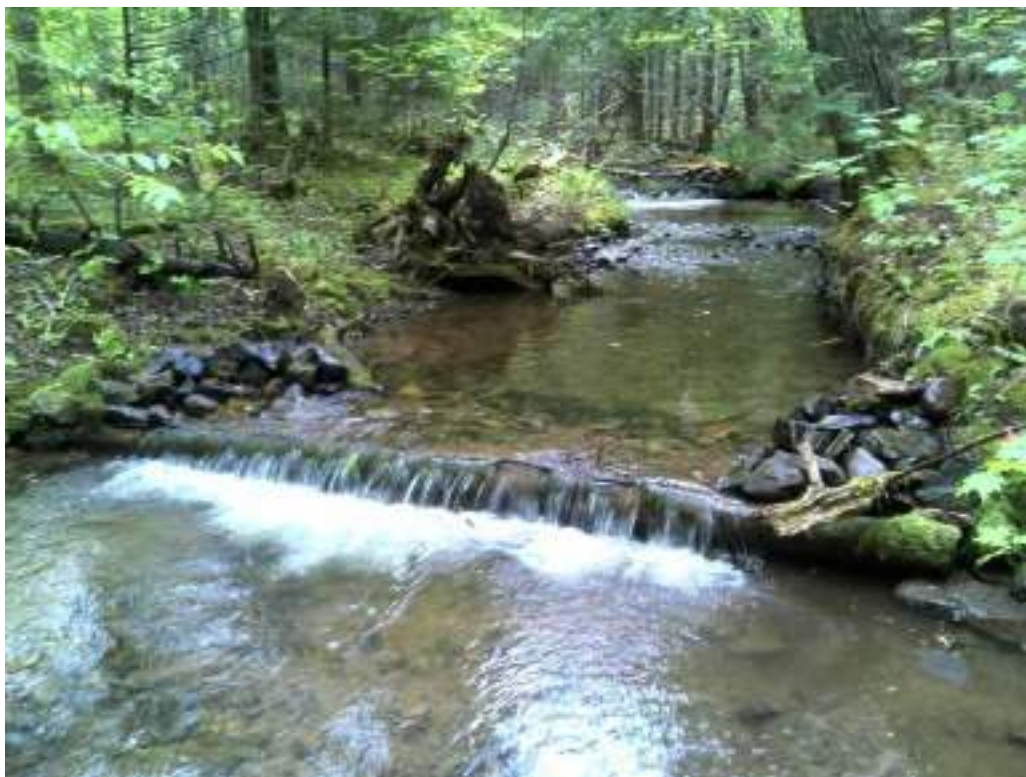
Figure 124. Diggerlog #30 - after picture of maintenance performed.

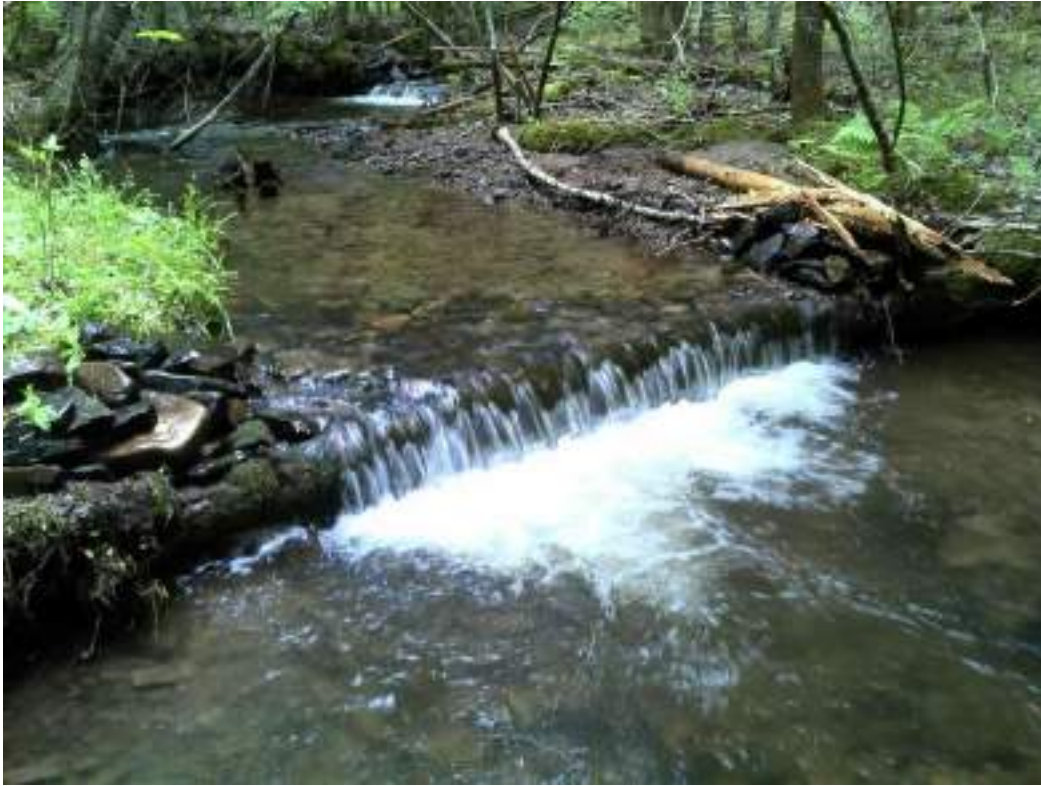
Figure 125. Diggerlog #31 - after picture of maintenance performed.

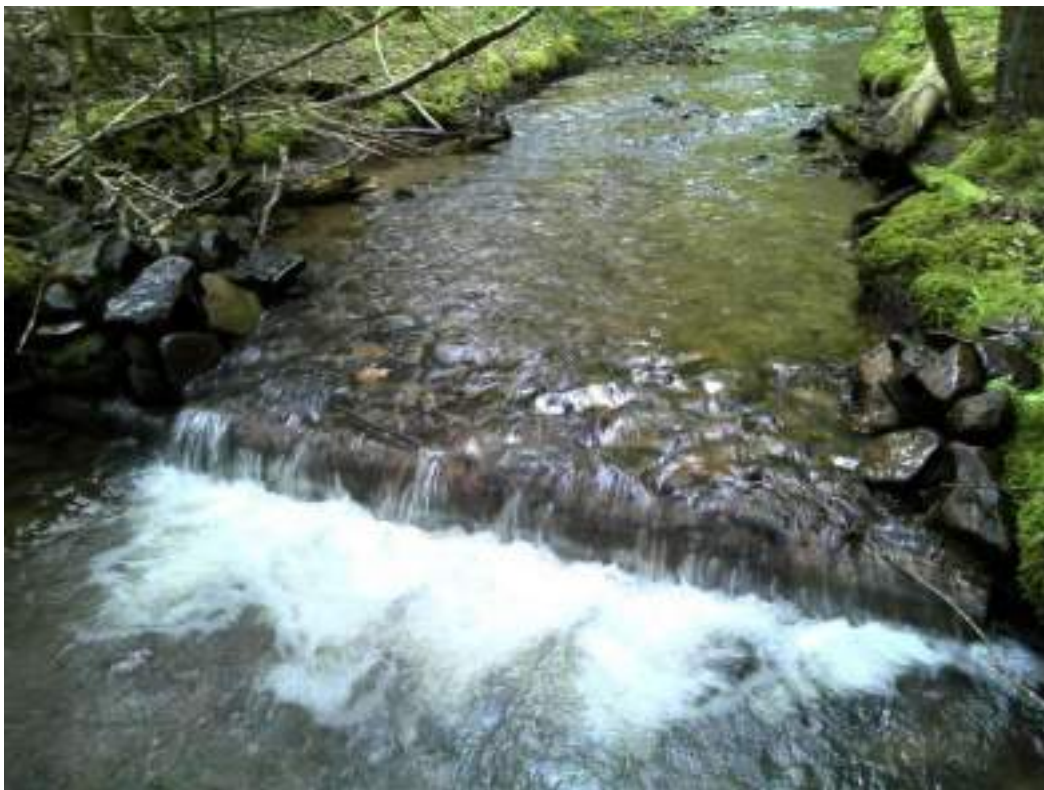
Figure 126. Diggerlog #32 - after picture of maintenance performed.

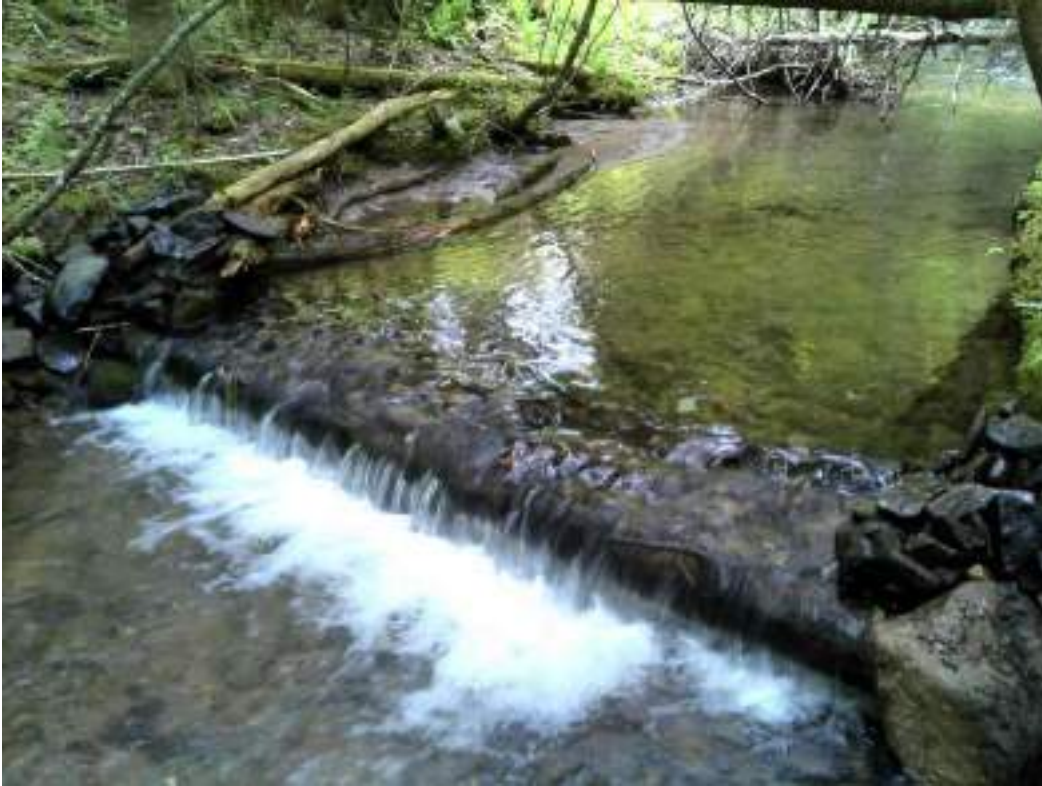
Figure 127. Diggerlog #33 - after picture of maintenance performed.

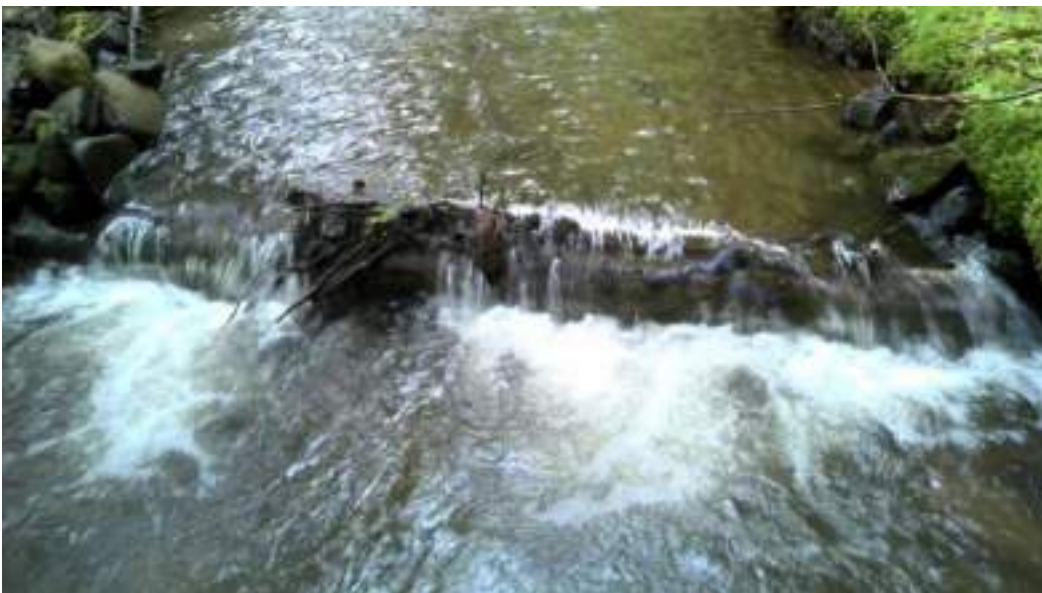
Figure 128. Diggerlog #34 - after picture of maintenance performed.

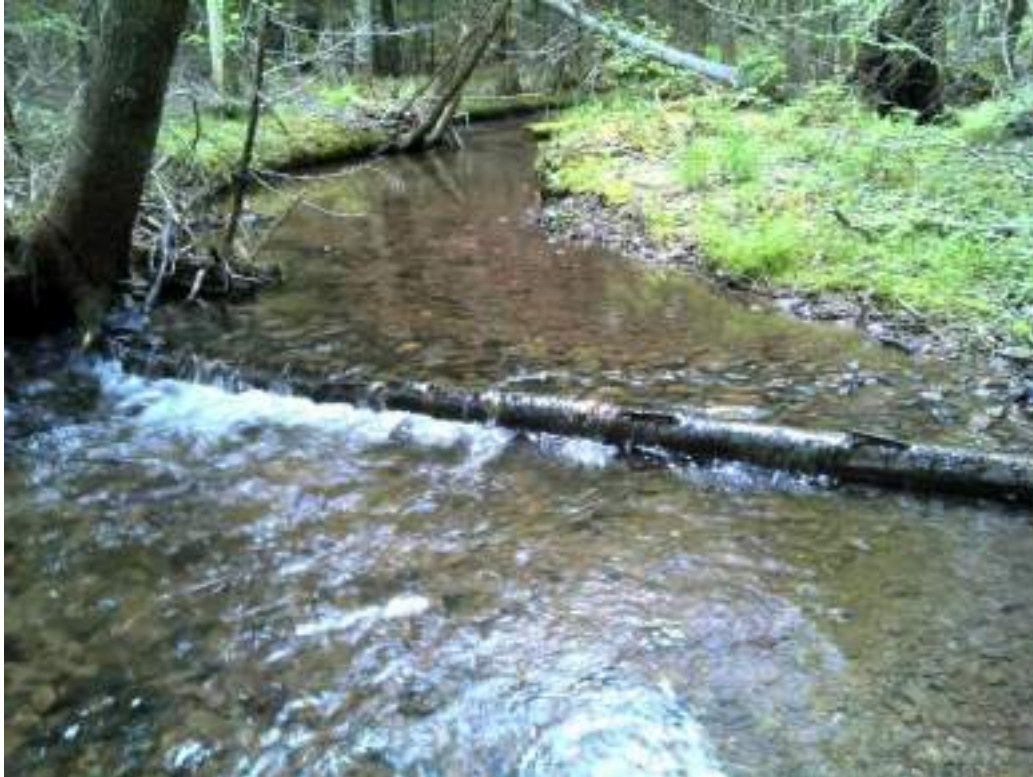
Figure 129. Diggerlog #35 - after picture of maintenance performed.

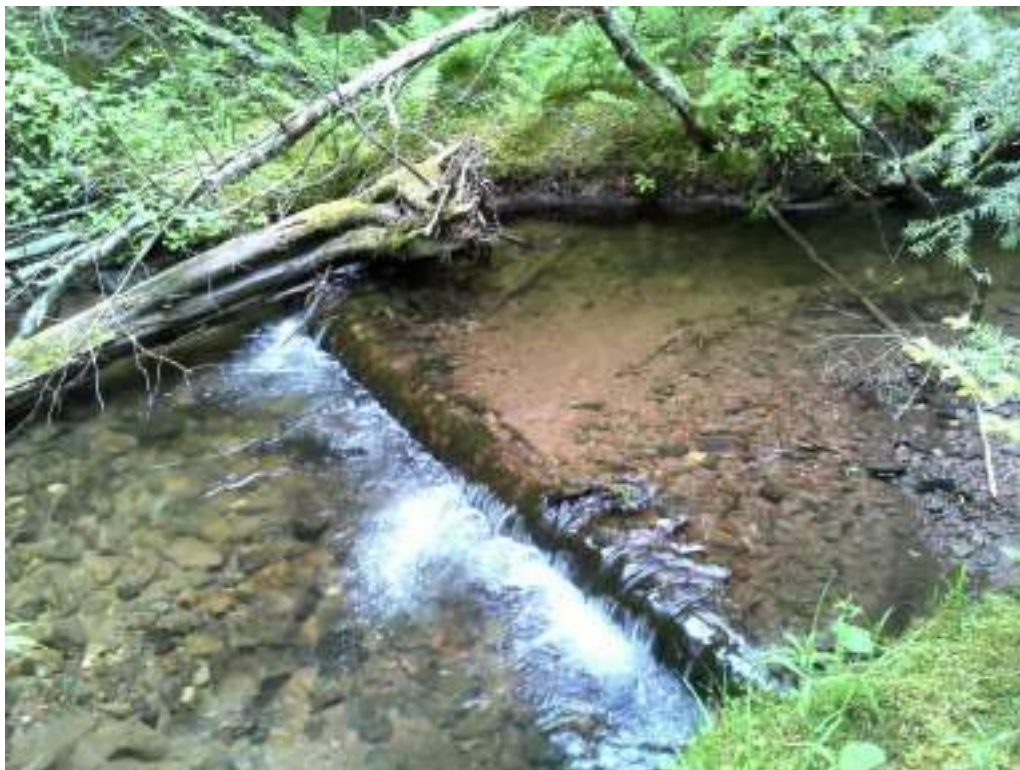
Figure 130. Diggerlog #36 - after picture of maintenance performed.

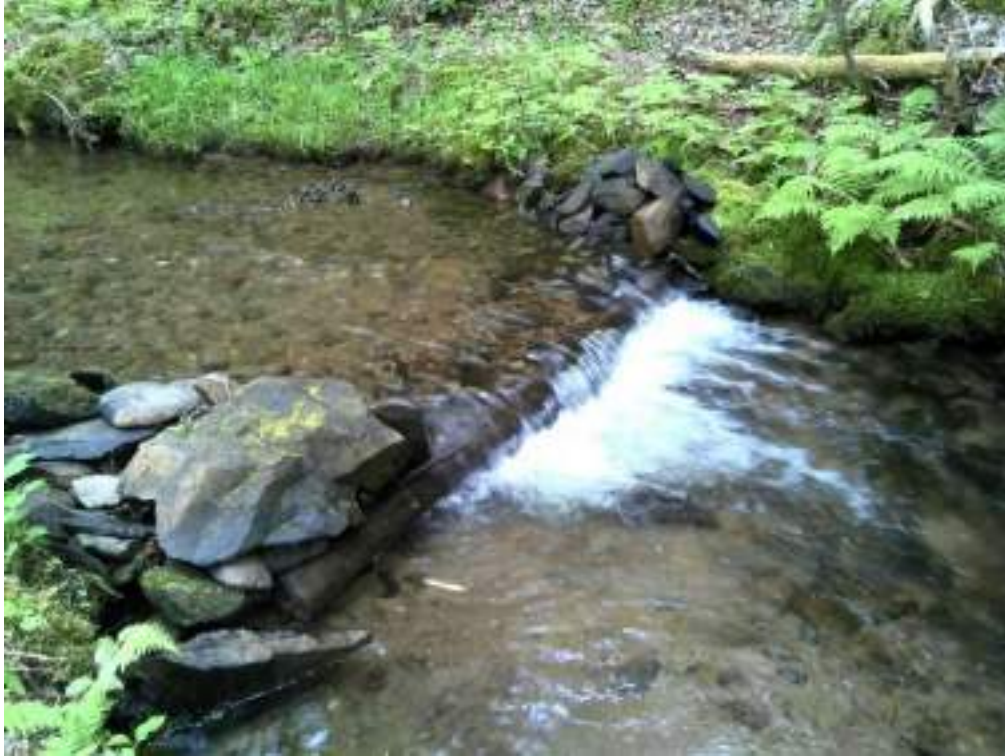
Figure 131. Diggerlog #37 - after picture of maintenance performed.

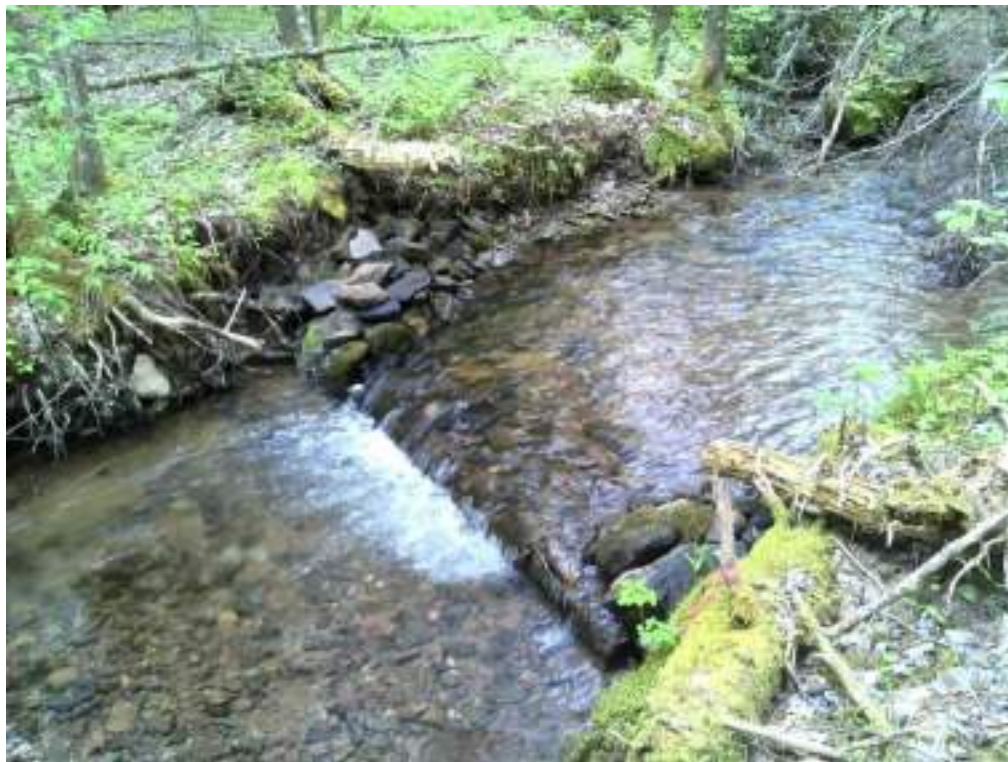
Figure 132. Diggerlog #38 - after picture of maintenance performed.

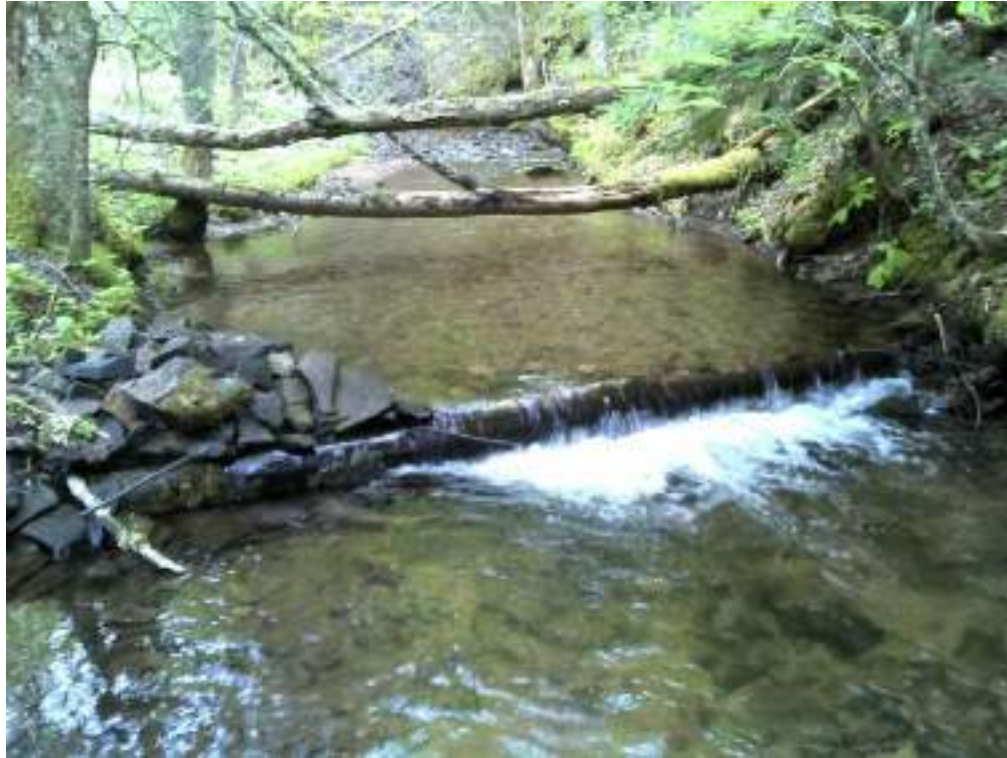
Figure 133. Diggerlog #39 - after picture of maintenance performed.

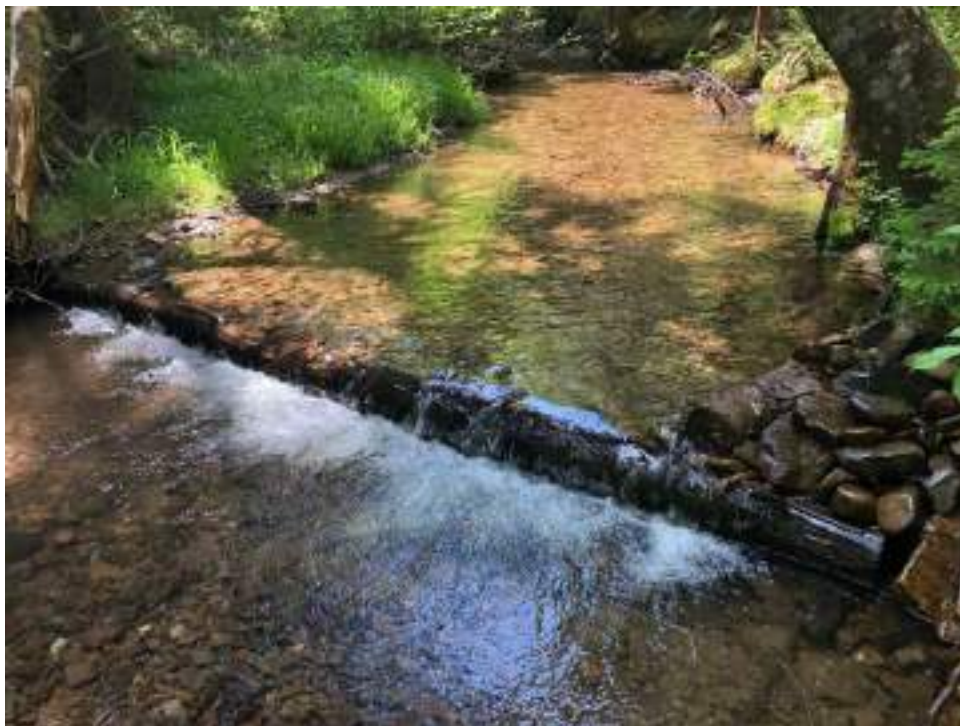
Figure 136. Diggerlog #42 - after picture of maintenance performed.

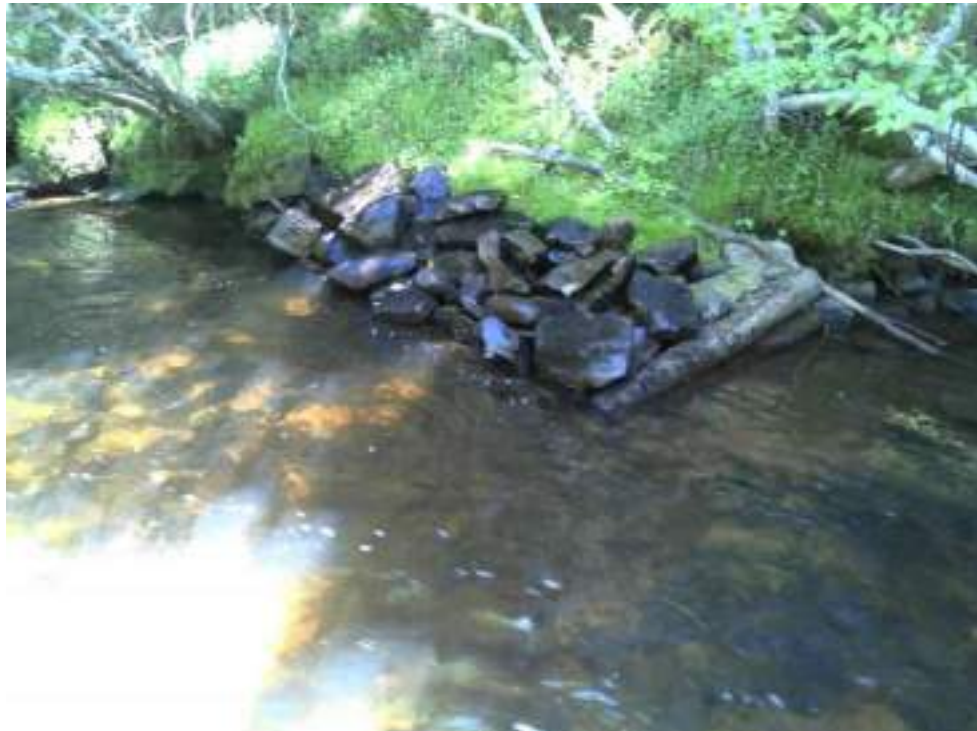
Figure 138. Before and after pictures of the maintenance performed on the furthest upstream structure - Deflector #1.

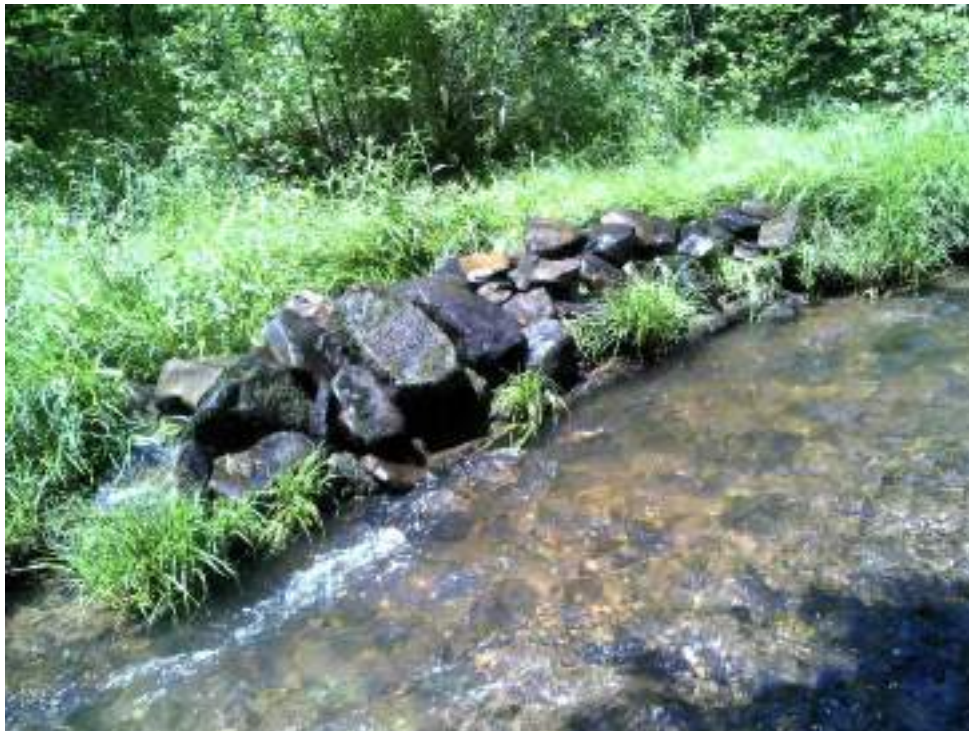
Figure 139. Before and after pictures of maintenance performed on deflector #2.

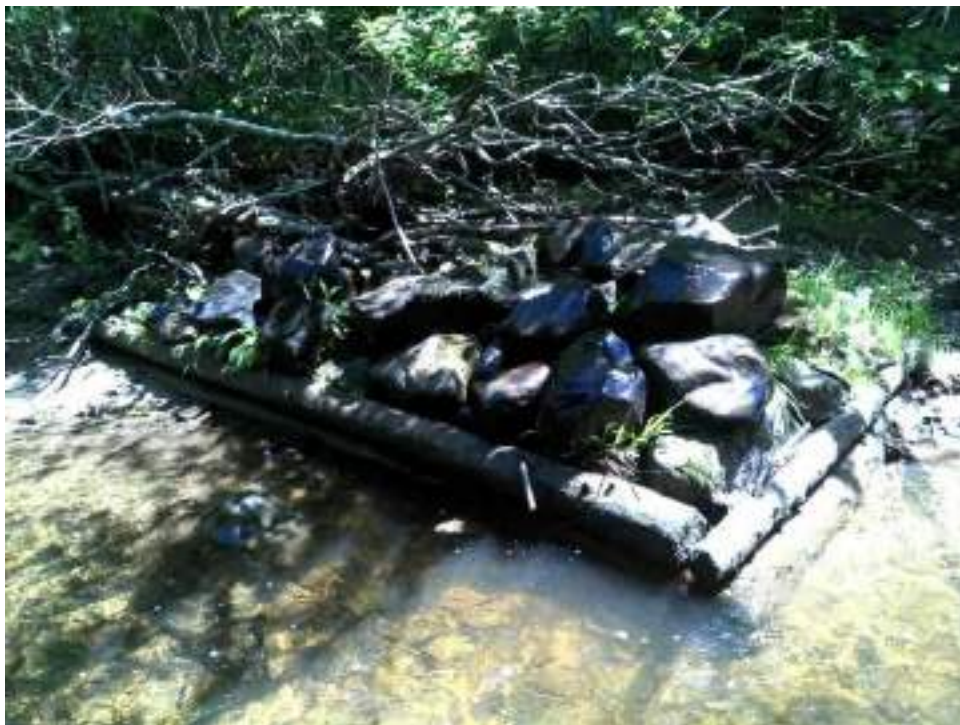
Figure 140. Before and after picture of the maintenance performed on deflector #3.

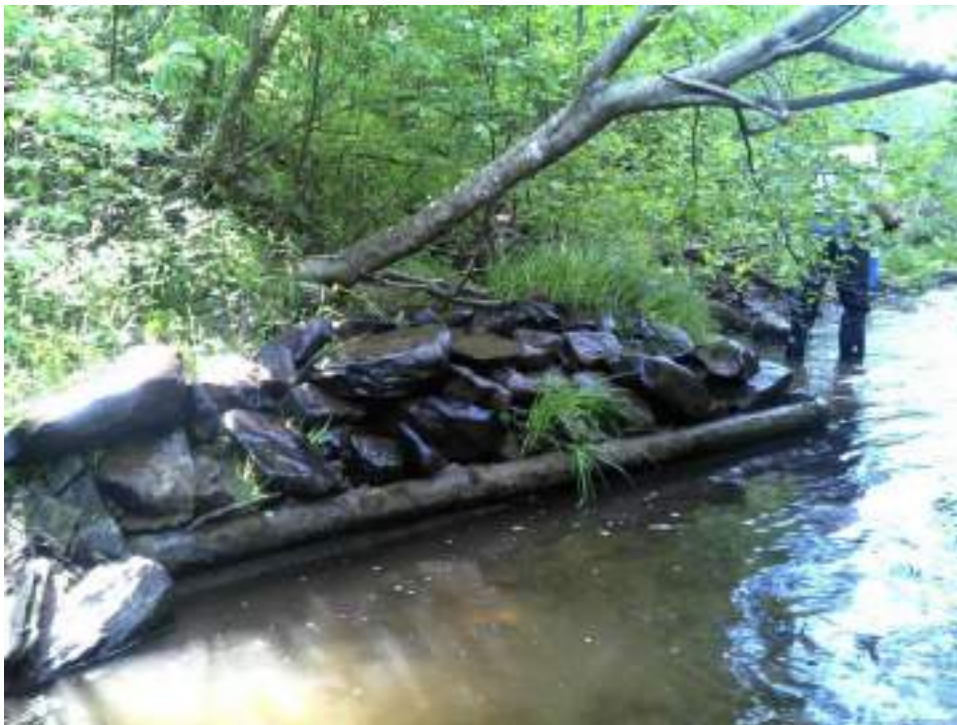
Figure 145. Deflector #8 - before and after picture of maintenance performed.

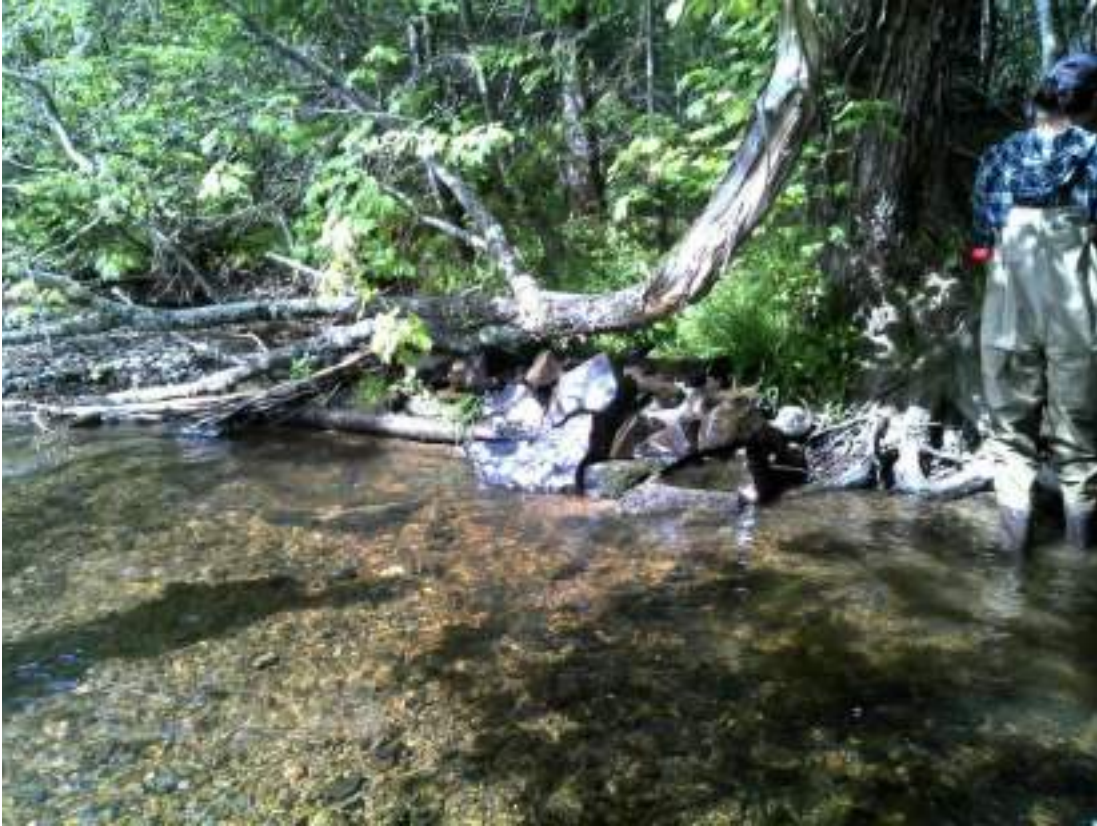
Figure 146. Deflector #9 - after picture of maintenance performed.

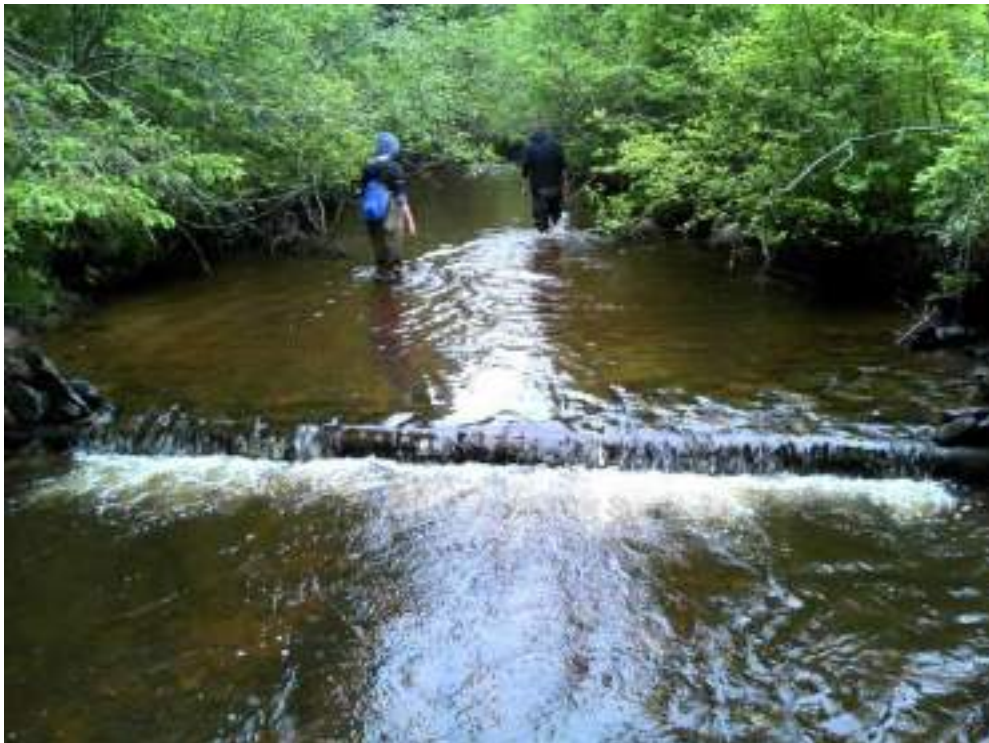
Figure 149. Diggerlog #1 - before and after picture of maintenance performed.

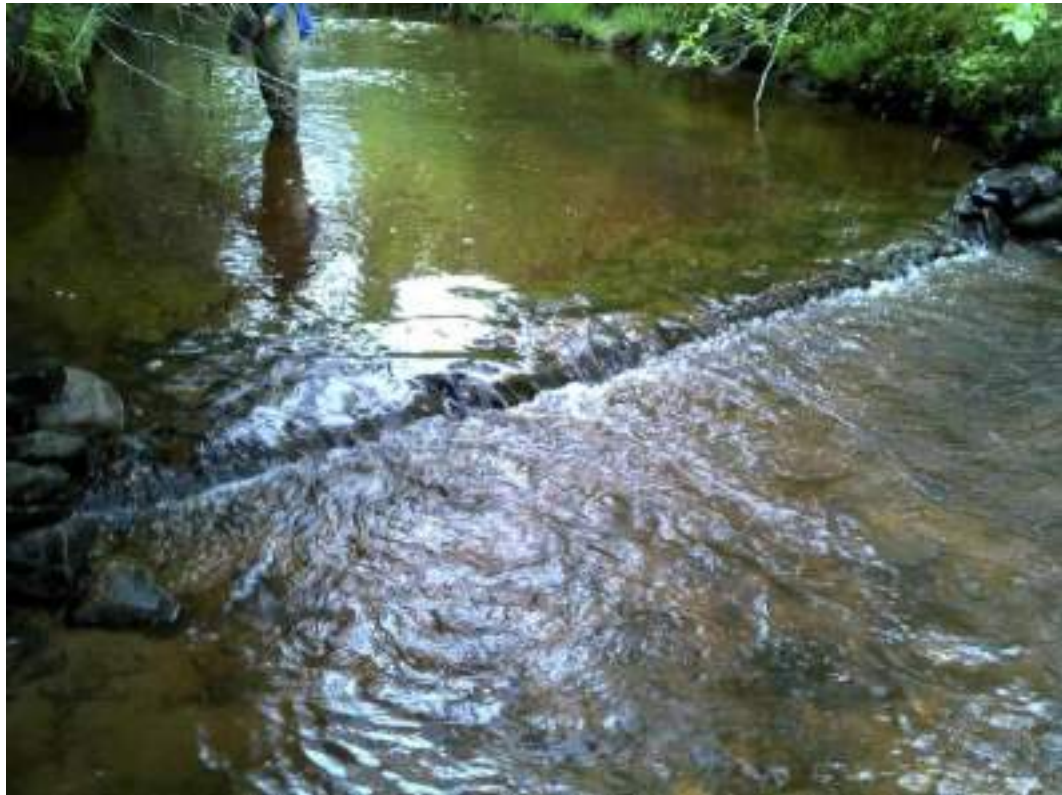
Figure 150. Diggerlog #2 – before and after picture of maintenance performed.

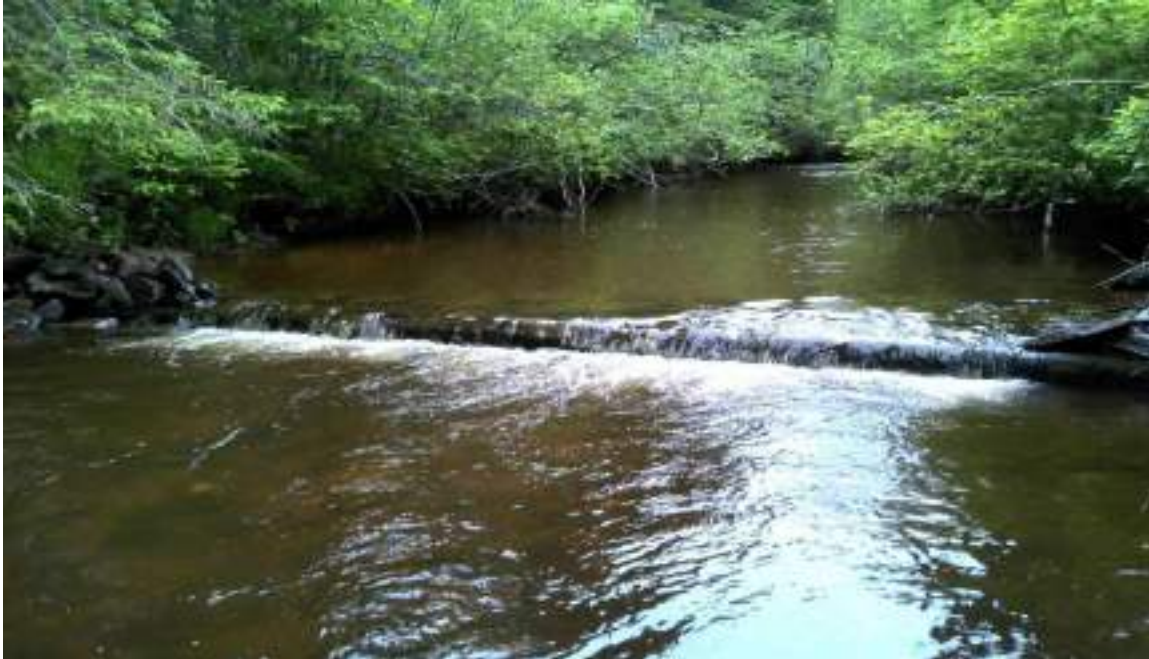
Figure 151. Diggerlog #4 - after picture of maintenance performed.

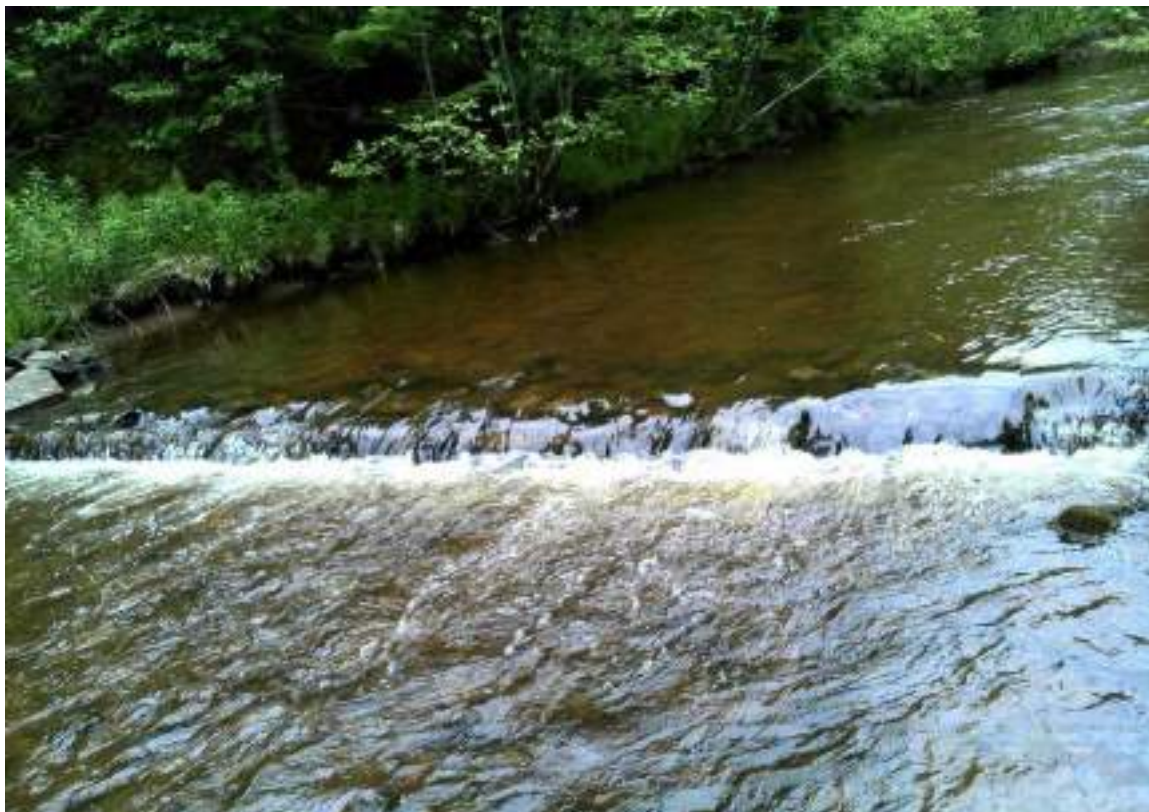
Figure 152. Diggerlog #5 - after picture of maintenance performed.

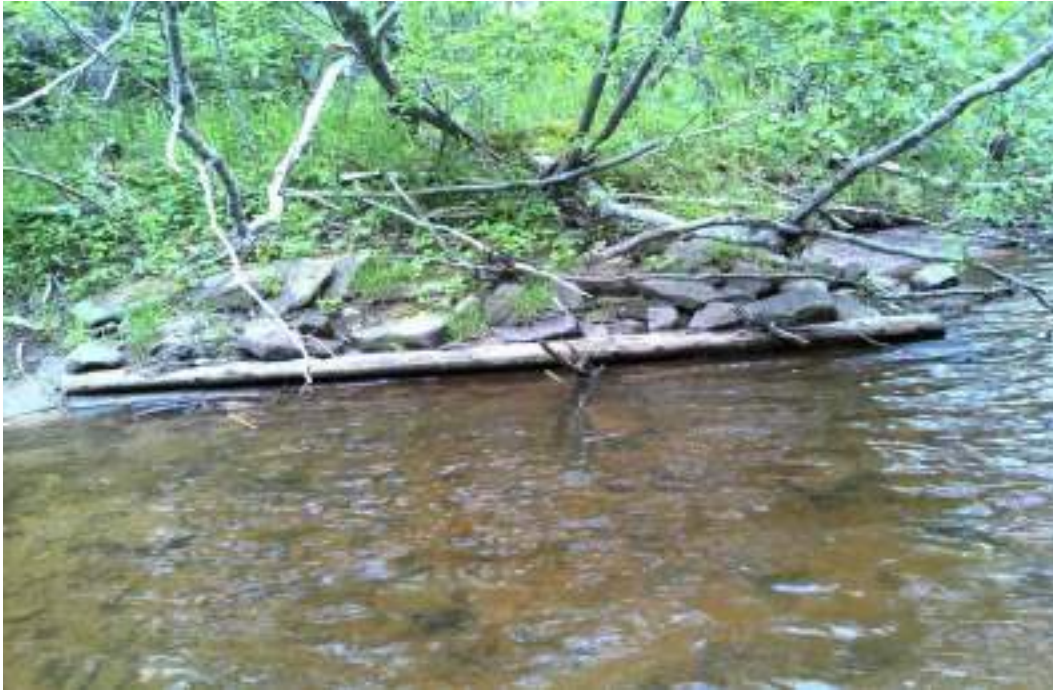
Figure 153. Deflector #6 - this deflector is now growing vegetation on it and is slowly becoming part of the bankside.

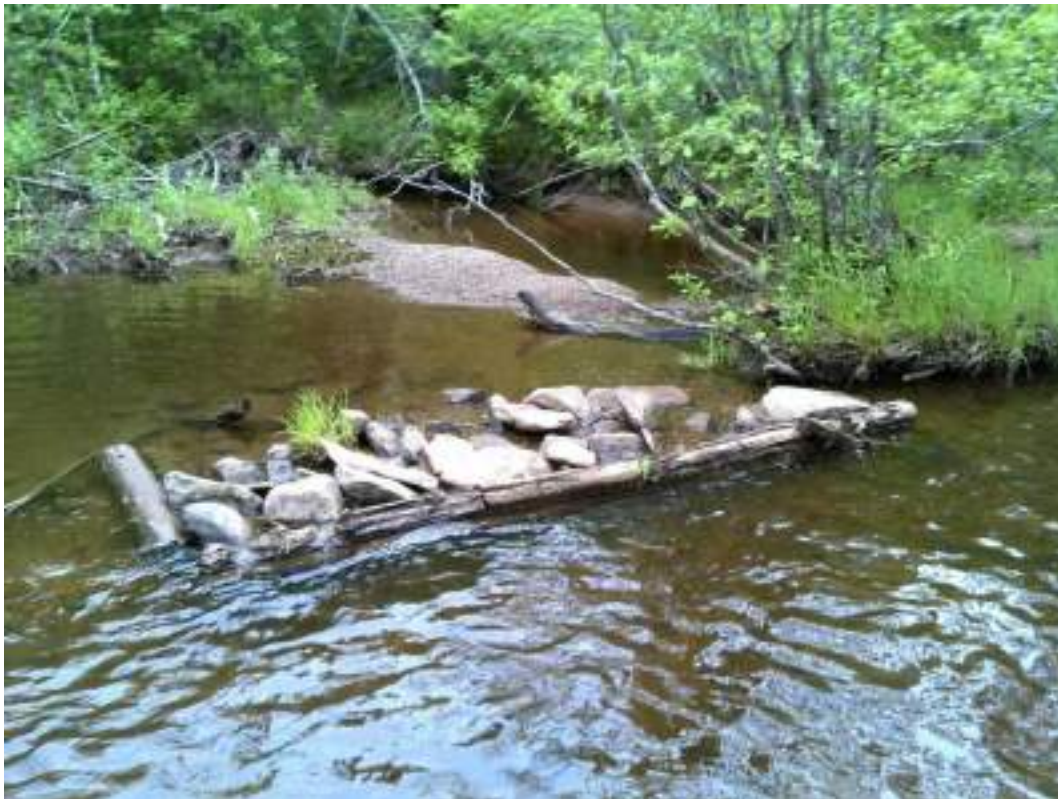
Figure 154. Deflector #7 - no maintenance performed. The channel started flowing around the structure, flooding it with water.

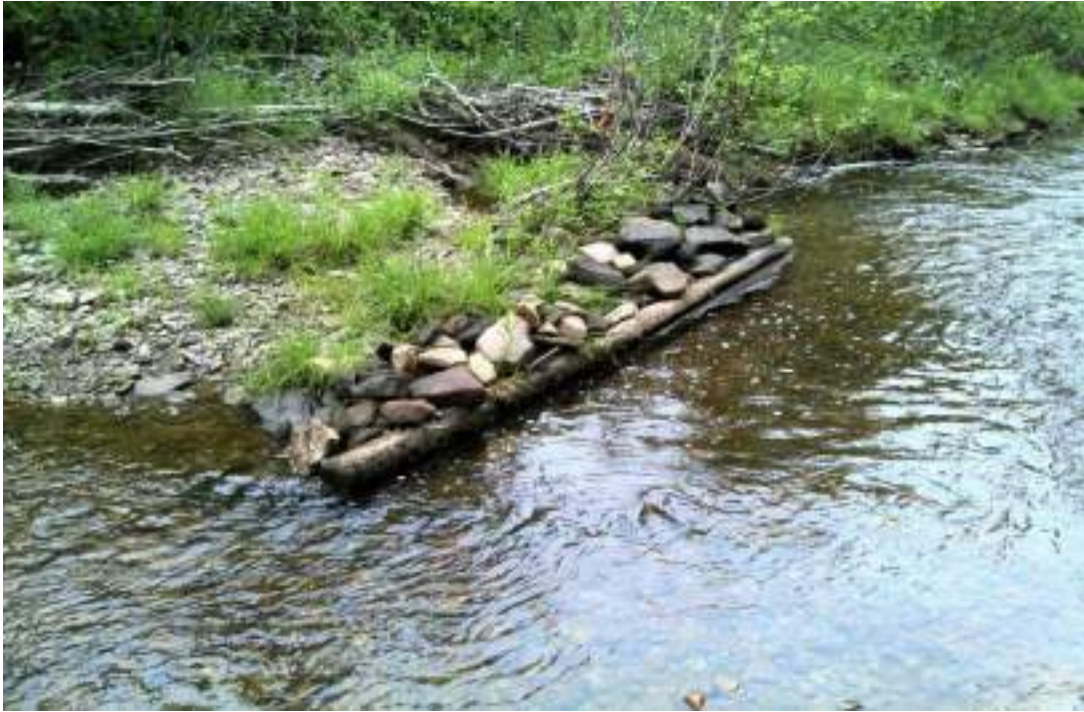
Figure 157. Deflector #10 - after picture of maintenance.

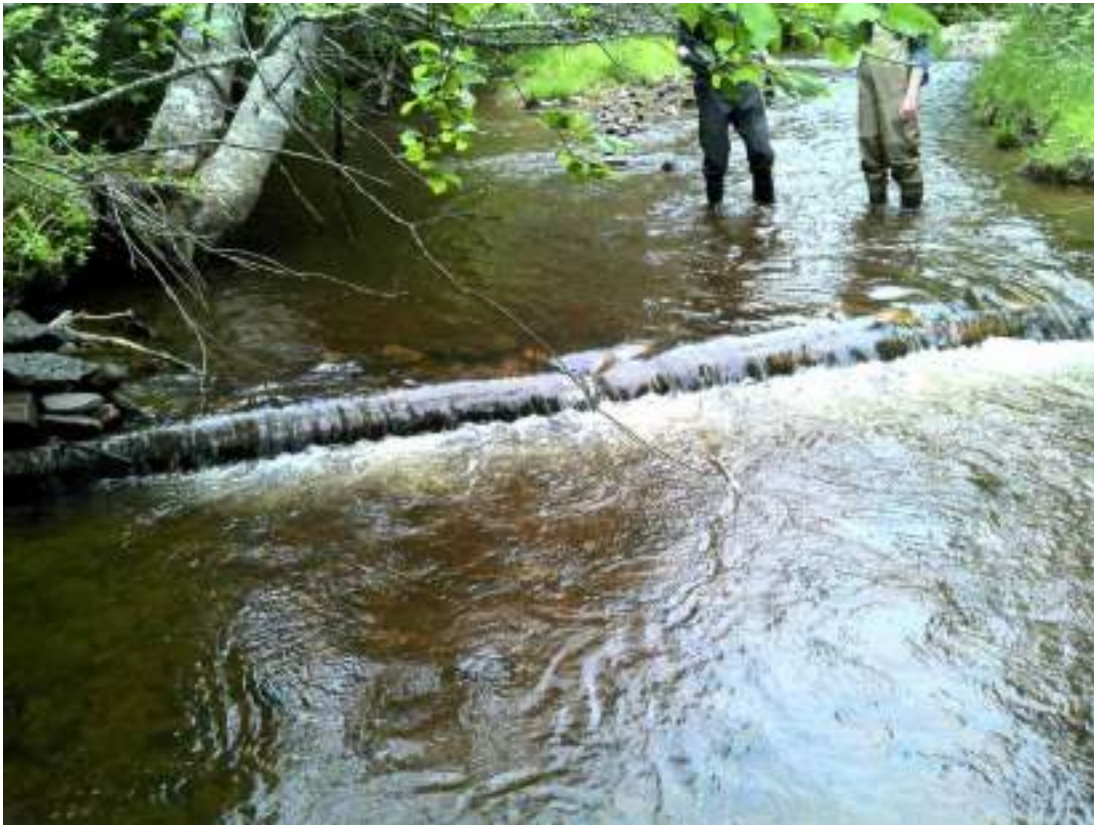
Figure 158. Diggerlog #11 - after picture of the maintenance performed.

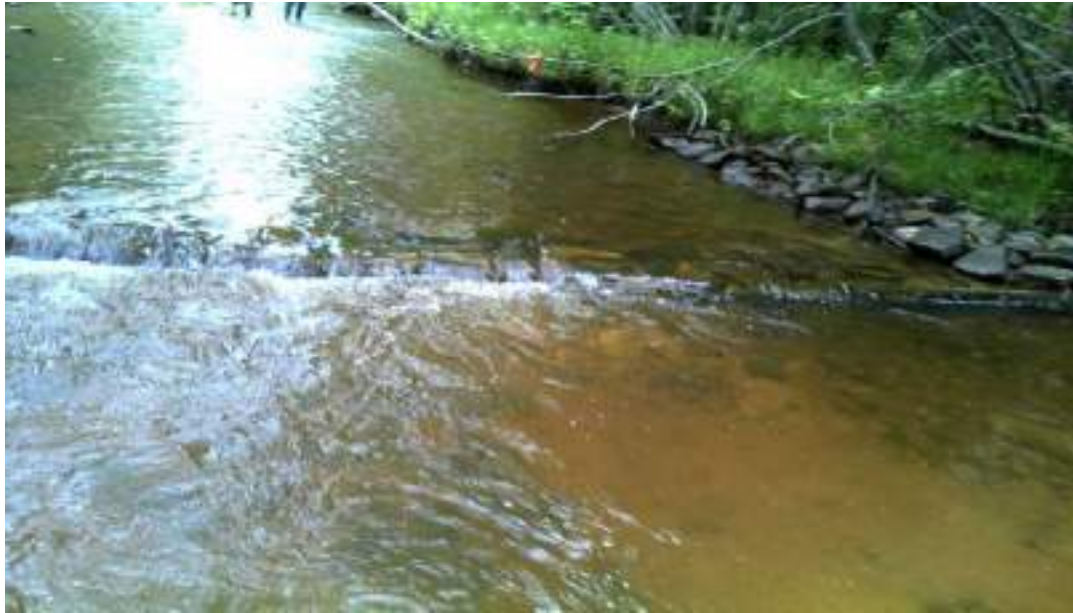
Figure 159. Diggerlog #12 - after picture of maintenance performed.

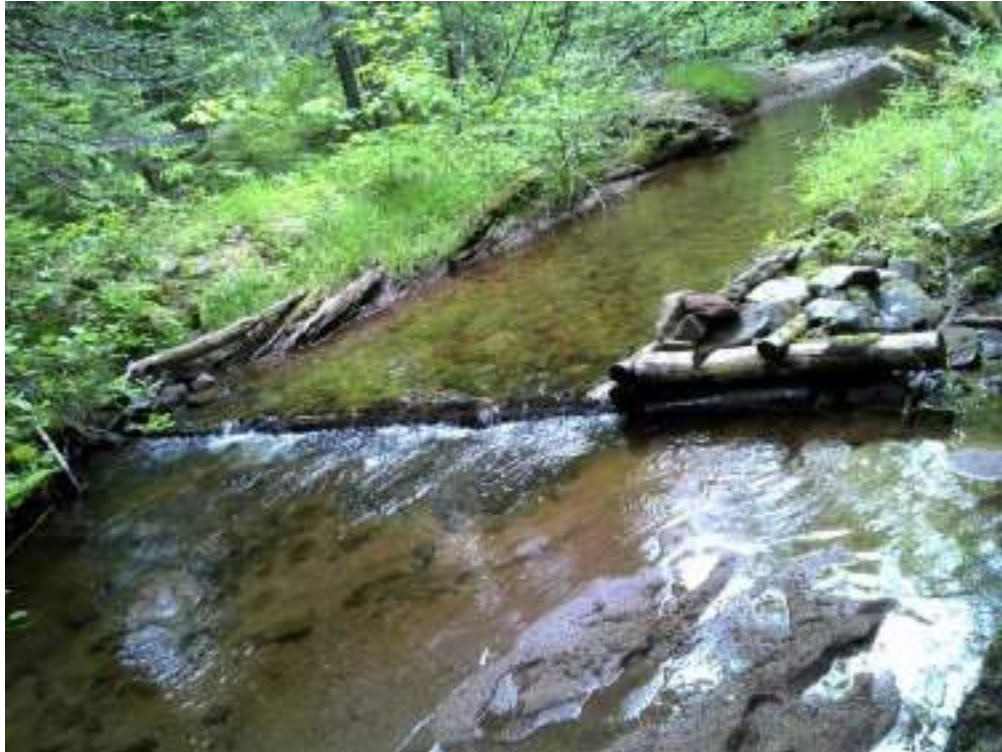
Figure 164 - Diggerlog #3 - after picture of the maintenance performed.

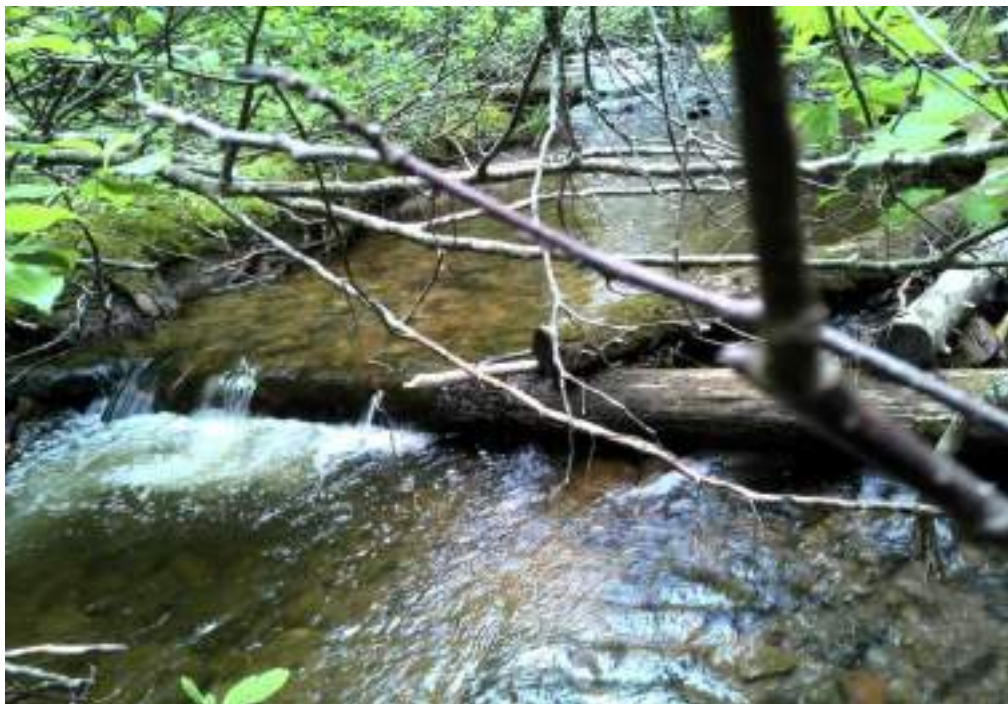
Figure 165. Diggerlog #4 - after picture of maintenance performed.

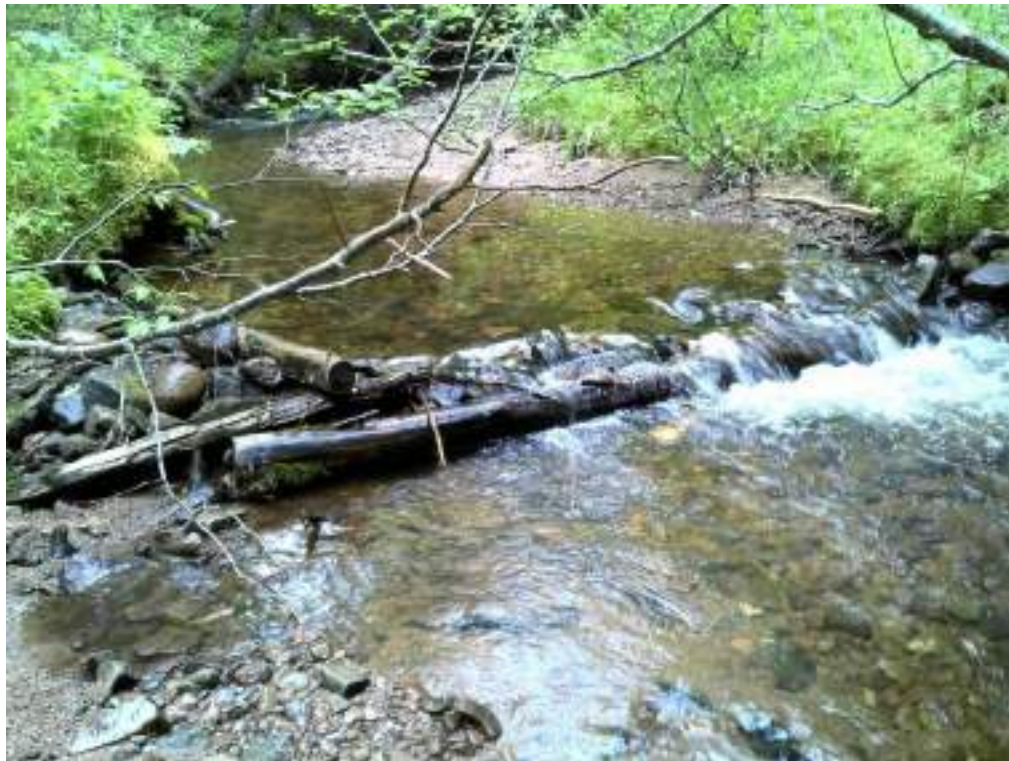
Figure 169.. Diggerlog #8 - after picture of the maintenance performed.

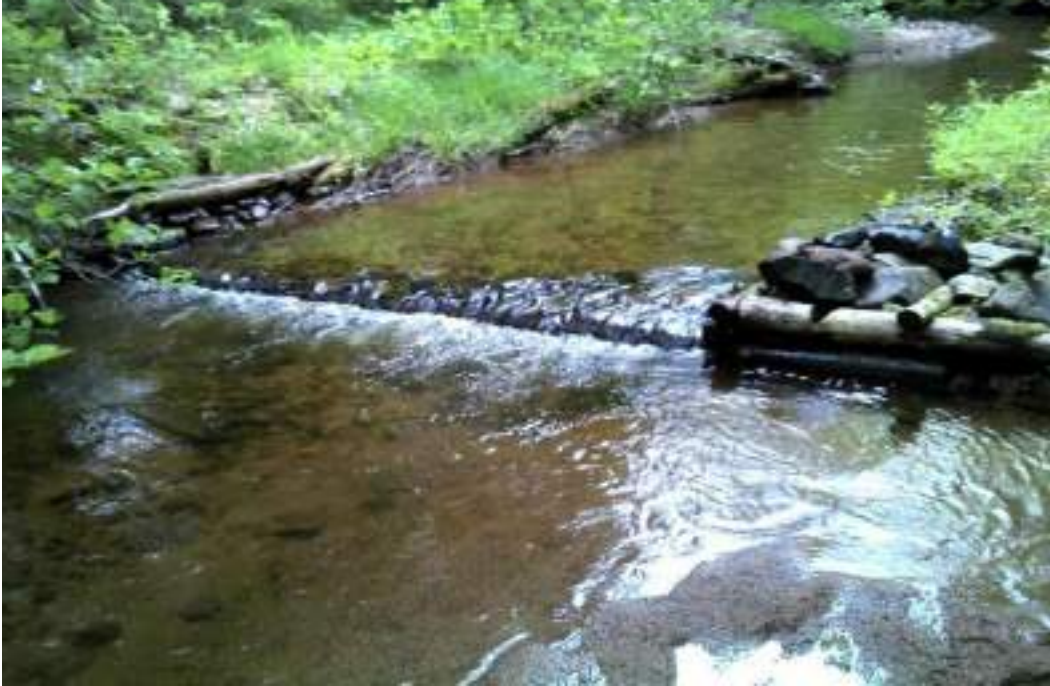
Figure 170. Diggerlog and deflector #9 - after picture of the maintenance performed.
