SALMONID HABITAT RESTORATION
INVERNESS SOUTH ANGLERS ASSOCIATION

Winter Damage Assessment

Date: 2019

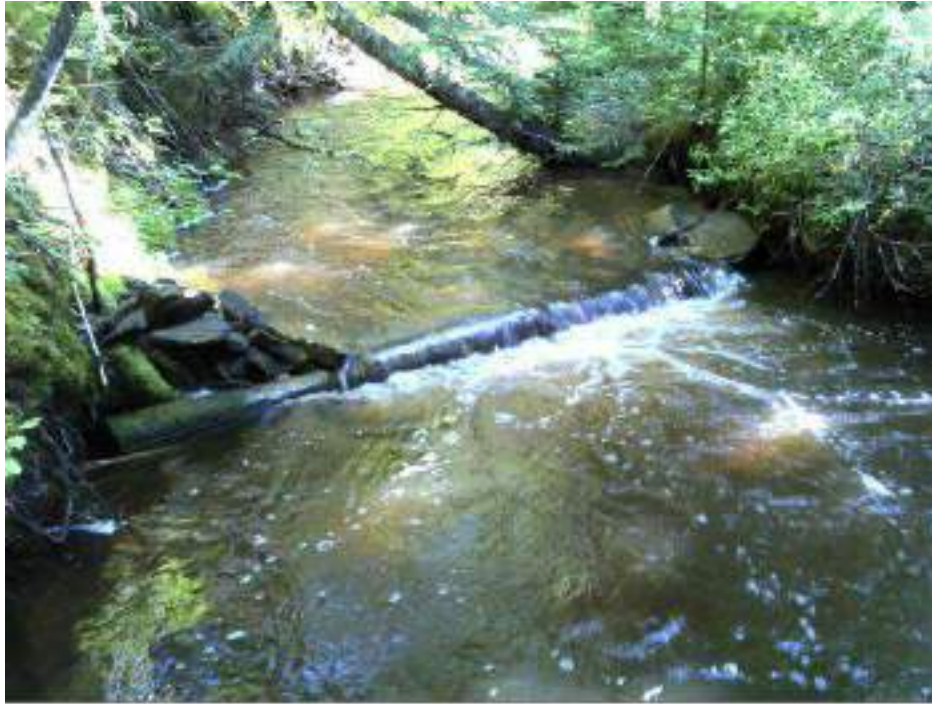
Figure 172. Structure #1 furthest downstream - After picture of the maintenance completed on a digger log.

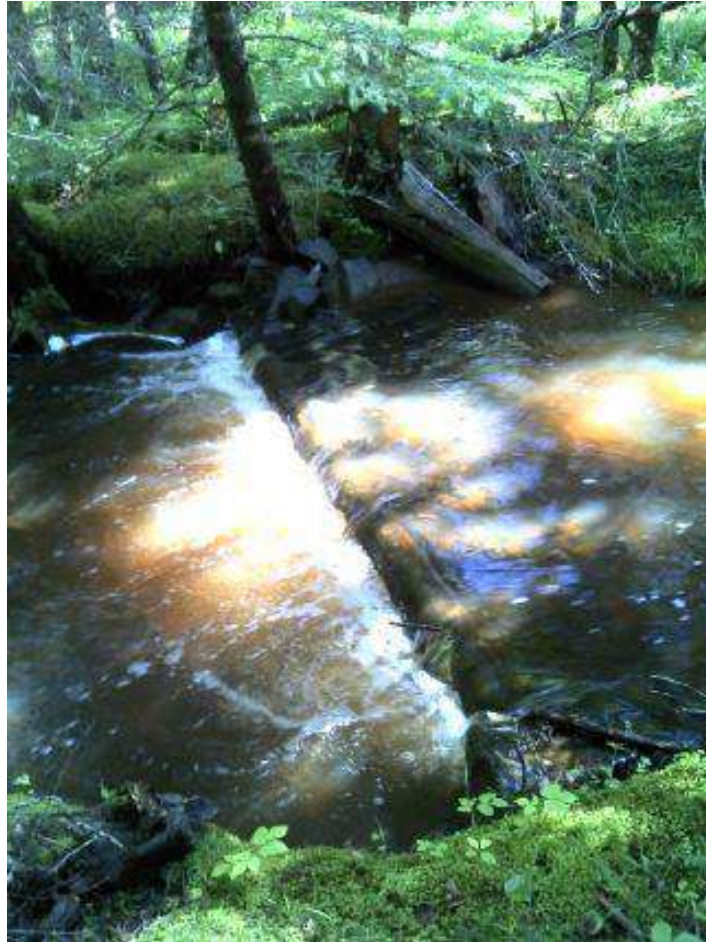
Figure 174. Structure #3 - After picture of the maintenance completed on a digger log.

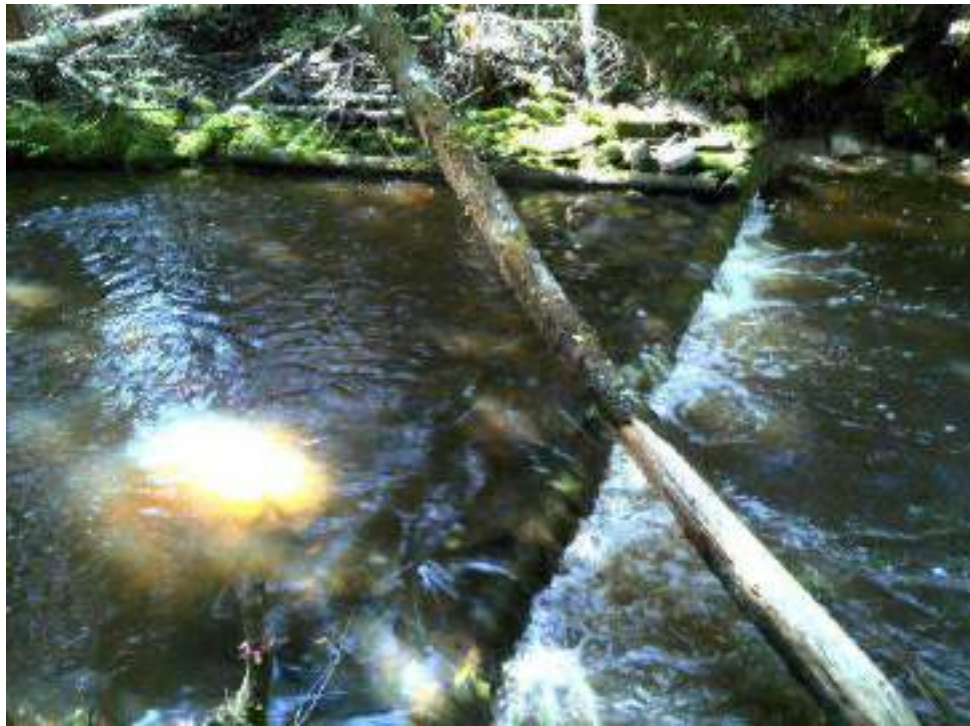
Figure 175. Structure #4 - After picture of the maintenance completed on a digger log and deflector structure.

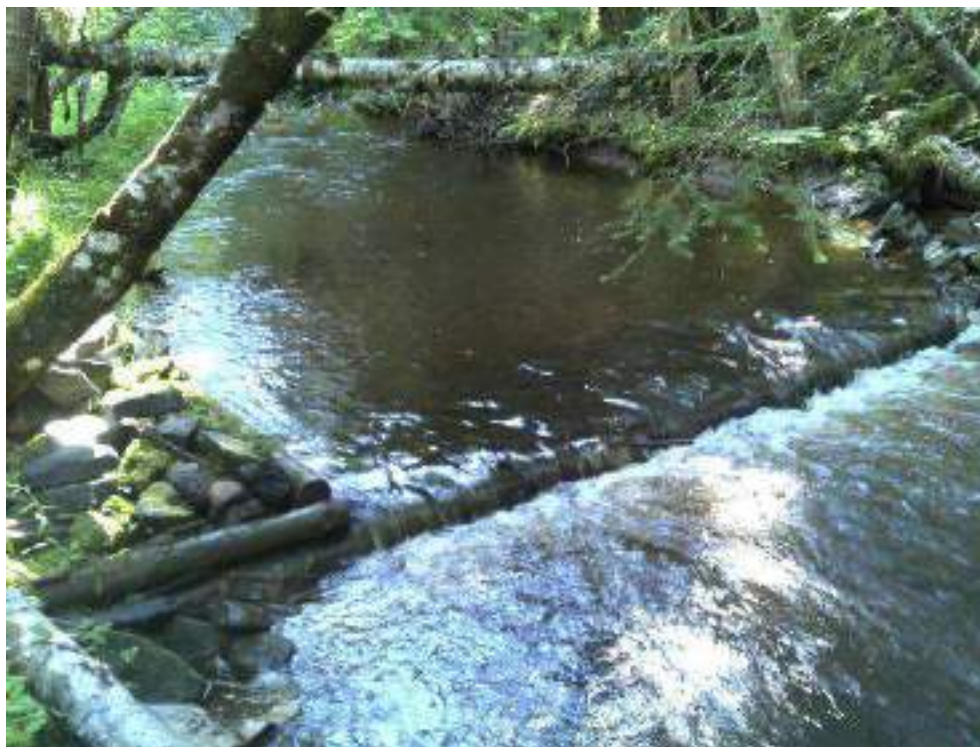
Figure 176. Structure #5 - After picture of the maintenance completed on a diggerlog and deflector structure.

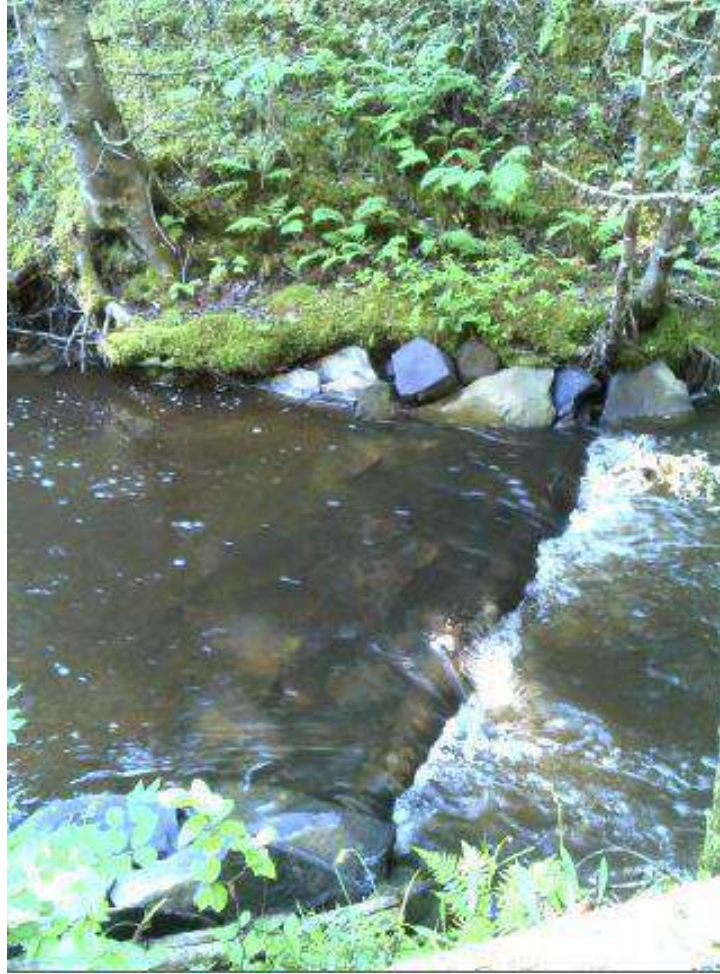
Figure 177. Structure #6 - After picture of the maintenance completed on a digger log.

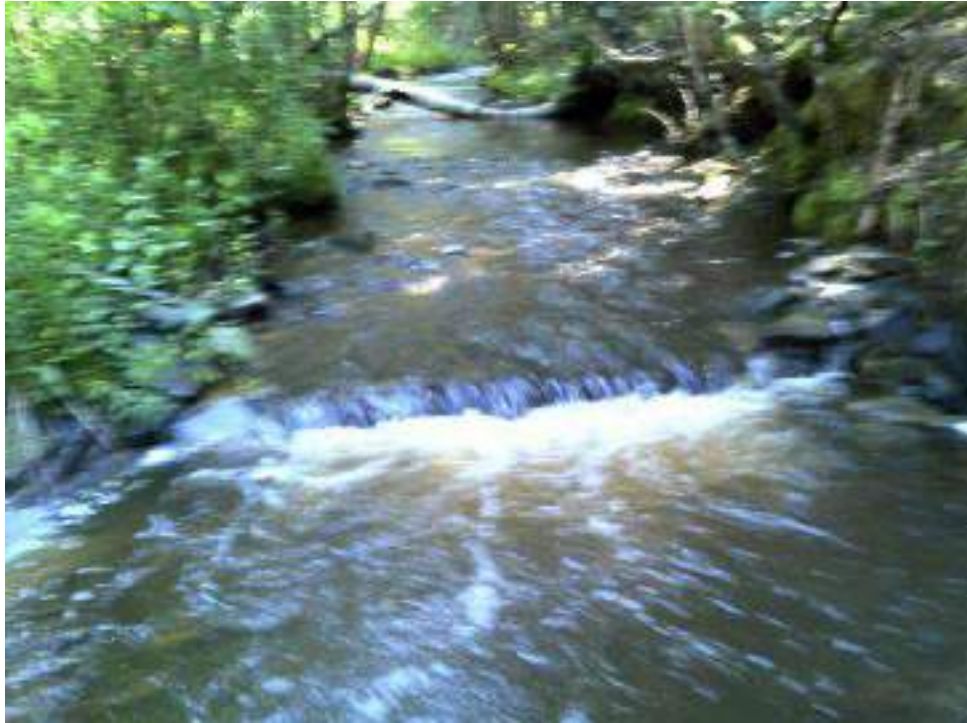
Figure 178. Structure #7 - After picture of the maintenance completed on a digger log.

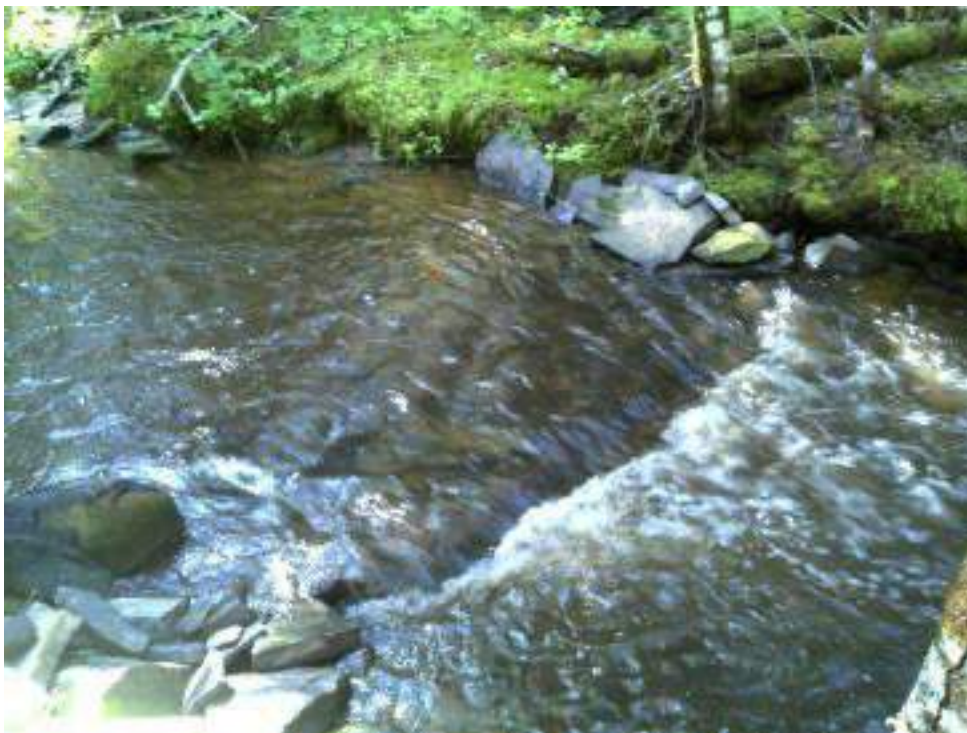
Figure 179. Structure #8 - After picture of the maintenance completed on a digger log.

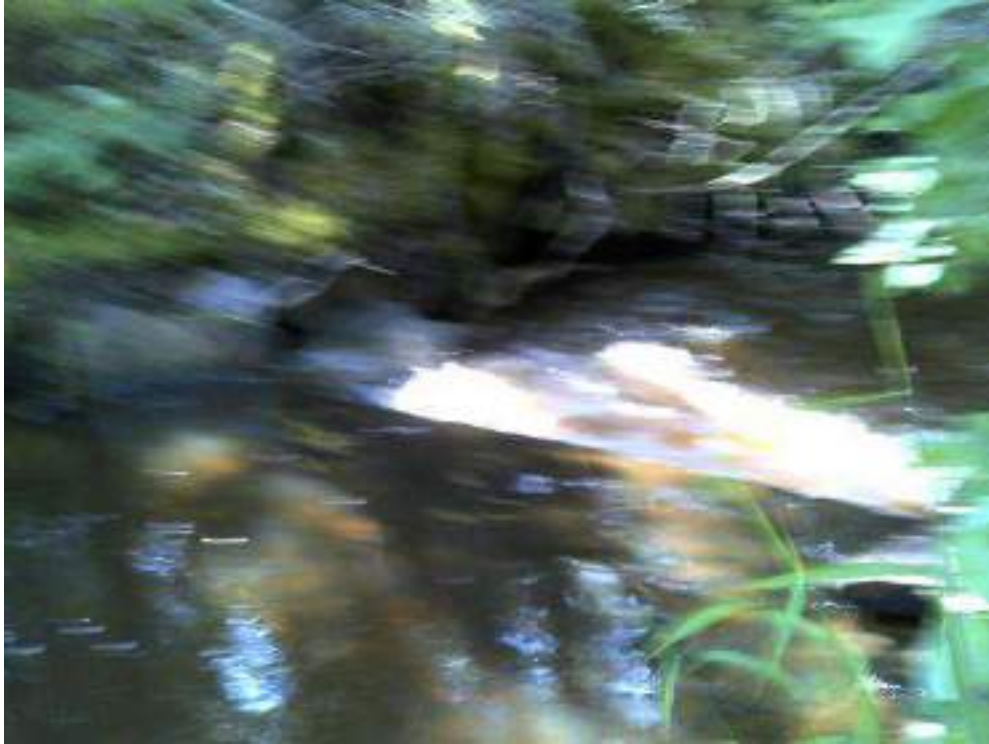
Figure 180. Structure #9 - After picture of the maintenance completed on a digger log. (This photo is very blurry)

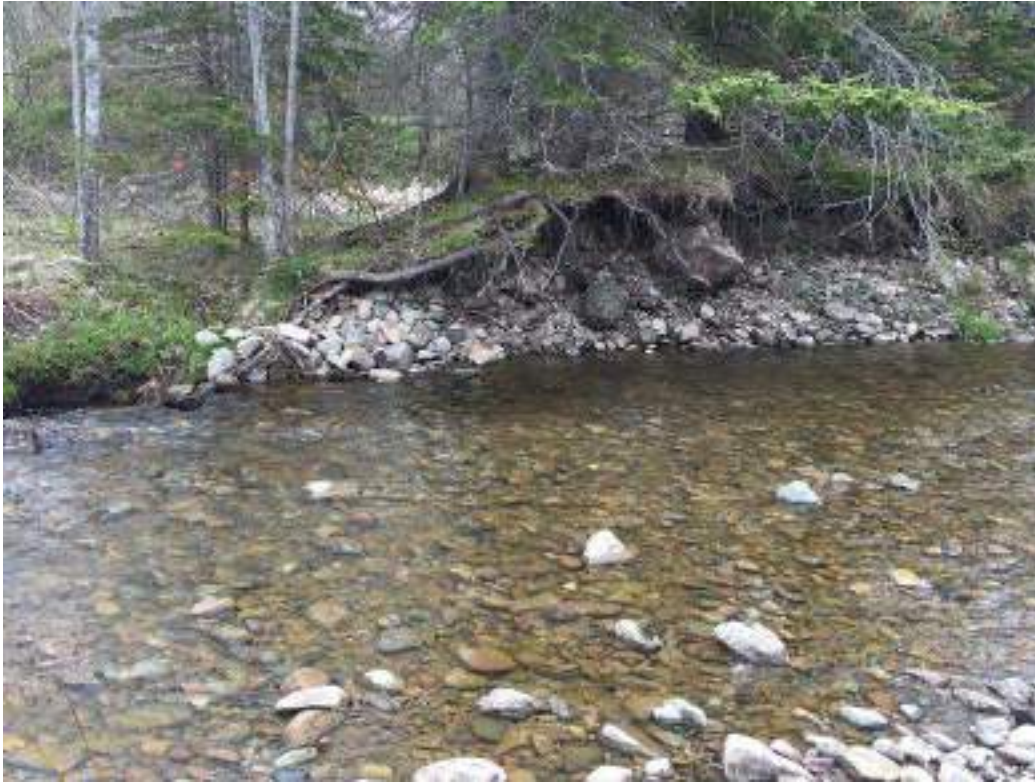
Figure 186. Structure #1 Bank Rock - before picture of maintenance, first structure starting upstream from Route 19 bridge. No after picture taken.

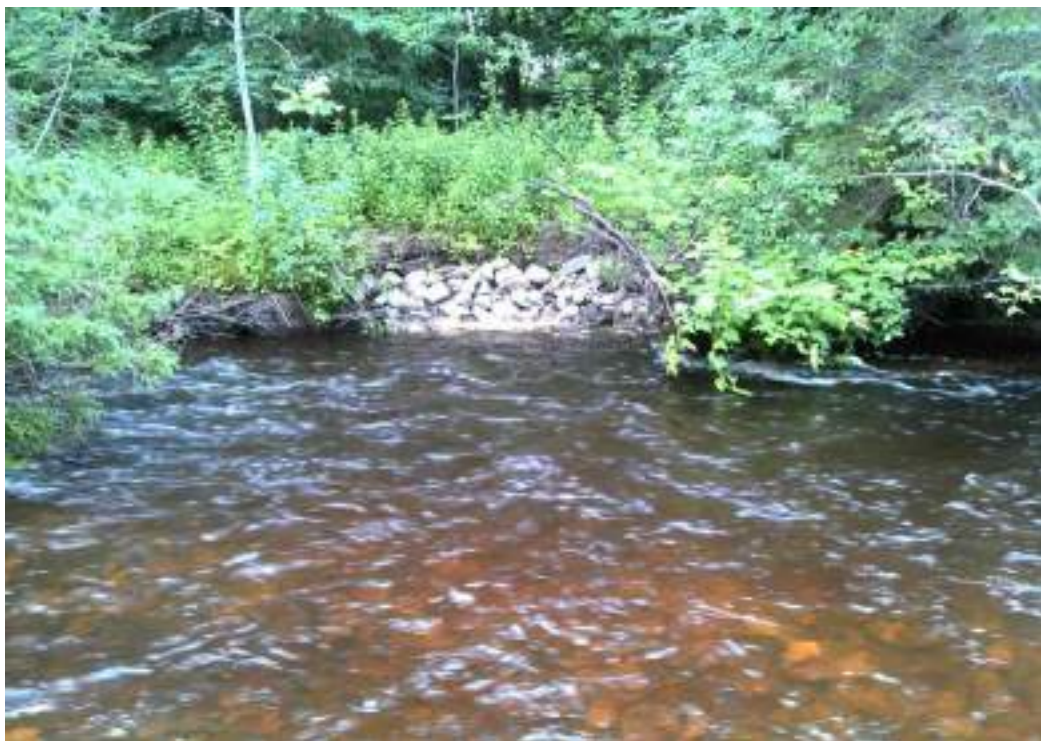
Figure 187. Structure #2 Bank Rock - before and after pictures of the completed maintenance.

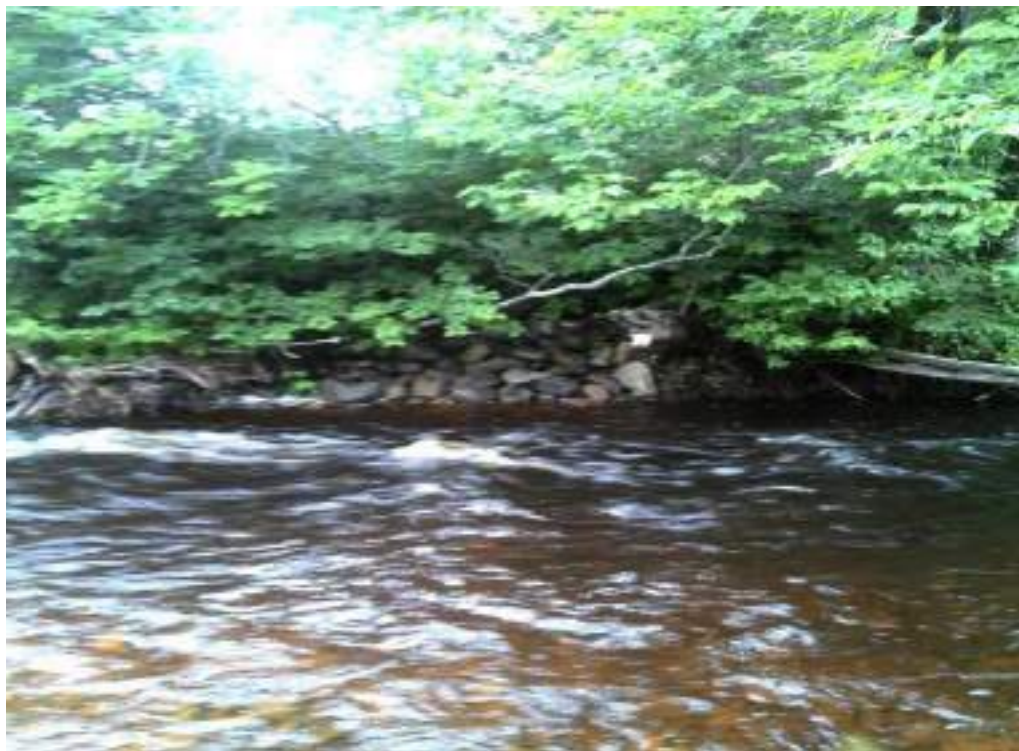
Figure 188. Structure #3 Bank Rock - before and after pictures of completed maintenance.

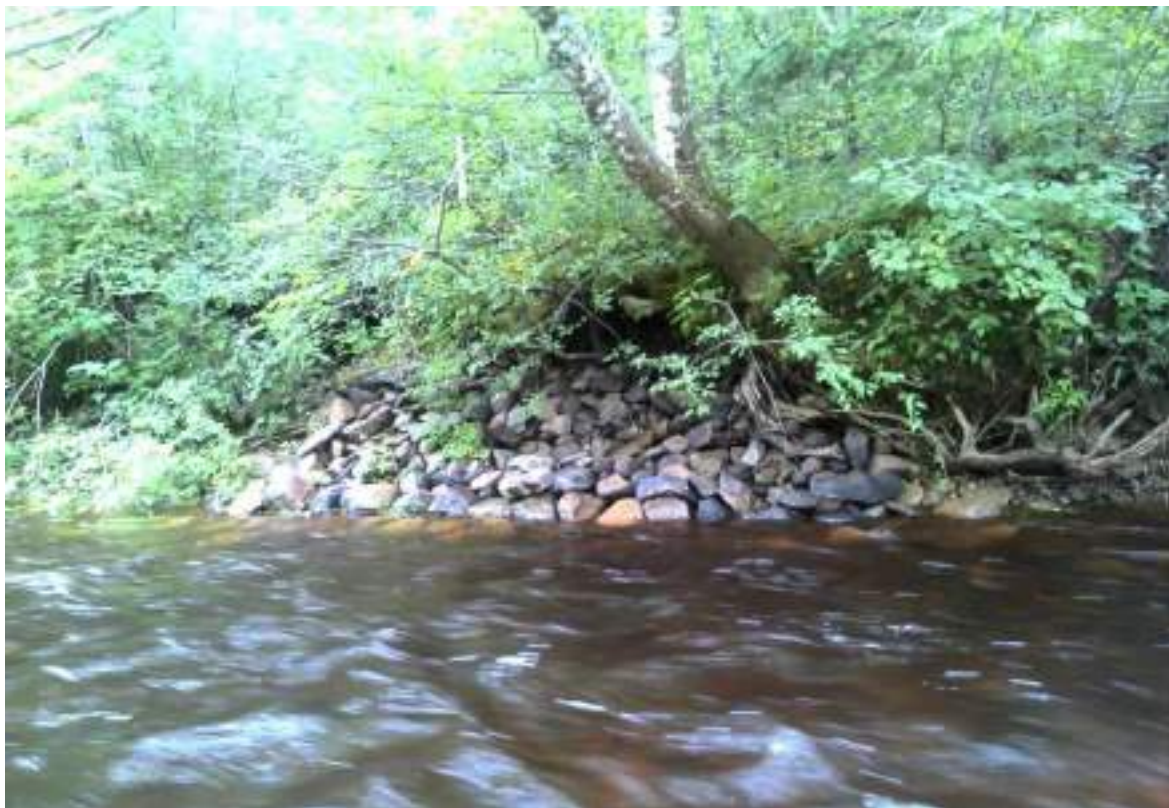
Figure 189. Structure #4 Bank Rock - before and after pictures of completed maintenance.

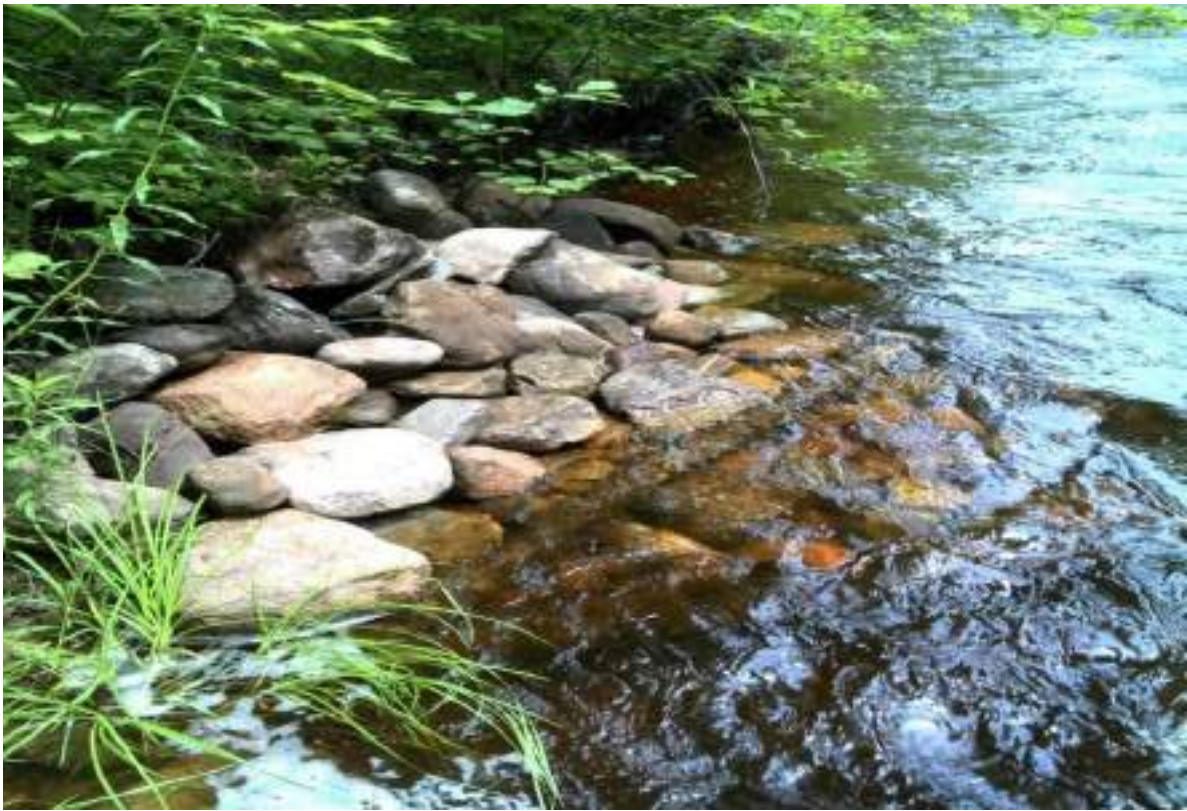
Figure 190. Structure #5 Deflector - before and after pictures of completed maintenance.

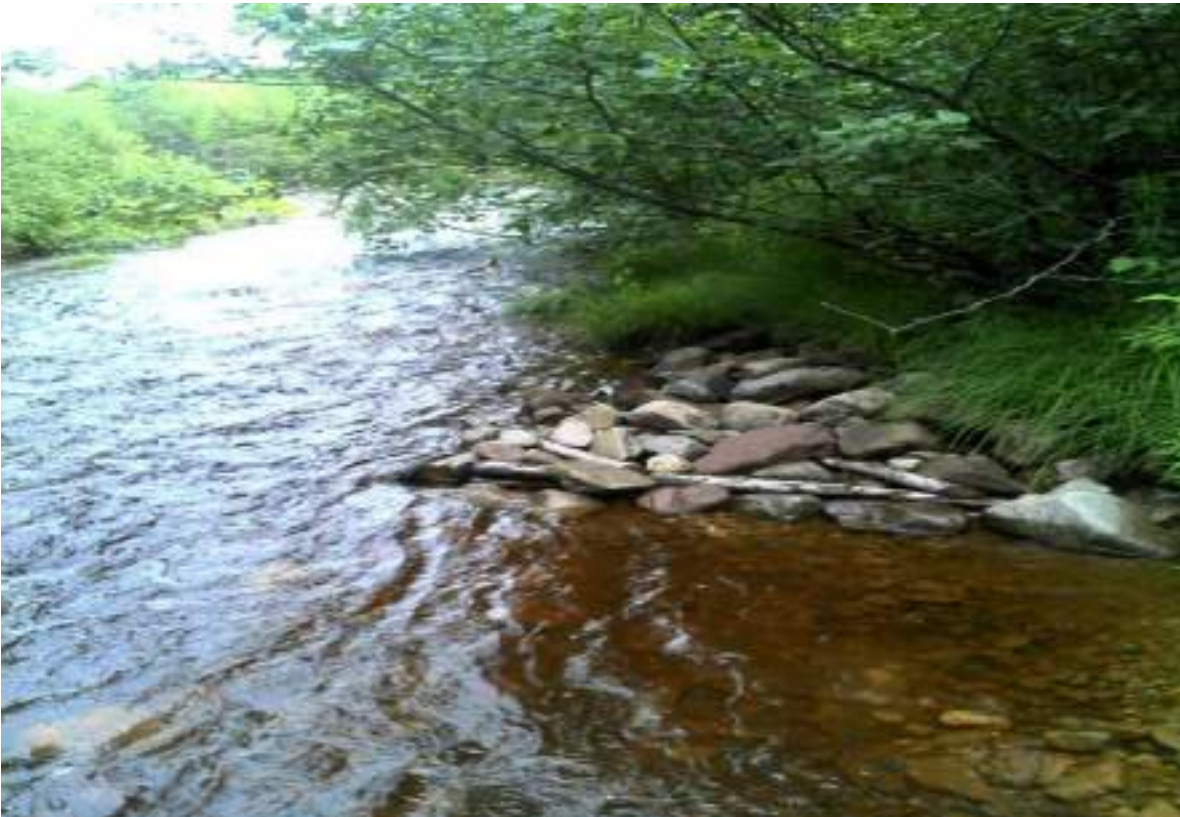
Figure 191. Structure #6 - before and after picture of completed maintenance.

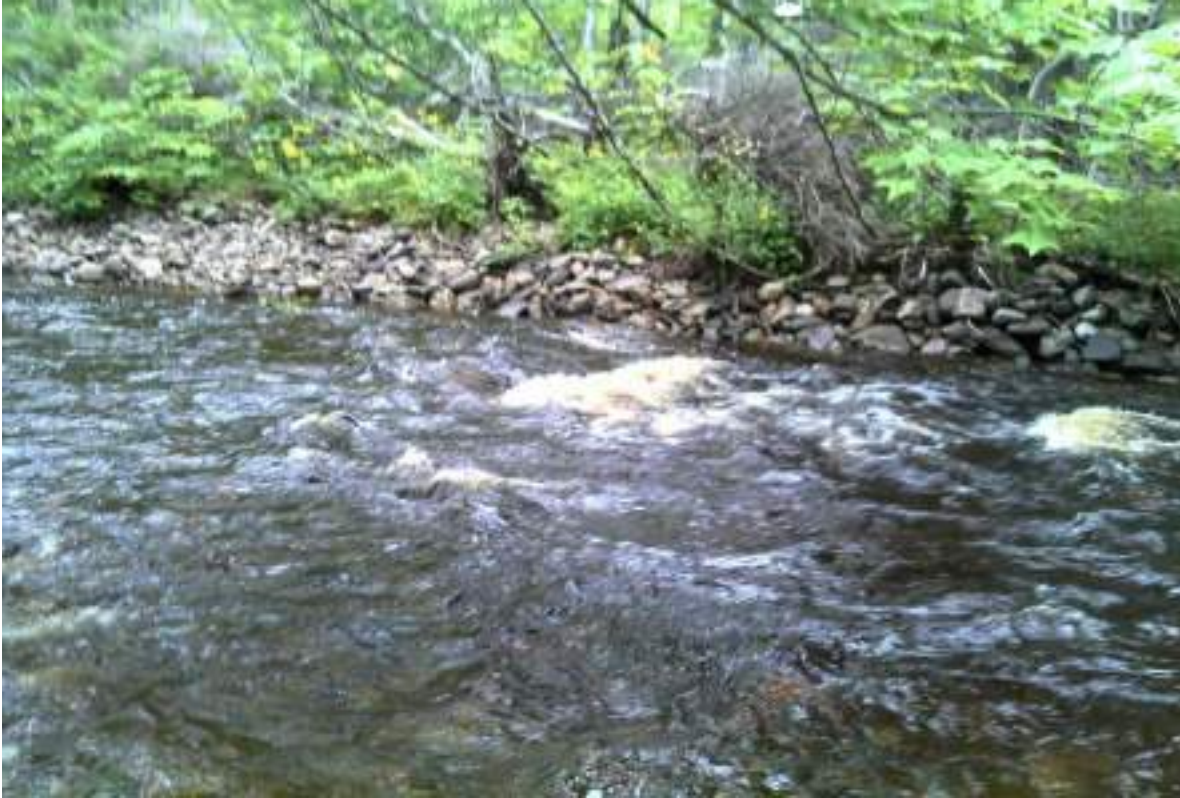
Figure 201. Structure #15 Bank Rock - before and after pictures of completed maintenance.

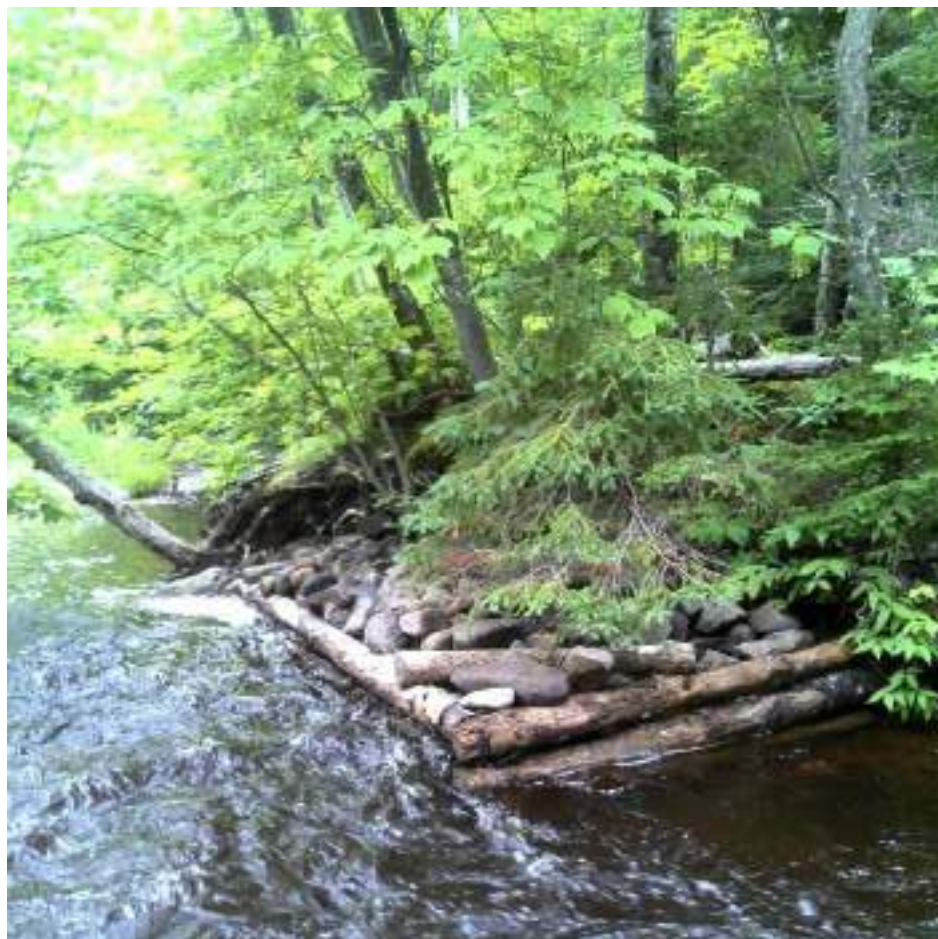
Figure 205. Structure #19 Deflector - before and after pictures of completed maintenance.

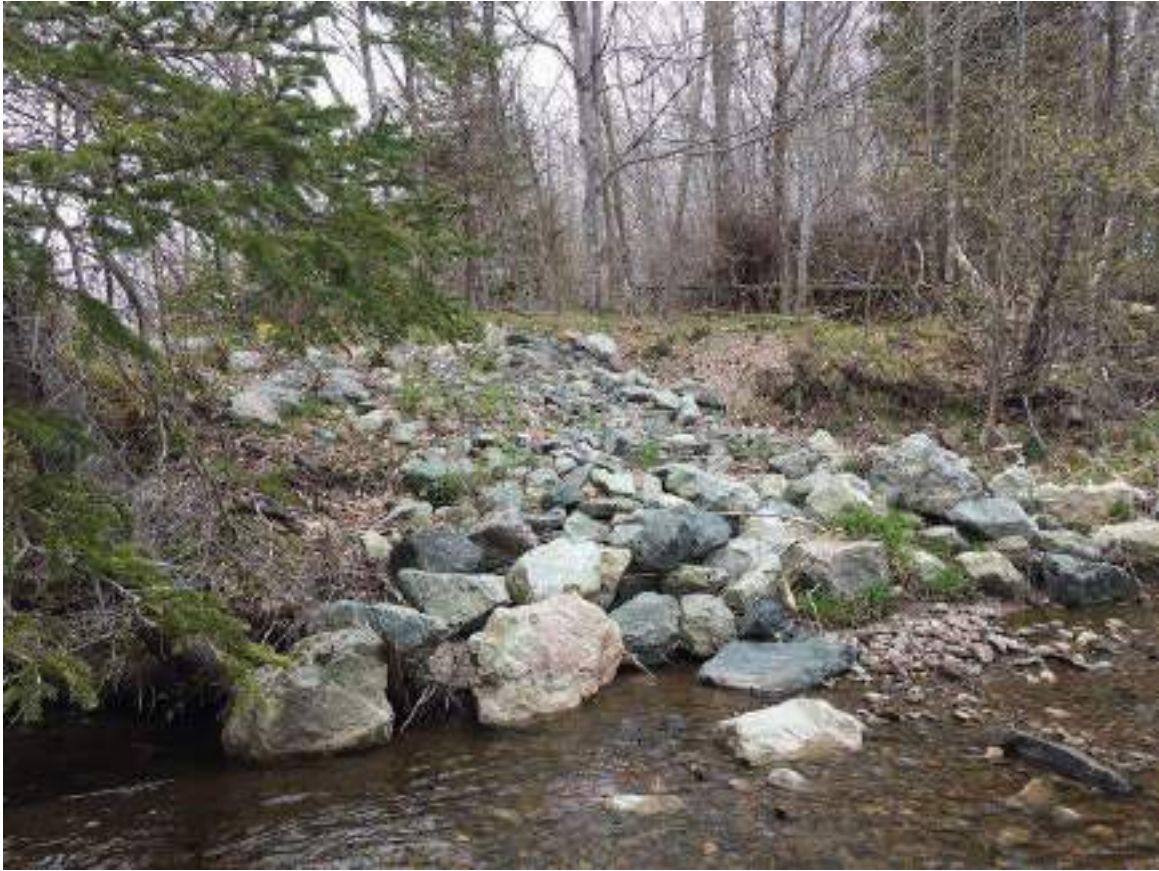
Figure 206. Structure #20 Armour Stone - bank stabilization, across from structure #19.

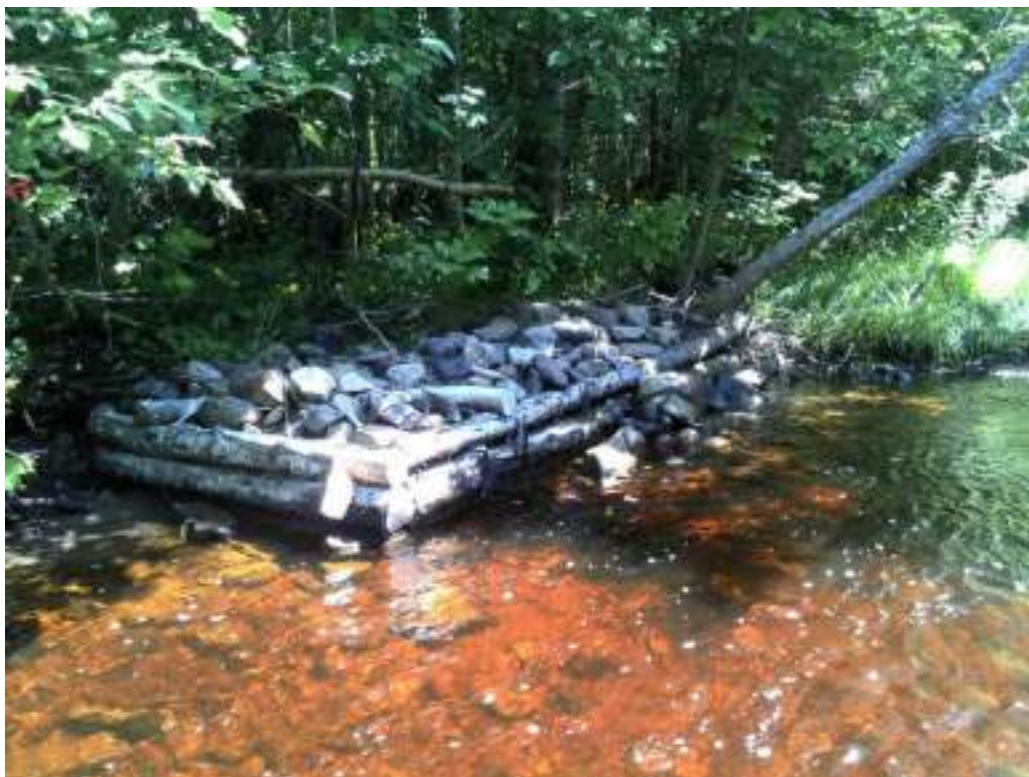
Figure 207. Structure #21 Deflector - before and after pictures of completed maintenance.

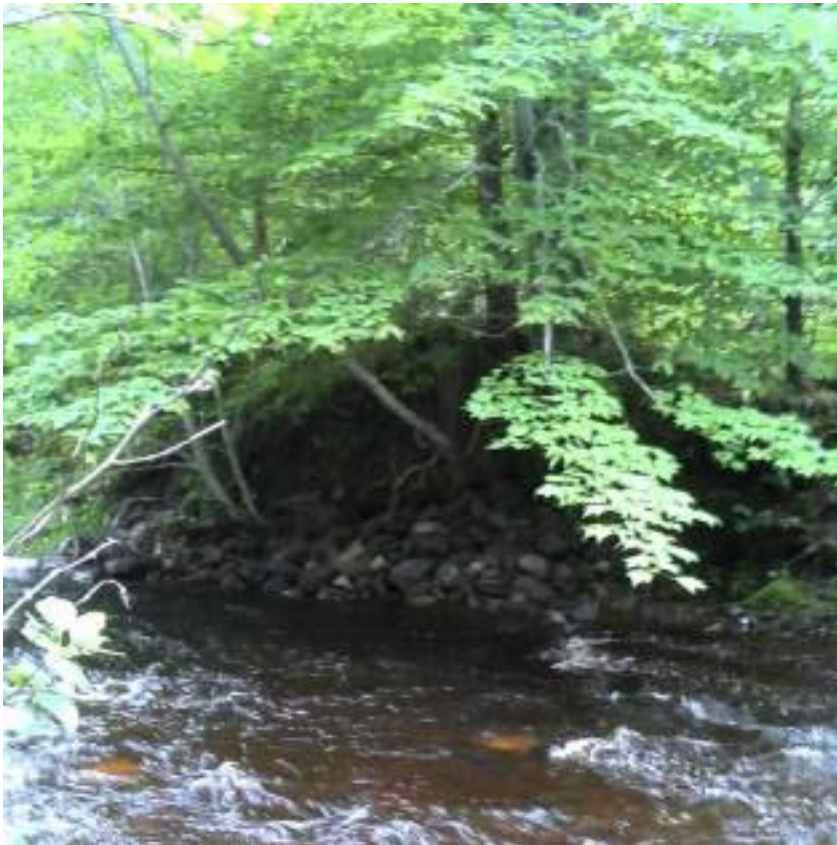
Figure 208. Structure #22 Bank Rock - before and after picture of completed maintenance.

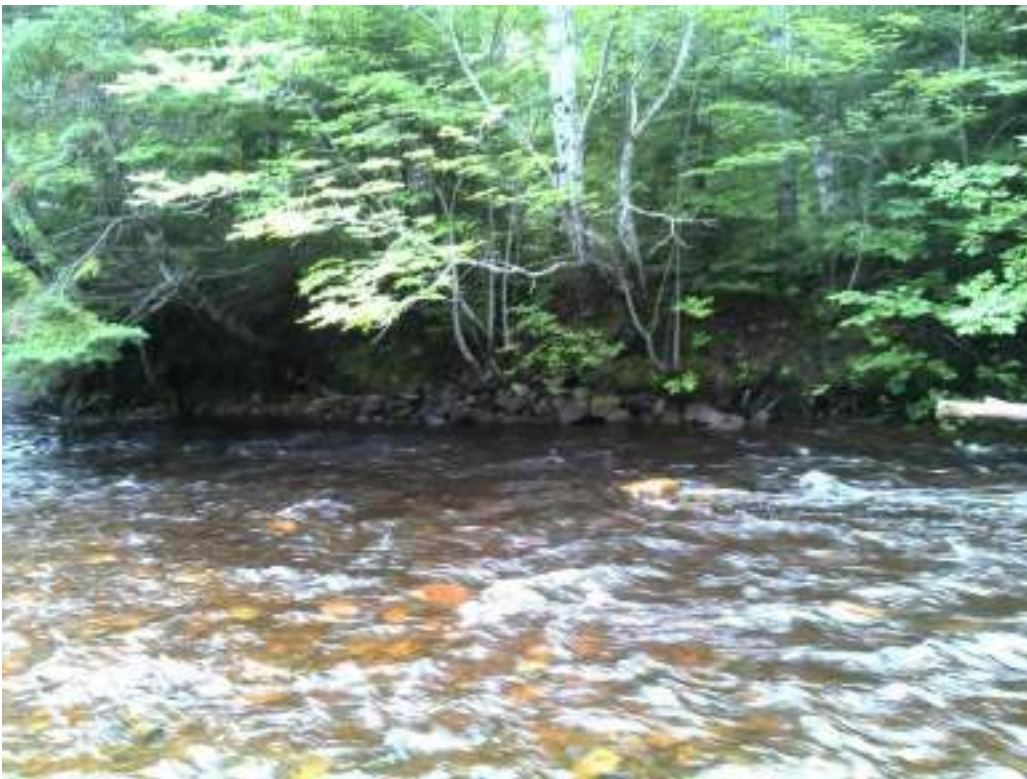
Figure 209. Structure #23 Bank Rock - before and after picture of completed maintenance.

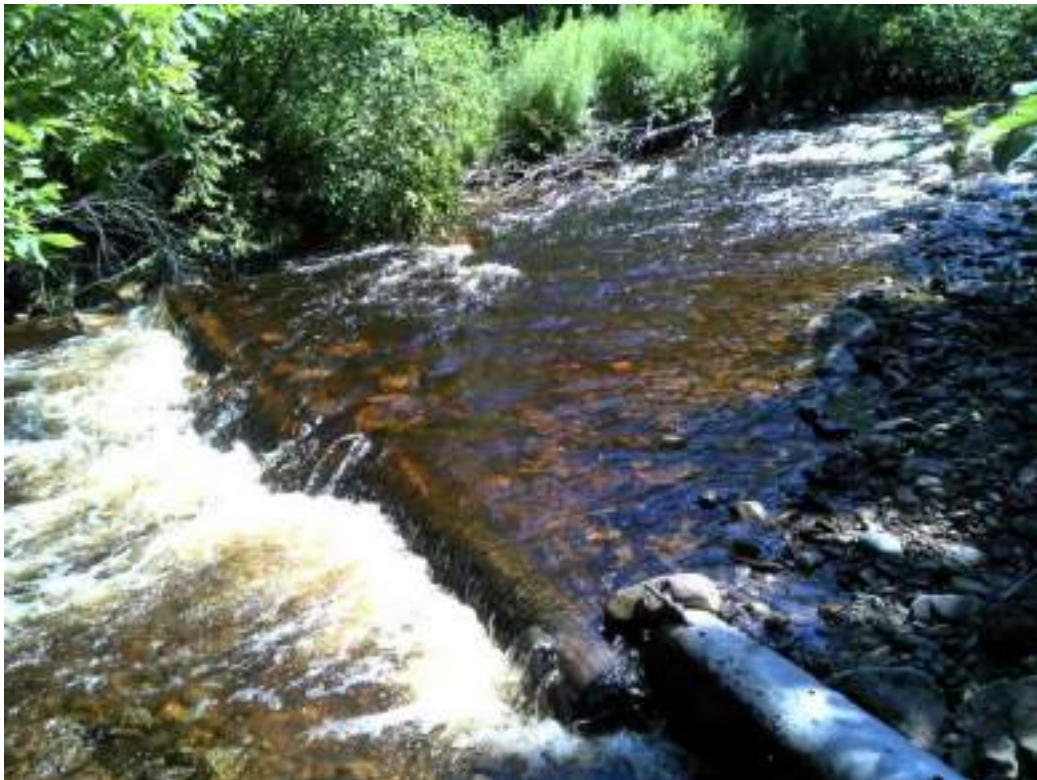
Figure 210. Structure #24 Diggerlog - before and after picture of completed maintenance. This log was cut in half during installation due to its weight.

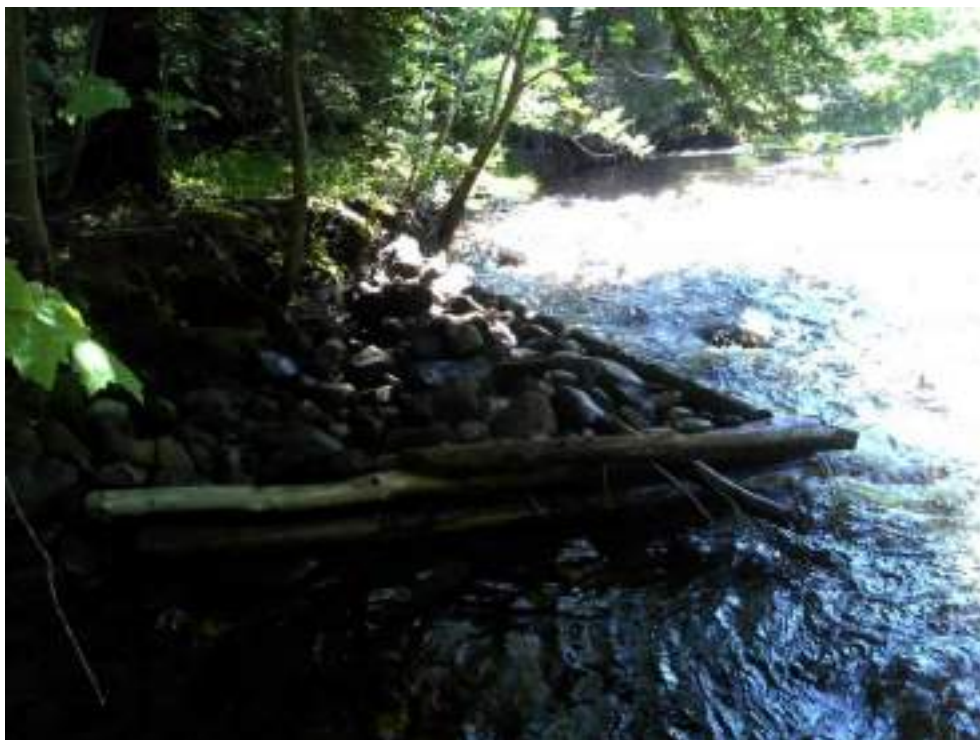
Figure 211. Structure #25 Deflector - before and after picture of completed maintenance.

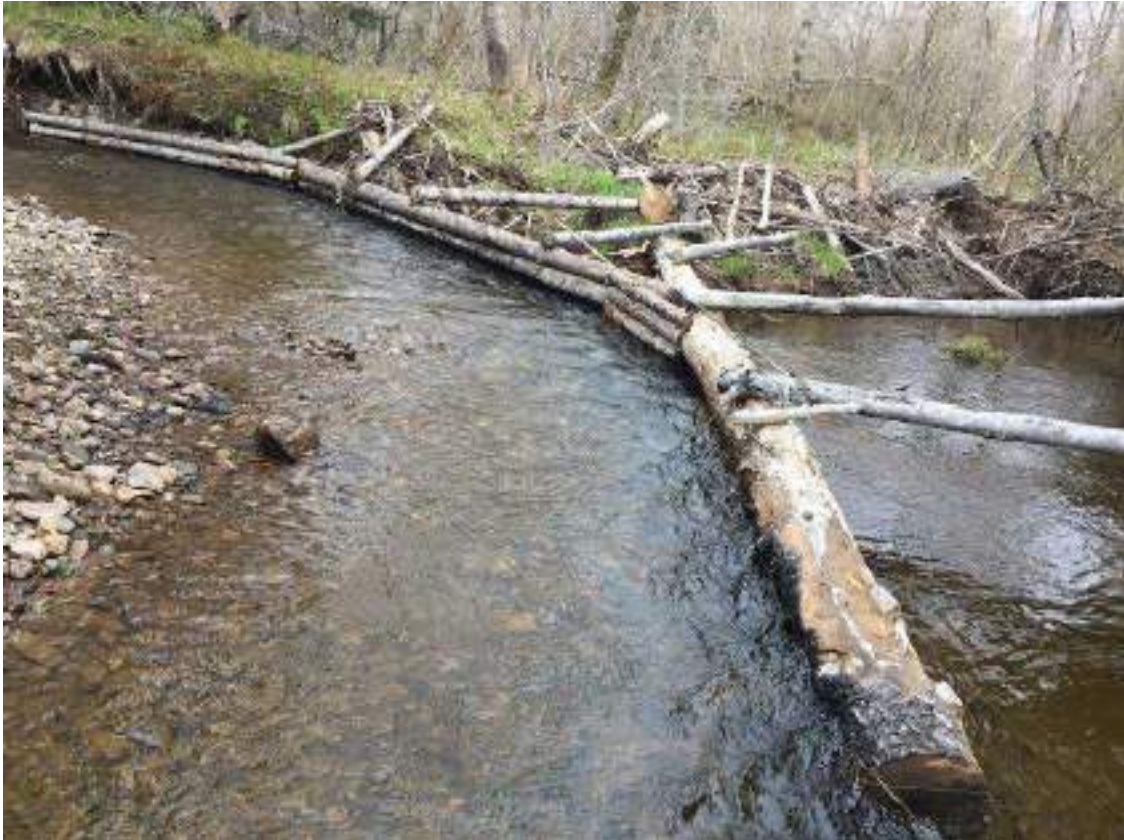
Figure 212. Structure #26 Channel Blocker - no maintenance required.

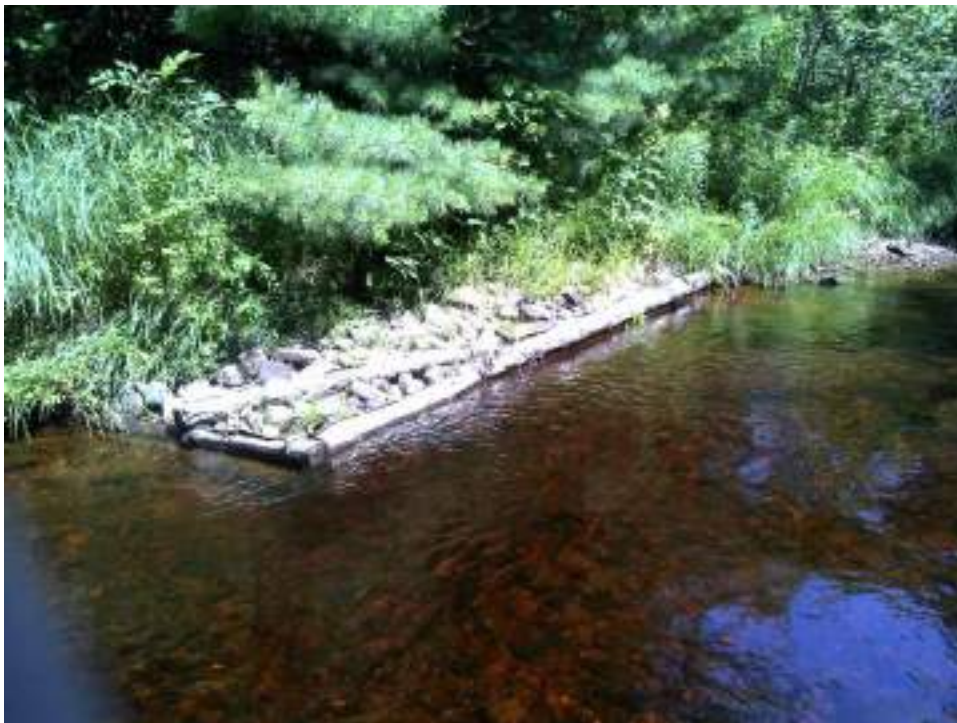
Figure 213. Structure #27 Deflector - before and after picture of completed maintenance.

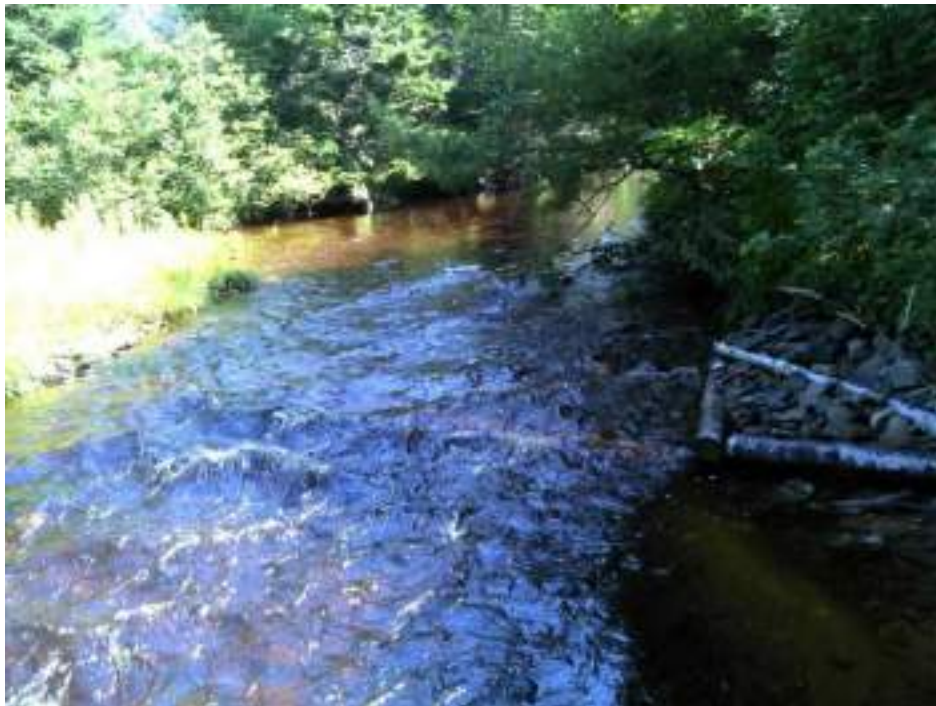
Figure 215. Structure #29 Diggerlog and Deflector - before and after picture of completed maintenance. (water levels are high in the after photo)

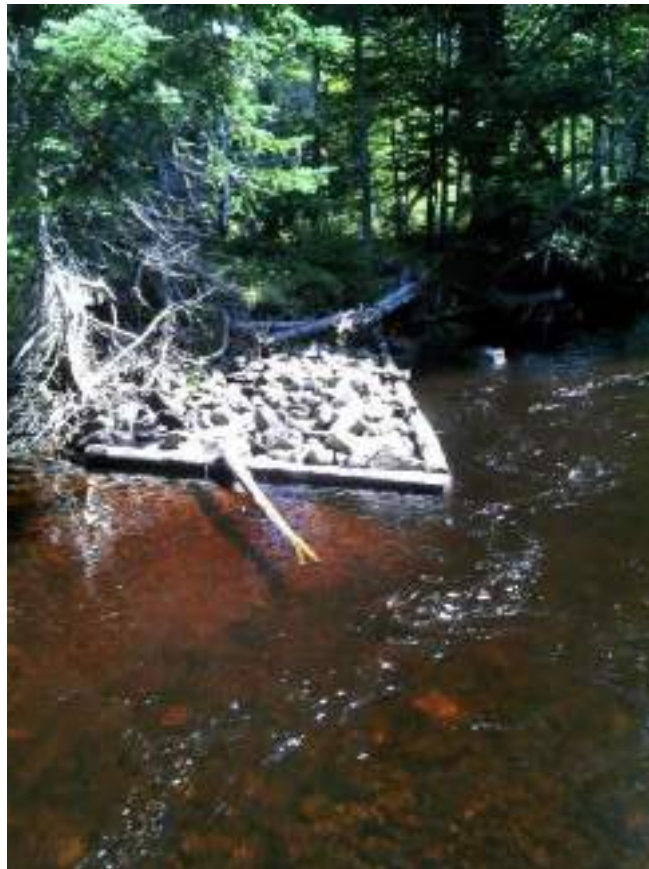
Figure 216. Structure #30 Deflector - before and after picture of completed maintenance.

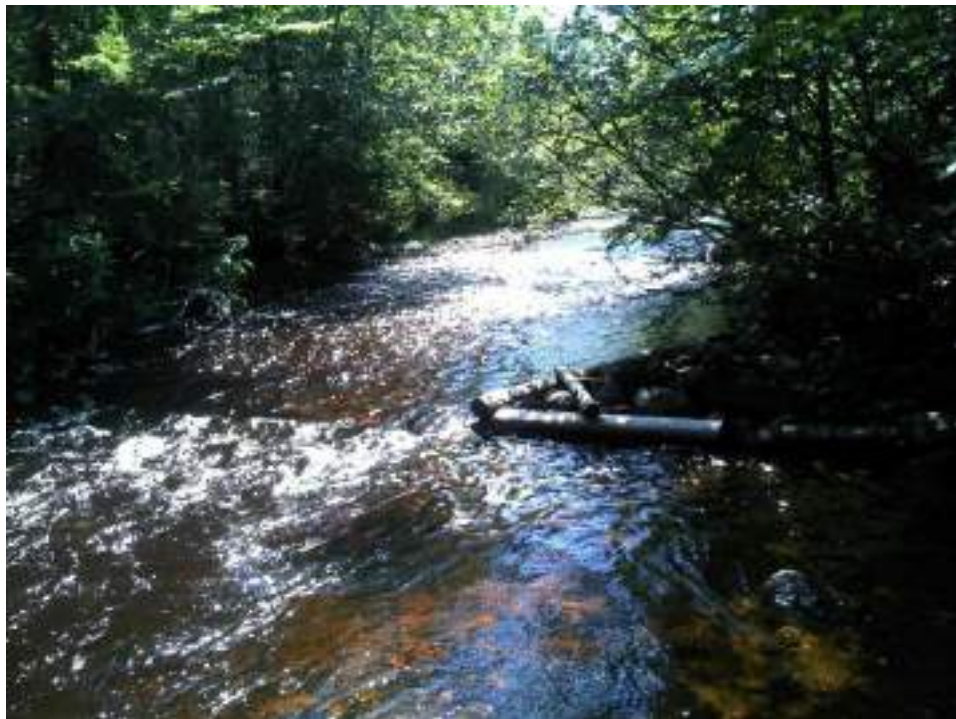
Figure 217. Structure #31 Diggerlog and Deflector - before and after picture of completed maintenance.

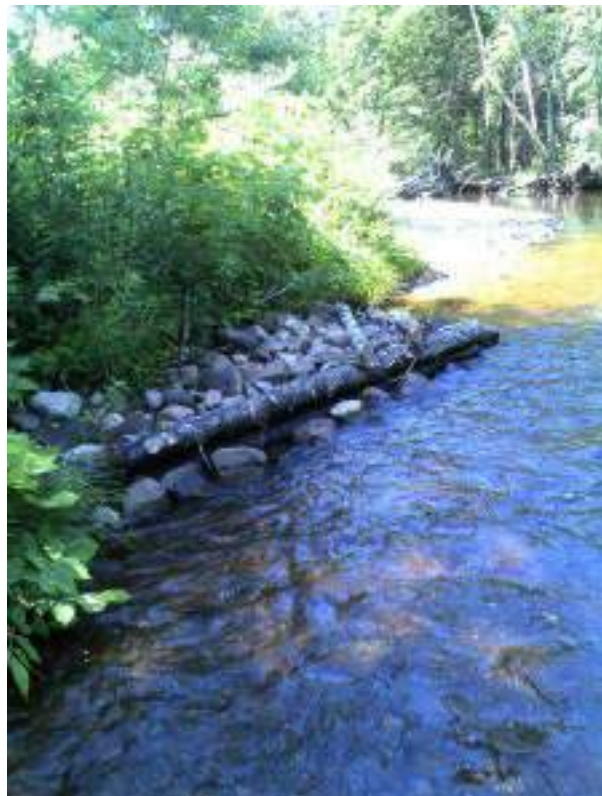
Figure 218. Structure #32 Deflector - before and after picture of completed maintenance.

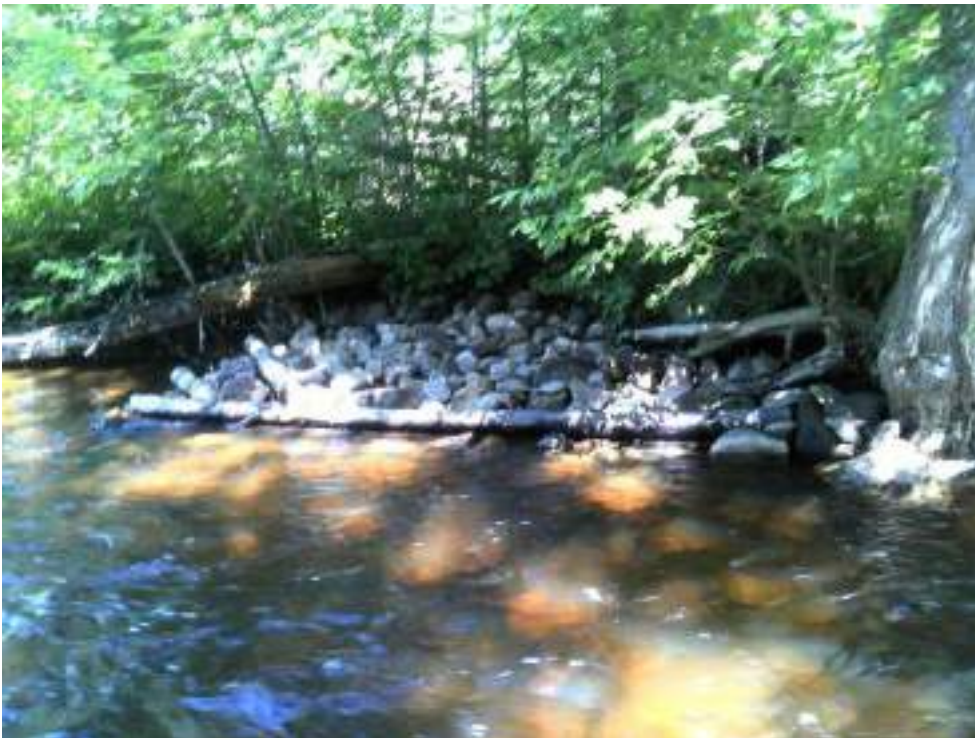
Figure 219. Structure #33 Deflector - before and after picture of completed maintenance.
