SALMONID HABITAT RESTORATION
INVERNESS SOUTH ANGLERS ASSOCIATION

Winter Damage Assessment

Date: 2019

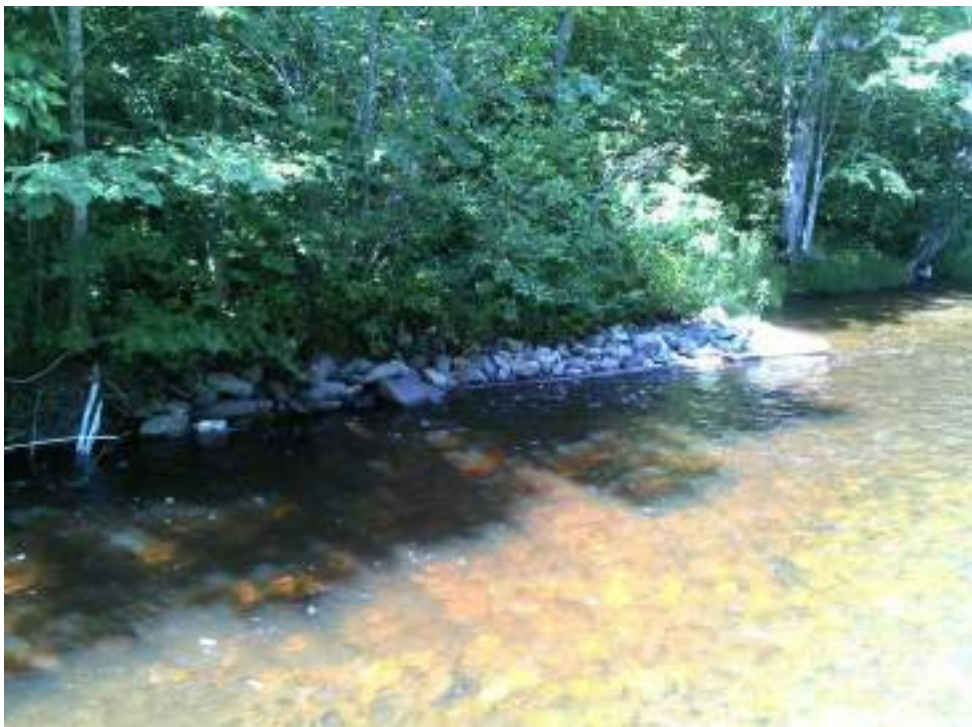
Figure 220. Structure #34 Deflector - before and after picture of completed maintenance.

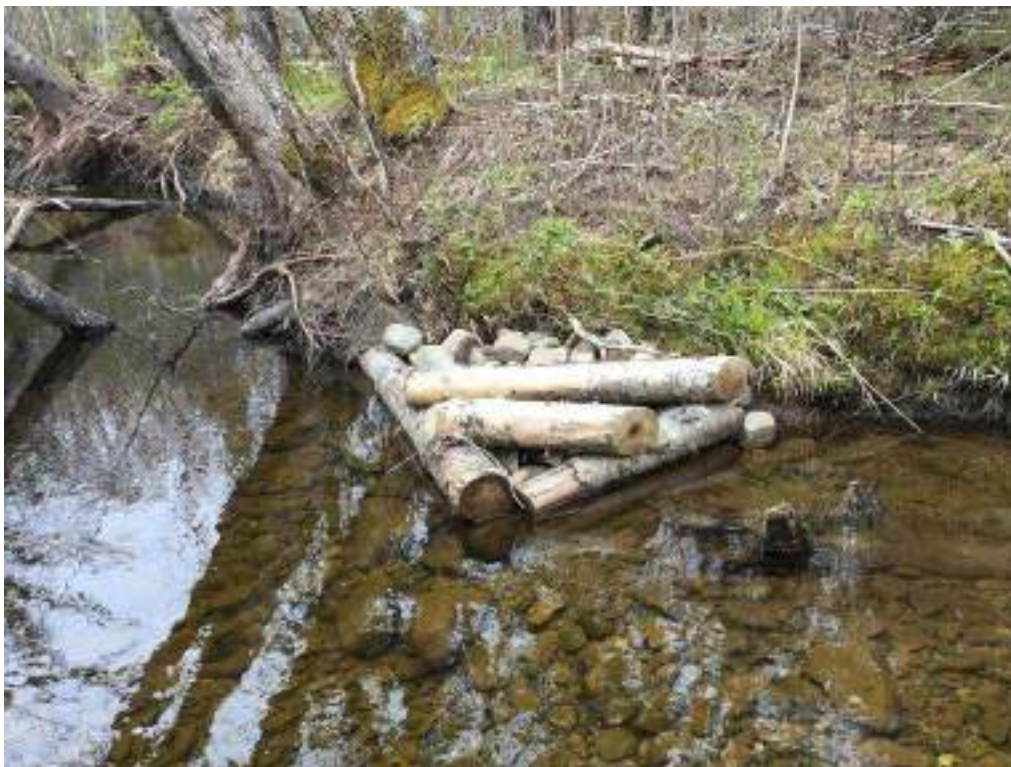
Figure 222. Structure #36 Deflector - didn't require any maintenance.

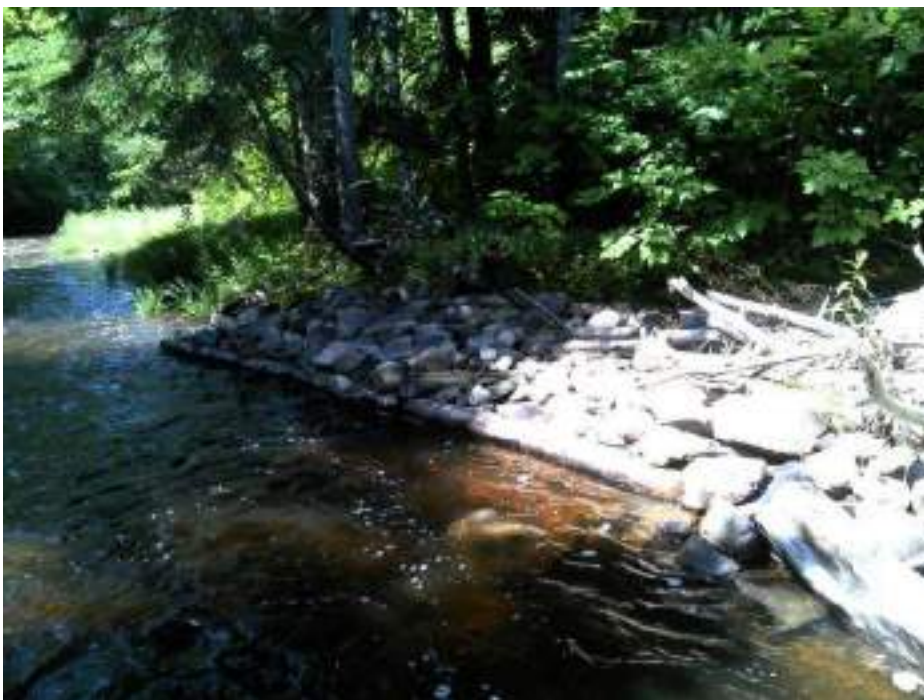
Figure 223. Structure #37 Deflector - before and after pictures of completed maintenance.

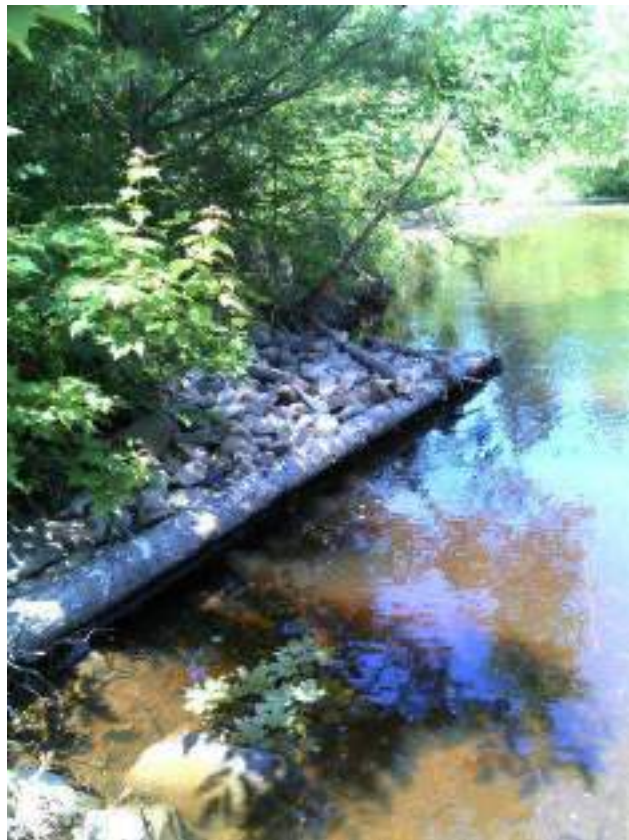
Figure 224. Structure #38 Deflector - before and after picture of completed maintenance.

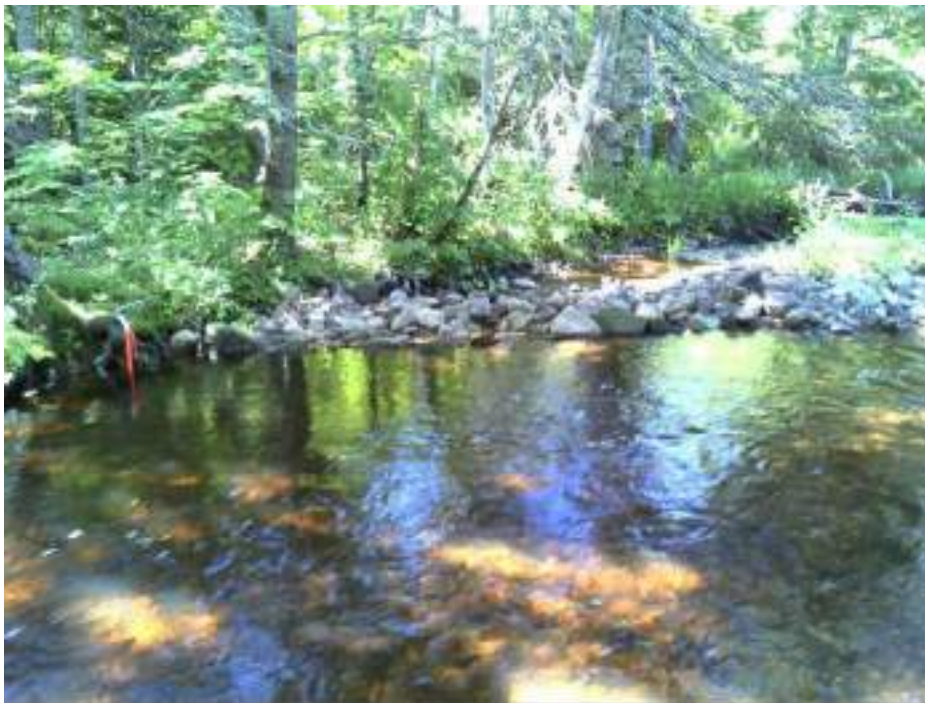
Figure 225. Structure #39 Channel Blocker constructed with rocks - before and after pictures of completed maintenance.

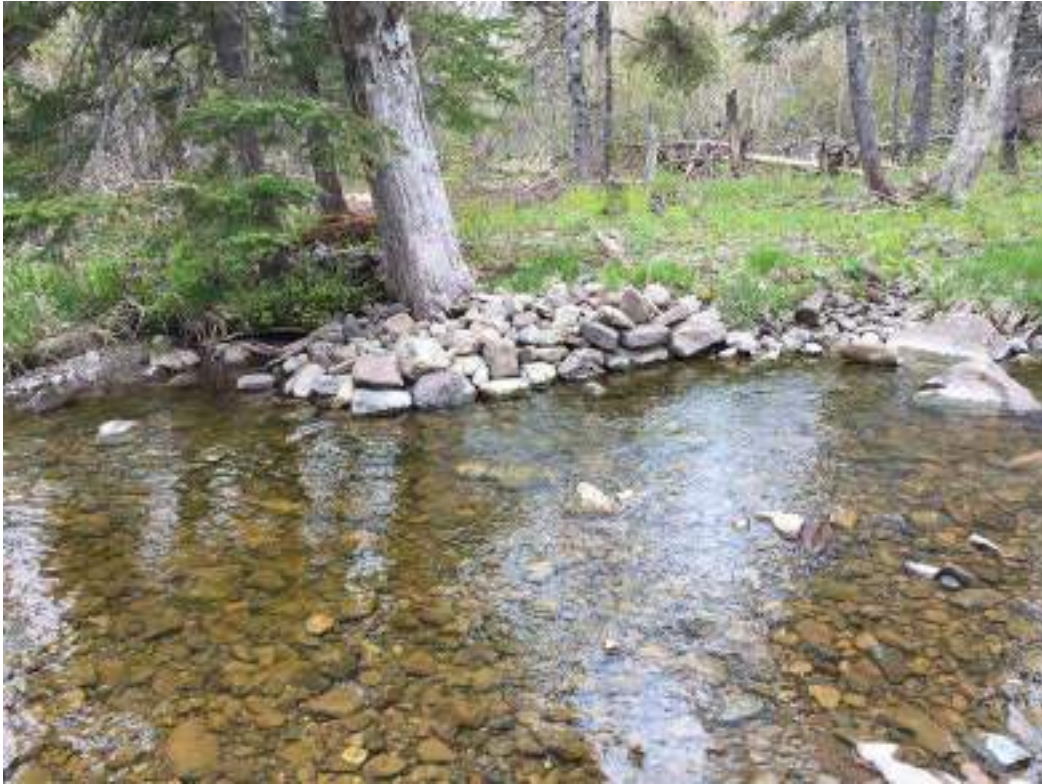
Figure 226. Structure #40 Bank Rock - no maintenance required.

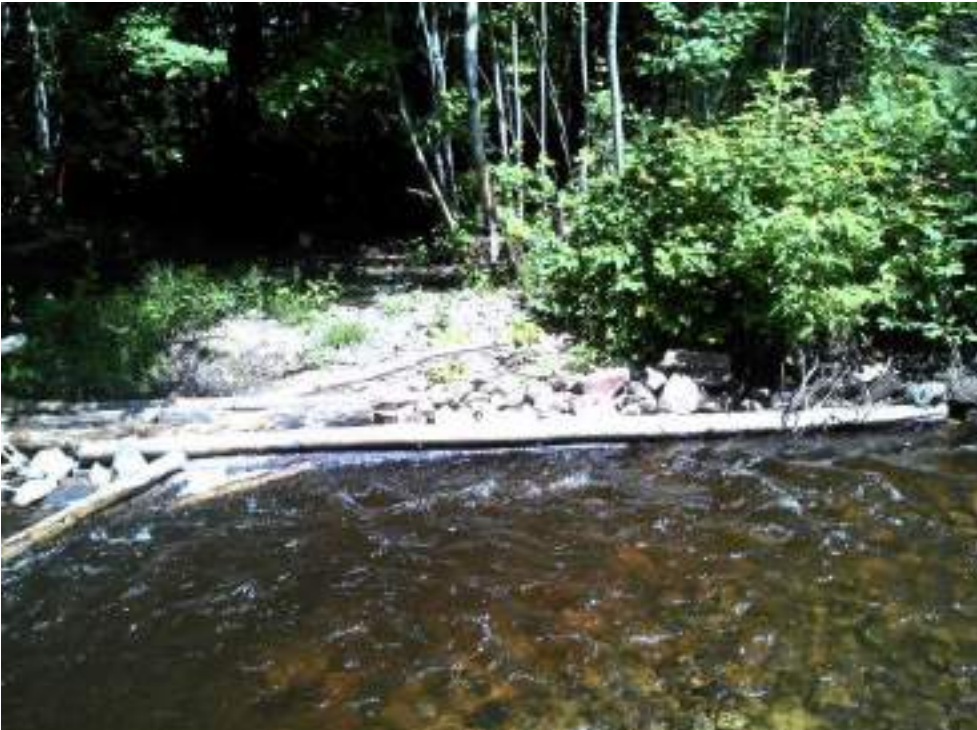
Figure 227. Structure #41 Two Tier Channel Blocker - before and after picture of completed maintenance.

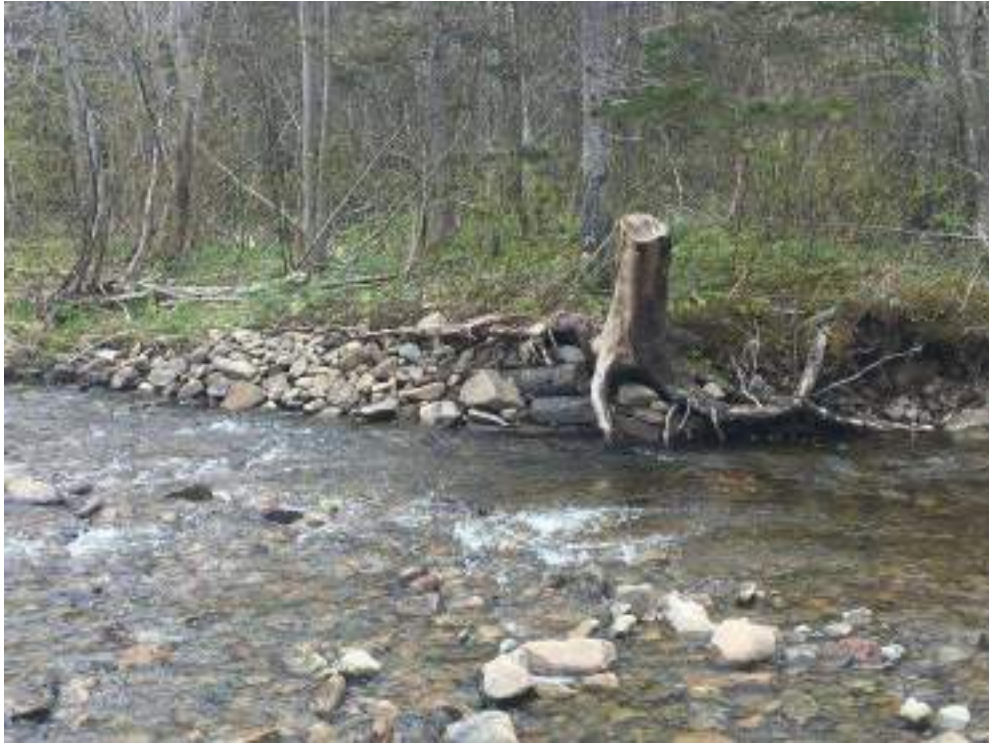
Figure 229. Structure #43 Bank Rock - no maintenance required.

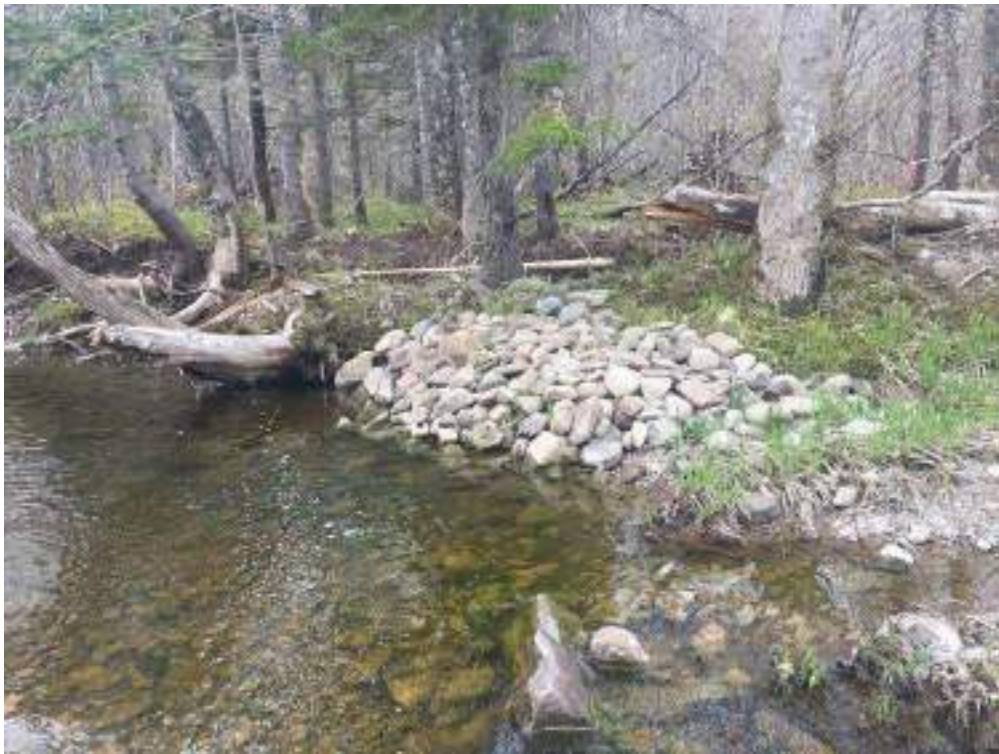
Figure 230. Structure #44 Bank Rock - no maintenance required.

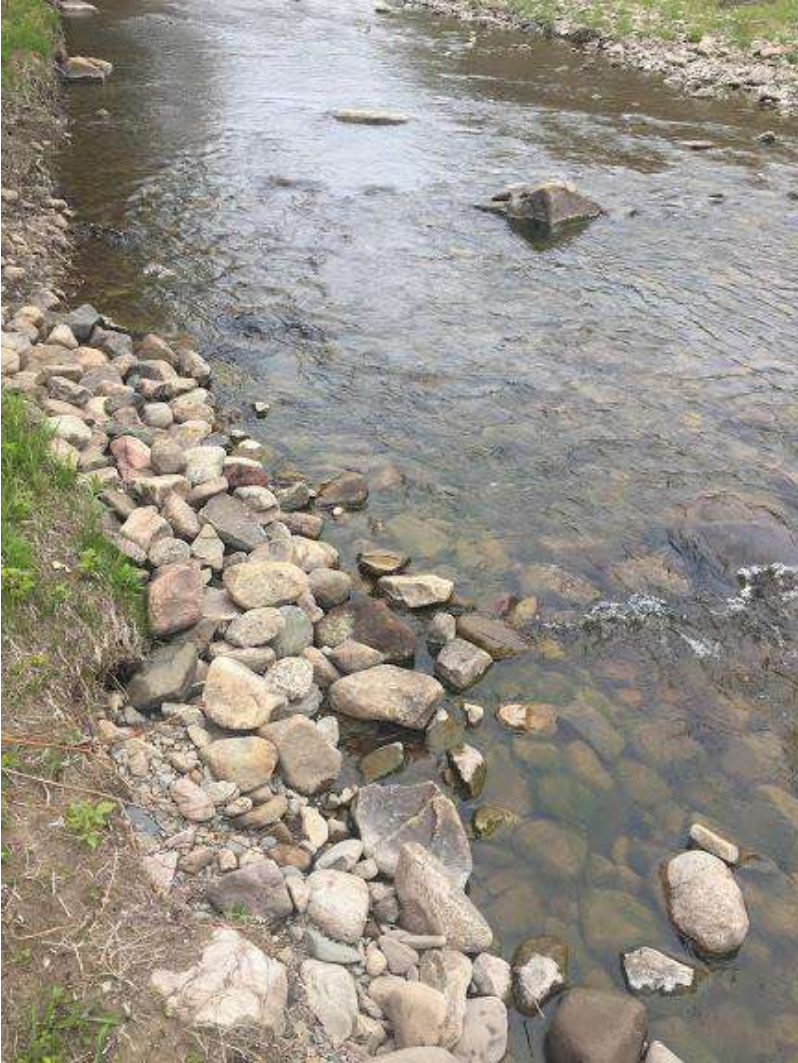
The photos below show the upstream structures from MacDonald Bridge on Campbells Road. No maintenance was done due to the poor condition of the structures. Bank rock remained in good condition, but the deflector structures had blown out over the winter months due to them not being braced in by logs and rebar. Each deflector and rock sill will require a full rebuild.

Figure 231. Structure #45 Deflector - requires full rebuild.

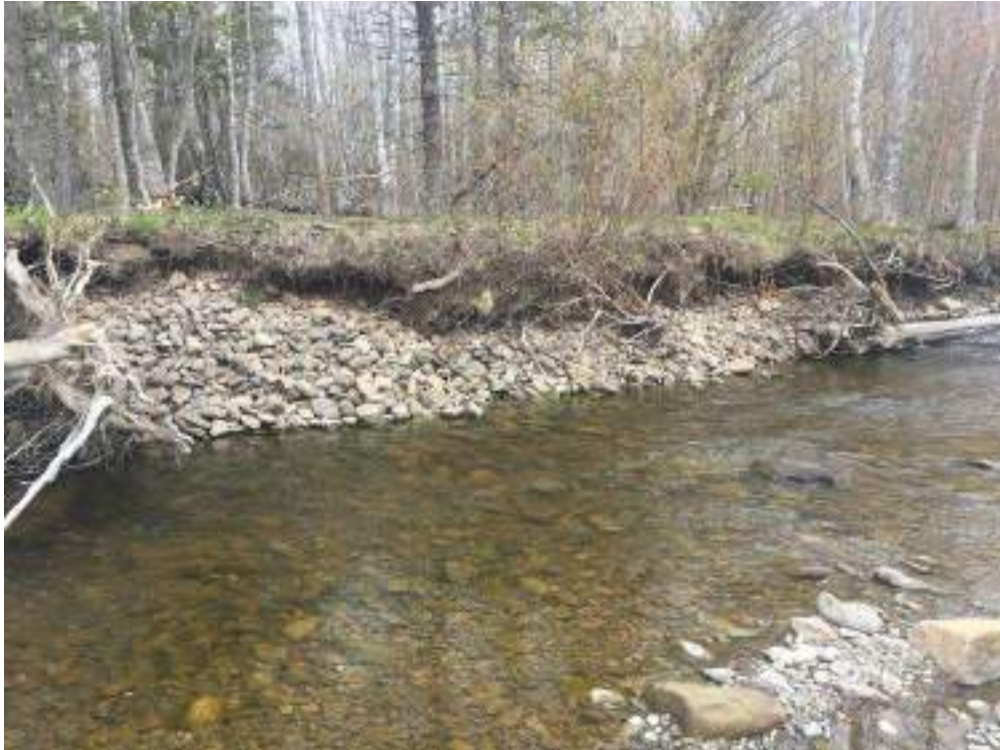
Figure 232. Structure #46 Bank Rock - no maintenance required.

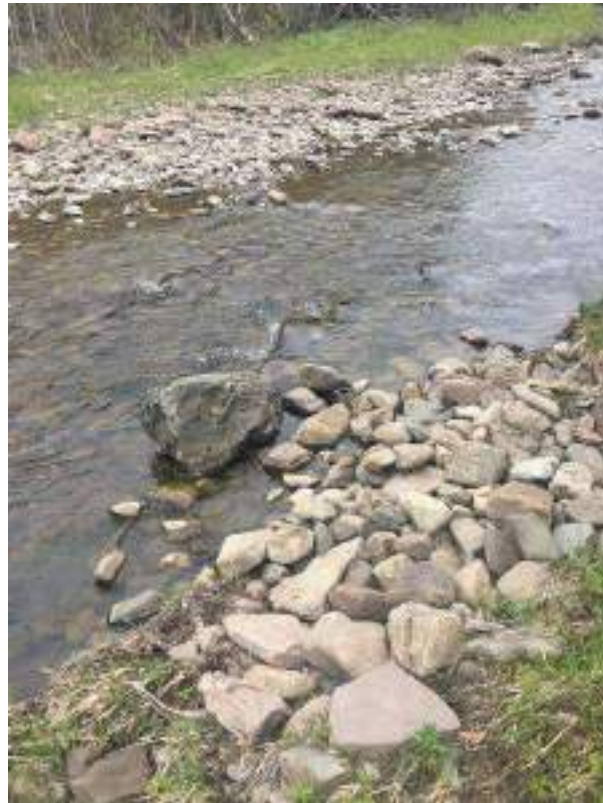
Figure 233. Structure #47 Deflector - requires full rebuild.

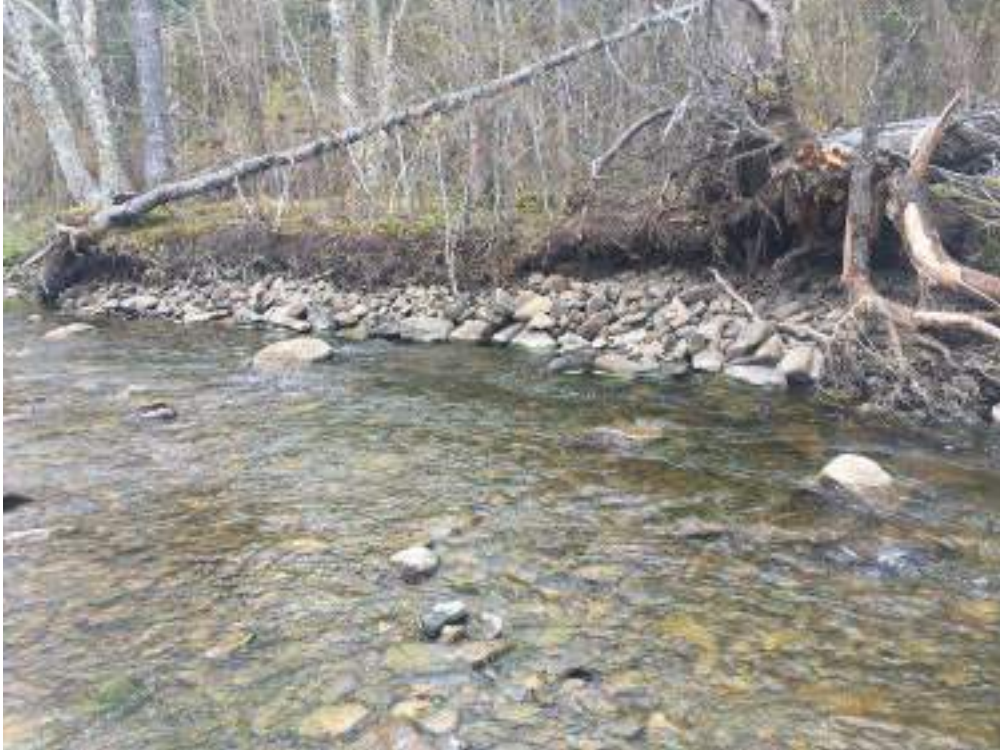
Figure 234. Structure #48 Bank Rock - no maintenance required.

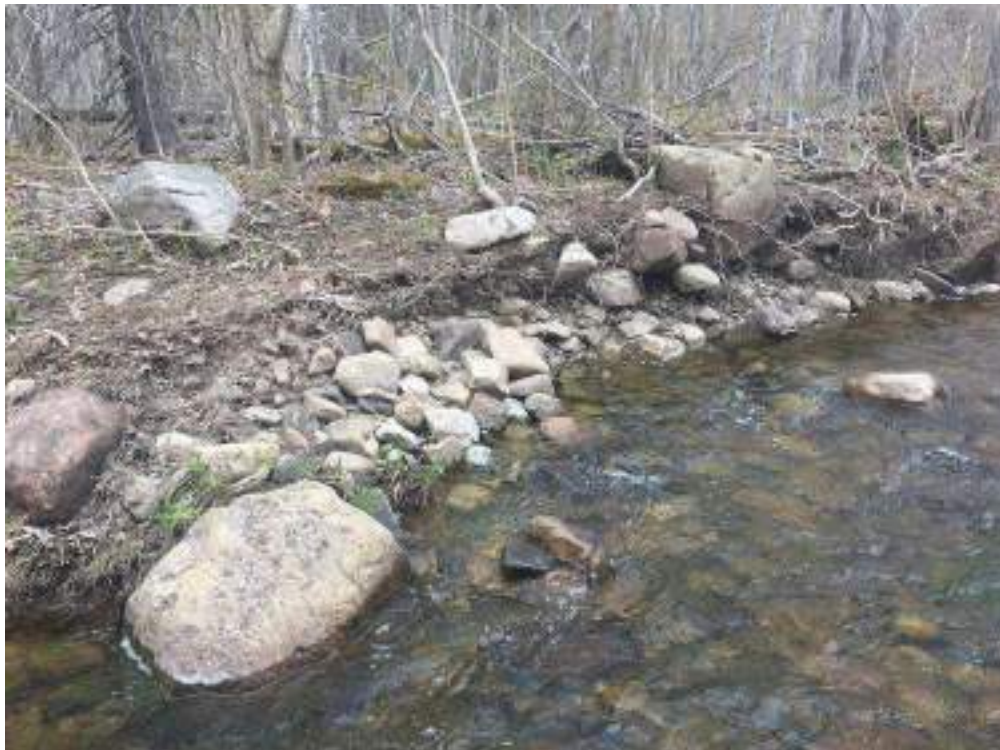
Figure 235. Structure #49 Deflector - requires full rebuild.

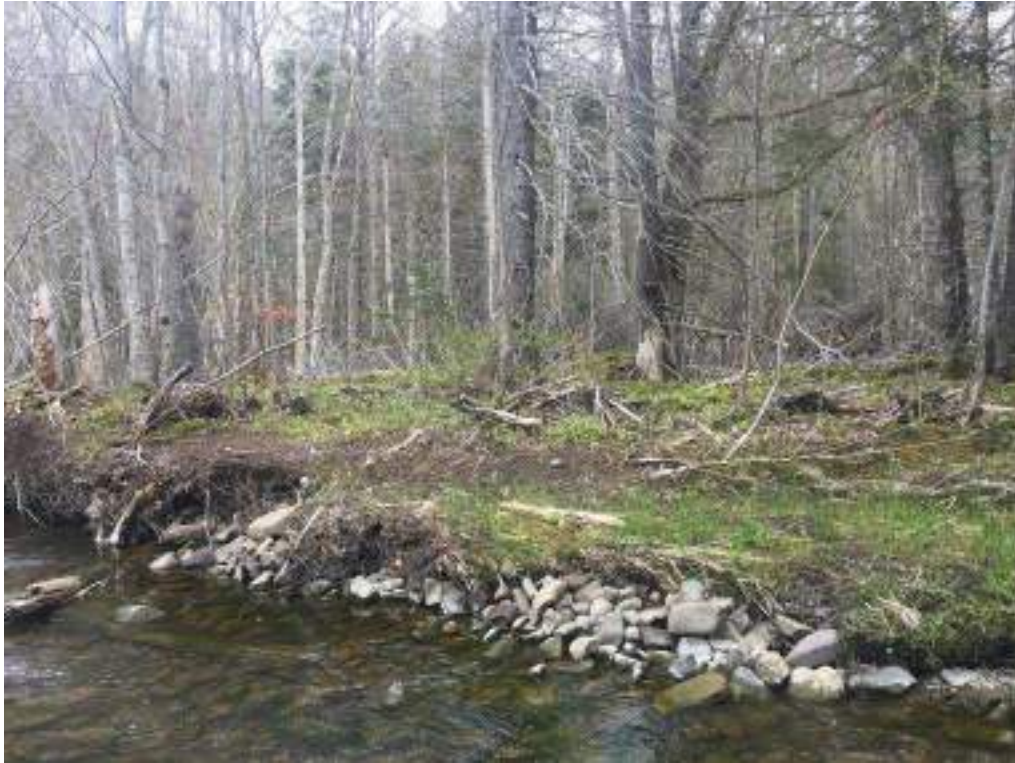
Figure 236. Structure #50 Bank Rock - no maintenance required.

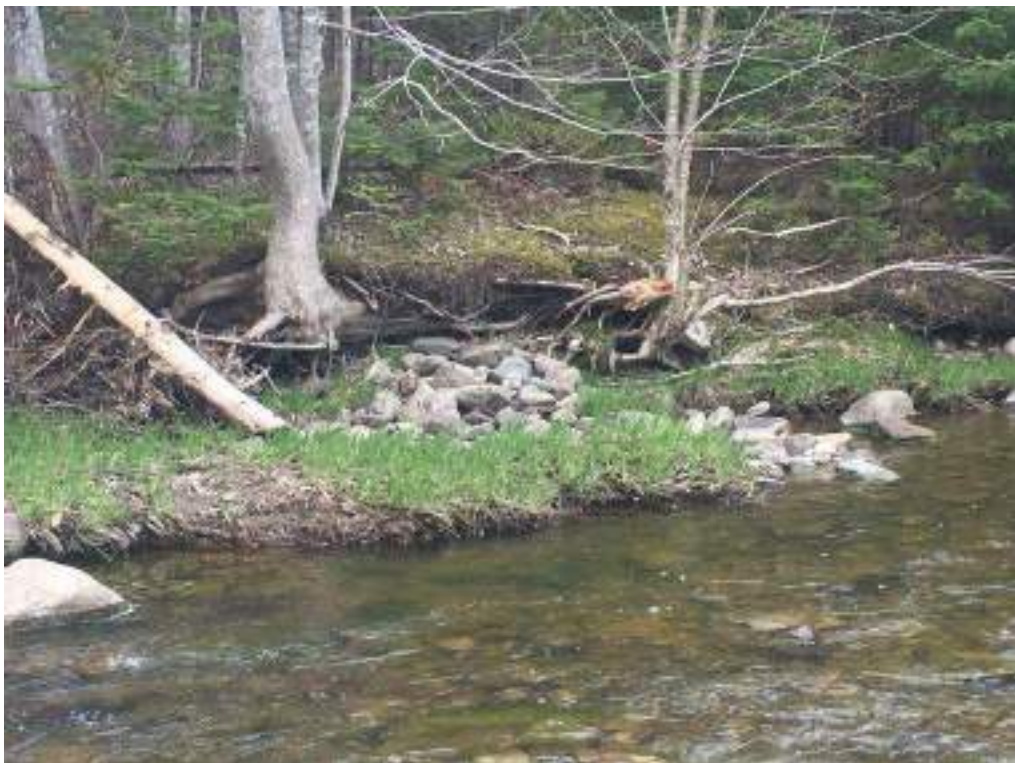
Figure 237. Structure #51 Bank Rock - no maintenance required.

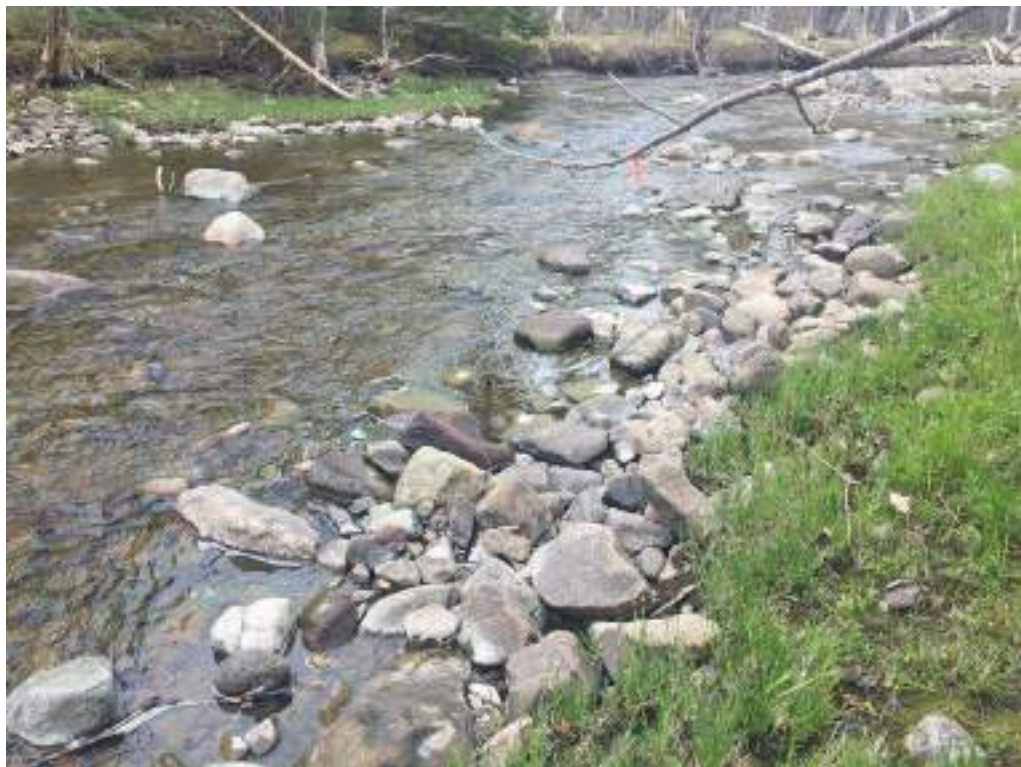
Figure 239. Structure #53 Deflector - requires a full rebuild.

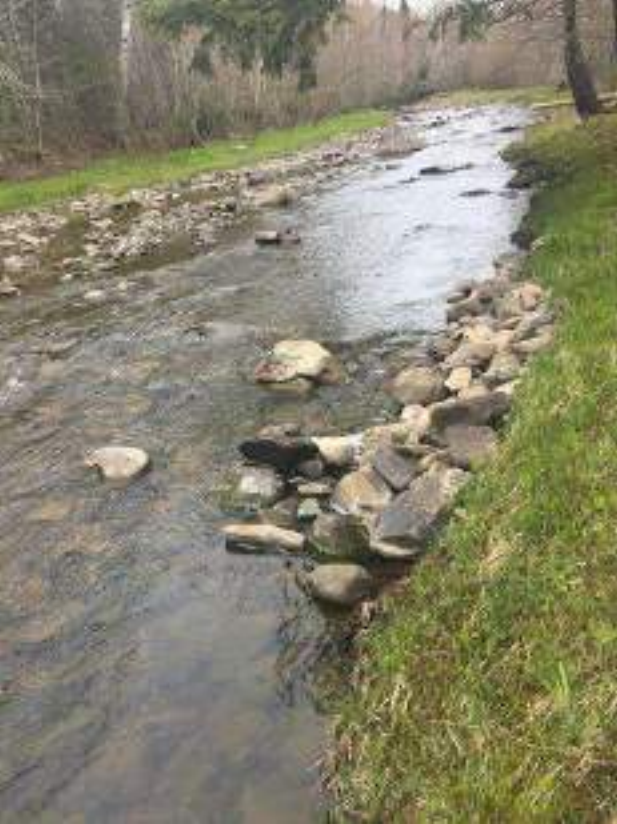
Figure 240. Structure #54 Deflector - requires a full rebuild.

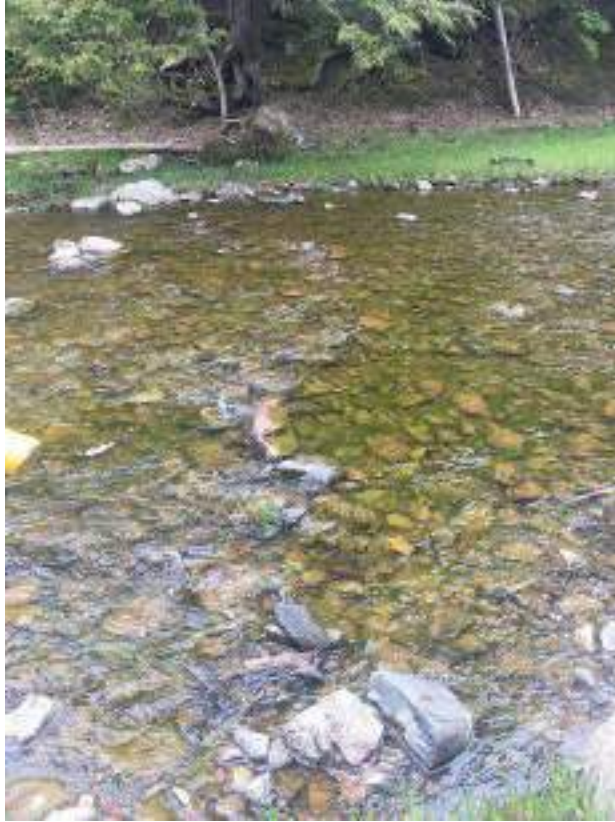
Figure 242. Structure #56 Rock Sill - requires maintenance.

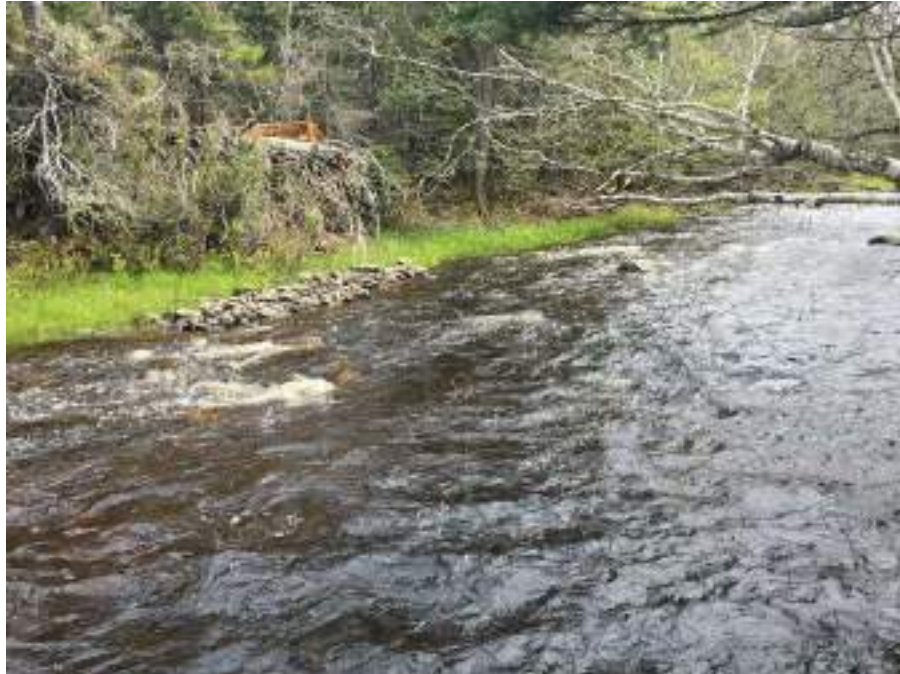
The photos below show the structures upstream from the bridge at the bottom of Campbell's Road. Most of the structures are deflectors and are blown out due to them not being braced in with logs and rebar. Each deflector will require a full rebuild.

Figure 243. Structure #57 Deflector - upstream from the bottom of Campbells road. This structure needs to be rebuilt.

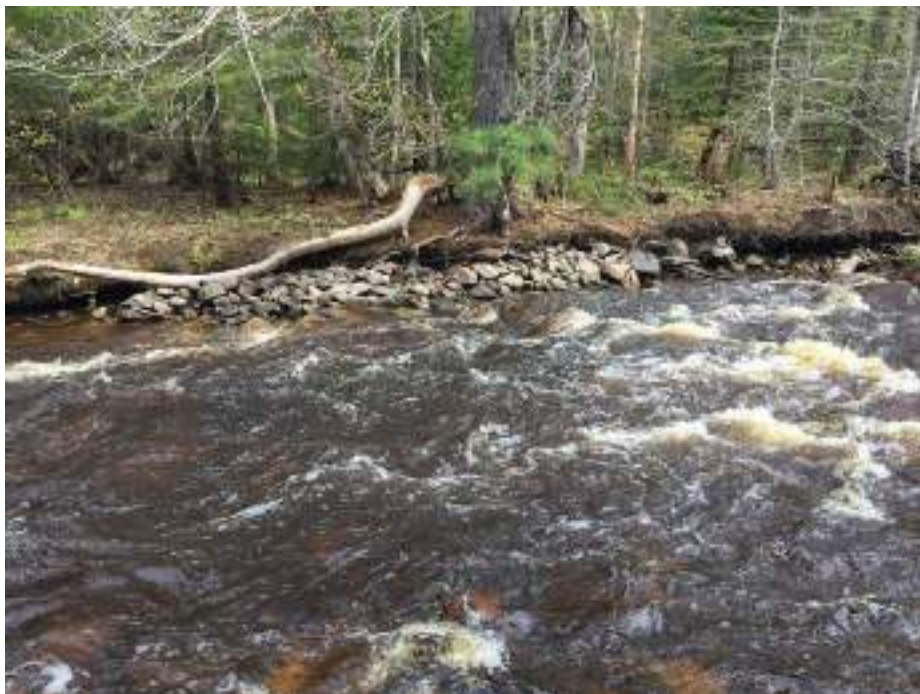
Figure 244. Structure #58 Deflector - requires a rebuild.

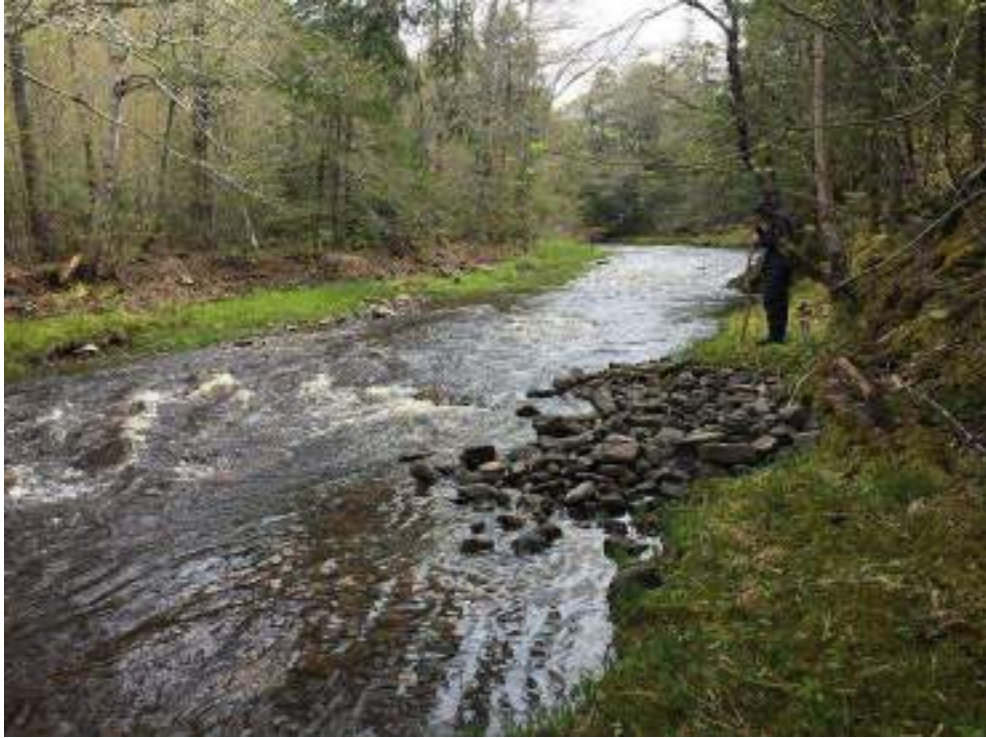
Figure 245. Structure #59 Double Deflectors - requires a rebuild.

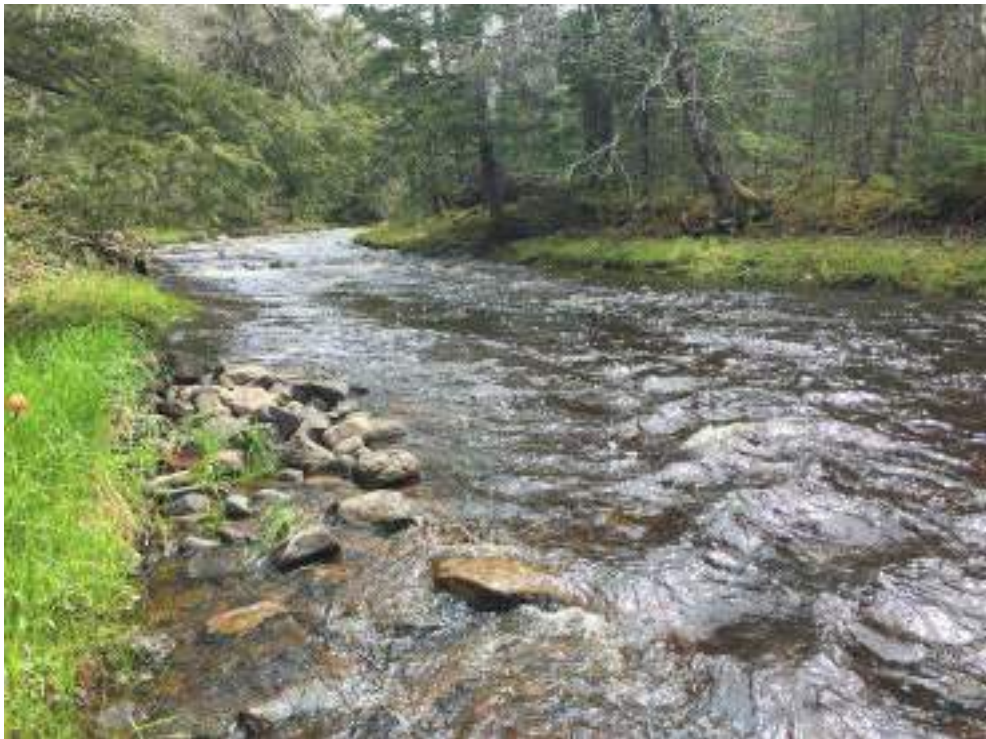
Figure 246. Structure #60 Double Deflectors - requires a rebuild.
