SALMONID HABITAT RESTORATION

INVERNESS SOUTH ANGLERS ASSOCIATION

Progress Report

Monday, June 12th, 2017

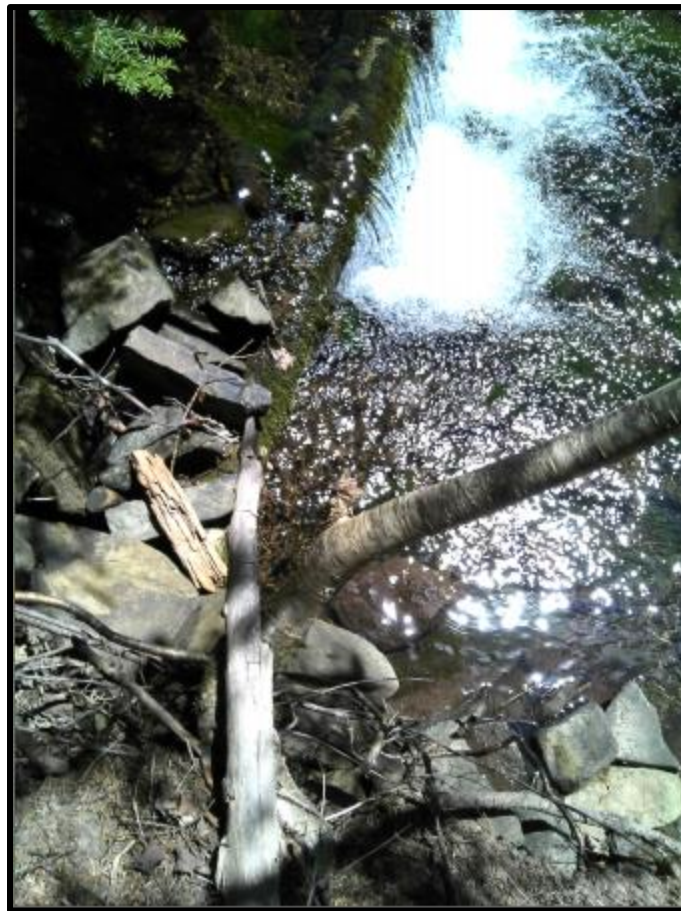
Way Point 57: Digger Log

Figure 17. Digger Log structure on the Glendyre River.

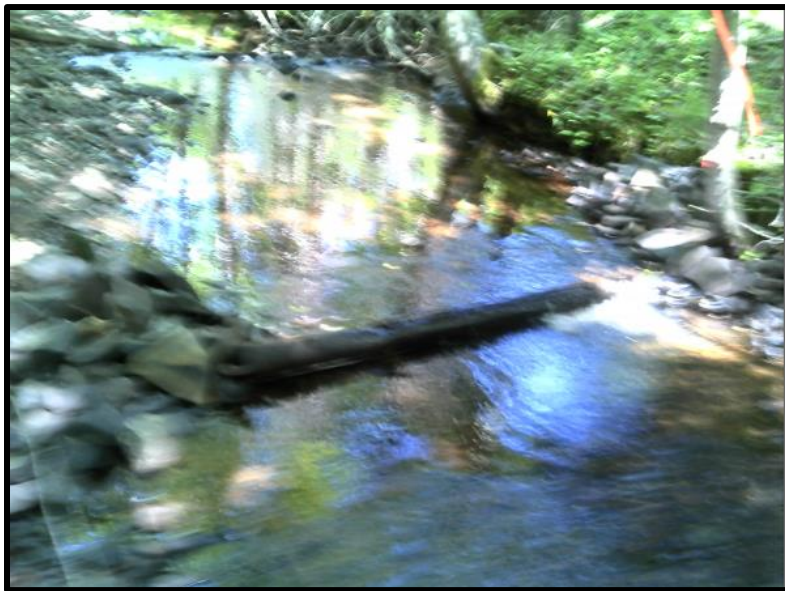
Way Point 39 – Digger Log

Figure 49. Before picture of a digger log structure.

Figure 50. An after picture of the digger log structure for waypoint 39.

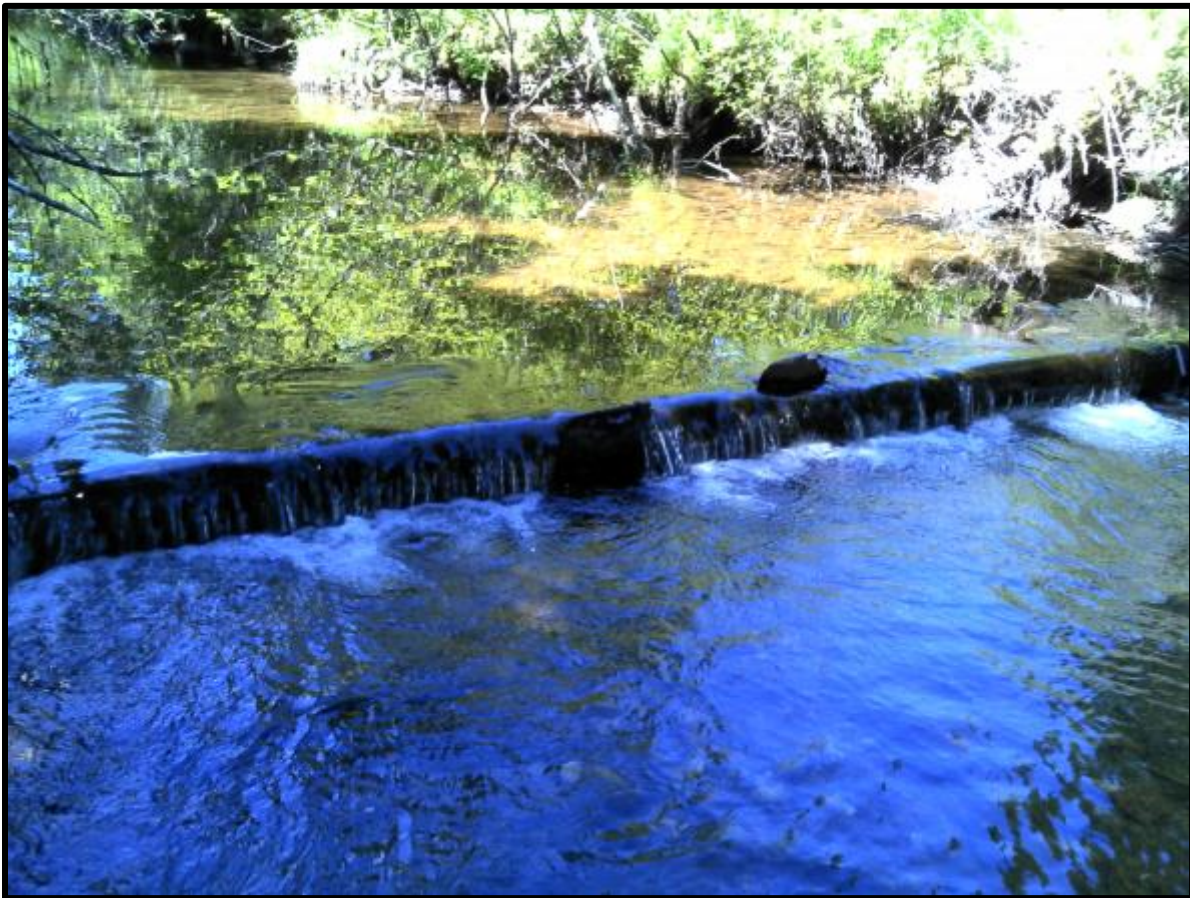
Way Point 146 – Digger Log

Figure 63. Digger log for waypoint 146.

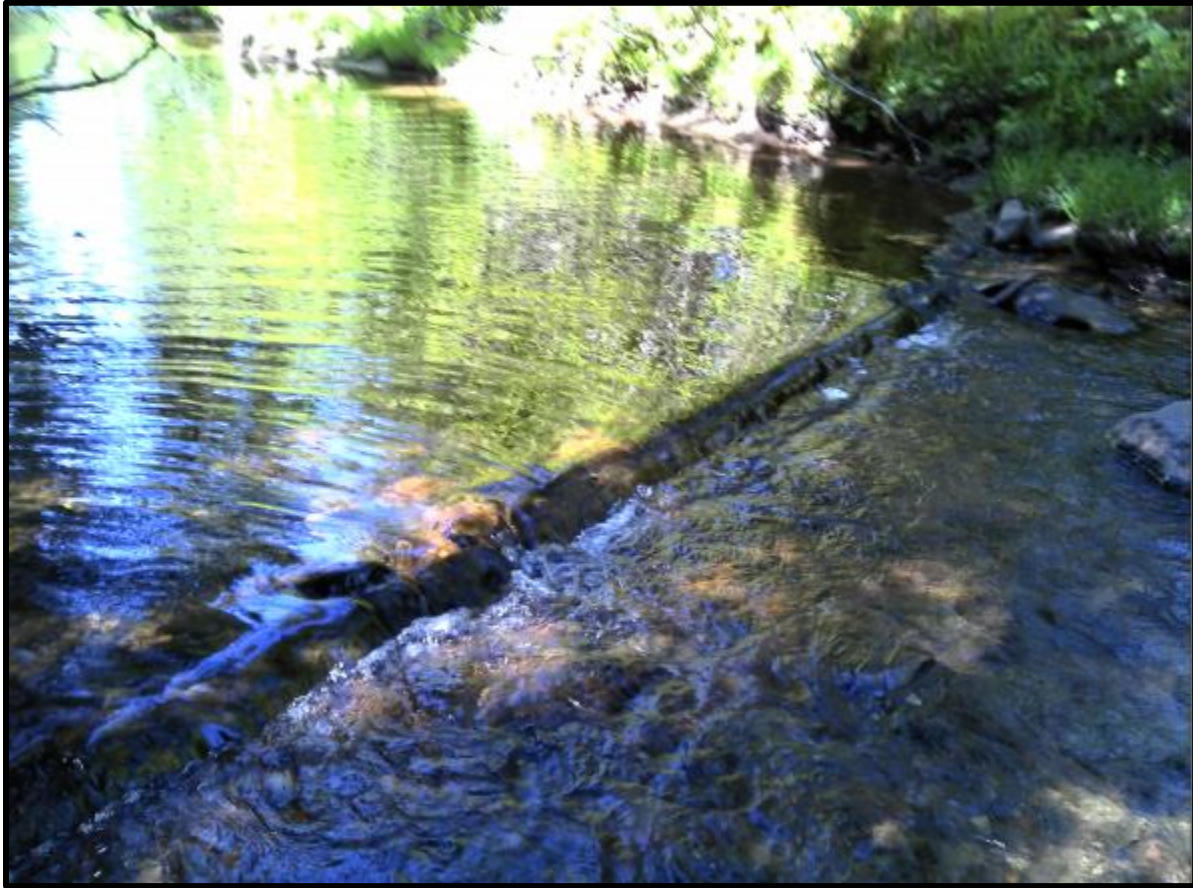
Way Point 147 – Digger Log

Figure 64. Digger log for waypoint 147.

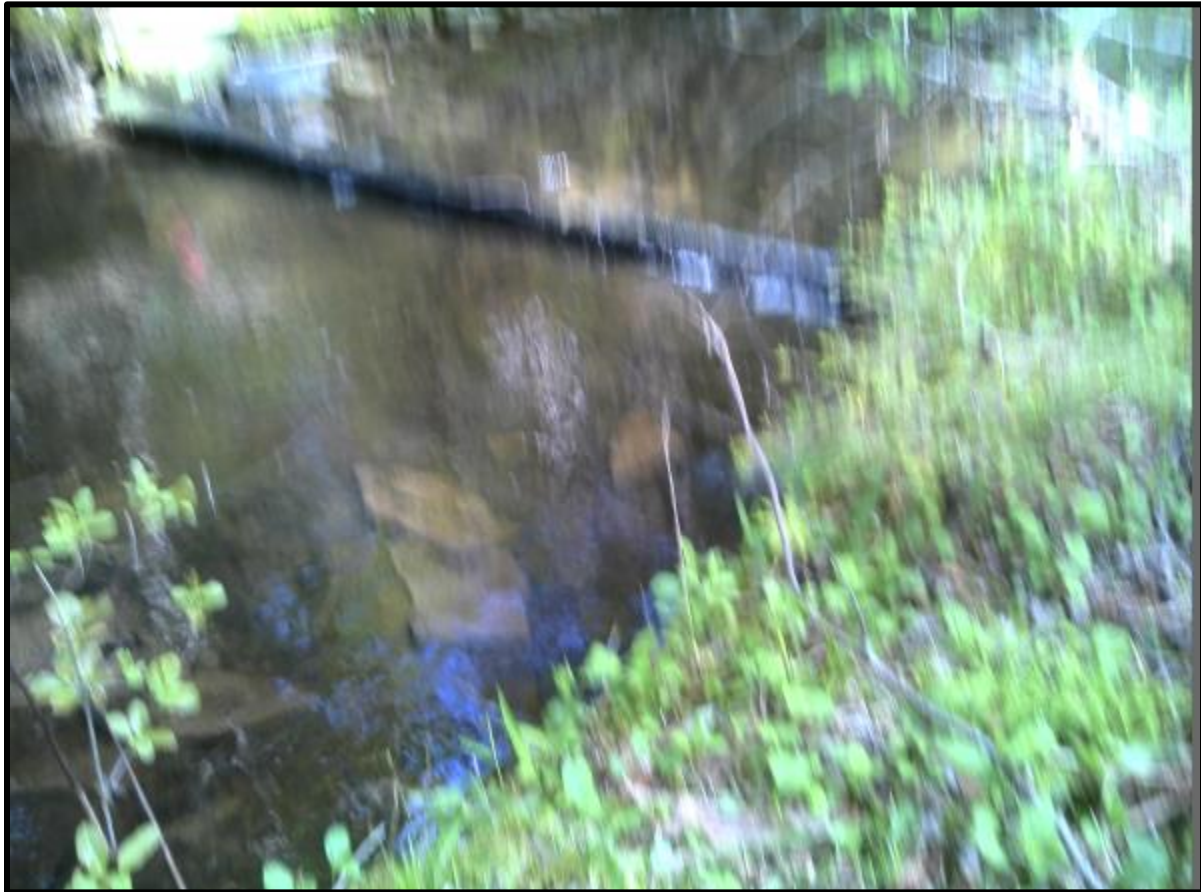
Way Point 123 – Digger Log

Figure 80. Digger Log at waypoint 123.

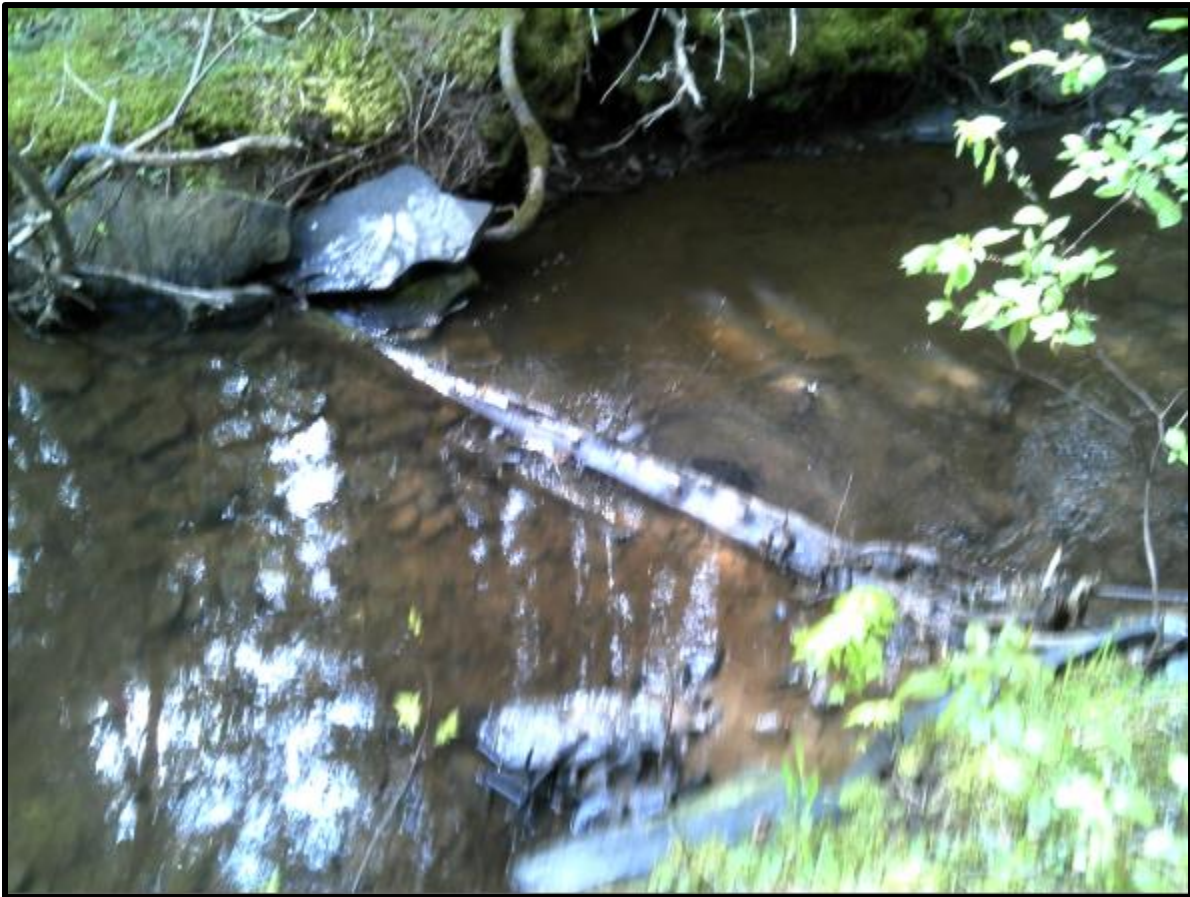
Way Point 131 – Digger Log

Figure 85. Digger Log Structure at way point 131.

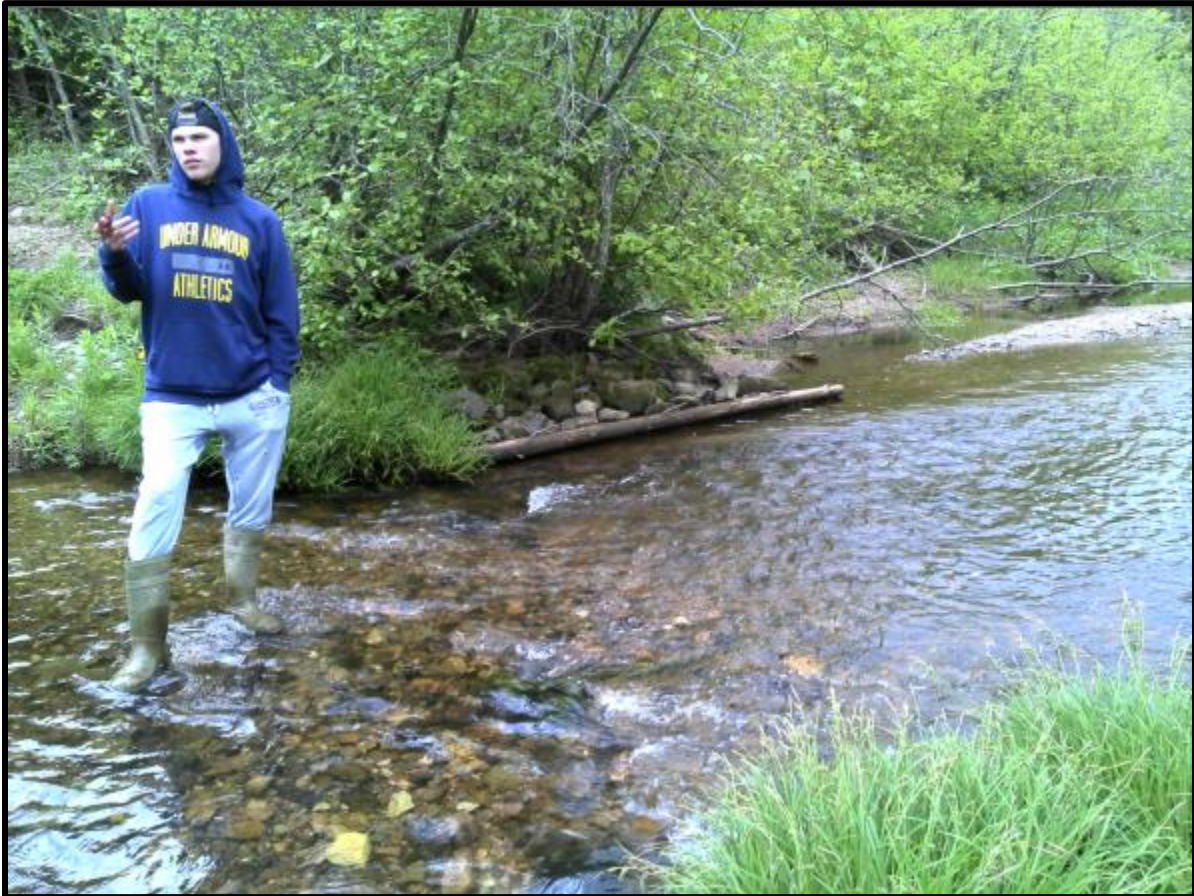
Way Point 135 – Deflector

Figure 88. Deflector at waypoint 135.

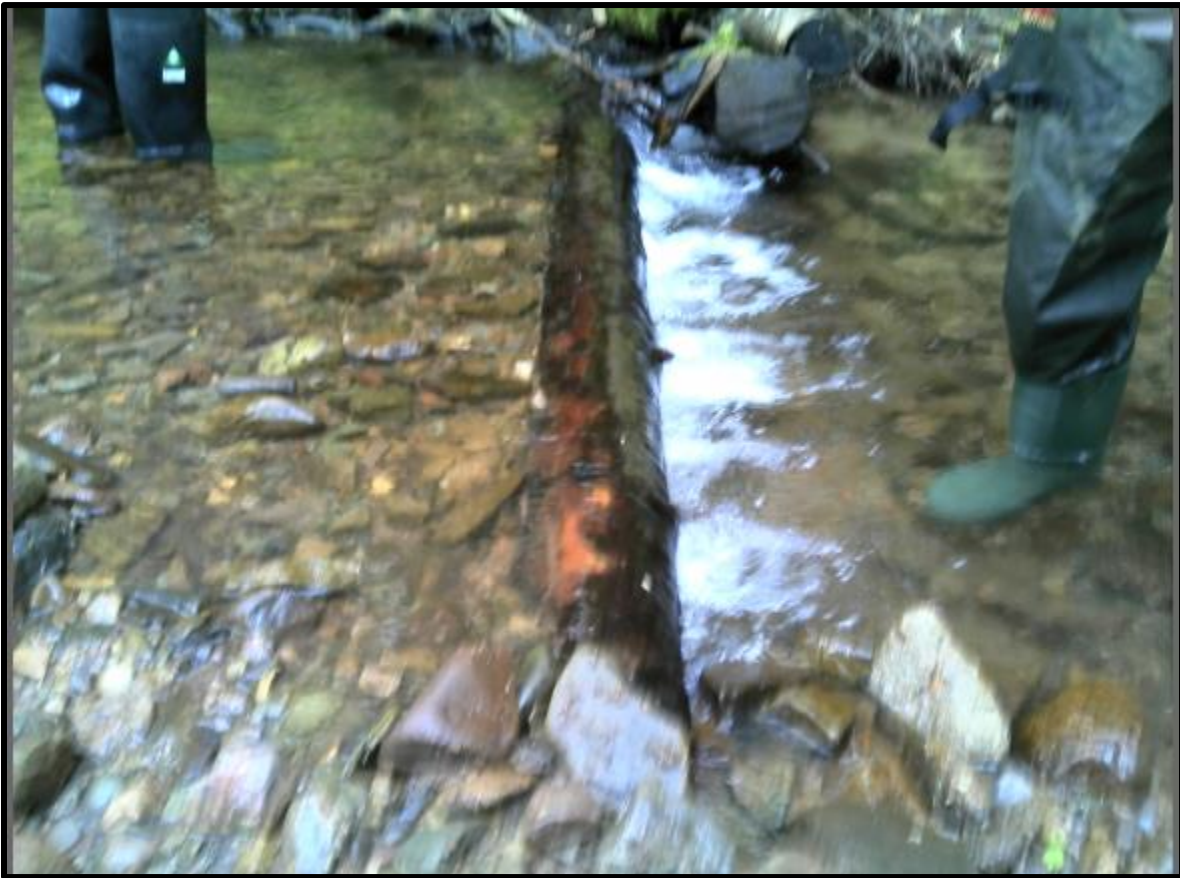
Way Point 85 – Digger Log

Figure 100. Digger Log at waypoint 85.

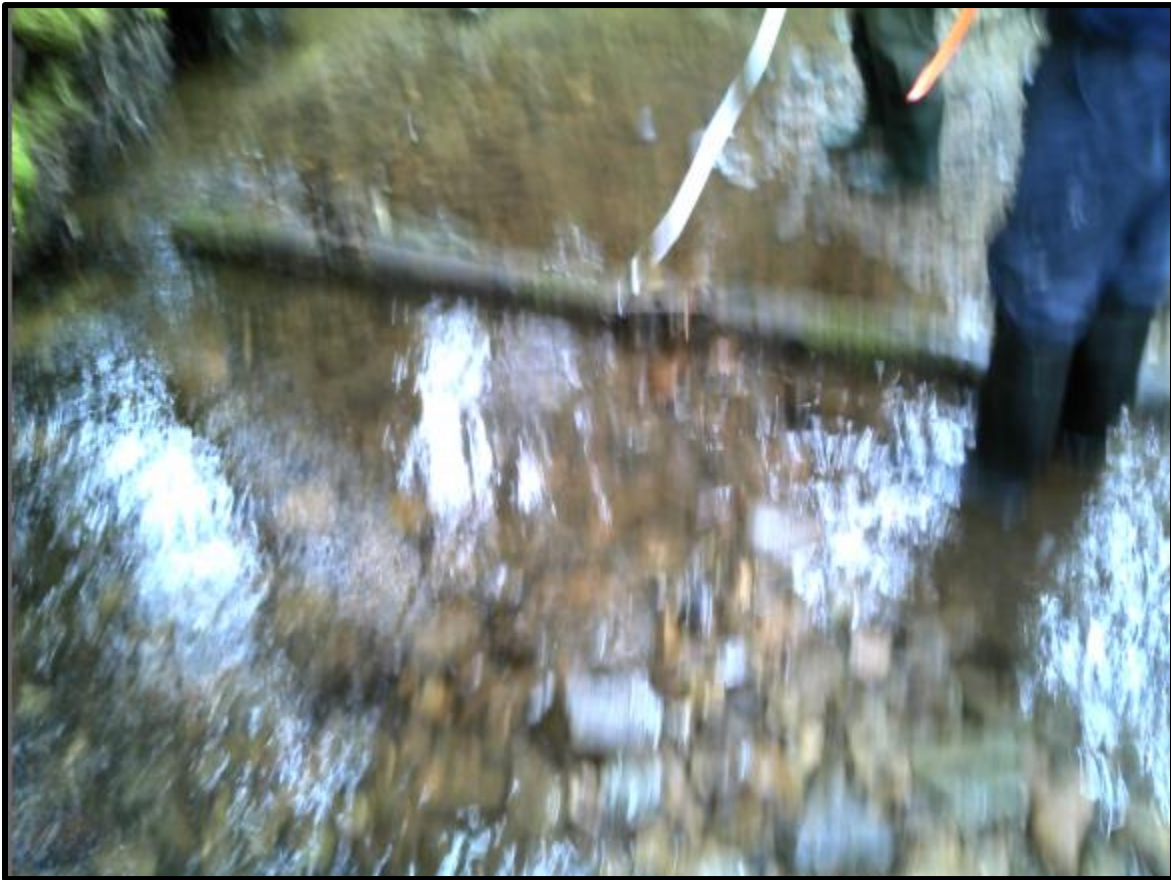
Way Point 90 – Digger Log

Figure 105. Digger Log at waypoint 90.

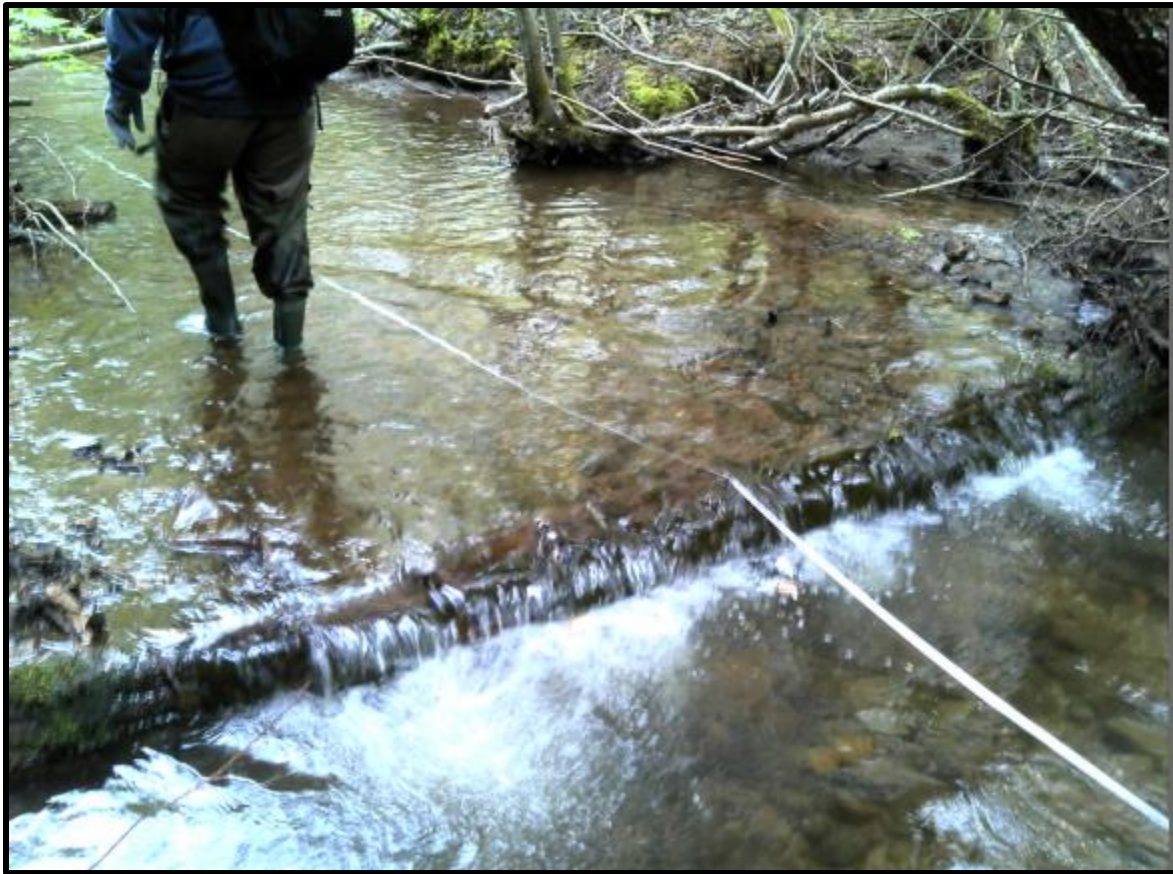
Way Point 91 – Digger Log

Figure 106. Digger Log at waypoint 91.

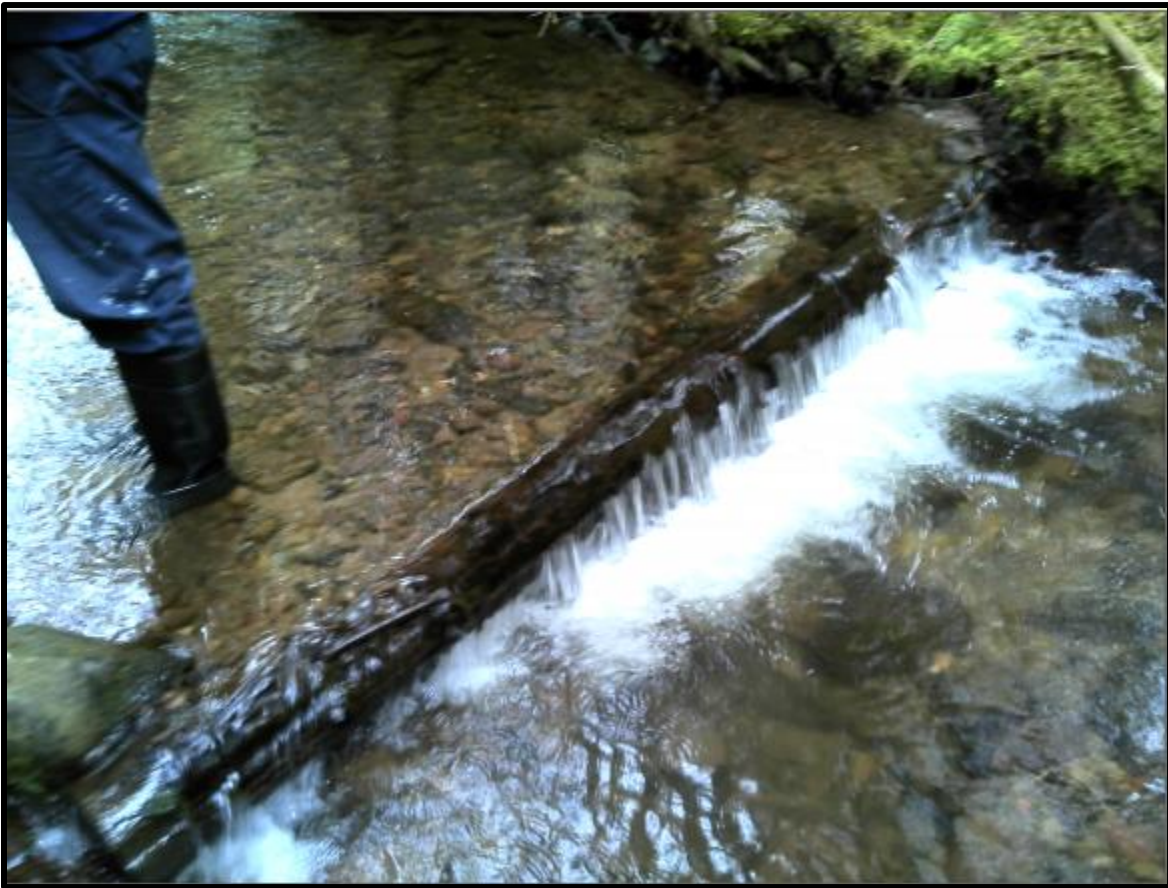
Way Point 92 – Digger Log

Figure 107. Digger Log at waypoint 92.

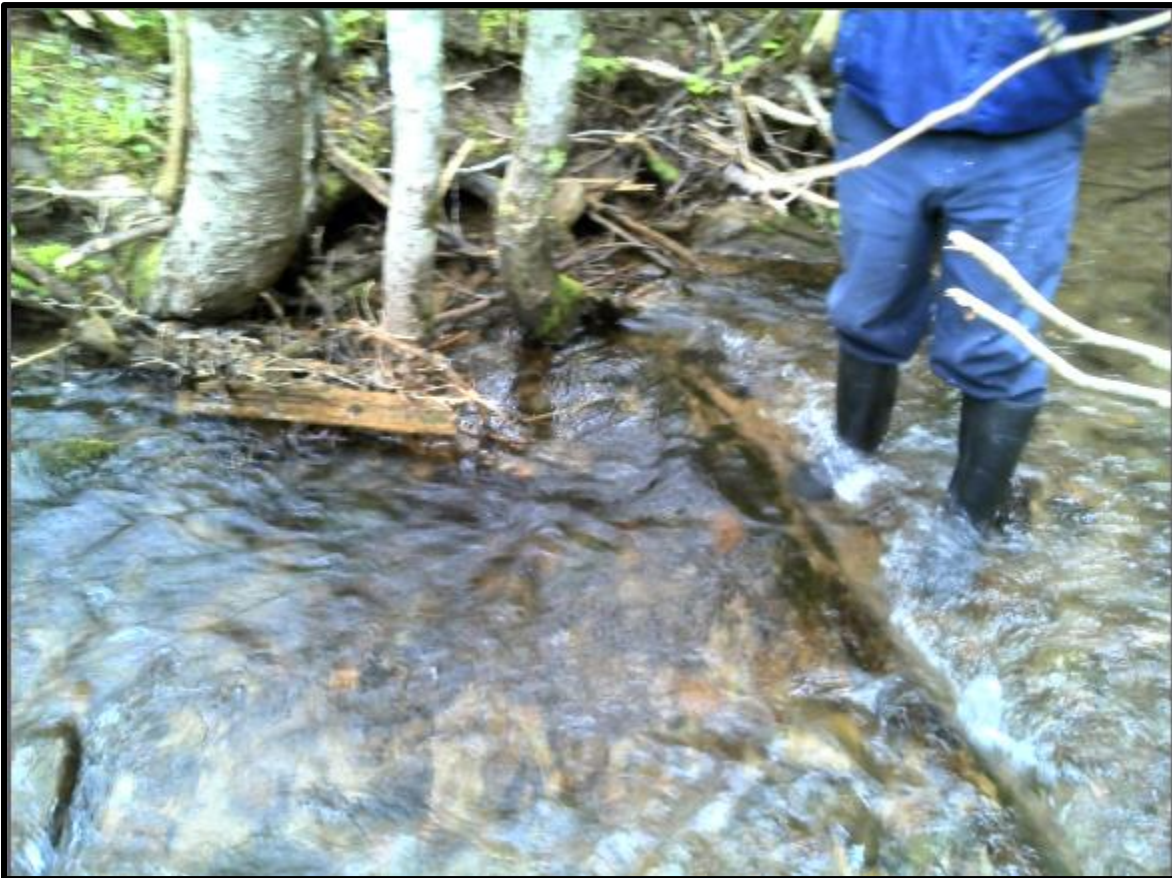
Way Point 93 – Digger Log

Figure 108. Digger Log at waypoint 93.

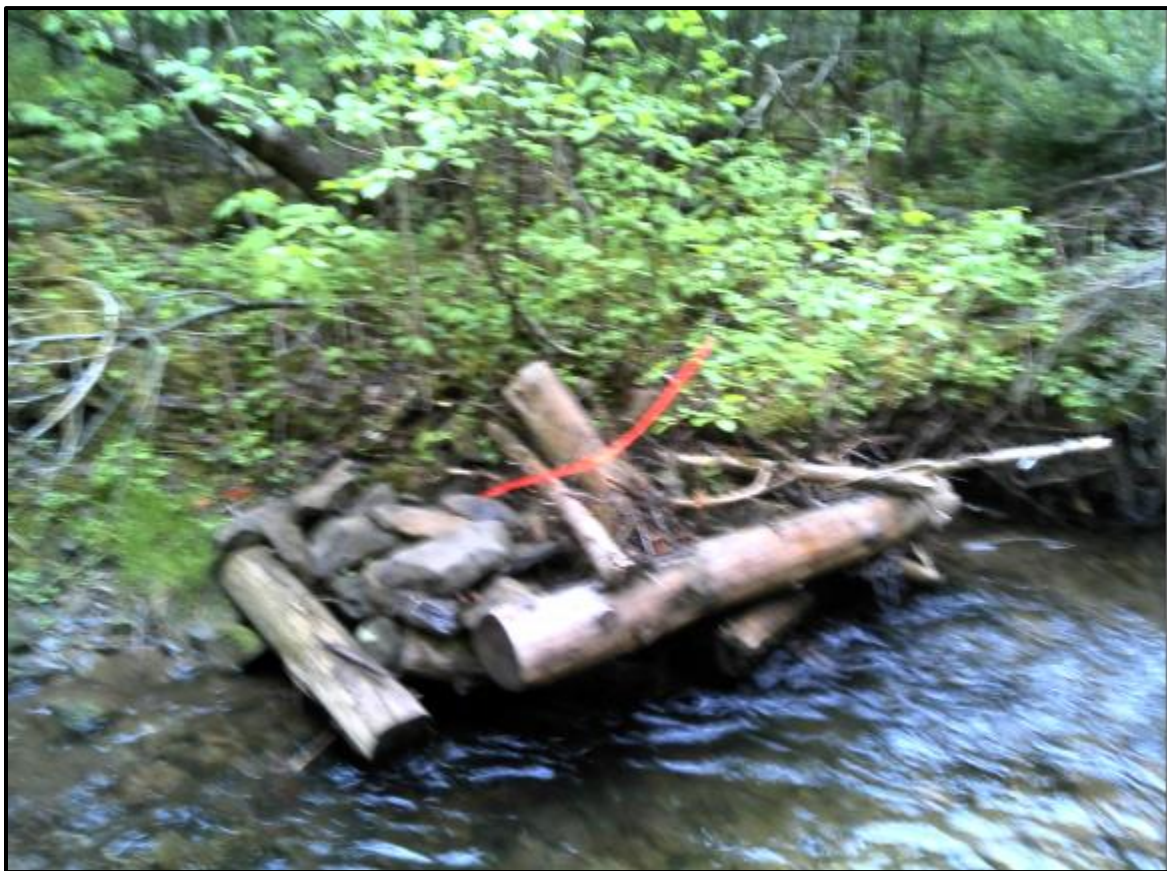
Way Point 94 – Deflector

Figure 109. Deflector at waypoint 94.

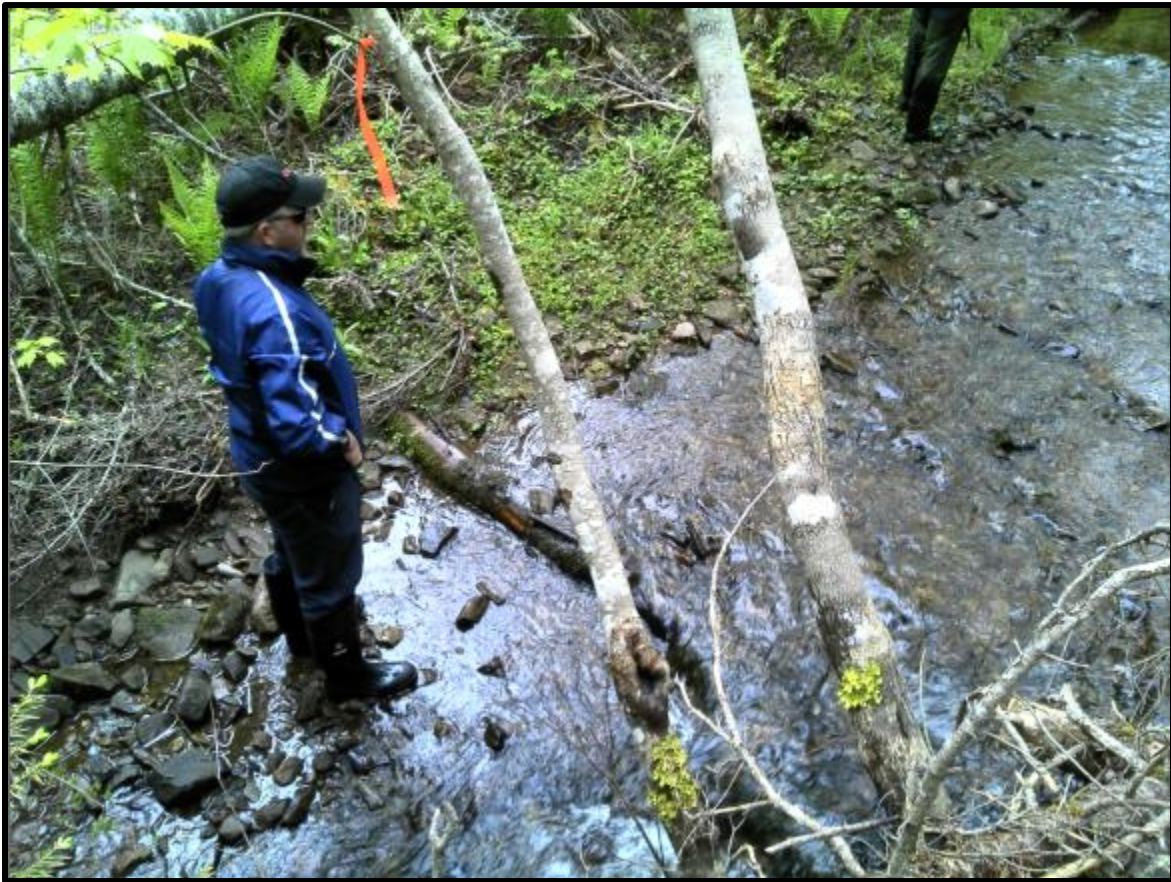
Way Point 95 – Digger Log

Figure 110. Digger Log at waypoint 95.

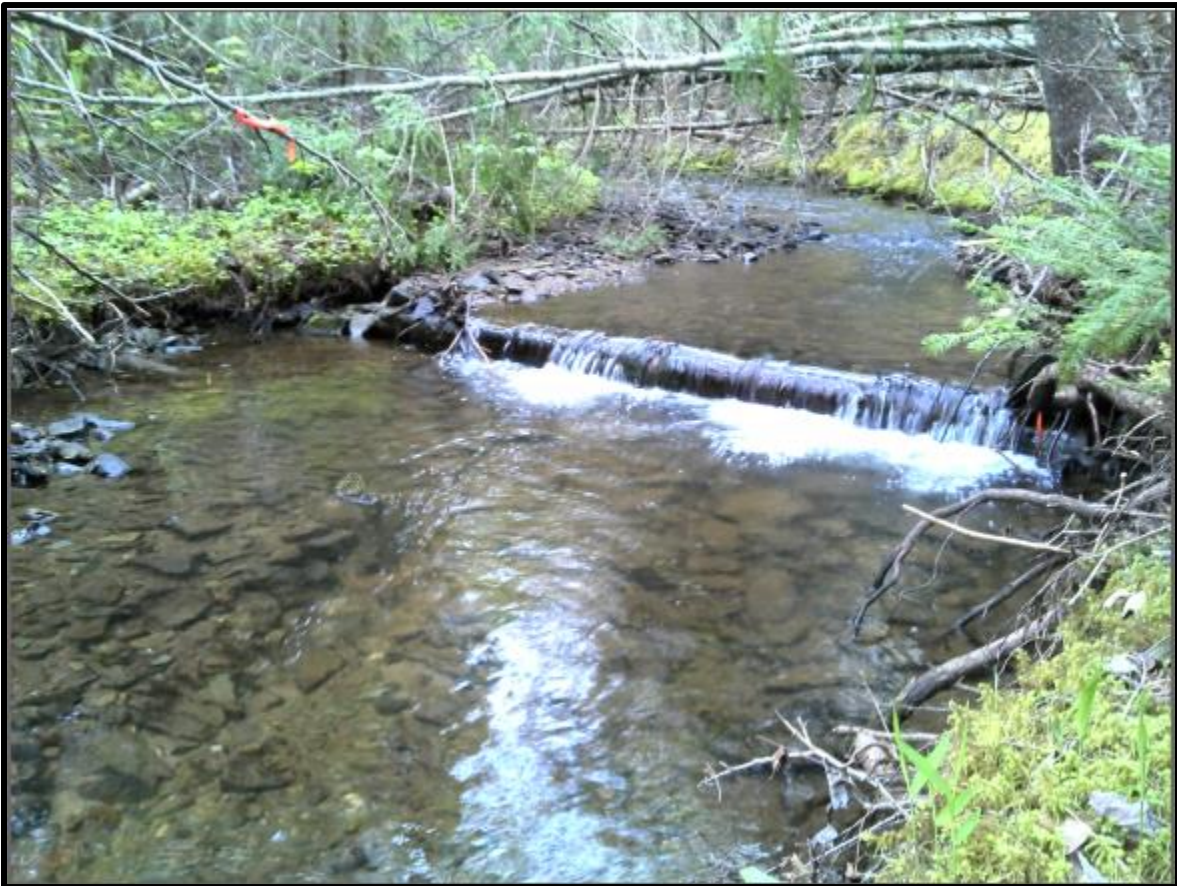
Way Point 98 – Digger Log

Figure 112. Digger log at waypoint 98.

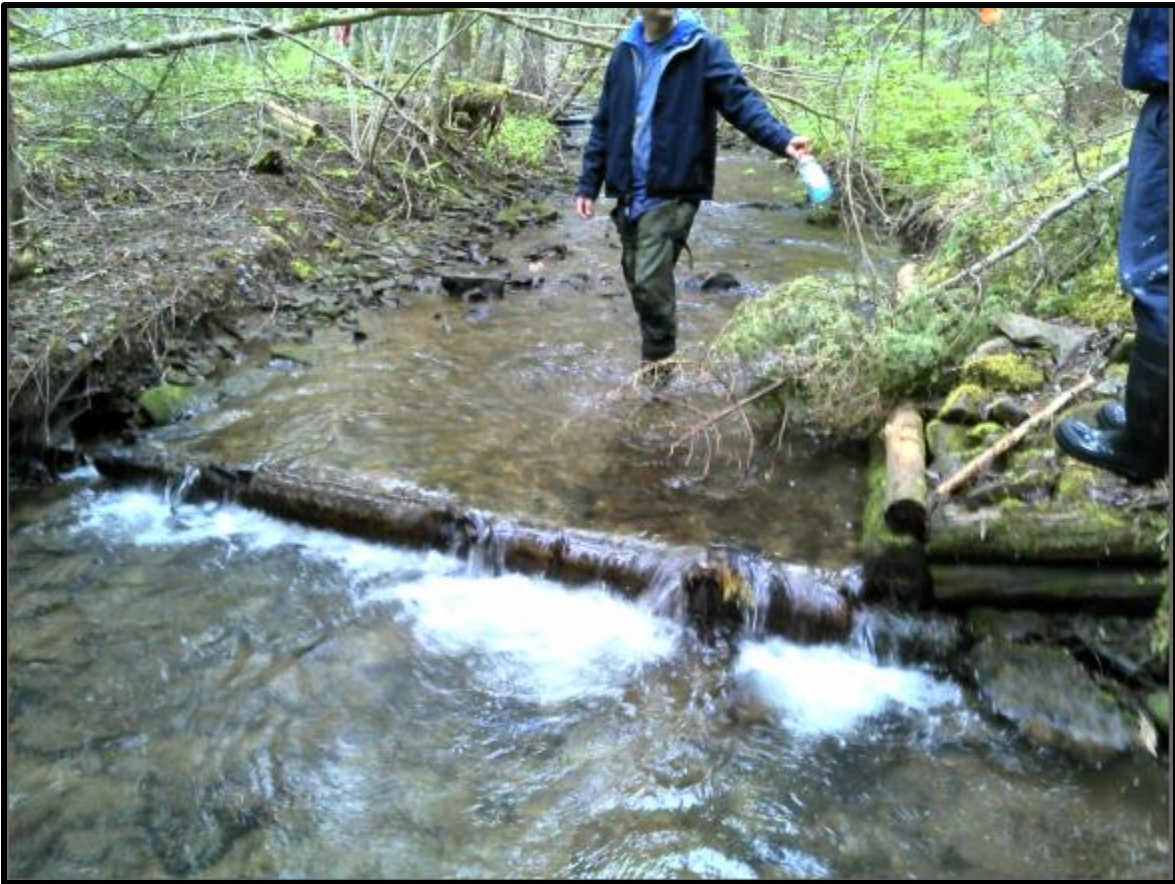
Way Point 99 – Digger Log and Deflector

Figure 113. Digger Log and Deflector at waypoint 99.

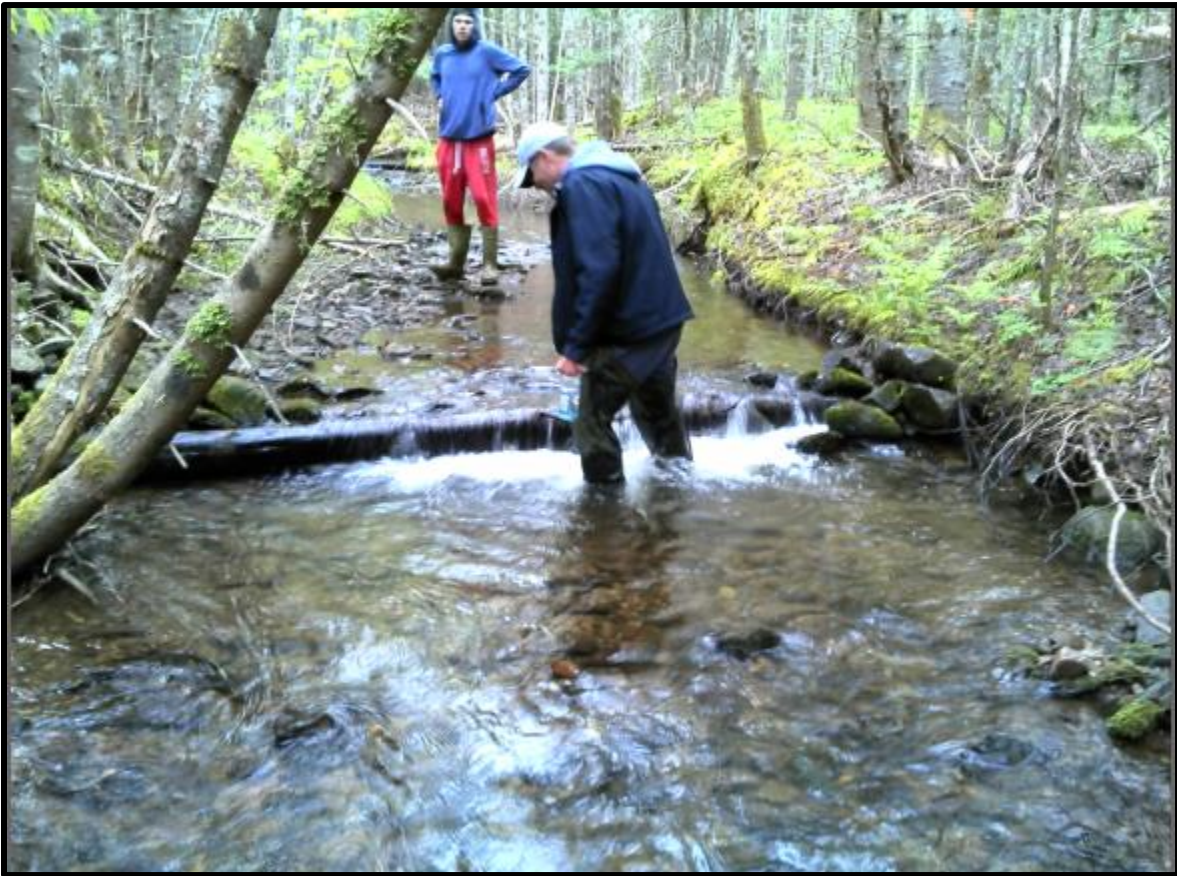
Way Point 100 – Digger Log and Deflector

Figure 114. Digger Log and Deflector at waypoint 100.

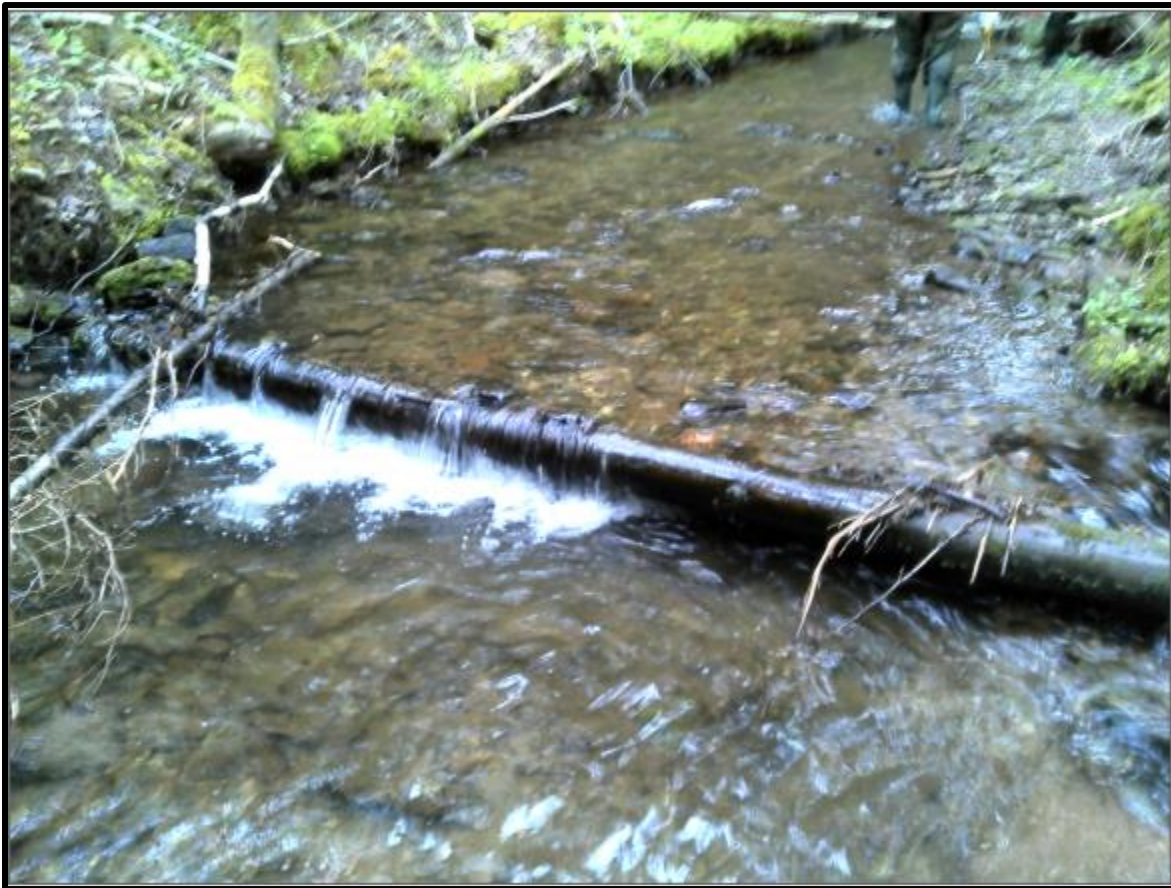
Way Point 101 – Digger Log

Figure 115. Digger Log at waypoint 101.

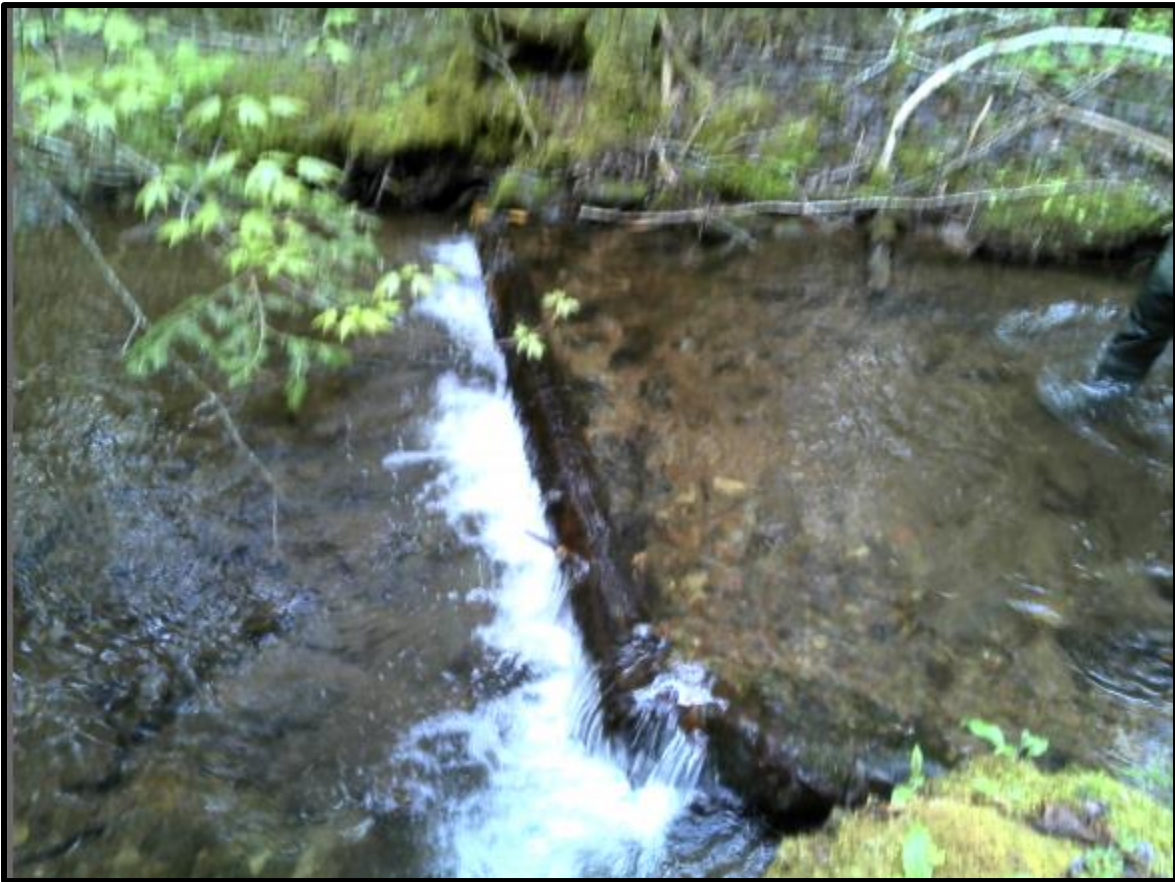
Way Point 102 – Digger Log

Figure 116. Digger Log at waypoint 102.

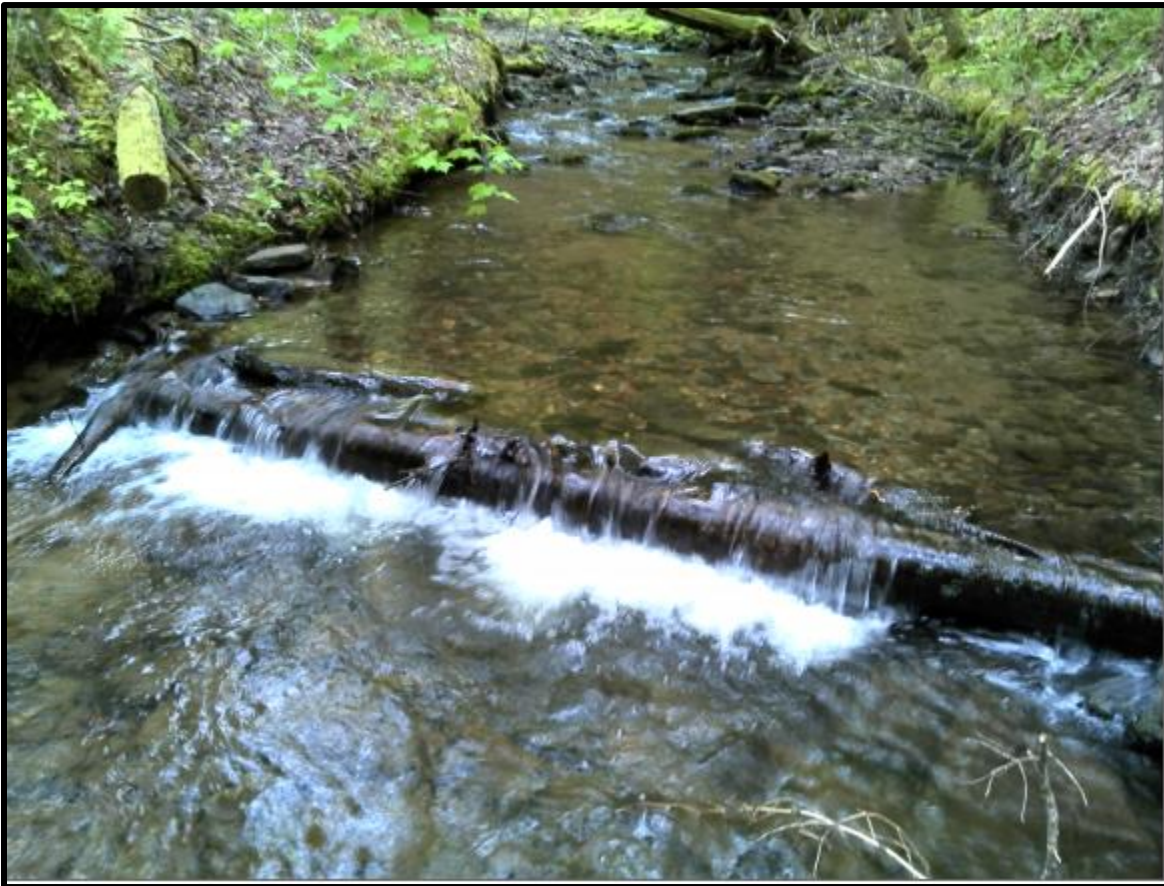
Way Point 103 – Digger Log

Figure 117. Digger Log at waypoint 103.

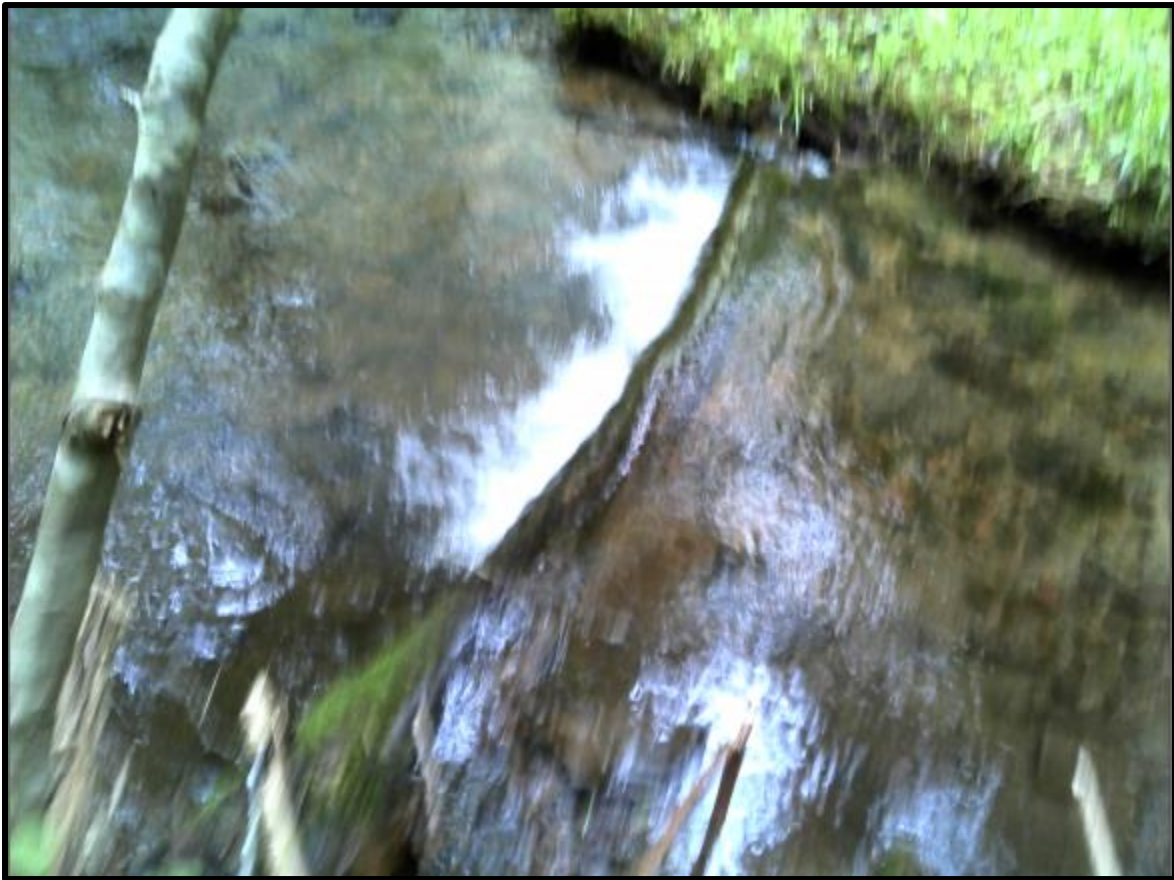
Way Point 105 – Digger Log

Figure 118. Digger Log at waypoint 105.

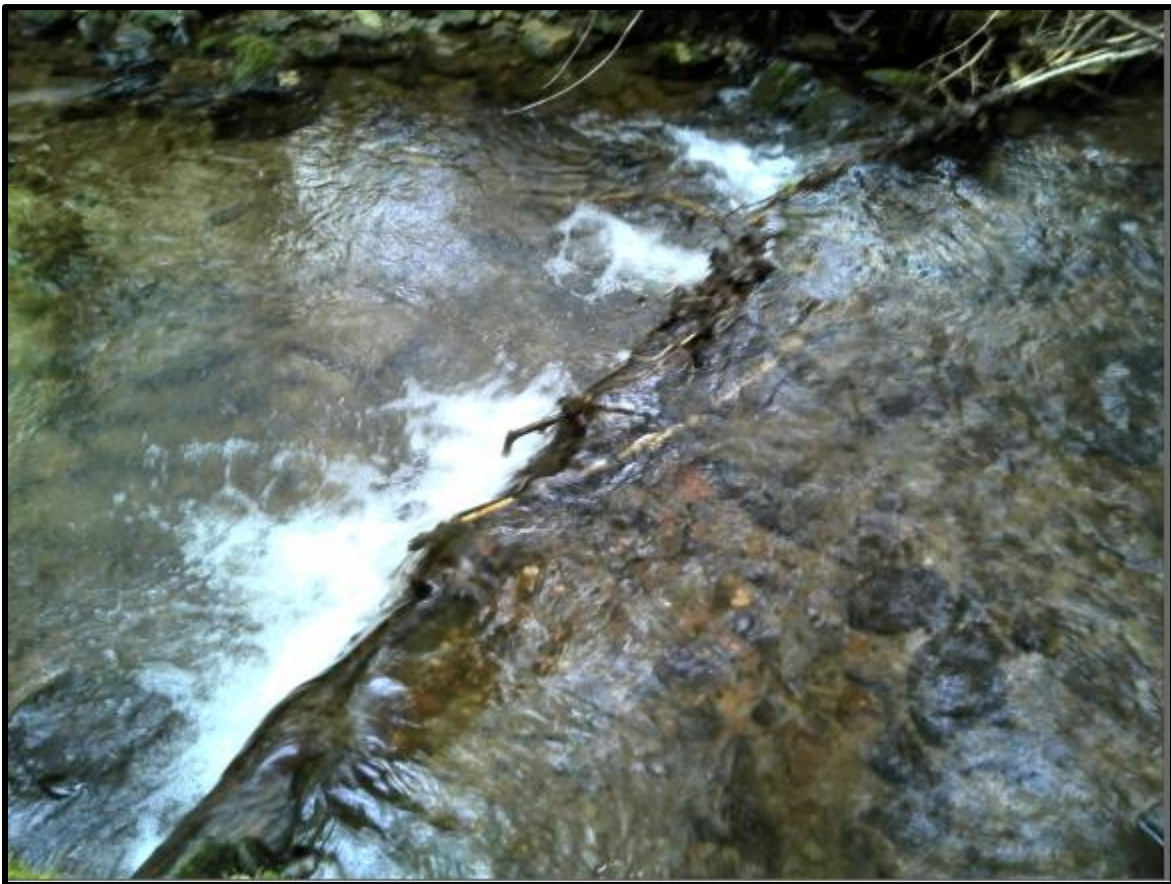
Waypoint 106 – Digger Log

Figure 119. Digger log at waypoint 106.

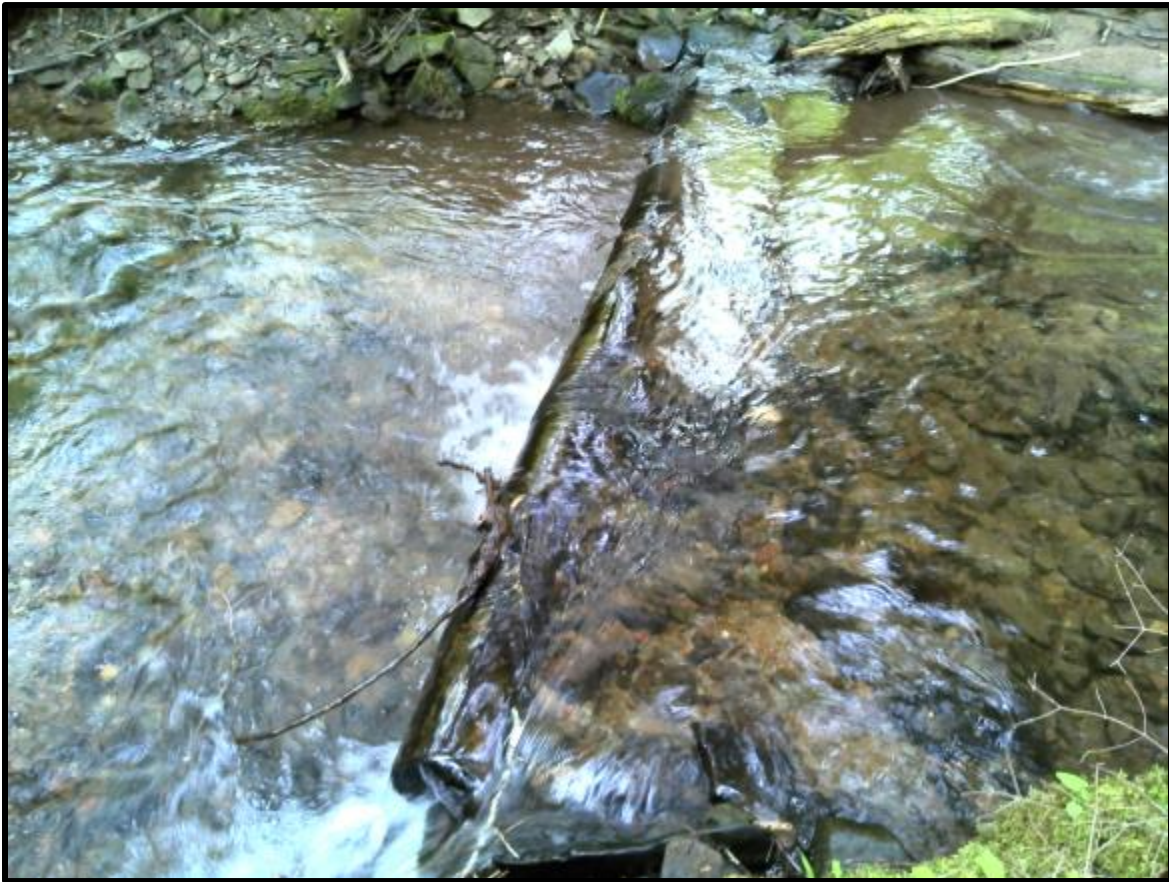
Way Point 107 – Digger Log

Figure 120. Digger Log at waypoint 107.
