SALMONID HABITAT RESTORATION

INVERNESS SOUTH ANGLERS ASSOCIATION

Progress Report

Monday, June 12th, 2017

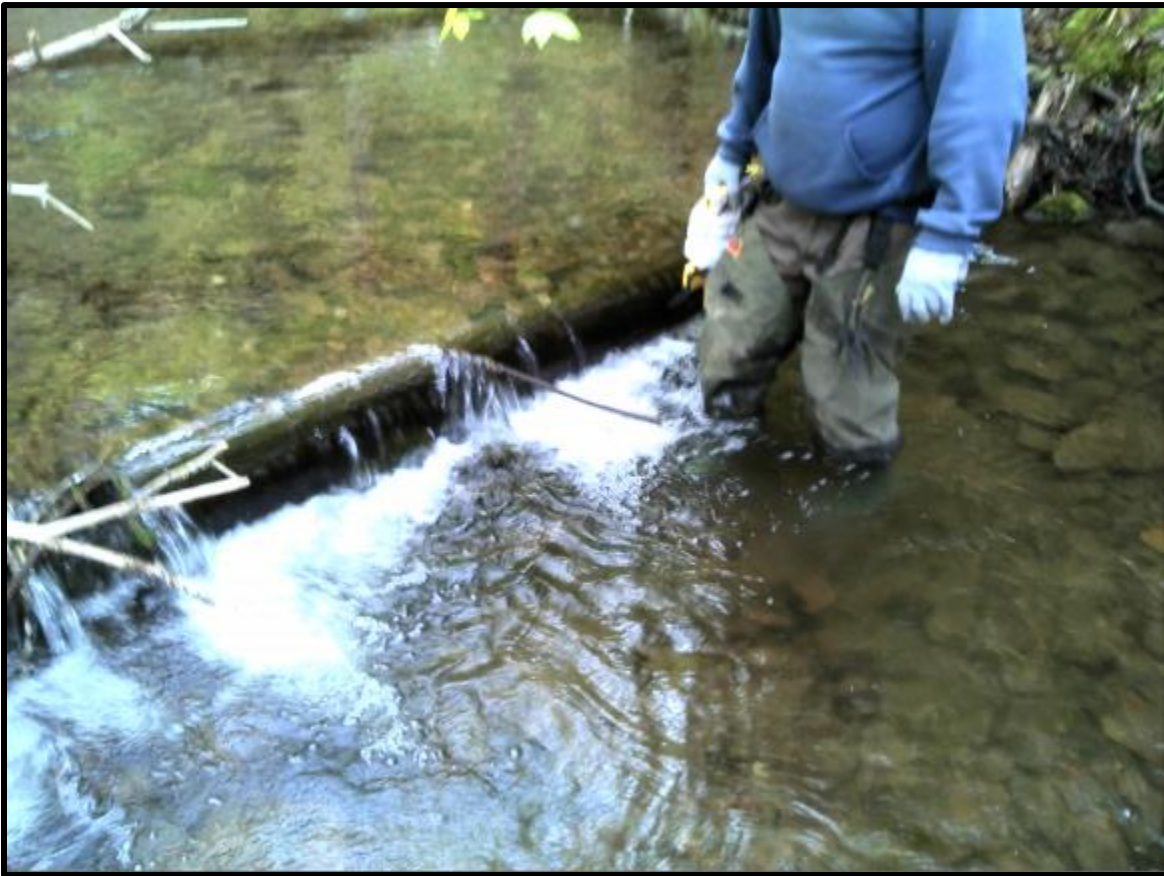
Way Point 108 – Digger Log

Figure 121. Digger Log at waypoint 108.

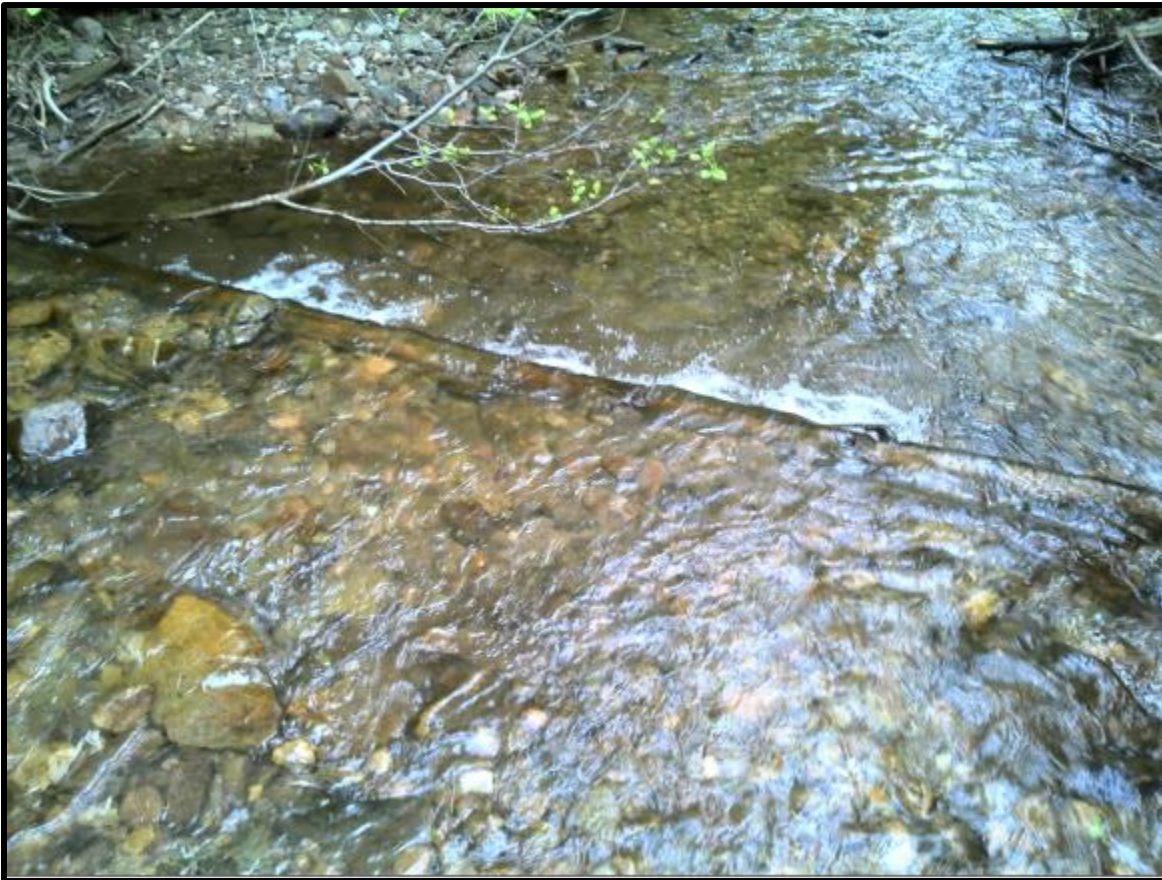
Way Point 109 – Digger Log

Figure 122. Digger log at waypoint 109.

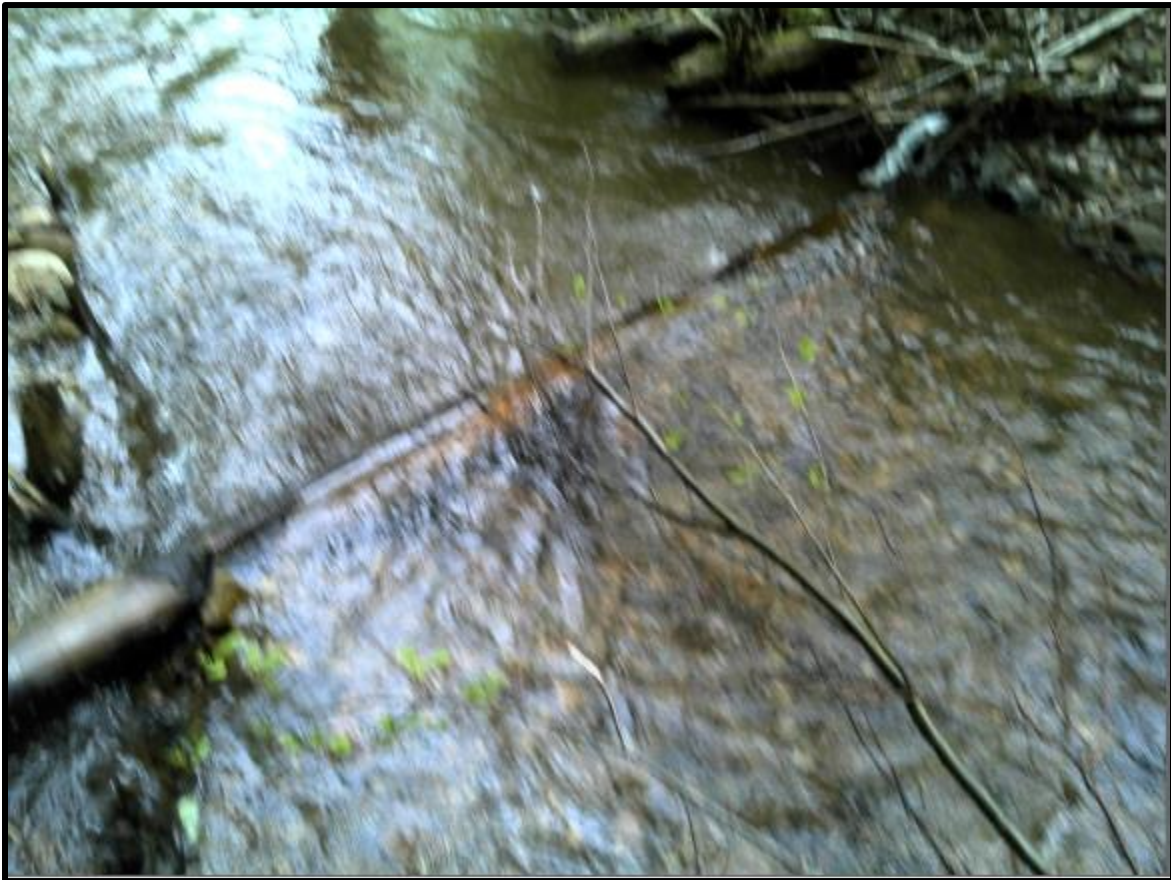
Way Point 110 – Digger Log

Figure 123. Digger Log at waypoint 110.

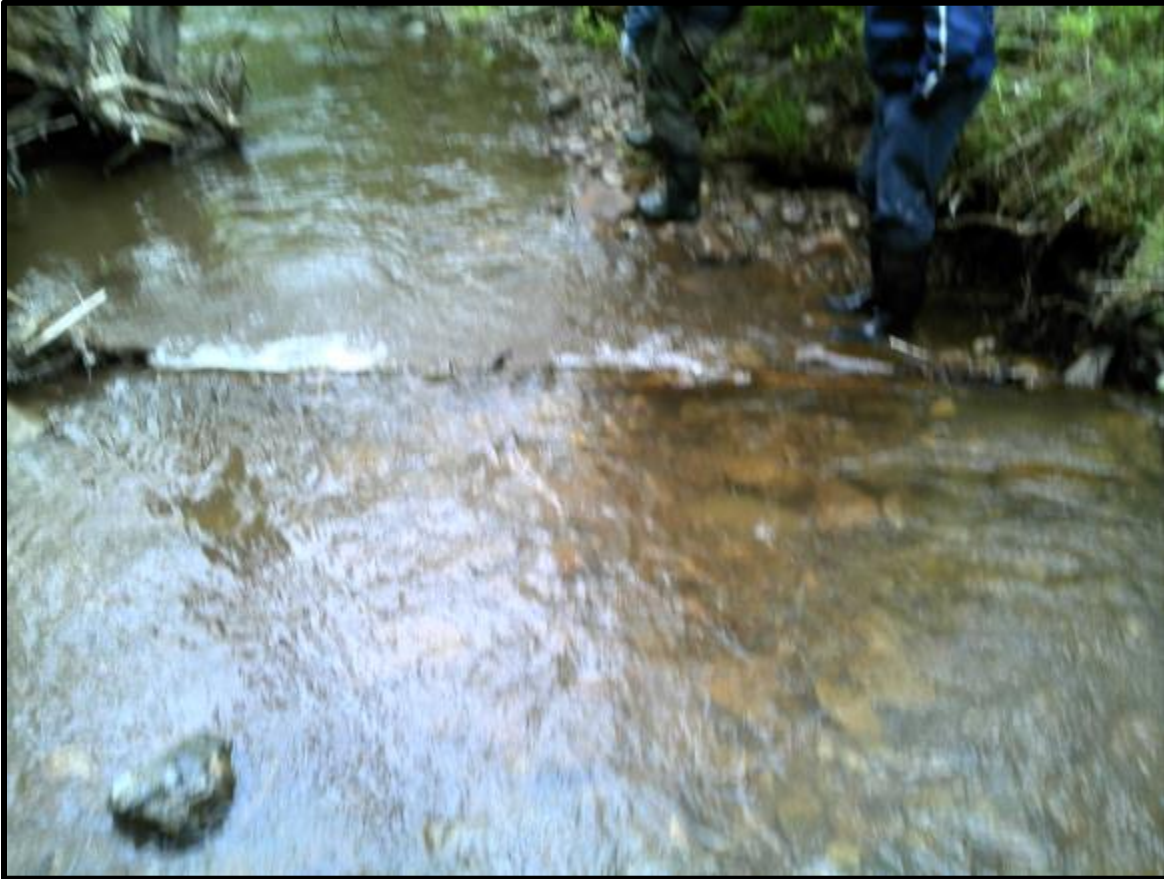
Way Point 111 – Digger Log

Figure 124. Digger Log at waypoint 111.

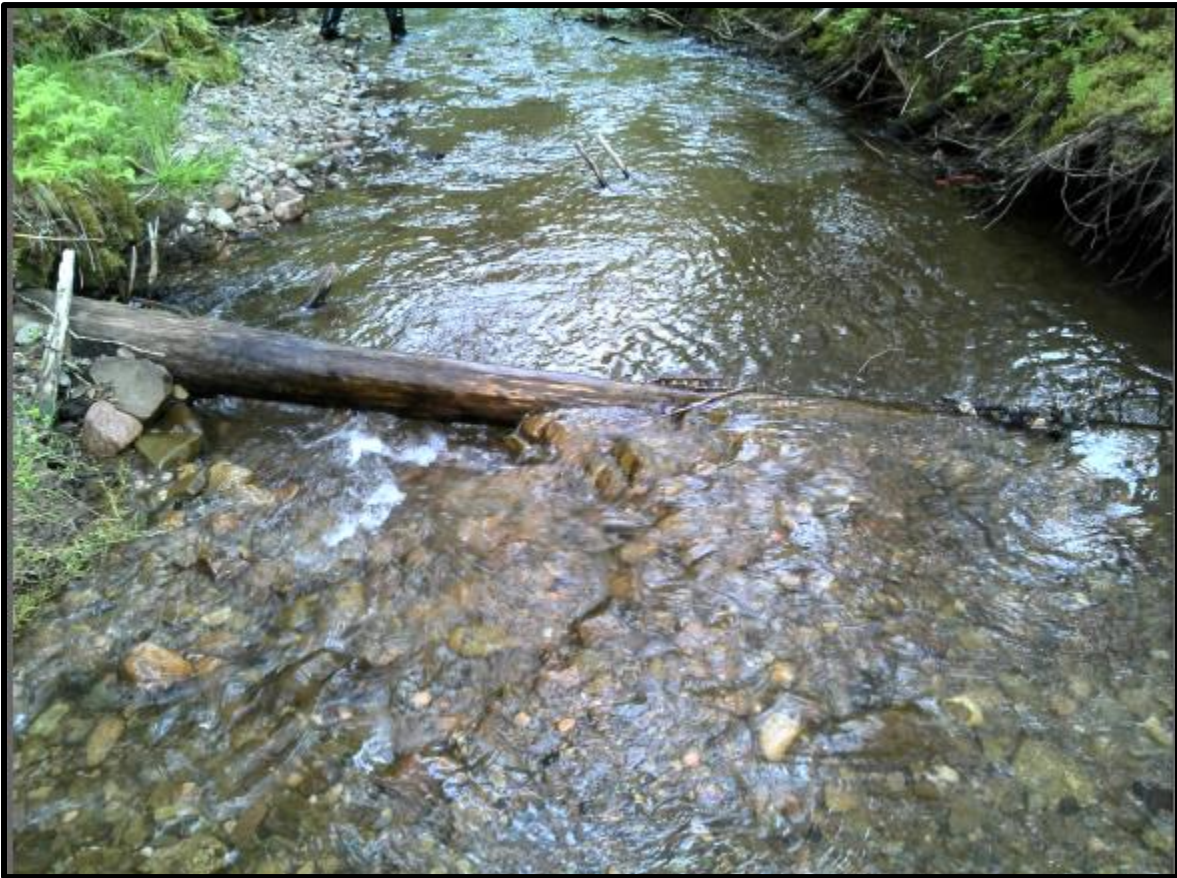
Way Point 112 – Digger Log

Figure 125. Digger log at waypoint 112.

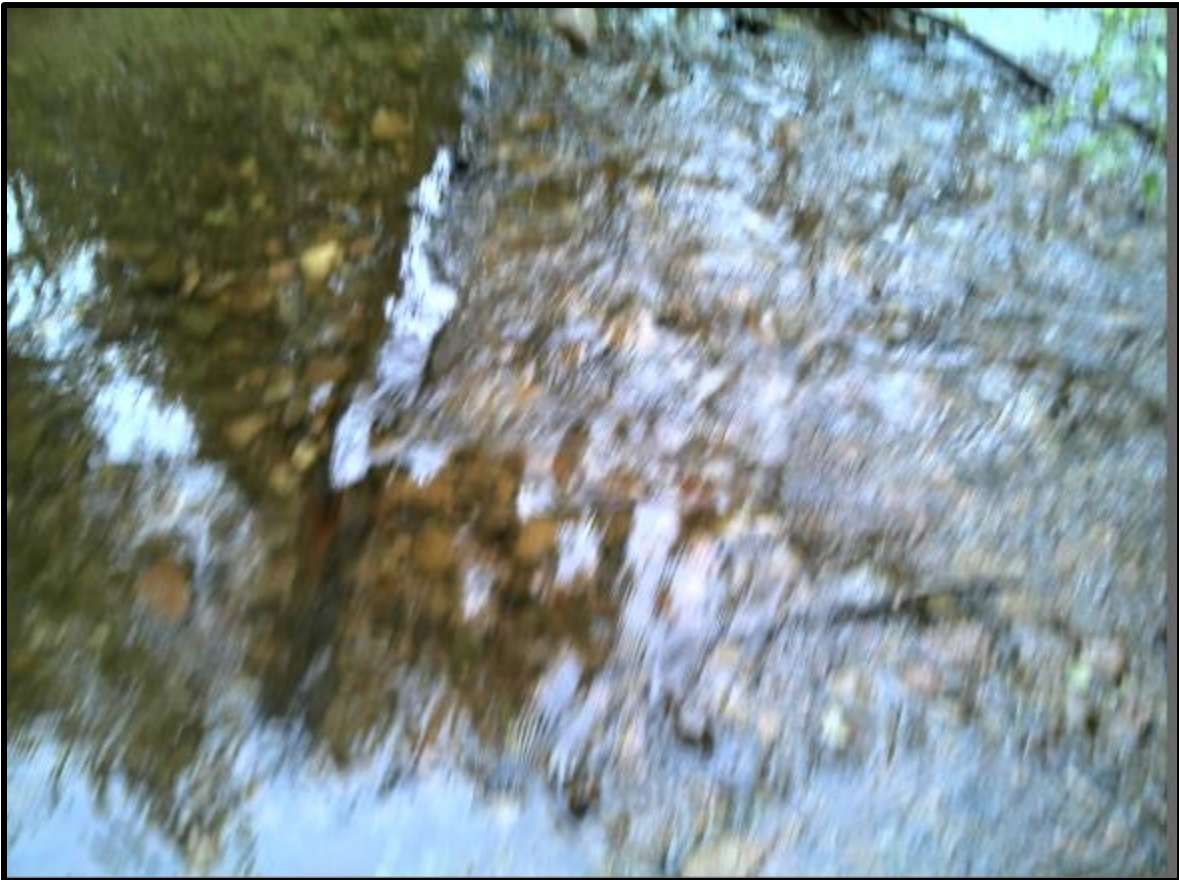
Way Point 115 – Digger Log

Figure 127. Digger log at waypoint 115.

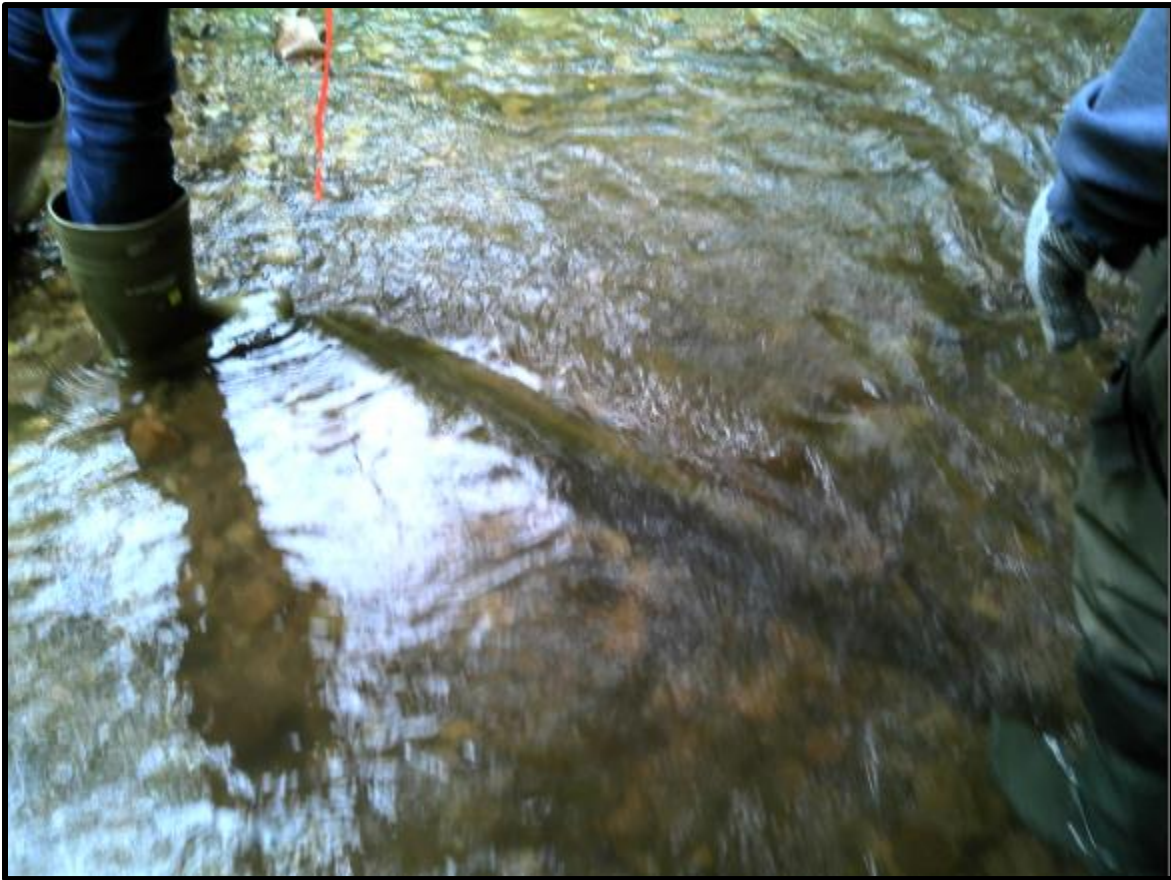
Way Point 118 – Digger Log

Figure 129. Digger Log at waypoint 118.

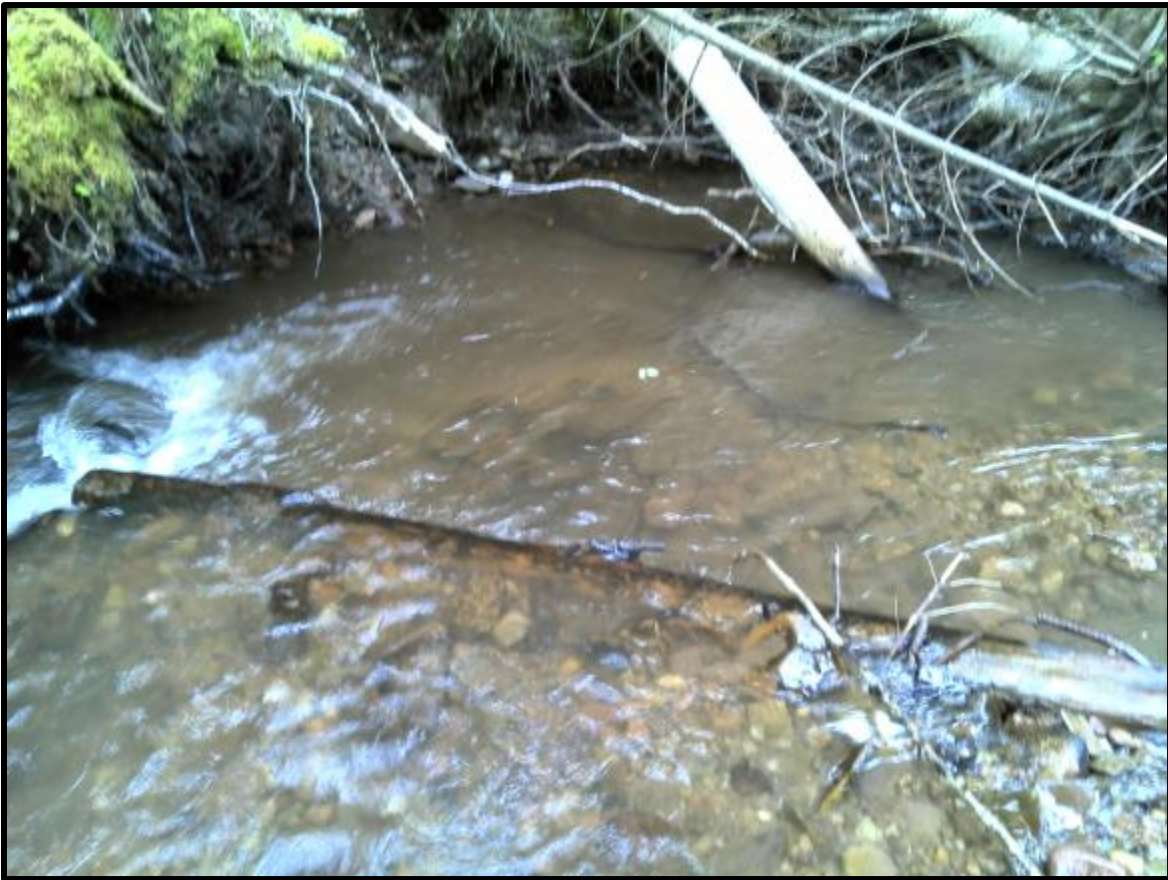
Way Point 119 – Digger Log

Figure 130. Digger Log at waypoint 119.

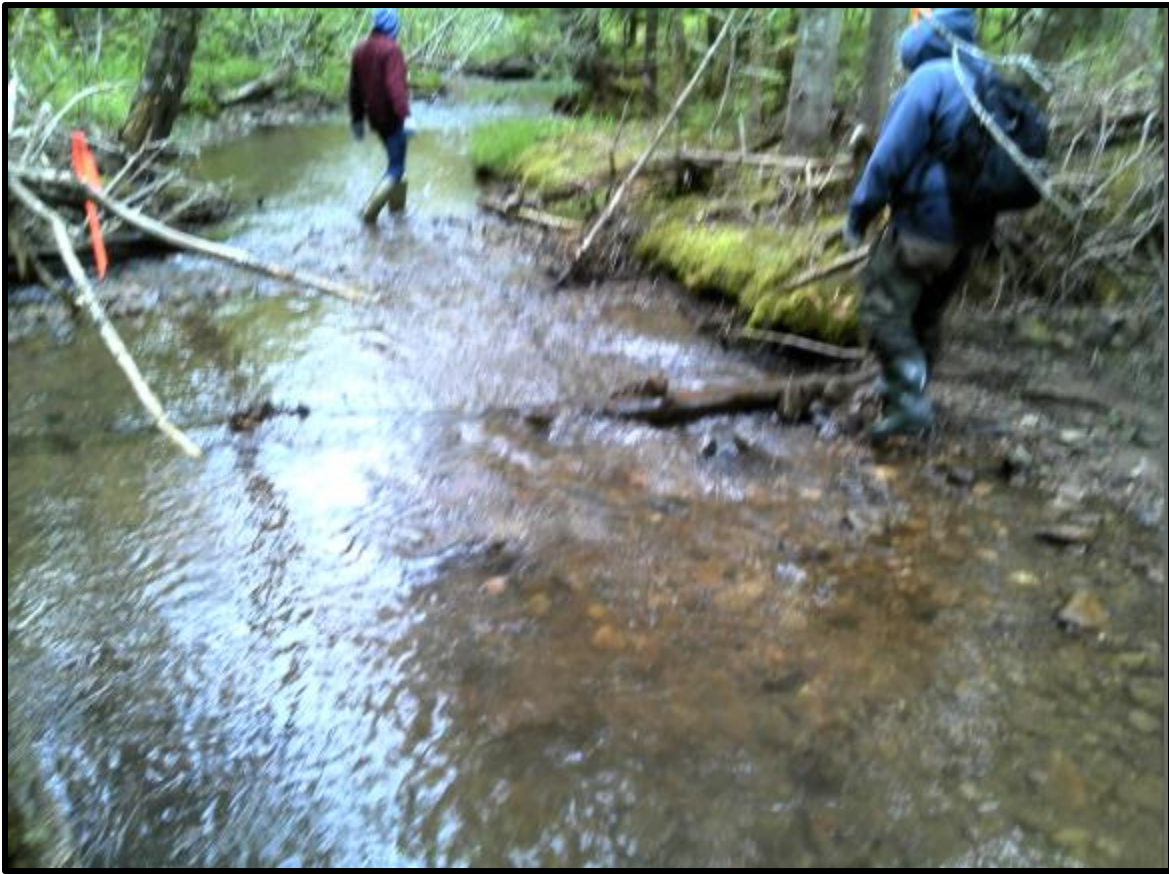
Way Point 120 – Digger Log

Figure 131. Digger Log at waypoint 120.

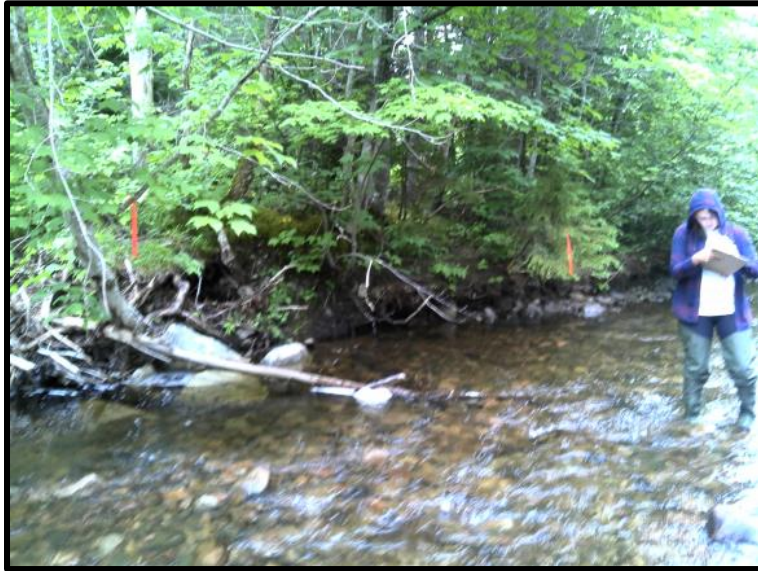
Way Point 206 – Deflector

Figure 146. Before picture of a deflector at waypoint 206.

Figure 147. After picture of deflector at waypoint 206.

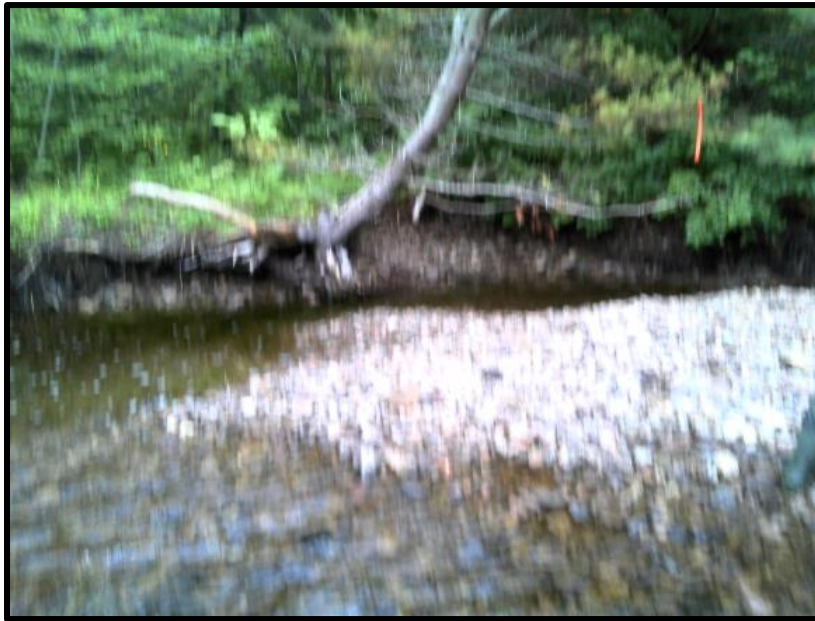
Way Point 213 – Two Tier Bank Rock

Figure 151. Before picture of two tier bank rock at way point 213.

Figure 152. After picture of two tier bank rock at way point 213.

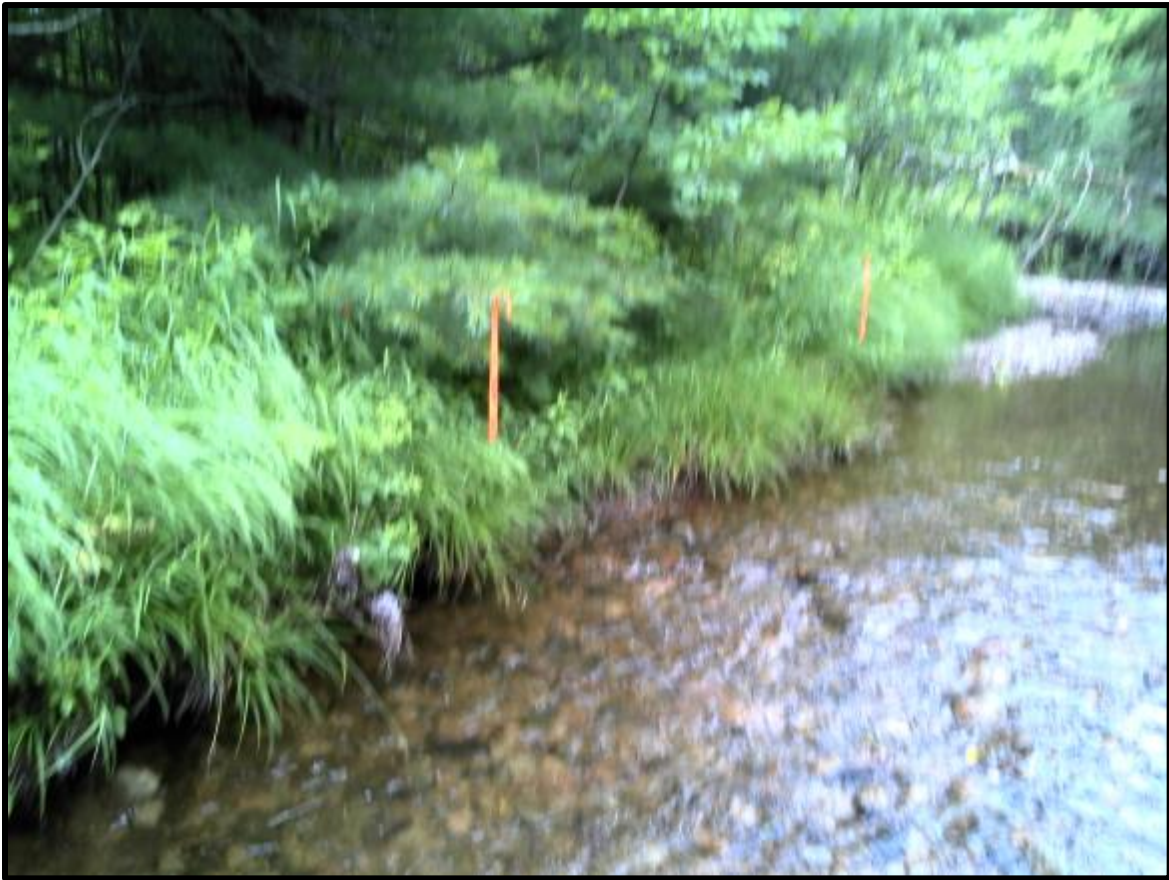
Way Point 215 – Two Tier Deflector

Figure 154. Before picture of a two-tier deflector for way point 215.

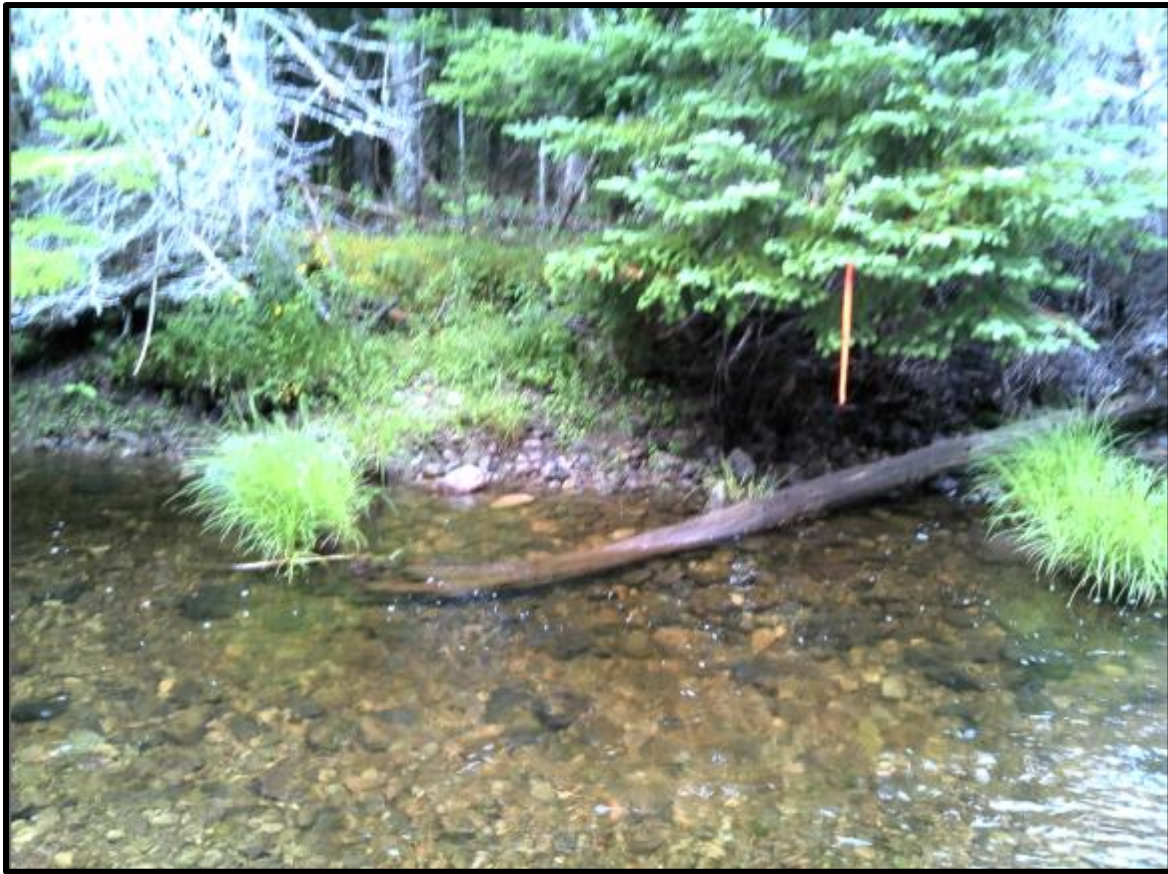
Way Point 219 – Deflector

Figure 157. Before picture of a deflector structure at way point 219.

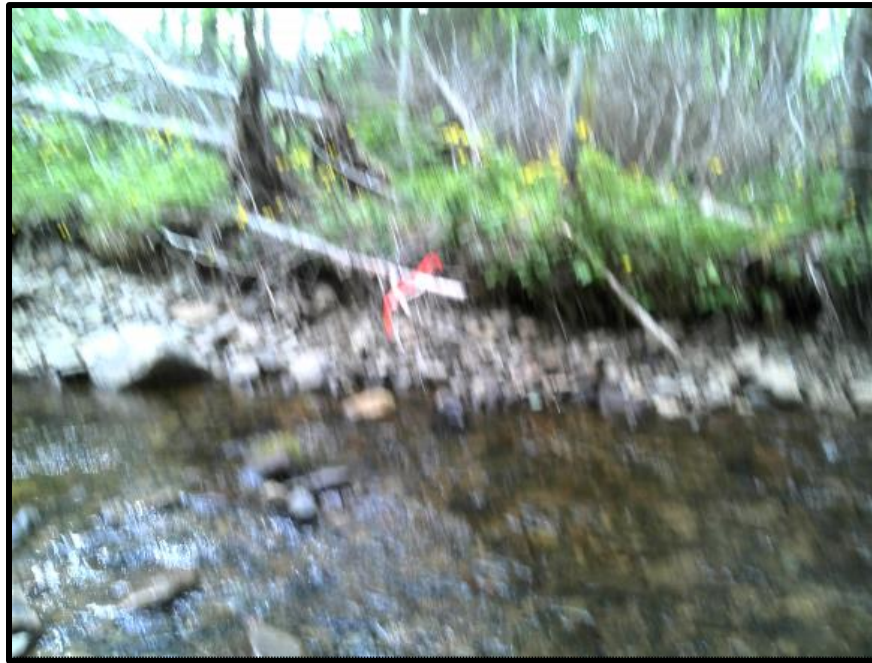
Way Point 222 – Hand Rock

Figure 159. Before picture of hand rock structure at way point 222.

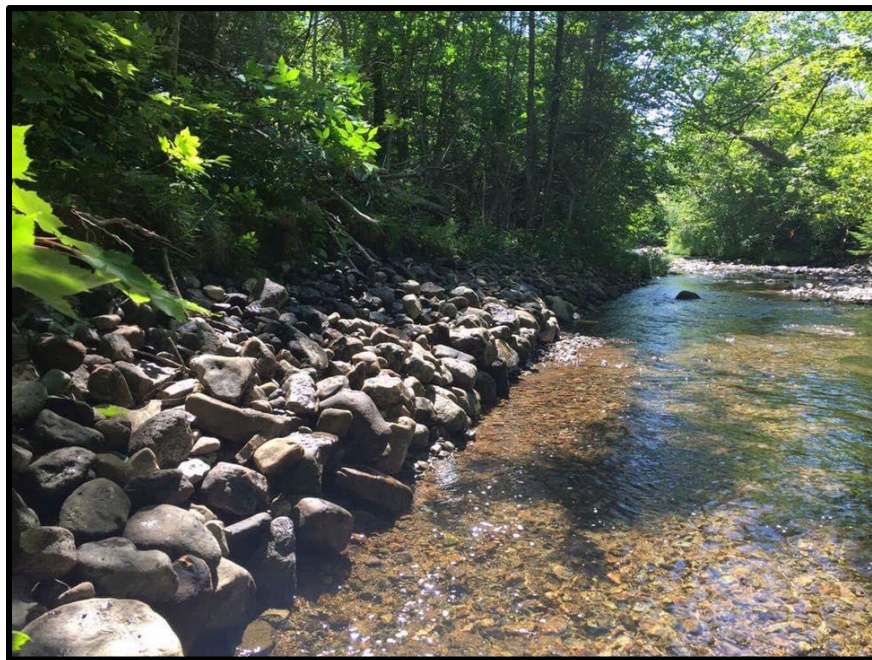
Figure 160. After picture of hand rock structure at way point 222.
