SALMONID HABITAT RESTORATION
INVERNESS SOUTH ANGLERS ASSOCIATION

Winter Damage Assessment

Date: 2019

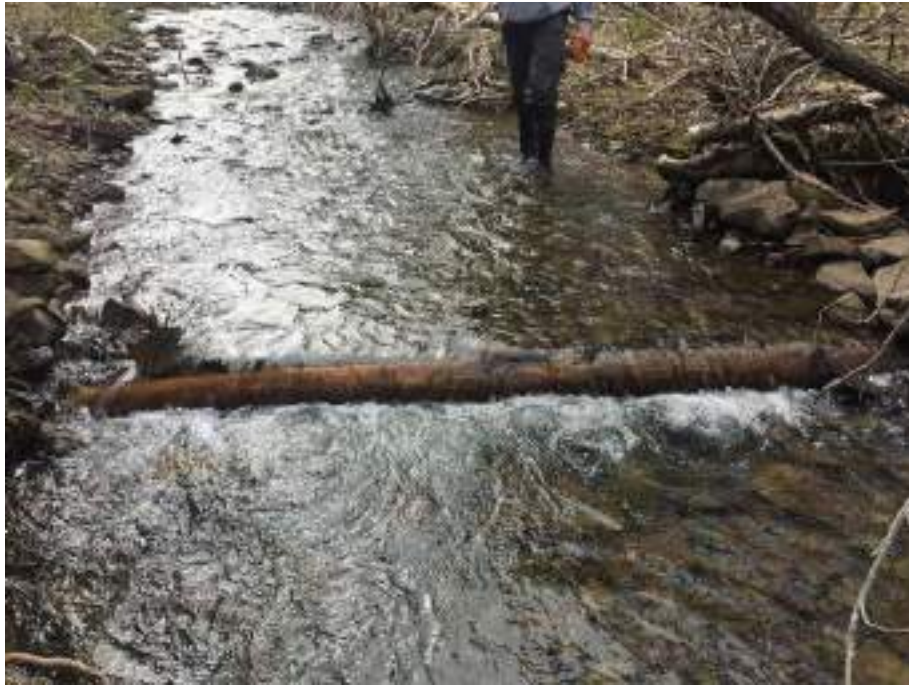
Figure 9. Showing the first digger log structure upstream from the road. Before and after picture of performed maintenance.

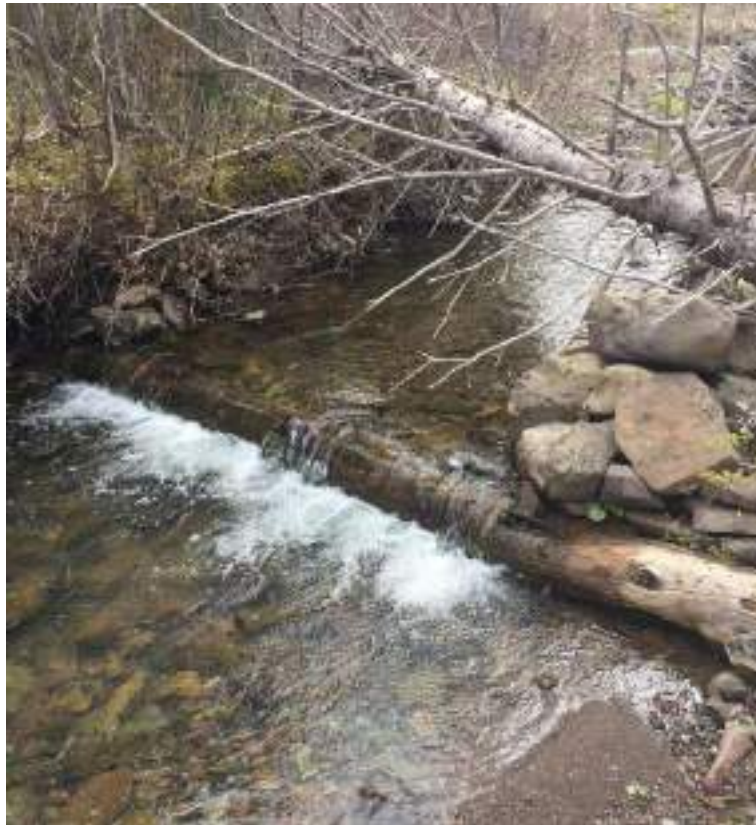
Figure 10. Showing a before and after picture of the maintenance preformed on the second diggerlog upstream from the road.

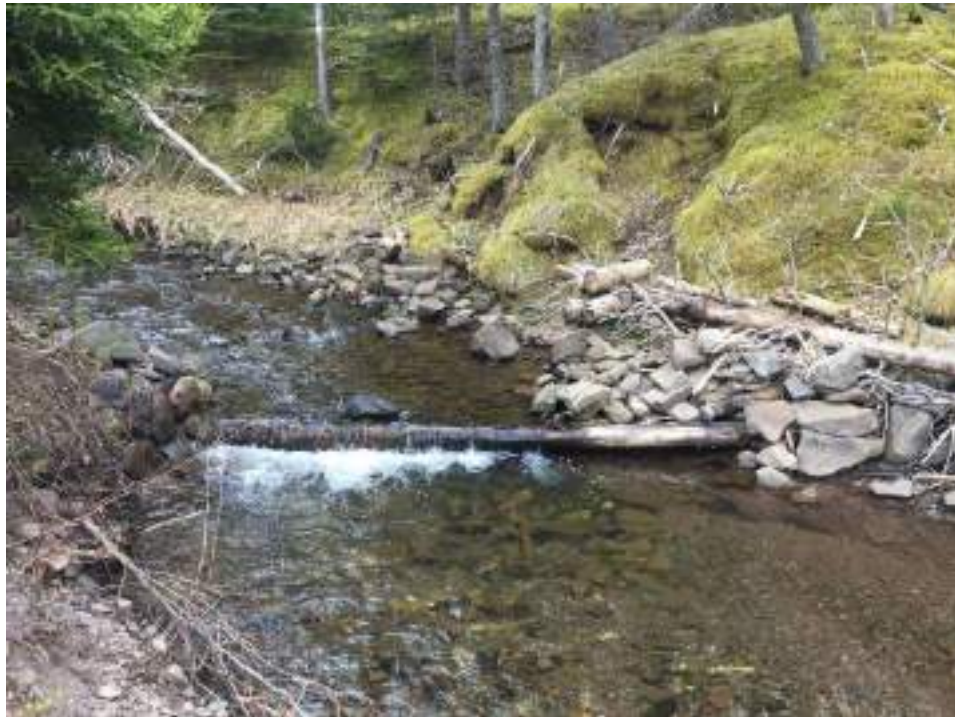
Figure 11. Before and after picture of digger log #3 upstream from the road.

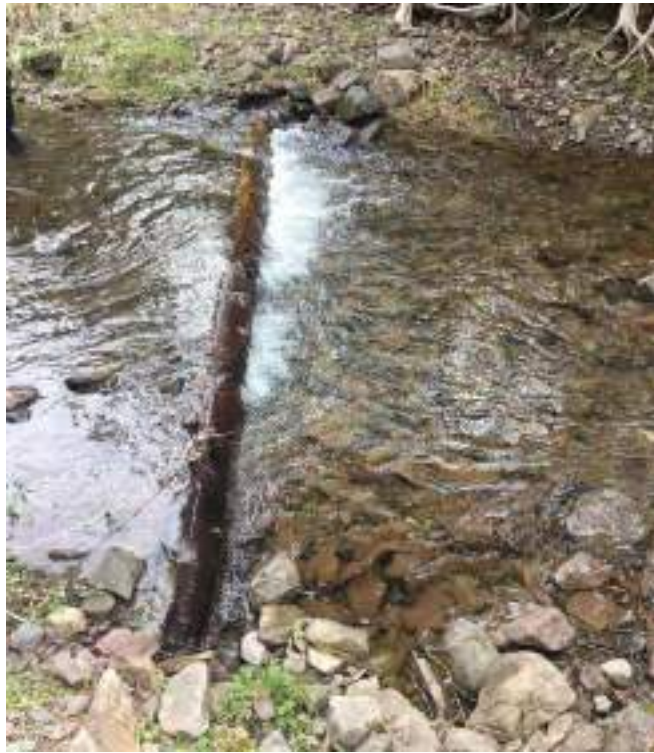
Figure 12. Showing before and after pictures of digger log #4 upstream from the road.

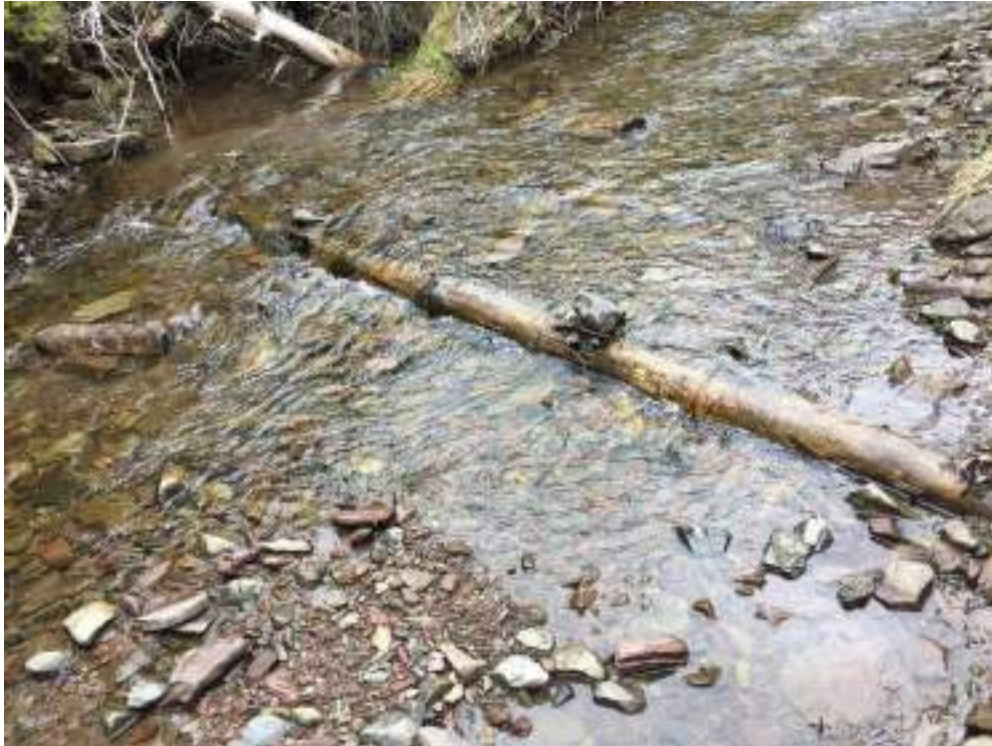
Figure 13. Showing before and after pictures of digger log #5 upstream from the road.

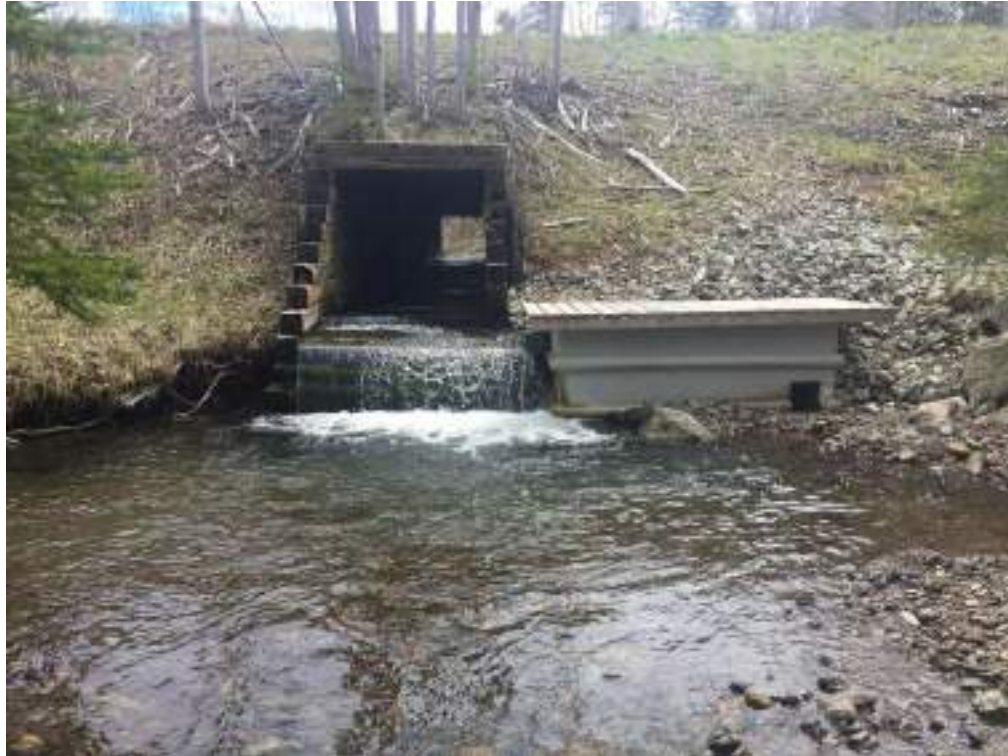
Figure 16. Showing the before and after photos of the fish ladder downstream from the road. The structure was fully blocked up with rock and other woody debris. The fish ladder is now flowing water and is providing upstream access to migrating fish species.

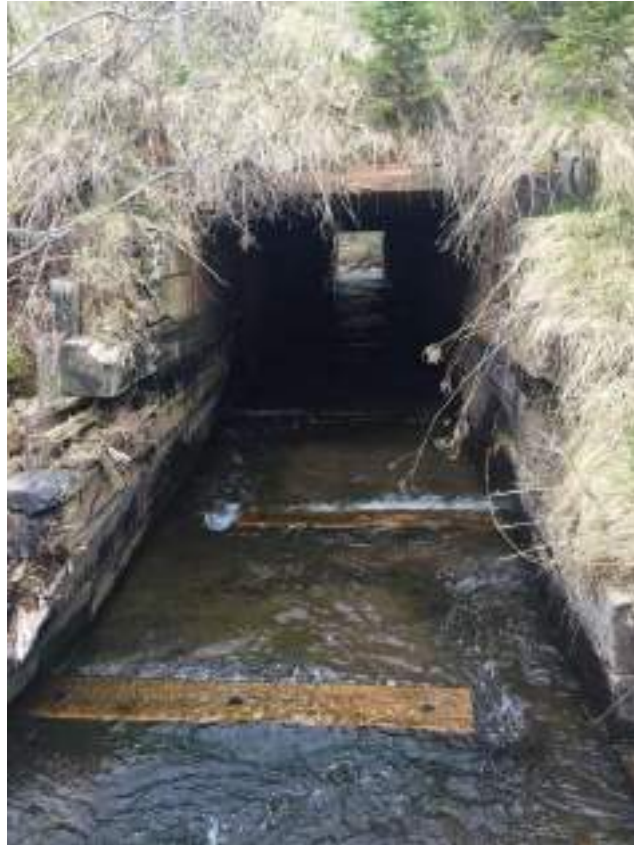
Figure 17. Showing the baffles in the boxed culvert. Rock was added on the left-hand side to avoid any further bank erosion from occurring.

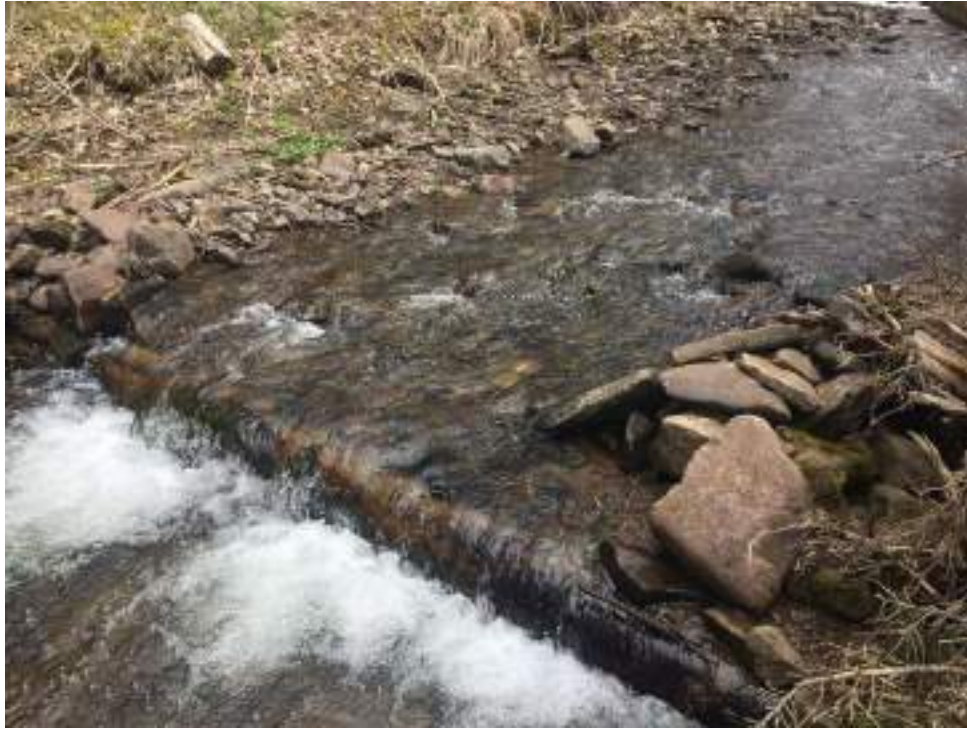
Figure 18. Showing the before and after photos of a digger log - structure #8 downstream from the road.

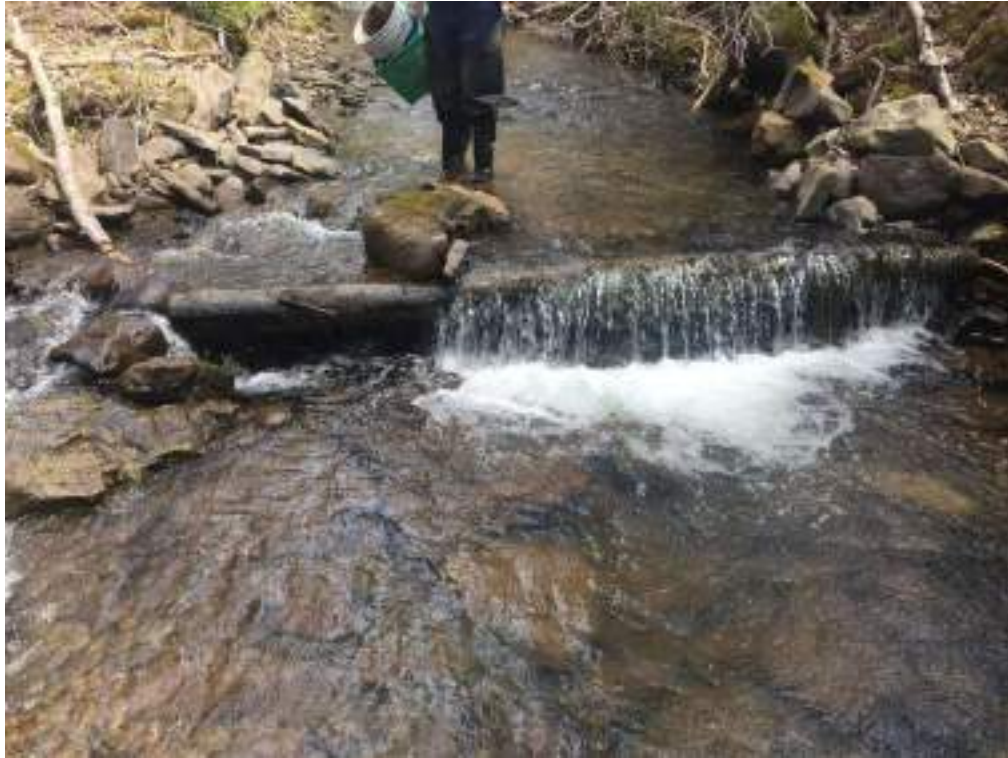
Figure 20. Showing the before and after photos of a diggerlog - structure #10 downstream from the road.

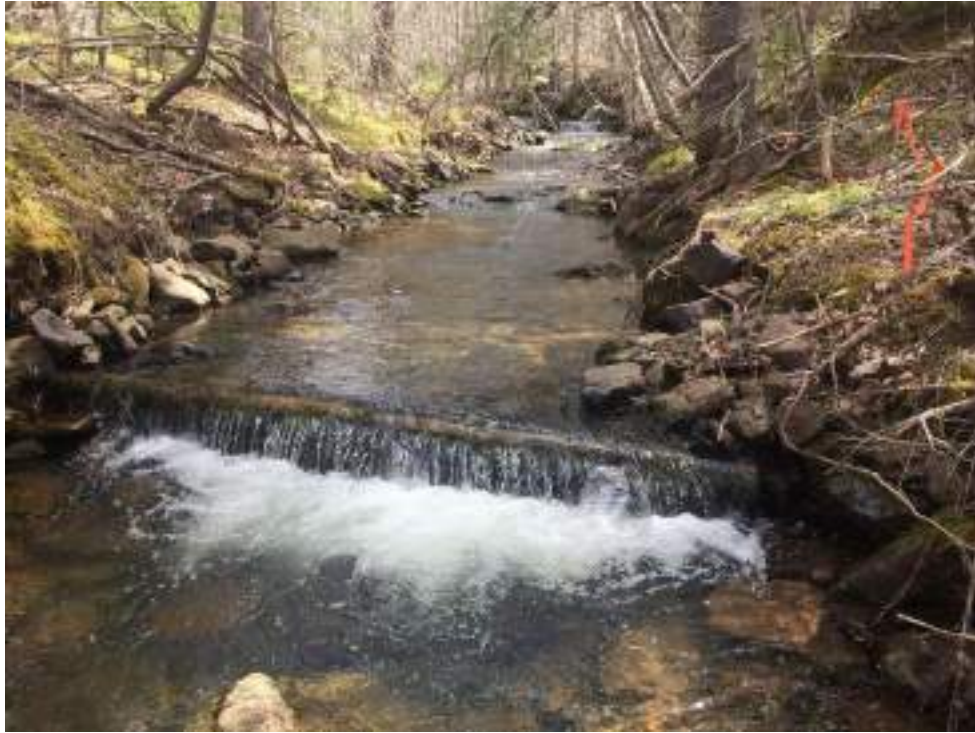
Figure 21. Showing the before and after photos of a digger log - structure #11 downstream from the road.

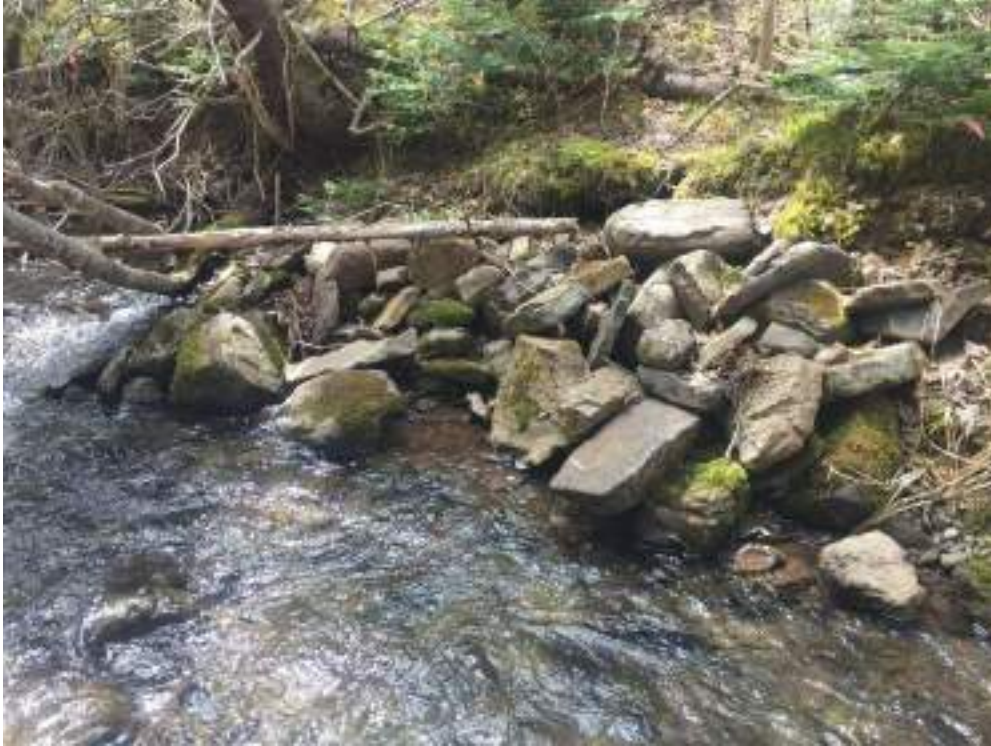
Figure 22. Showing the before and after pictures of a bank stabilization structure #12 - downstream from the road.

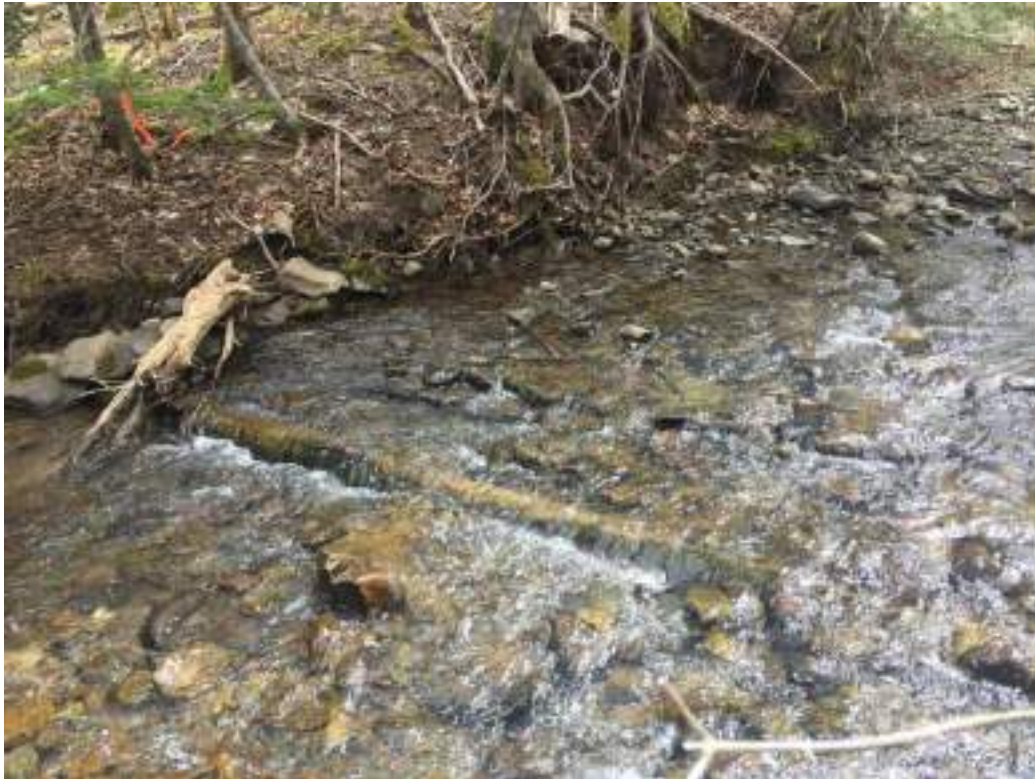
Figure 25. Showing the before and after photos of a digger log structure - #15 downstream from the road.

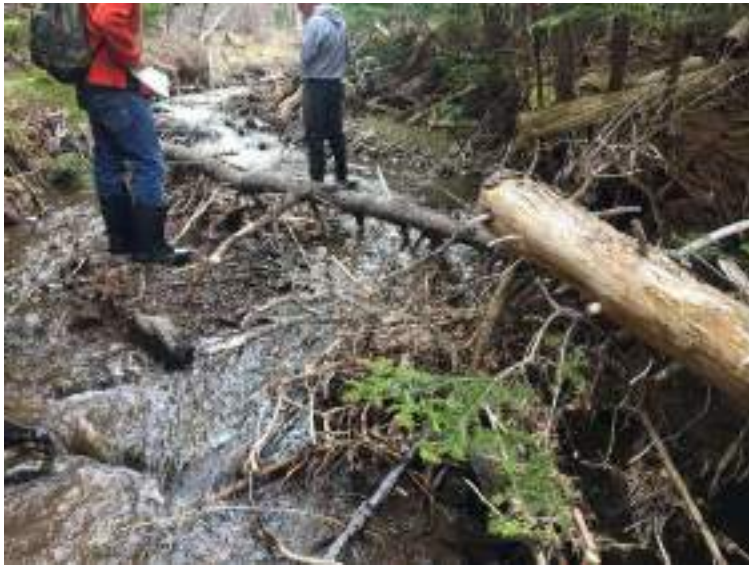
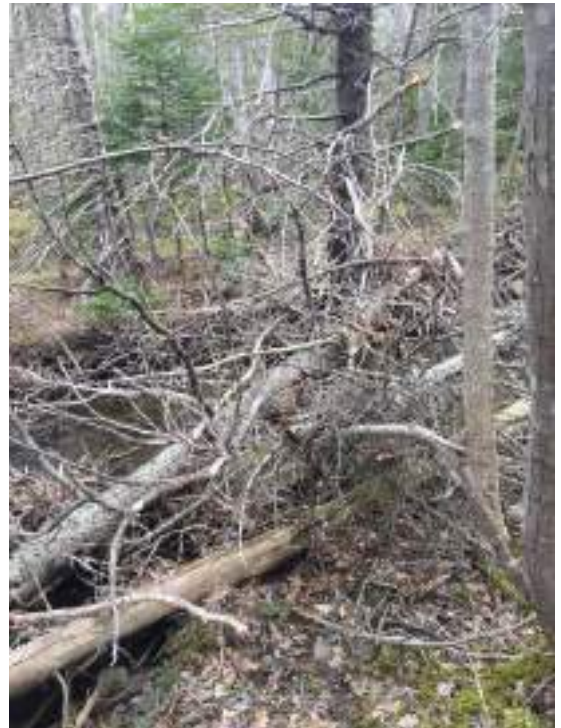
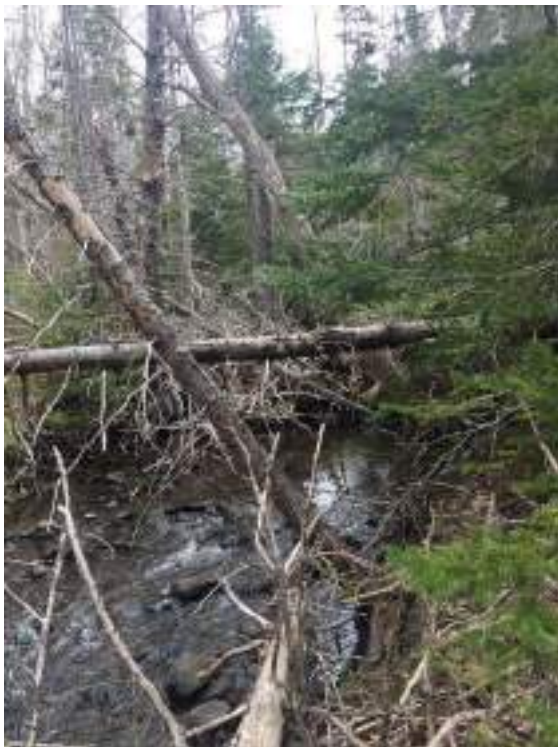
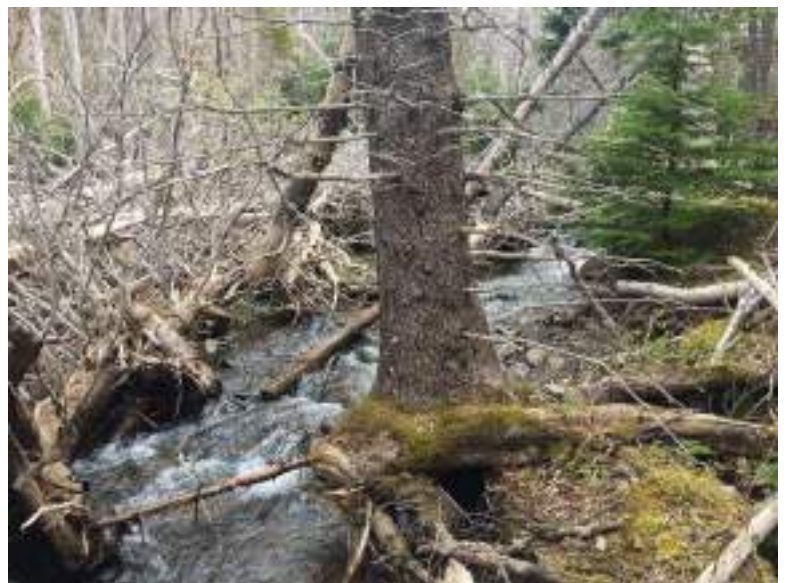
Debris Jams:

The photos seen below display the multiple debris jams located on the More Brook along with an old braid channel in the river.

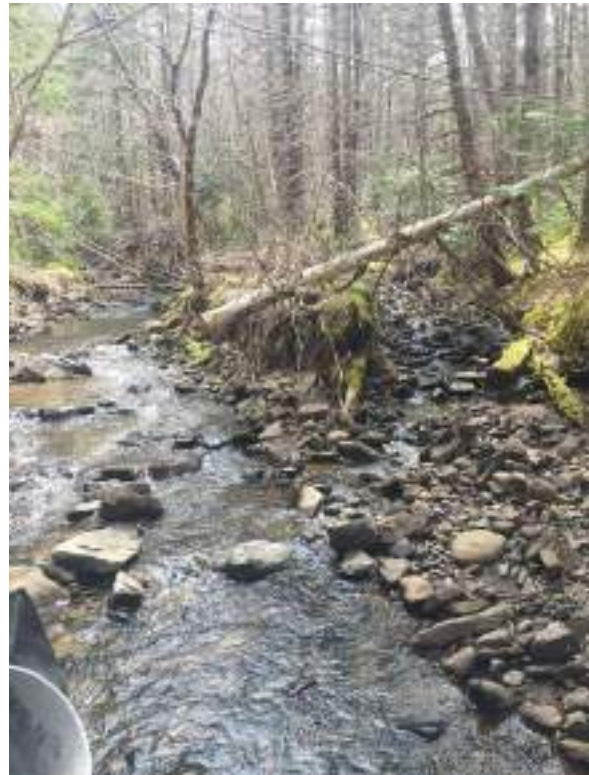
Braid in river:

Found after structure #13 Downstream from the road.

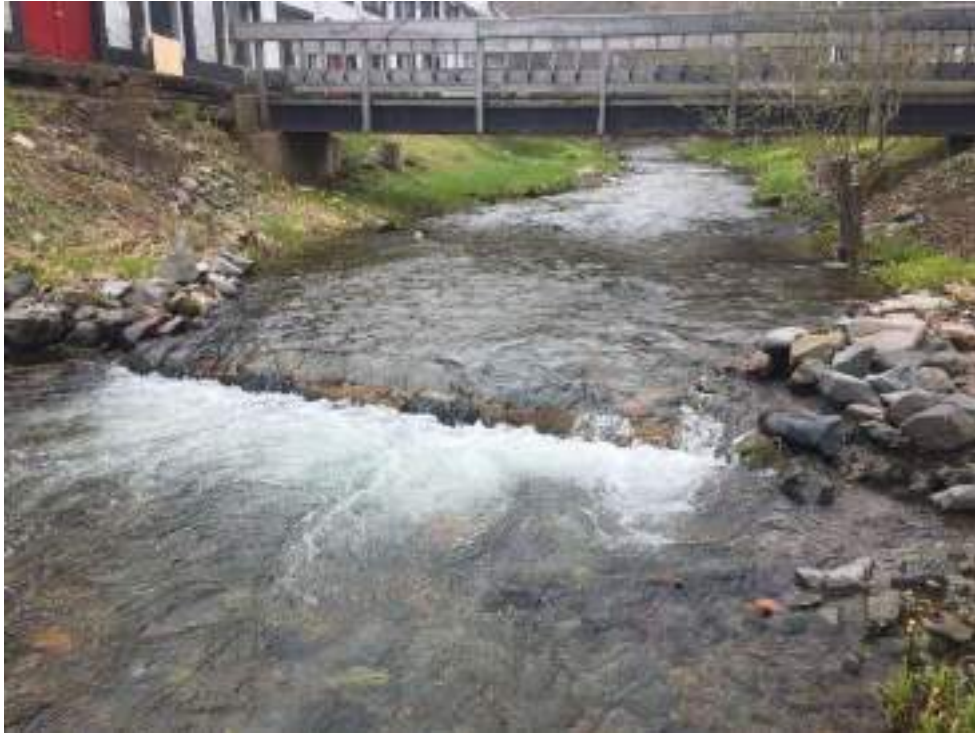
Figure 28. Diggerlog #1 - before and after pictures of maintenance. This is the furthest structure downstream.

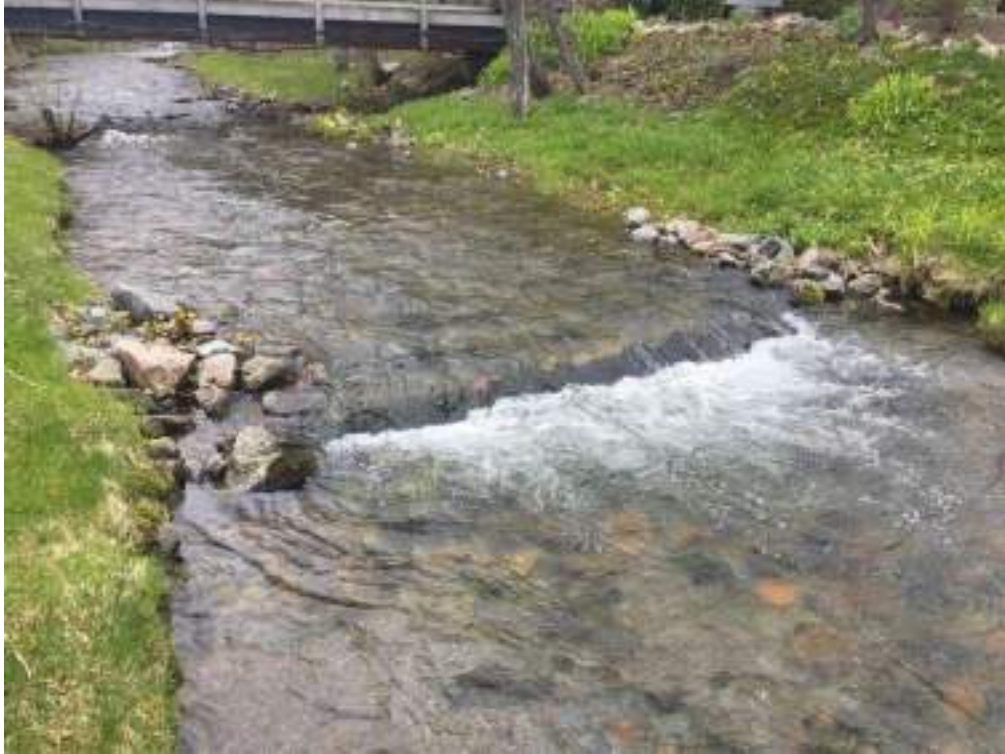
Figure 29. Diggerlog #2 - before and after pictures of maintenance.

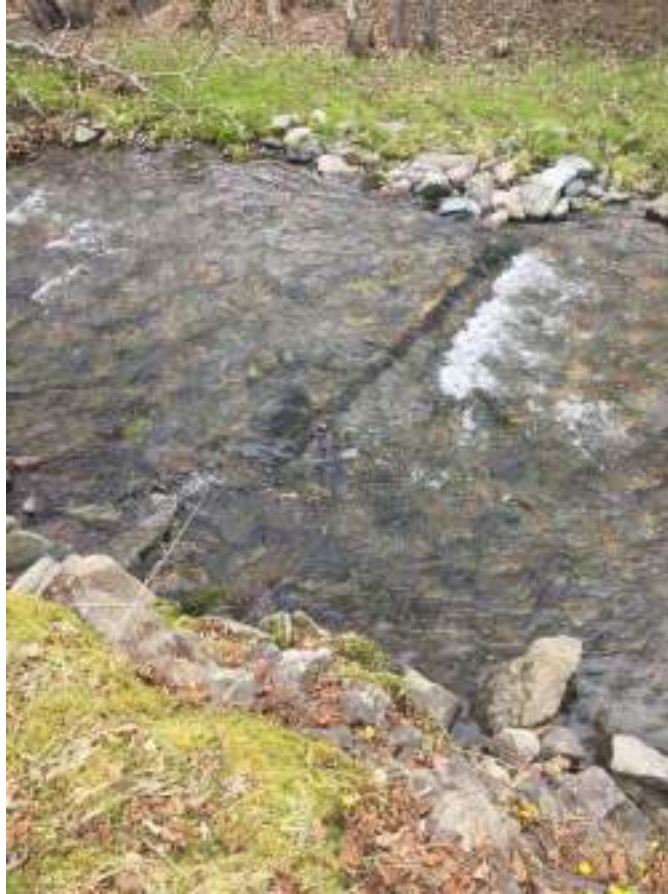
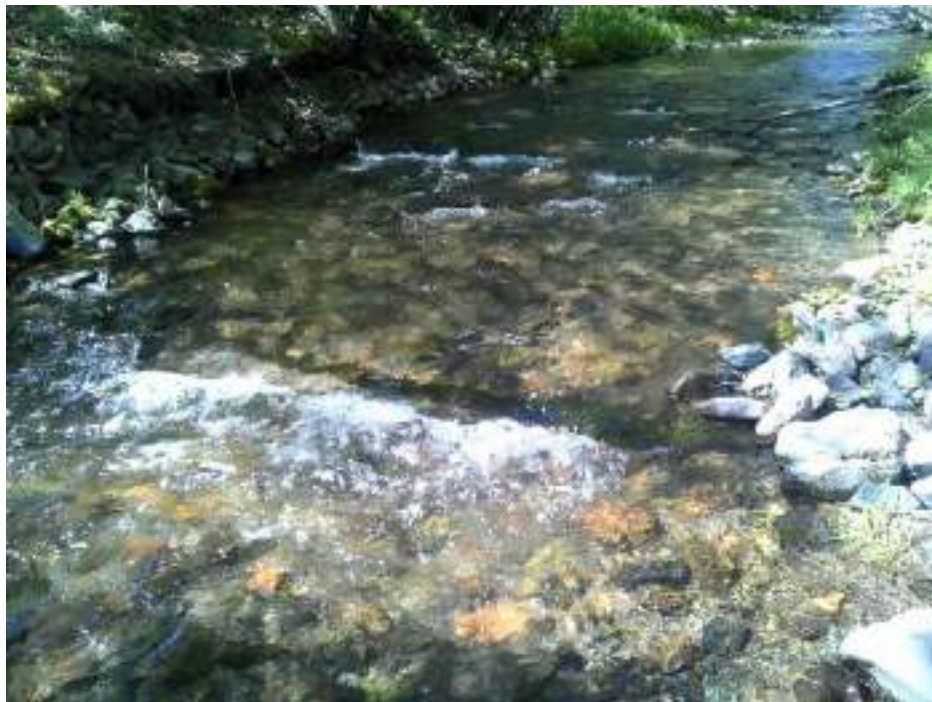
Figure 30. Diggerlog #3 - before and after pictures of attempted maintenance.

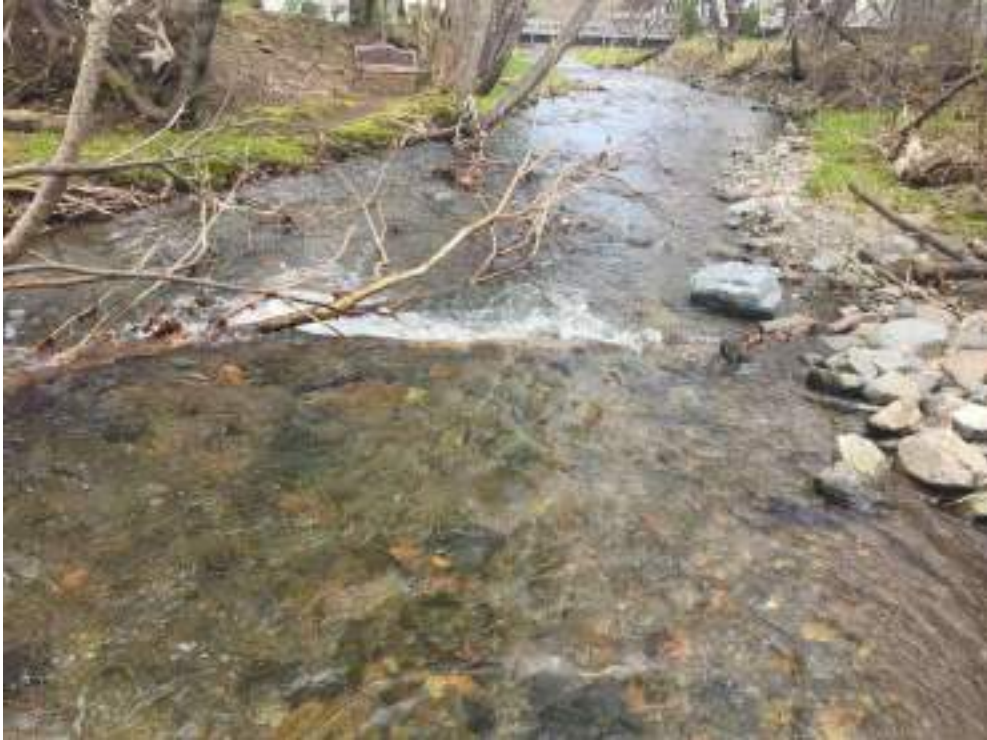
Figure 31. Diggerlog #4 - before and after pictures of maintenance.

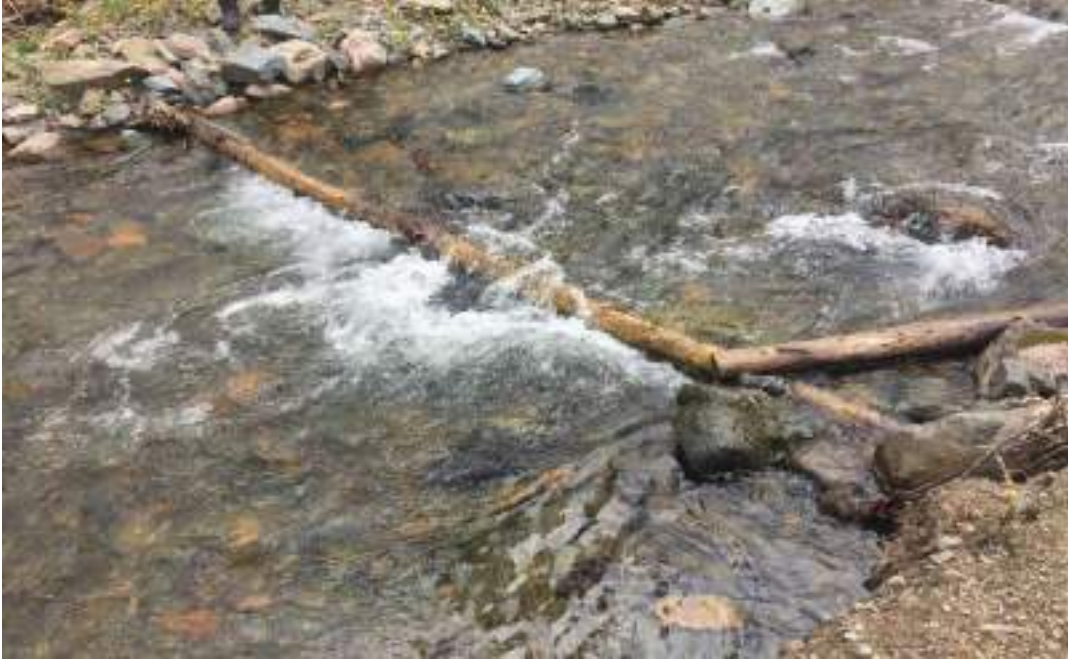
Figure 32. Diggerlog #5 - before and after pictures of maintenance.

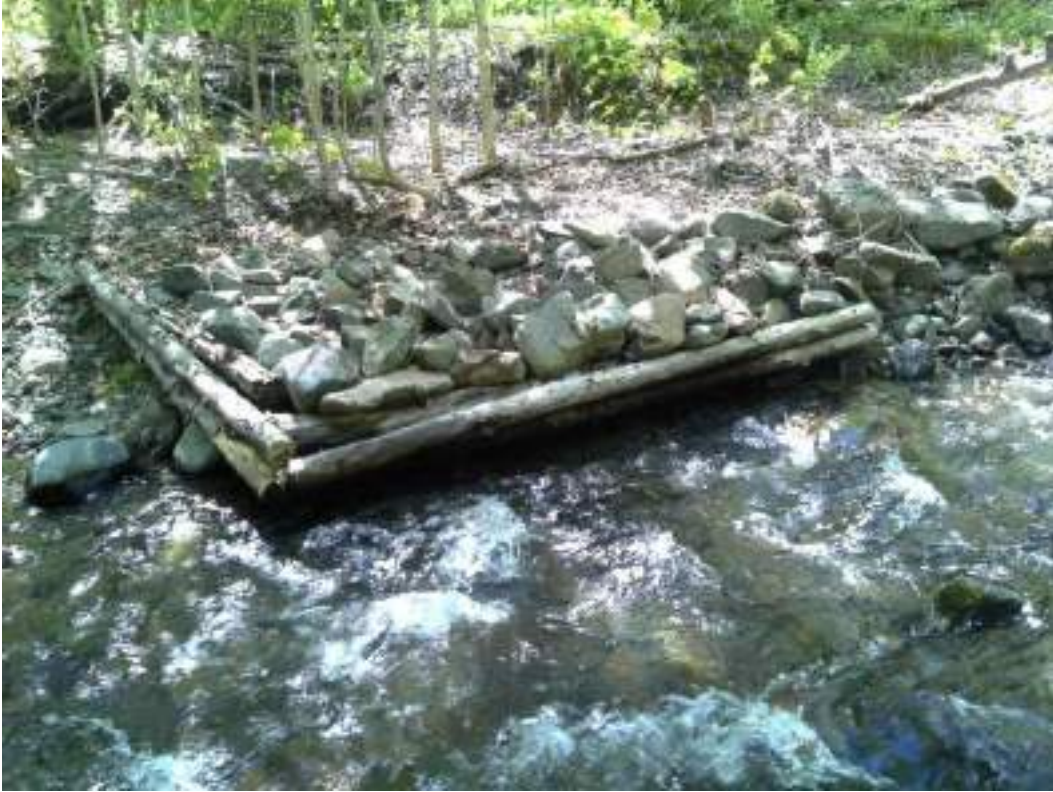
Figure 33. Deflector #6 - before and after picture of maintenance performed.

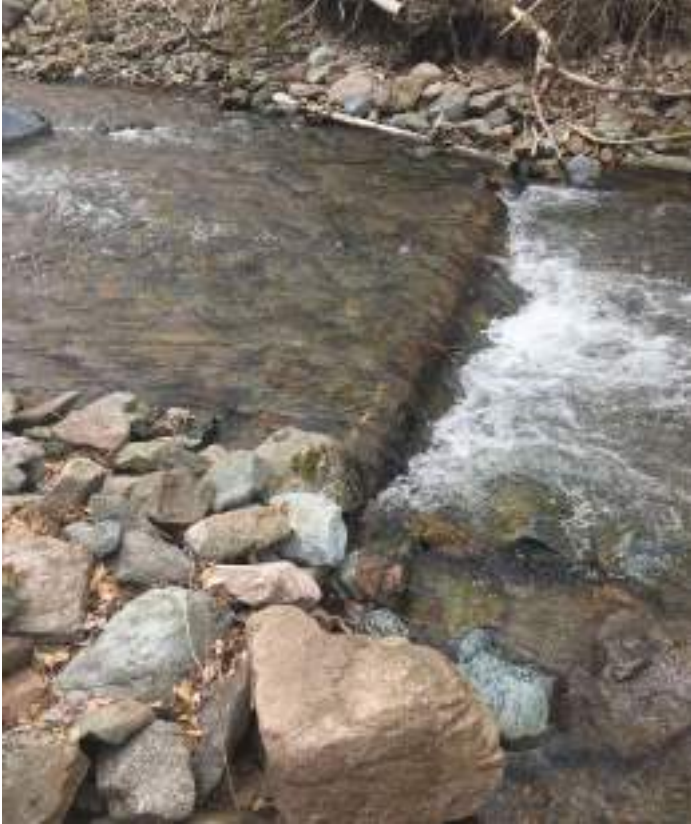
Figure 34 - Diggerlog #7 - before and after pictures of maintenance performed.

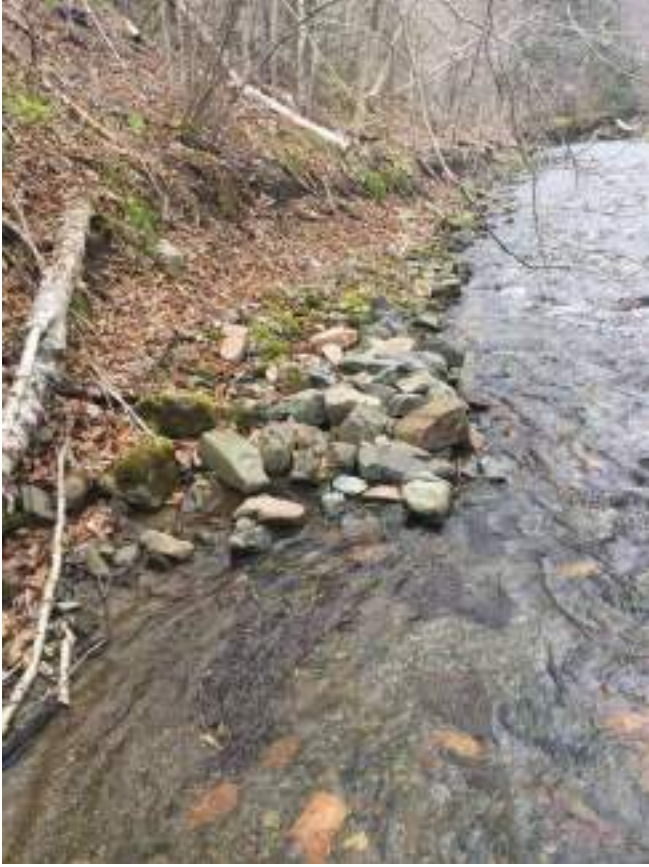
Figure 35. Deflector #8 - before and after pictures of maintenance.

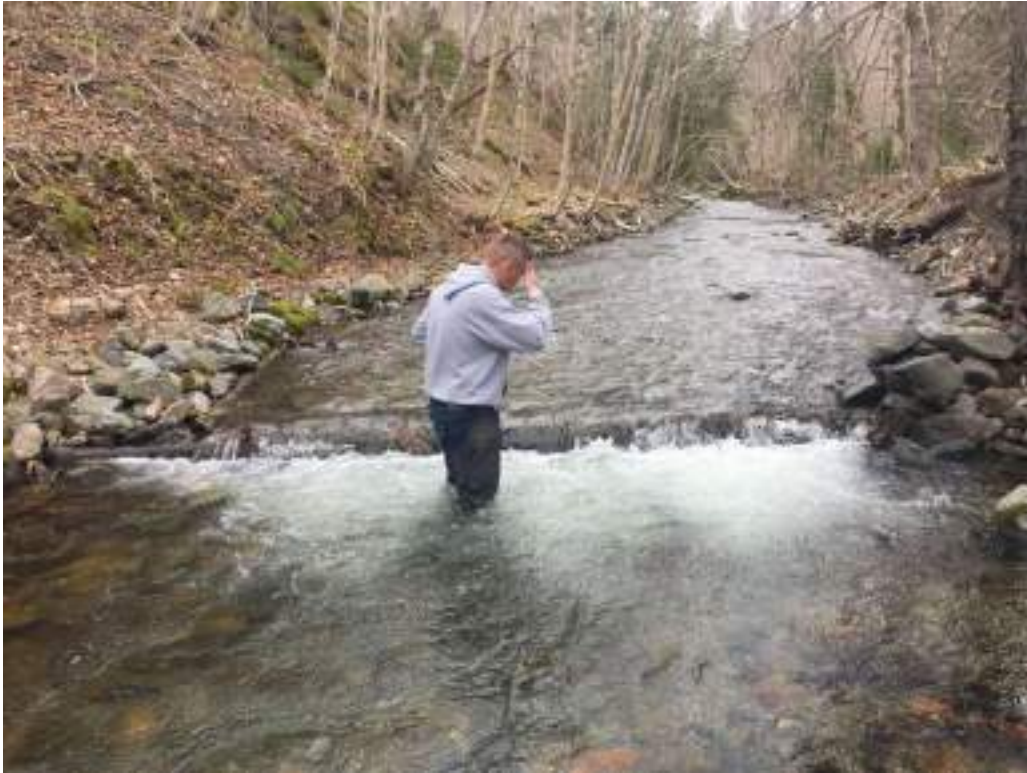
Figure 36. Diggerlog #9 - before and after pictures of maintenance.

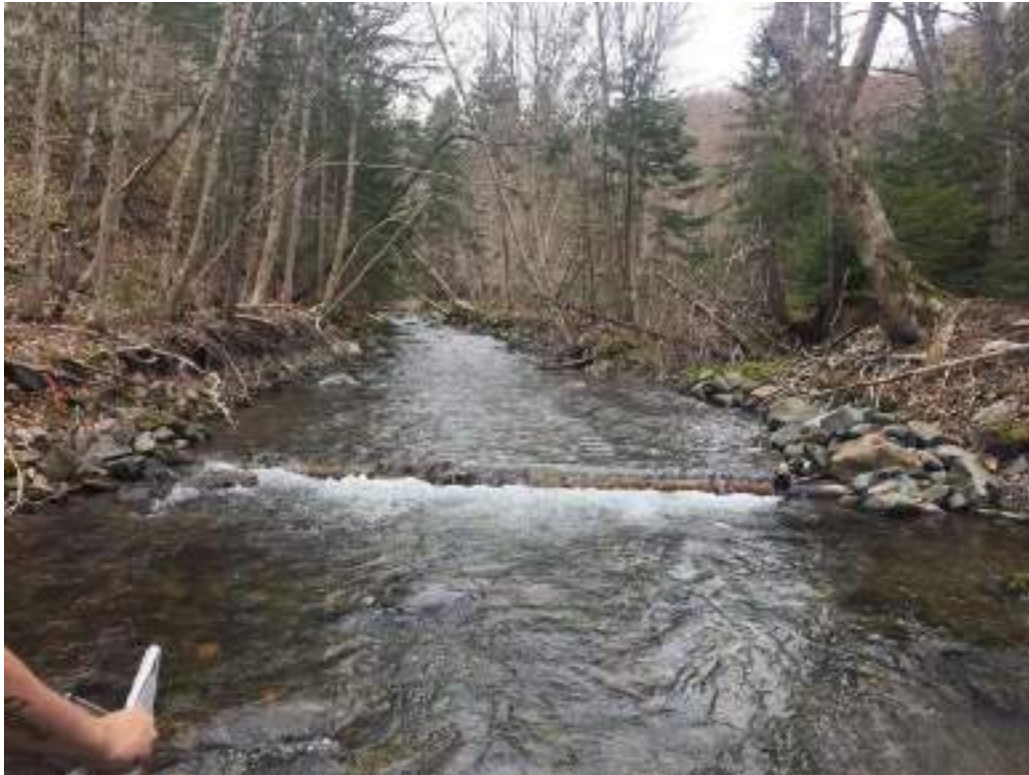
Figure 37. Diggerlog #10 - before and after pictures of maintenance.

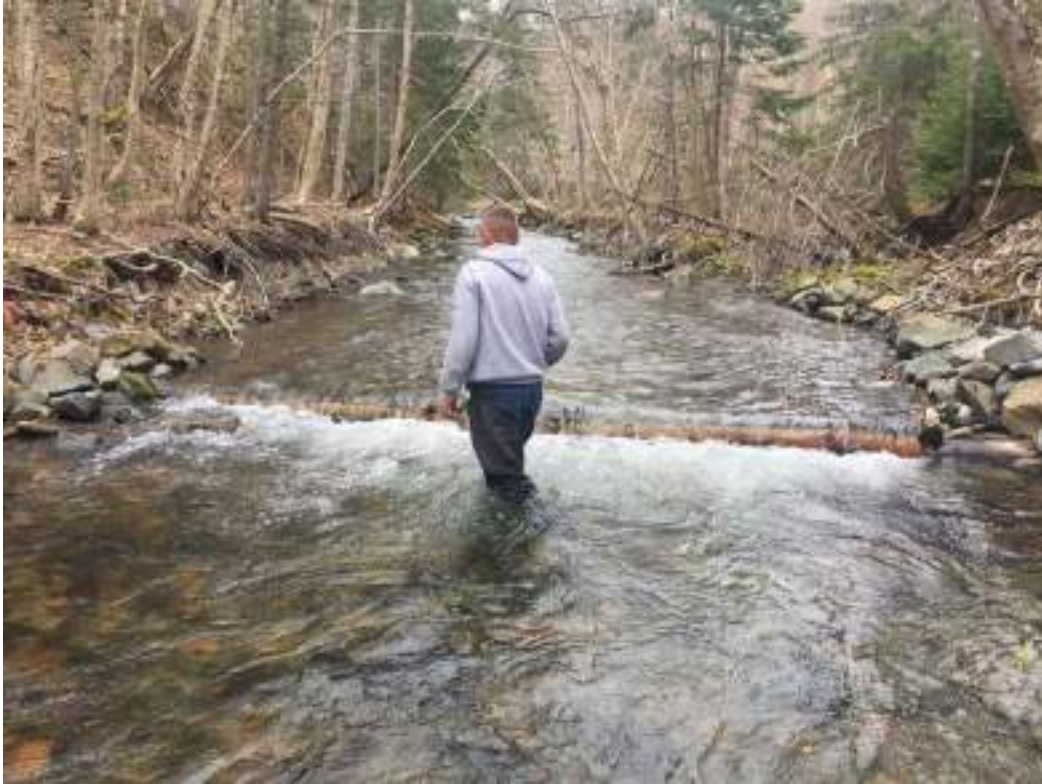
Figure 38. Diggerlog #11 - before and after pictures of maintenance.

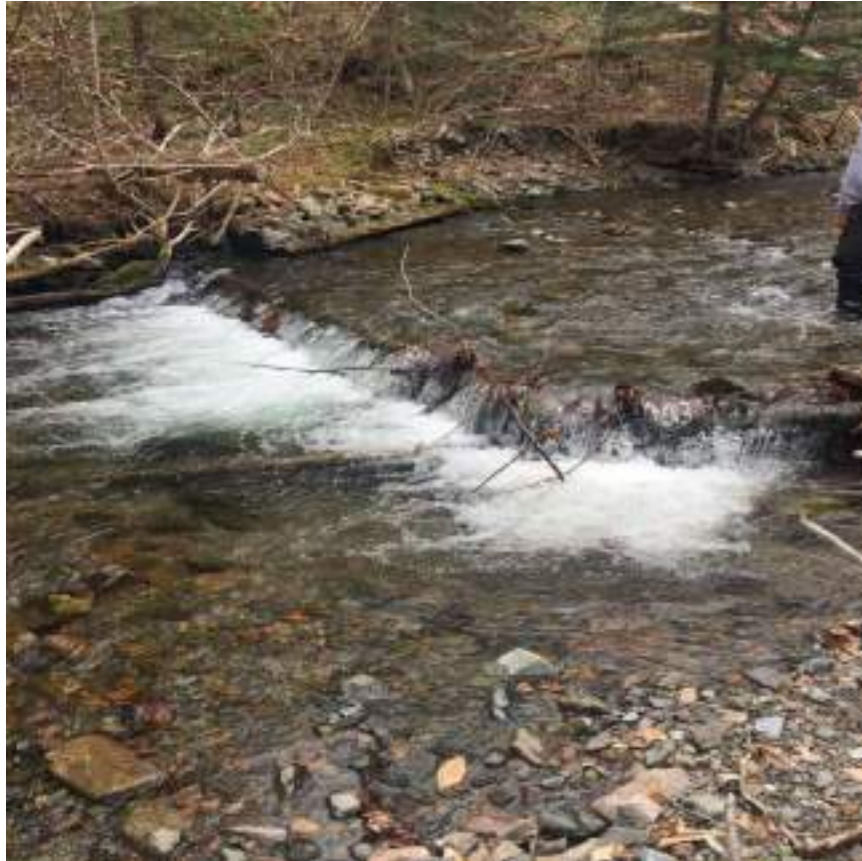
Figure 41. Diggerlog #14 - before and after pictures of maintenance.

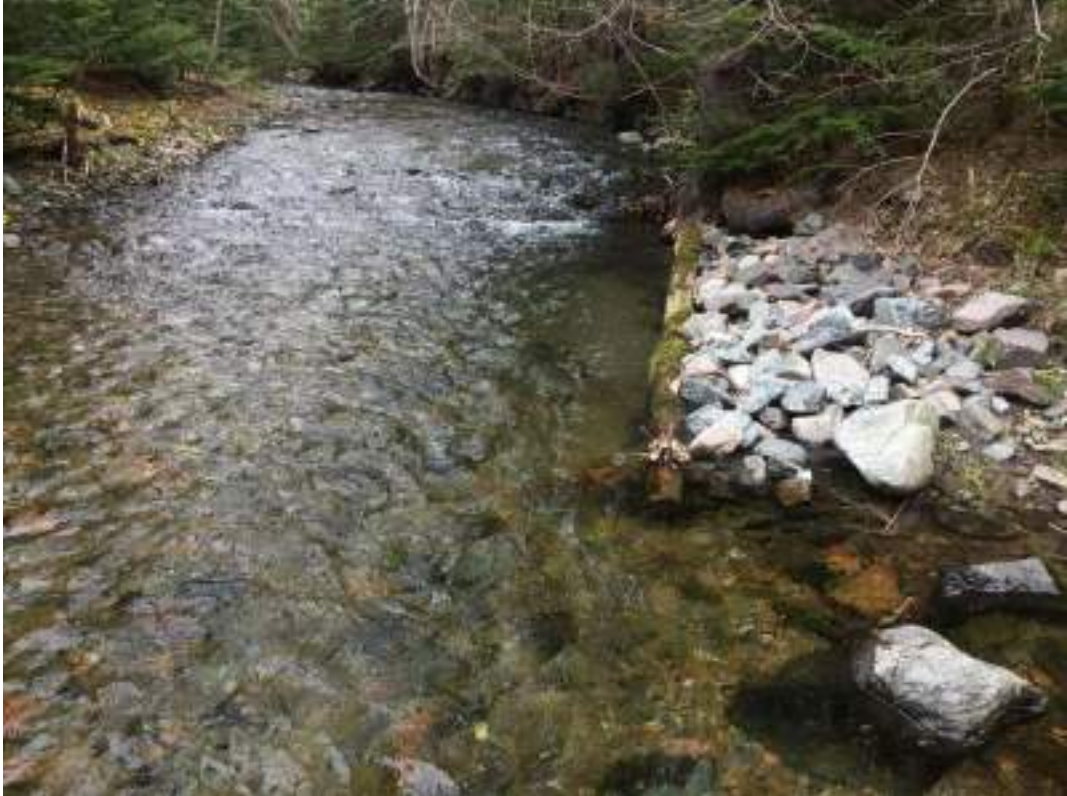
Figure 42. Deflector #15 - before and after pictures of maintenance.

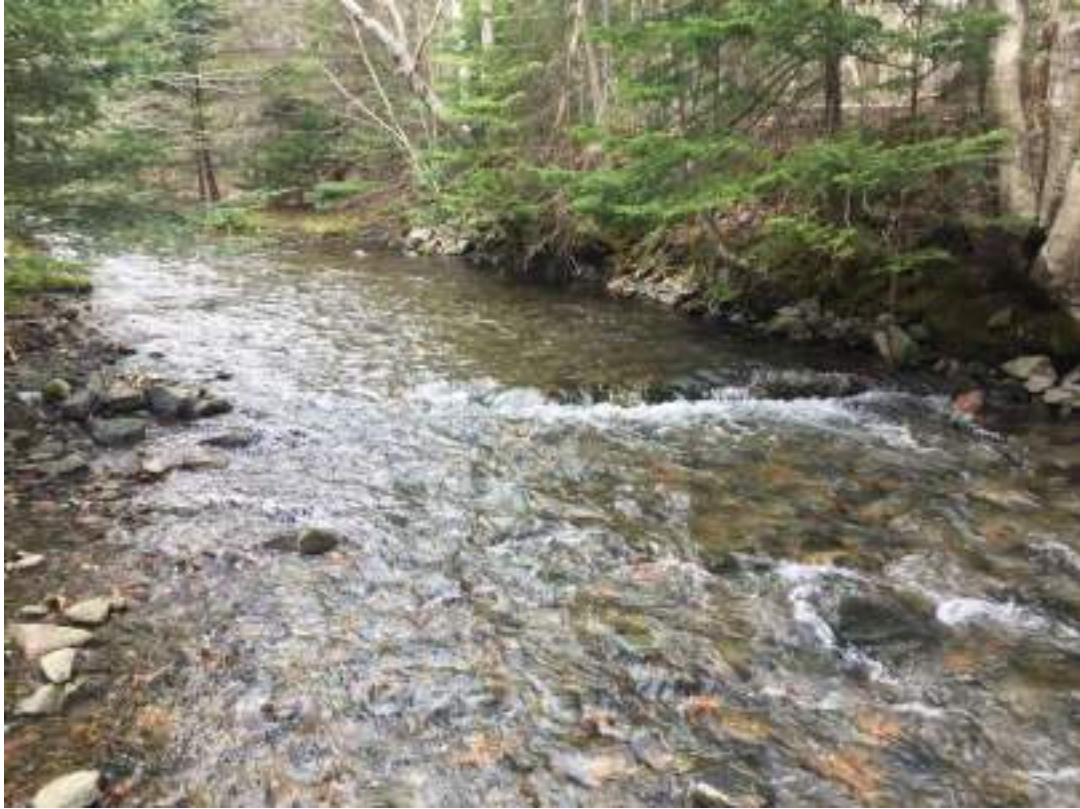
Figure 43. Diggerlog #16 - buried diggerlog. Before and after pictures show attempted maintenance on the structure.

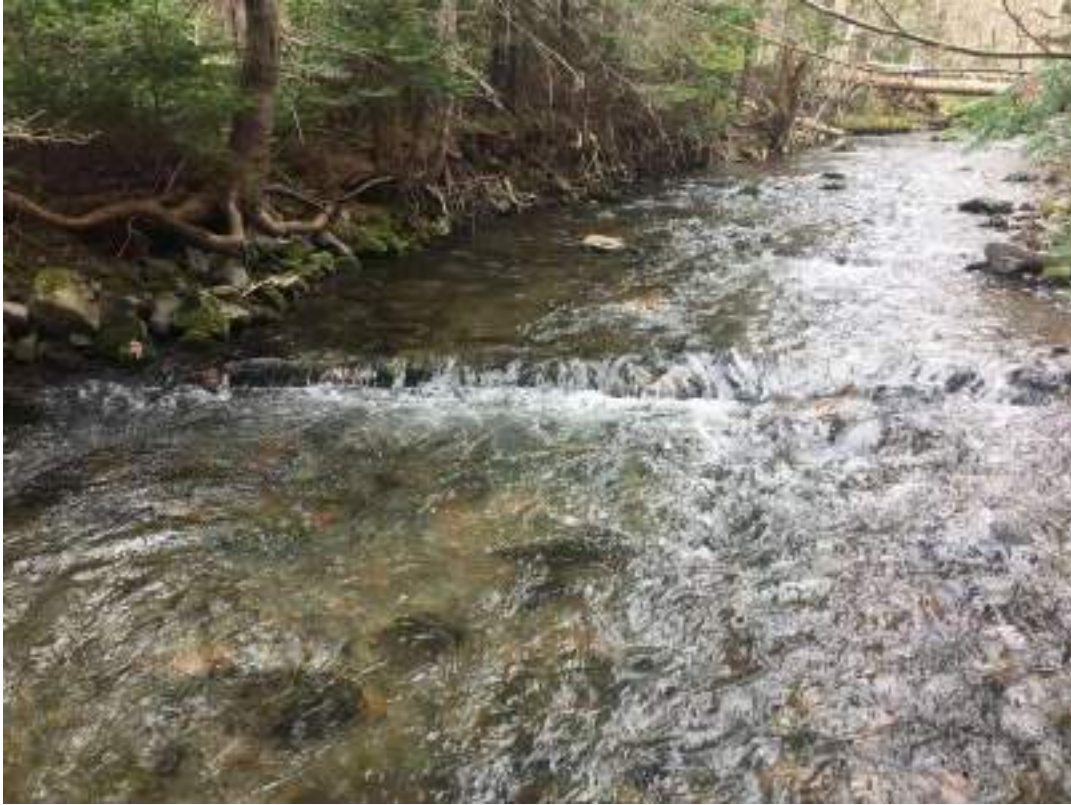
Figure 44. Diggerlog #17 - before and after pictures of maintenance.
