SALMONID HABITAT RESTORATION
INVERNESS SOUTH ANGLERS ASSOCIATION

Winter Damage Assessment

Date: 2019

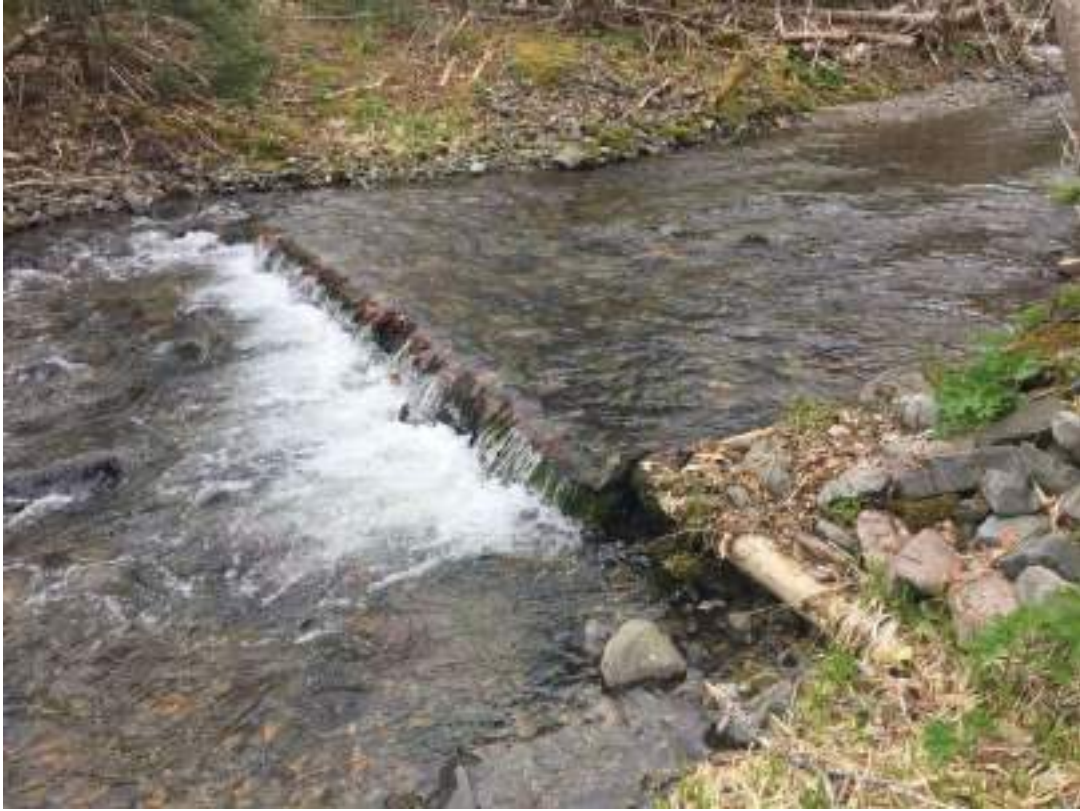
Figure 45. Diggerlog and deflector #18 - before and after pictures of maintenance.

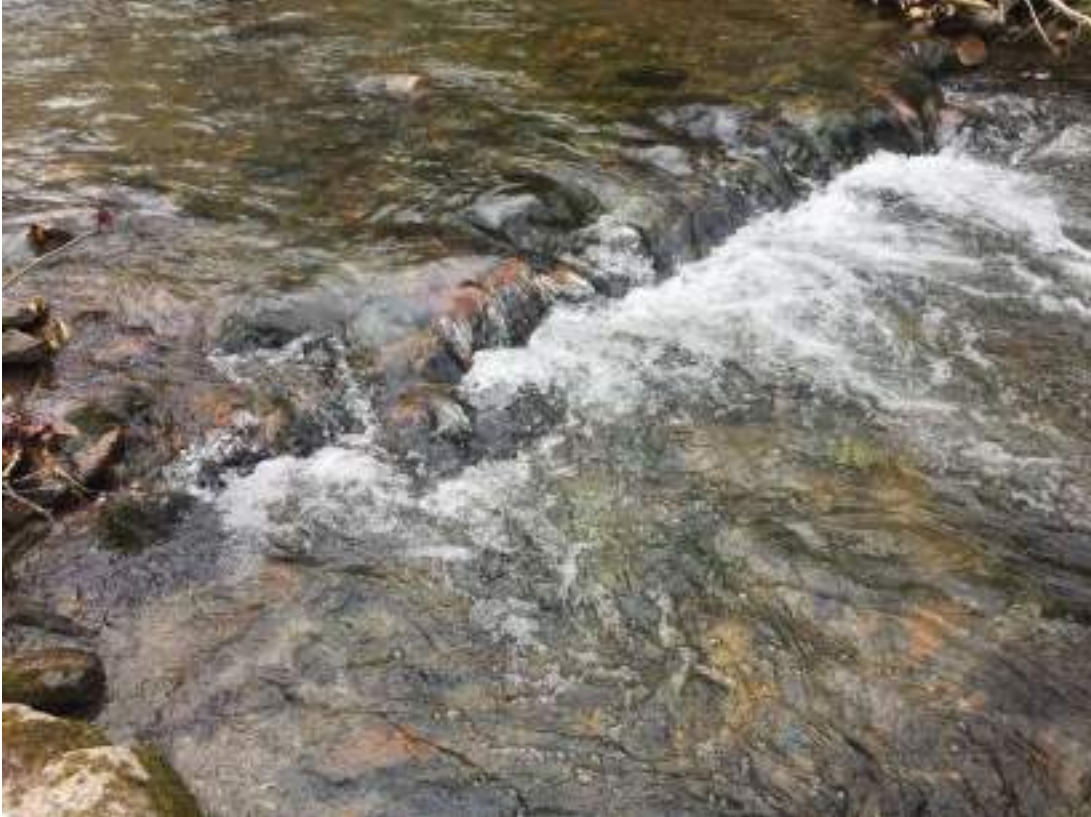
Figure 46. Diggerlog #19 - before and after pictures of maintenance.

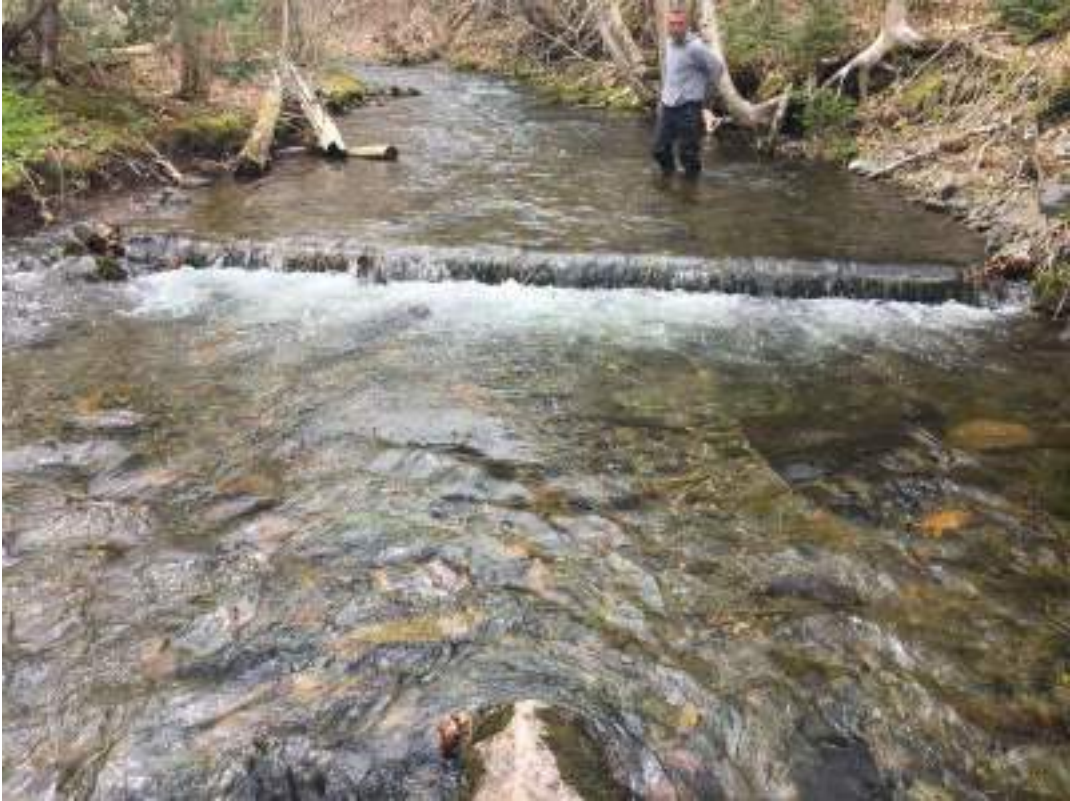
Figure 47. Diggerlog #20 - before and after pictures of maintenance.

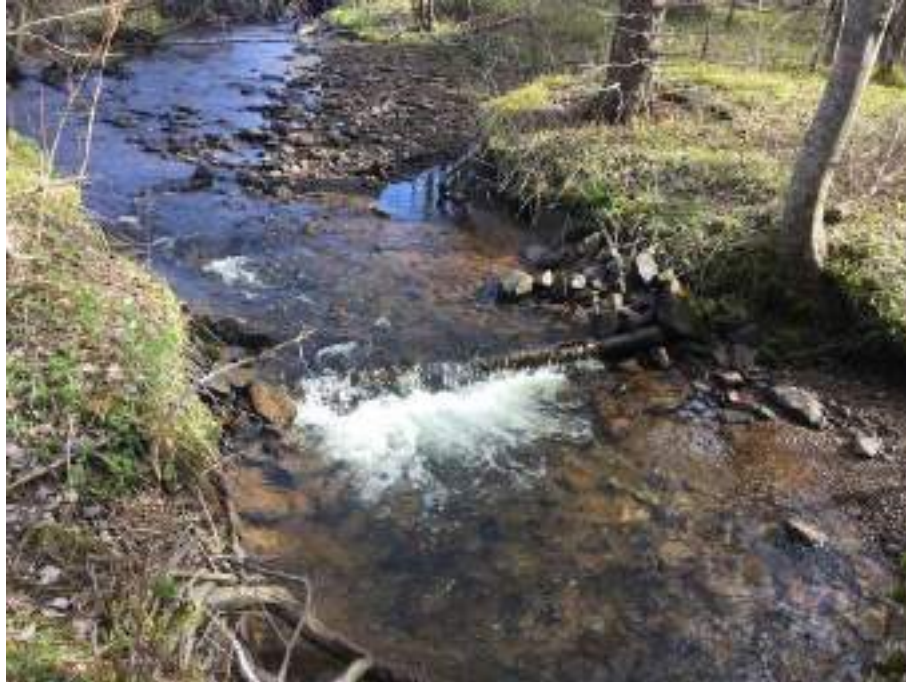
Figure 49. Digger log #1 - furthest structure upstream. Before and after pictures of the completed maintenance.

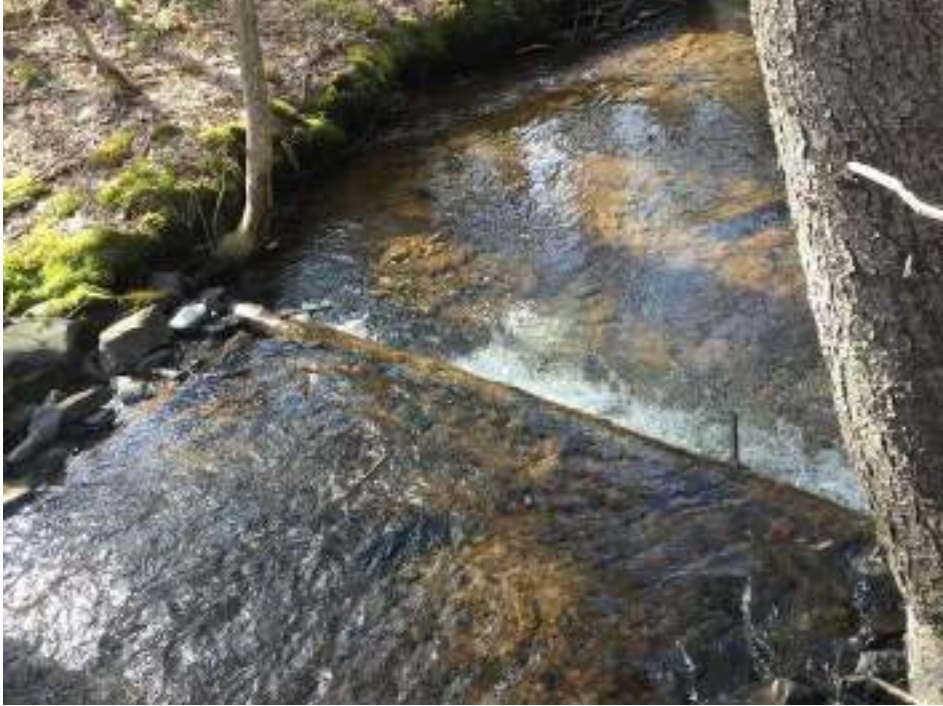
Figure 52. Structure #4 - Before and after picture of the maintenance completed on a digger log.

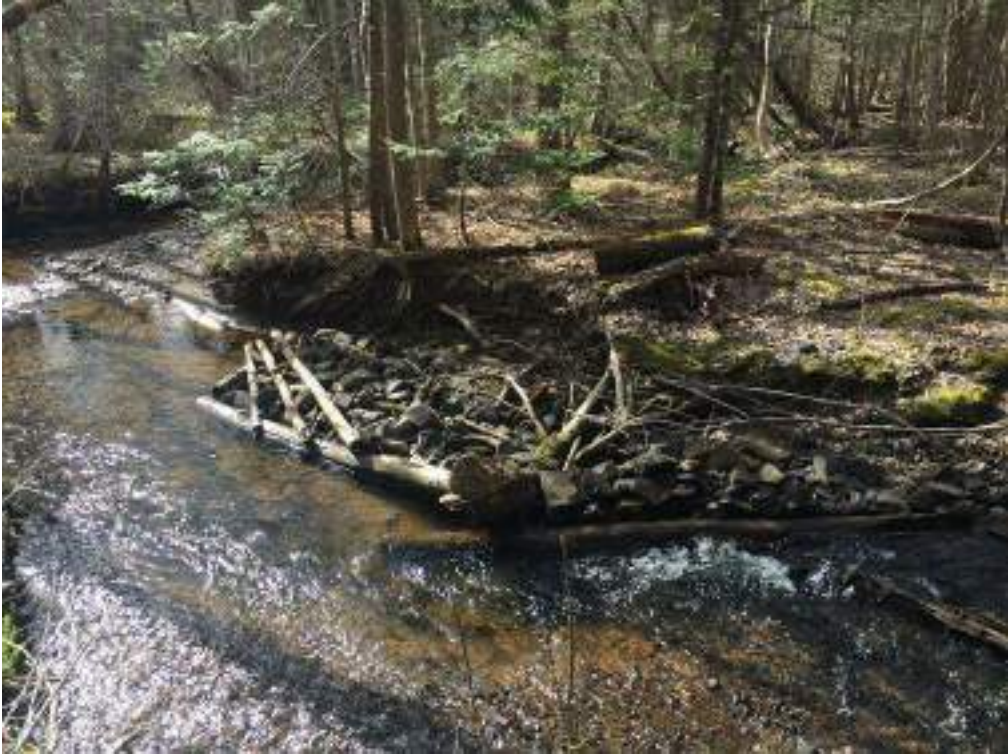
Figure 54. Structure #6 - before and after picture of the maintenance completed on a deflector.

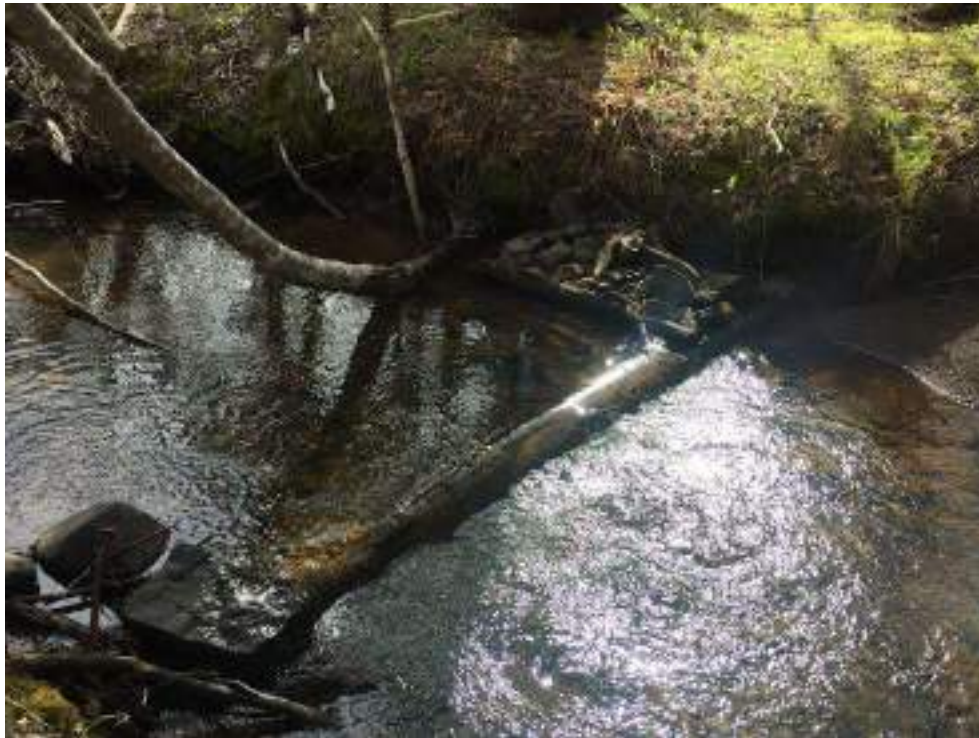
Figure 55. Structure #7 - Before and after picture of the maintenance completed on a digger log and deflector structure.

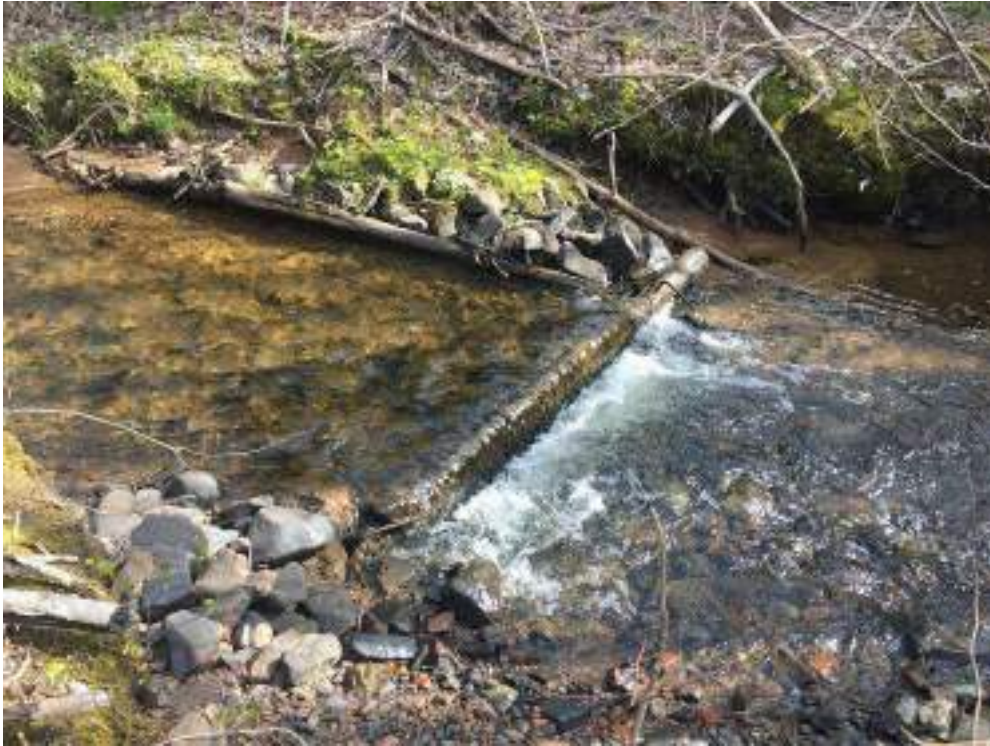
Figure 56. Structure #8 - before and after picture of the maintenance completed on a digger log and deflector structure.

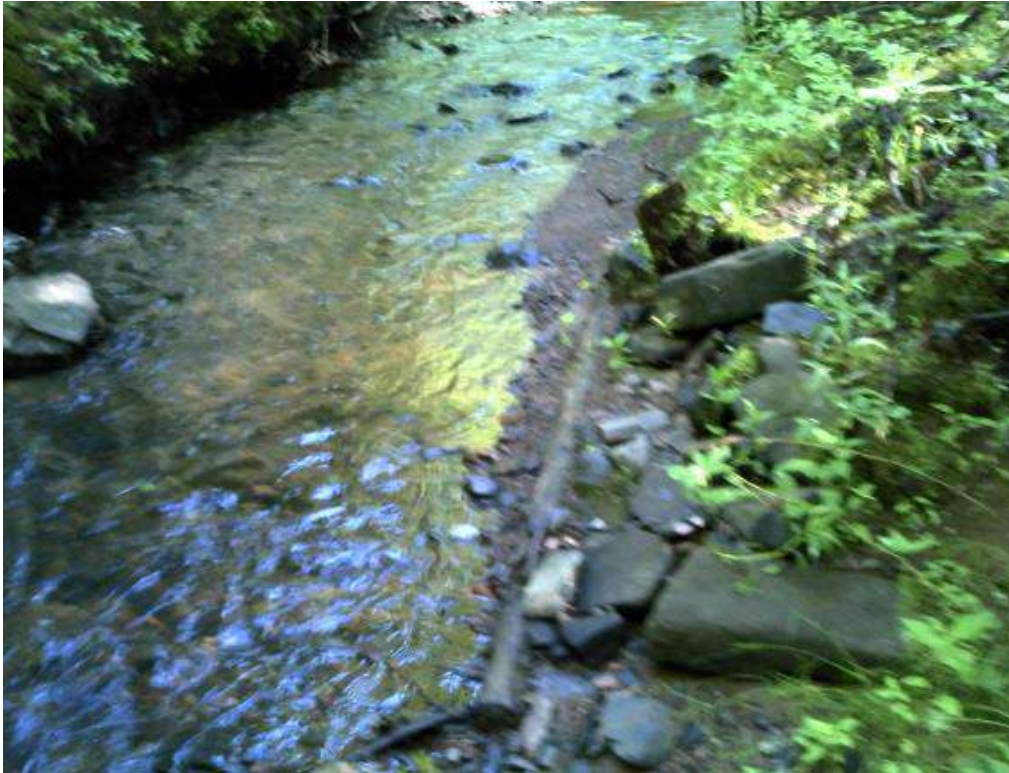
Figure 57. Structure #9 - Before and after picture of the maintenance completed on a deflector.

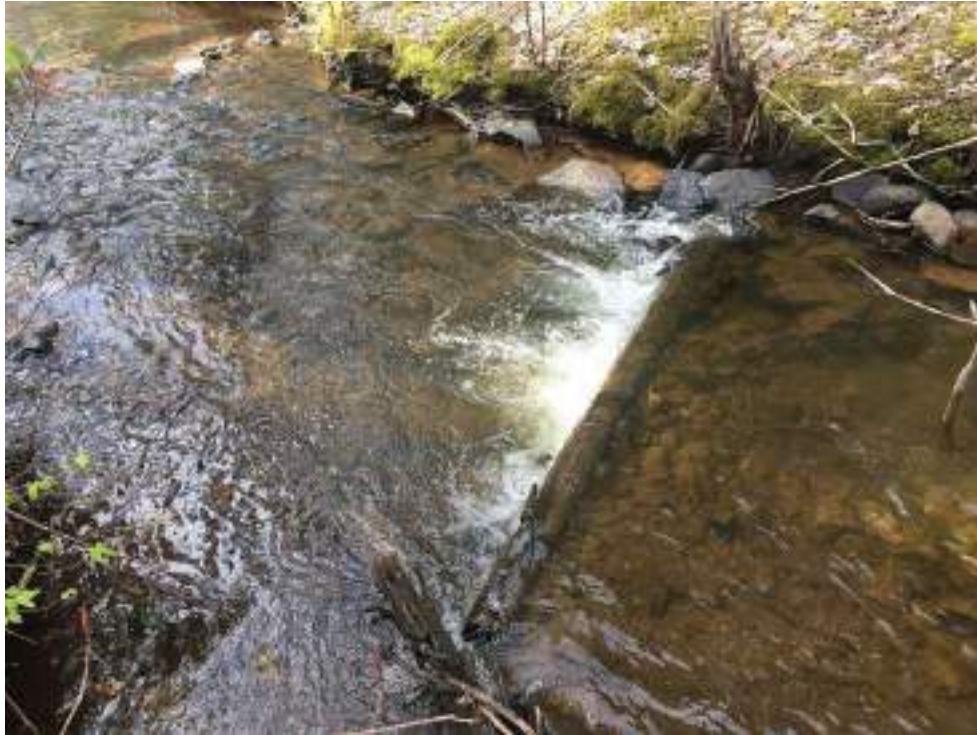
Figure 58. Structure #10 - Before and after picture of the maintenance completed on a diggerlog.

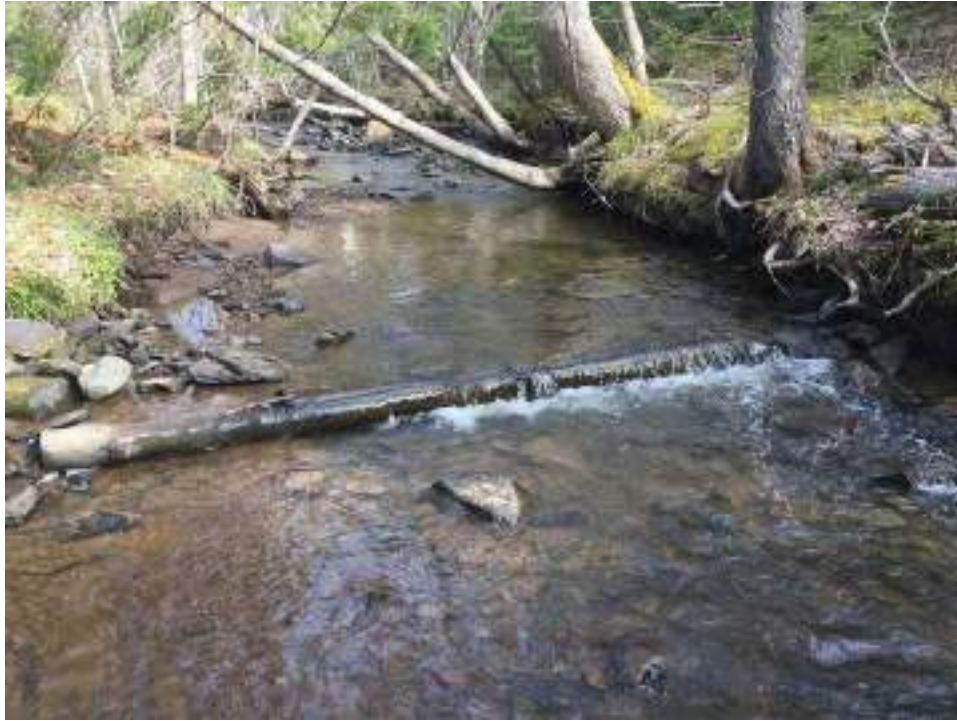
Figure 59. Structure #11 - Before and after picture of the maintenance completed on a digger log.

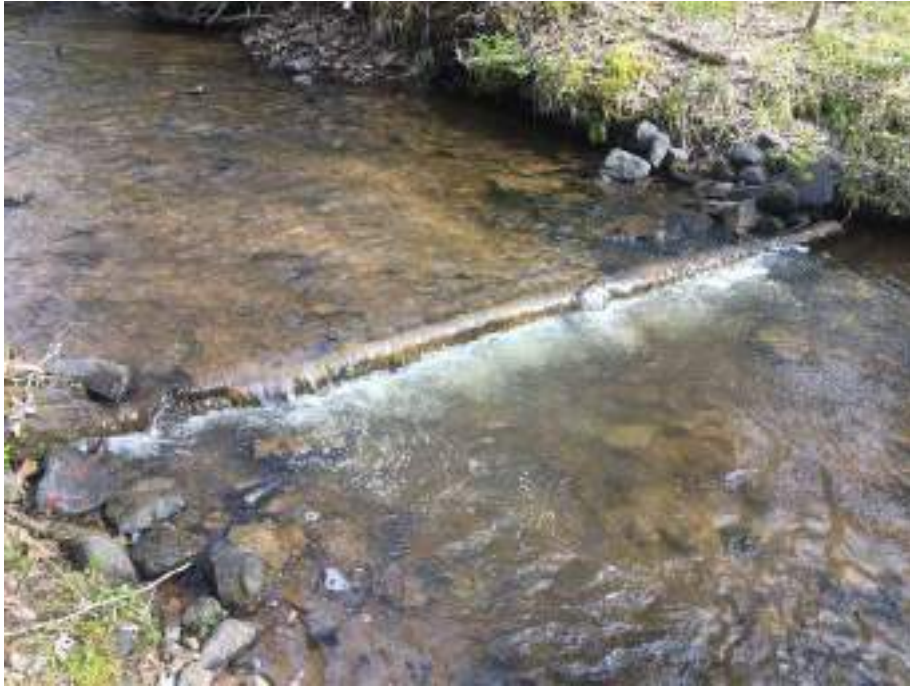
Figure 61. Structure #13 - Before and after picture of the maintenance completed on a digger log.

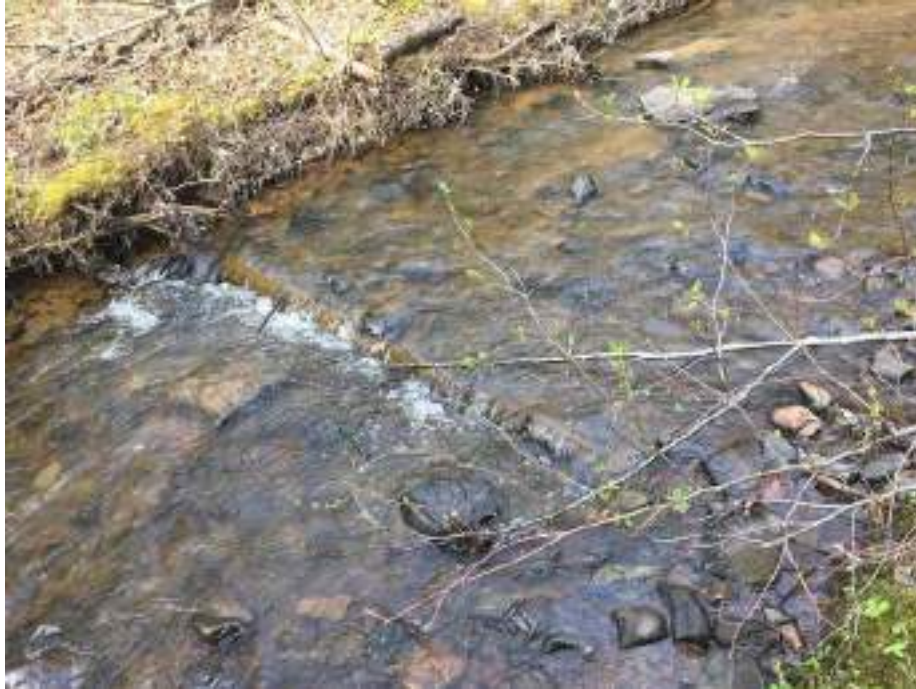
Figure 62. Structure #14 - Before and after picture of the maintenance completed on a diggerlog.

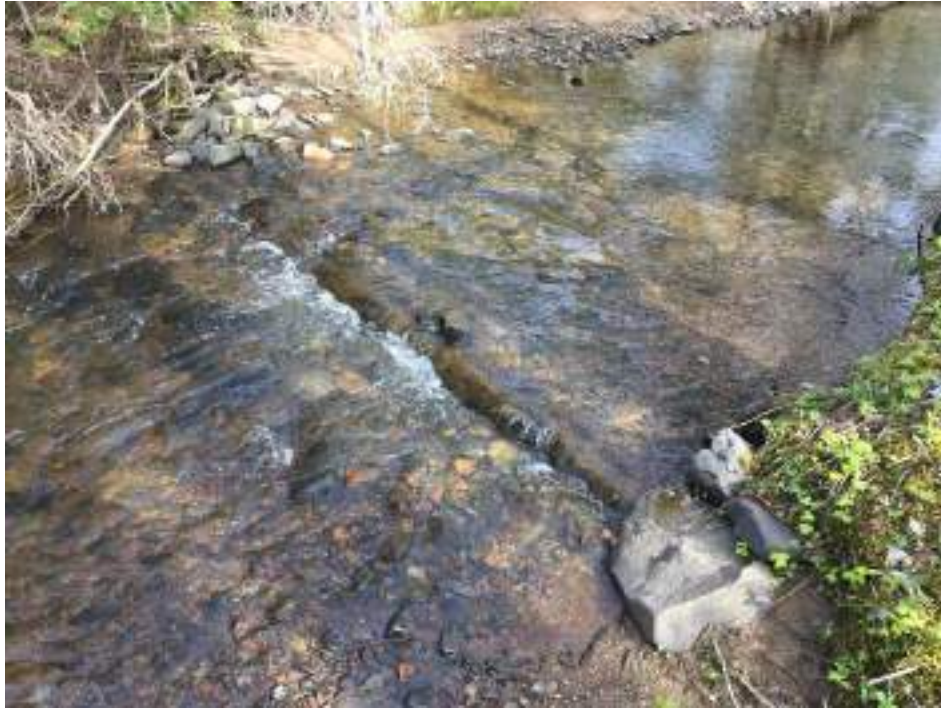
Figure 63. Structure #15 - Before and after picture of the maintenance completed on a digger log.

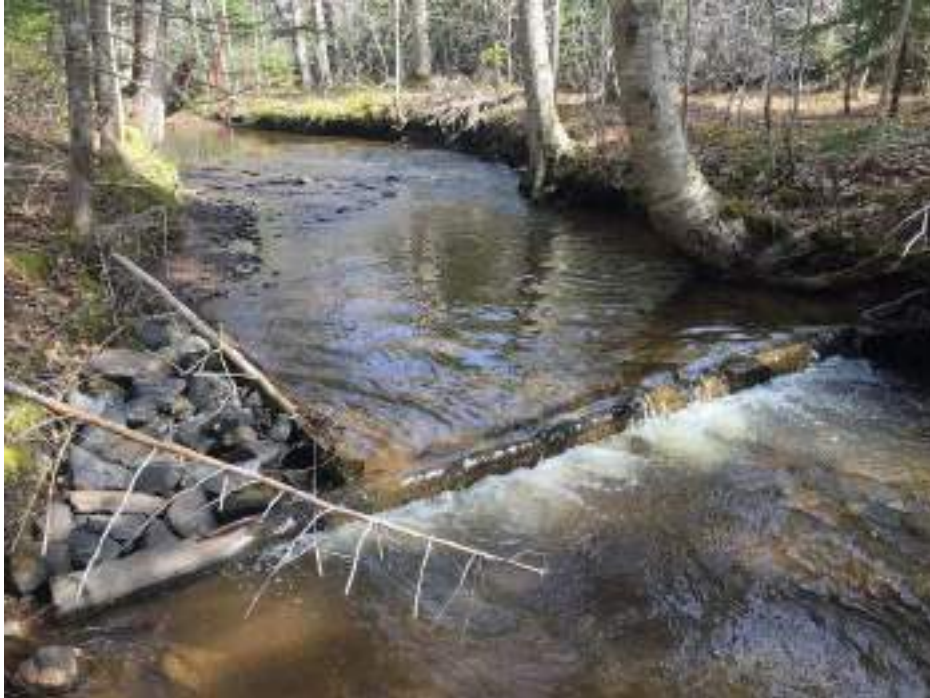
Figure 64. Structure #16 - Before and after picture of the maintenance completed on a digger log and deflector structure.

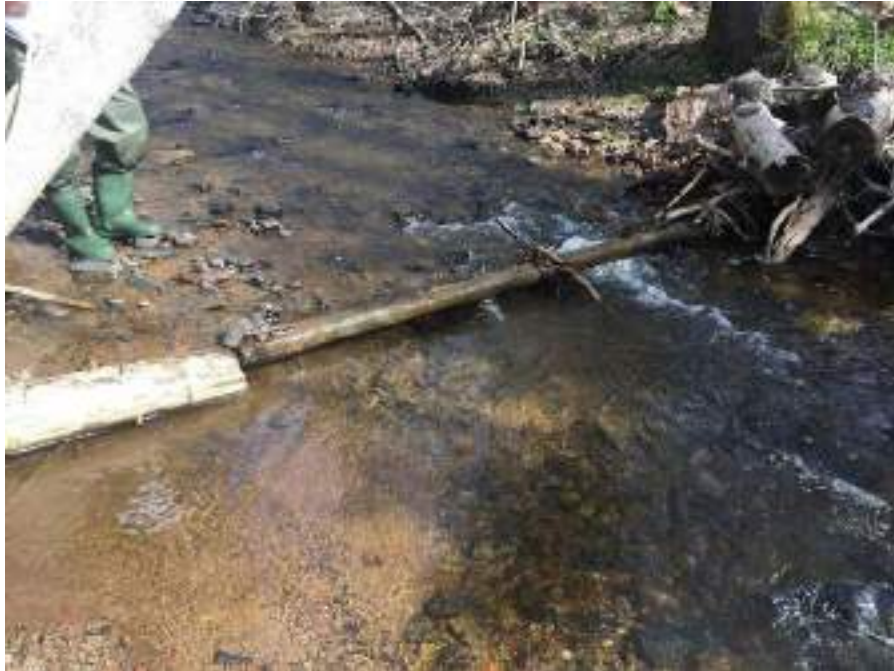
Figure 65. Structure #17 - Before and after picture of the maintenance completed on a diggerlog.

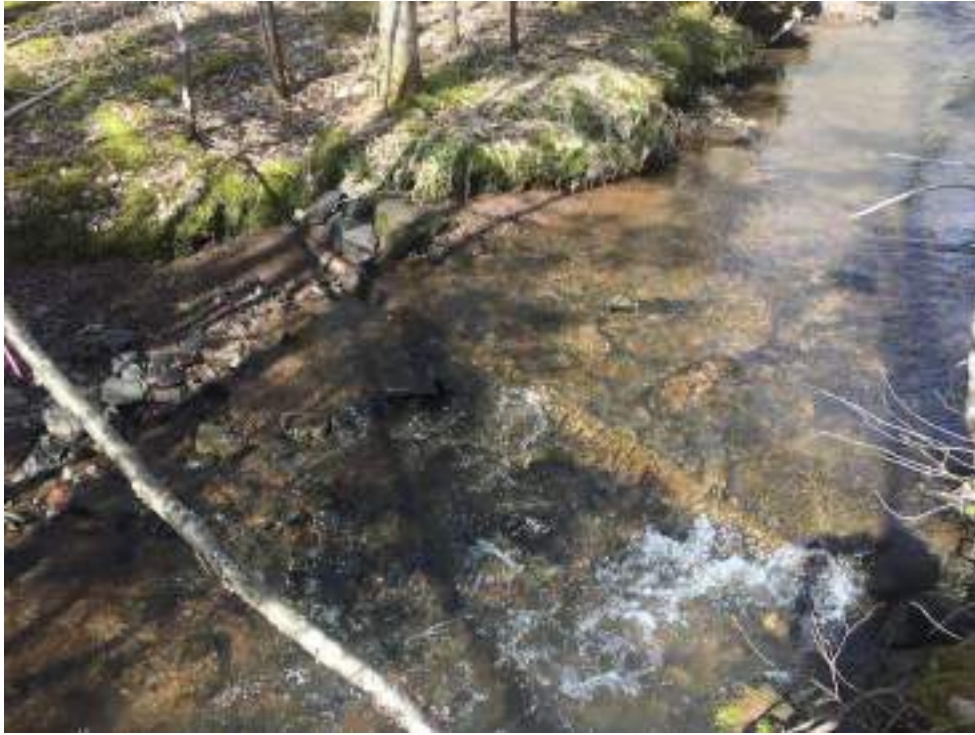
Figure 67. Structure #19 - Before and after picture of the maintenance attempted on a digger log.

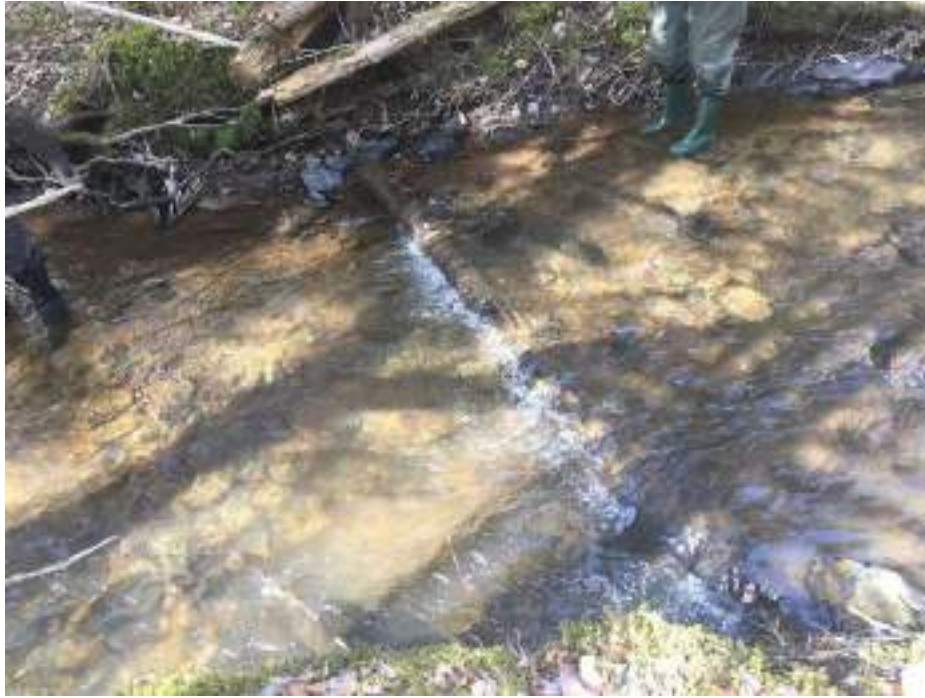
Figure 68. Structure #20 - Before and after picture of the maintenance completed on a diggerlog.

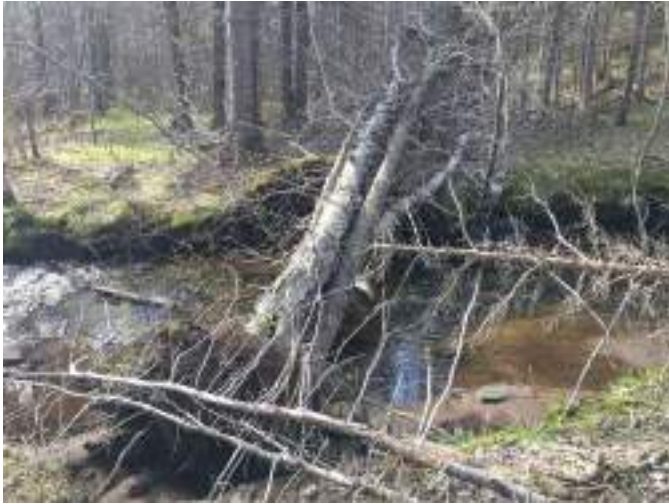
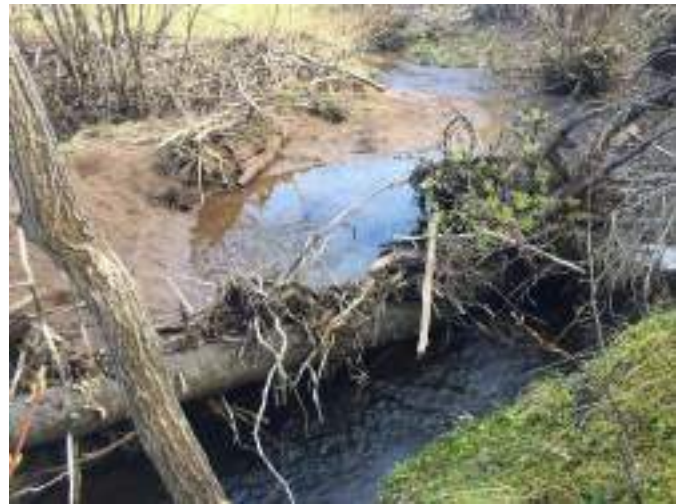
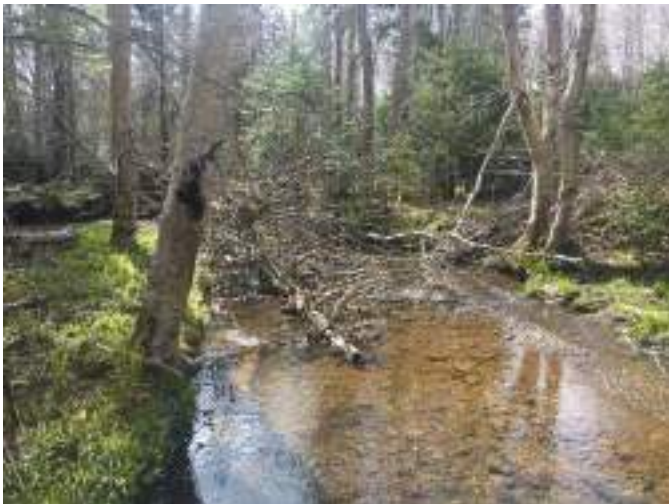
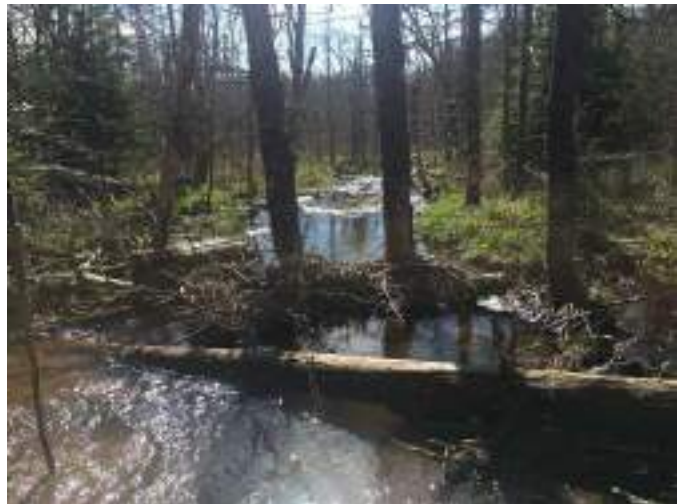
Debris Jams:

The photos seen below show the multiple debris jams located on Frasers Brook.

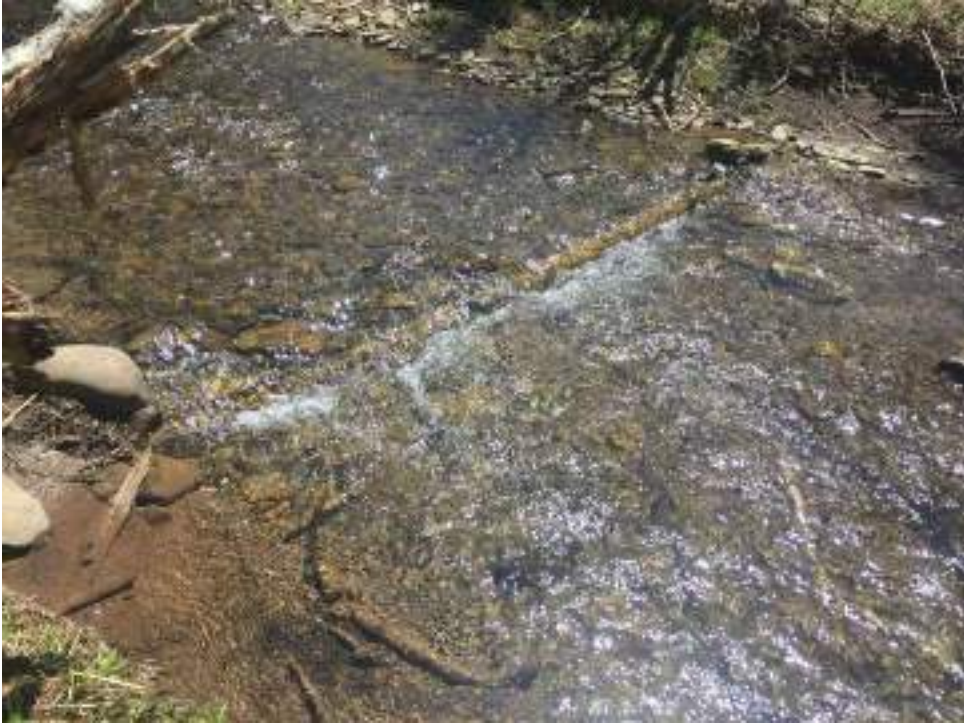
Figure 76. First diggerlog structure upstream from Trans Canada Trail

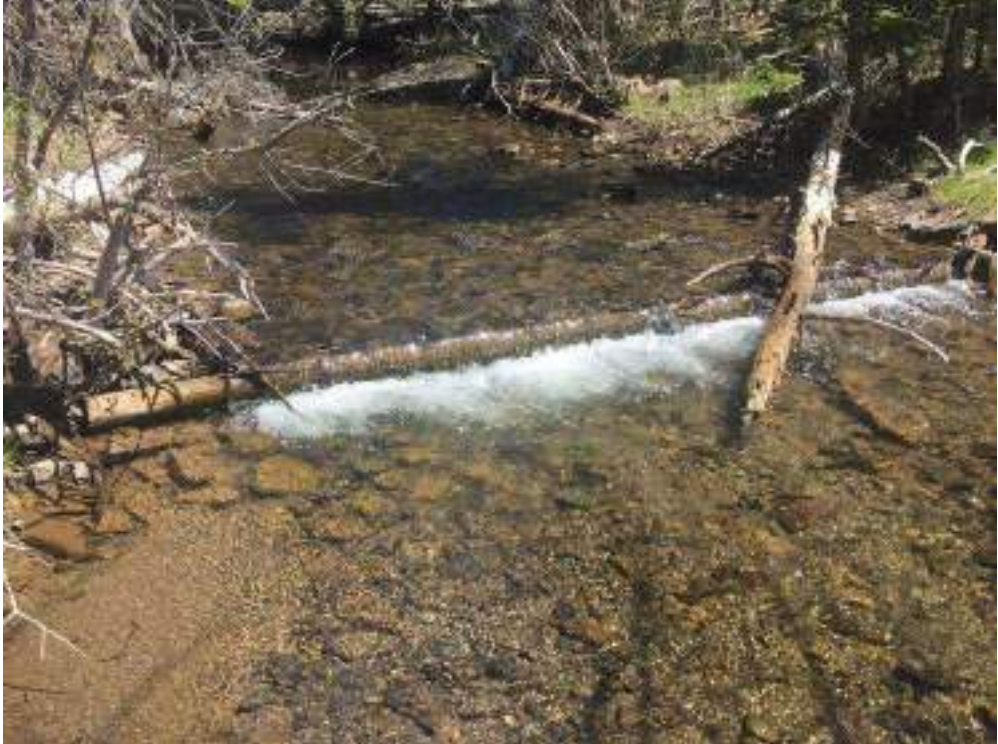
Figure 77. Digger log structure #2 upstream from the Trans Canada Trail.

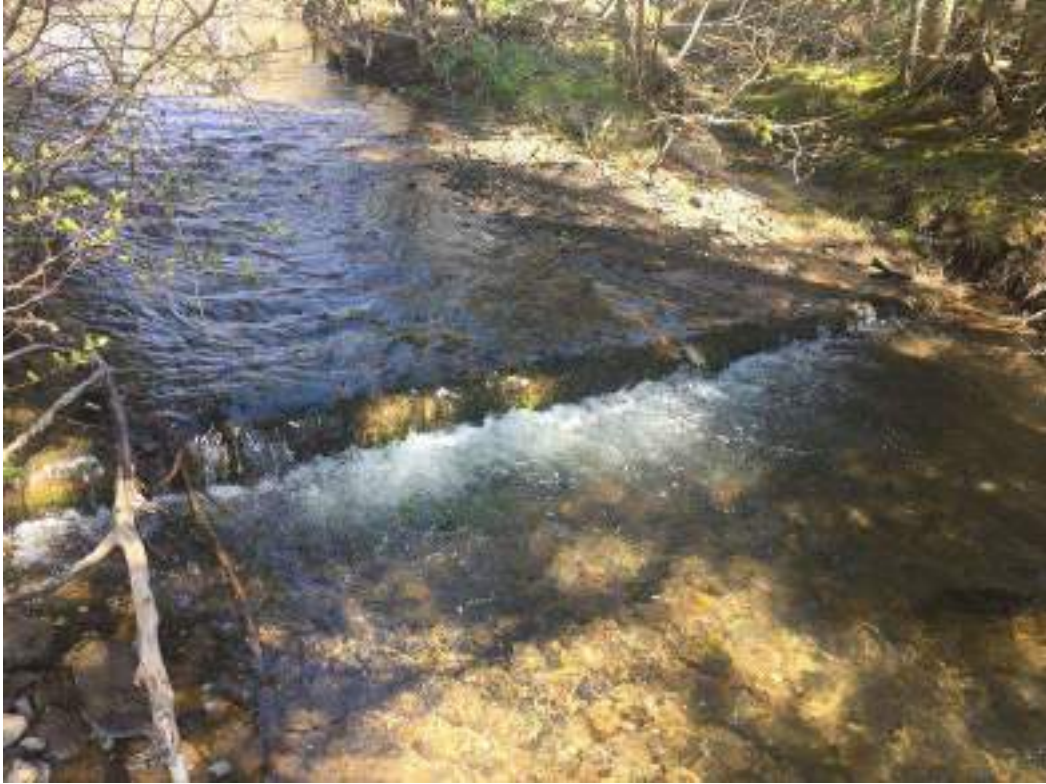
Figure 78. Diggerlog structure #3 upstream from the Trans Canada Trail.

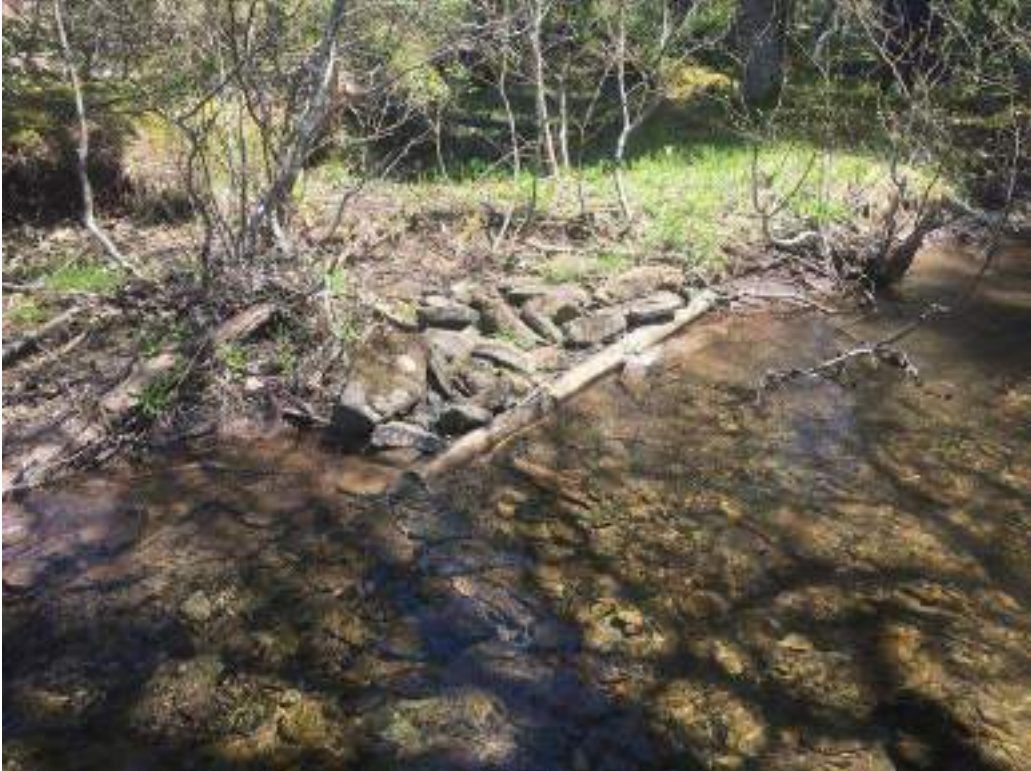
Figure 79. Deflector structure #4 upstream from the Trans Canada Trail..

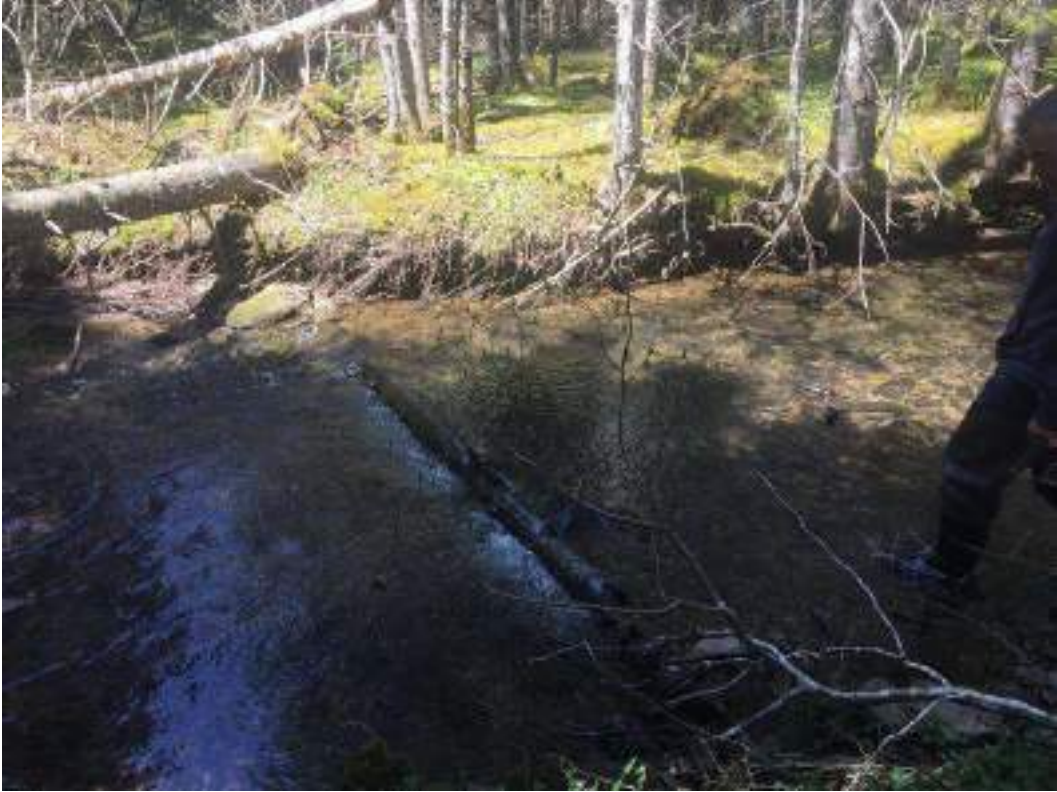
Figure 80. Diggerlog structure #5 upstream from the Trans Canada Trail.

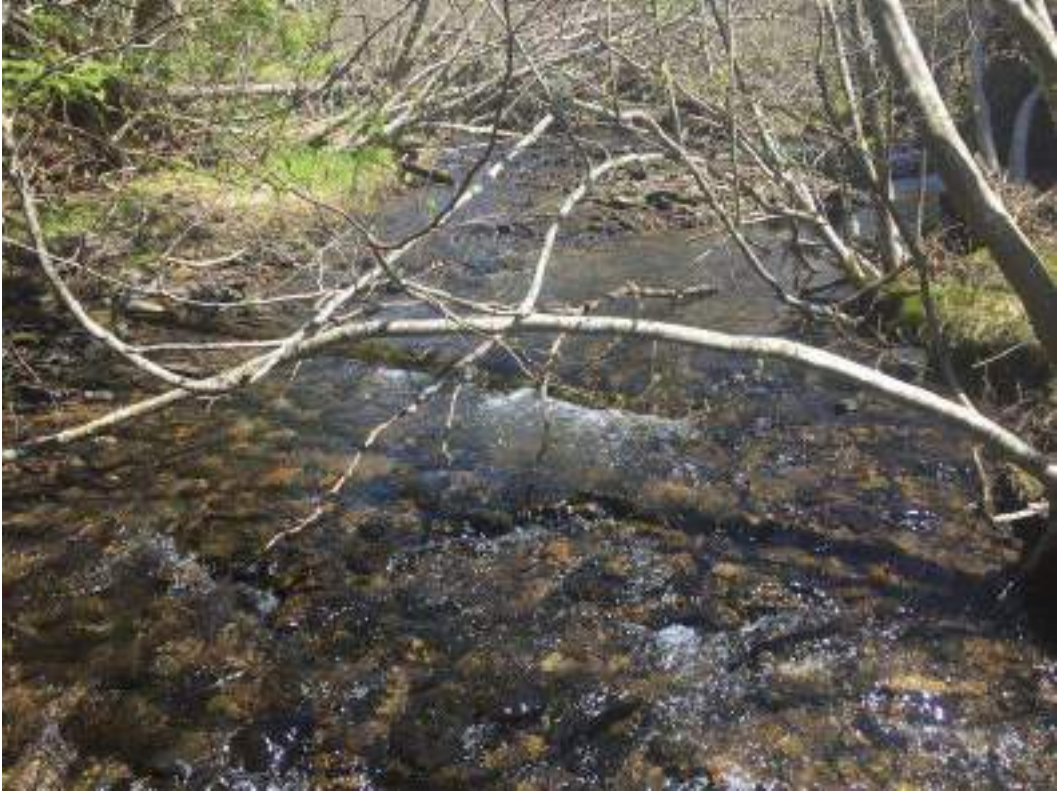
Figure 81. Diggerlog structure #6 upstream from the Trans Canada Trail.

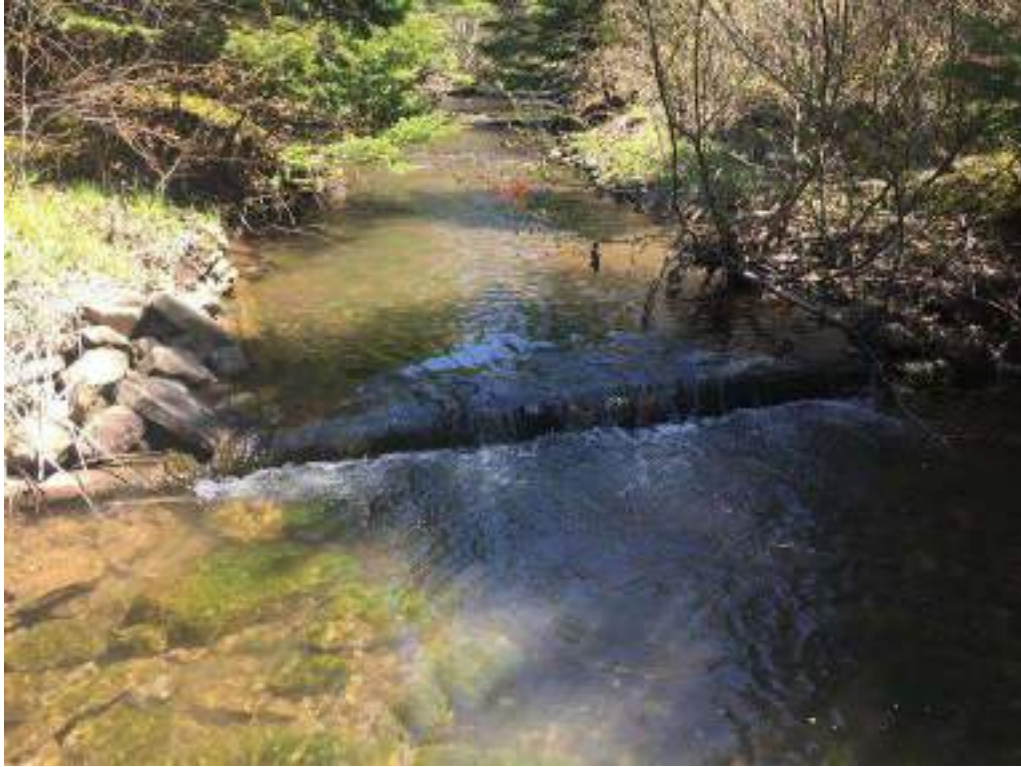
Figure 84. Diggerlog structure #9 - downstream side of Smithville Road.

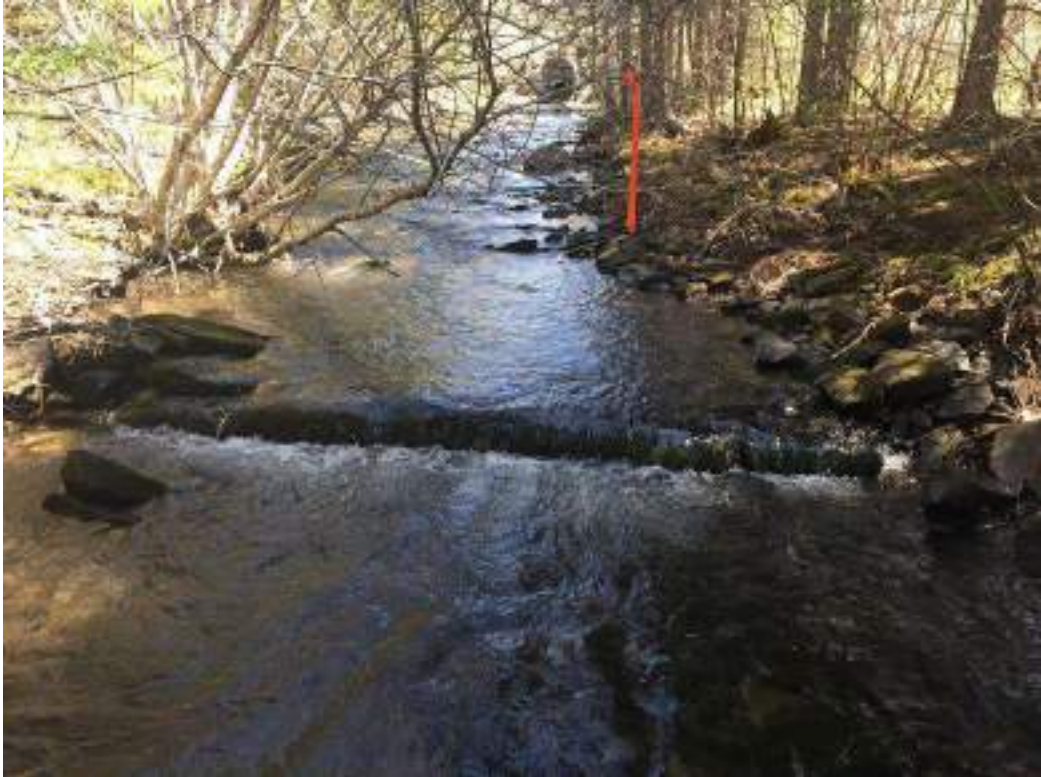
Figure 85. Diggerlog structure #10 - downstream side of Smithville Road.

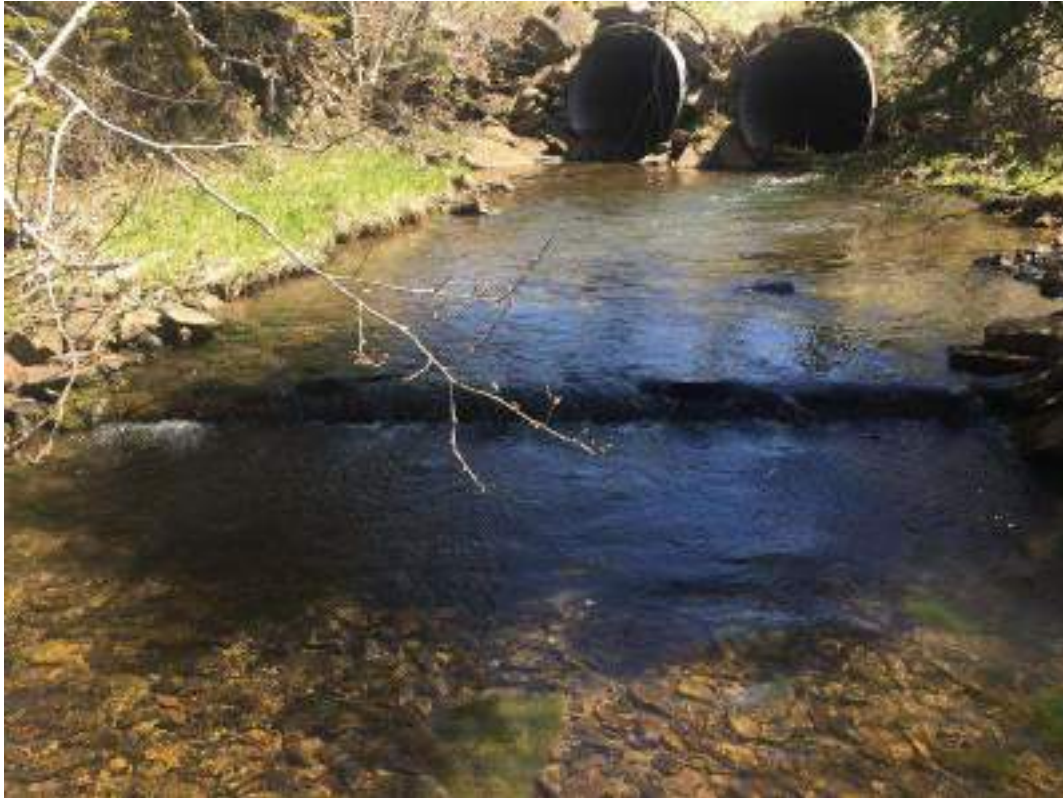
Figure 86. Diggerlog structure #11 - downstream side of Smithville Road.
