SALMONID HABITAT RESTORATION
INVERNESS SOUTH ANGLERS ASSOCIATION

Winter Damage Assessment

Date: 2019

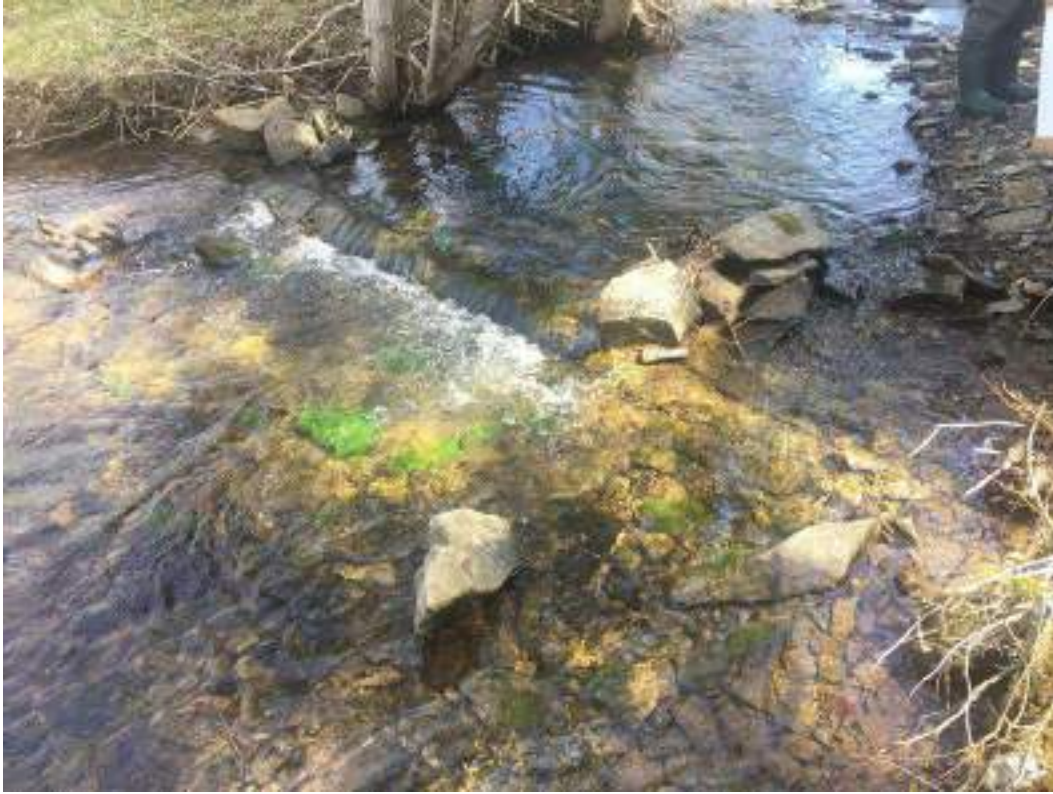
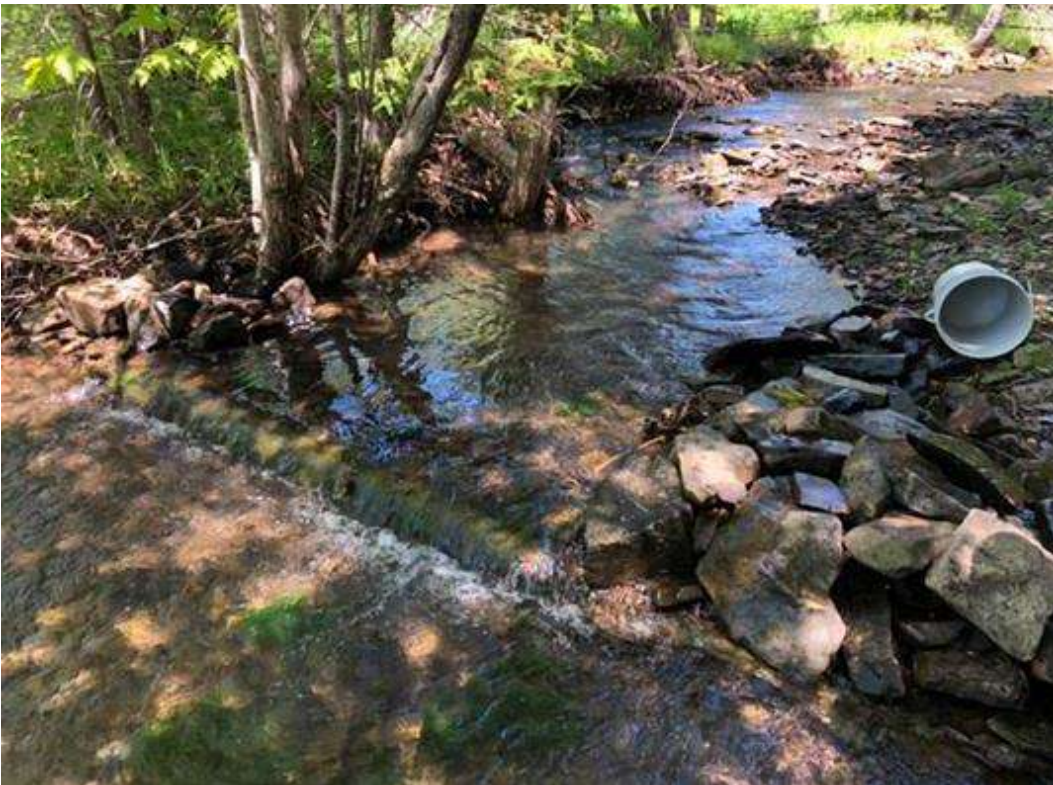
Figure 87. Diggerlog #12 - first structure on the upstream side of Smithville Road.

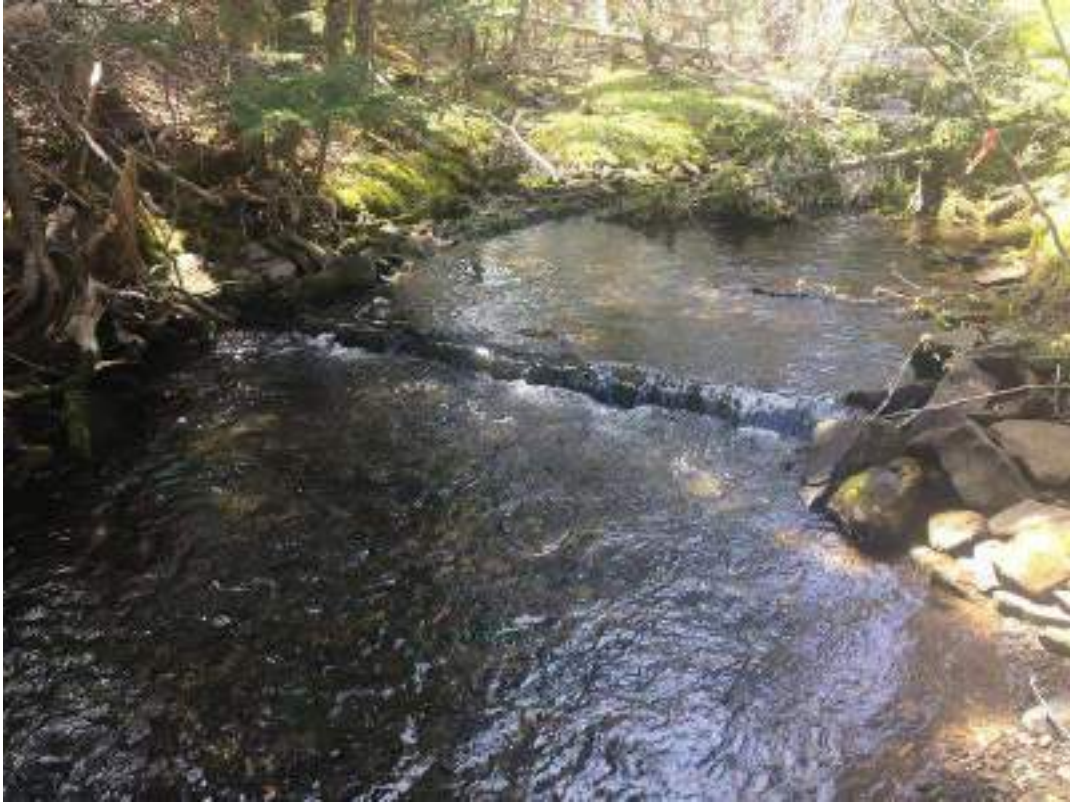
Figure 89. Diggerlog #14 - upstream from Smithville Road.

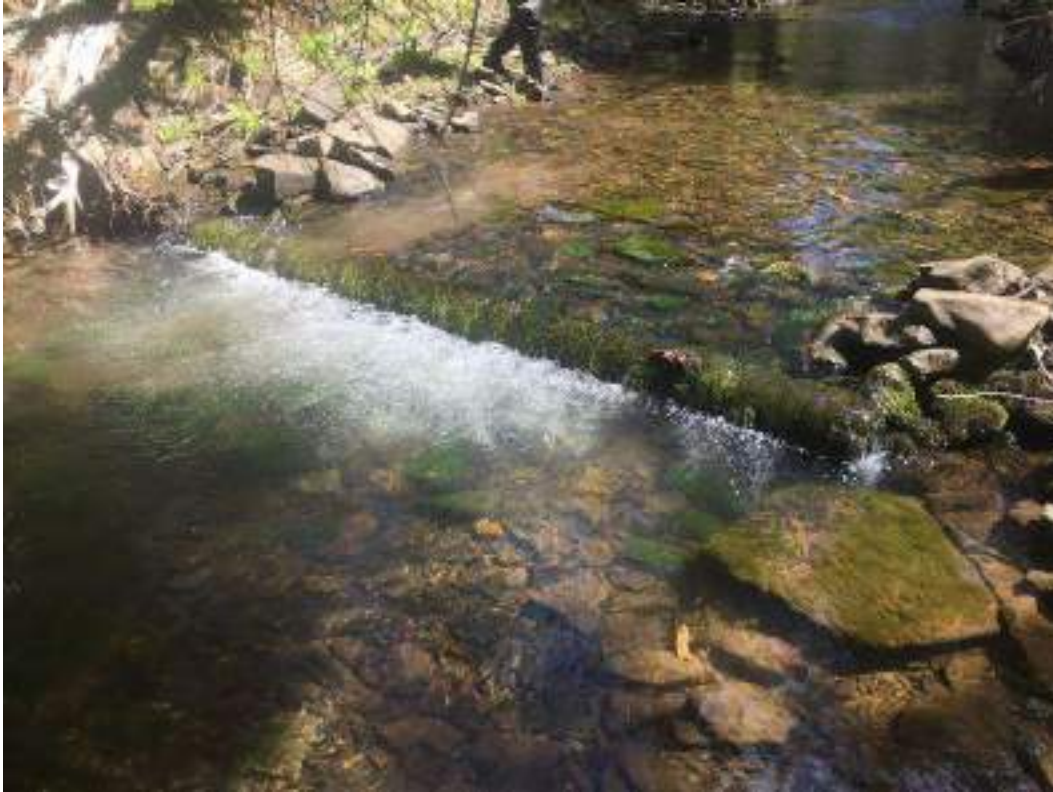
Figure 90. Diggerlog #15 - upstream from Smithville Road.

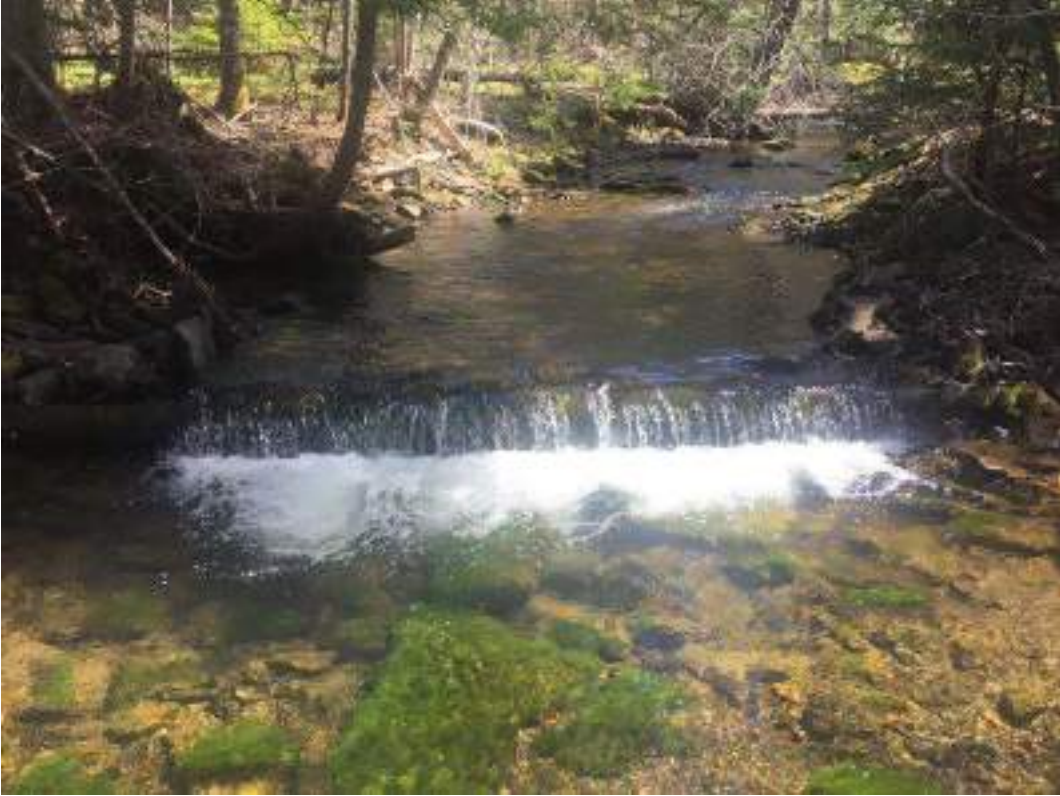
Figure 91. Diggerlog #16 - upstream from Smithville Road.

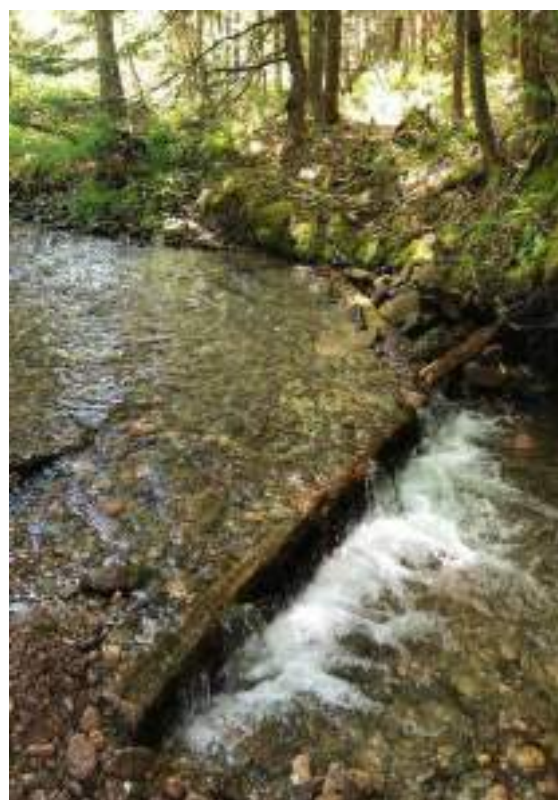
Figure 134. Before and after picture of the maintenance performed on diggerlog #40

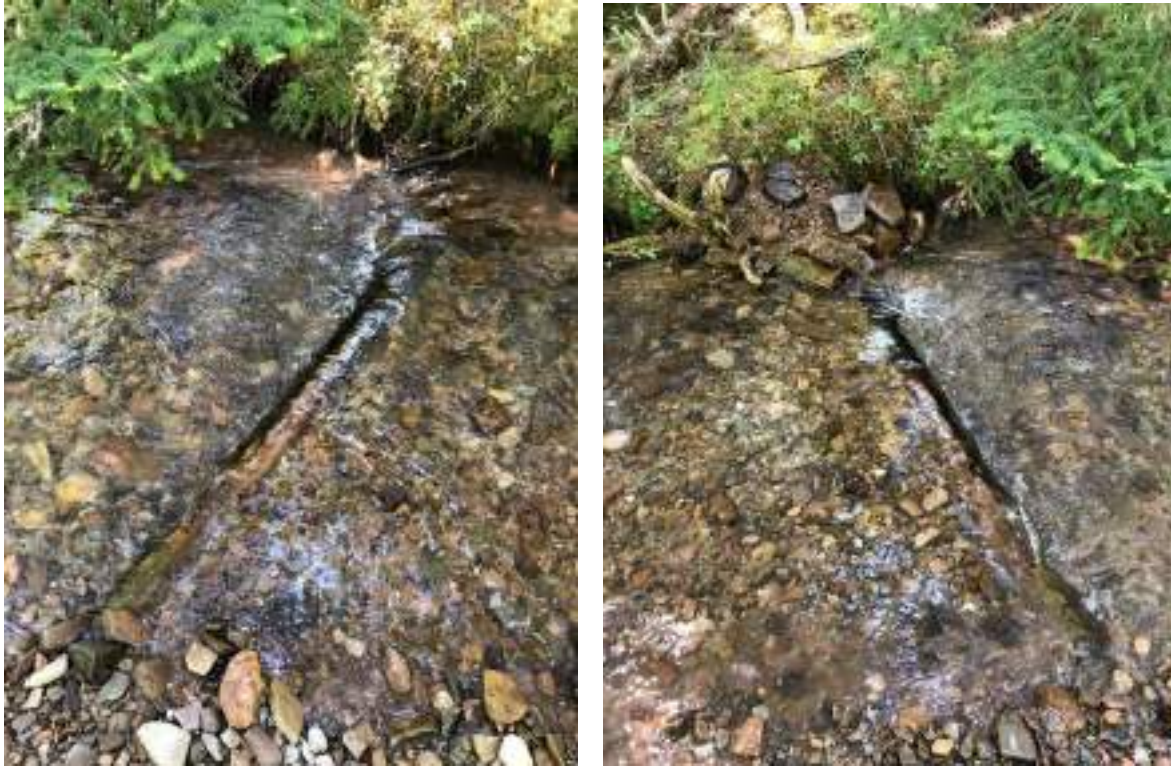
Figure 135. Before and after picture of the maintenance performed on digger log #41.

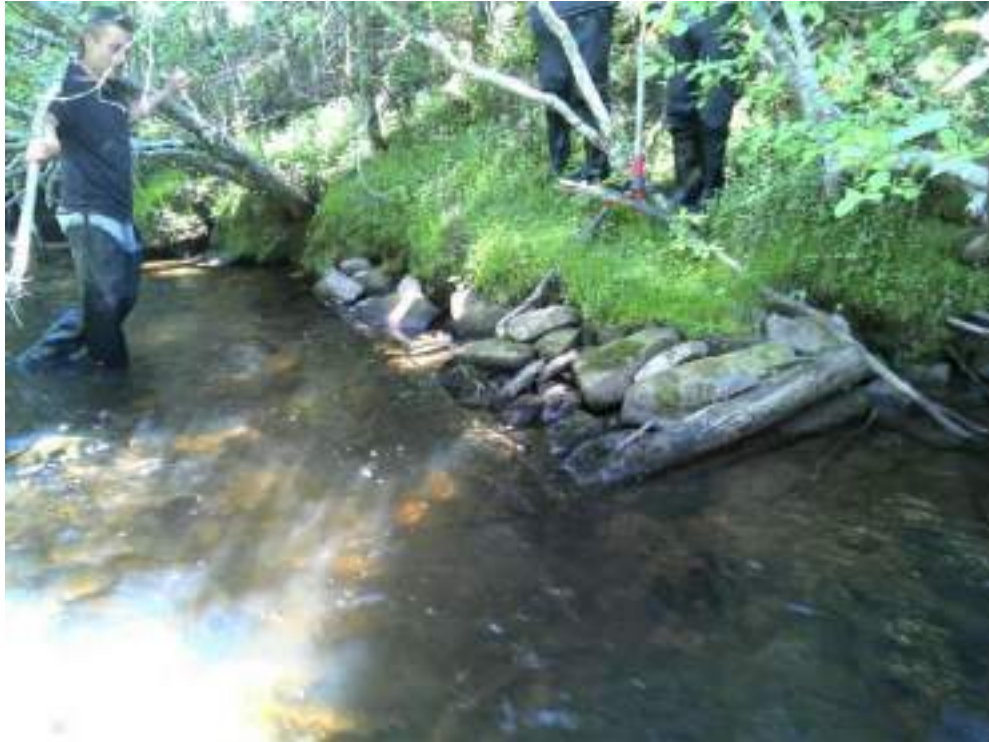
Figure 138. Before and after pictures of the maintenance performed on the furthest upstream structure - Deflector #1.

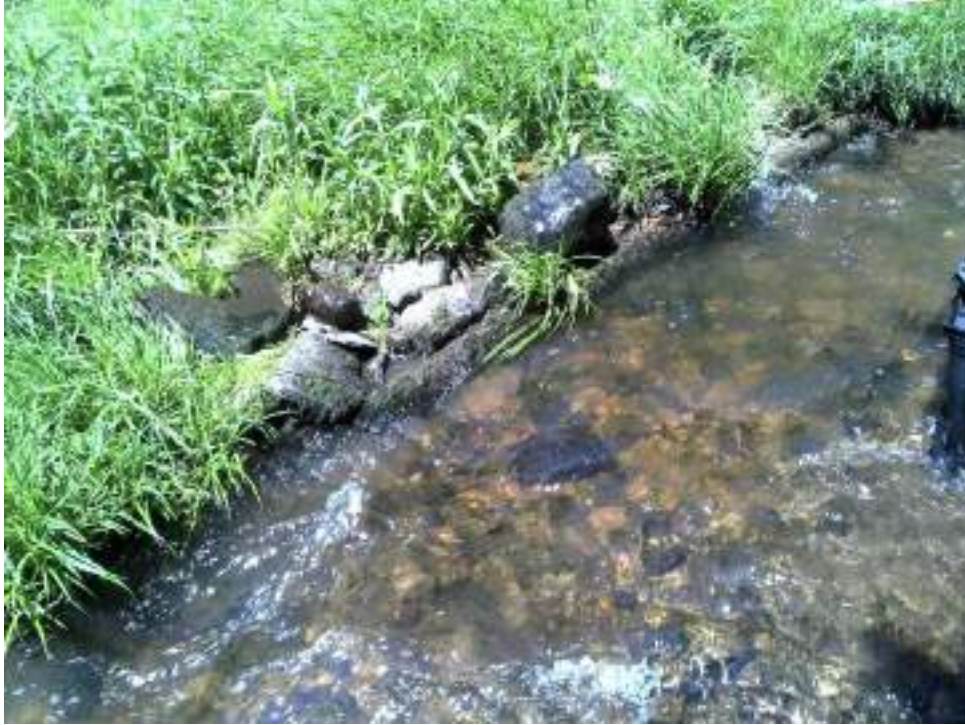
Figure 139. Before and after pictures of maintenance performed on deflector #2.

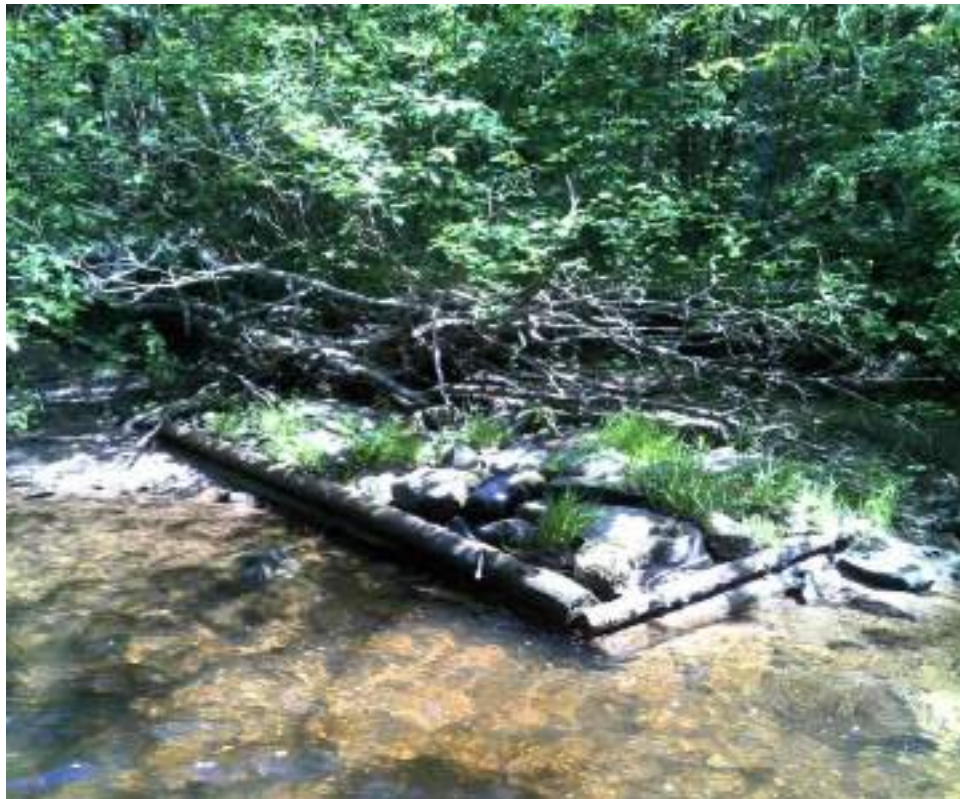
Figure 140. Before and after picture of the maintenance performed on deflector #3.

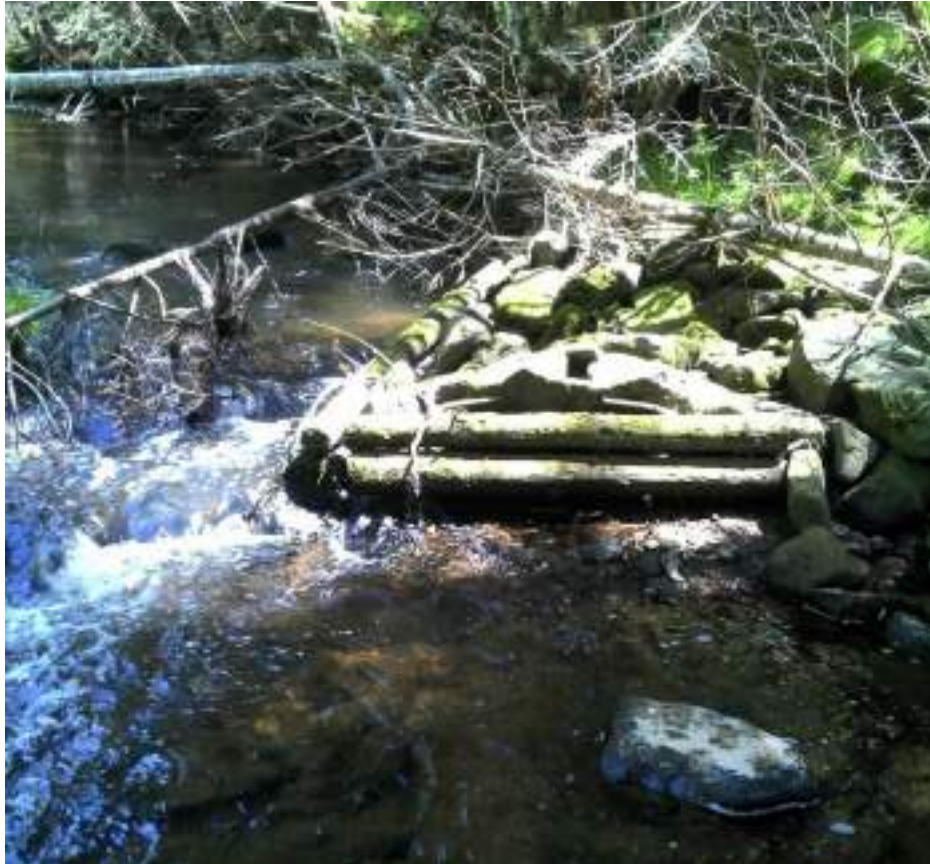
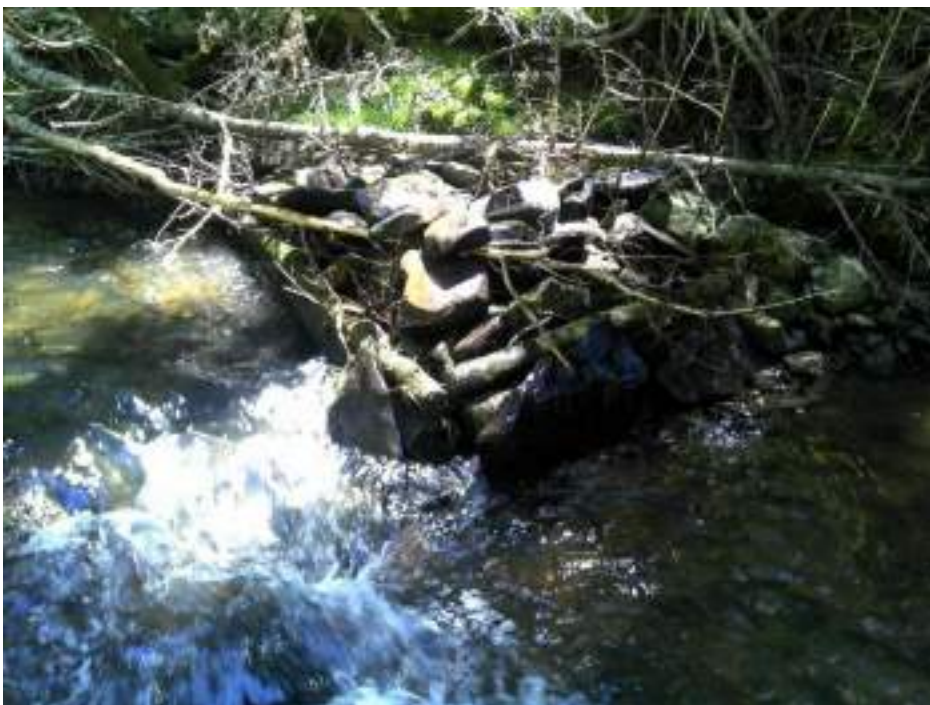
Figure 141. Before and after picture of the maintenance performed on deflector #4.

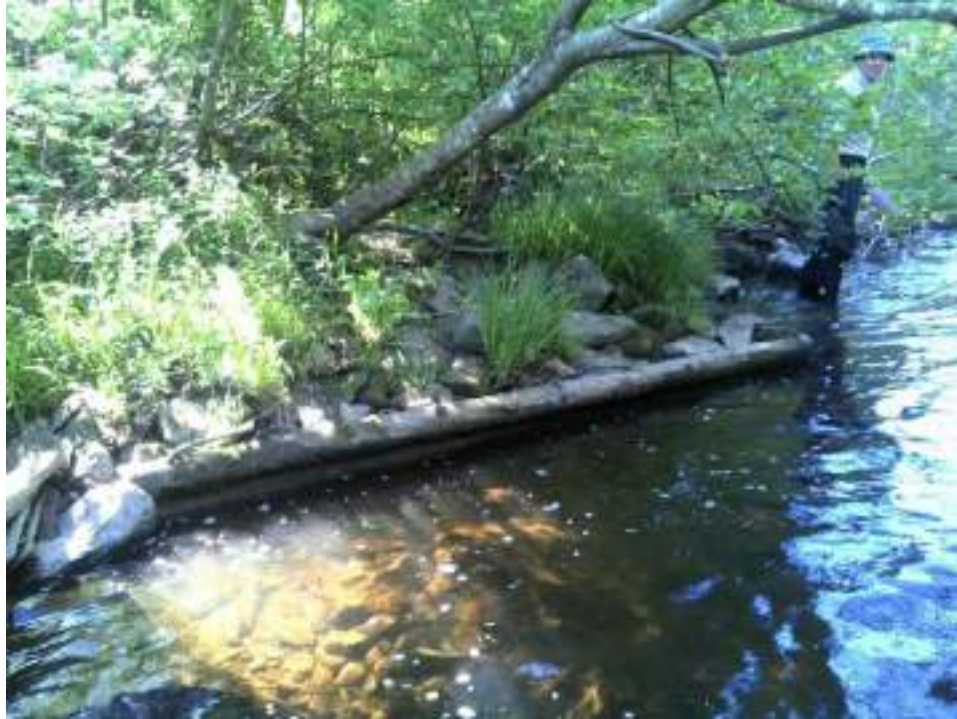
Figure 145. Deflector #8 - before and after picture of maintenance performed.

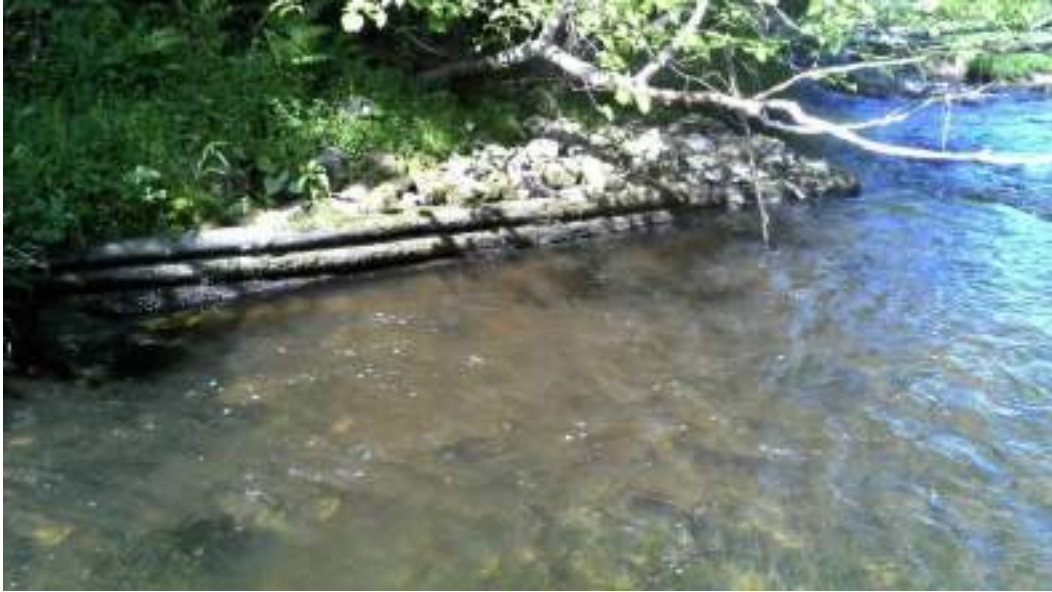
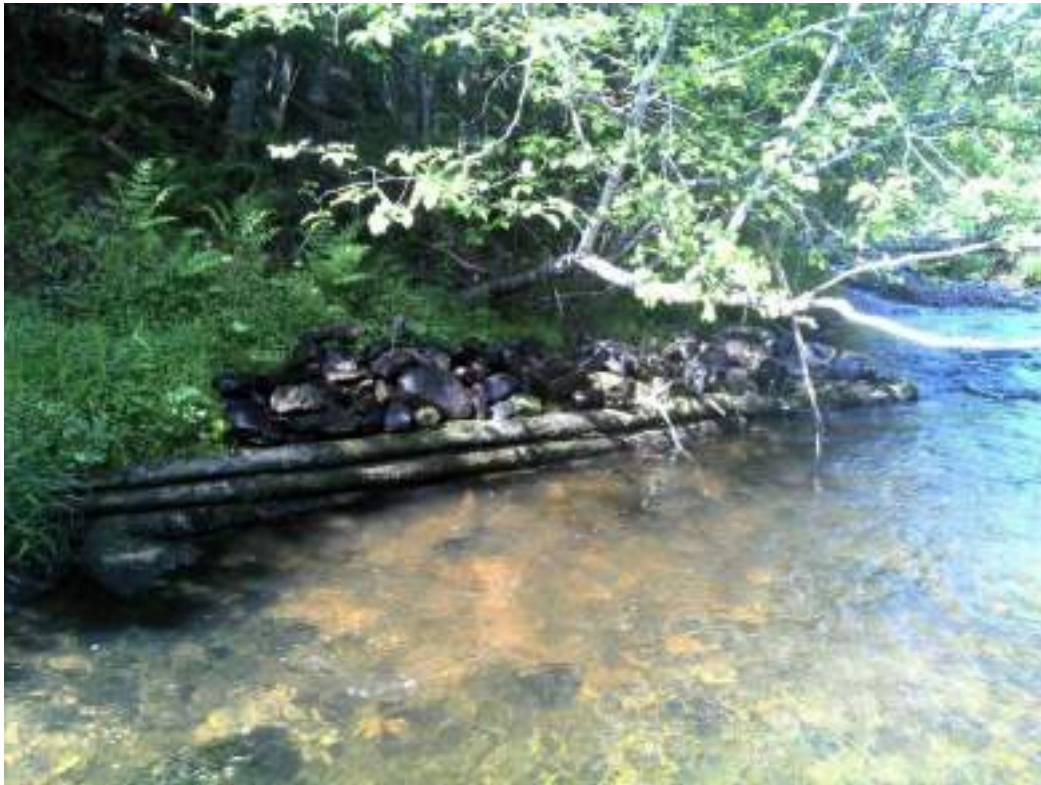
Figure 147. Deflector #10 - before and after pictures of maintenance performed.

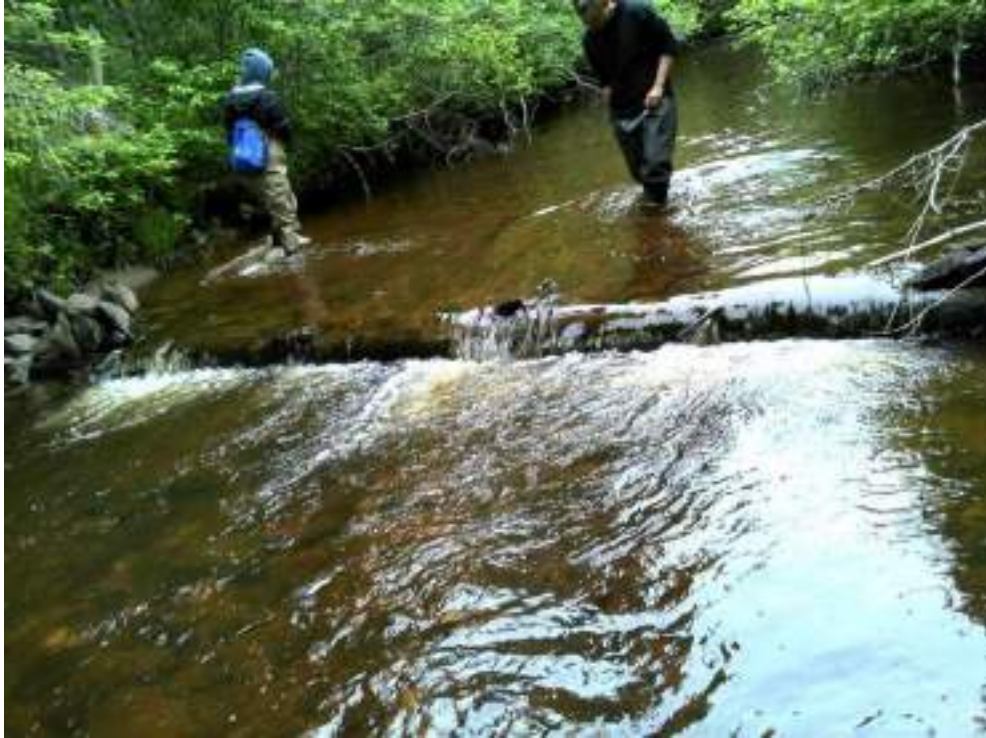
Figure 149. Diggerlog #1 - before and after picture of maintenance performed.

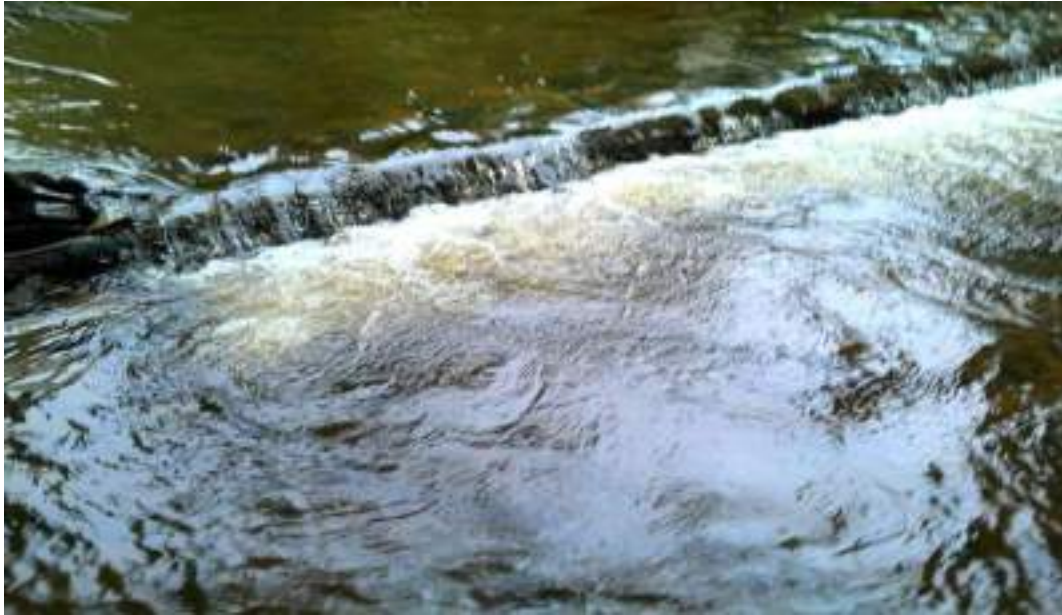
Figure 150. Diggerlog #2 – before and after picture of maintenance performed.

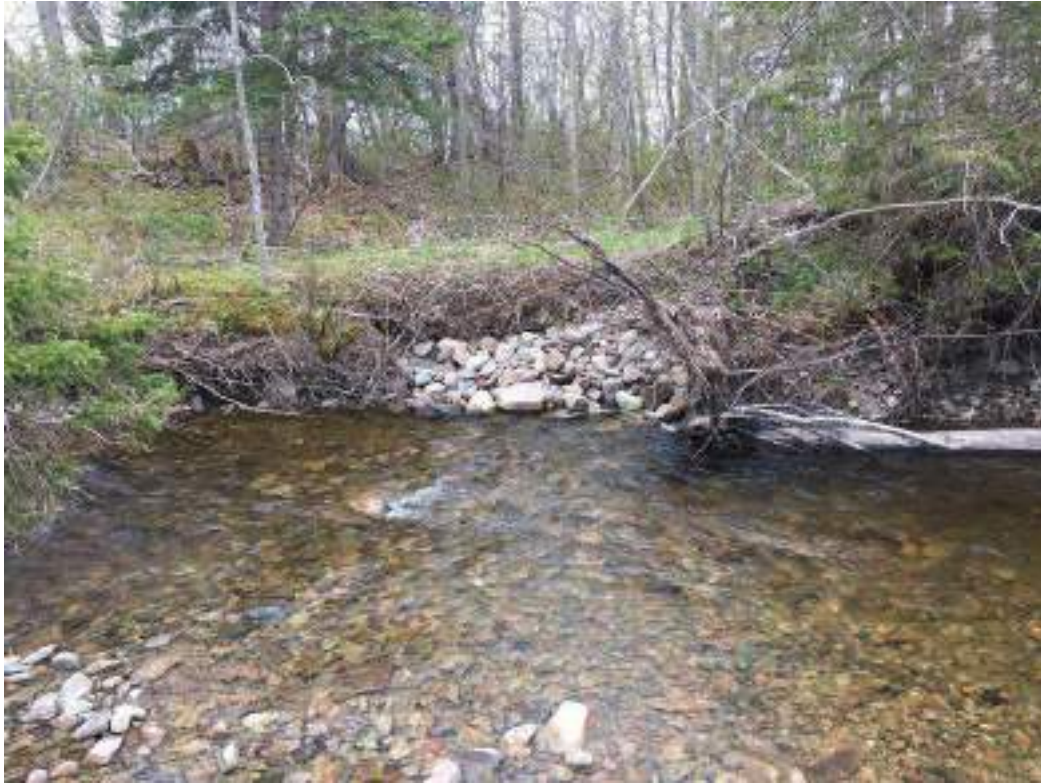
Figure 187. Structure #2 Bank Rock - before and after pictures of the completed maintenance.

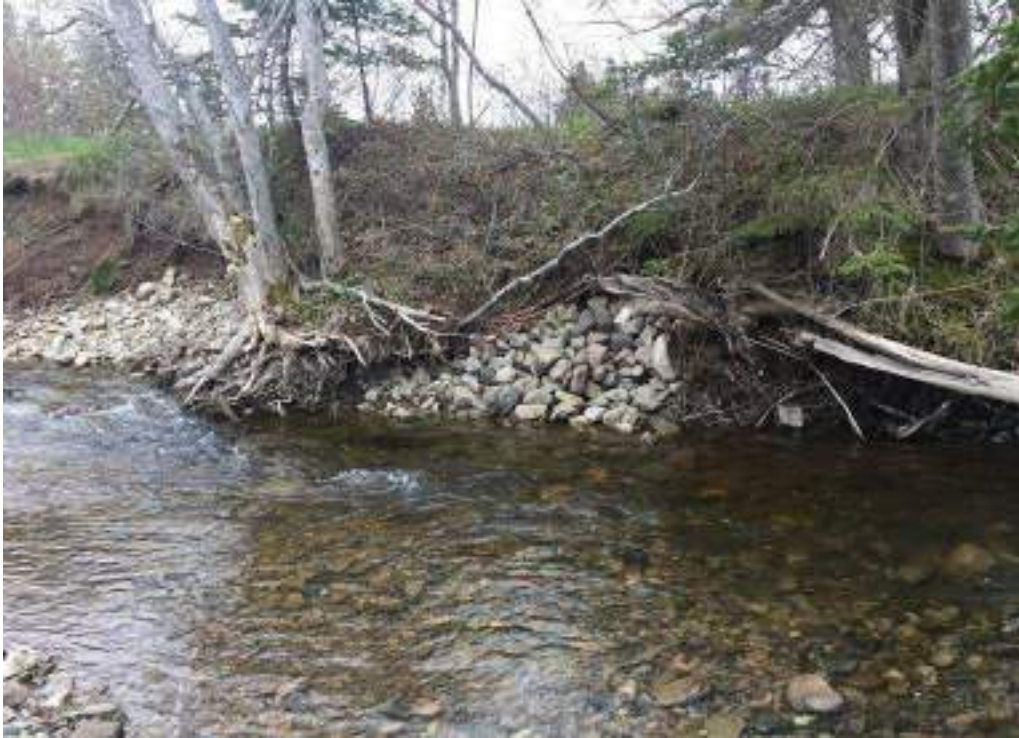
Figure 188. Structure #3 Bank Rock - before and after pictures of completed maintenance.

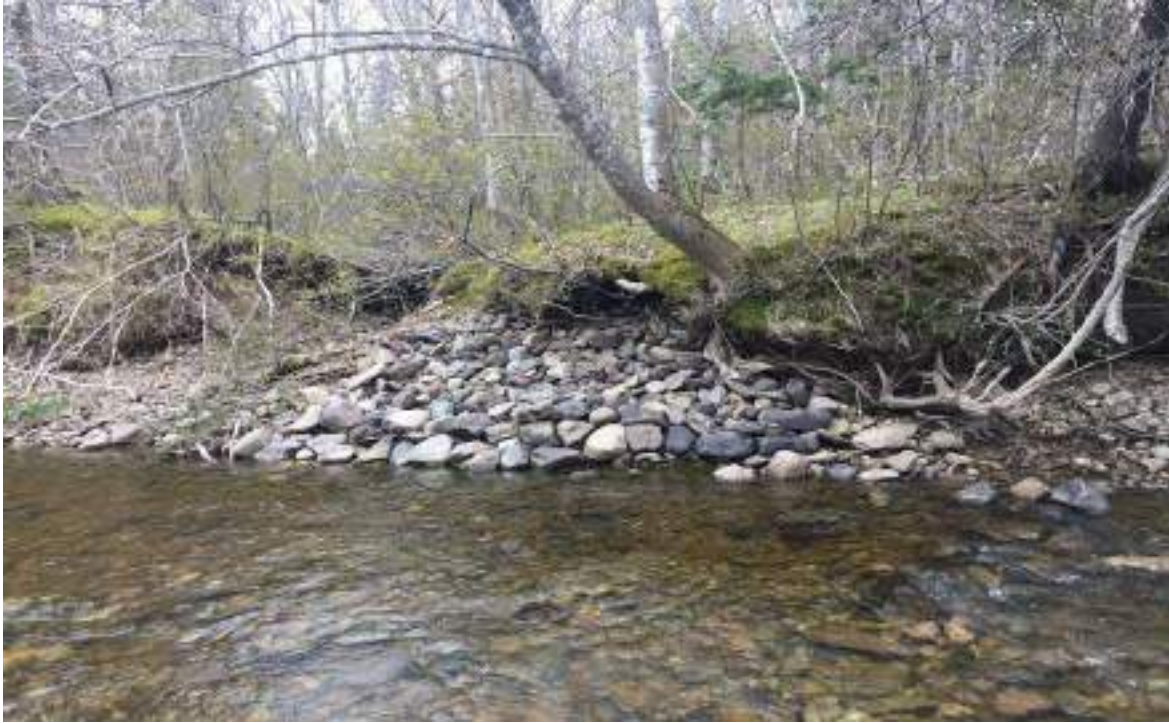
Figure 189. Structure #4 Bank Rock - before and after pictures of completed maintenance.

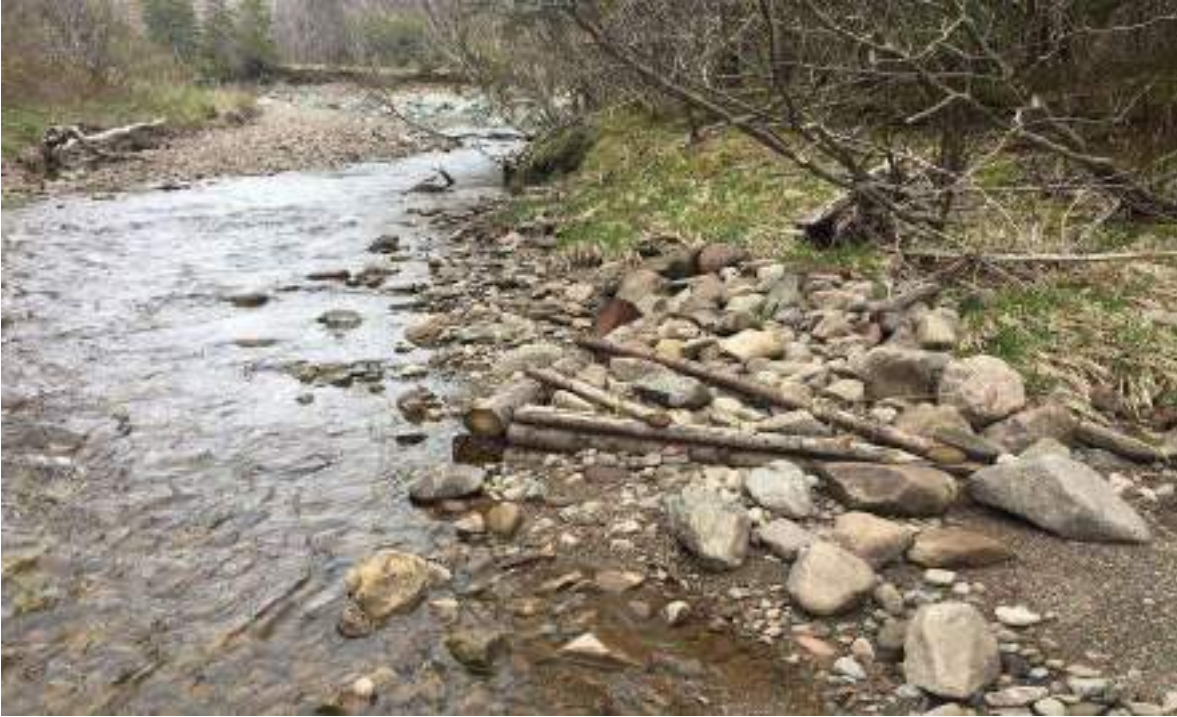
Figure 190. Structure #5 Deflector - before and after pictures of completed maintenance.

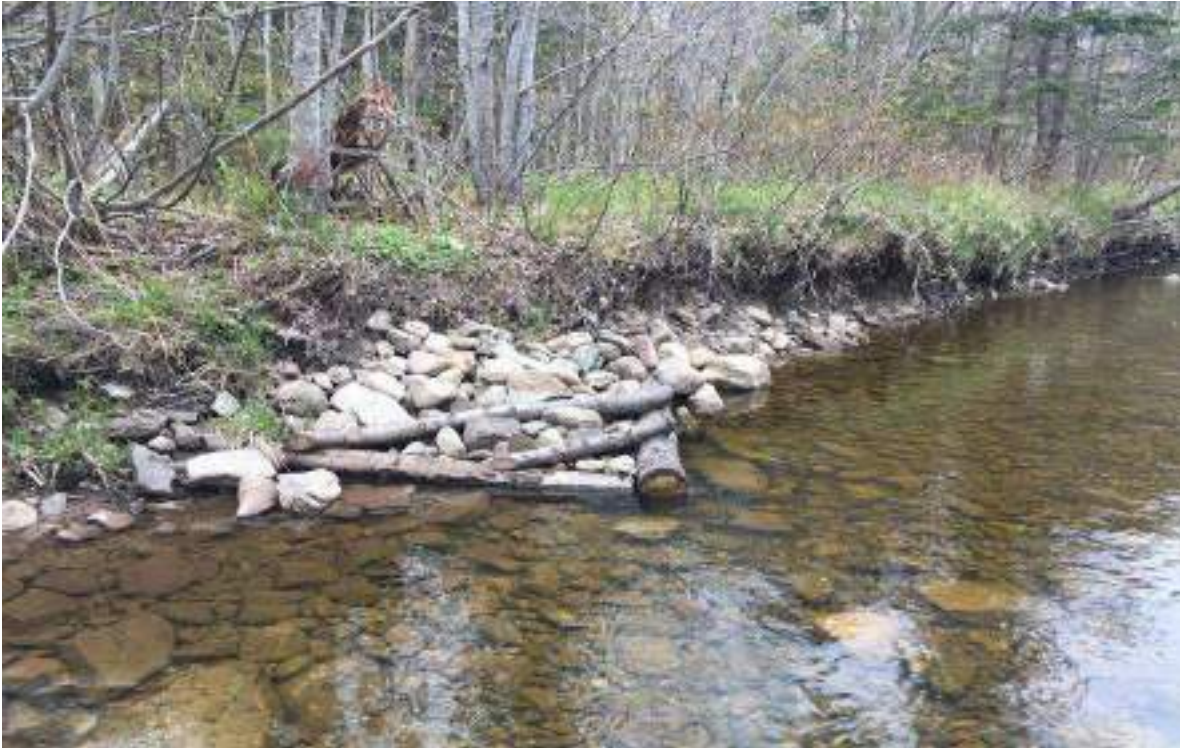
Figure 191. Structure #6 - before and after picture of completed maintenance.

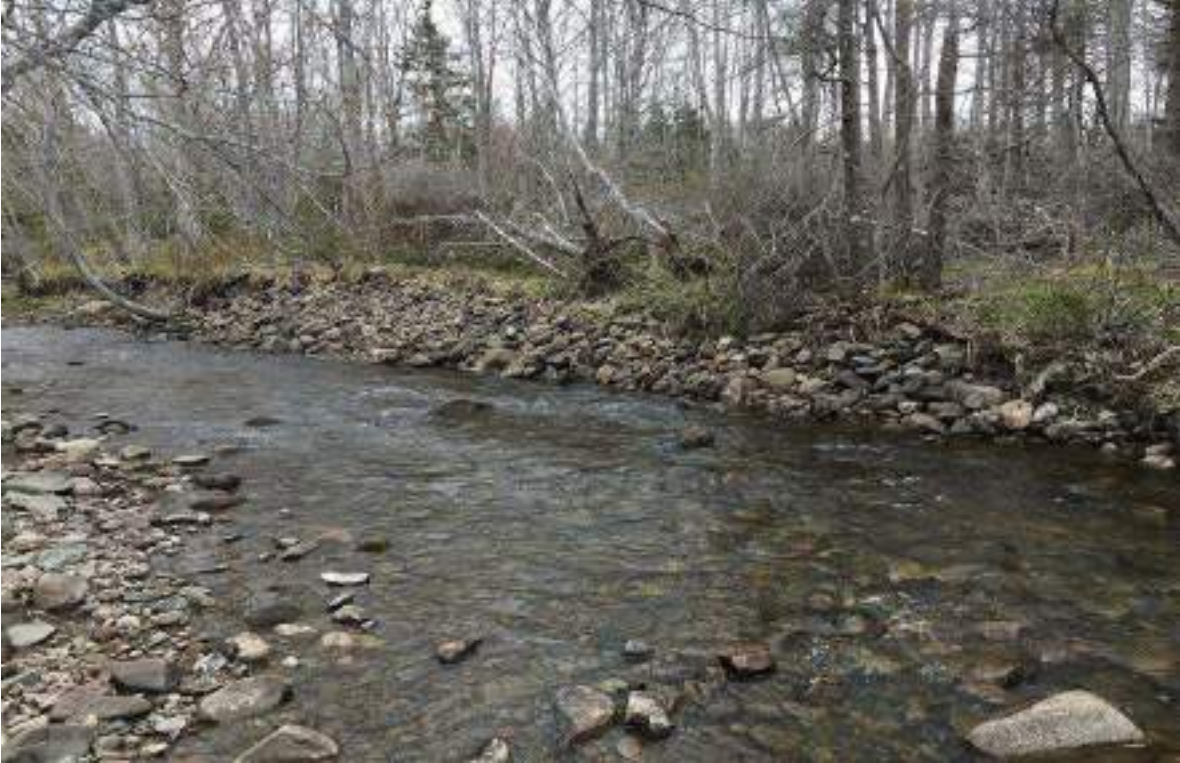
Figure 201. Structure #15 Bank Rock - before and after pictures of completed maintenance.

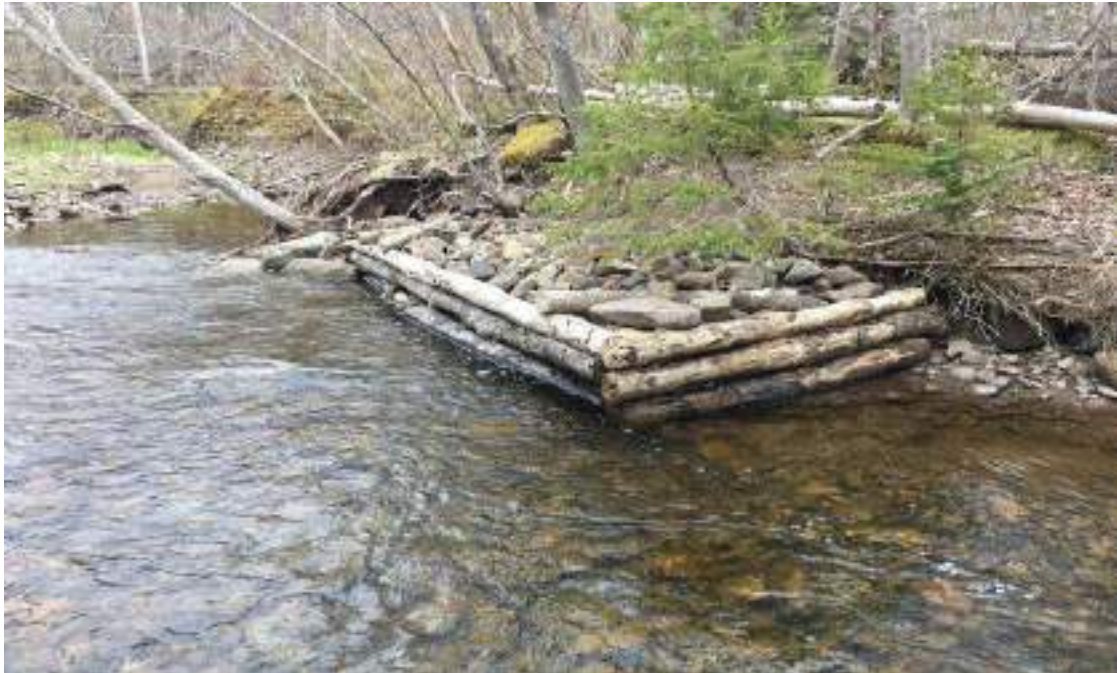
Figure 204. Structure #18 Armour Stone - bank stabilization.

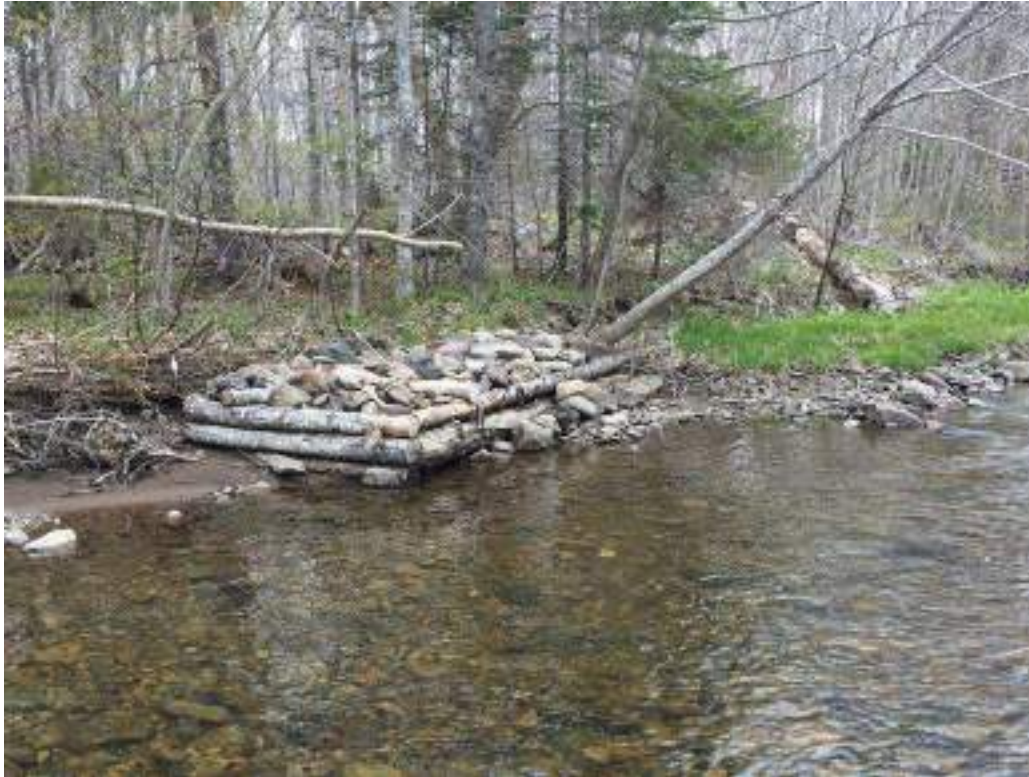
Figure 207. Structure #21 Deflector - before and after pictures of completed maintenance.

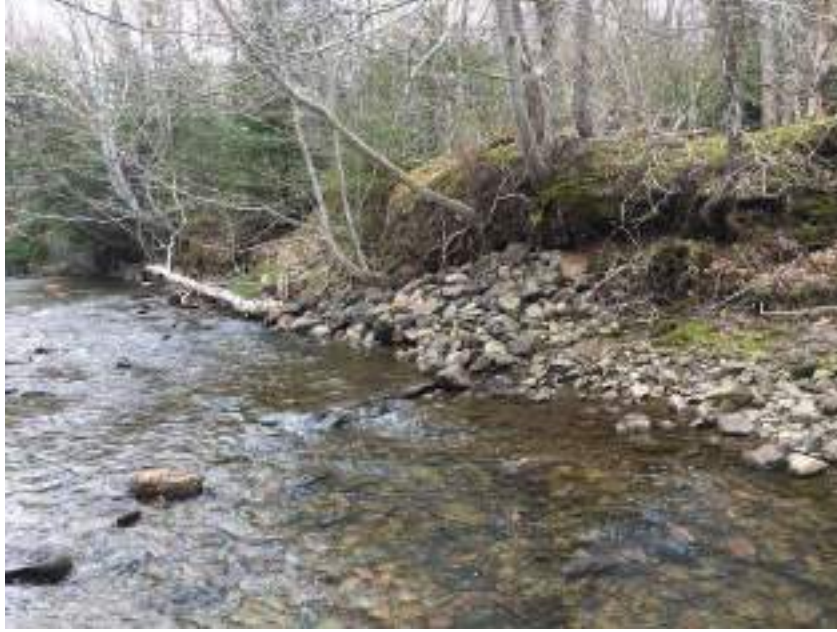
Figure 208. Structure #22 Bank Rock - before and after picture of completed maintenance.

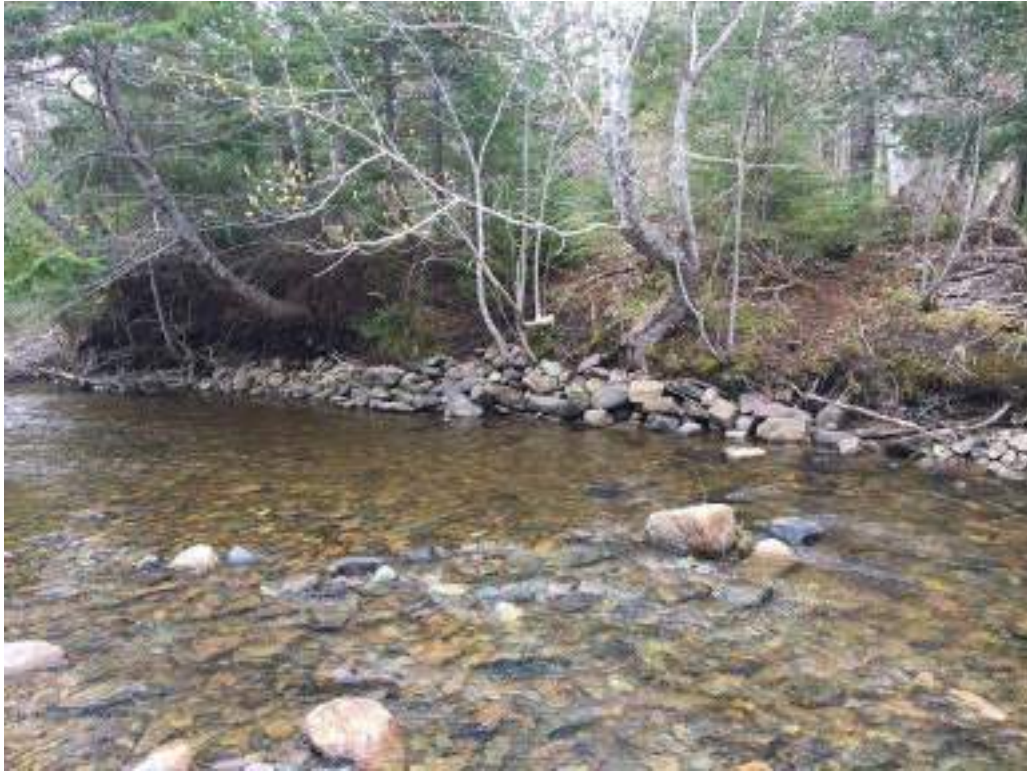
Figure 209. Structure #23 Bank Rock - before and after picture of completed maintenance.

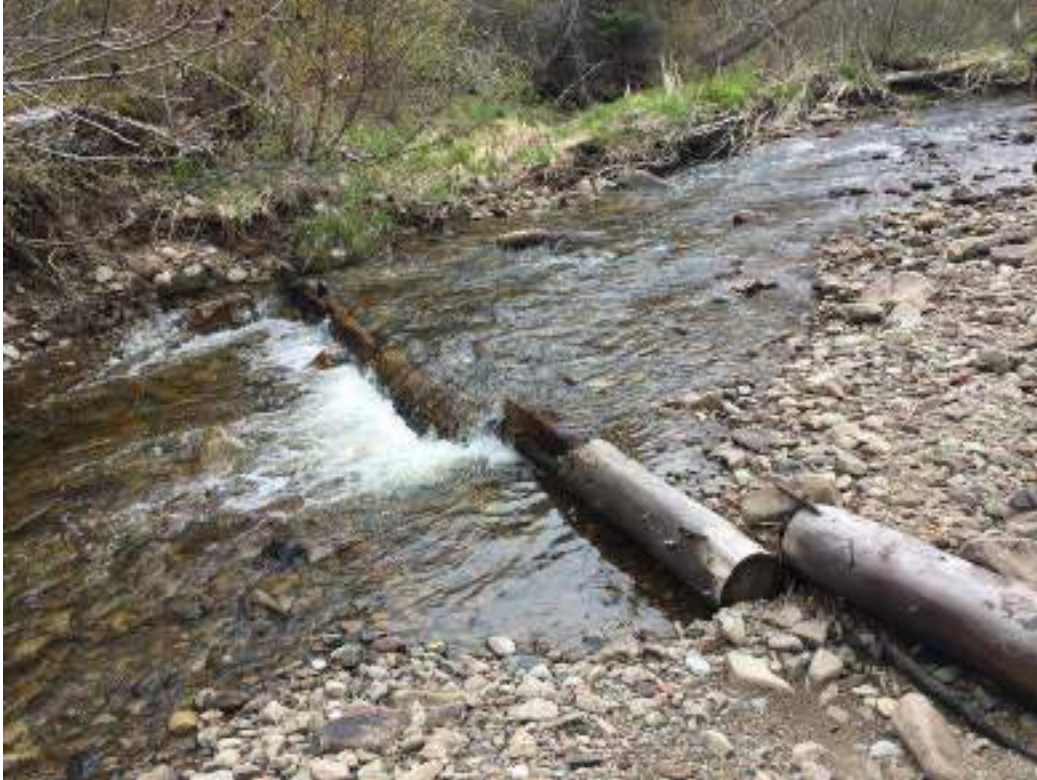
Figure 210. Structure #24 Diggerlog - before and after picture of completed maintenance. This log was cut in half during installation due to its weight.

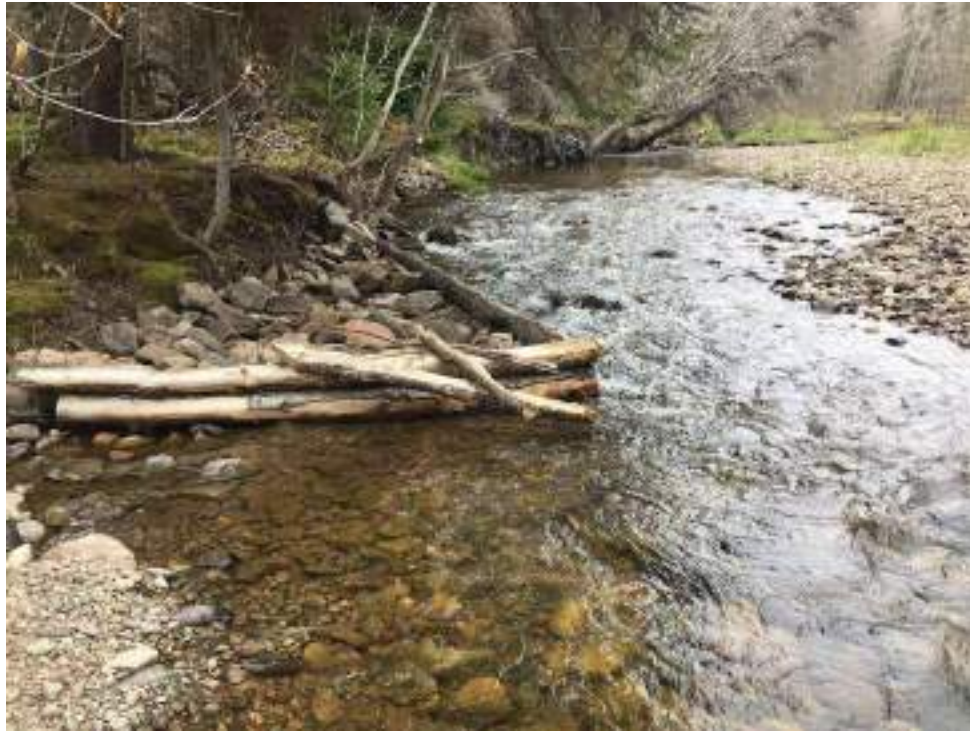
Figure 211. Structure #25 Deflector - before and after picture of completed maintenance.
