SALMONID HABITAT RESTORATION
INVERNESS SOUTH ANGLERS ASSOCIATION

Winter Damage Assessment

Date: 2019

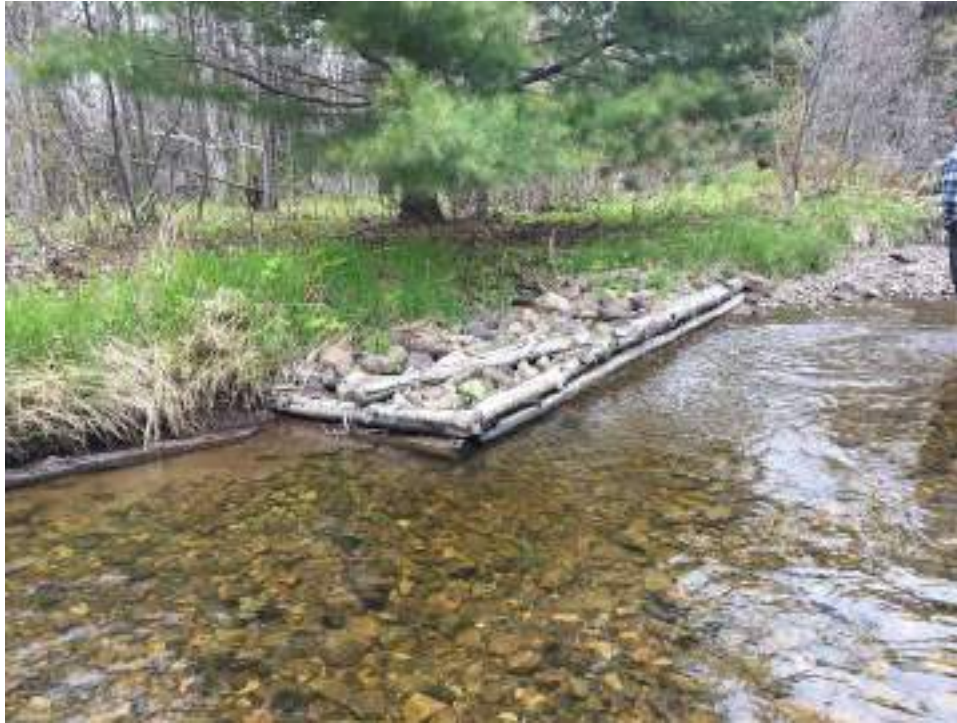
Figure 213. Structure #27 Deflector - before and after picture of completed maintenance.

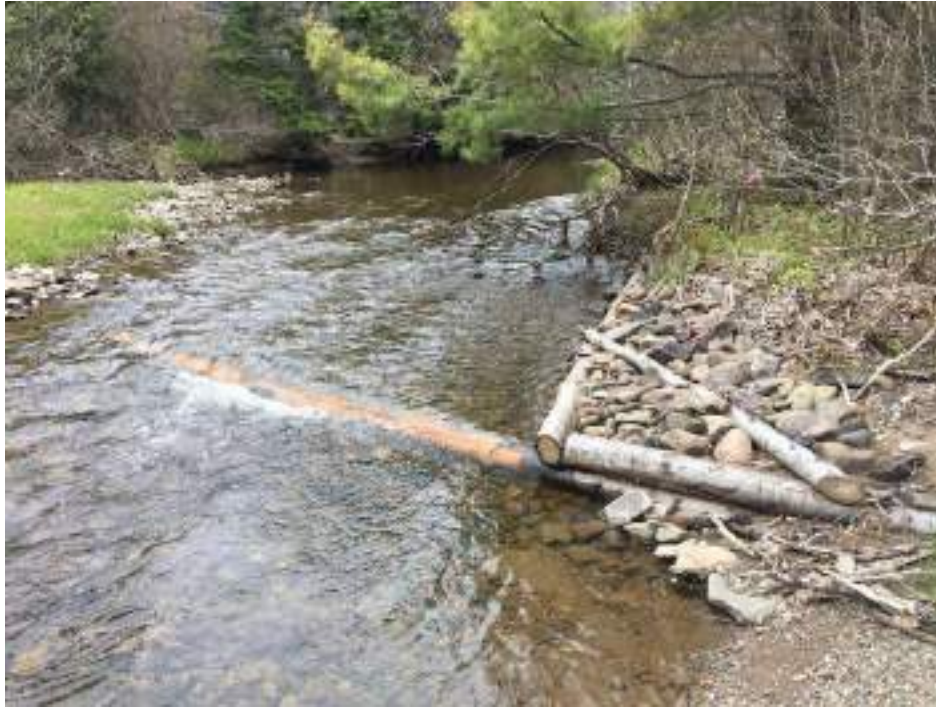
Figure 215. Structure #29 Diggerlog and Deflector - before and after picture of completed maintenance. (water levels are high in the after photo)

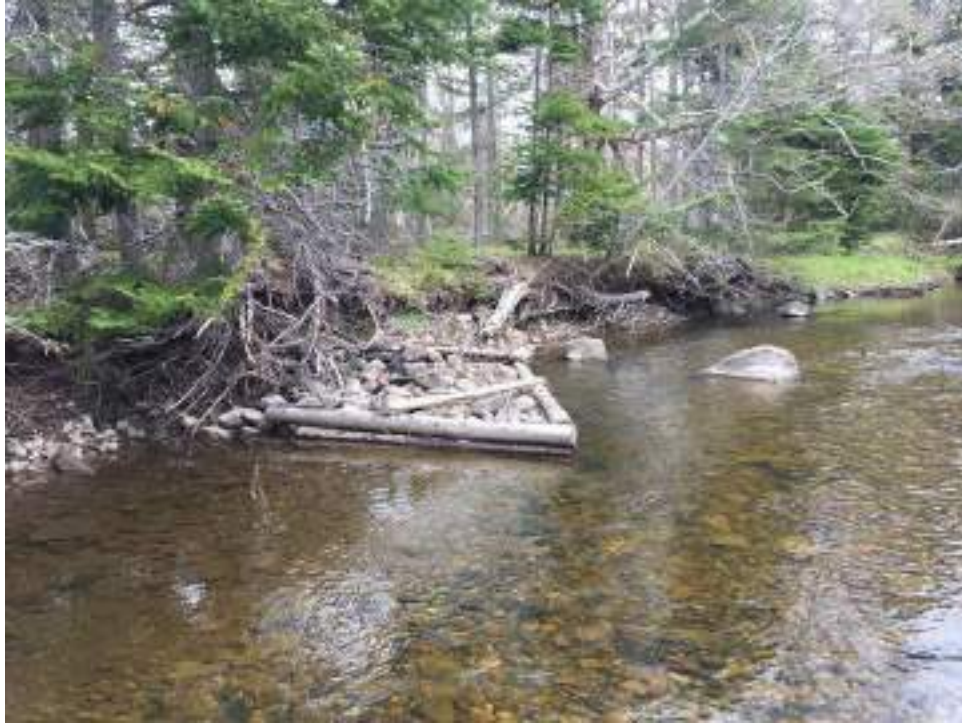
Figure 216. Structure #30 Deflector - before and after picture of completed maintenance.

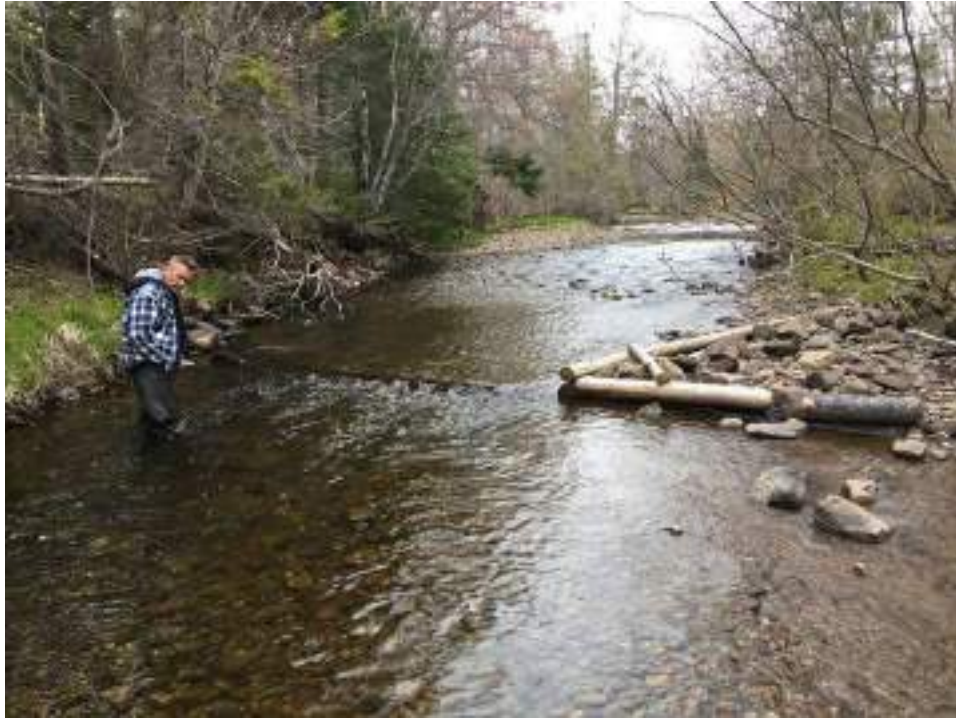
Figure 217. Structure #31 Diggerlog and Deflector - before and after picture of completed maintenance.

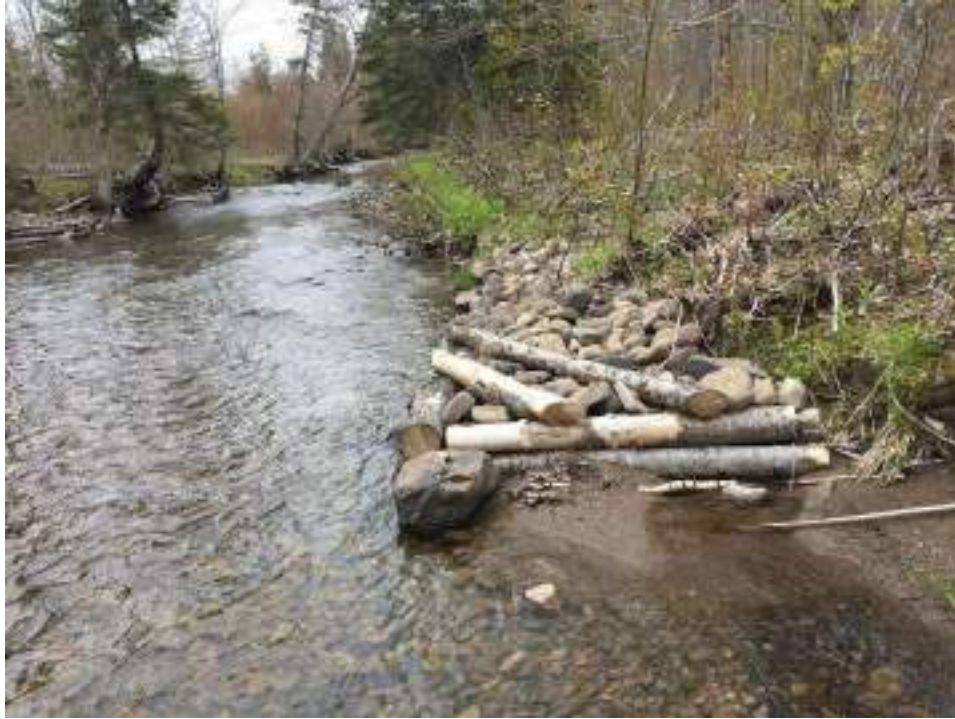
Figure 218. Structure #32 Deflector - before and after picture of completed maintenance.

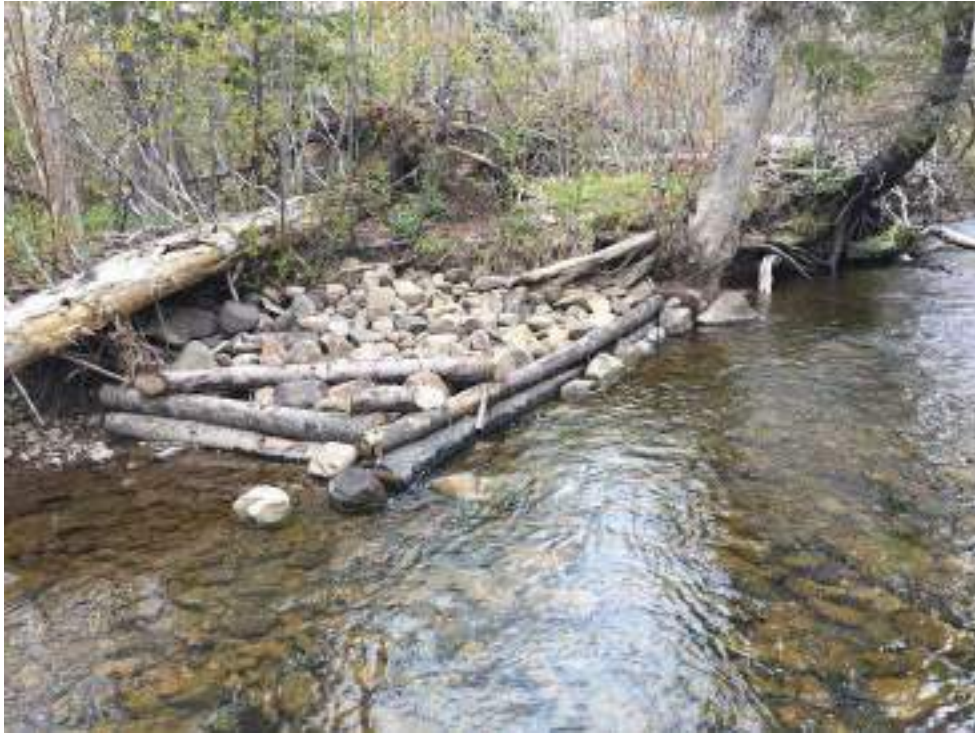
Figure 219. Structure #33 Deflector - before and after picture of completed maintenance.

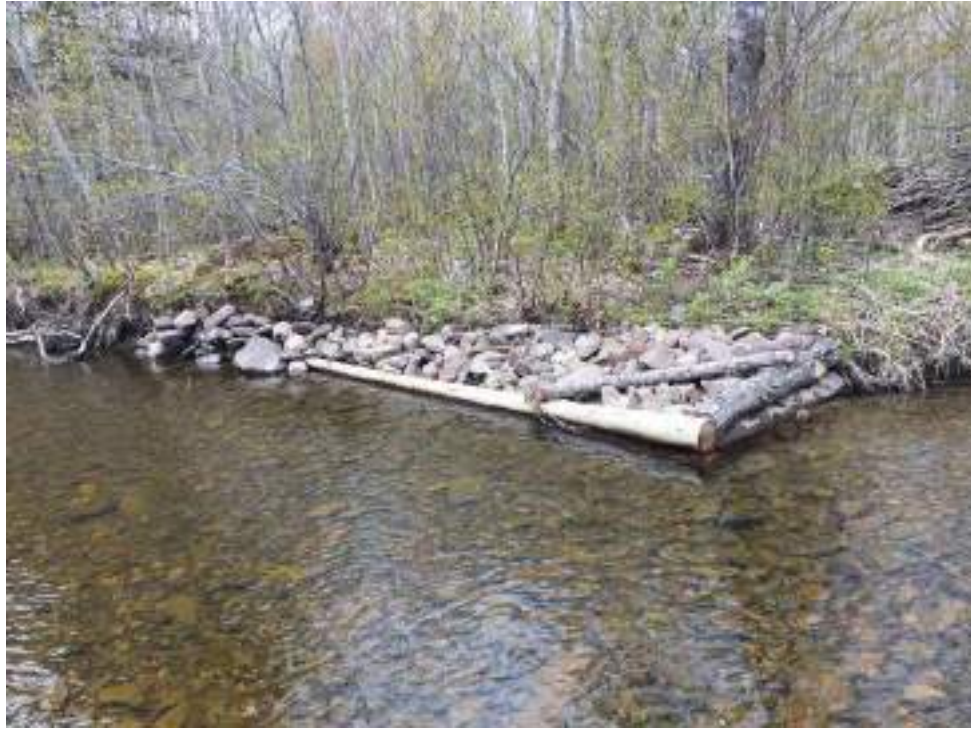
Figure 220. Structure #34 Deflector - before and after picture of completed maintenance.

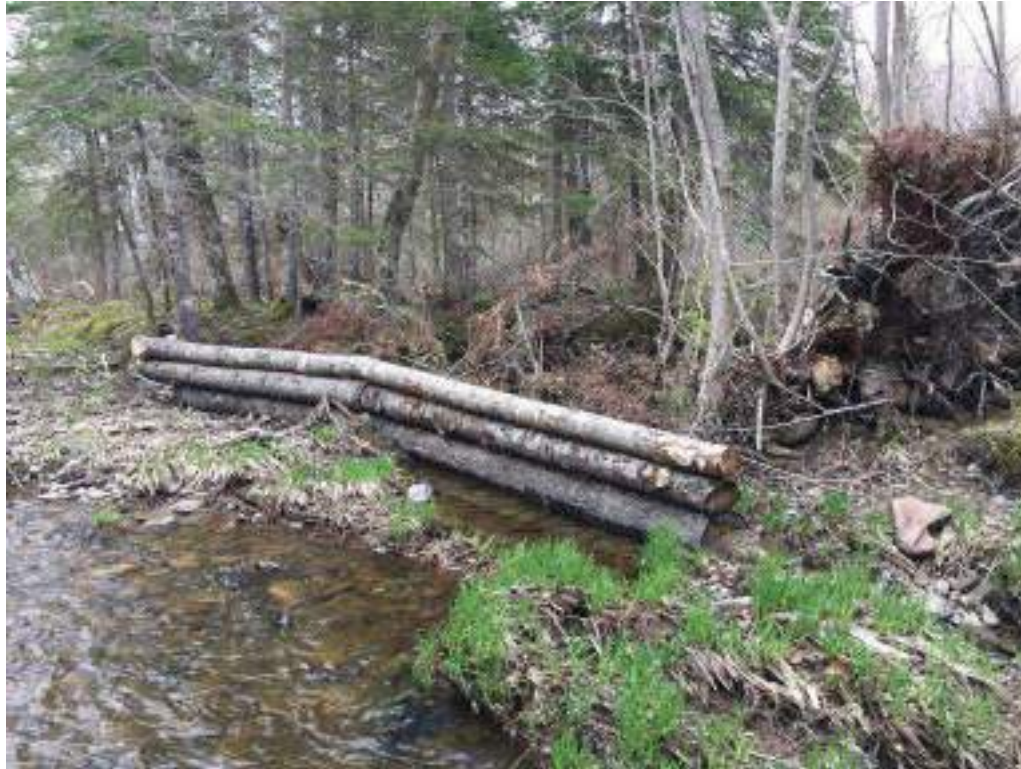
Figure 221. Structure #35 Channel Blocker - no maintenance required.

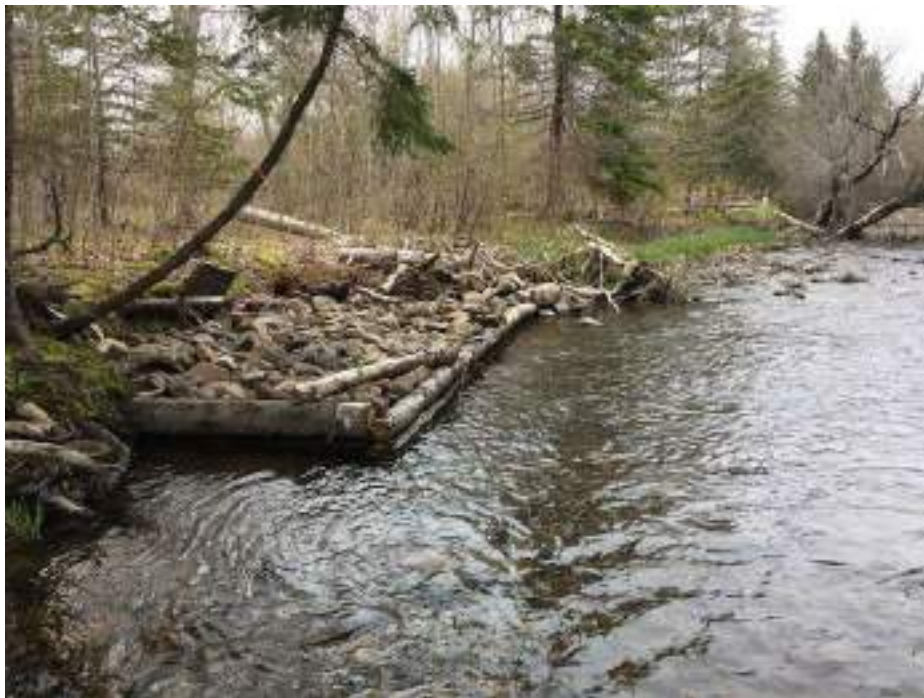
Figure 223. Structure #37 Deflector - before and after pictures of completed maintenance.

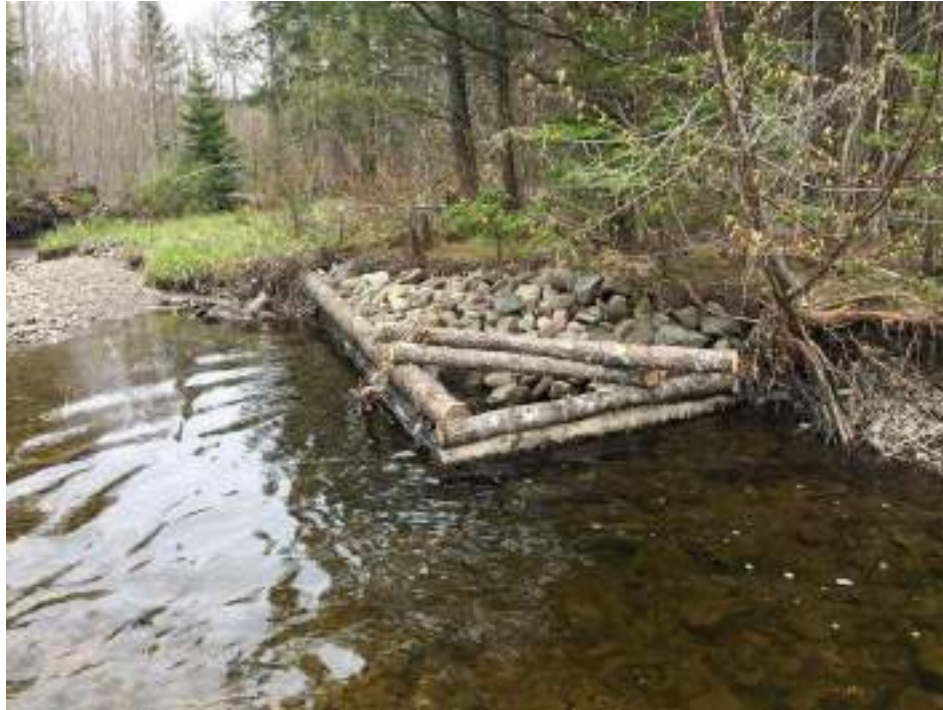
Figure 224. Structure #38 Deflector - before and after picture of completed maintenance.

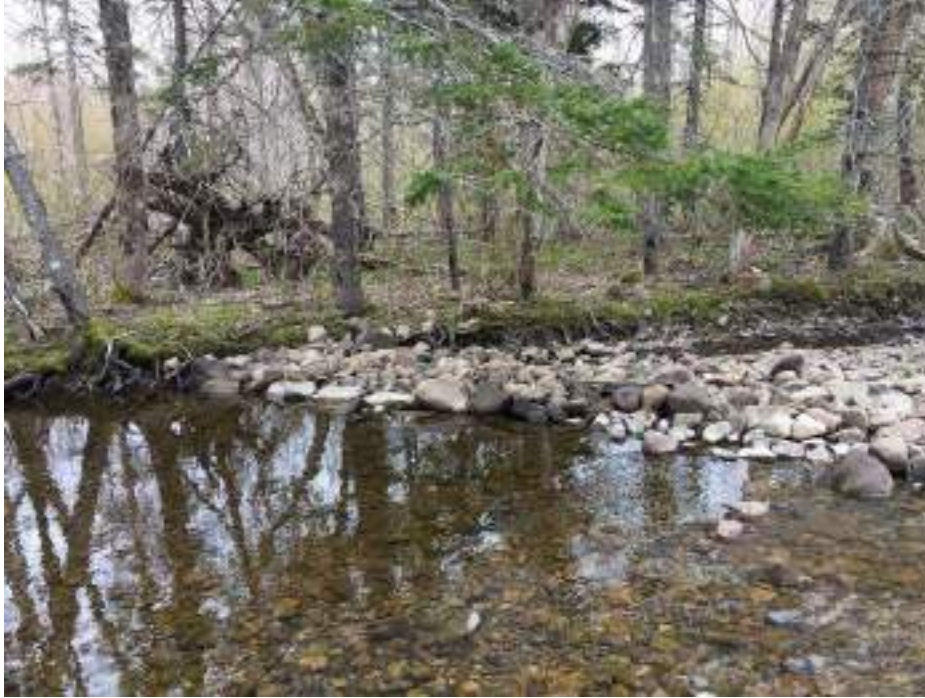
Figure 225. Structure #39 Channel Blocker constructed with rocks - before and after pictures of completed maintenance.

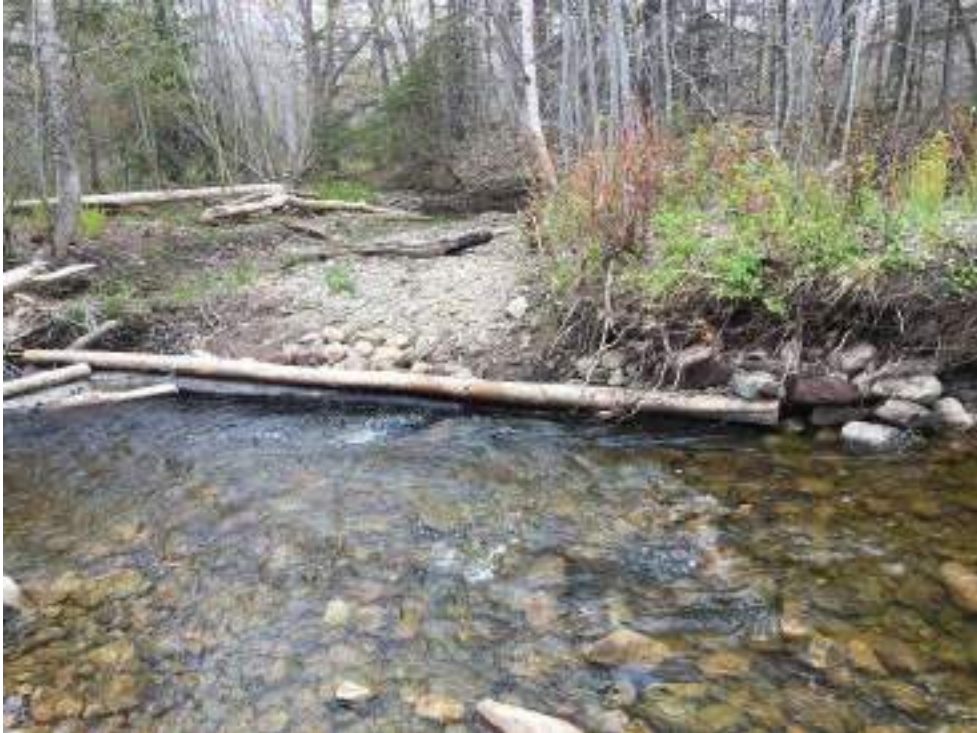
Figure 227. Structure #41 Two Tier Channel Blocker - before and after picture of completed maintenance.

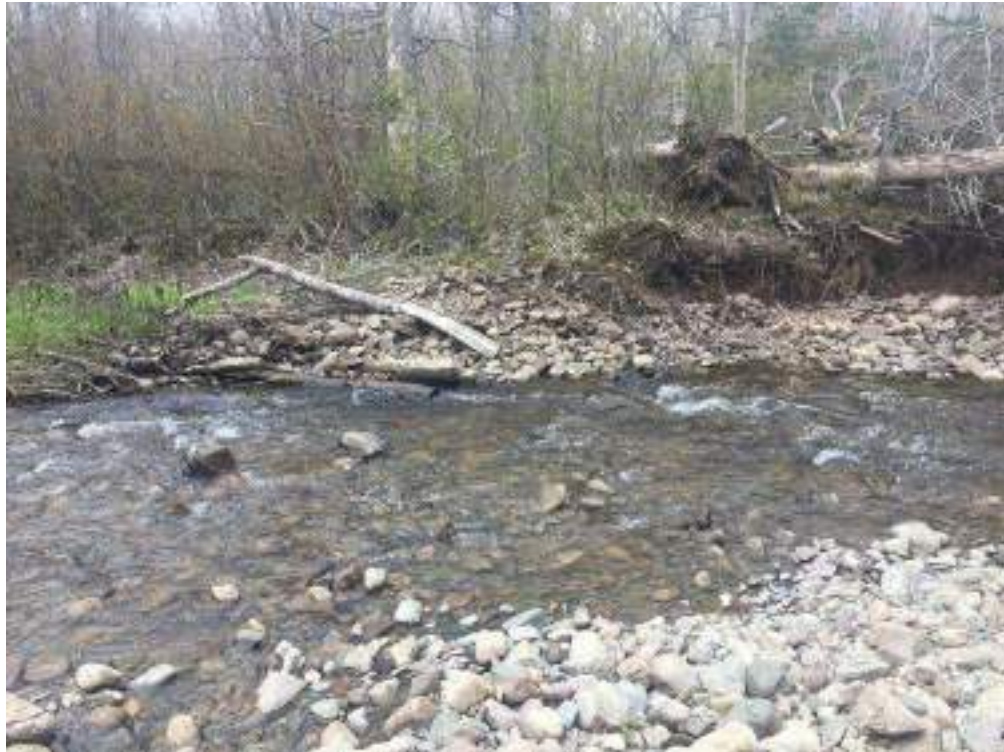
Figure 228. Structure #42 Bank Rock

The photos below show the upstream structures from MacDonald Bridge on Campbells Road. No maintenance was done due to the poor condition of the structures. Bank rock remained in good condition, but the deflector structures had blown out over the winter months due to them not being braced in by logs and rebar. Each deflector and rock sill will require a full rebuild.

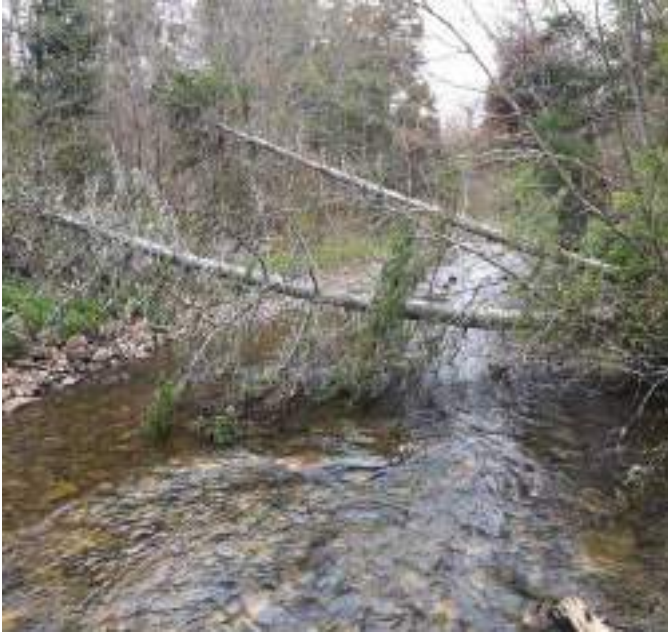
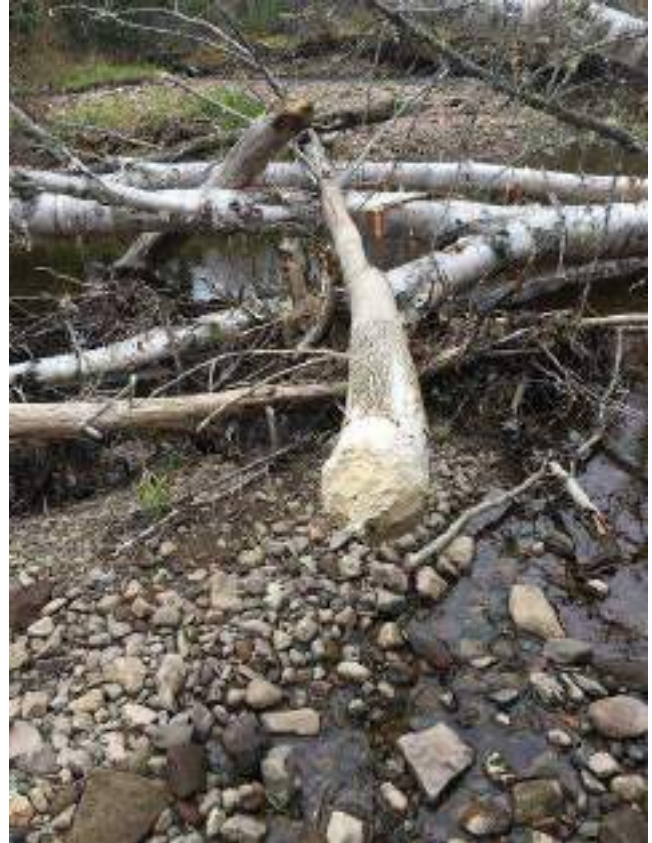
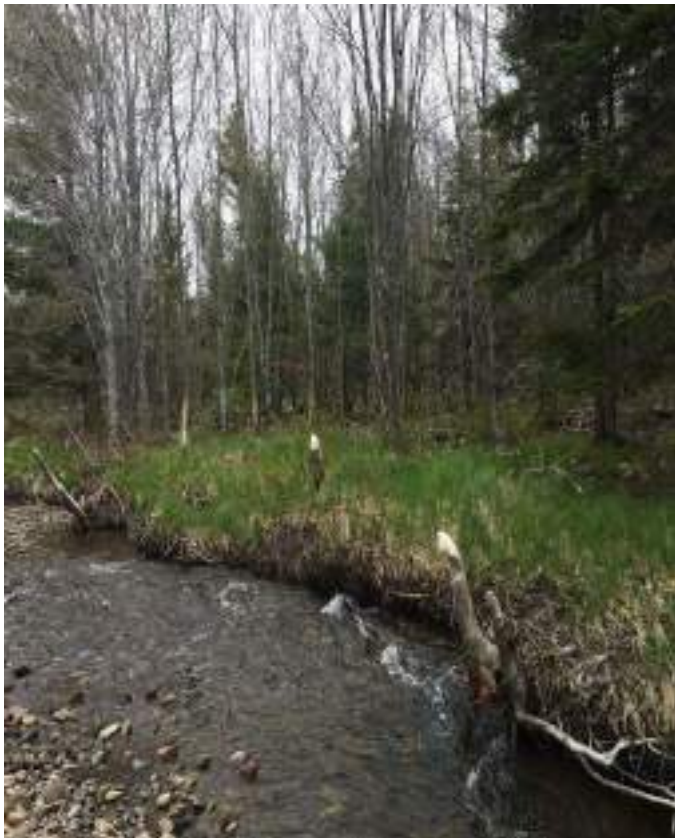
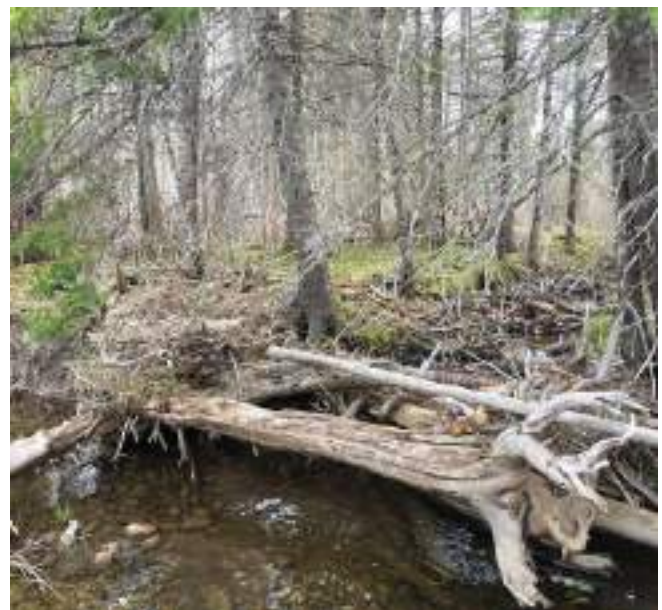
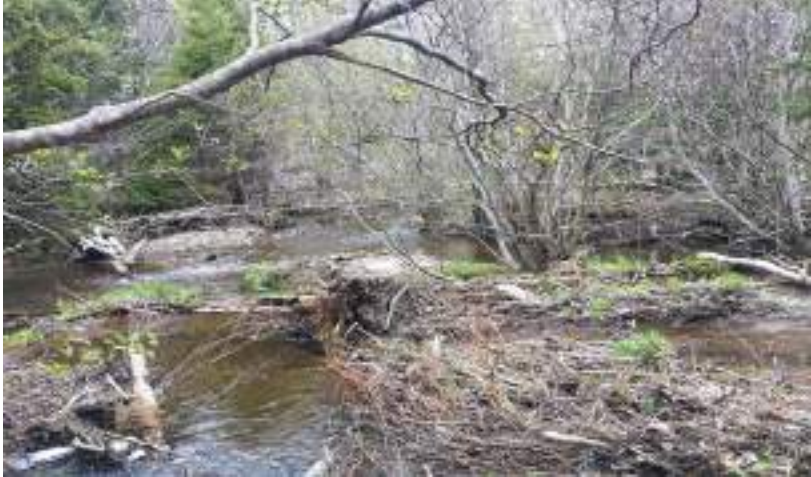
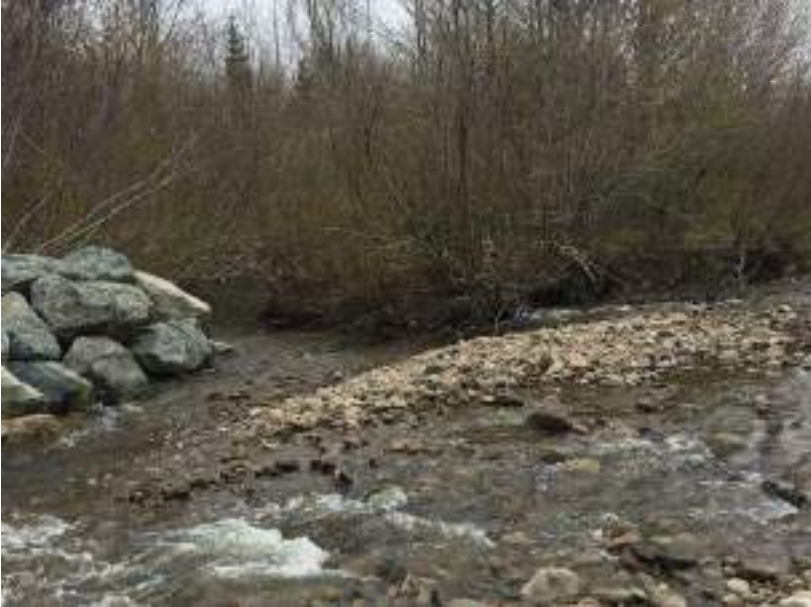
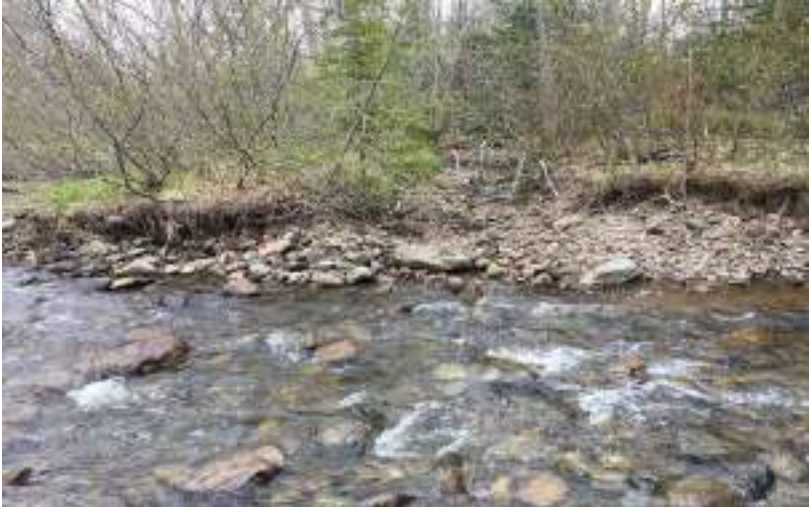
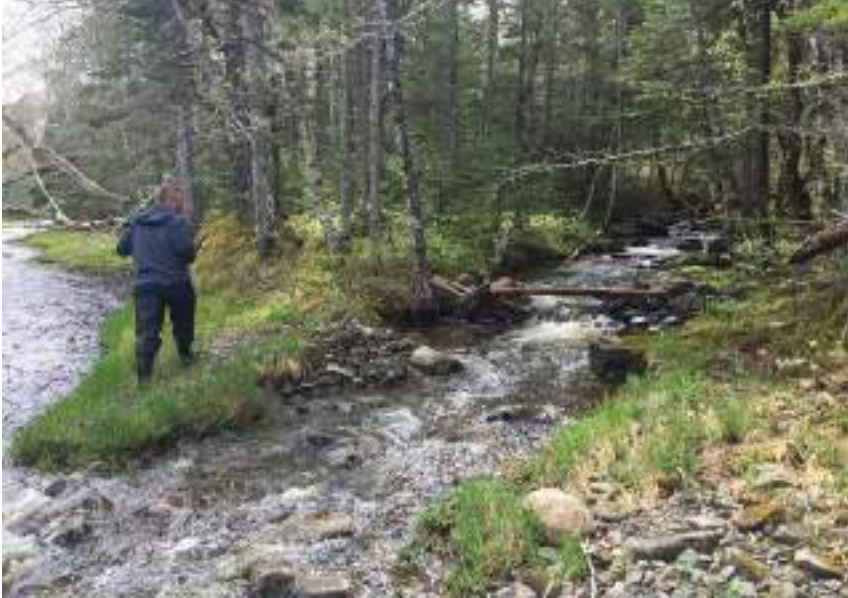
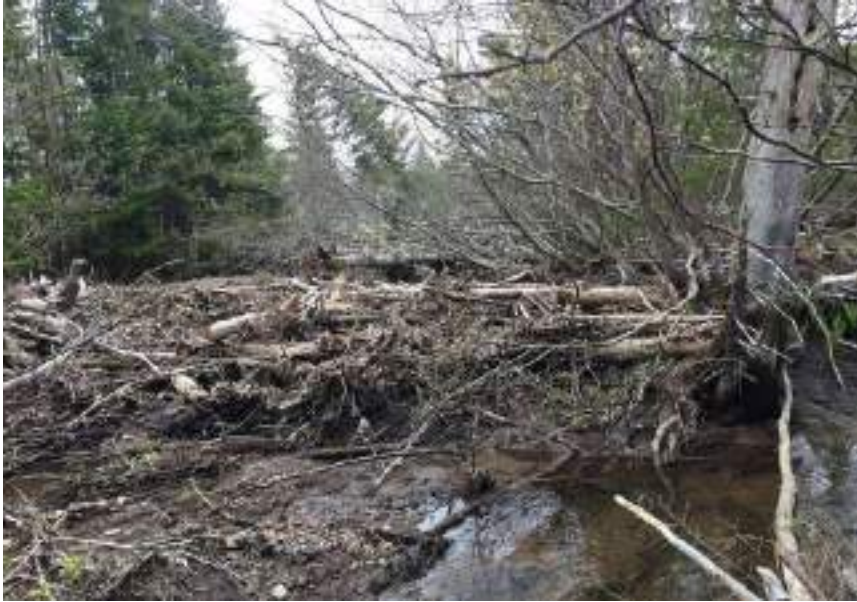
Other Photos:

Photos taken of debris jams, cut trees and remnants of beaver dams, tributaries and braiding.
